# Concession of TRIM B-Network in the Eastern Region

Online Site Visit

29 June 2026

**Rosemead - Klipplaat - Uitenhage Branch Line.**

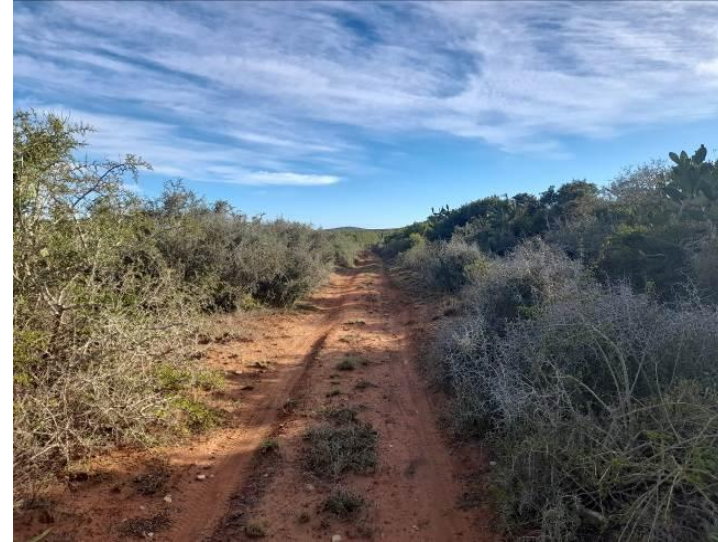
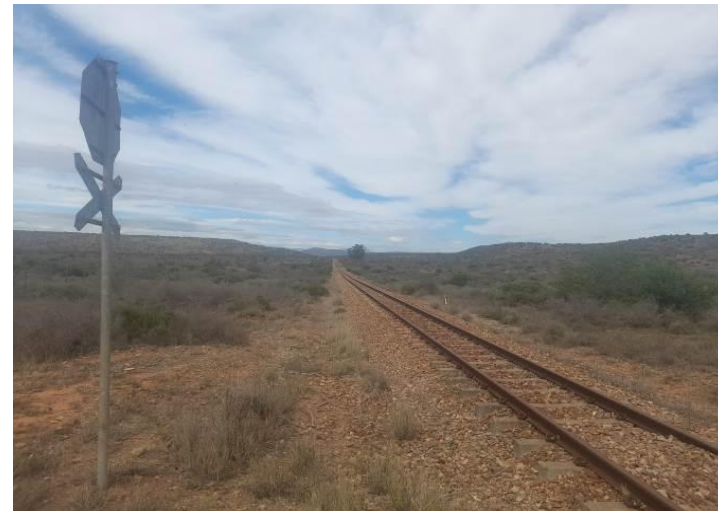
Access to the railway line is done via access roads which ideally run parallel to the railway line. It has been observed that these require attention to improve maintenance inspection capabilities. The roads have not been used for some time and are encroached by vegetation, and the ride quality has deteriorated.

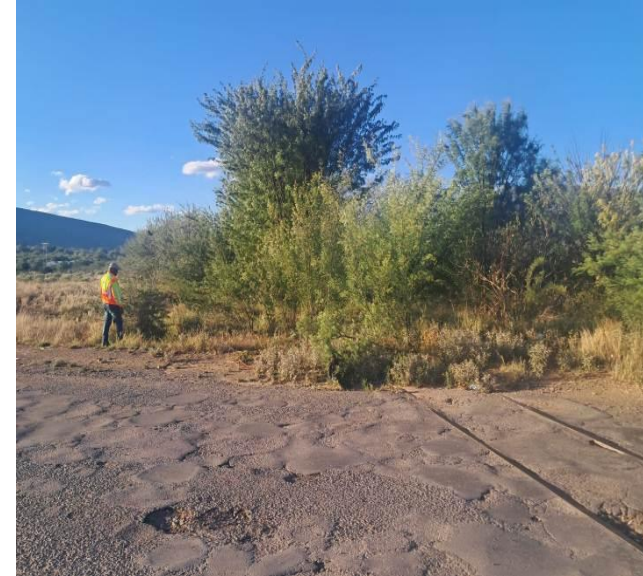
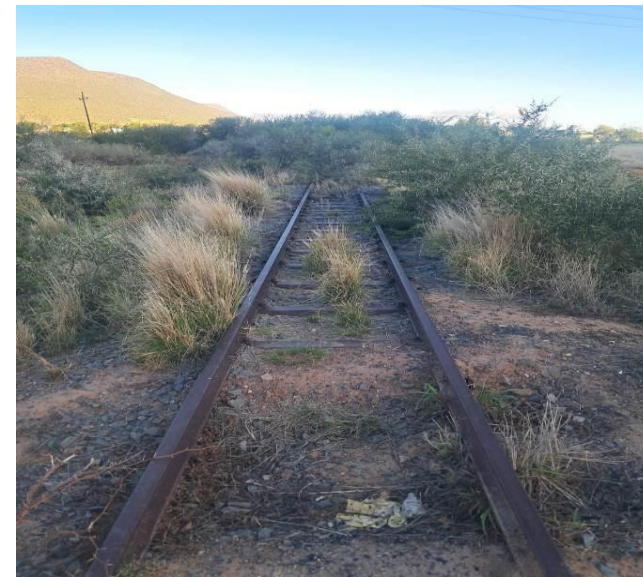
As a result of the line not being operational for an extended period, large trees have grown in the track and are encroaching over the track. A large concentration of the overgrown trees were observed in and around Graaf – Reinet.

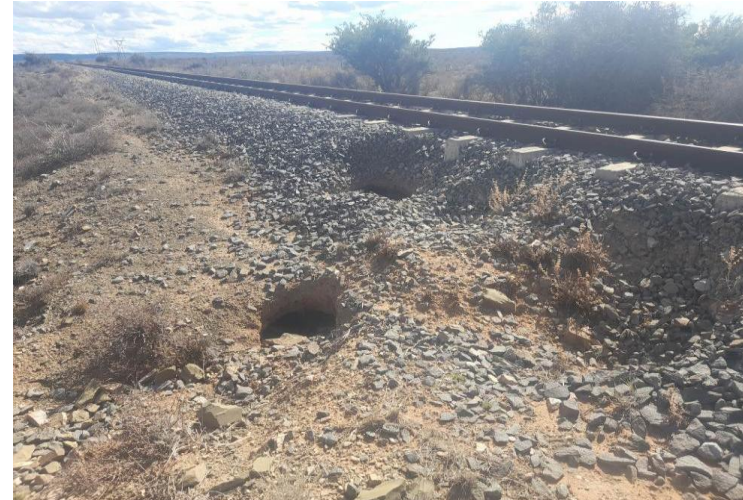
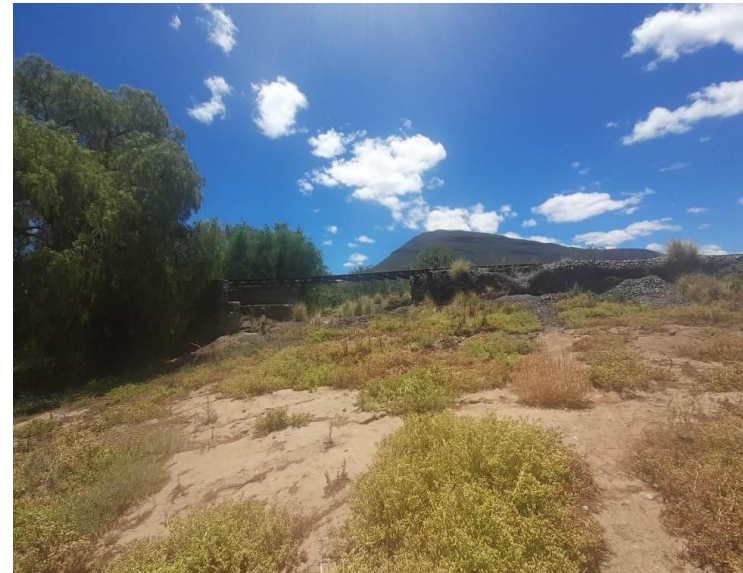
Problems with the substructure are mostly observed during operations, in particular, formation failure, since there are no operations on the line, this is not something easily picked up. It has, however, been observed that there are burrows in the embankments, which could affect the stability of the track these parts of the embankment will need to be reinstated, and protection systems against further burrowing to be put in place. In other instances, such as where big trees are growing on the track, there may be a need to excavate out the tree and fill it with appropriate layers of formation material.

Some of the embankments contain ash material, and it is also observed that the material is being removed from the track. It is suggested that in such areas close to communities, the material be removed and replaced with more suitable formation material.

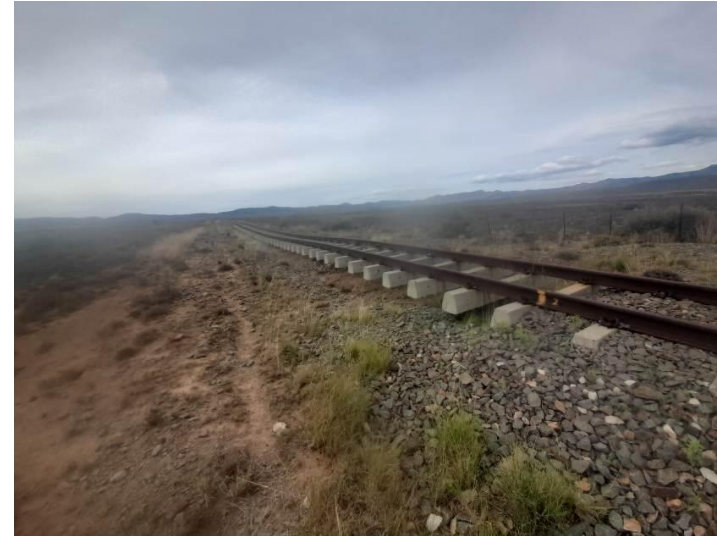
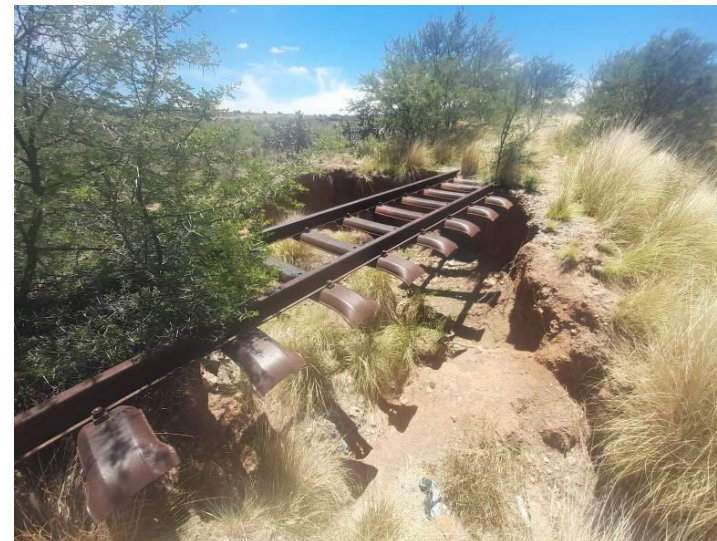
Washaways were observed on multiple areas on the line, and these need to be addressed before any operations can begin on the line. An assessment of the catchment areas needs to be done, to determine if any systems need to be put in place where the washaways have occurred.

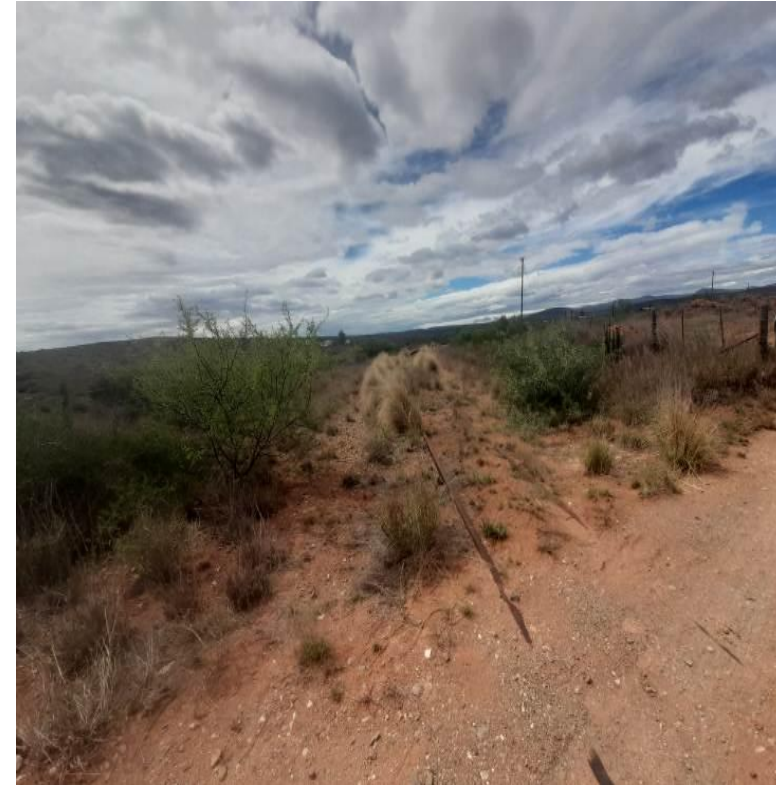
Cutt- off drains along the track need to be reinstated, this is to be done along the entire line where necessary, as it has been observed that, in parts where the cut off drain was not sufficient, the track became compromised in terms of ballast wash of, and formation washaways.

It was observed that the catchwater water drains need to be reinstated.

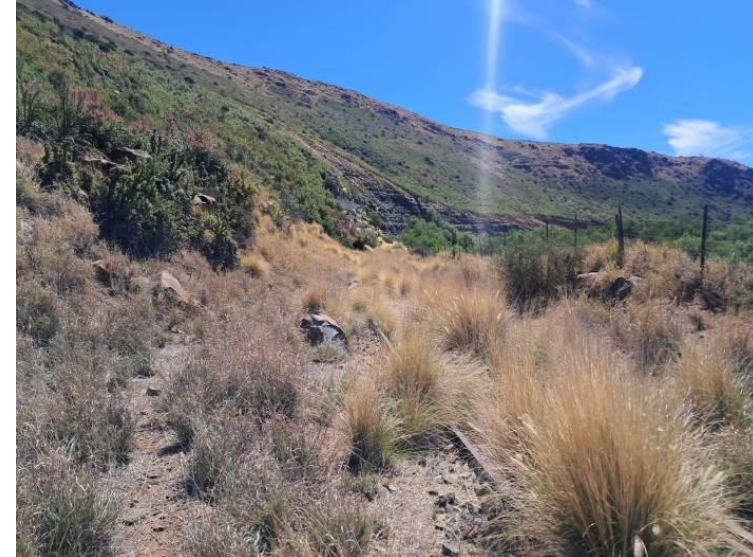
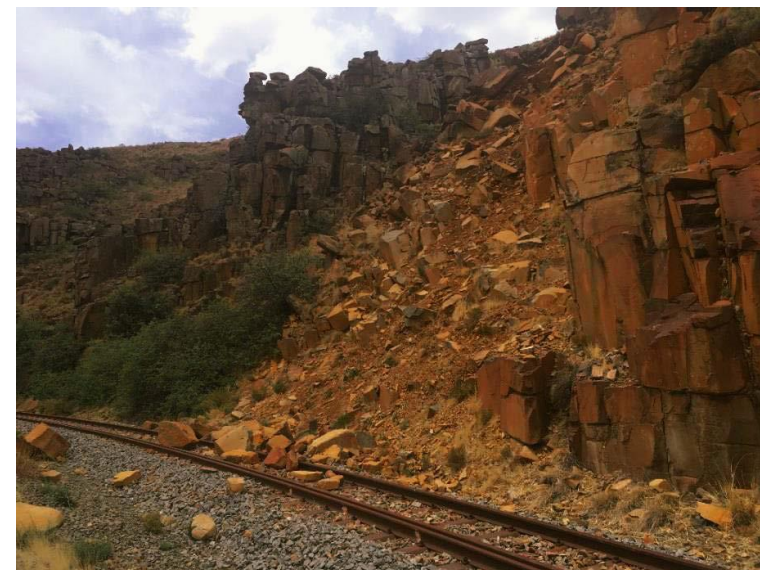
The cuttings need maintenance in terms of reinstating the table drains and cutoff drains at the top of the cuttings.

In large, an assessment of the cuttings for erosion and rockfall potential needs to be done, as it is observed that rock fall is a problem which is experienced on the route and erosion on the cutting faces which soil build up on the track.

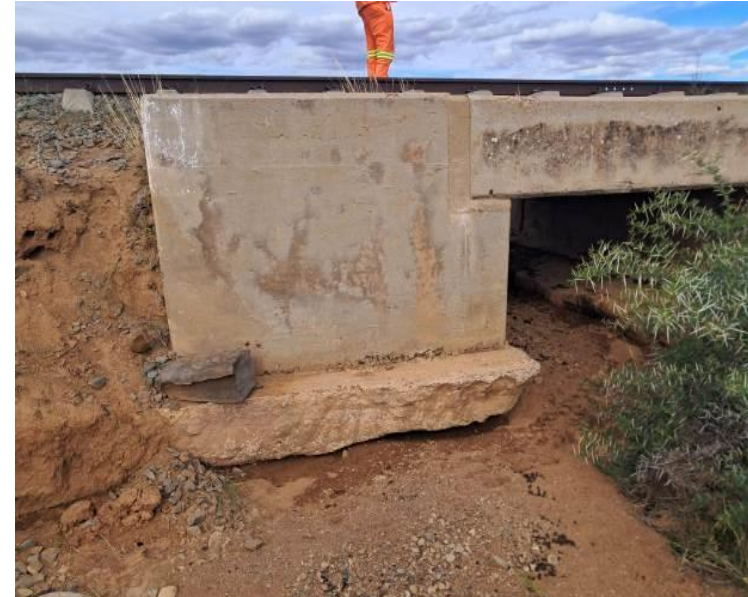
No structural damage was observed on the bridges and culverts, yet principal inspection will be required to be done to ensure the integrity of the bridges and culverts on the line. Some work around the bridges will need to be done as the ash material around the bridge has been excavated by the community next to the railway line. Scouring at some of the culverts was observed. Scouring protection to be done.

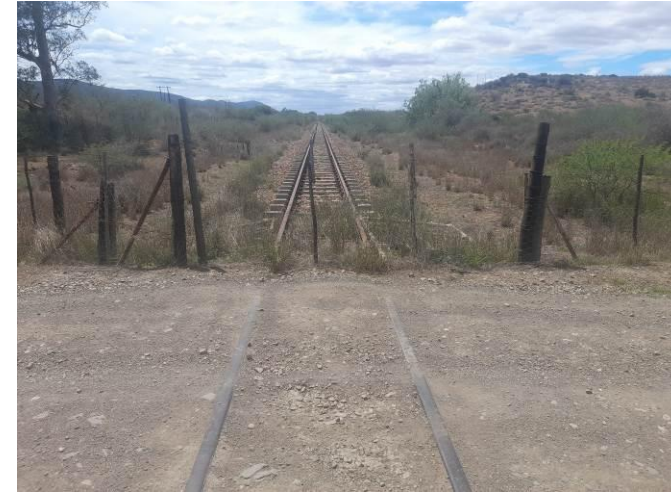
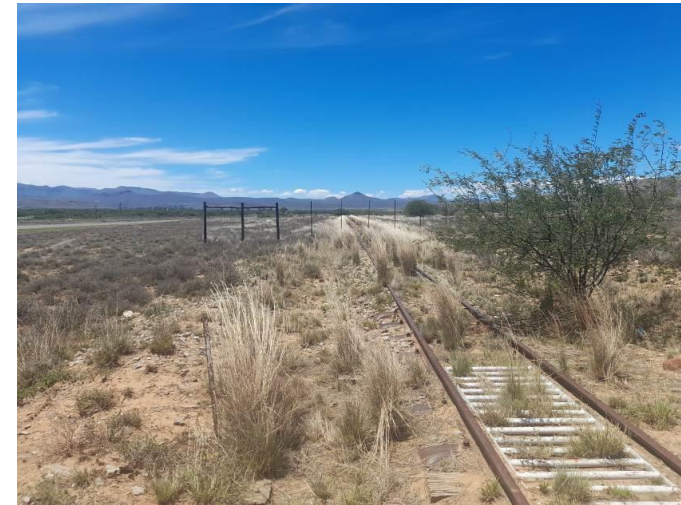
There are multiple farms, private and public properties in which the railway line interacts with, such that you may have to traverse through the farm to gain access to the rail reserve, and as such, it is important to have and maintain a working relationship with the different stakeholders.

It has further been observed that a number of these properties have got fences and gates running across the track and thus obstructing the railway line, this is due to the observation that there have been no operations on the railway line for years.

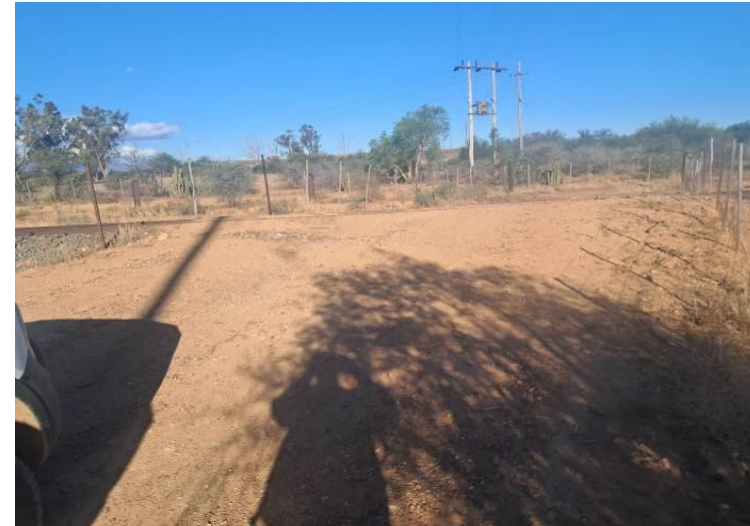
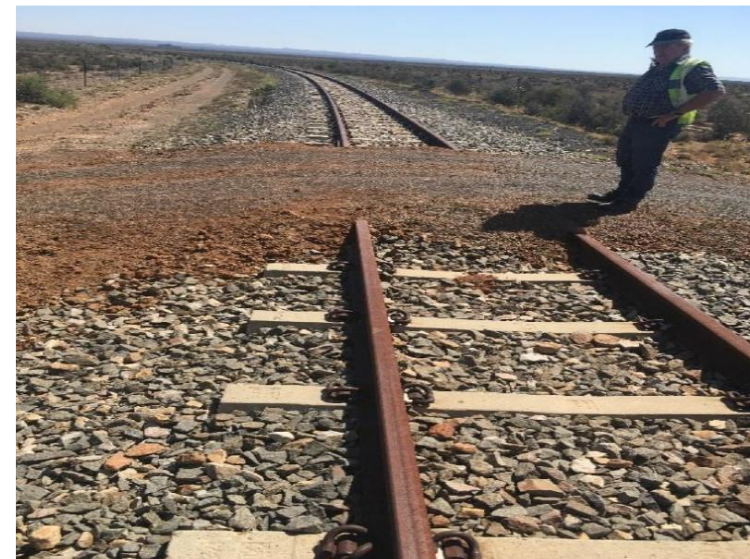
Due to the line not being operational for a period, principle, physical and risk assessments will need to be done on the level crossings. This will then be used to determine which aspects of the level crossings need to be improved, replaced and maintained.

Illegal level crossings have been observed as well, in such instances, the level crossings will need to be reviewed and an application to be done with the RSR to formalize them if all criteria is met.

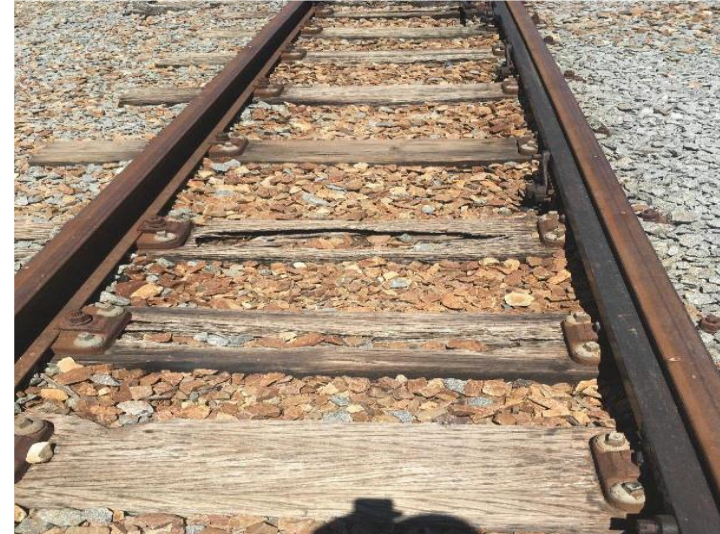
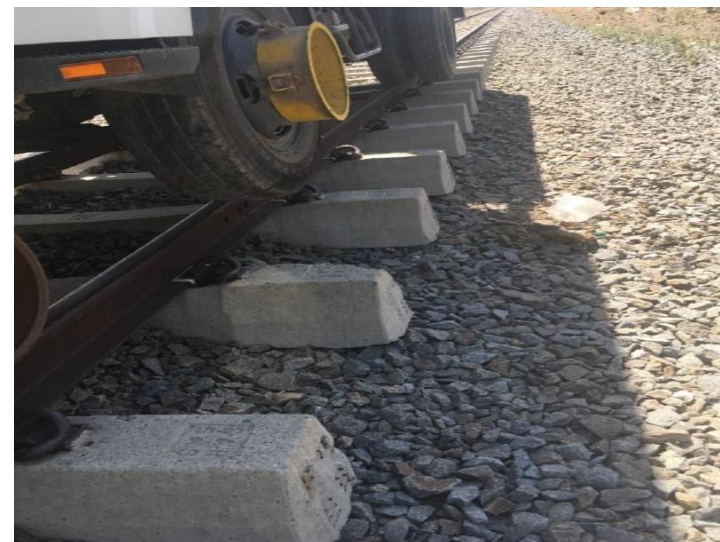
- Rails – The rails along the line are still in good condition, mostly attributed to there being no operations on the line.
- Sleepers and Fastenings – The line consists of different sleeper types (concrete, steel and wooden sleepers). Depending on the operations which are planned for the line, the main thing is to replace the rotten/ broken wooden sleepers.
- Ballast – Ballast needs to be replenished in certain areas along the line. And in areas where washaways have occurred and have just washed off the ballast, ballast top ups need to happen.
- Alignment – The alignment on the track needs to be maintained, this can be done using a tamping machine.
