A Division of Transnet SOC Limited

# Track Performance Assessment: Upington - Kakamas

Date: 04 May 2022

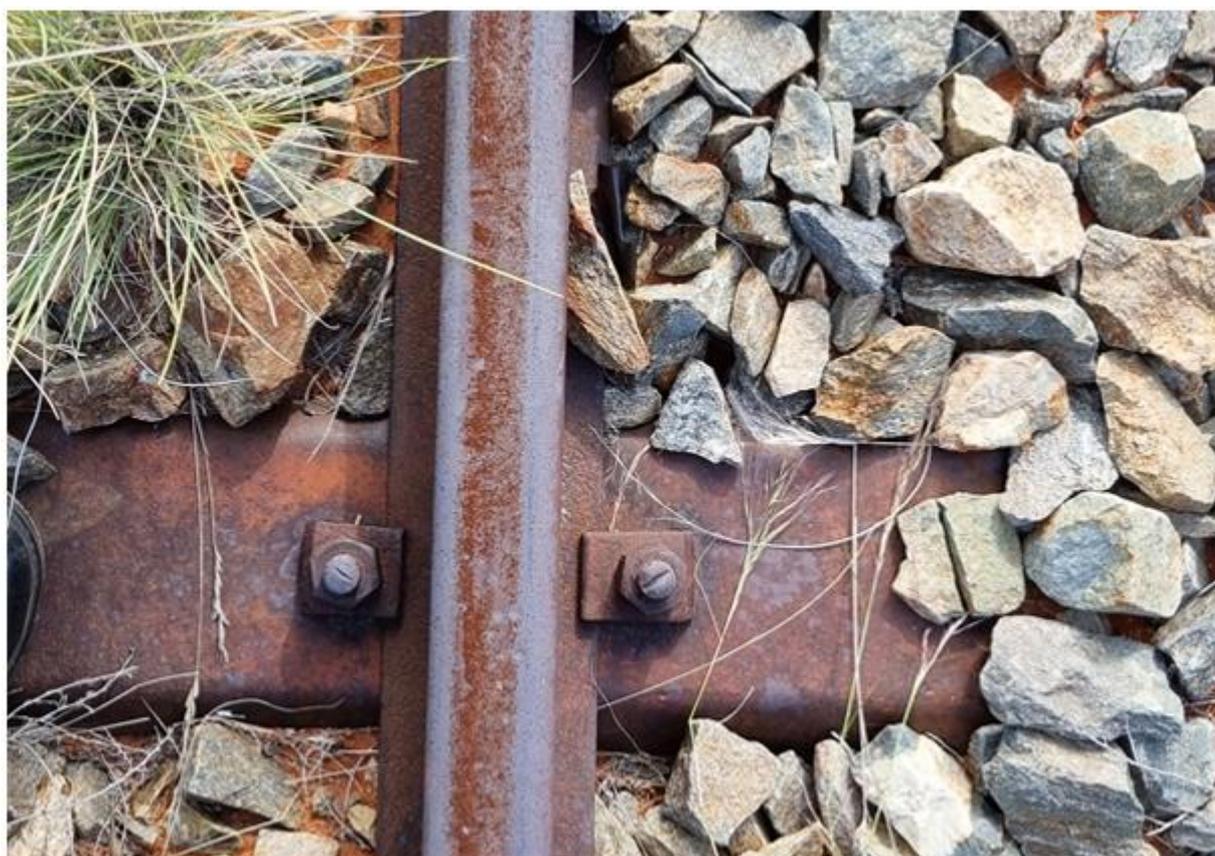
**Figure 2: Condition of rails at km 6**

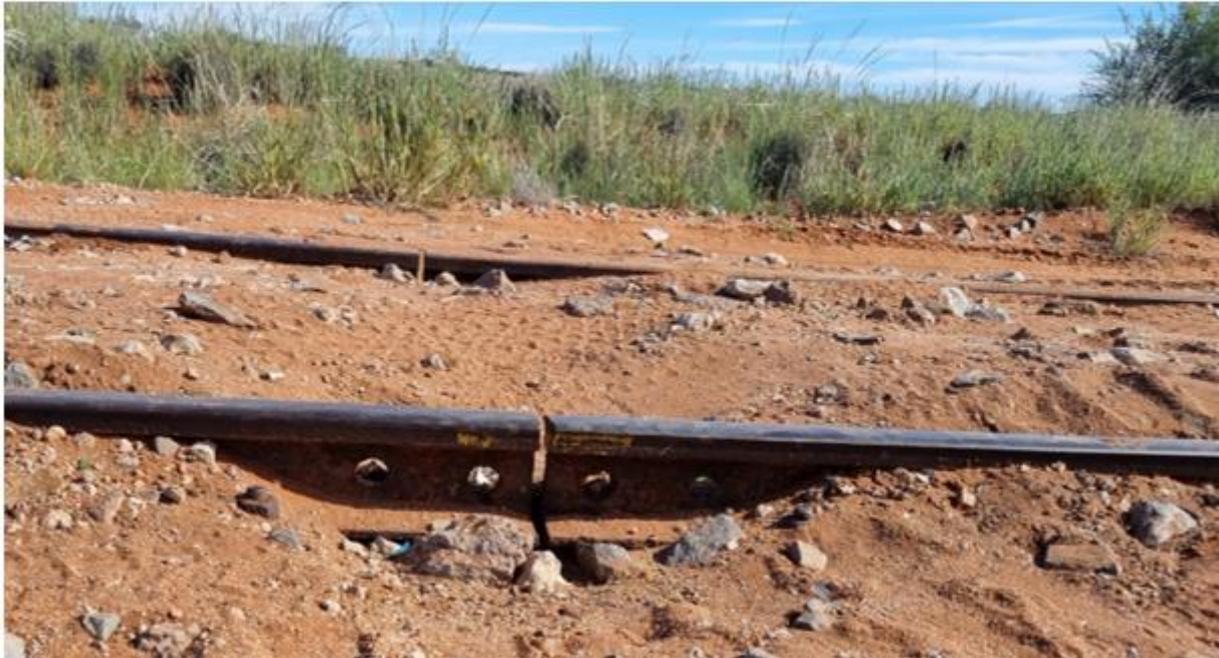
**Figure 3: Missing fishplates and bolts at km 4**

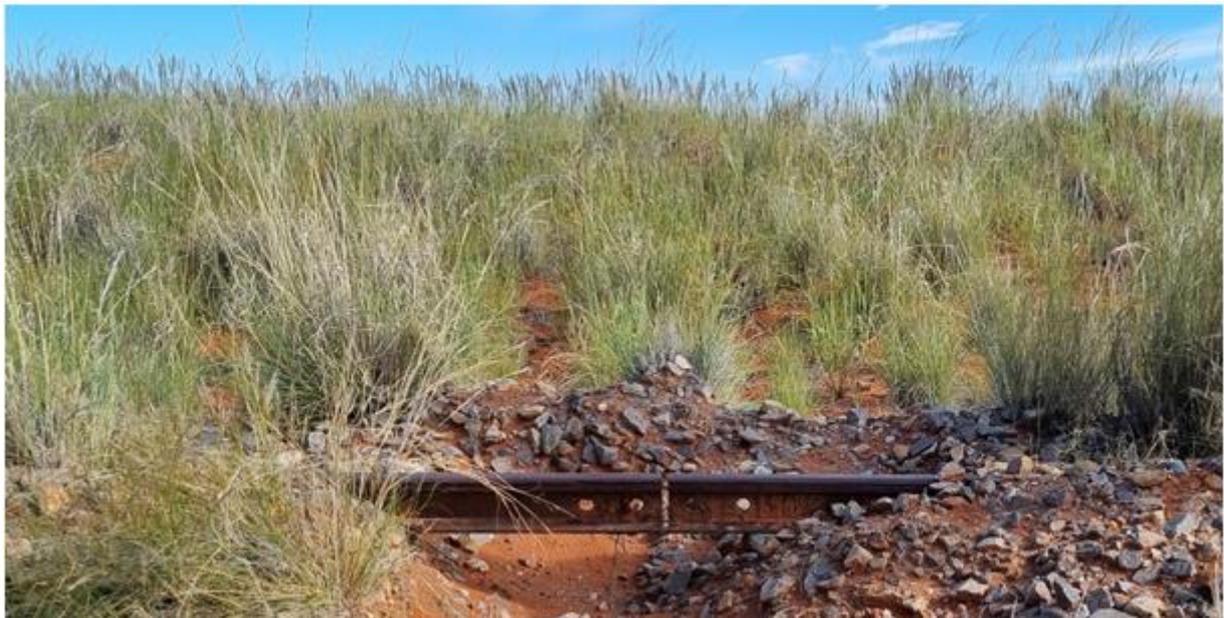
**Figure 4: Missing fishplate and bolts at km 7**

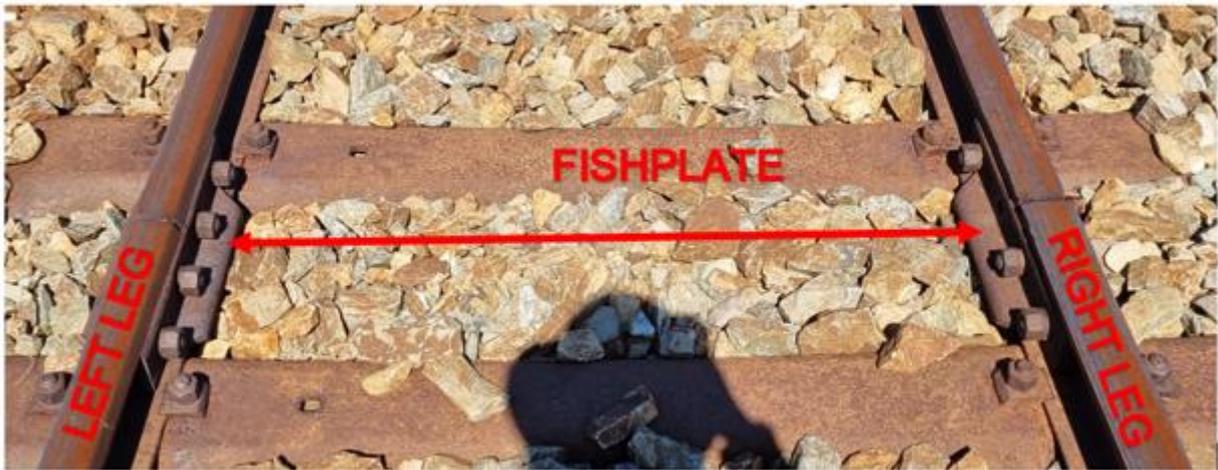
Figure 5: Fishplates on both legs at km 28/ km 29 (between Kanoneilandweg and Geelkop)

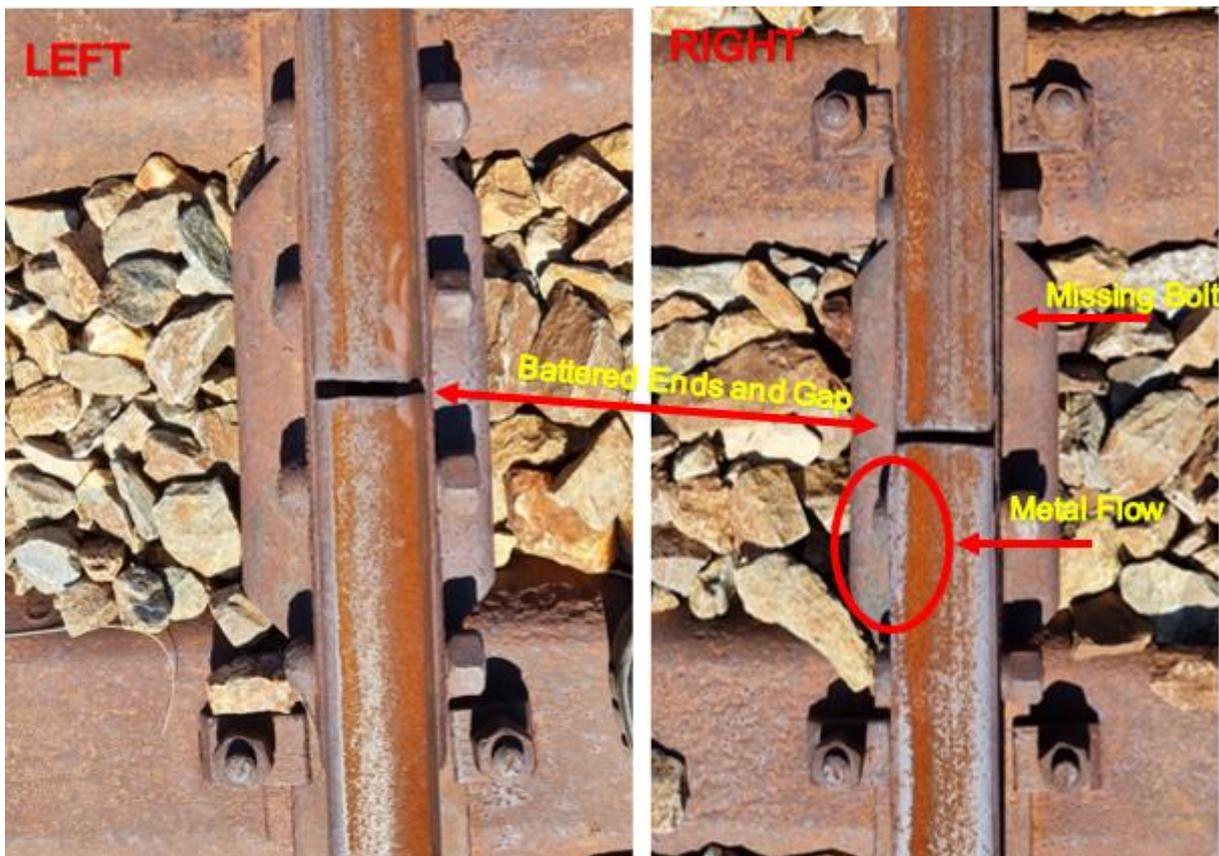
The Upington-Kakamas route has 30kg/m rails that are connected by fish plates. This connection has the advantage of less stress induced rail breaks or kickouts. The onsite assessment indicates that the rails are in an average condition. However, there is rust forming along the length of the track due to being unused since 2018 see Figure 2 below. The fishplates are missing from km 4 up until km 8 (between Upington and Klippunt), as seen in Figure 3 and 4. Figure 5 shows the fishplates on both legs at km 28/ km 29 (between Kanoneilandweg and Geelkop). The fishplates are intact with only one bolt missing on the right leg, with battered ends, metal flow and noticeable gap as seen in Figure 6.

Figure 6: Left and Right Leg defects at km 28/ km29 fishplate

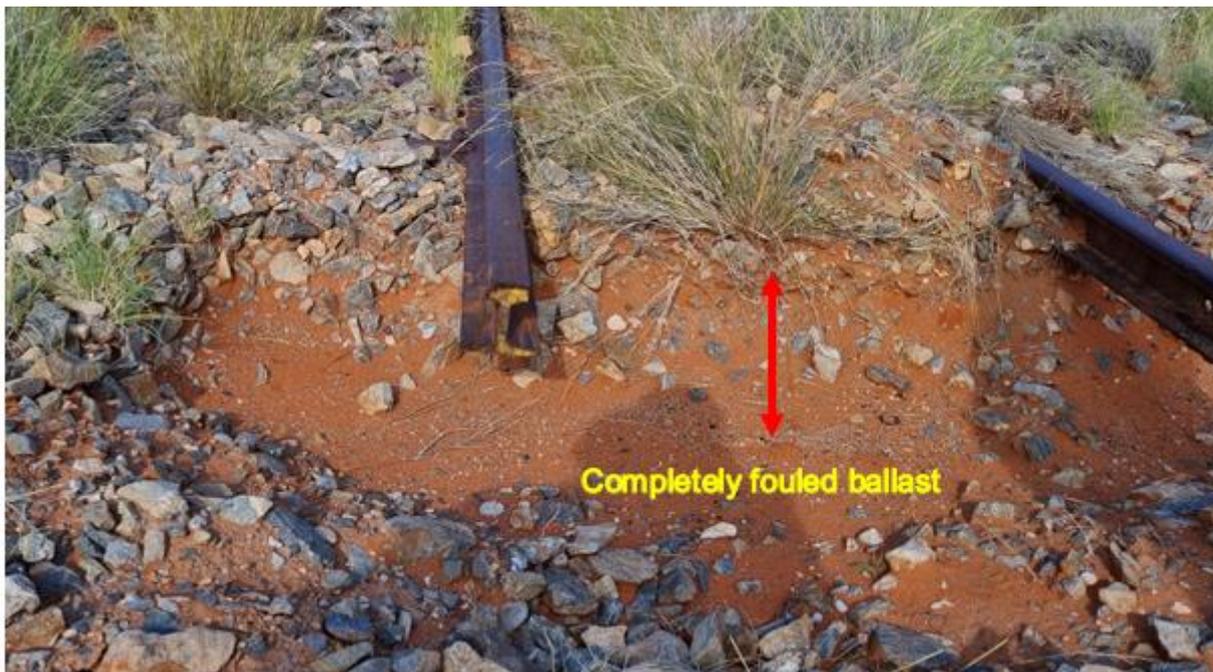
Ballast is an important component in the track structure as it provides drainage and resist forces exerted onto the track. After inspecting the track there were sections that were completely fouled km 4 to km 8 as seen in Figure 7 and 8. The ballast condition improves from km 27 to km 30 however, the ballast needs re-profiling as seen in Figure 9. Lastly, the shoulder ballast erosion and fouling at the start of the Kakamas bridge at km 86 as seen in Figure 10. Ballast regulating, replenishment and screening will be necessary to restore condition of the line.

**Figure 7: Completely fouled Top ballast layers at km 4**

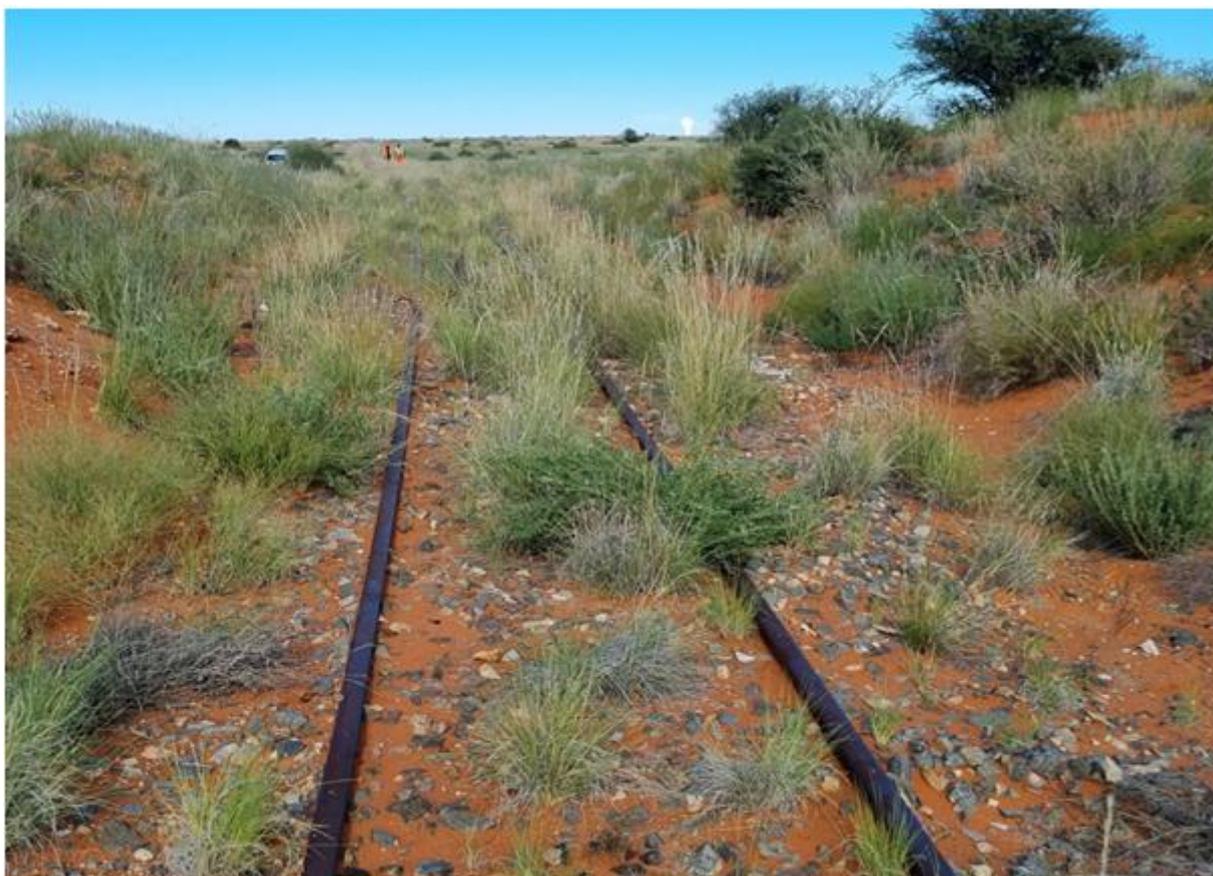
**Figure 8: Completely fouled crib and shoulder ballast at km 8**

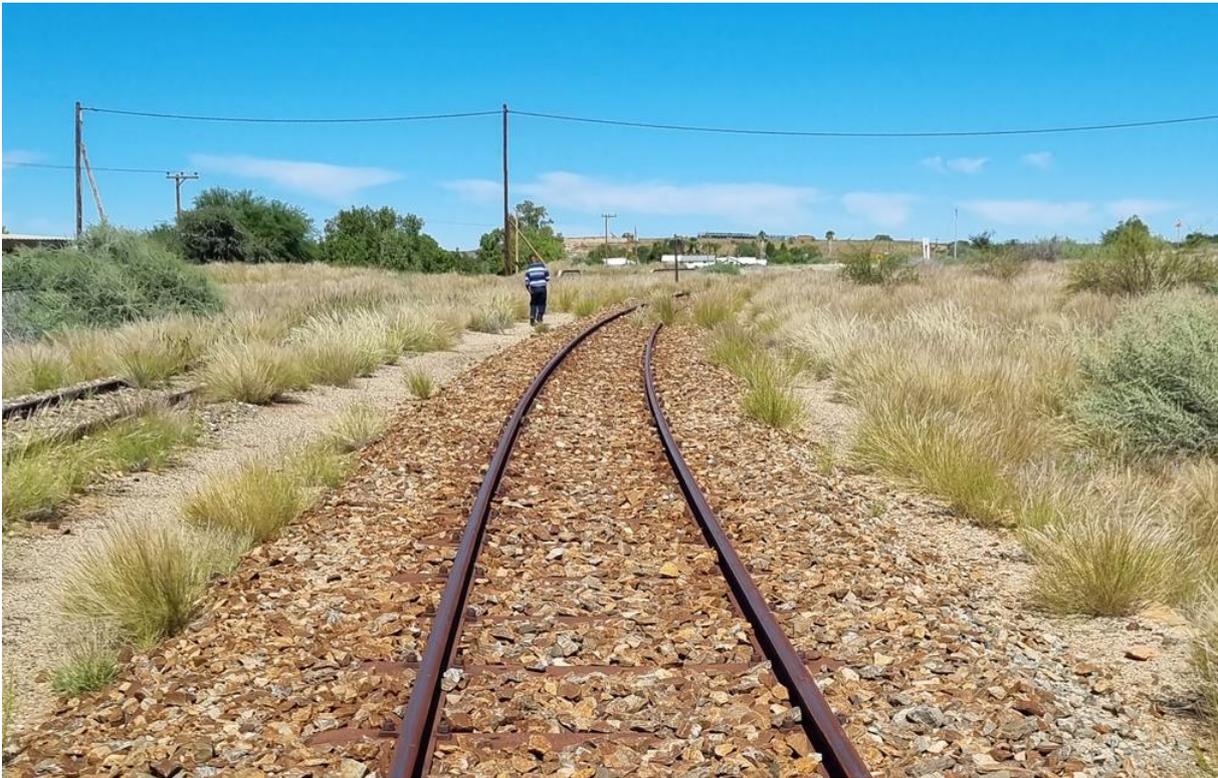
**Figure 9: Improved ballast condition but still requiring re-profiling at km 28**

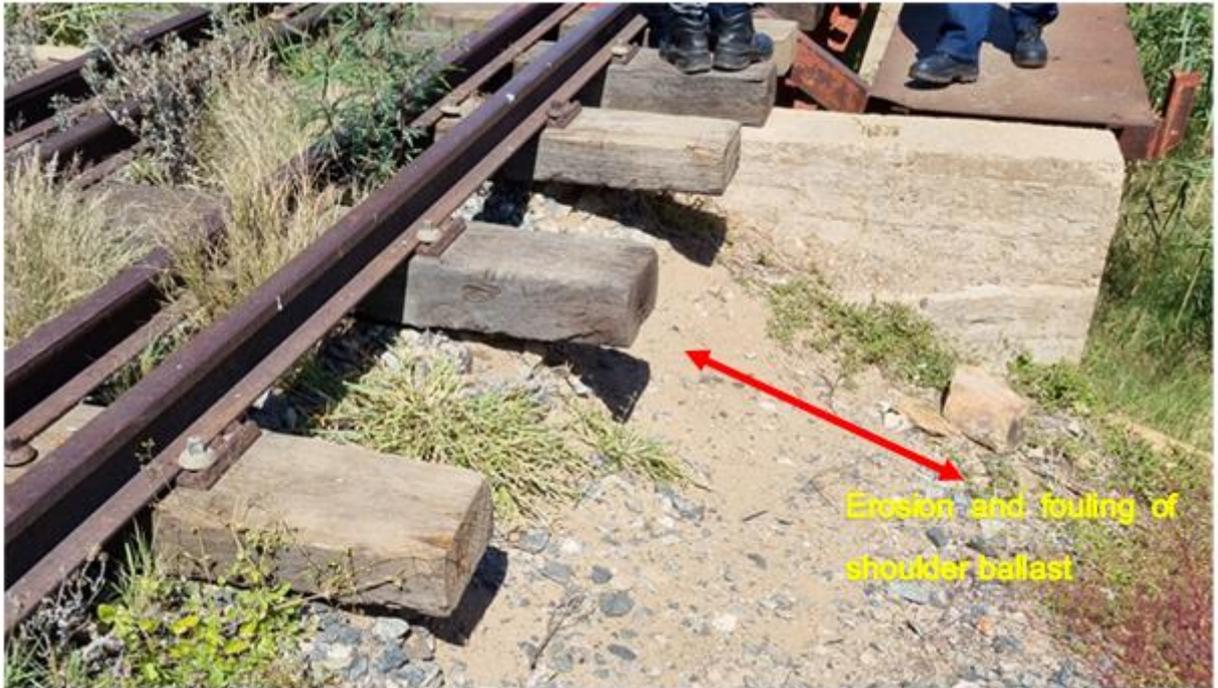
**Figure 10: Shoulder ballast erosion and fouling at the Kakamas Bridge Abutment**

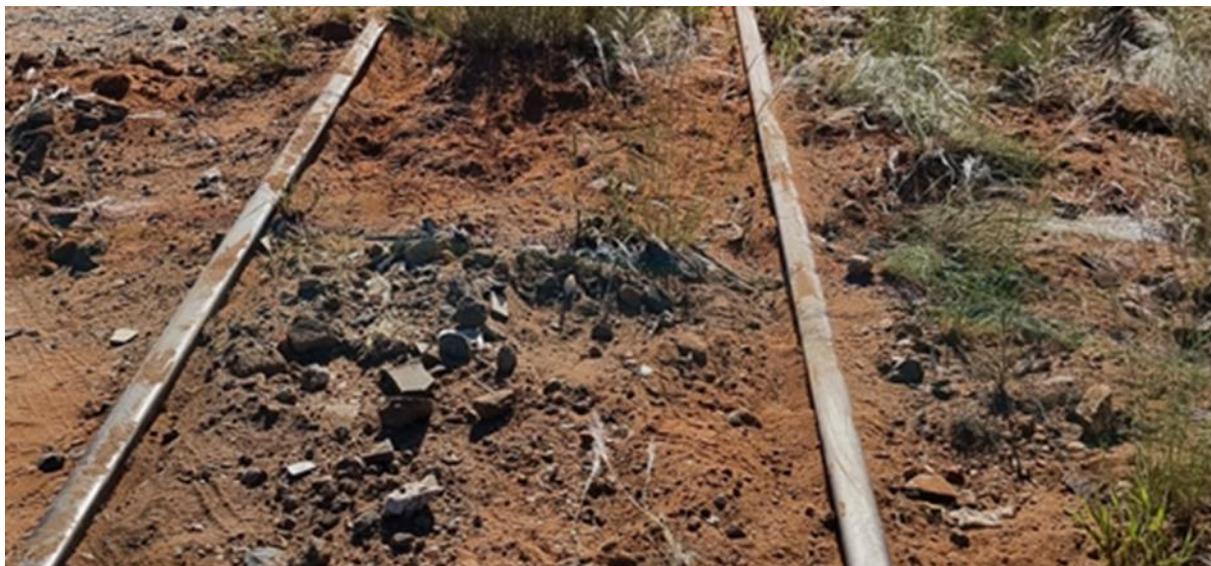
**Figure 11: Sleepers fully submerge in sand at km 4**

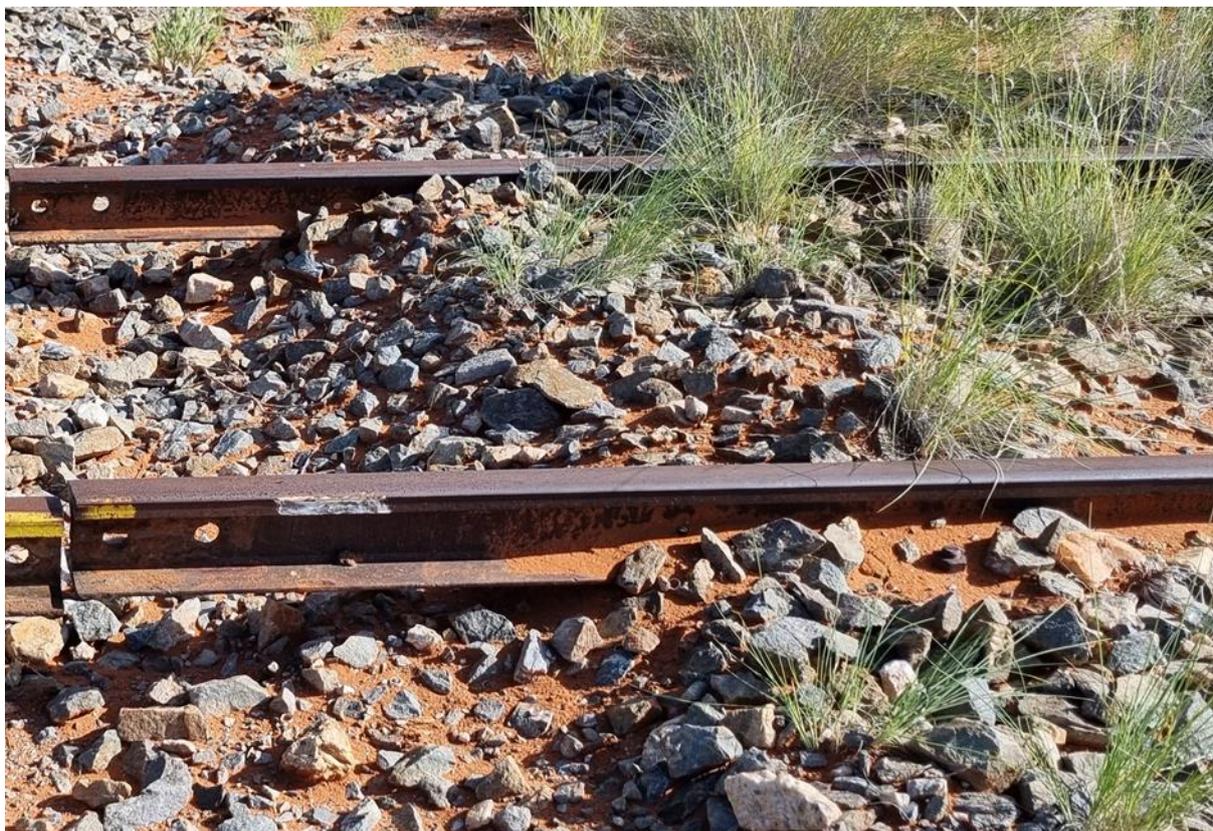
**Figure 12: Missing steel sleepers at km 7**

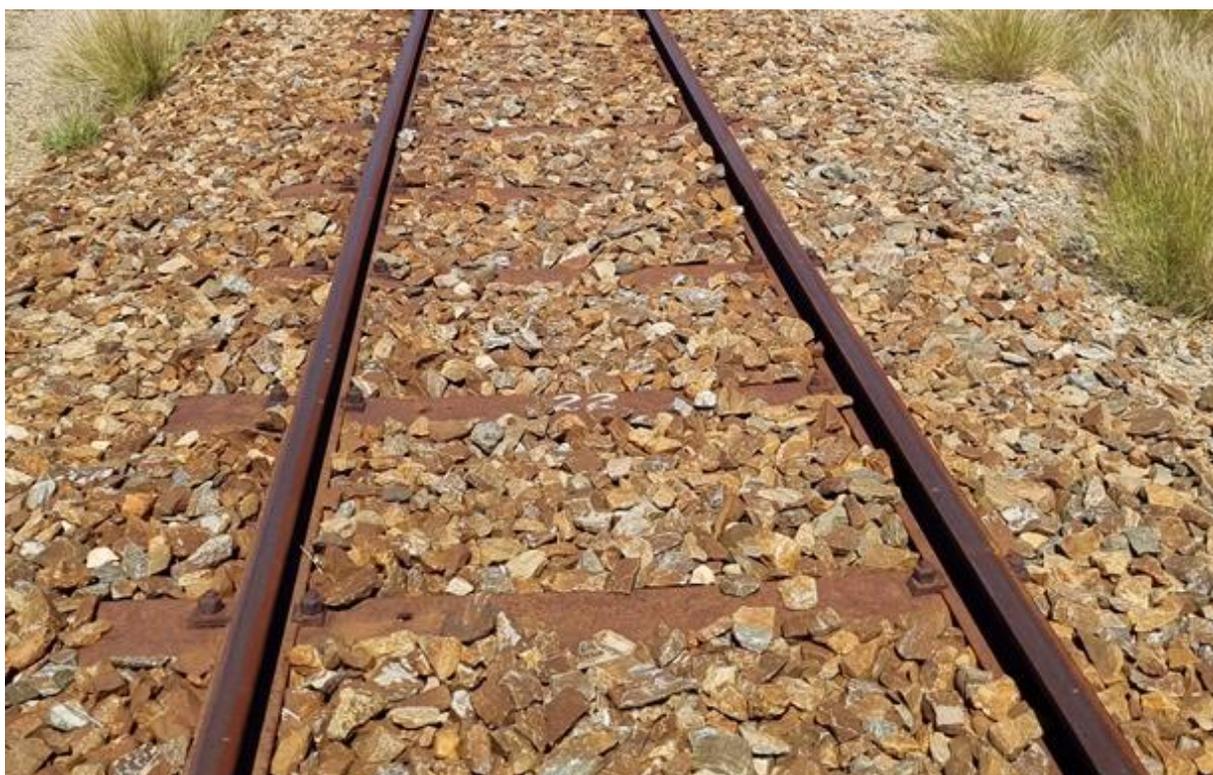
**Figure 13: Sleepers and fastenings are intact and in a good condition between km 27 to km 30**

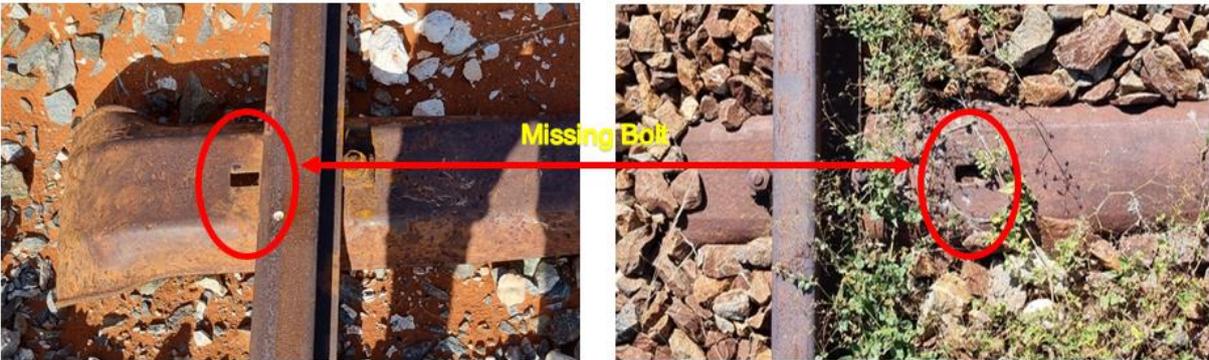
Figure 14: Missing bolts at km 4 and km 26 respectively

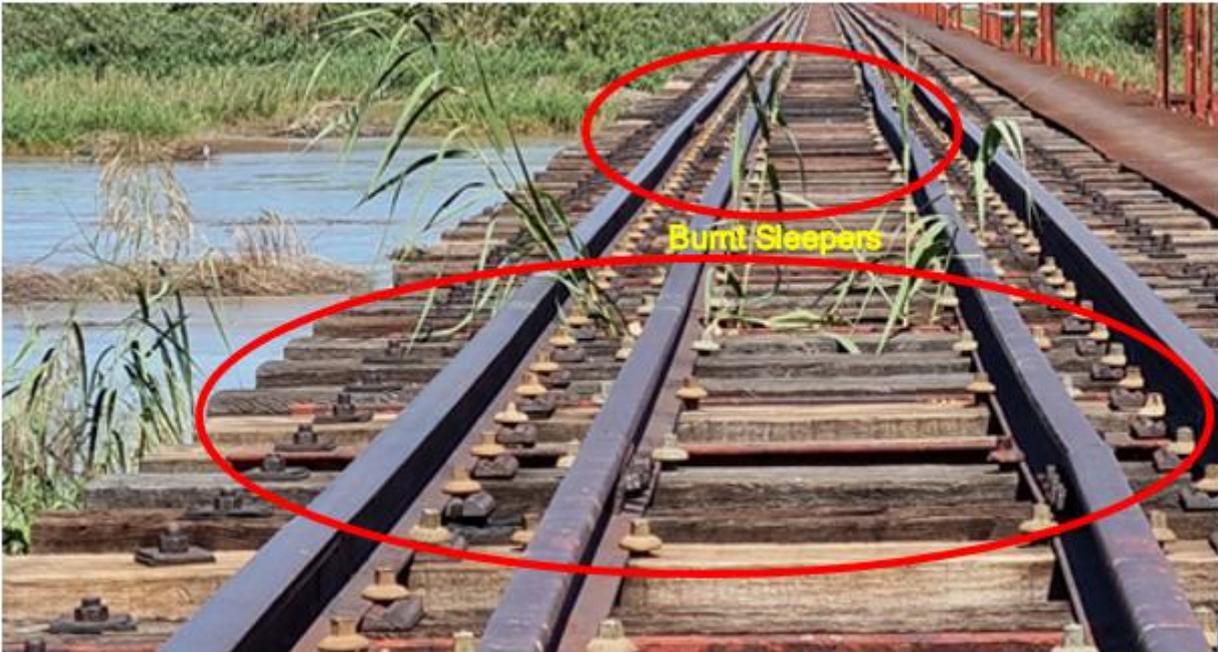
Figure 15: Burnt sleepers on the Kakamas Bridge

The Upington-Kakamas route has three bridges as indicated in Table 1 (BBF0901) and only the rail bridge is at Kakamas. The track infrastructure appeared to be in a good condition with the following concerns: burnt sleepers, missing hand railings, slacks and corrosion to the steel structure, as seen in Figure 15, 21 and 22 respectively. The entire bridge could not be inspected due the missing hand railings and no access to the bottom of the concrete supports. Therefore, refurbishment to preserve the steel members is required.

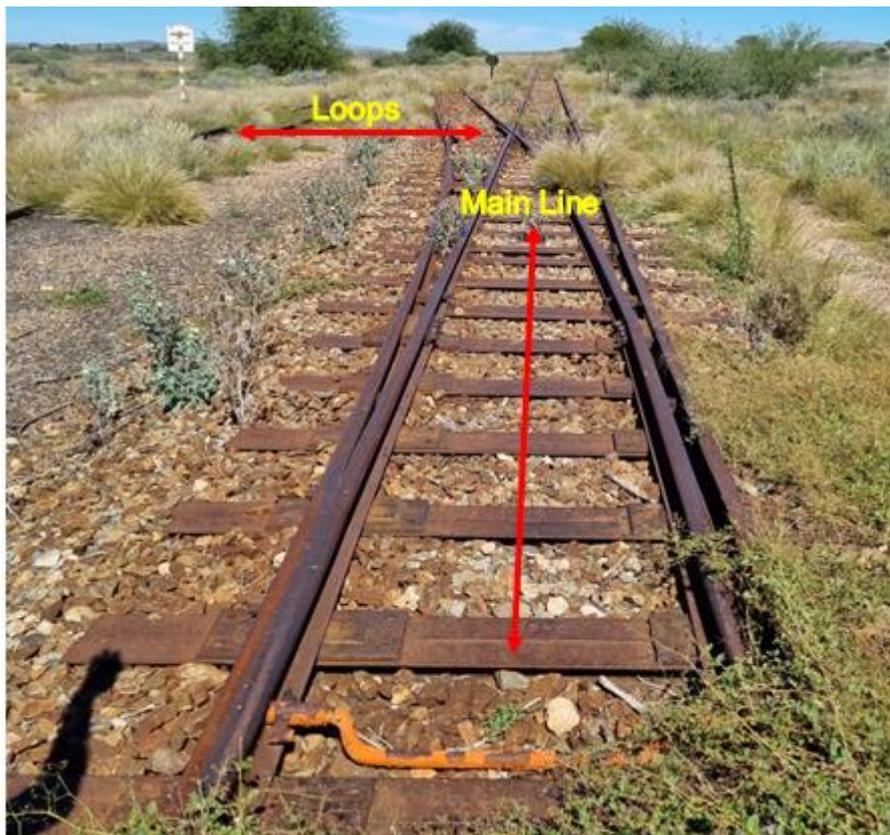
**Figure 17: Turnout at Kanoneilandweg in good condition, with over grown vegetation**

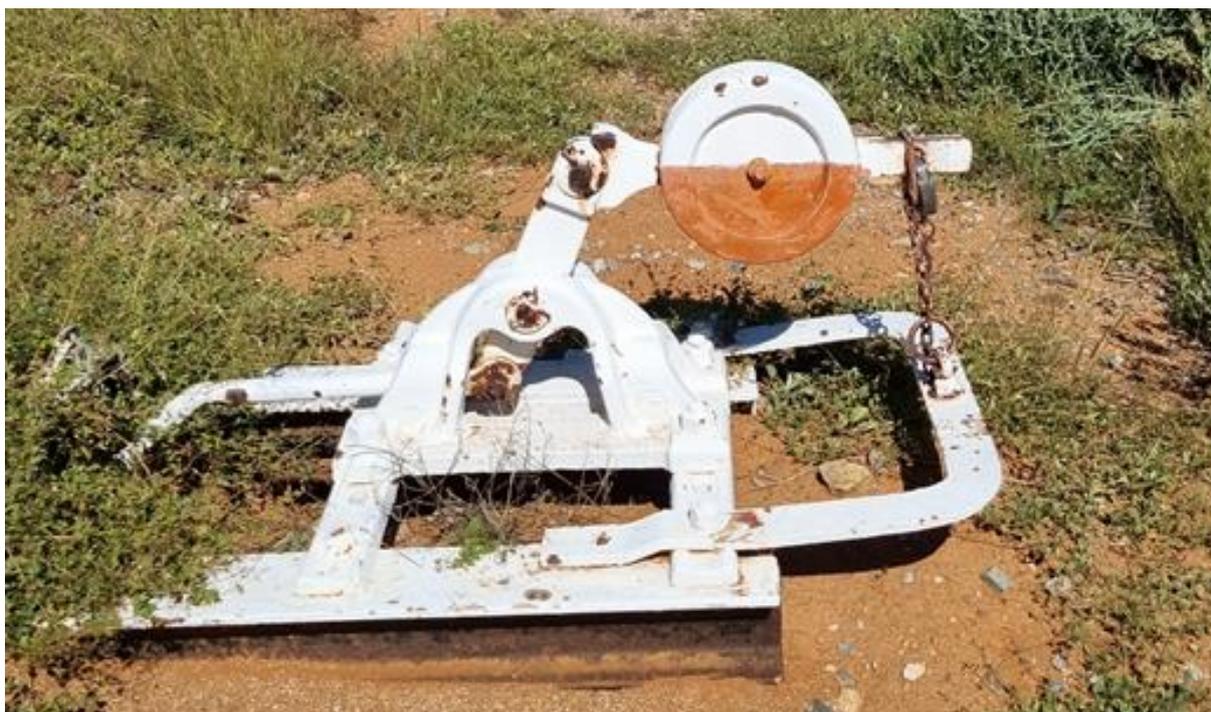
**Figure 18: Hand Tumbler in good condition and surrounded by vegetation**

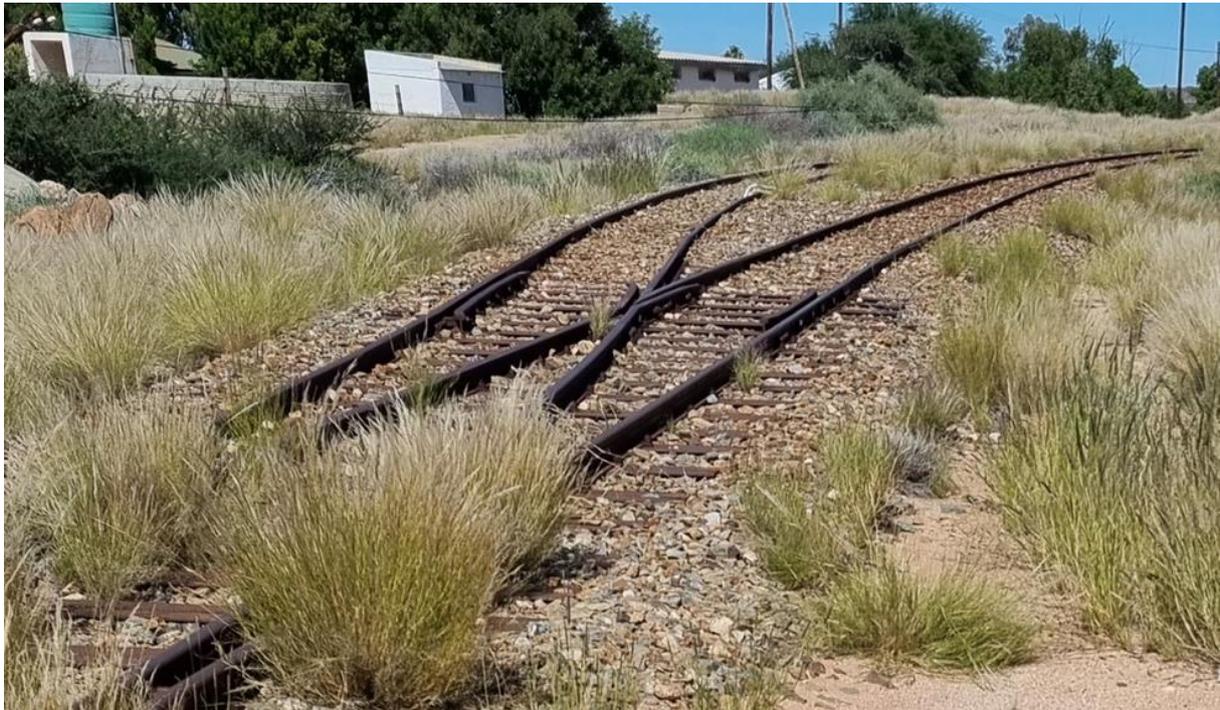
**Figure 19: Turnout at Geelkop in good condition, with over grown vegetation**

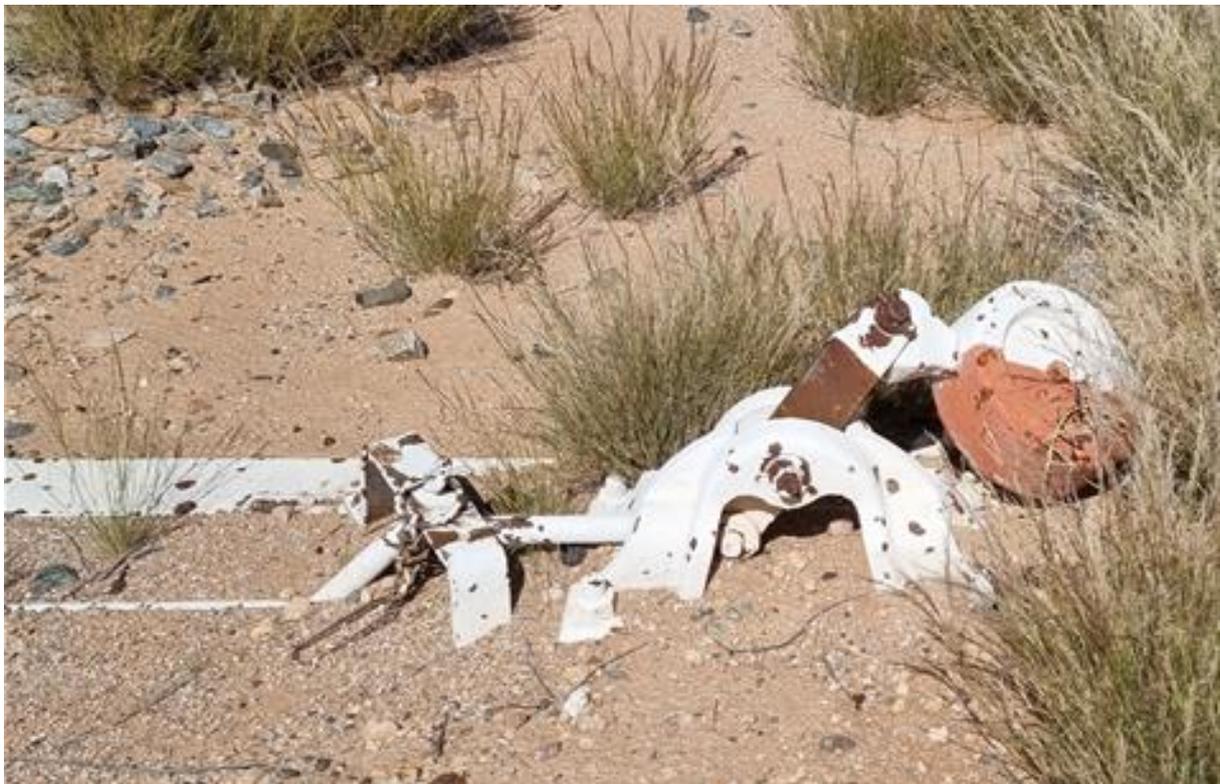
**Figure 20: Hand Tumbler is broken and surrounded by vegetation**

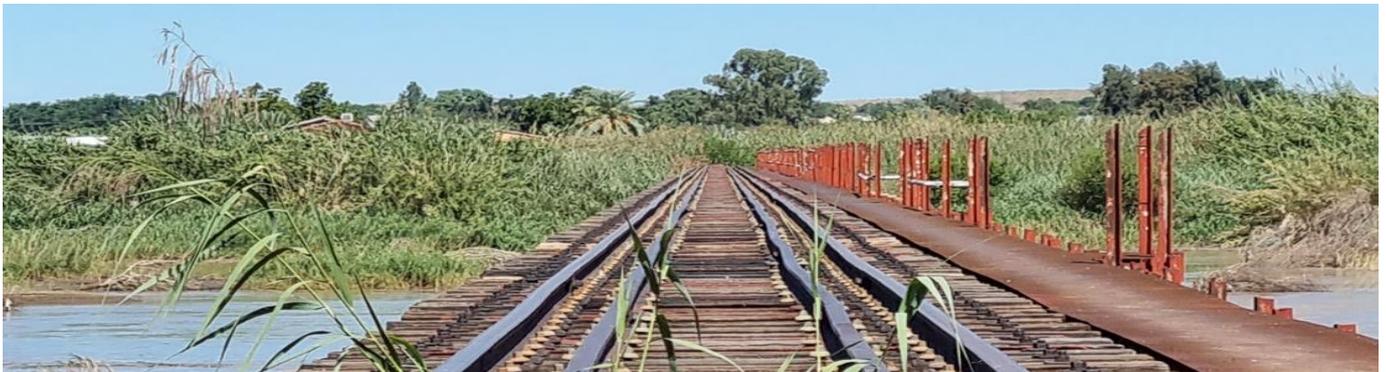
**Figure 21: Slacks along the length of the track and missing hand railings on the right**

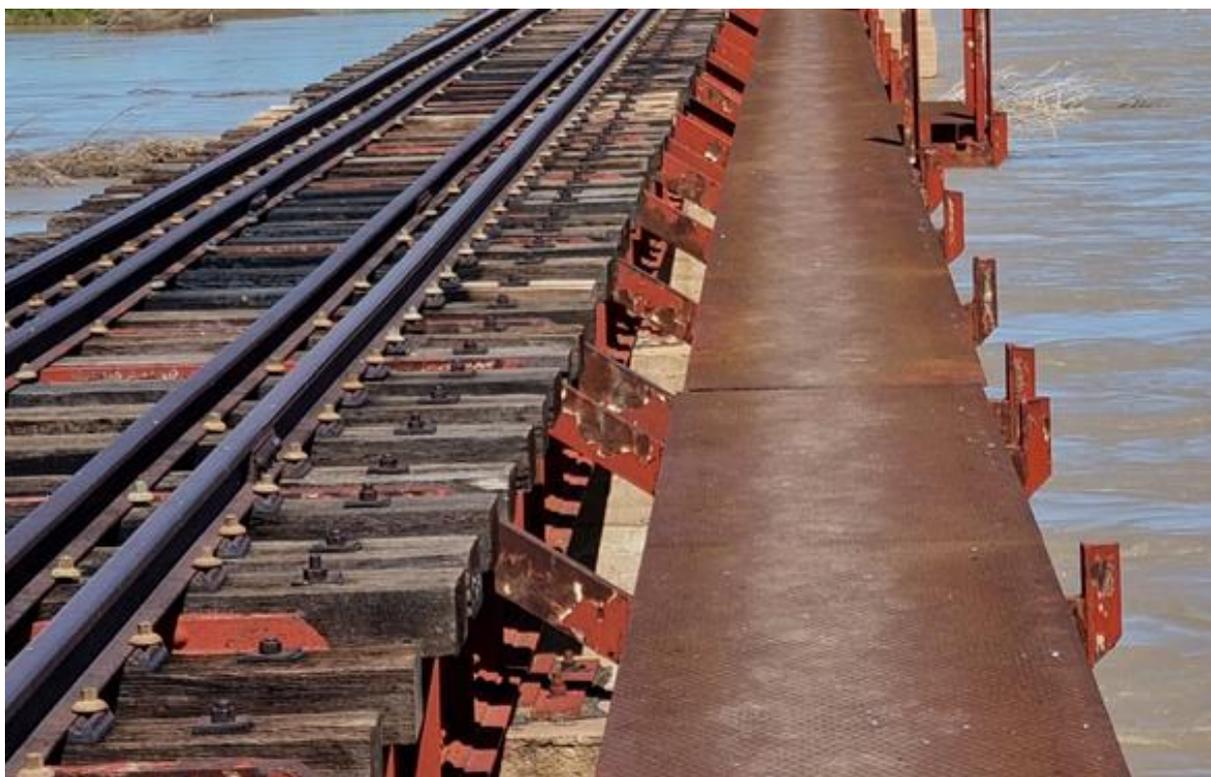
**Figure 22: Corrosion of steel bridge**

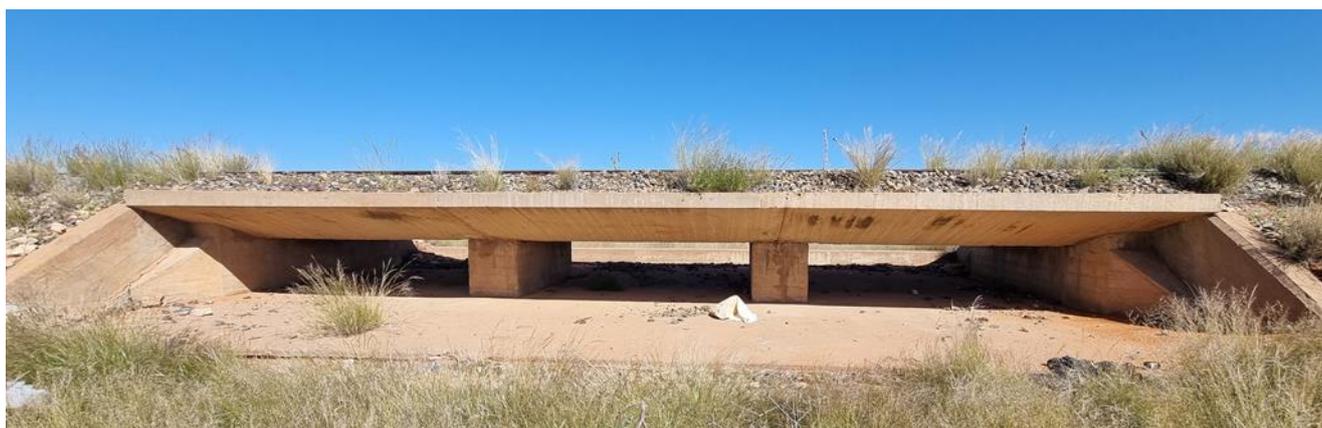
**Figure 23: Culvert in good condition at km 13**

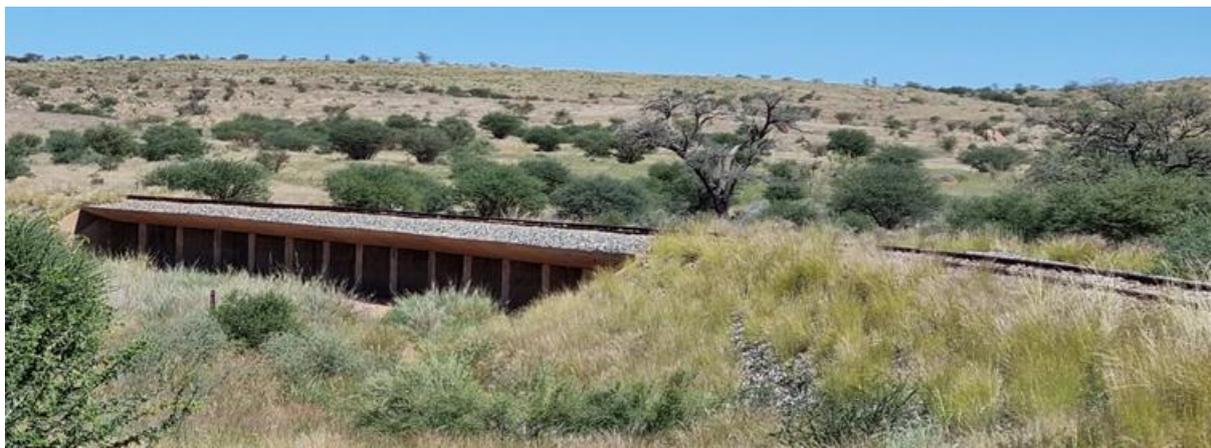
**Figure 24: Culvert between Geelkop and Keimoes appears to be in a good condition**

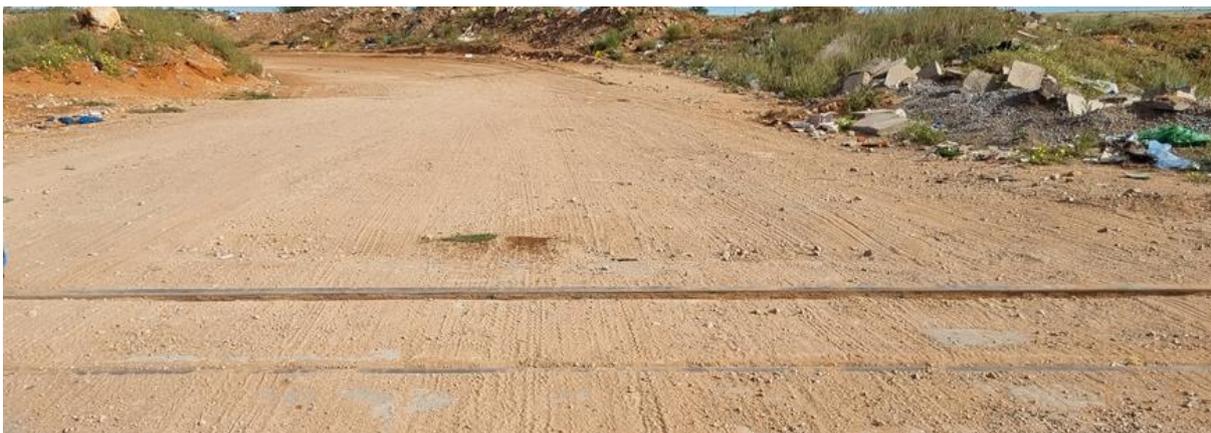
**Figure 25: Level Crossing at km 7 covered in sand**

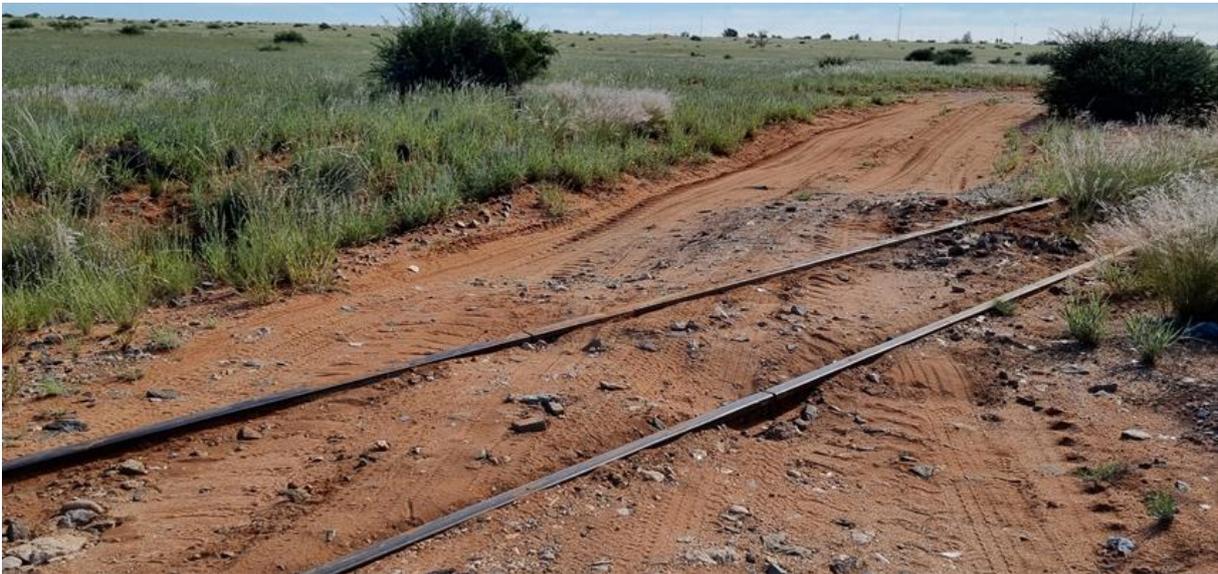
**Figure 26: Illegal Level Crossing at km 4**

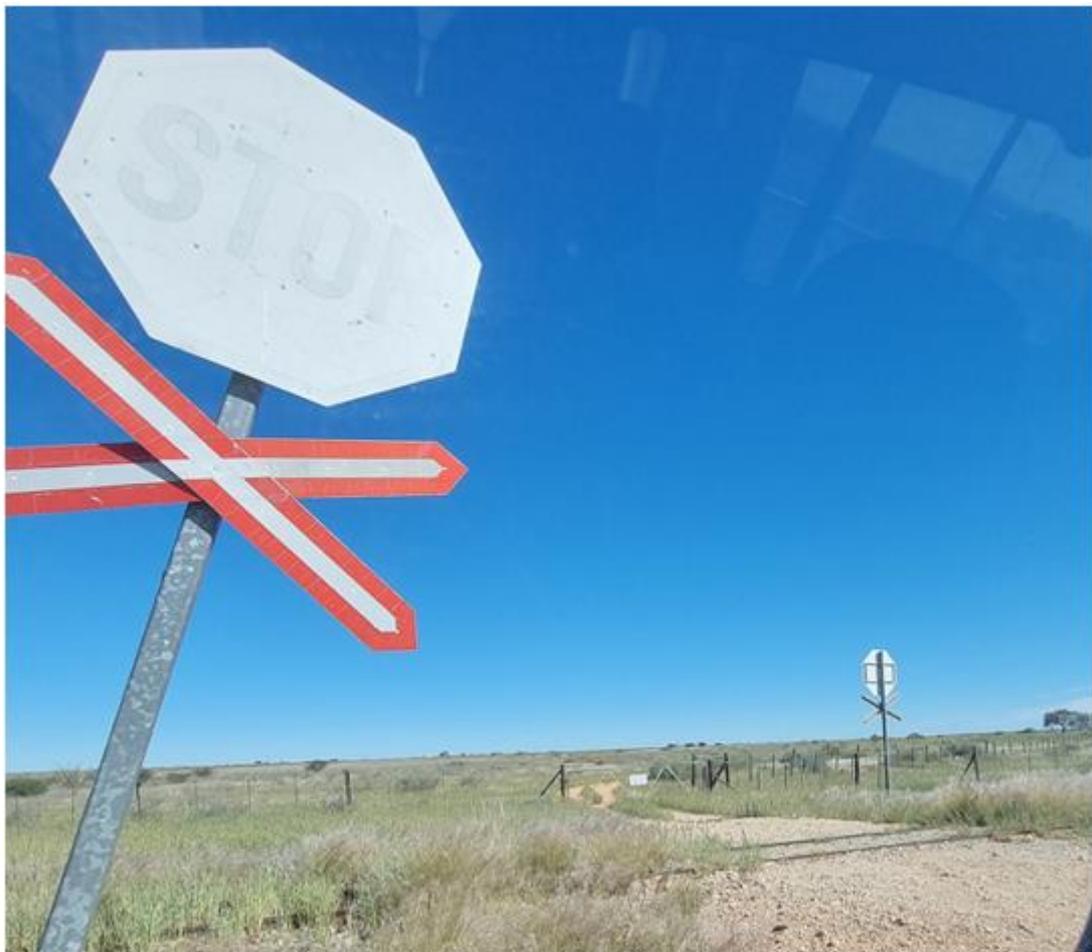
**Figure 27: Faded and skew stop sign at km 13**

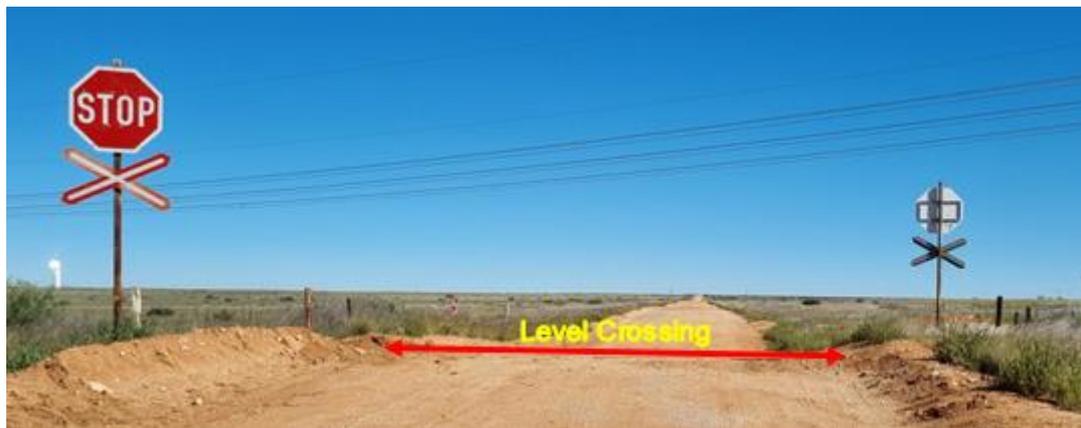
**Figure 28: Graded road covering the track and excess material obstructing the line at km 22**

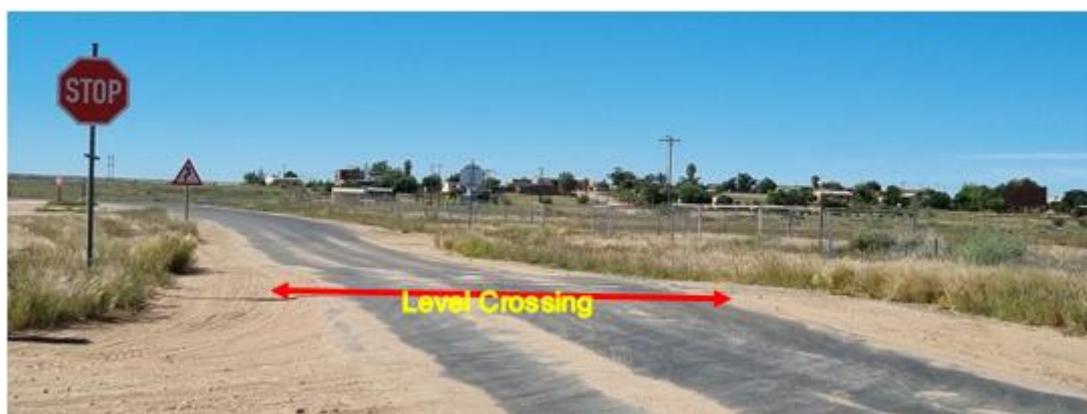
**Figure 29: Uneven tar road across track at km 25**

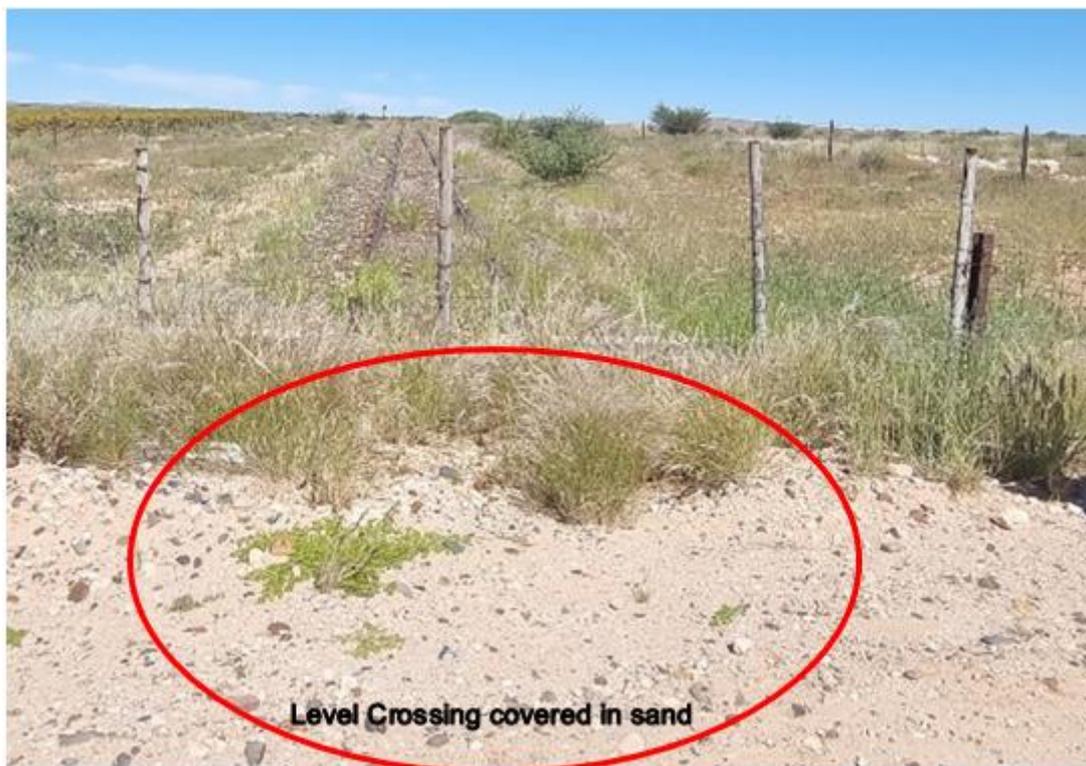
**Figure 30: A gate build on track and track covered in sand at level crossing at km 27**
