A Division of Transnet SOC Limited

# Track Performance Assessment: Upington - Kakamas

Date: 04 May 2022

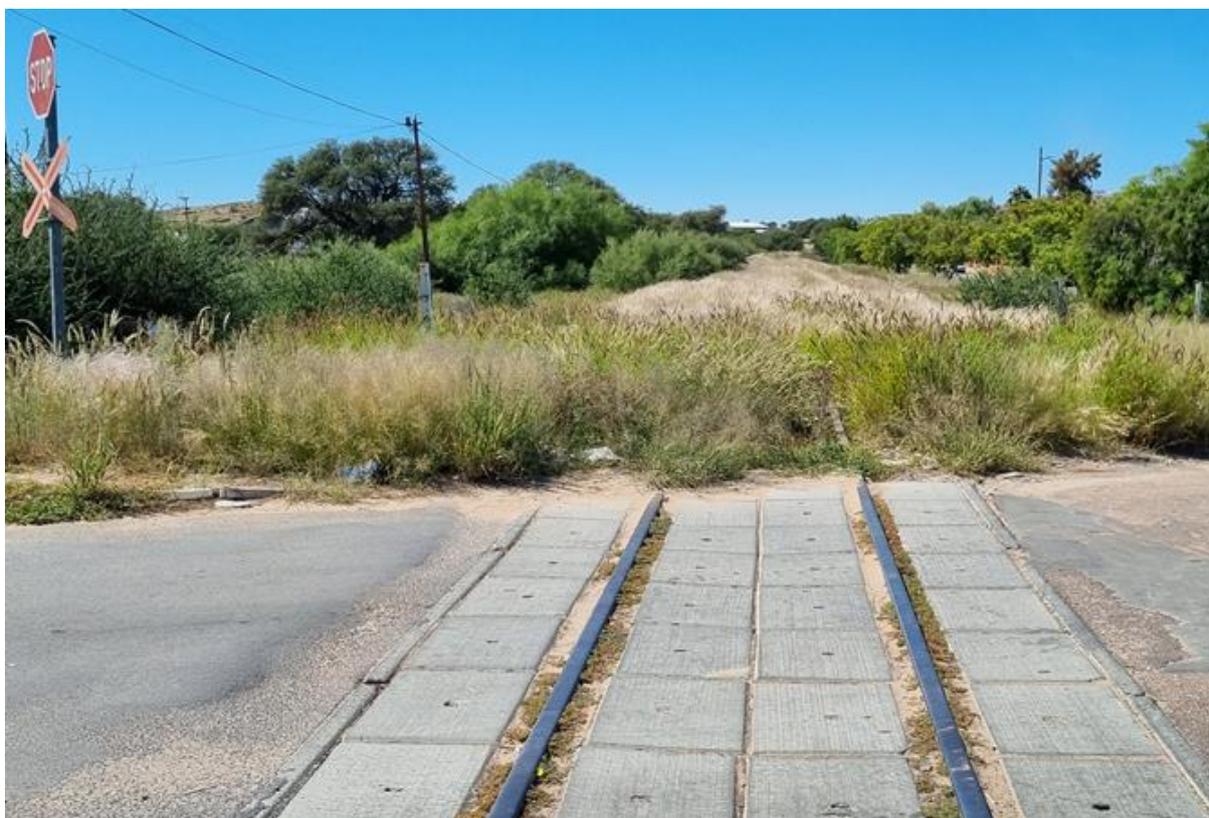
**Figure 31: Sand and vegetation between rail and concrete block at the level crossing at km 43**

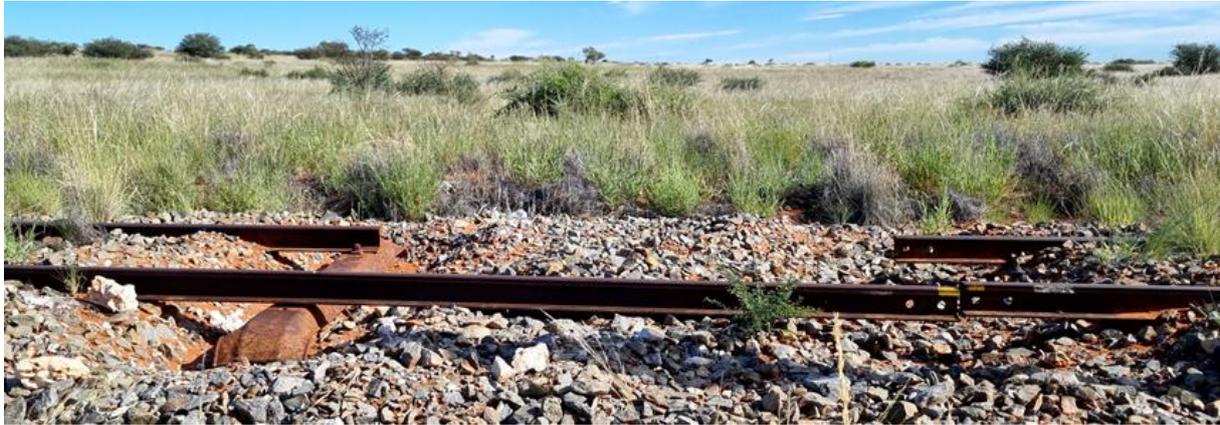
**Figure 32: Stolen rails, sleepers and fishplates at km 4**

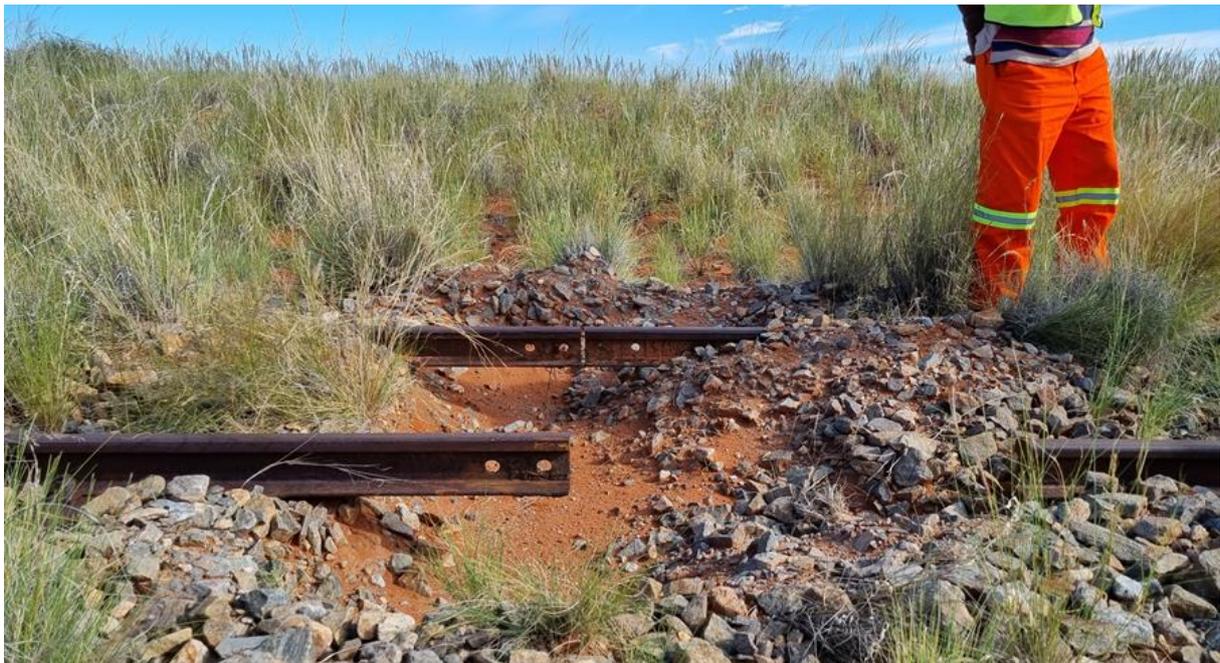
**Figure 33: Stolen rails, sleepers and fishplates at km 6**

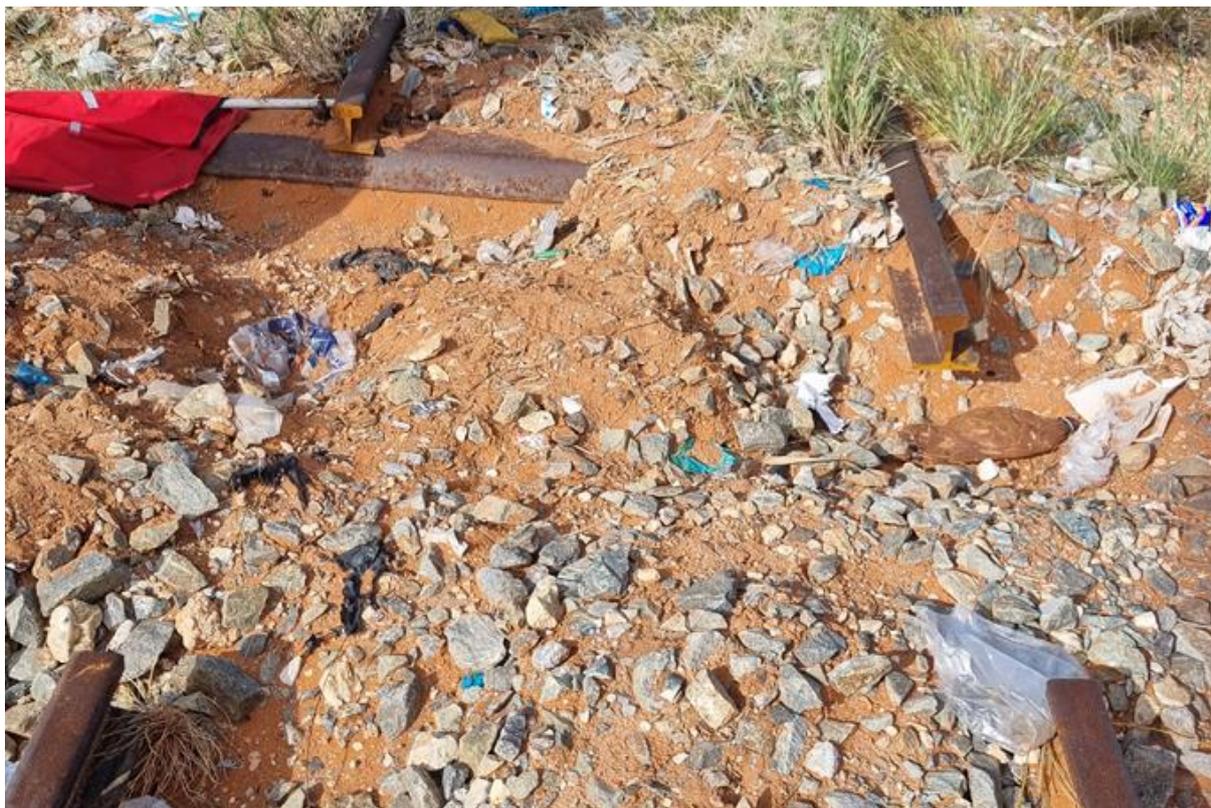
**Figure 34: Stolen rails, sleepers and fishplates at km 7**

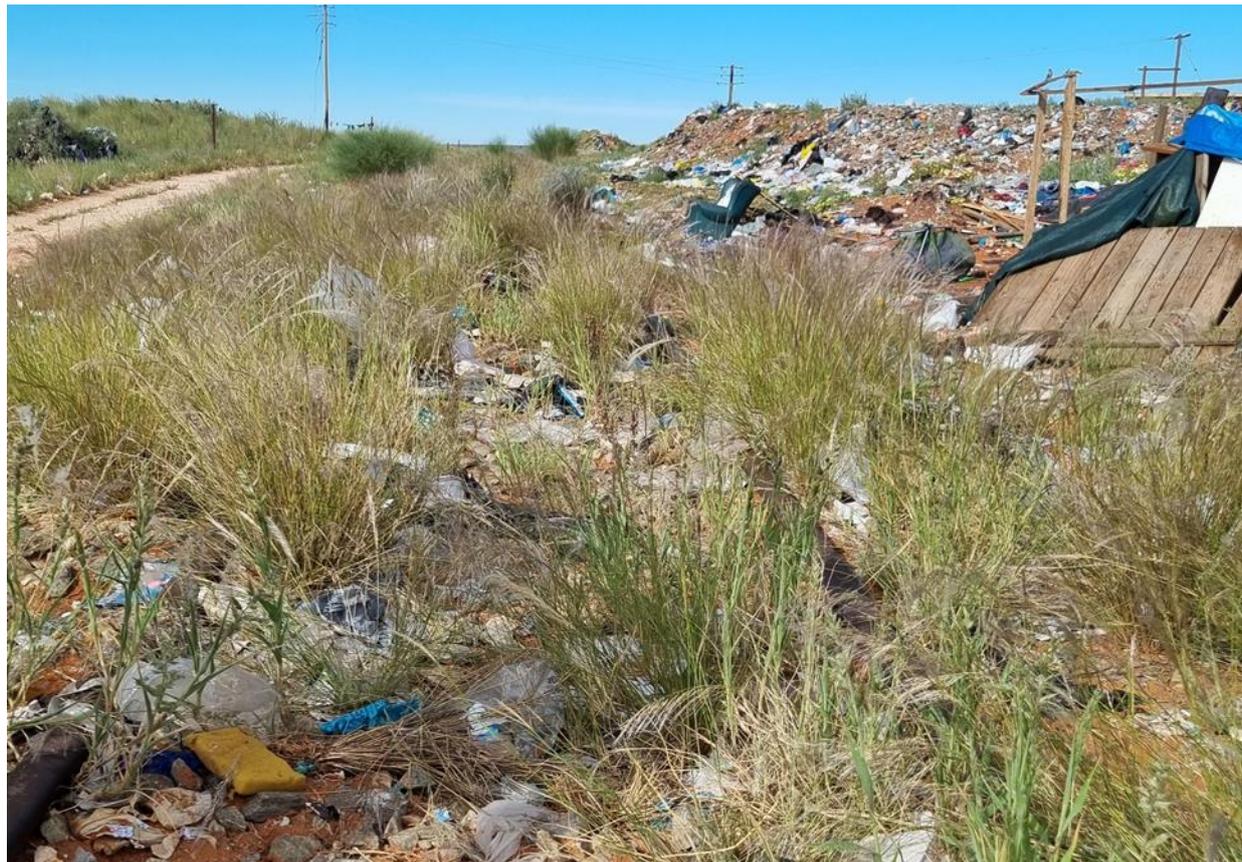
**Figure 35: Illegal dump adjacent to the track at km 7**

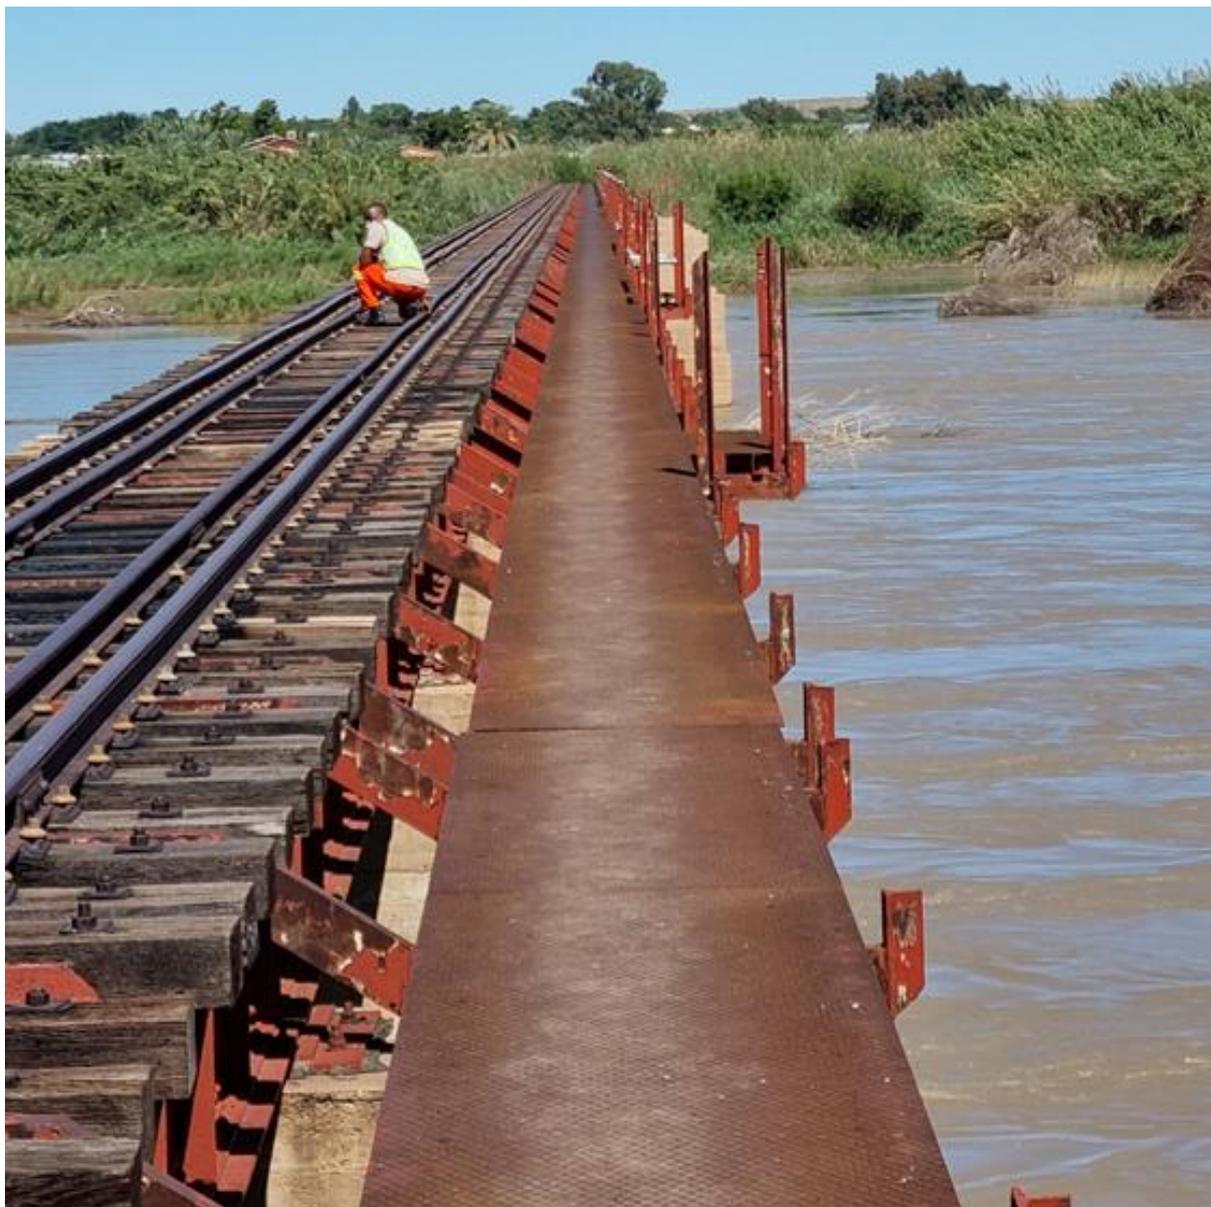
**Figure 36: Handrails stolen along the Kakamas Bridge**

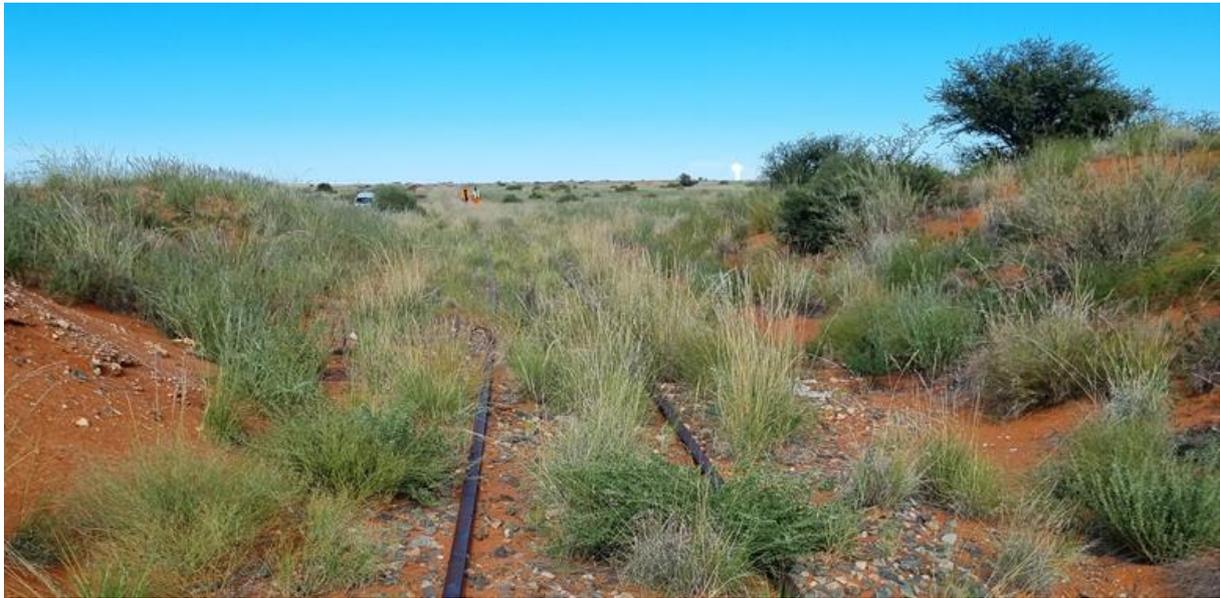
**Figure 37: Overgrown vegetation at km 4**

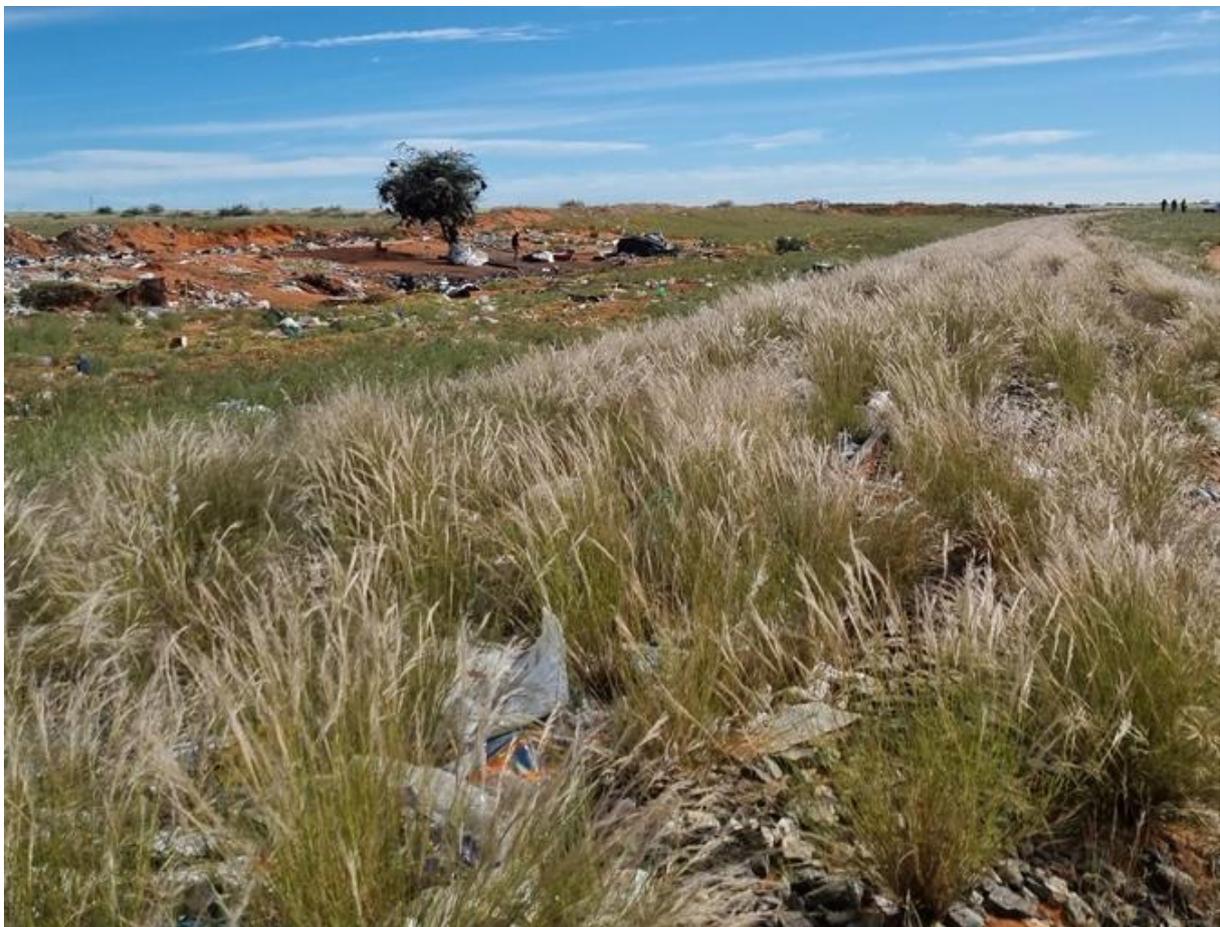
**Figure 38: Overgrown vegetation at km 8**

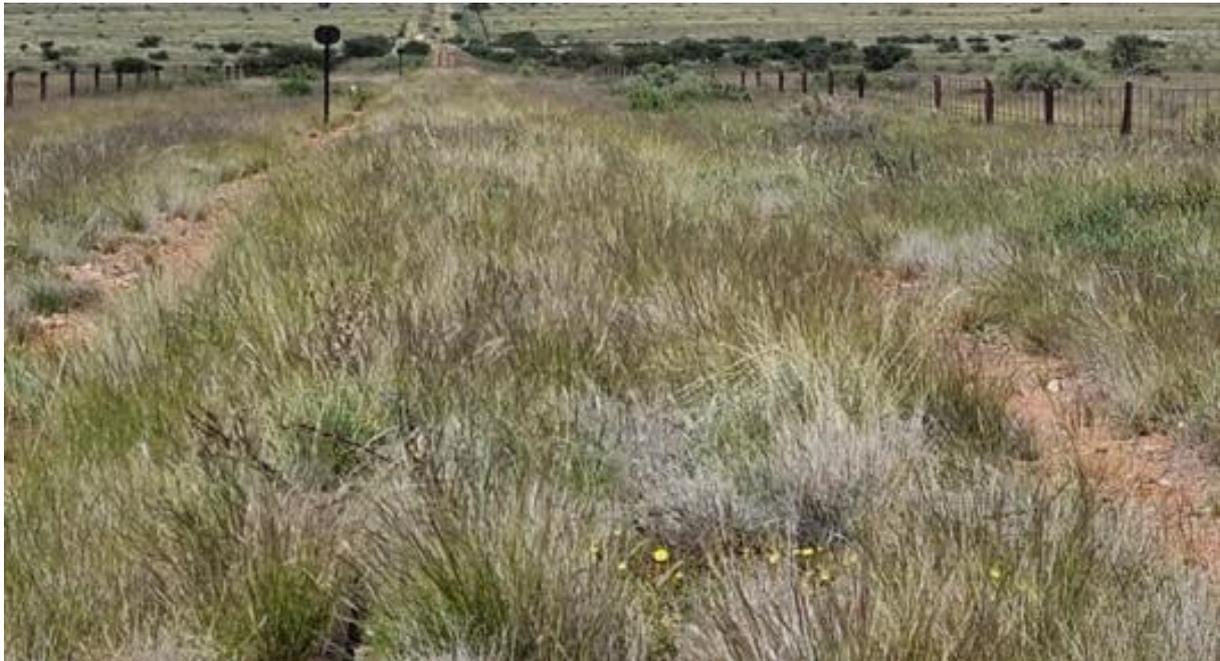
**Figure 39: Overgrown vegetation at km 22**

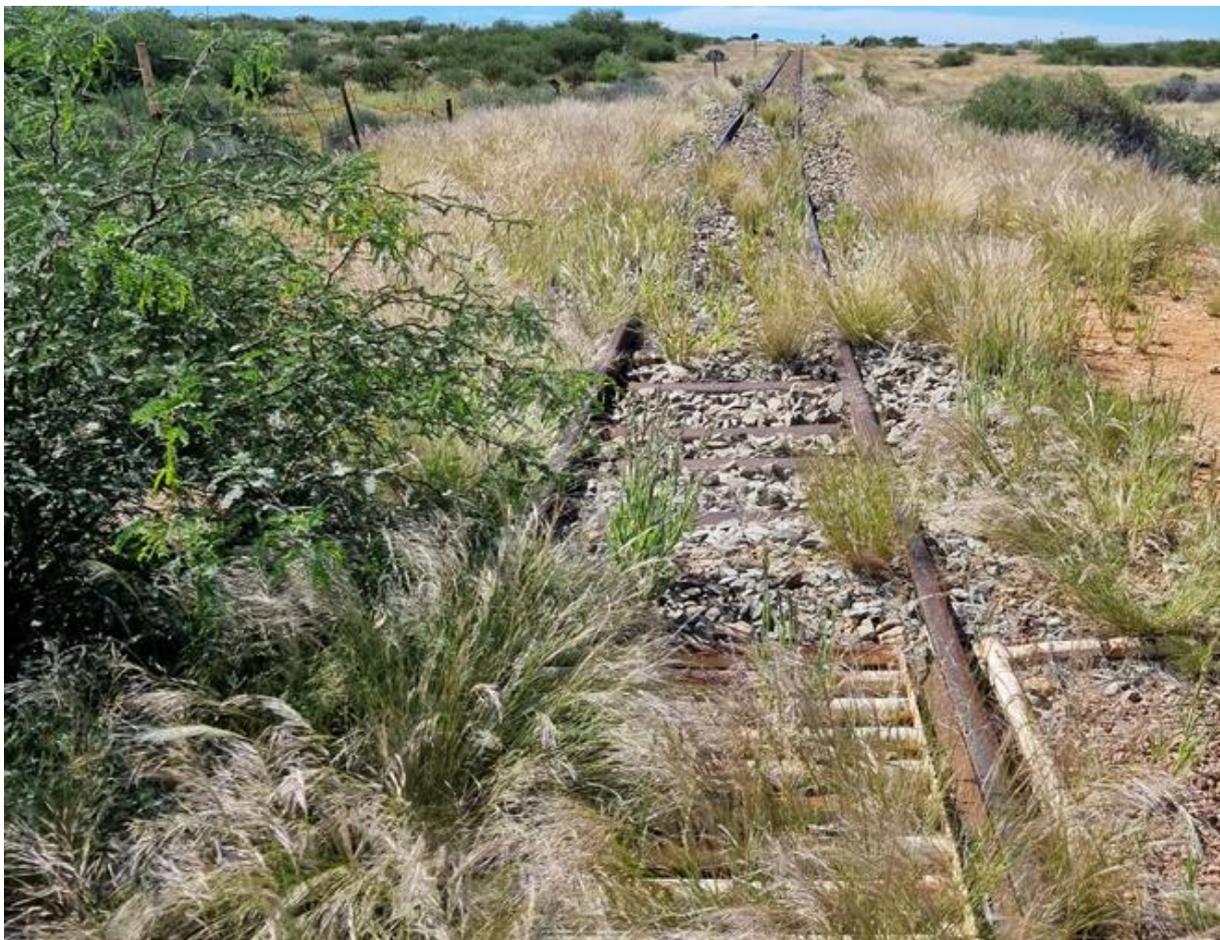
**Figure 40: Overgrown vegetation at km 27**

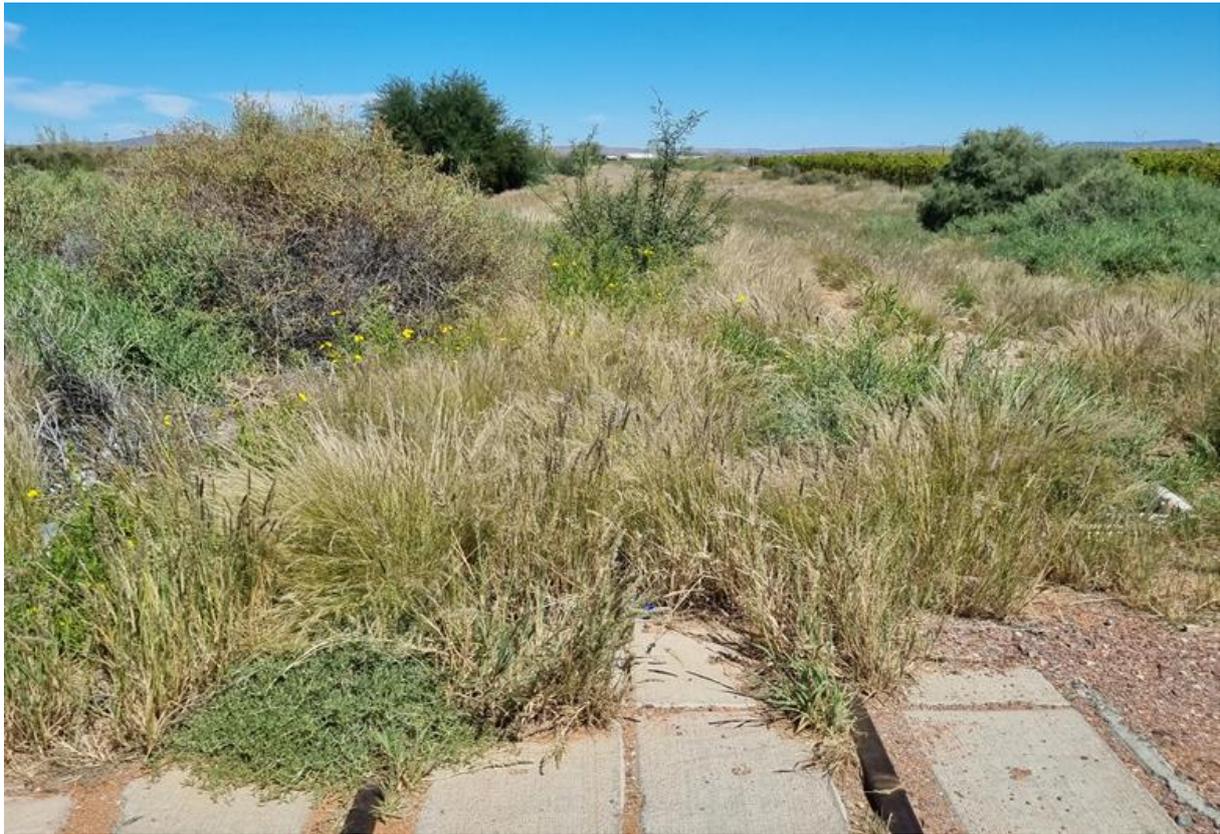
**Figure 41: Overgrown vegetation, trees growing in the centre and adjacent to the track at km42**

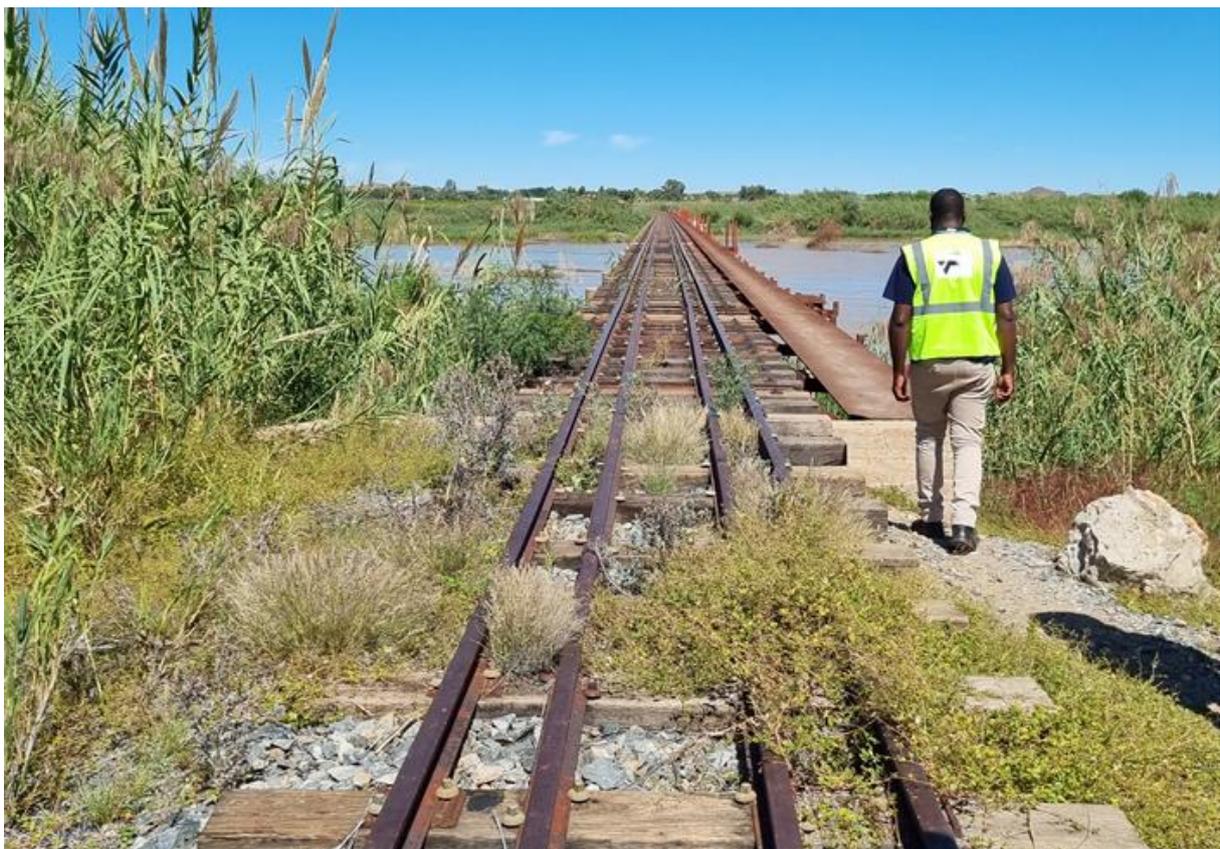
**Figure 42: Overgrown vegetation before the Kakamas Bridge**
