Geotechnical Investigation Report

Investigation for the Proposed Watermain

from Blackburn Reservoir to Phoenix 1

Reservoir Supply Area

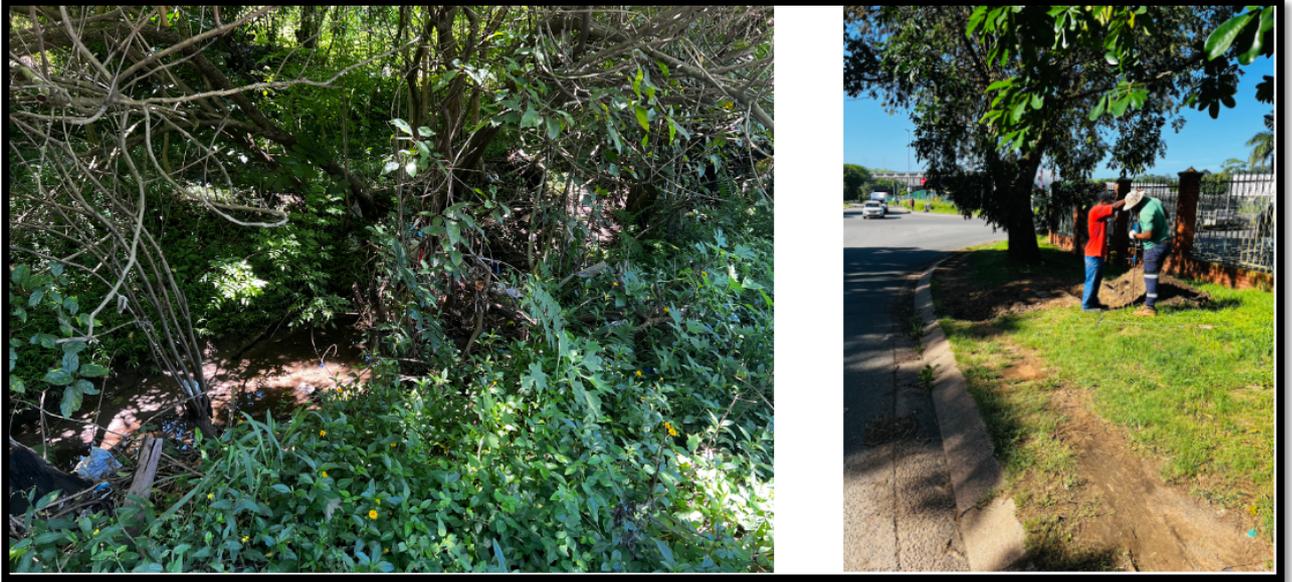
Figure 2: Showing the vegetation cover, stream, and the road within the pipe route.

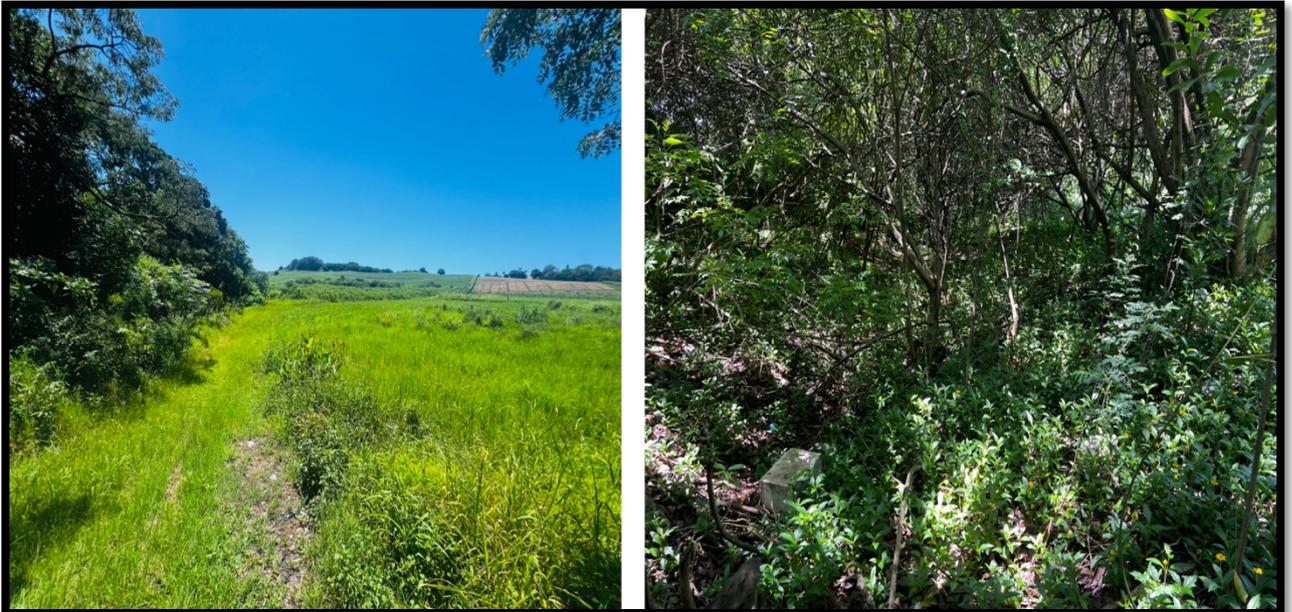
Figure 3: Showing the vegetation cover within the pipe route.

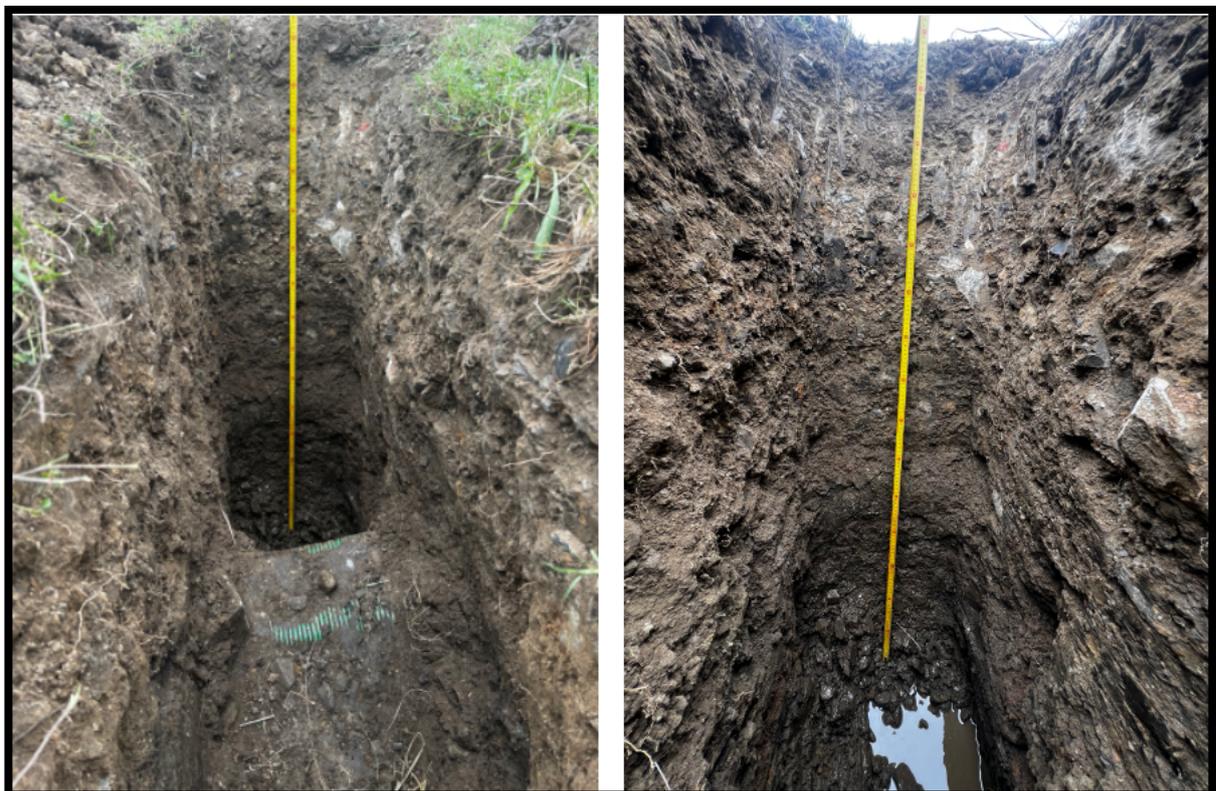
The area is heavily saturated with a variety of underground utilities, including water pipelines, electrical cables, and fibre optic lines, particularly between TP7 and TP29. This significantly complicates excavation activities, requiring careful attention due to the sensitivity of these existing services.

NB: It was difficult to excavate between TP7 and TP29 at the site due to the underground services, including water pipelines, electrical cables, and fibre optic lines, Figure 9 below shows the exposed cables inside the test pit and underground water seepage. Test pit 6 showing the stable test pit walls excavated at the site. The summary of test pit lithology is given in Table 2 below.

Figure 9: Showing the exposed cables inside the test pit and underground water seepage conservatively.

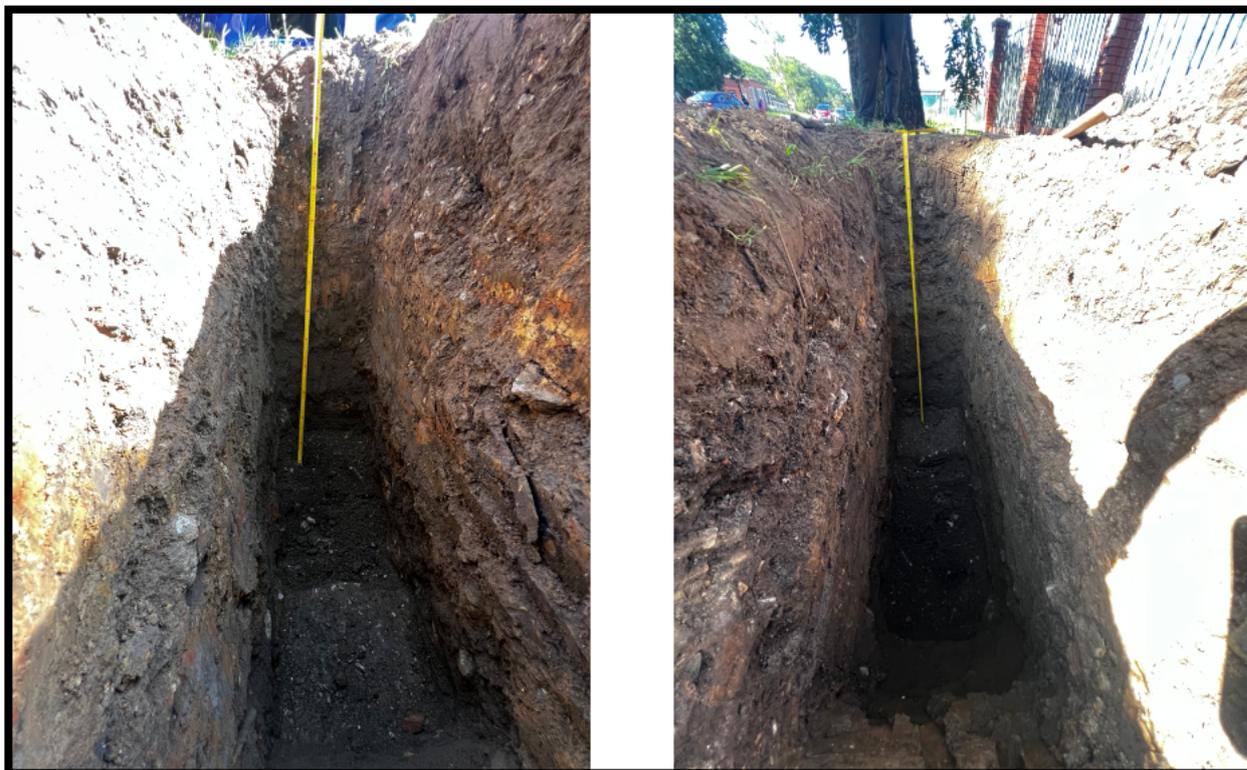
Figure 10: showing the stable test pit walls excavated at the site.

In general, it is expected that the vertical sidewalls of trench excavations will remain stable under typical conditions. However, should any areas of instability arise during excavation, it is important to address these promptly to maintain safety and structural integrity. For trenches with a depth not exceeding 1.0 m, they can generally remain open for periods up to 24 hours without significant risk of collapse, assuming there are no significant rainfall events or associated increases in groundwater seepage during this time frame.

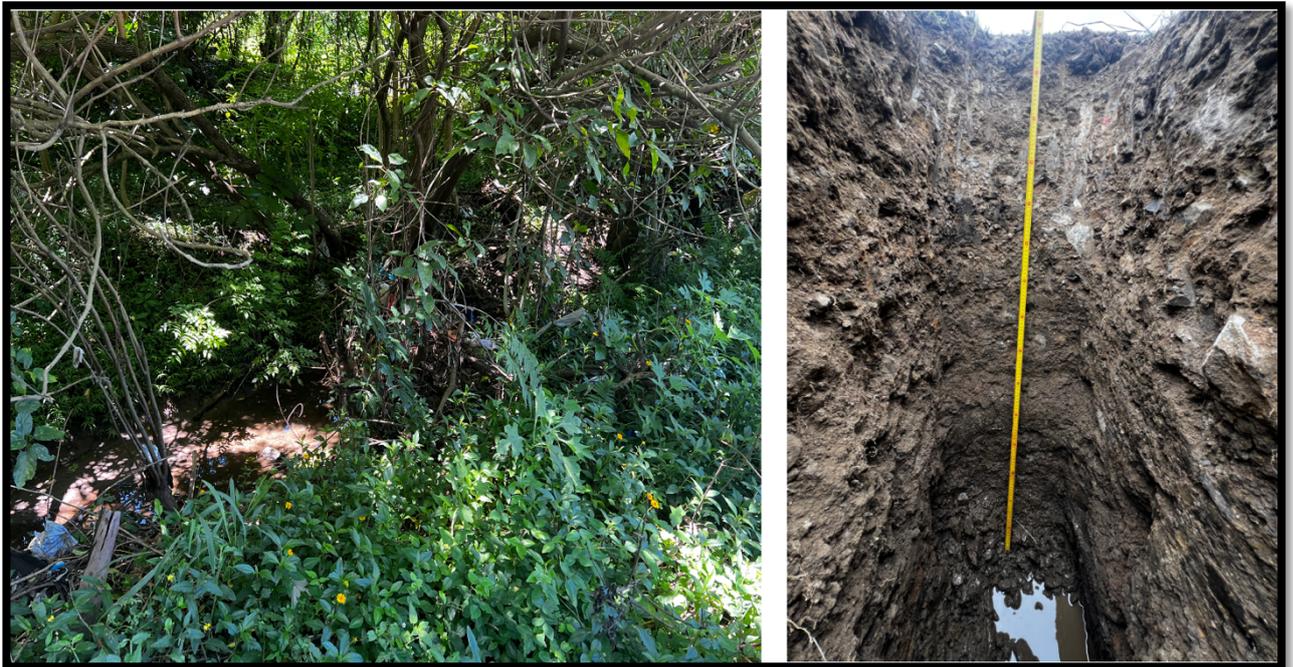
Groundwater seepage and the water table were intercepted at TP4, TP5, TP7, and TP29. Additionally, there are stream crossings between test pits 7 and test pits 8, 4 and 5, and between test pits 6 and 7, where the pipeline runs adjacent to the stream. Consequently, water issues are expected at various locations along the pipeline, particularly during the rainy season. Figure 11 below shows the water in a stream intercepted along the pipeline as well as the groundwater in test pit 29.

Figure 11: Showing the water in a stream intercepted along the pipeline as well as the groundwater seepage in a test pit.
