Title: **Roof and Ceiling Repairs of the Maintenance Service (MSB) Complex**

Document Identifier: **331-619**

REPAIR OF ROOF CLADDING RECOMMENDATION (S) FOR THE MAINTENANCE SERVICE COMPLEX (MSB)

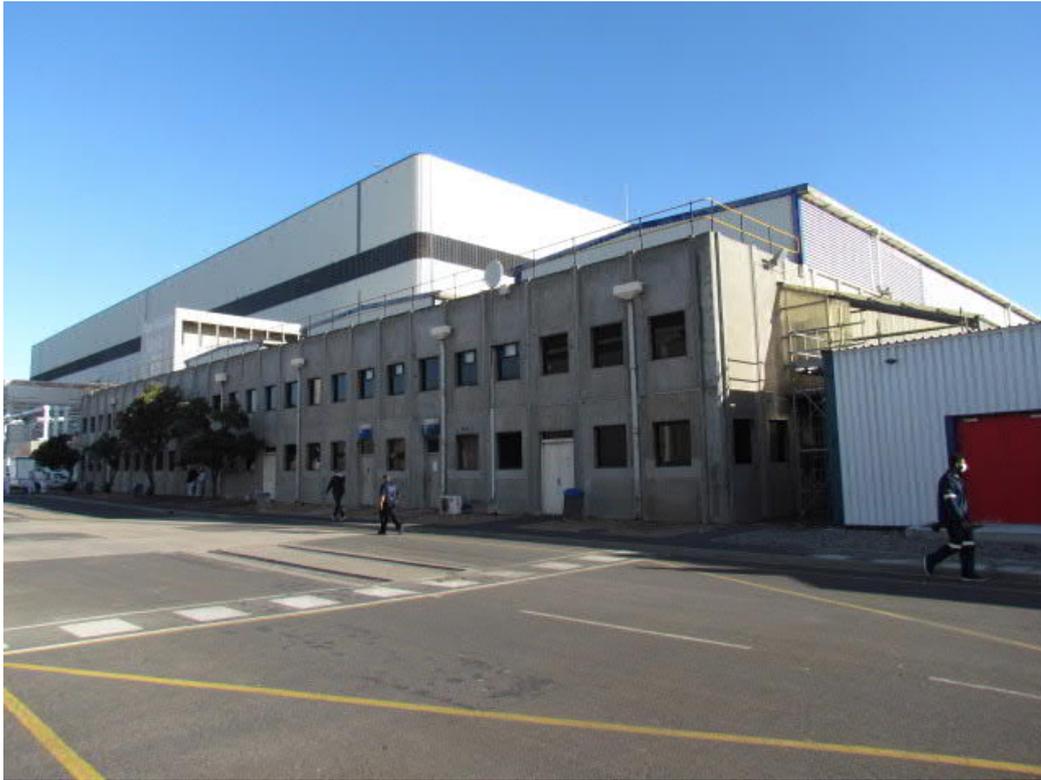
In 2010 the roof cladding was replaced. However, throughout the years, regular defects were noted on the roof cladding and by the building occupants. The main issues pointed out regarding the facility are blowing off of the roof cladding, roof water leakages, collapsing of the ceiling panels and drainage. The maintenance department has attended to the interim local roof repairs over the years, but the entire roof cladding has not been repaired as a whole since 2010. Hence, this contract seeks to restore the entire roof structure, ceiling panel and the associated roof drainage system. The following defects have been noted over the past years:

- The state of the roof cladding and fasteners has corroded beyond an acceptable condition.
- Visible water damage was observed in several ceiling panels of the complex.
- Multiple ceiling panels have caved in or collapsed due to the leaking roof cladding.
- Multiple roof gutters and downpipes are blocked, damaged and non-functional.

Figure 1: MSB Complex at Koeberg Nuclear Power Station

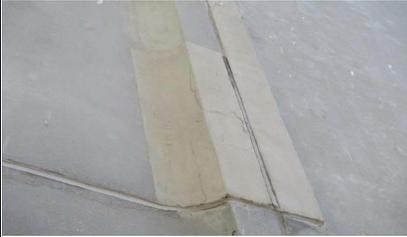
5.7					
Component defect for - Load Bearing Walls		Defect Number: 6HSM-C-001	Prior to 2016	Defect Factors	Corrective Actions SAP Number: 23994500
7.4

Delamination and repair failure noted on the pre-cast concrete wall panels caused by rebar corrosion. Most delamination has been repaired.		IF = 8	Break out all delaminated concrete and repair in accordance with Civil Maintenance Repair manual C-02A.

At various locations on the external façade of the Maintenance Service Complex.		EF = 8	
		Complexity	Moderate	DF = 10	
		Urgency	Within 1 Year	ED = 30	
				CF = 7,0	
Component defect for - Cable/Ducting/Pipes		Defect Number: 6HSM-C-004	Prior to 2016	Defect Factors	Corrective Actions SAP Number: 25424528

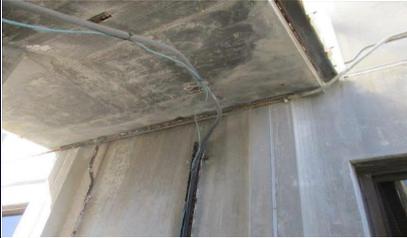
Severely corroded conduit pipes.		IF = 3	For System Engineers attention.

On the northern side below the staircase landing of the Maintenance Service Building.		EF = 8	
		Complexity	Simple	DF = 6	
		Urgency	Immediately	ED = 100	
				CF = 8,0	
Component defect for - Doors		Defect Number: 6HSM-C-005	Prior to 2016	Defect Factors	Corrective Actions SAP Number: 22757906 Xref 715895539

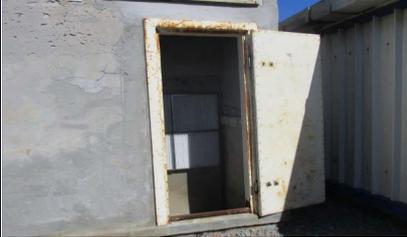
Door frame is severely corroded.		IF = 5	Coat in accordance with Eskom Procedure 331-170.

Ventilation structure on the roof of the Maintenance Service Building situated between Decon and Site Stores.		EF = 8	
		Complexity	Moderate	DF = 10	
		Urgency	Immediately	ED = 90	
				CF = 9,0

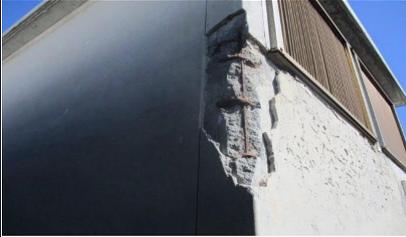
5.7					
Component defect for - Load Bearing Walls		Defect Number: 6HSM-C-006	Prior to 2016	Defect Factors	Corrective Actions SAP Number: 23994500
7.4

Large area of spalled concrete caused by rebar corrosion. The plaster covering the structure has degraded extensively in some areas.		IF = 8	Break out all delaminated concrete and repair in accordance with Civil Maintenance Repair Manual C-02A. Remove degraded plaster and reinstate to original condition.

Ventilation structure on the roof of the Maintenance Service Building situated between Decon and Site Stores.		EF = 8	
		Complexity	Moderate	DF = 10	
		Urgency	Within 1 Year	ED = 30	
				CF = 7,0	
Component defect for - Gutters/Down Pipes/Drains & Channels		Defect Number: 6HSM-C-010	Prior to 2016	Defect Factors	Corrective Actions SAP Number: 23994500

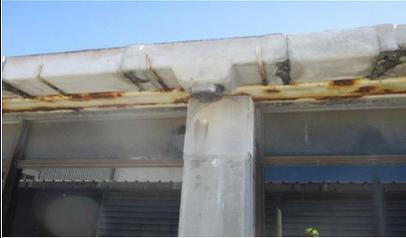
Missing downpipes.		IF = 4	Replace missing down pipes with equivalent. Ensure all stormwater is able to drain freely to catchpit areas.

Various locations on the Maintenance Service Complex roof.		EF = 8	
		Complexity	Simple	DF = 10	
		Urgency	Immediately	ED = 30	
				CF = 7,0	
Component defect for - Roof Structure		Defect Number: 6HSM-C-011	Prior to 2016	Defect Factors	Corrective Actions SAP Number: 24586571

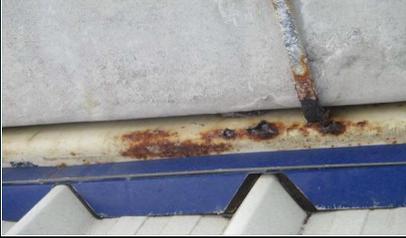
Extensive corrosion on soffit plate to which gutters are fixed.		IF = 10	Remove all corrosion from repairable plates and re-coat according to Eskom Procedure 331-170. Irreparable items to be replaced with equivalent. Return gutters to original position once repairs are complete.

Various locations on the Maintenance Service Complex roof.		EF = 8	
		Complexity	Simple	DF = 8	
		Urgency	Immediately	ED = 90	
				CF = 8,3

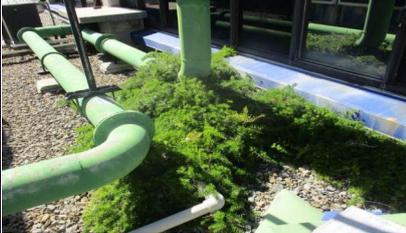
5.7				
Component defect for - Gutters/Down Pipes/Drains & Channels		Defect Number: 6HSM-C-012	Prior to 2016	Defect Factors
5.0

Extensive vegetation growth covering sections of the chipstone, impeding storm water flow.		IF = 4
		Various locations on the Maintenance Service Complex roof.		EF = 8
		Complexity	Simple	DF = 6
		Urgency	Immediately	ED = 30
				CF = 5,7
				Corrective Actions
				SAP Number: 23994500
				Remove all vegetation growth from the roof and ensure storm water is able to drain freely towards the catchpits.

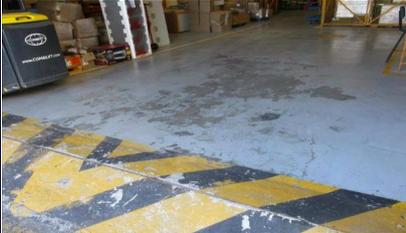
Component defect for - Stairs/Platforms/Ladders		Defect Number: 6HSM-C-014	Prior to 2016	Defect Factors

Degraded coating on landing and floor due to high traffic.		IF = 8
		On the south eastern and north western sides inside the Maintenance Service Complex and Site Store.		EF = 6
		Complexity	Simple	DF = 6
		Urgency	Within 1 Year	ED = 70
				CF = 6,3
				Corrective Actions
				SAP Number: 22895016
				Re-coat in accordance with Eskom Procedure 331-170.

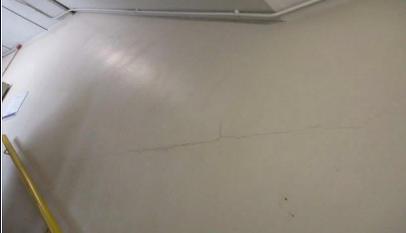
Component defect for - Load Bearing Walls		Defect Number: 6HSM-C-015	Prior to 2016	Defect Factors

Horizontal and vertical cracks < 0.5mm in width.		IF = 8
		On the southern side of the building, adjacent to fire door 6JFD008DF along stairwell leading down to the -2.00m level.		EF = 6
		Complexity	Not Applicable	DF = 6
		Urgency	No action required	ED = 15
				CF = 4,5
				Corrective Actions
				SAP Number: N/A
				No action required. Defect does not affect structural integrity of the wall.

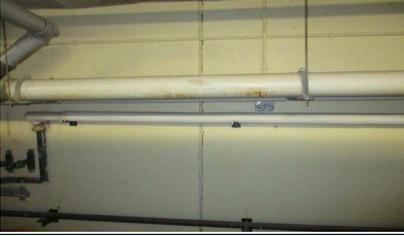
5.7					
Component defect for - Joint/Seal		Defect Number: 6HSM-C-016	Prior to 2016	Defect Factors	Corrective Actions SAP Number: 23994309
5.0

Construction joint on concrete wall has degraded.		IF = 4	Repair according to Civil Maintenance Repair Manual J-03.

On the -2.00m level of the Maintenance Service Complex building, along the western wall of the gallery.		EF = 6	
		Complexity	Simple	DF = 6	
		Urgency	Within 1 Year	ED = 50	
				CF = 5.7	
Component defect for - Gutters/Down Pipes/Drains & Channels		Defect Number: 6HSM-C-017	Prior to 2016	Defect Factors	Corrective Actions SAP Number: 23994309

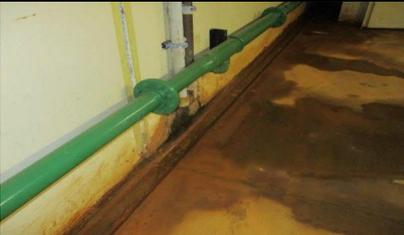
Blocked channel due to a build up of sludge.		IF = 4	Source of leakage to be identified and repaired. All sludge and debris to be removed from channel. Ensure water is able to flow freely along channel.

On the -2.00m level of the Maintenance Service Complex building along the western wall of the gallery.		EF = 6	
		Complexity	Simple	DF = 8	
		Urgency	Immediately	ED = 70	
				CF = 7.0	
Component defect for - Joint/Seal		Defect Number: 6HSM-C-018	Prior to 2016	Defect Factors	Corrective Actions SAP Number: 23994309

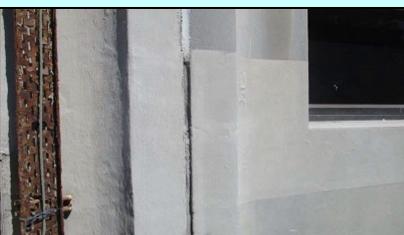
Joint sealant between the pre-cast concrete wall panels has degraded.		IF = 4	Degraded sealant to be removed. Joint to be resealed with Sikaflex-1a non-sag elastomeric sealant.

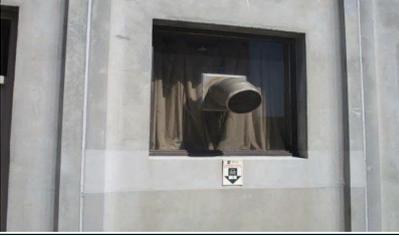
5.7				
Component defect for - Windows		Defect Number: 6HSM-C-019	Prior to 2016	Defect Factors
6.8

Cracked window pane.		IF = 5
		Eastern side of the Maintenance Service complex, between the Medical Centre and Whole Body Count room.		EF = 8
		Complexity	Simple	ED = 80
		Urgency	Immediately	CF = 8,0
Corrective Actions		SAP Number: 23994309		
		Replace cracked window pane with equivalent and in accordance with SANS 10400 N.B.R.

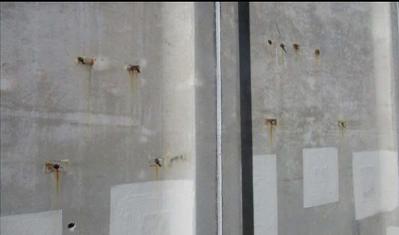
Component defect for - Load Bearing Walls		Defect Number: 6HSM-C-020	Prior to 2016	Defect Factors

Obsolete anchors in wall have corroded extensively. The corroded anchors could eventually cause concrete delamination.		IF = 8
		Northern and western sides of the Maintenance Service Complex.		EF = 8
		Complexity	Simple	ED = 20
		Urgency	Within 1 Year	CF = 6,0
Corrective Actions		SAP Number: 23994309		
		Obsolete anchors to be removed and the holes to be repaired with Sika Rep LW repair mortar.

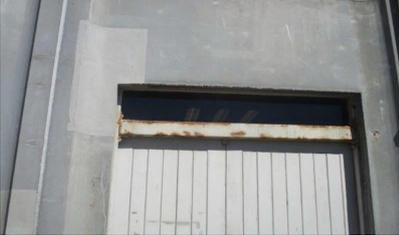
Component defect for - Doors		Defect Number: 6HSM-C-021	Prior to 2016	Defect Factors

Repaired door and frame have started to corrode again.		IF = 5
		On the south eastern and northern sides of the Maintenance Service Complex.		EF = 8
		Complexity	Simple	ED = 20
		Urgency	Within 1 Year	CF = 6,0
Corrective Actions		SAP Number: 24586572		
		Remove all corrosion and re-coat in accordance with Eskom Procedure 331-170.

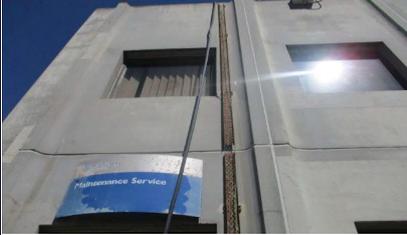
5.7					
Component defect for - Cable/Ducting/Pipes		Defect Number: 6HSM-C-022	Prior to 2016	Defect Factors	Corrective Actions SAP Number: 24586573
5.2

Cable tray is severely corroded. Cable hanging loose outside cable tray.		IF = 3	For System Engineers attention.

On the south and east sides of the Maintenance Service Complex.		EF = 8	
		Complexity	Simple	ED = 60	
		Urgency	Immediately	CF = 6,7	
Component defect for - Load Bearing Walls		Defect Number: 6HSM-C-023	Prior to 2016	Defect Factors	Corrective Actions SAP Number: 23994405

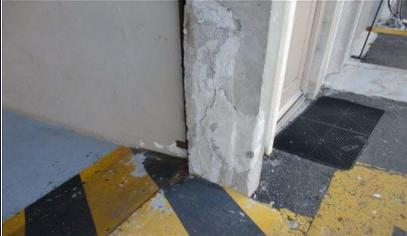
Previous patch repairs are cracking and delaminating. Impact damage noted in places.		IF = 8	Remove all previous repair material. Repair concrete in accordance with Civil Maintenance Repair Manual C-02A.

On the western side by the entrance to MMS and Site Store of the Maintenance Service Complex.		EF = 8	
		Complexity	Moderate	ED = 20	
		Urgency	Within 1 Year	CF = 6,0	
Component defect for - Cable/Ducting/Pipes		Defect Number: 6HSM-C-025	Prior to 2016	Defect Factors	Corrective Actions SAP Number: 23994410

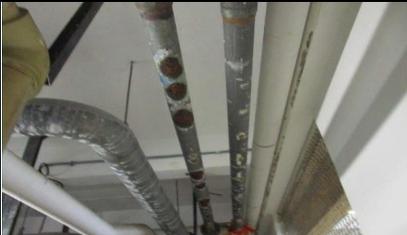
Severe localized corrosion has created holes in the steel DVA pipes allowing water to leak out .		IF = 8	For System Engineers attention.

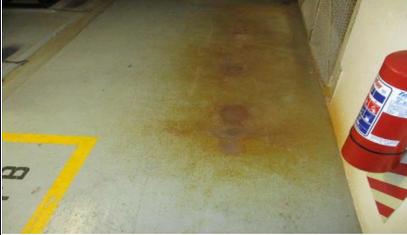
5.7					
Component defect for - Slabs Suspended		Defect Number: 6HSM-C-026	Prior to 2016	Defect Factors	Corrective Actions SAP Number: 23994405
6.8

Corrosion staining on the floor caused by corroding steel pipes overhead.		IF = 10	Re-coat affected area in accordance with Eskom Procedure 331-170 once pipes have been repaired.

On the +3.00m level, site store area of the Maintenance Service Complex.		EF = 6	
		Complexity Simple		DF = 6	
		Urgency Within 1 Year		ED = 20	
				CF = 4,7	
Component defect for - Louvres/Vents		Defect Number: 6HSM-C-027	Prior to 2016	Defect Factors	Corrective Actions SAP Number: 24676601

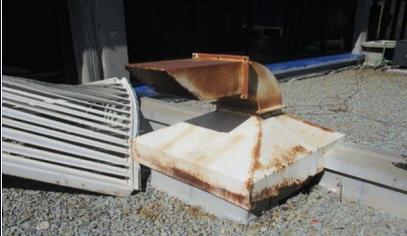
Extensively corroded vent exhaust and aircon unit.		IF = 6	Remove corrosion and re-coat in accordance with Eskom Procedure 331-170. Irreparable items to be replaced with equivalent.

On the roof of the Maintenance Service Complex.		EF = 8	
		Complexity Simple		DF = 8	
		Urgency Immediately		ED = 80	
				CF = 8,0	
Component defect for - Gutters/Down Pipes/Drains & Channels		Defect Number: 6HSM-C-028	Prior to 2016	Defect Factors	Corrective Actions SAP Number: 23994405

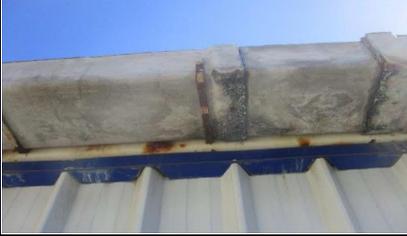
Metal brackets supporting gutters are severely corroded.		IF = 4	Remove corrosion from repairable items and re-coat in accordance with Eskom Procedure 331-170. Irreparable items to be replaced with galvanized equivalent.

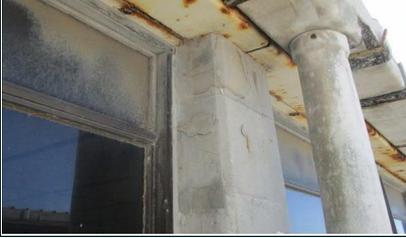
5.7					
Component defect for - Columns		Defect Number: 6HSM-C-029	Prior to 2016	Defect Factors	Corrective Actions SAP Number: 23994405
7.6

Delaminating concrete on column.		IF = 10	Break out delaminating concrete and repair in accordance with Civil Maintenance Repair Manual C-02A.

On the roof of the Maintenance Service Complex.		EF = 8	
				DF = 8	
		Complexity	Moderate	ED = 20	
		Urgency	Immediately	CF = 6.0	
Component defect for - Columns		Defect Number: 6HSM-C-030	Prior to 2016	Defect Factors	Corrective Actions SAP Number: 23994405

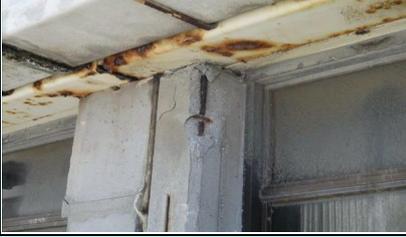
Spalled concrete caused by rebar corrosion.		IF = 10	Break out loose concrete, remove corrosion from rebar and repair in accordance with Civil Maintenance Repair Manual C-02A.

On the roof of the Maintenance Service Complex.		EF = 8	
				DF = 10	
		Complexity	Moderate	ED = 10	
		Urgency	Immediately	CF = 6.3	
Component defect for - Stairs/Platforms/Ladders		Defect Number: 6HSM-C-031	Prior to 2016	Defect Factors	Corrective Actions SAP Number: 24676601

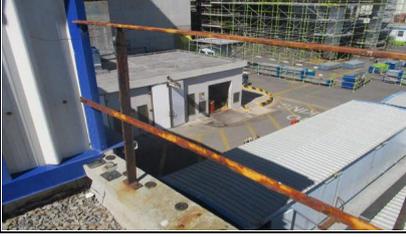
Balustrade is extensively corroded.		IF = 8	Remove corrosion and re-coat in accordance with Eskom Procedure 331-170. Irreparable items to be replaced with equivalent.

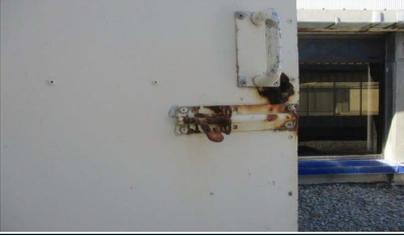
5.7						
Component defect for - Doors		Defect Number: 6HSM-C-032	Prior to 2016	Defect Factors	Corrective Actions X-Ref 715895539	
6.8

Metal door has large hole behind handle caused by corrosion. Sliding bolt corroded.		IF = 5	Remove door handle and corrosive product from door. Weld a suitable metal plate over damaged section of the door and re-coat in accordance with Eskom Procedure 331-170. Reinstall door handle and fit new sliding bolt.

On the roof of the Maintenance Service Complex.		EF = 8		
		Complexity		Simple		DF = 8
		Urgency		Immediately		ED = 80
						CF = 8,0
Component defect for - Foundation Walls/Bases/Plinths/Anchors		Defect Number: 6HSM-C-033	Prior to 2016	Defect Factors	Corrective Actions SAP Number: 24676601

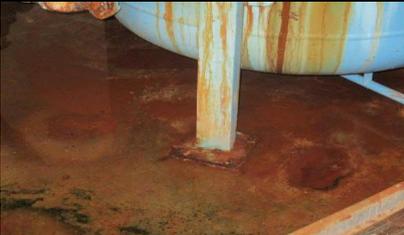
Base plate and anchor bolts supporting tank are severely corroded.		IF = 10	Remove corrosion from base plate and re-coat in accordance with Eskom Procedure 331-170. Replace anchor bolts with equivalent and cover with denso tape.

On the -2.00m level of the Maintenance Service Complex along the eastern wall of the gallery.		EF = 6		
		Complexity		Simple		DF = 8
		Urgency		Immediately		ED = 70
						CF = 7,0
Component defect for - Beams/Struts & Ties		Defect Number: 6HSM-C-034	Prior to 2016	Defect Factors	Corrective Actions SAP Number: 24676601

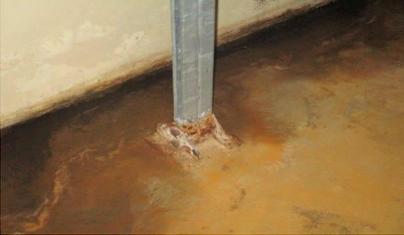
Cable tray support stanchions are severely corroded.		IF = 10	Remove corrosion from stanchions and re-coat in accordance with Eskom Procedure 331-170. Remove one anchor bolt for inspection. Replace bolts if condition is unacceptable.

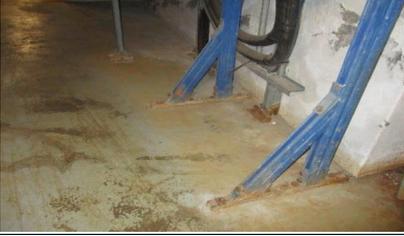
5.7					
Component defect for - Beams/Struts & Ties		Defect Number: 6HSM-C-035	Prior to 2016	Defect Factors	Corrective Actions SAP Number: 24676601
7.6

Halfen rails and anchor bolts supporting electrical box are corroded.		IF = 10	Remove all corrosion from rails and re-coat in accordance with Eskom Procedure 331-170. Remove one anchor bolt for inspection. Replace bolts if condition is unacceptable.

On the -2.00m level of the Maintenance Service Complex along the western wall of the gallery.		EF = 6	
		Complexity	Simple	DF = 8	
		Urgency	Immediately	ED = 40	
				CF = 6.0	
Component defect for - Ceilings		Defect Number: 6HSM-C-037	Identified: 2017 Q4	Defect Factors	Corrective Actions SAP Number: 24676602

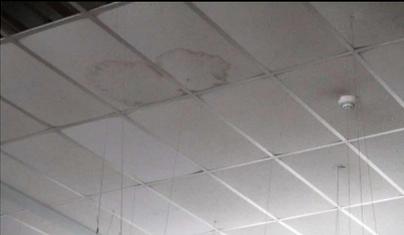
Leaking in various areas is causing extensive damage to ceilings and office equipment.		IF = 8	Locate source of the leaks and repair. Damaged ceiling panels to be replaced with equivalent once all leaks have been repaired.

Above radiation protection offices.		EF = 4	
		Complexity	Moderate	DF = 10	
		Urgency	Immediately	ED = 60	
				CF = 6.7	
Component defect for - Ceilings		Defect Number: 6HSM-C-039	Identified: 2017 Q4	Defect Factors	Corrective Actions SAP Number: 25004627

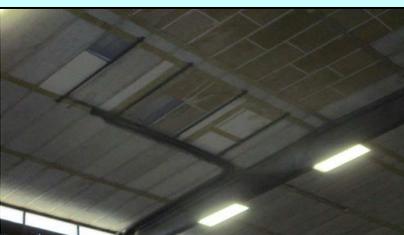
Loose ceiling boards. Risk of personnel being injured and damage to equipment.		IF = 8	Reinstate all loose ceiling boards to original position. Damaged ceiling boards or support framework to be replaced with equivalent.

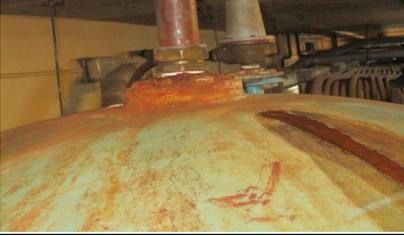
5.7					
Component defect for - Other		Defect Number: 6HSM-C-040 Identified: 2017 Q4	Defect Factors	Corrective Actions	SAP Number: 24890712
7.8

Component on top of tank is severely corroded.	IF = 8	For System Engineers attention.

On the -2.00m level of the Maintenance Service Complex along the eastern wall of the gallery.	EF = 6		
			DF = 8		
			Complexity: Simple		
Urgency: Immediately	CF = 7,7				
Component defect for - Other		Defect Number: 6HSM-C-041 Identified: 2017 Q4	Defect Factors	Corrective Actions	SAP Number: 24676604

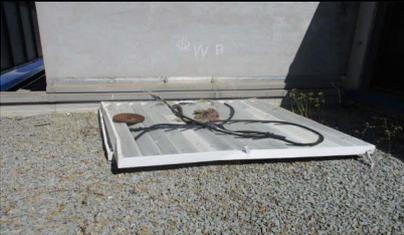
Poor housekeeping. Loose steel components have been left lying on the roof. Strong winds could blow the components off the roof. Risk of personnel being injured.	IF = 10	All loose steel components and debris to be removed.

On the roof of the Maintenance Service Complex.	EF = 8		
			DF = 10		
			Complexity: Simple		
Urgency: Immediately	CF = 9,3				
Component defect for - Other		Defect Number: 6HSM-C-042 Identified: 2017 Q4	Defect Factors	Corrective Actions	SAP Number: 24507059 24509869

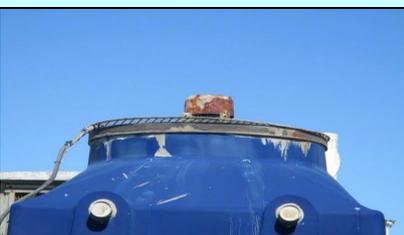
Motor on the cooling tower is extensively corroded.	IF = 8	For System Engineers attention.

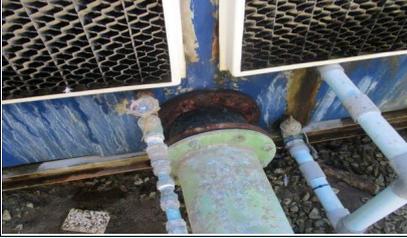
5.7					
Component defect for - Other		Defect Number: 6HSM-C-043 Identified: 2017 Q4	Defect Factors	Corrective Actions	SAP Number: 24507059 24509969
7.0

Flange on the cooling Tower is severely corroded.	IF = 6	For System Engineers attention.

On the roof of the Maintenance Service Complex.	EF = 8		
			DF = 8		
		Complexity	Simple		
		Urgency	Immediately	CF = 7,7	
Component defect for - Doors		Defect Number: 6HSM-C-045 Identified: 2020 Q3	Defect Factors	Corrective Actions	SAP Number: 25429485

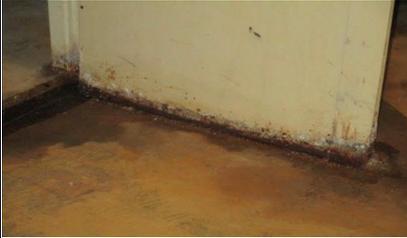
Bottom section of door is extensively corroded.	IF = 5	Remove corrosion and re-coat in accordance with Eskom Procedure 331-170. Irreparable items to be replaced with equivalent

On the -2.00m level of the Maintenance Service Complex, on the northern end of the gallery.	EF = 6		
			DF = 8		
		Complexity	Moderate		
		Urgency	Immediately	CF = 5,7	
Component defect for - Stabs on Fill		Defect Number: 6HSM-C-048 Identified: 2020 Q3	Defect Factors	Corrective Actions	SAP Number: 25429486

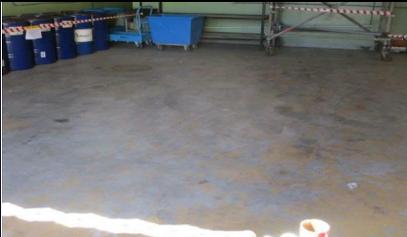
Floor Coating has deteriorated.	IF = 6	Remove degraded coating and re-coat in accordance with Eskom Procedure 331-170.

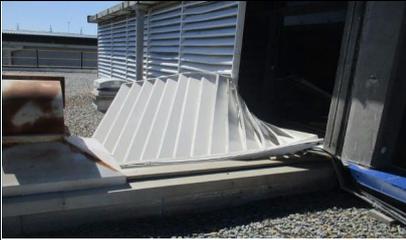
5.7				
Component defect for - Louvres/Vents		Defect Number: 6HSM-C-049 Identified: 2021 Q3	Defect Factors	Corrective Actions SAP Number:
8.0

Steel louvre has dislodged from original position and is damaged. This is a safety concern as strong winds could blow the louvre off the roof, endangering personnel walking below	IF = 6	Reinstate louvre to original position. Irreparable items to be replaced with equivalent.

On the roof between the Site Store and Decon Workshop.	EF = 8	
			DF = 10	
		Complexity Simple	ED = 100	
		Urgency Immediately	CF = 9,3	
Component defect for - Gutters/Down Pipes/Drains & Channels		Defect Number: 6HSM-C-050 Identified: 2021 Q3	Defect Factors	Corrective Actions SAP Number:

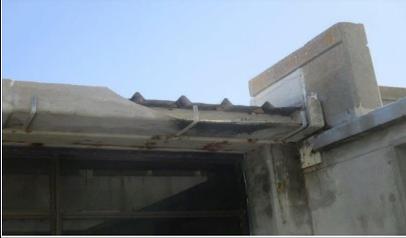
Section of gutter is broken.	IF = 4	Replace damaged section of gutter with equivalent.

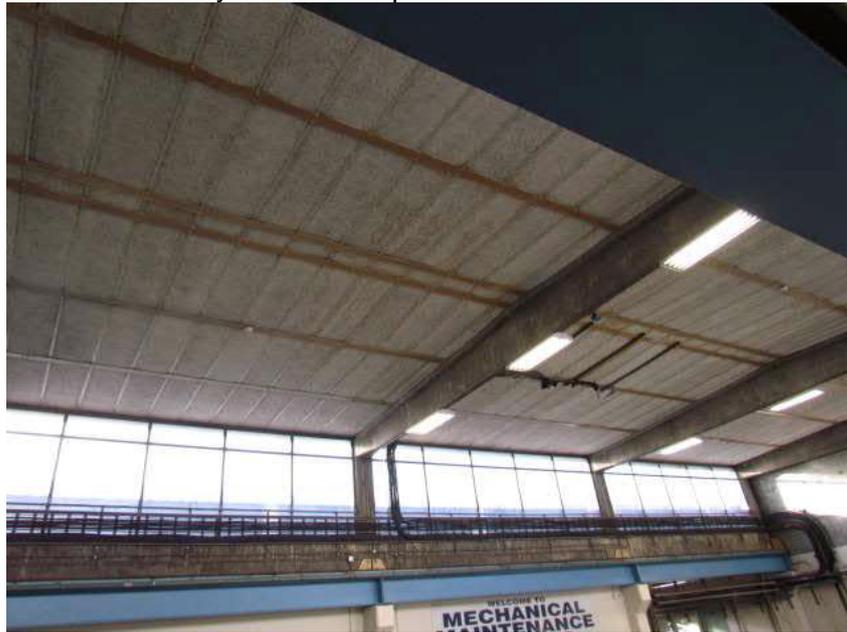
- From the walk down, it was evident that the state of the roof cladding and fixing components has corroded beyond an acceptable state.

Figure 1. The general condition of the internal roof structure

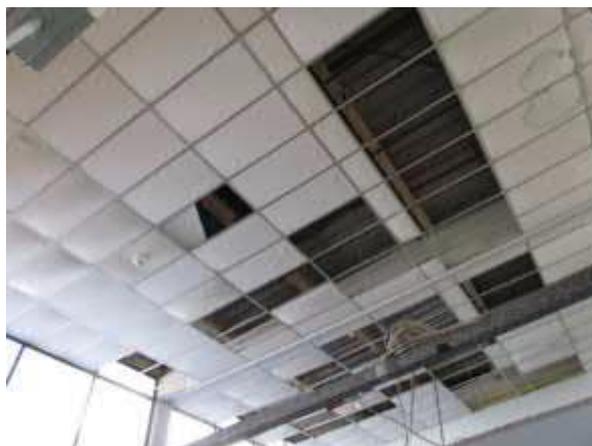
- Visible water damage was observed in several ceiling panels of the complex. Multiple ceiling panels have caved in or collapsed due to the leaking roof cladding.

Figure 2. Damaged ceiling panels

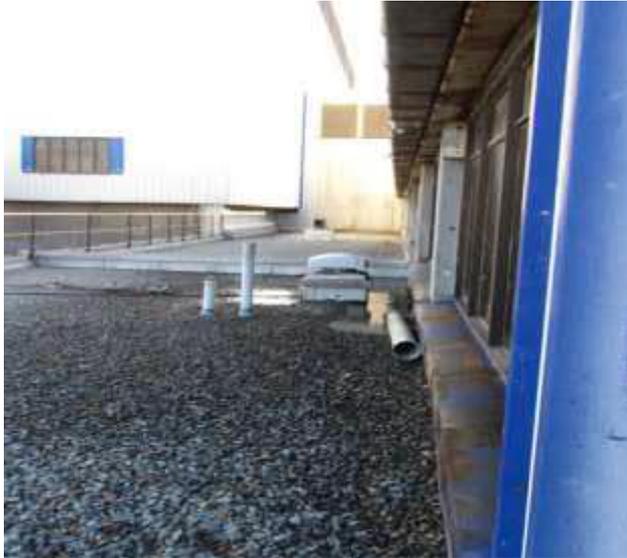
- The walk down also revealed that multiple roof gutters and downpipes are blocked or damaged and non-functional.

Figure 3. Damaged roof drainage system
