## REQUEST FOR BID CIDB

### 10397088 – Scope of Work

Repair all non-compliance at no.1 Control room as per Scope Below:

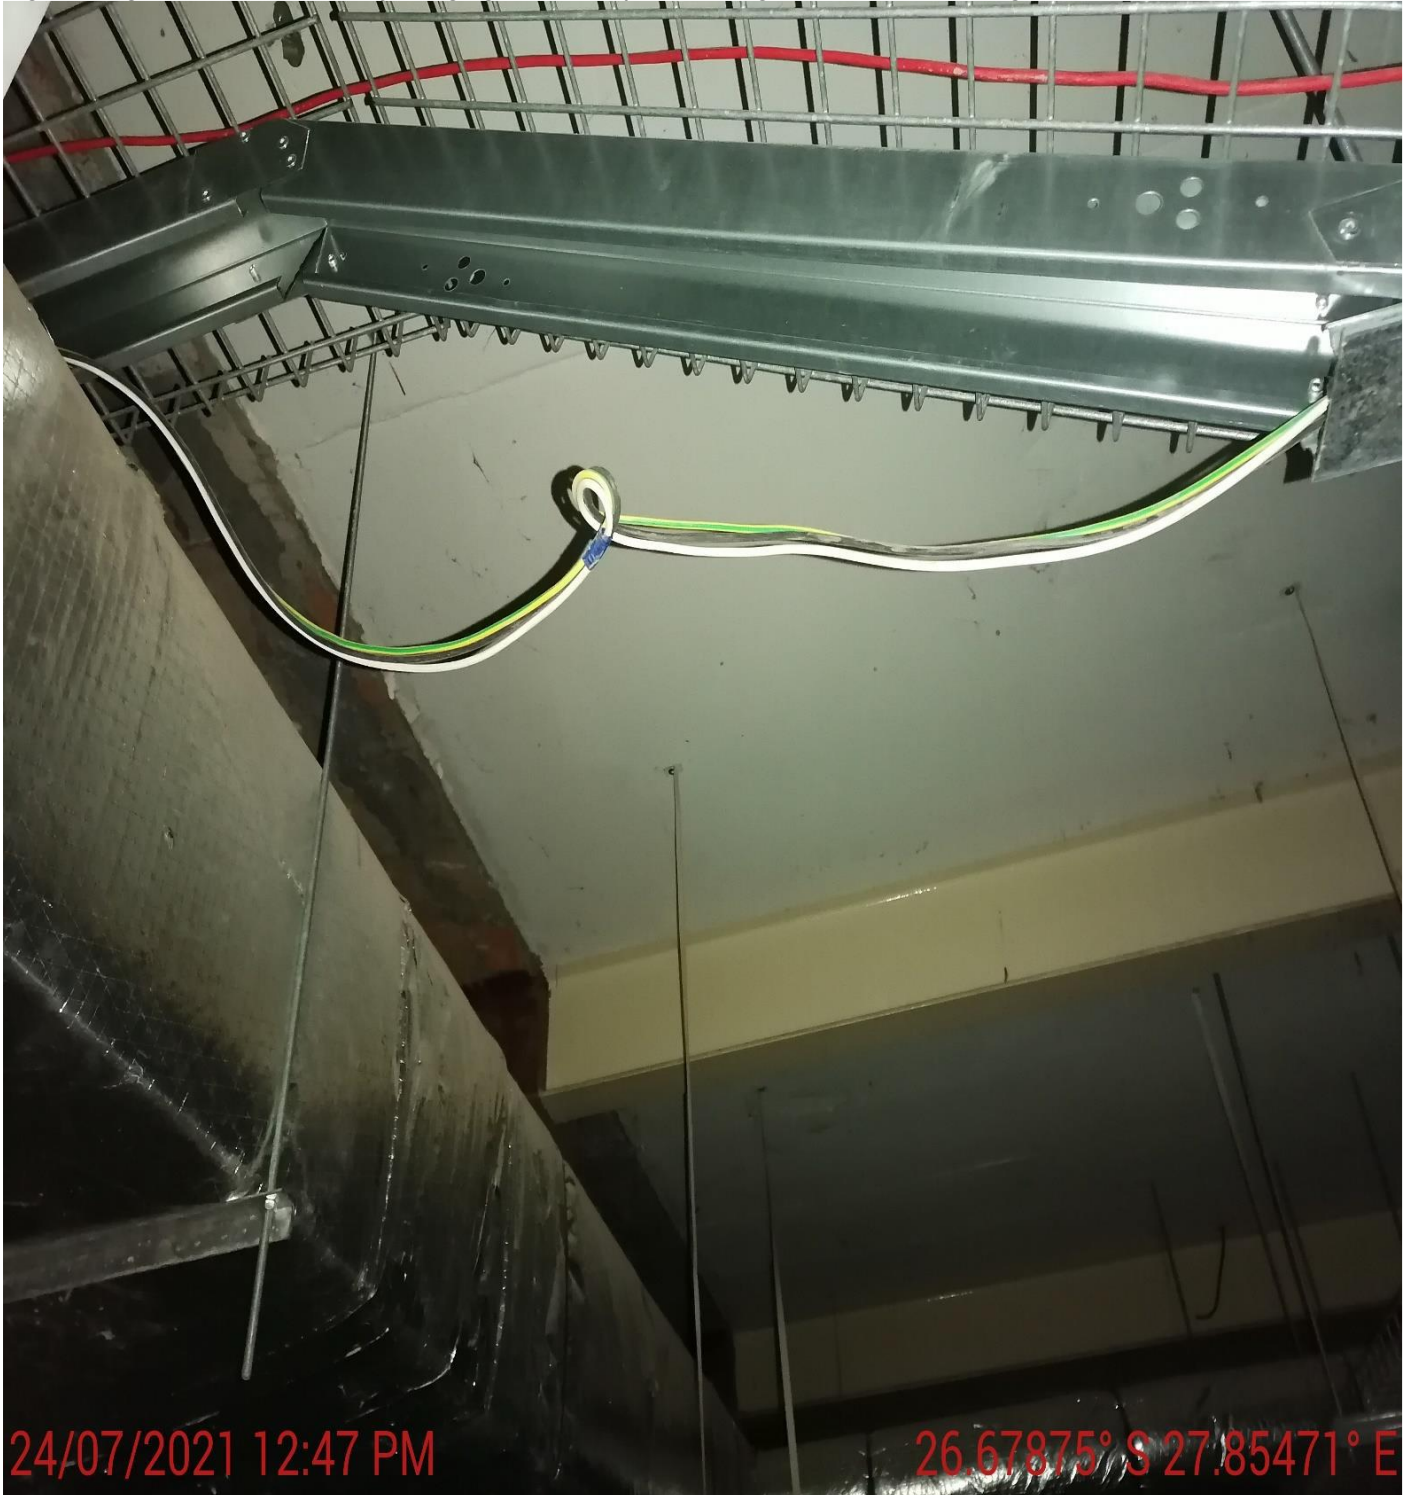
Fig 4 - Single core cables loosely hanging from the open trunking – Office 7 & 8 ceiling Void.

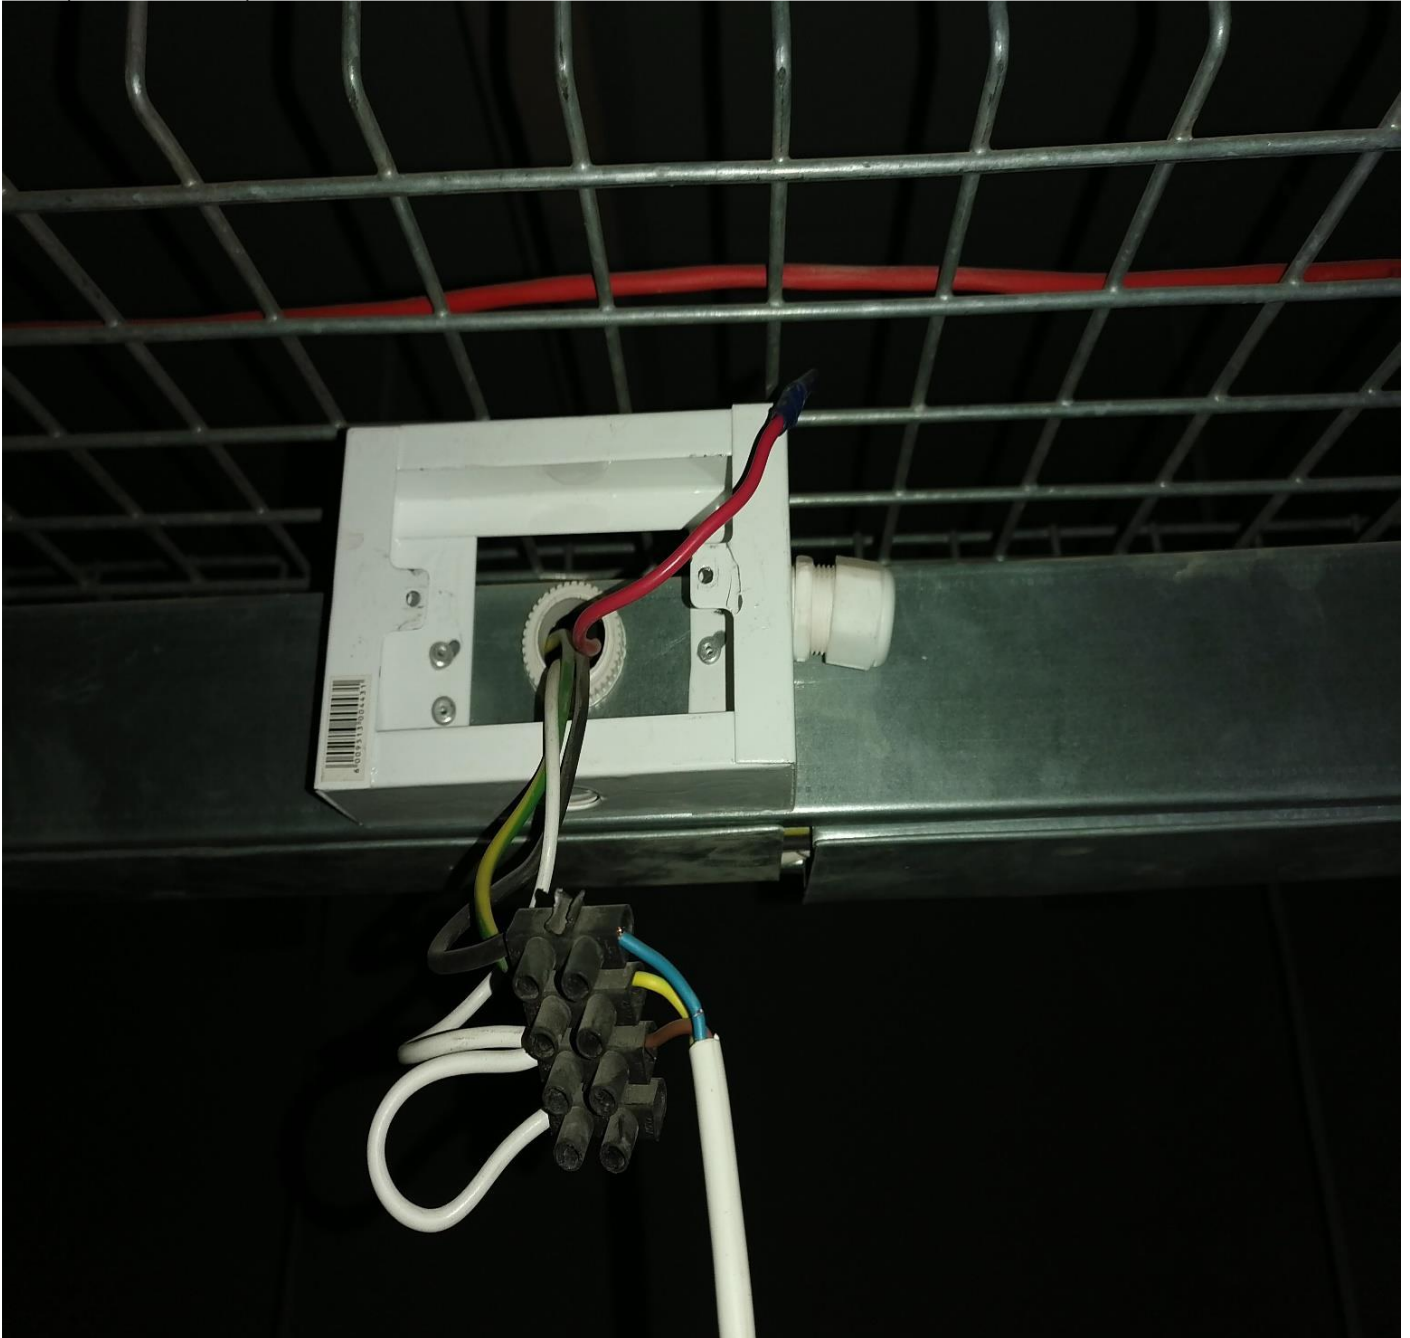
4. Improper cable terminations: This is mostly found on junction boxes mounted by the cable trunking side, connections were made without compression glands, allowing cable cords to be suspended by connections.

Fig 5 - Open junction boxes exposing connections and improper cable termination (without the use of glands) – Open Plan (Lavika's Office)

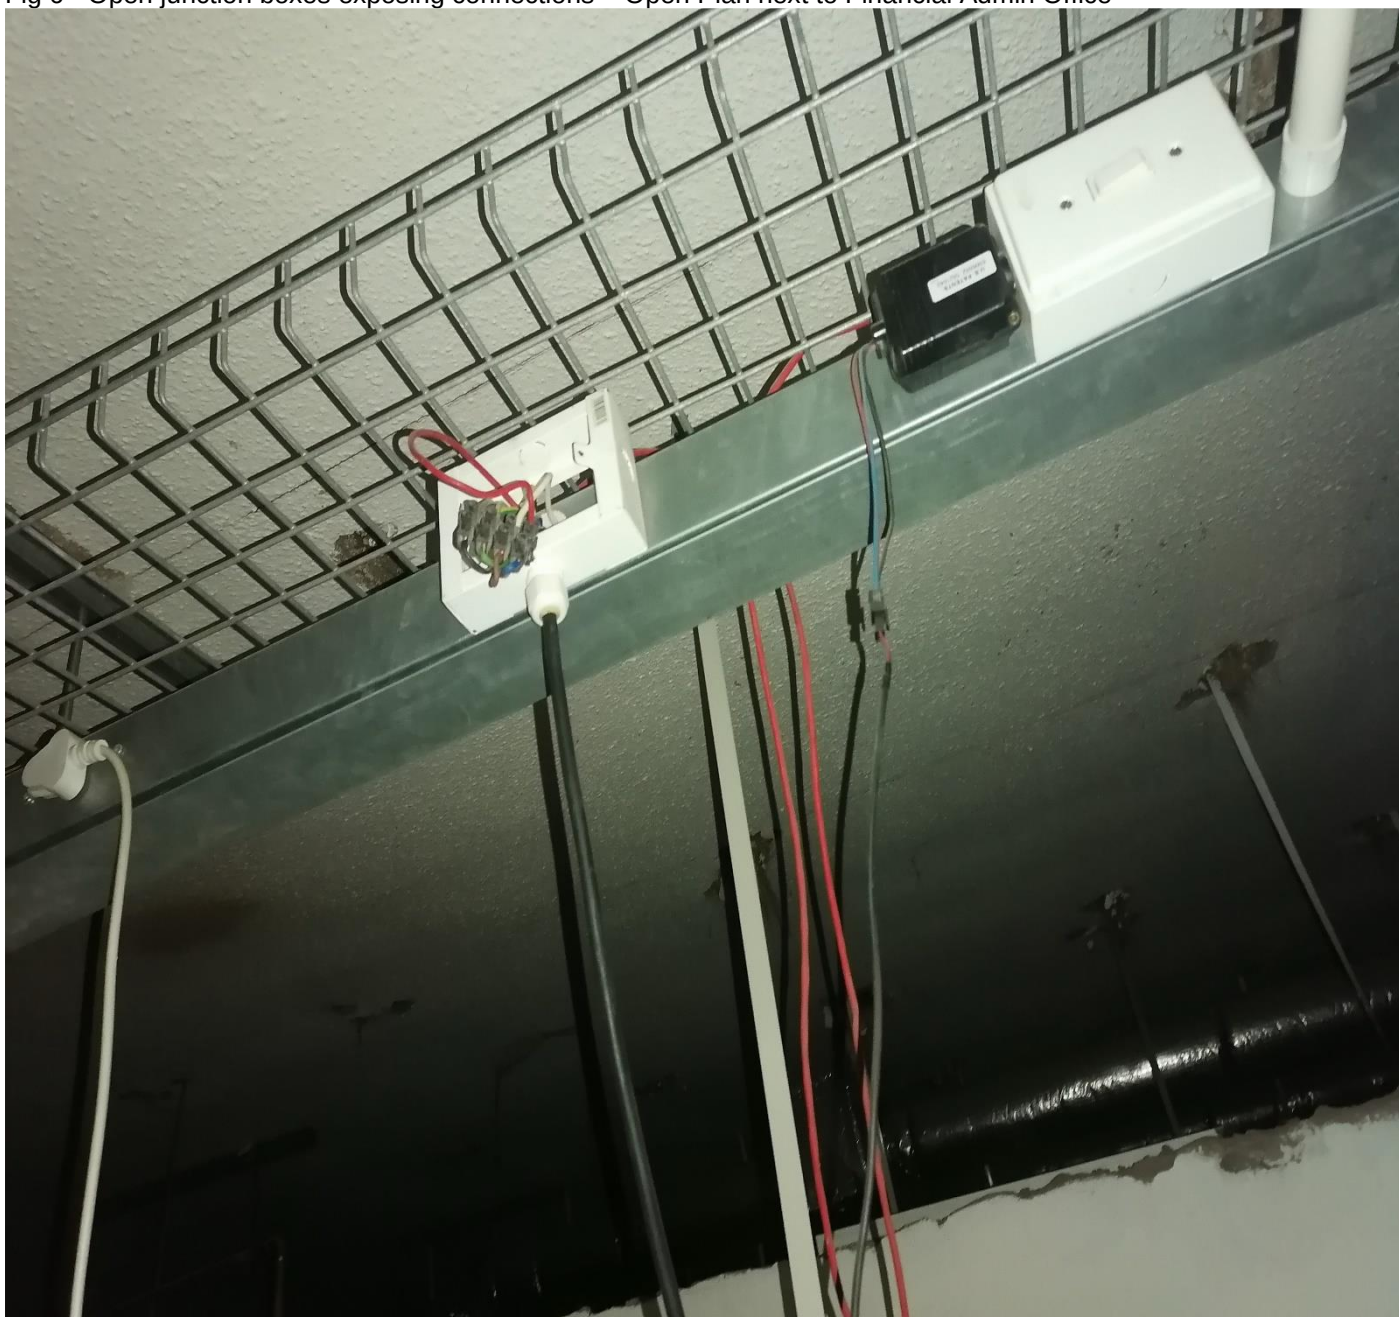
Fig 6 - Open junction boxes exposing connections – Open Plan next to Financial Admin Office

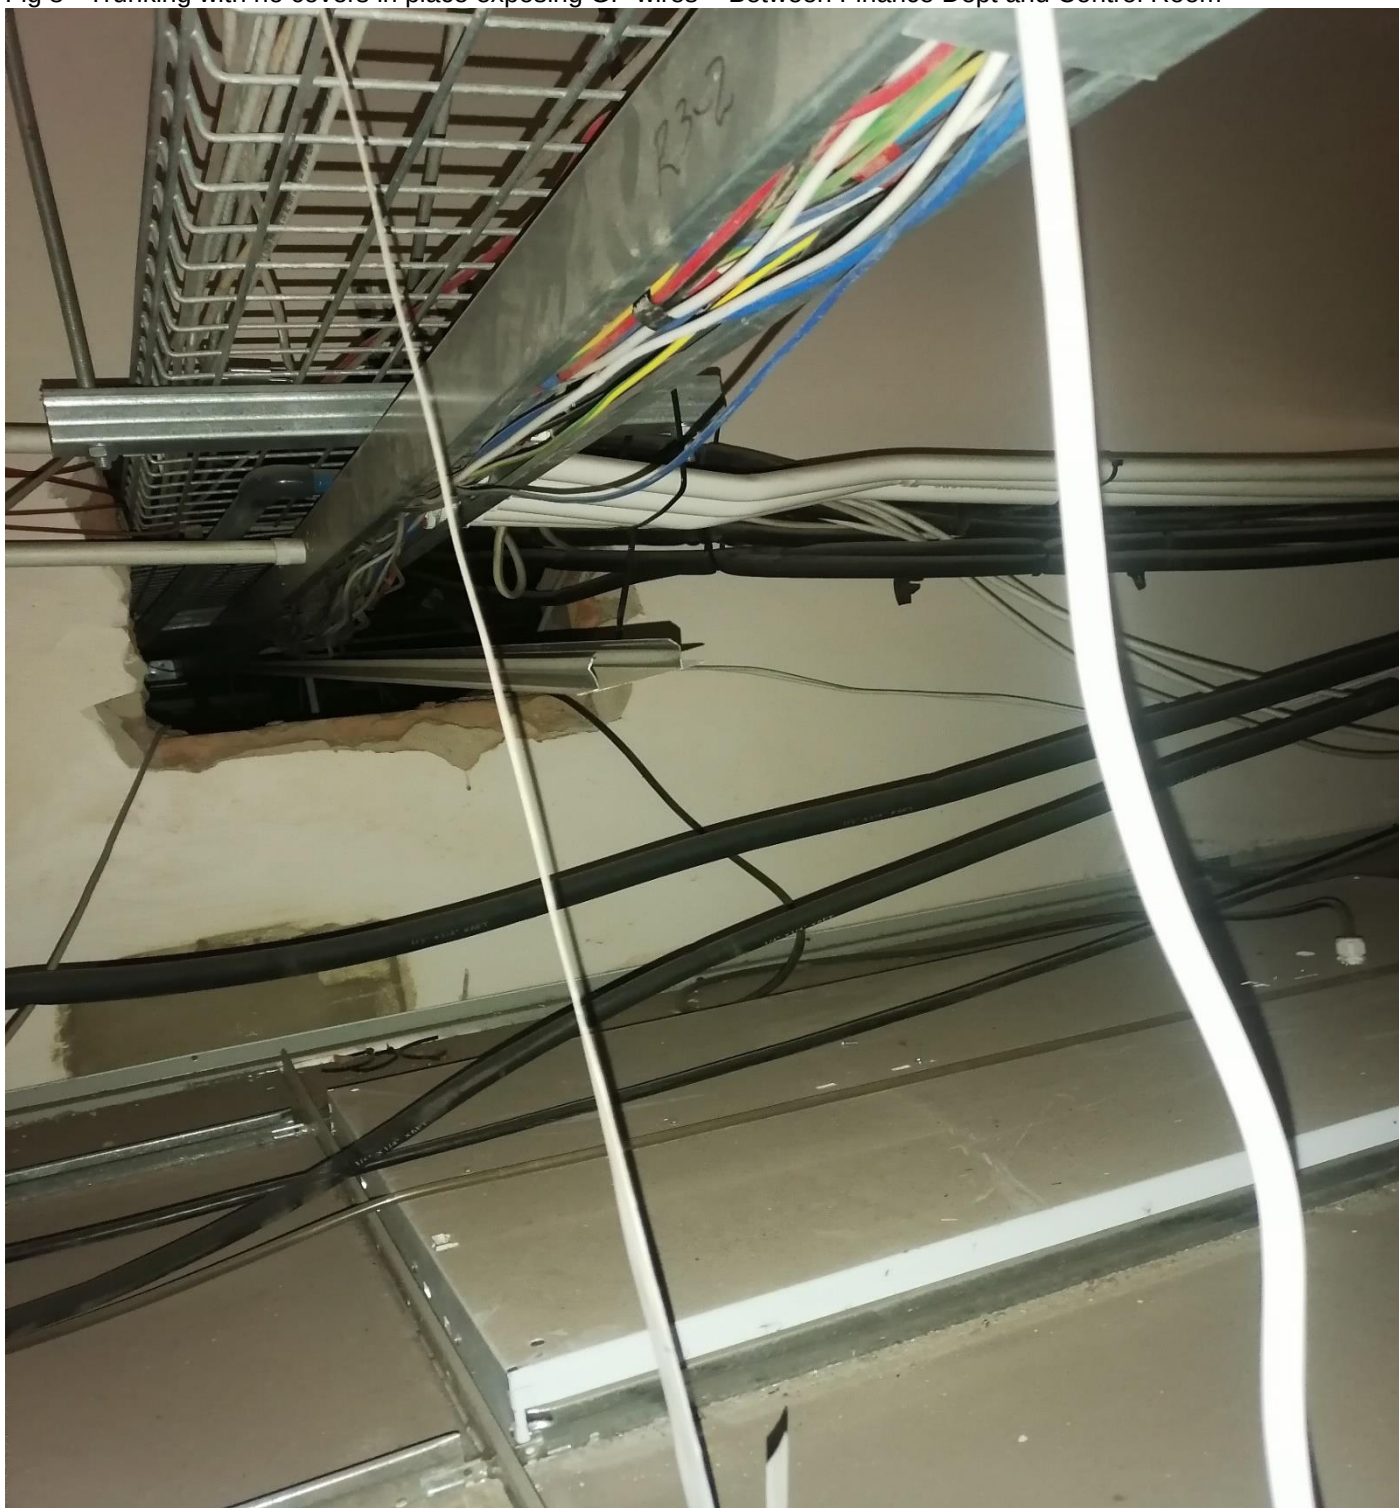
Fig 8 - Trunking with no covers in place exposing GP wires – Between Finance Dept and Control Room

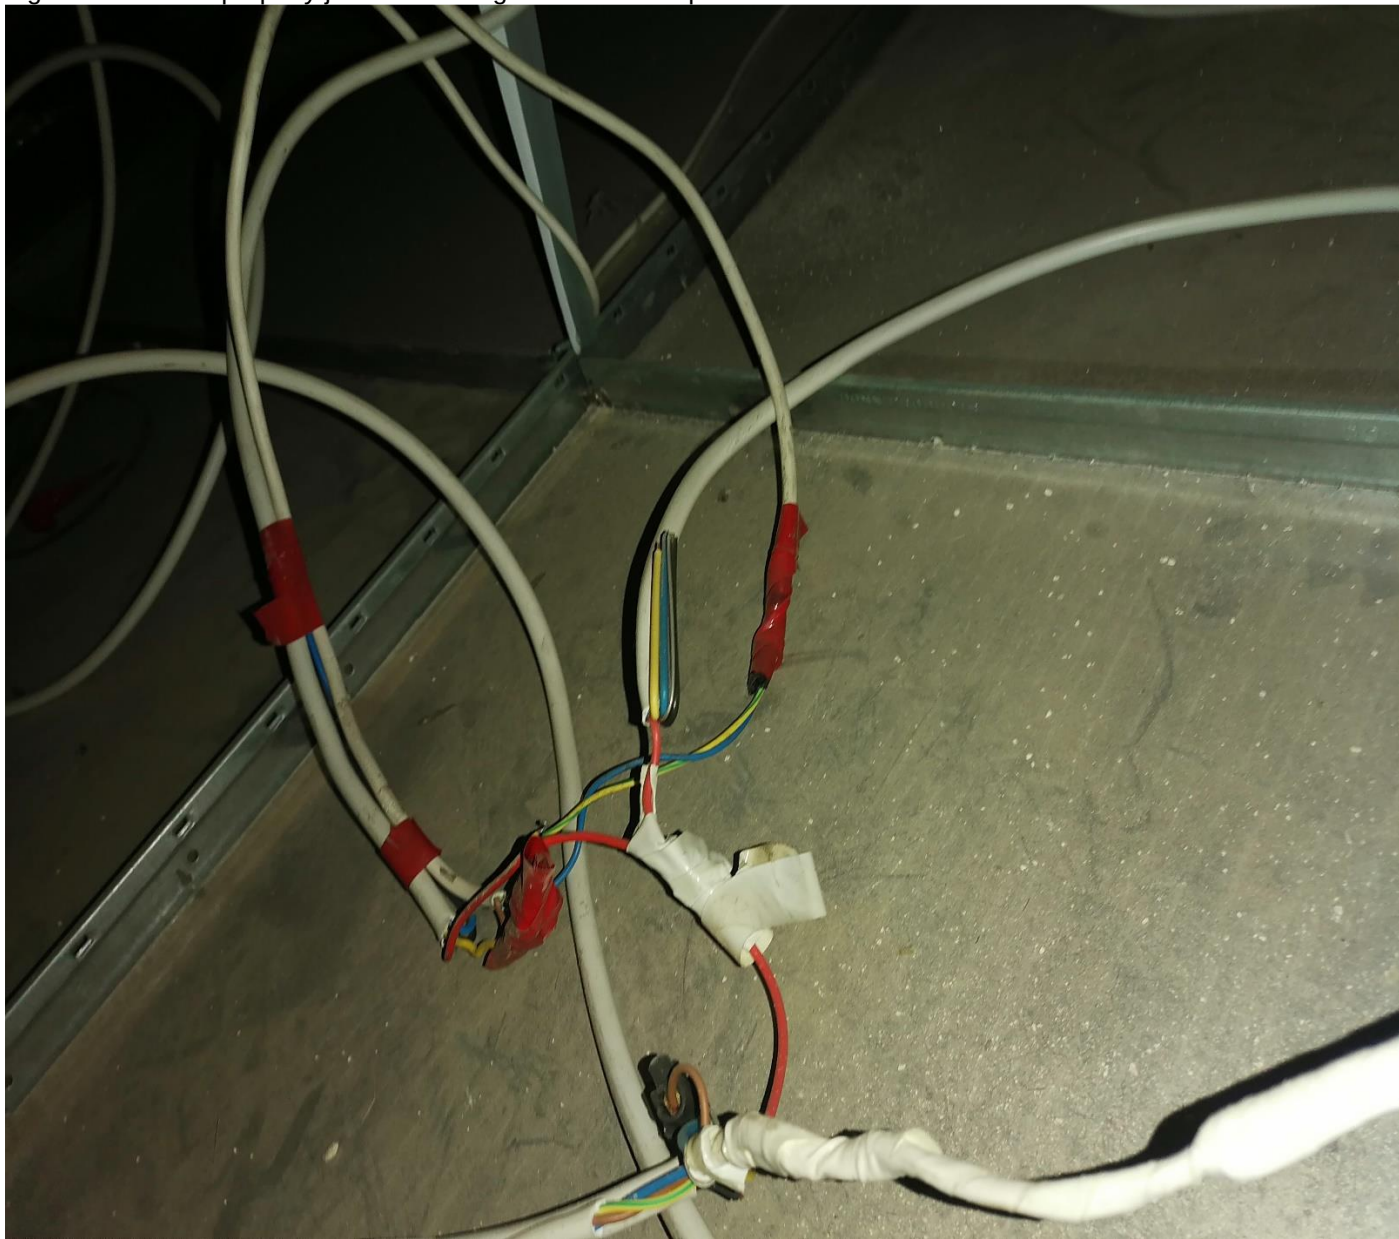
5. Improper cable joints: Open joints were randomly done inside the ceiling void, taped with insulating tape and left without protection. In some cases, such joints are suspected to have affected the resistance of the earth continuity conductor. The resistance of the earth continuity conductor on the following circuits were found to be above the limit:

Fig 10 - Cables improperly joined – Ceiling Void above Supervisor's Office

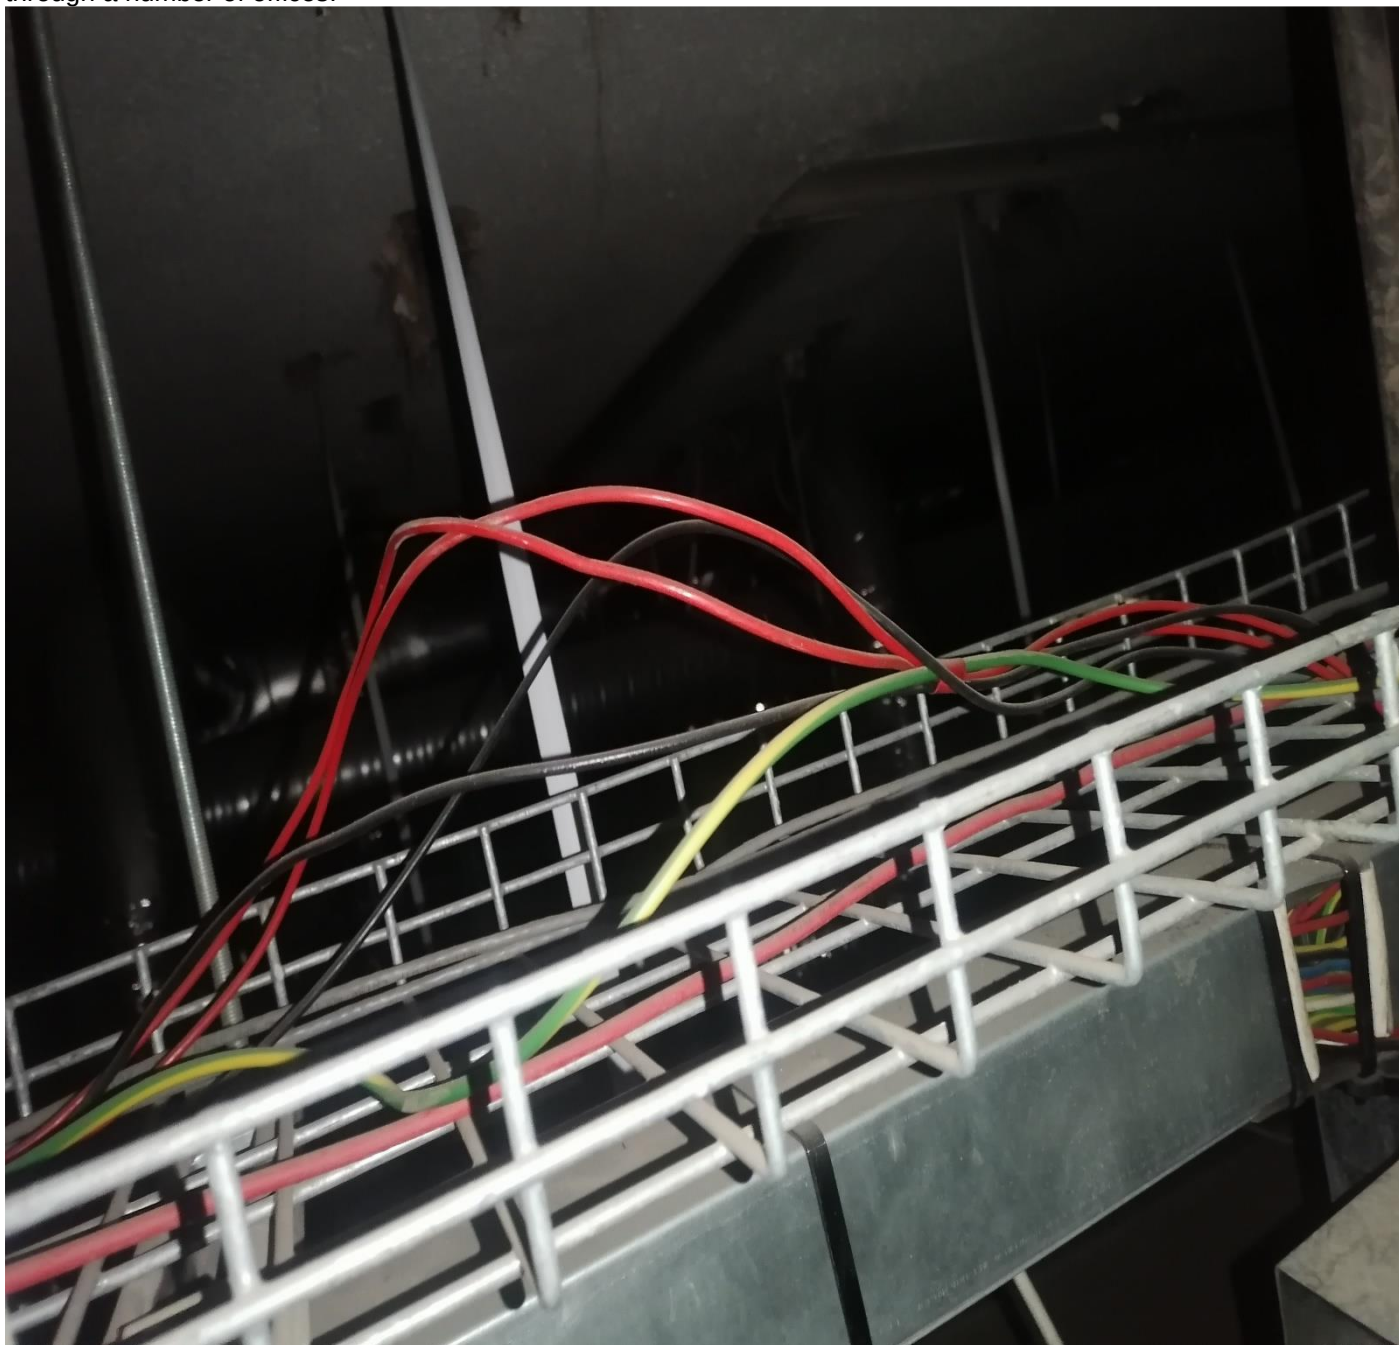
Fig 12 - General Purpose wires running in the cable tray instead of proper enclosed wireway – Cable tray running through a number of offices.

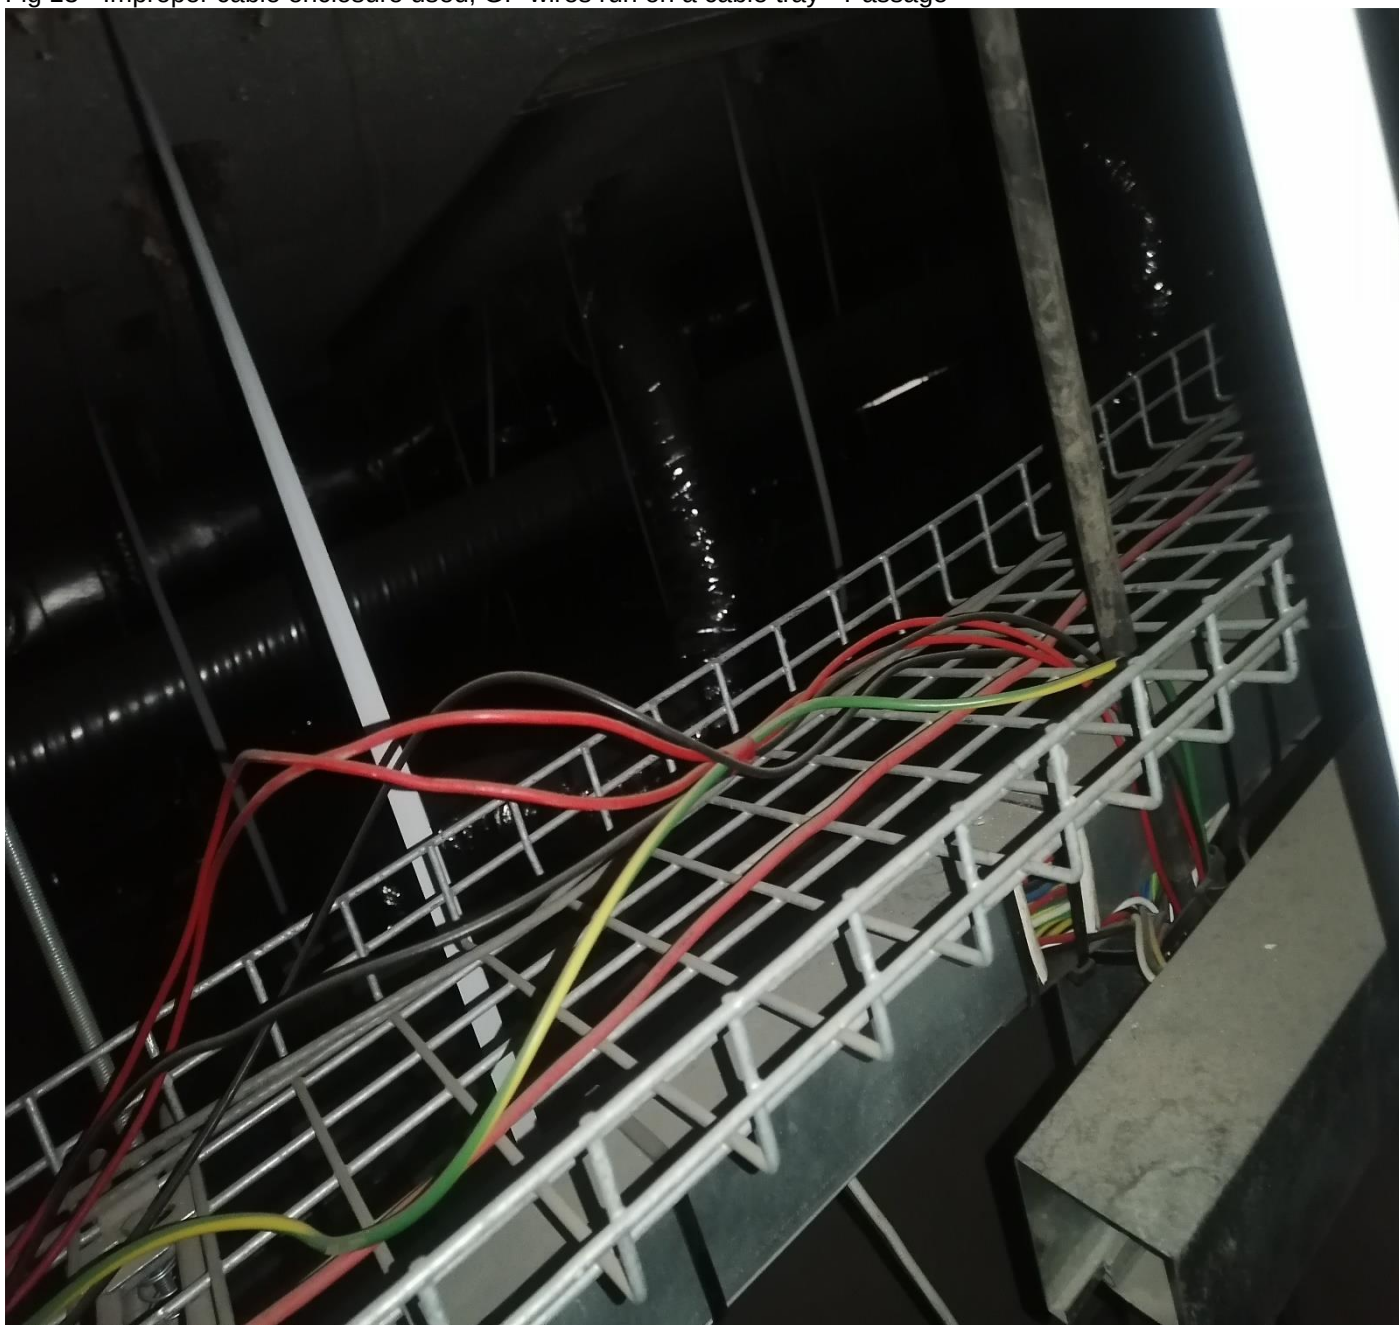
Fig 13 - Improper cable enclosure used, GP wires run on a cable tray - Passage

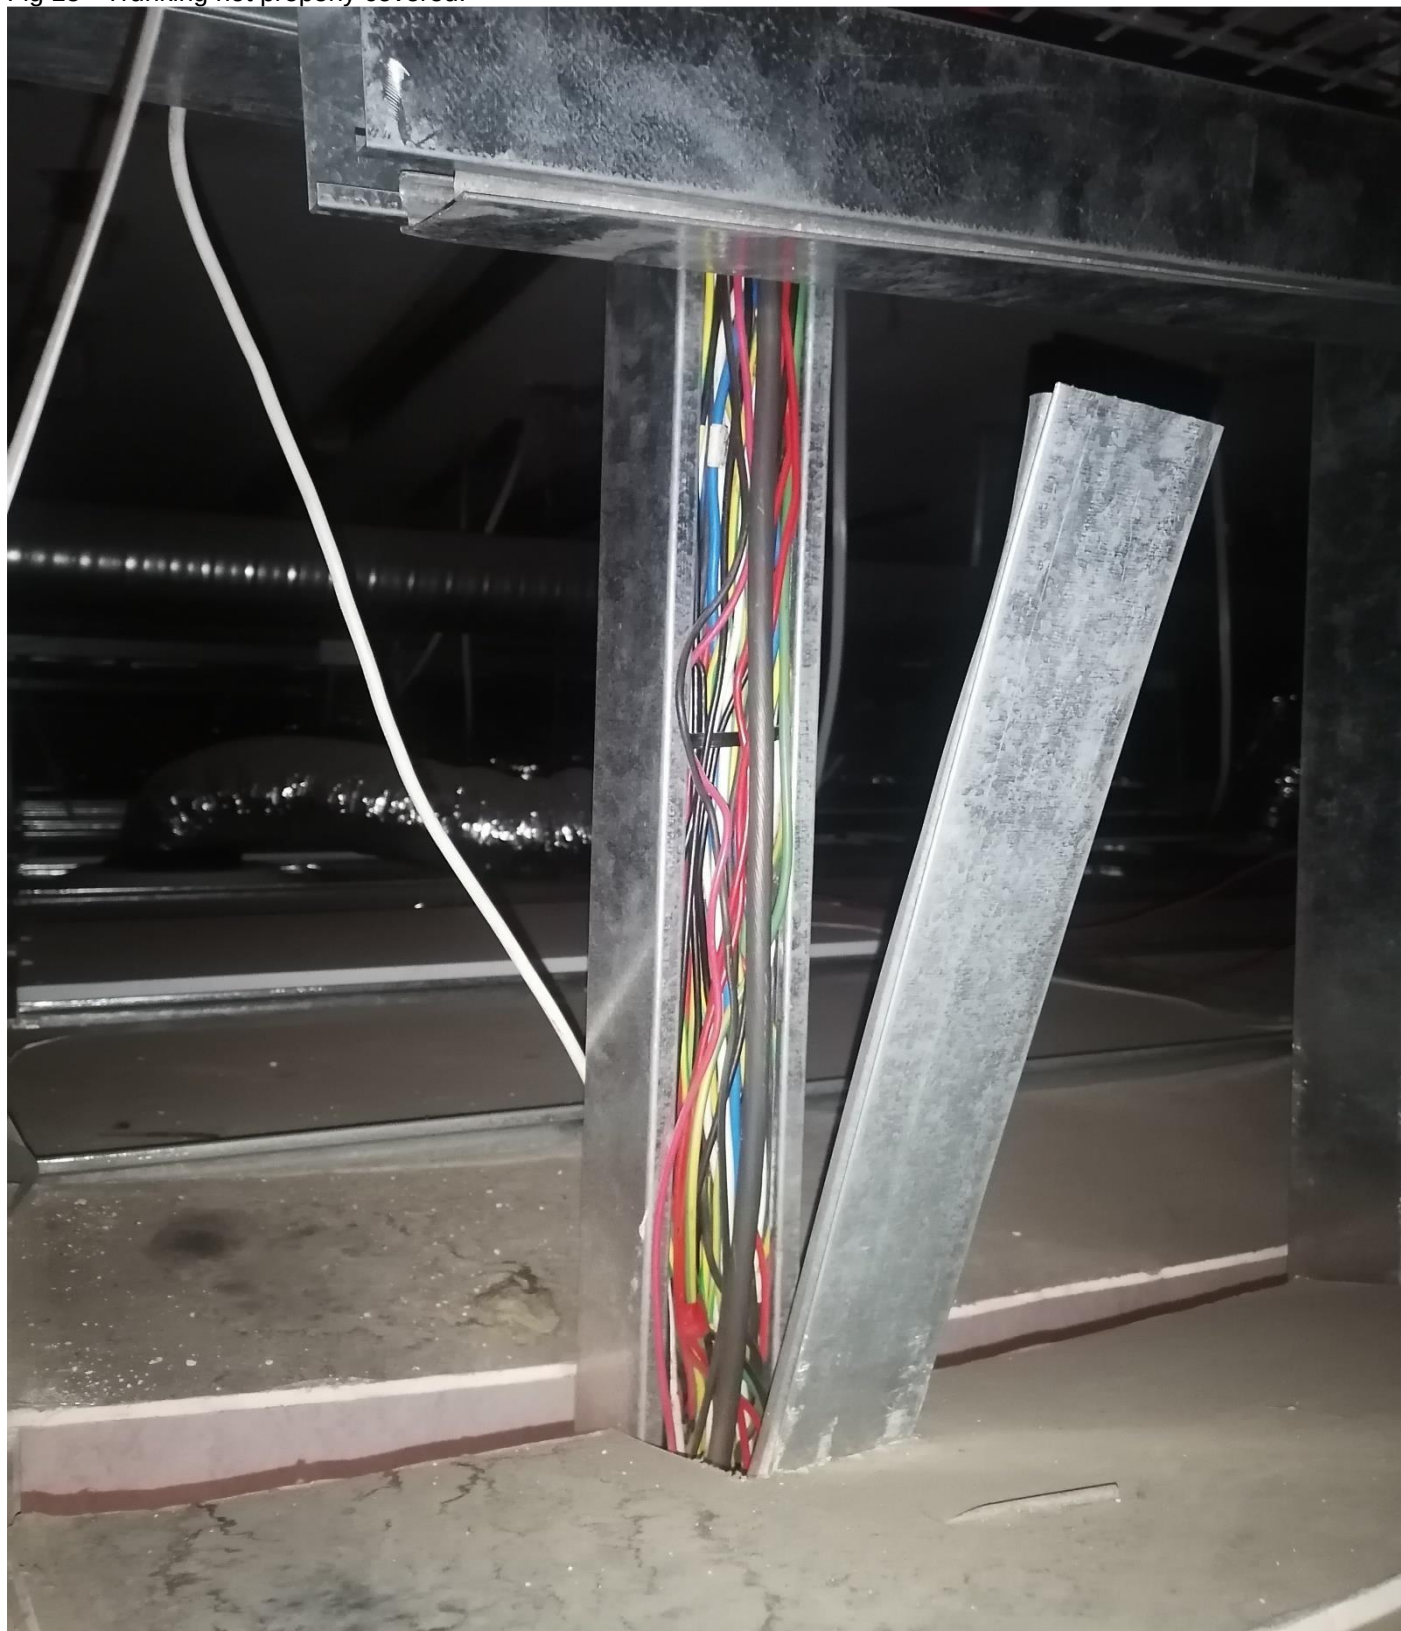
Fig 15 - Trunking not properly covered.

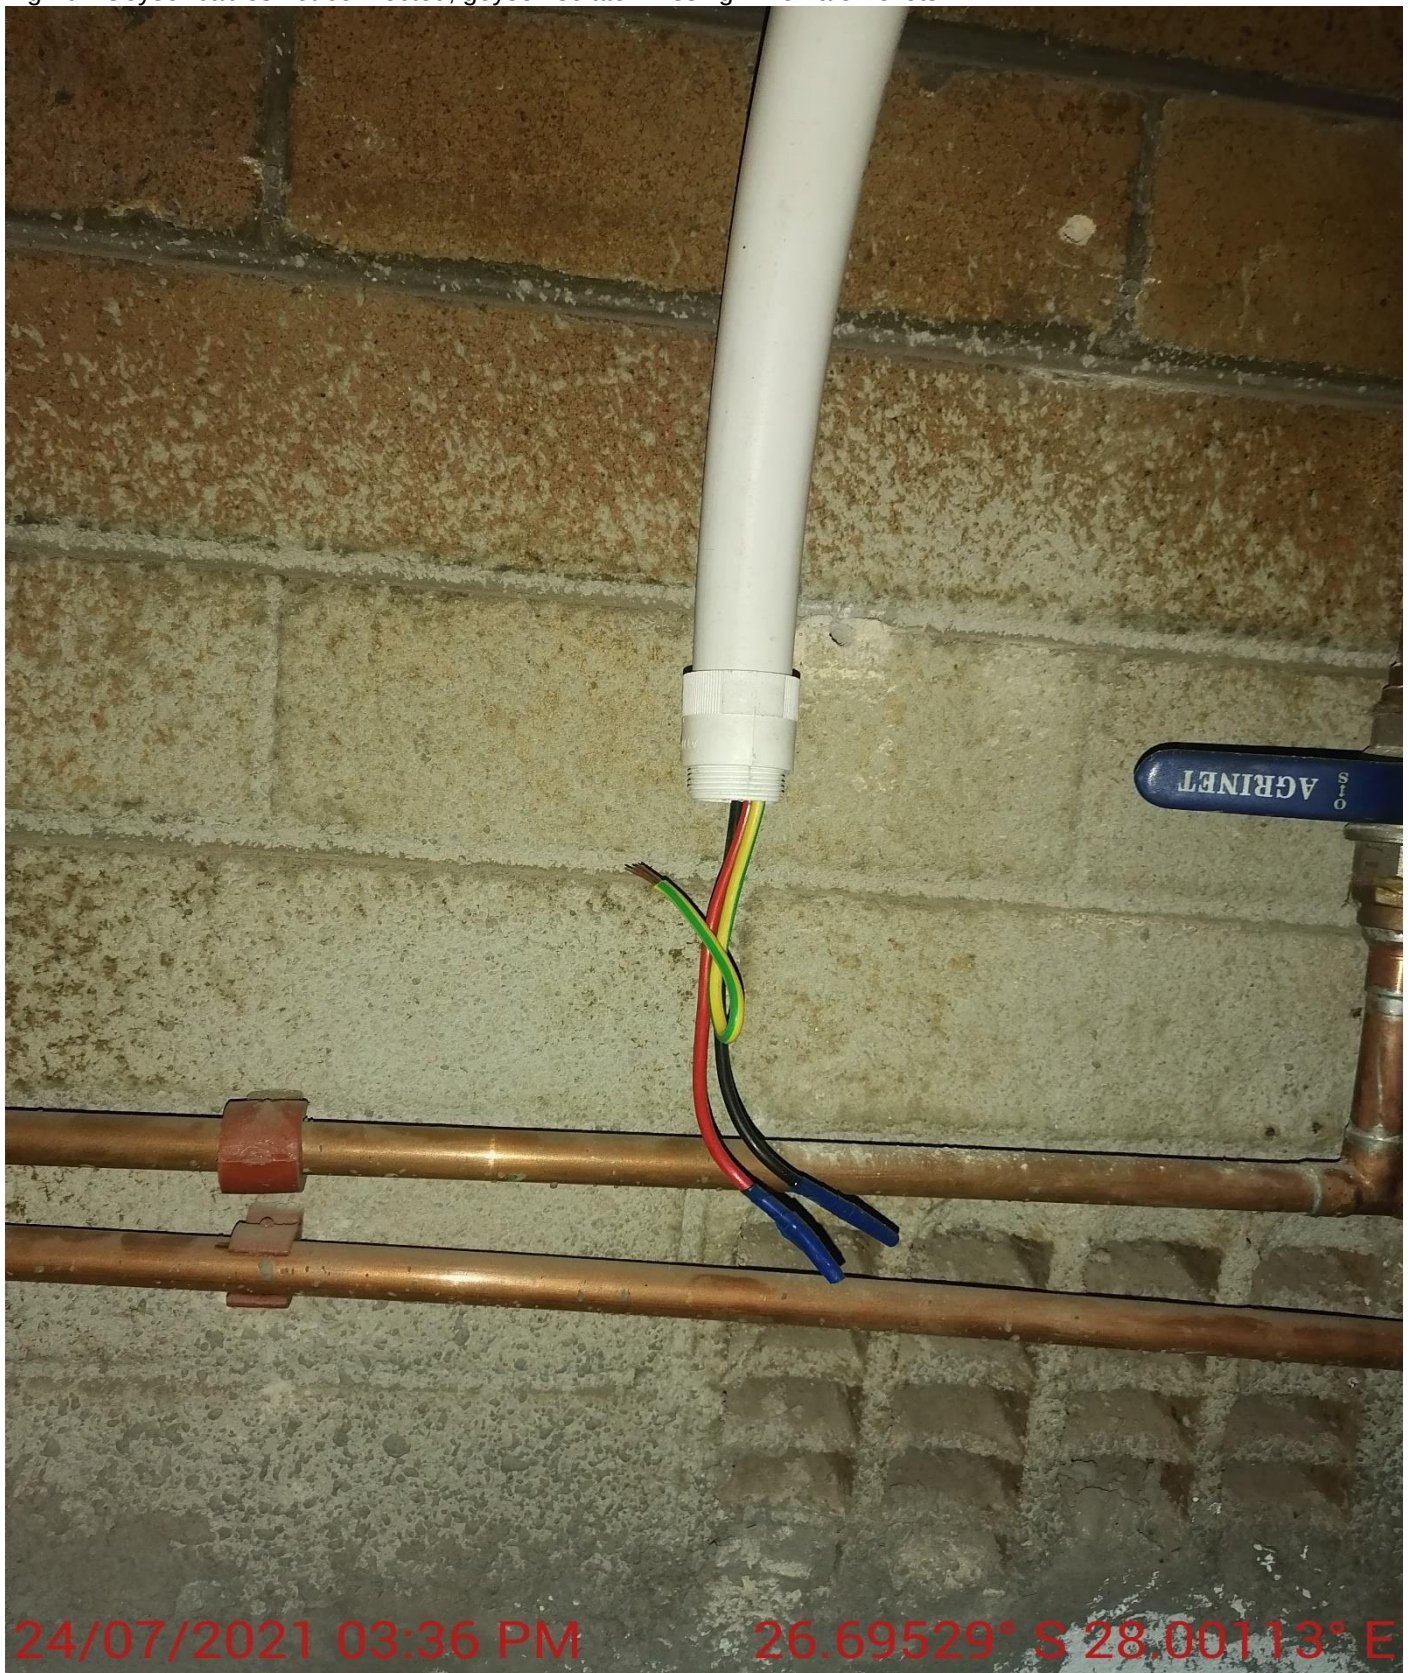
Fig 16 - Geyser cables not connected, geyser isolator missing – Female Toilets

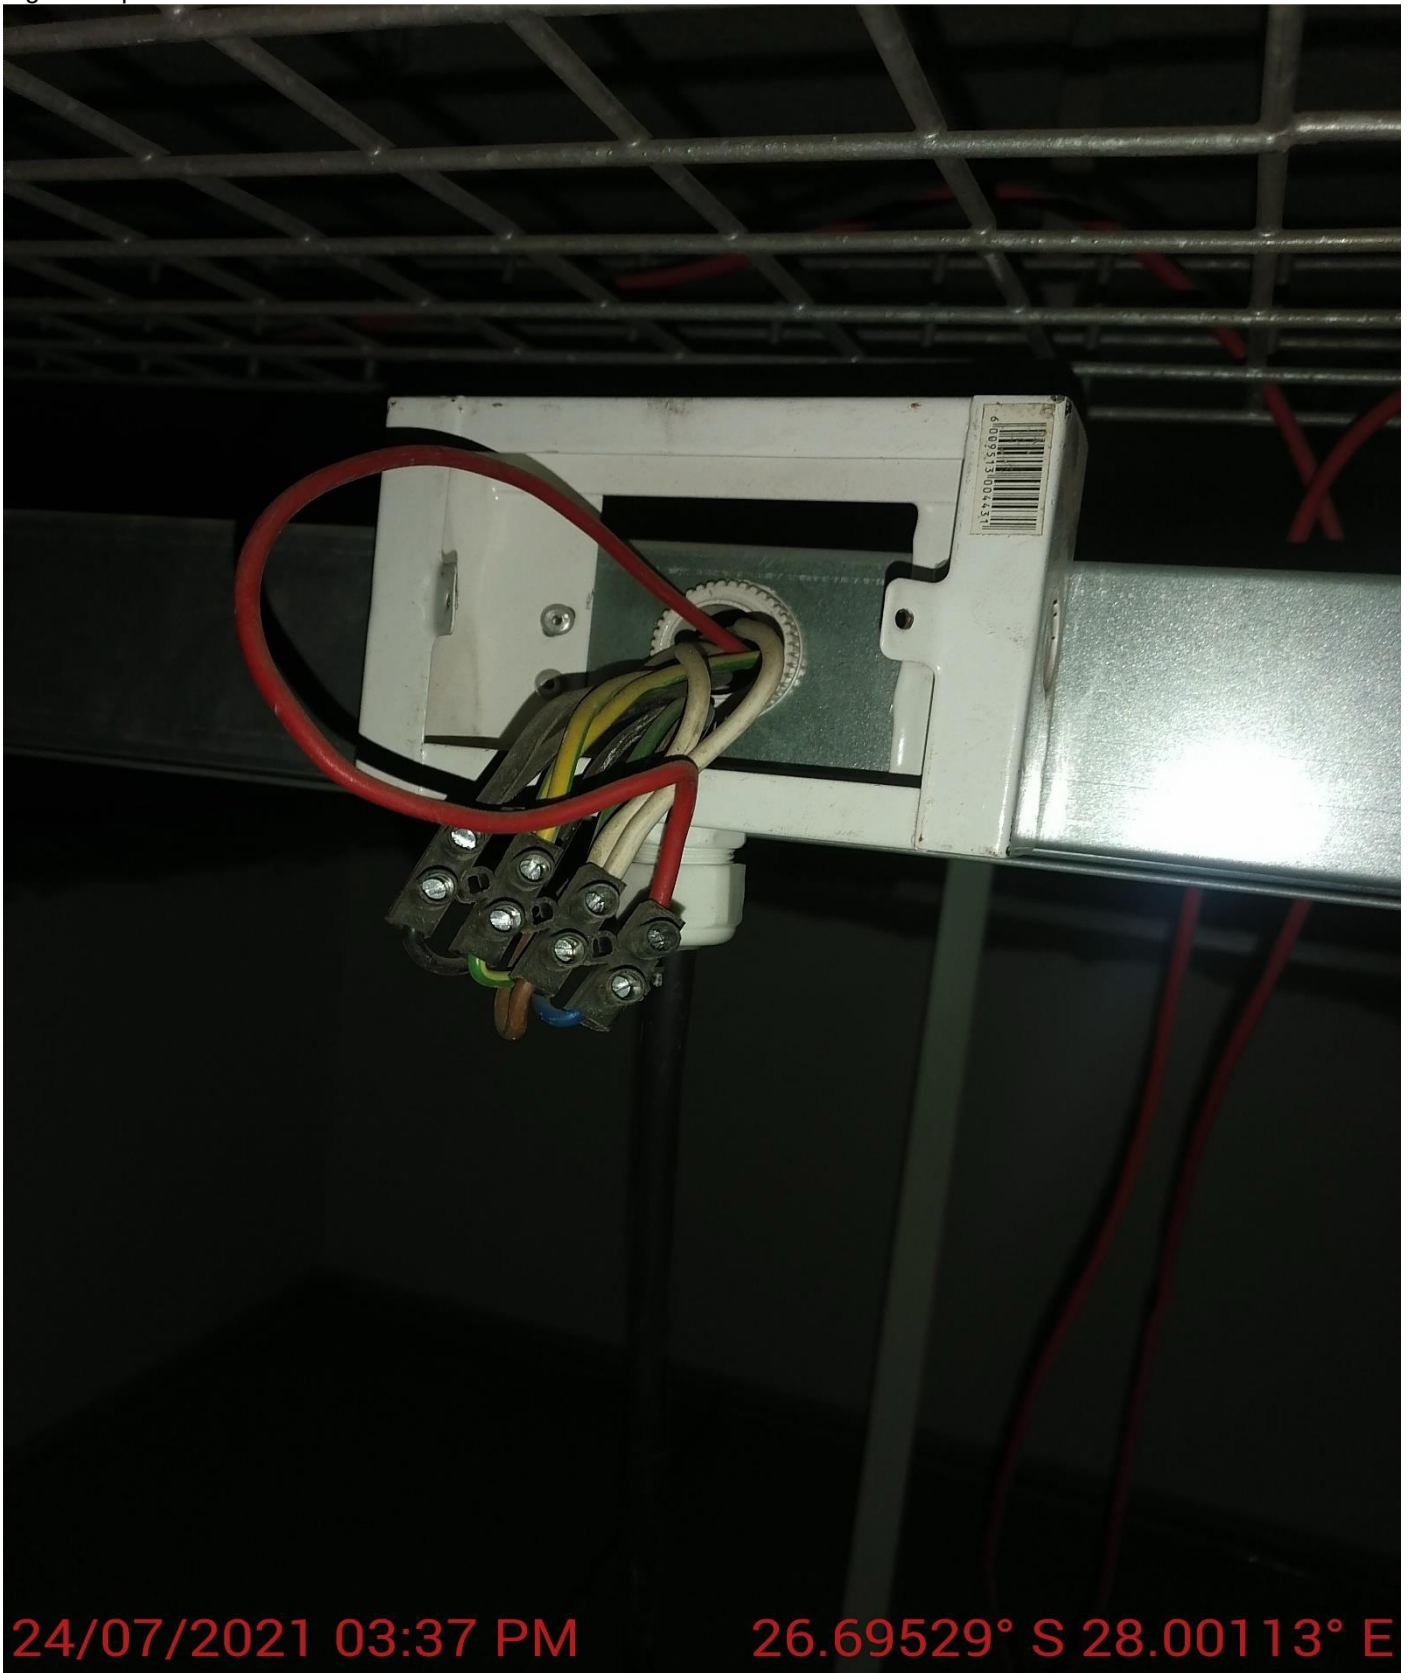
Fig 17 - Open Junction boxes

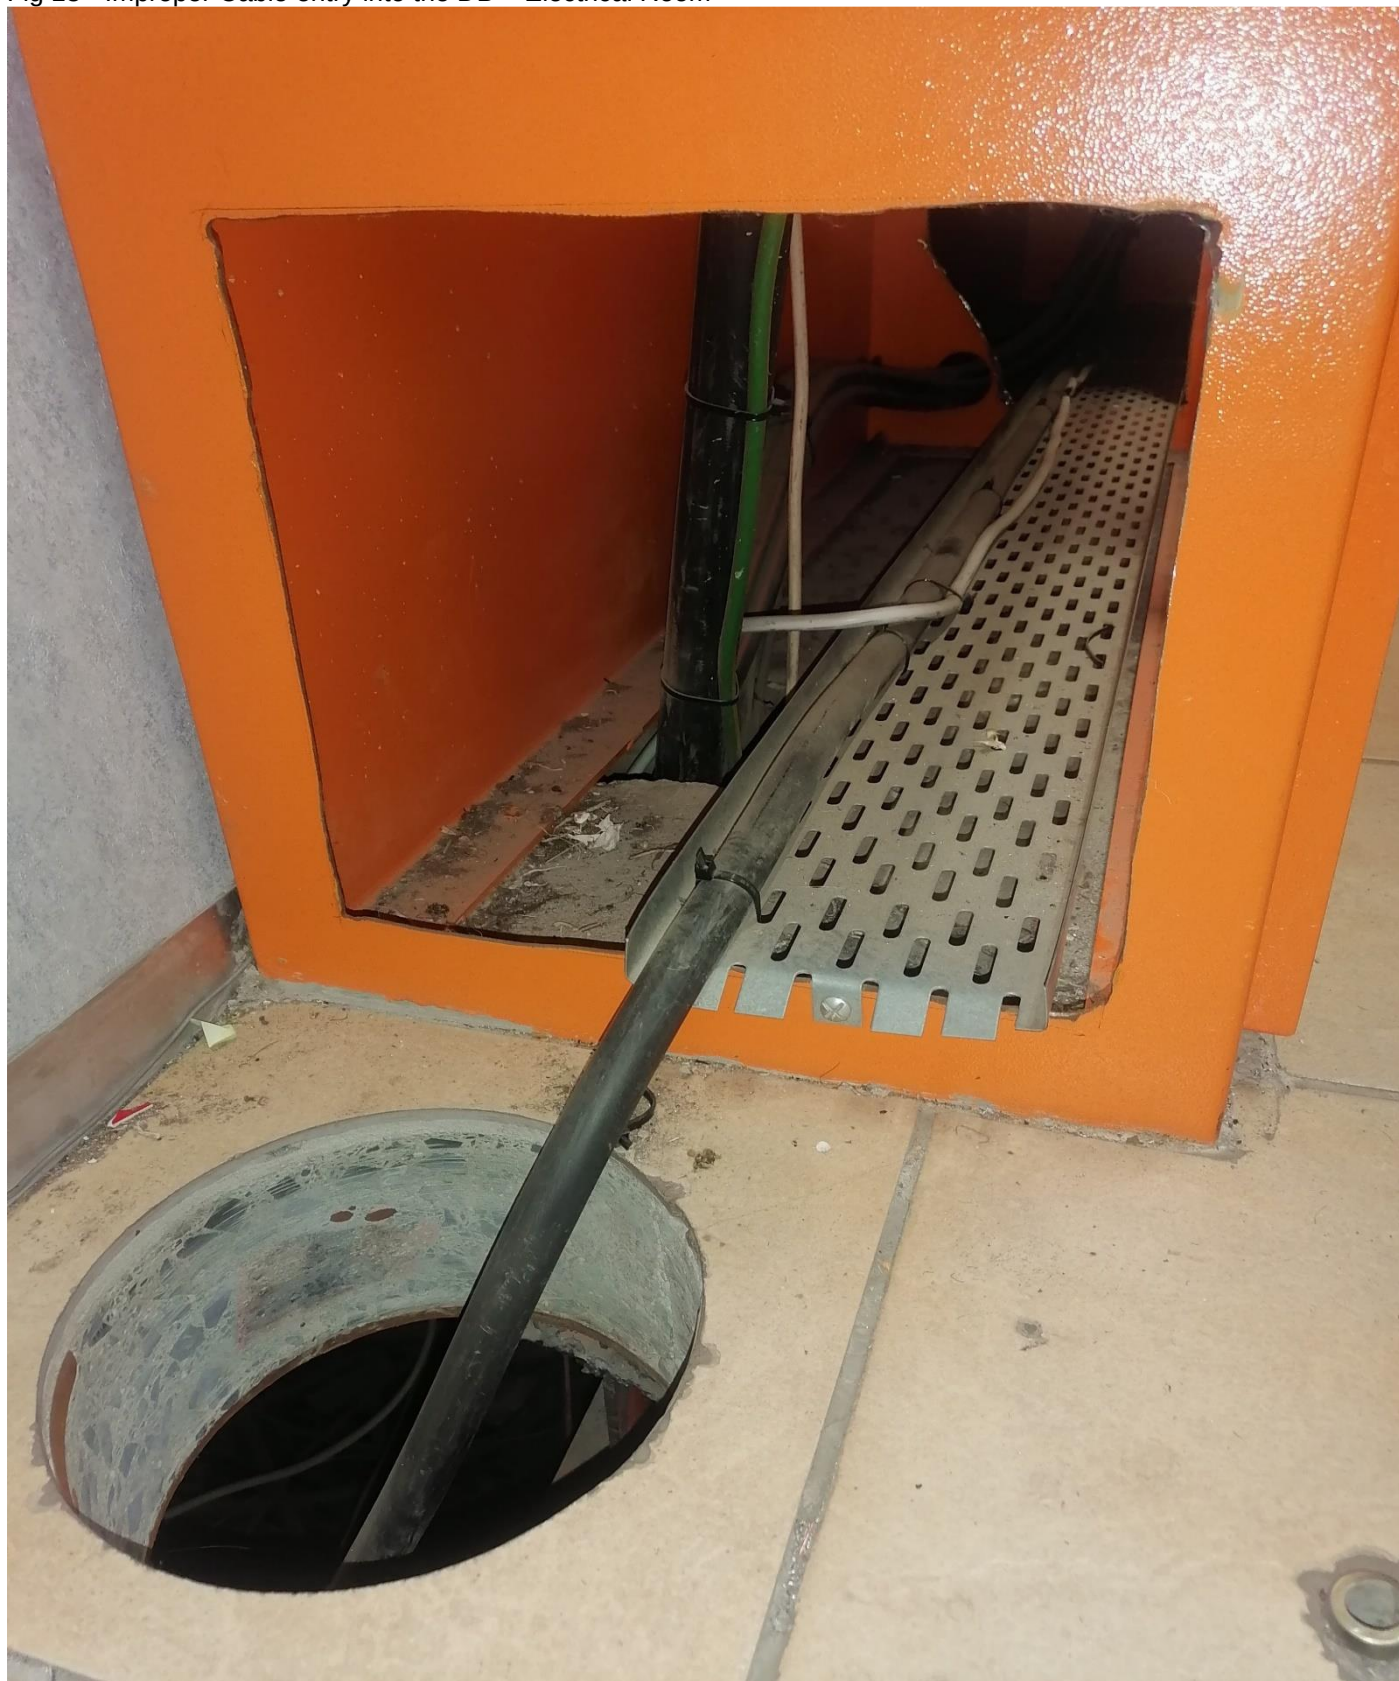
Fig 18 - Improper Cable entry into the DB – Electrical Room
