## REQUEST FOR BID CIDB

### 10397088 – Scope of Work

Repair all non-compliance at no.1 Control room as per Scope Below:

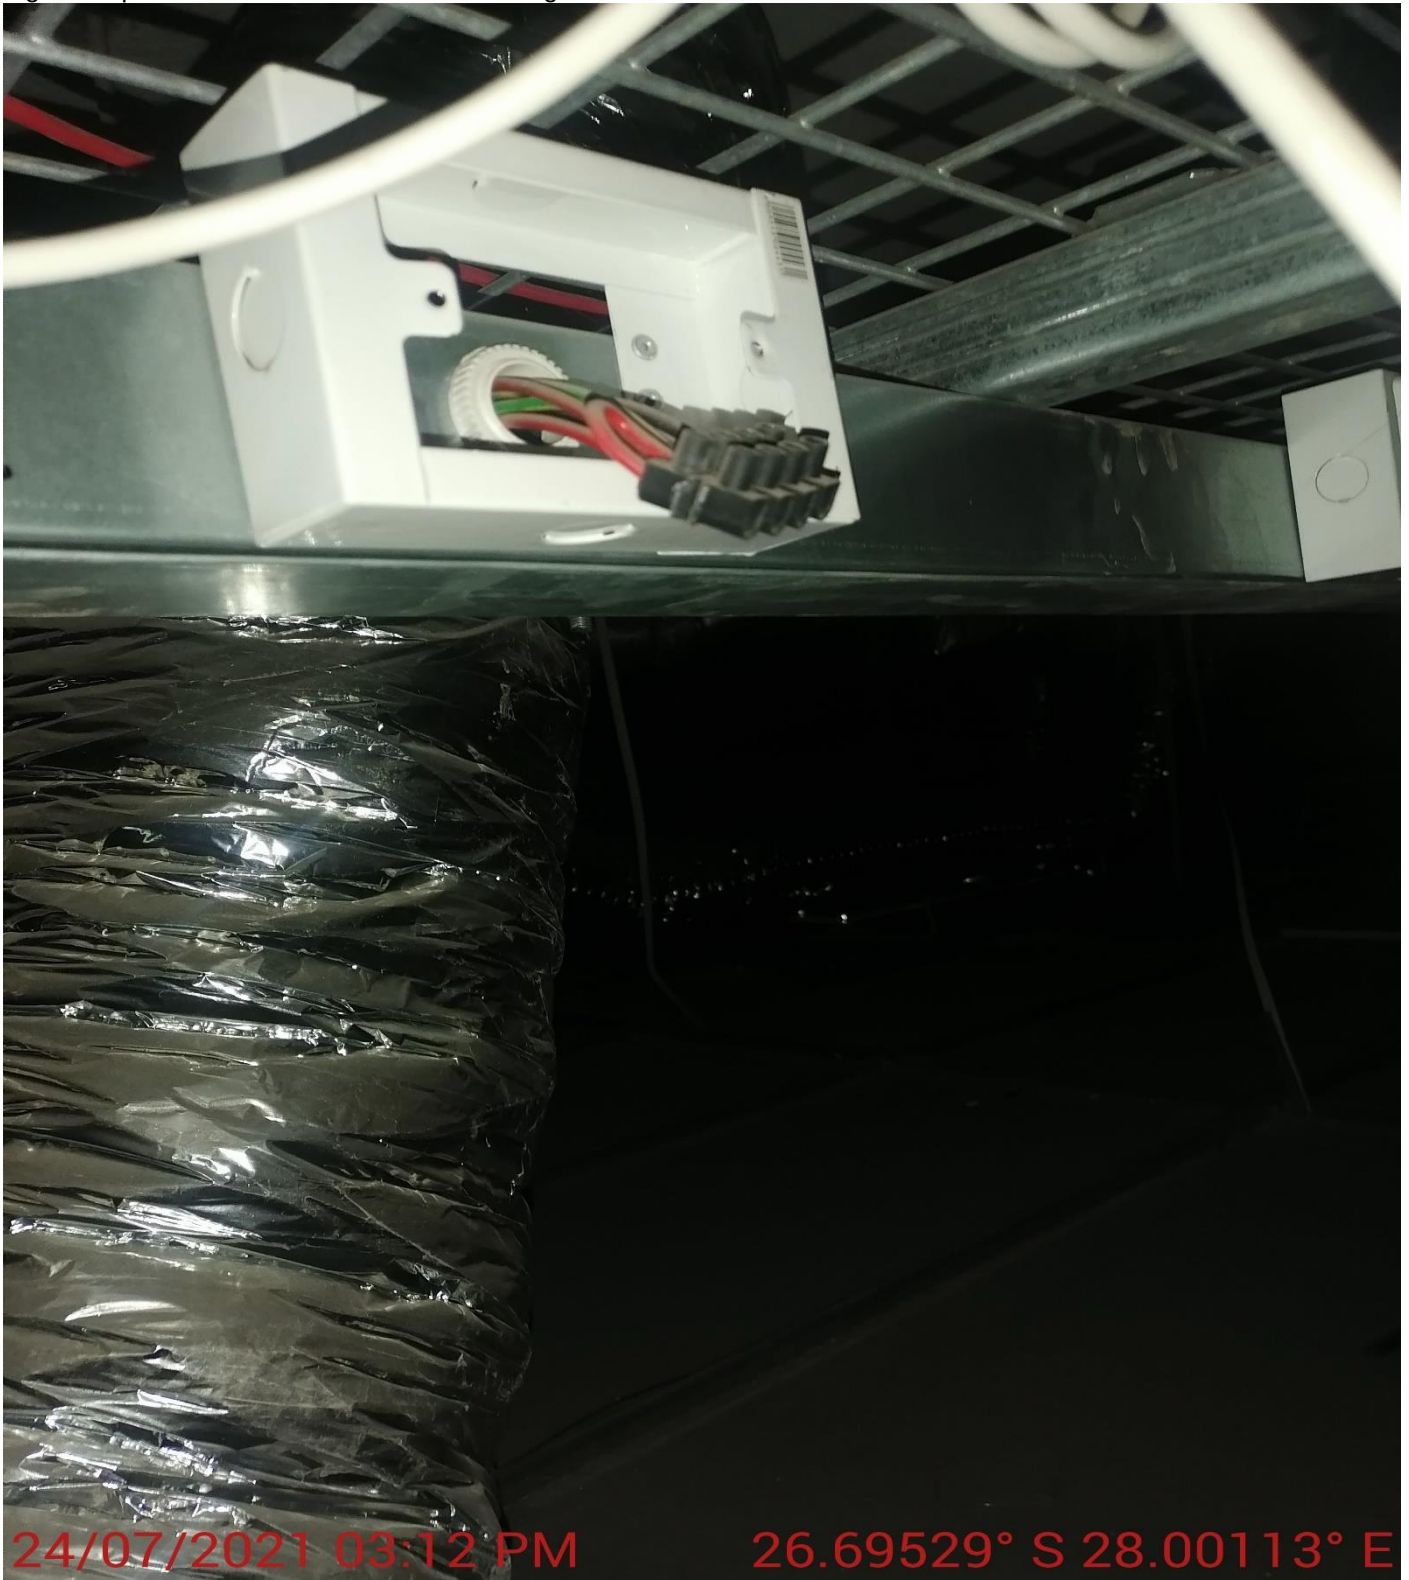
Fig 19 - Open Junction Boxes inside the ceiling void

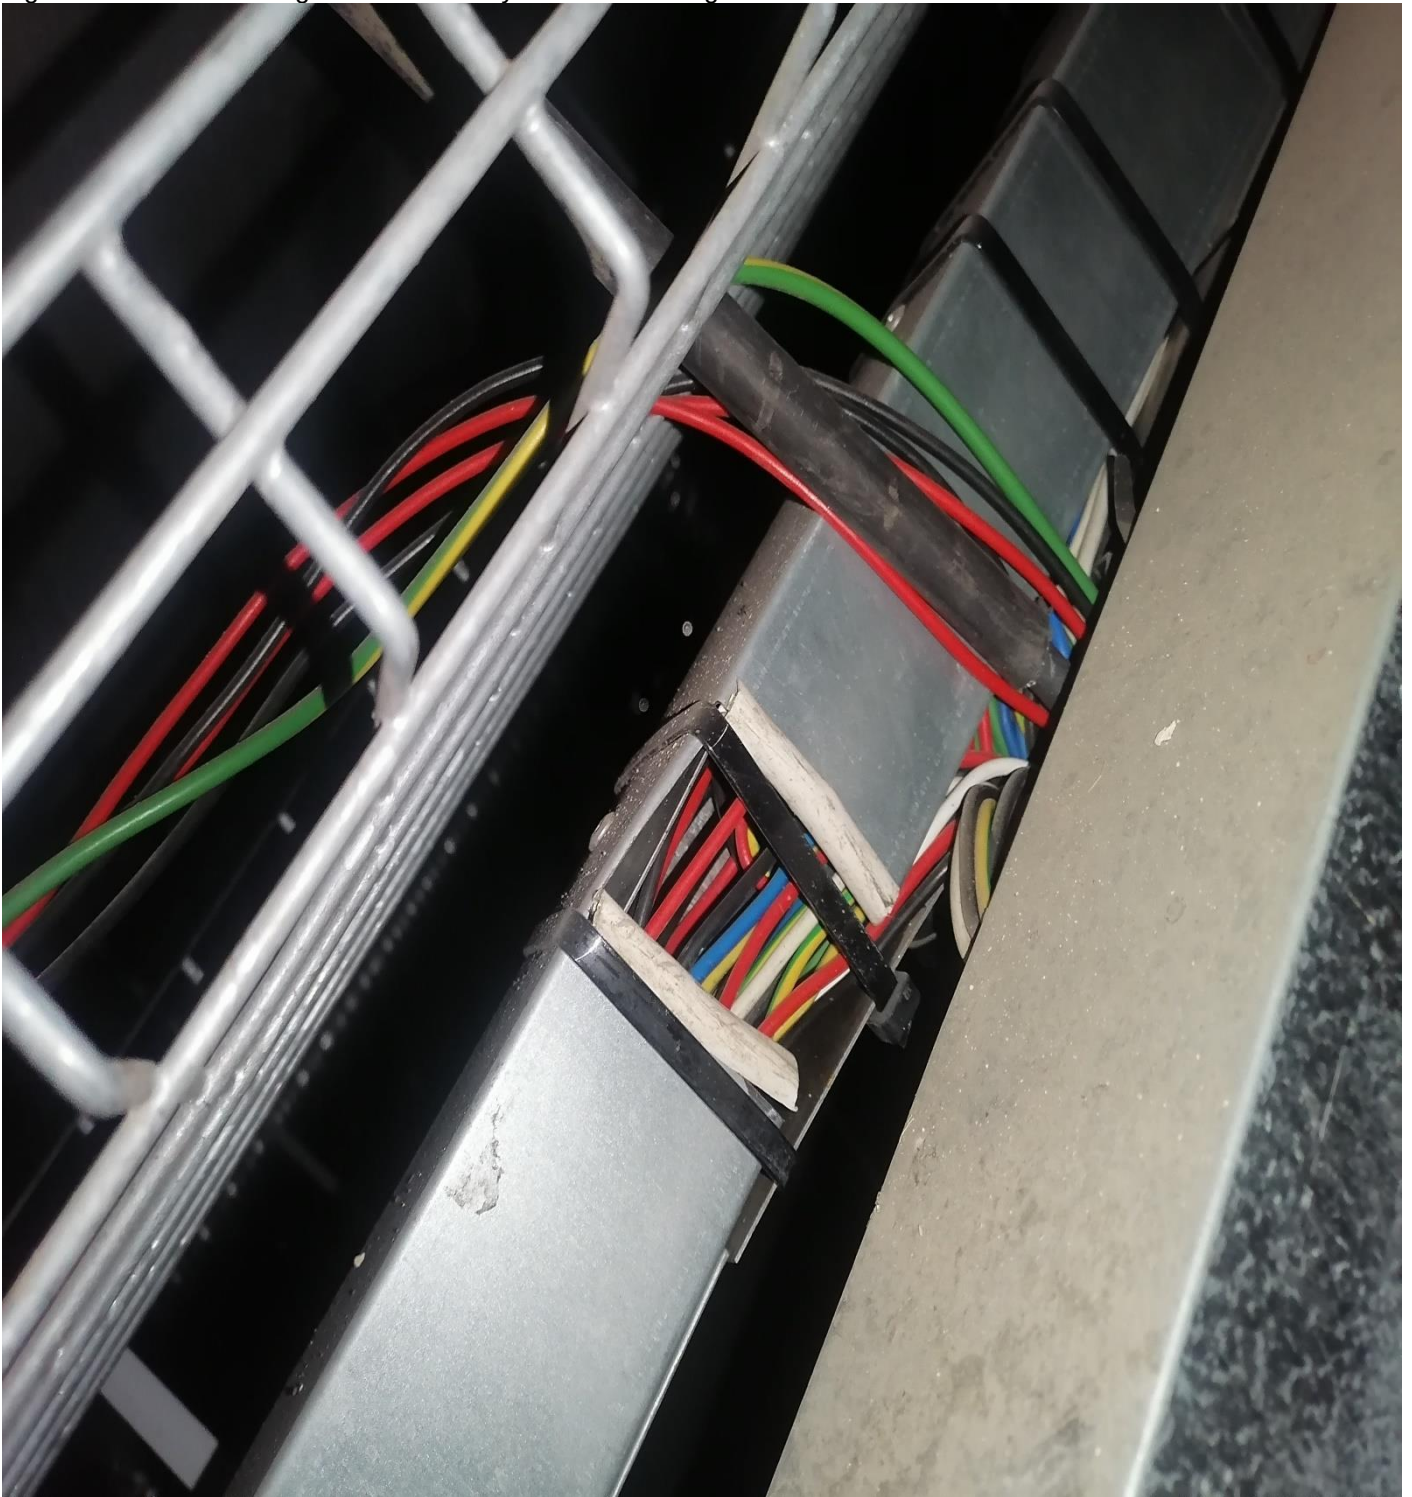
Fig 20 - GP Wires running on the cable tray inside the ceiling.

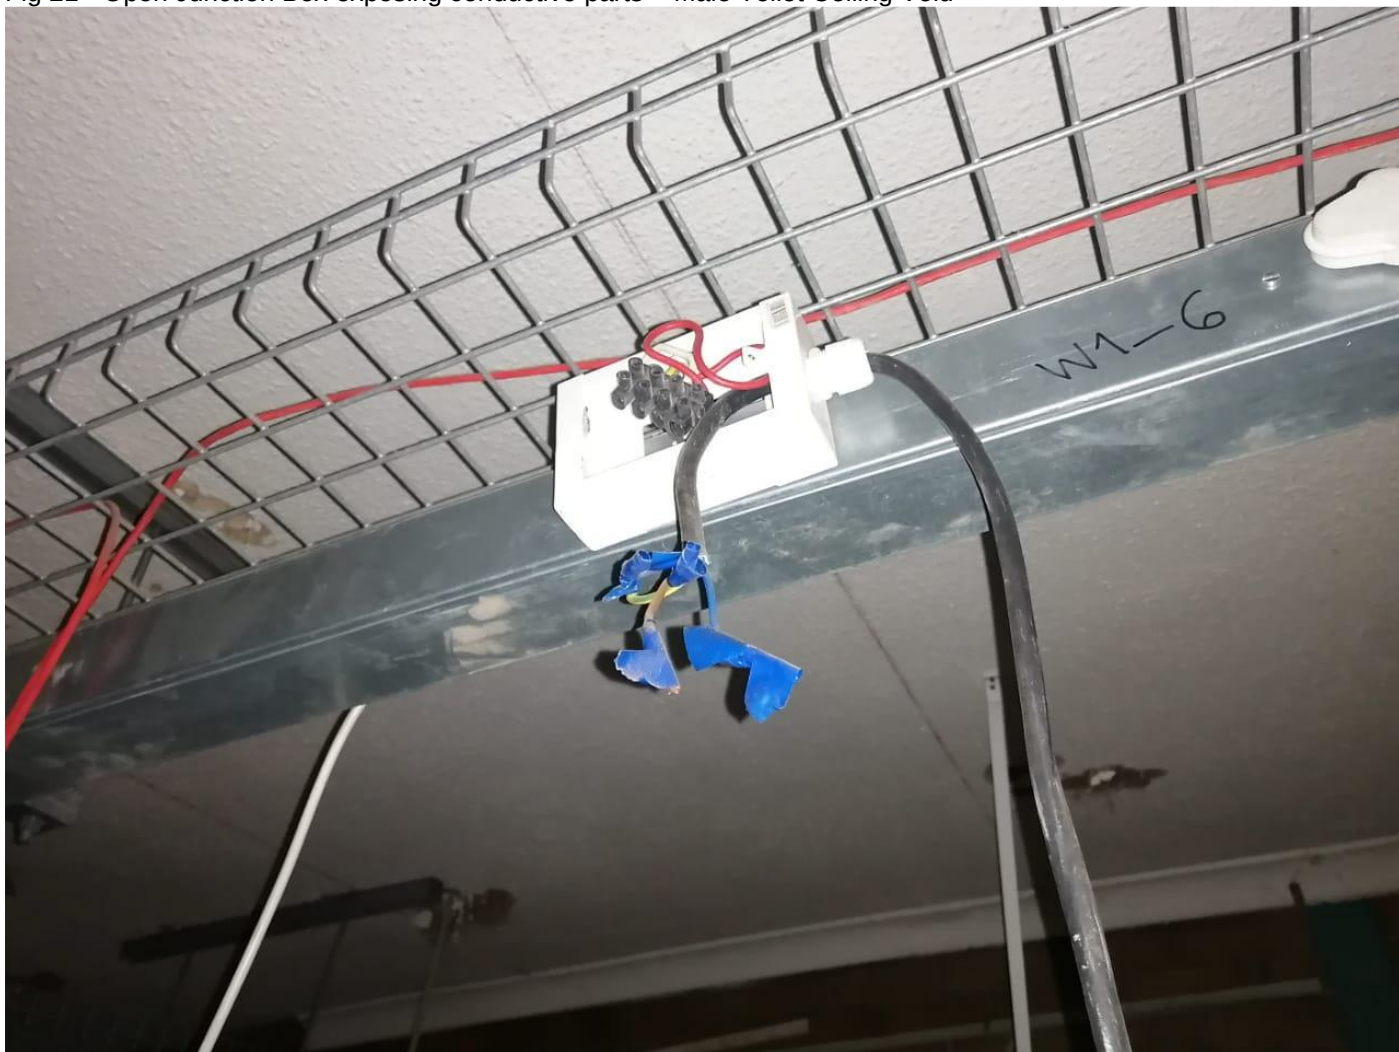
Fig 21 - Open Junction Box exposing conductive parts – Male Toilet Ceiling Void

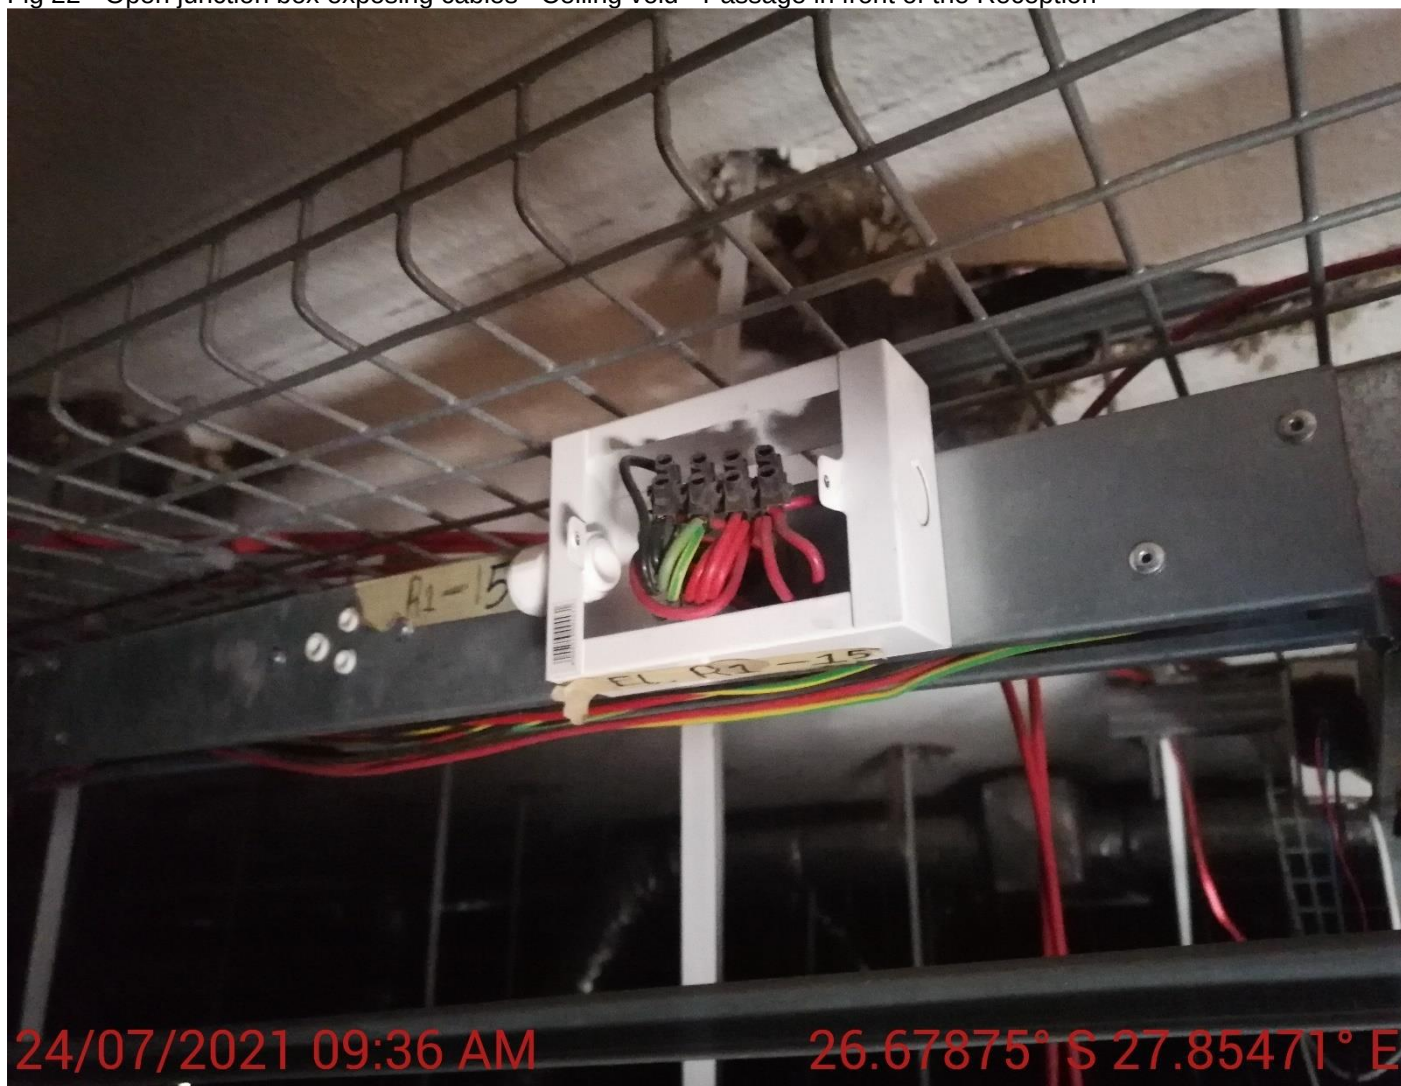
Fig 22 - Open junction box exposing cables– Ceiling void - Passage in front of the Reception

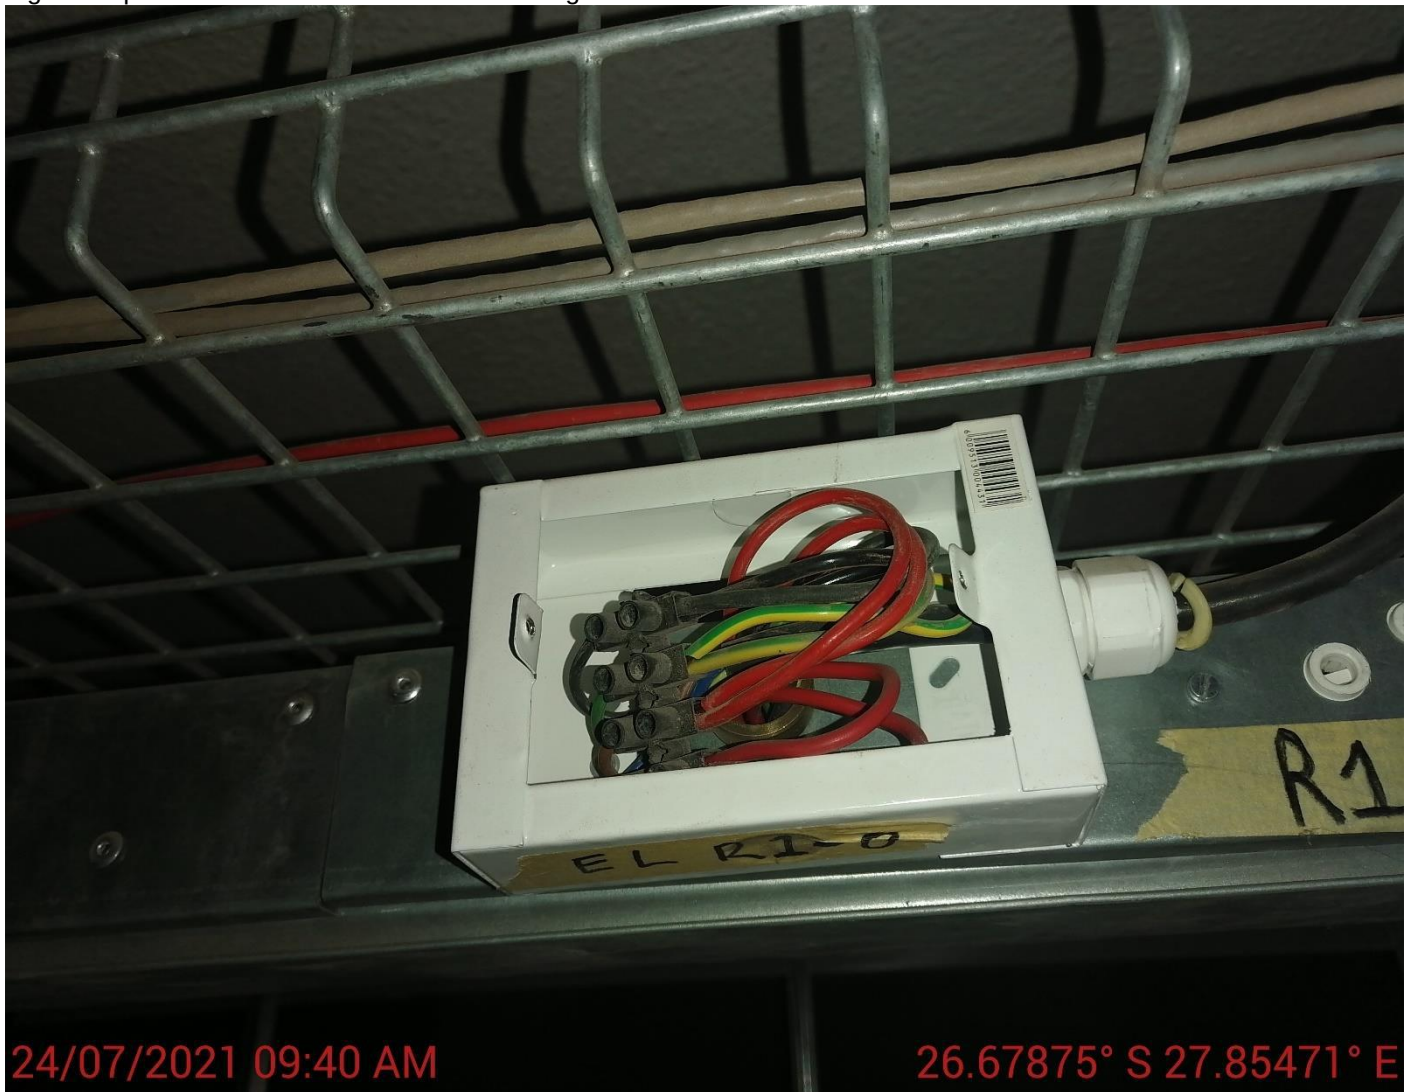
Fig 23 - Open Junction box – Tea Kitchen ceiling Void

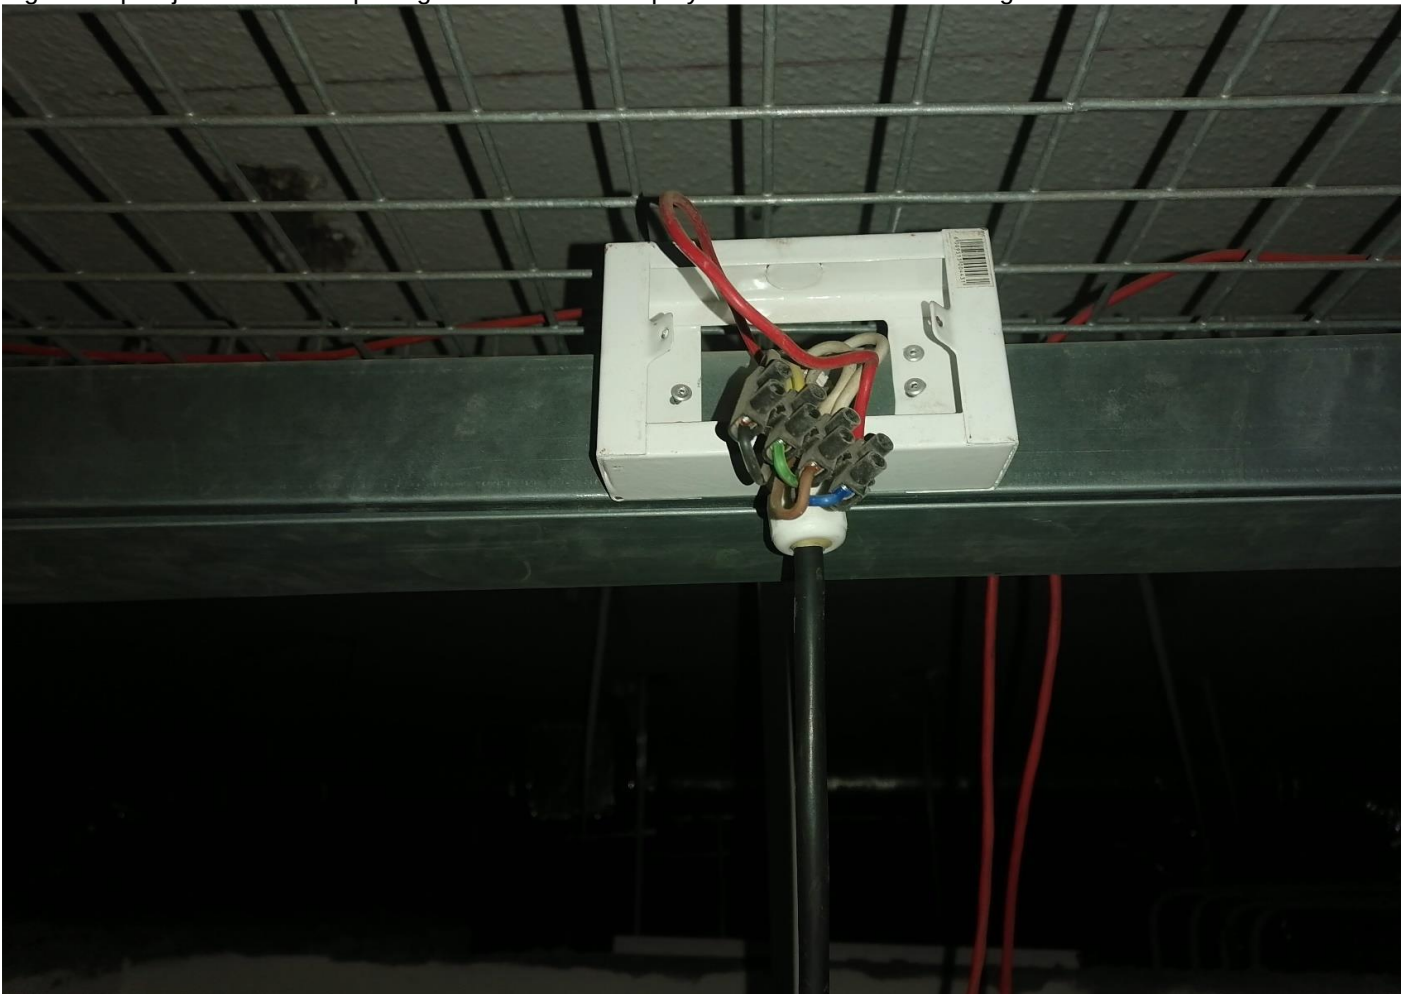
Fig 24 - Open junction Box exposing connections – Employee Relations Office Ceiling Void.

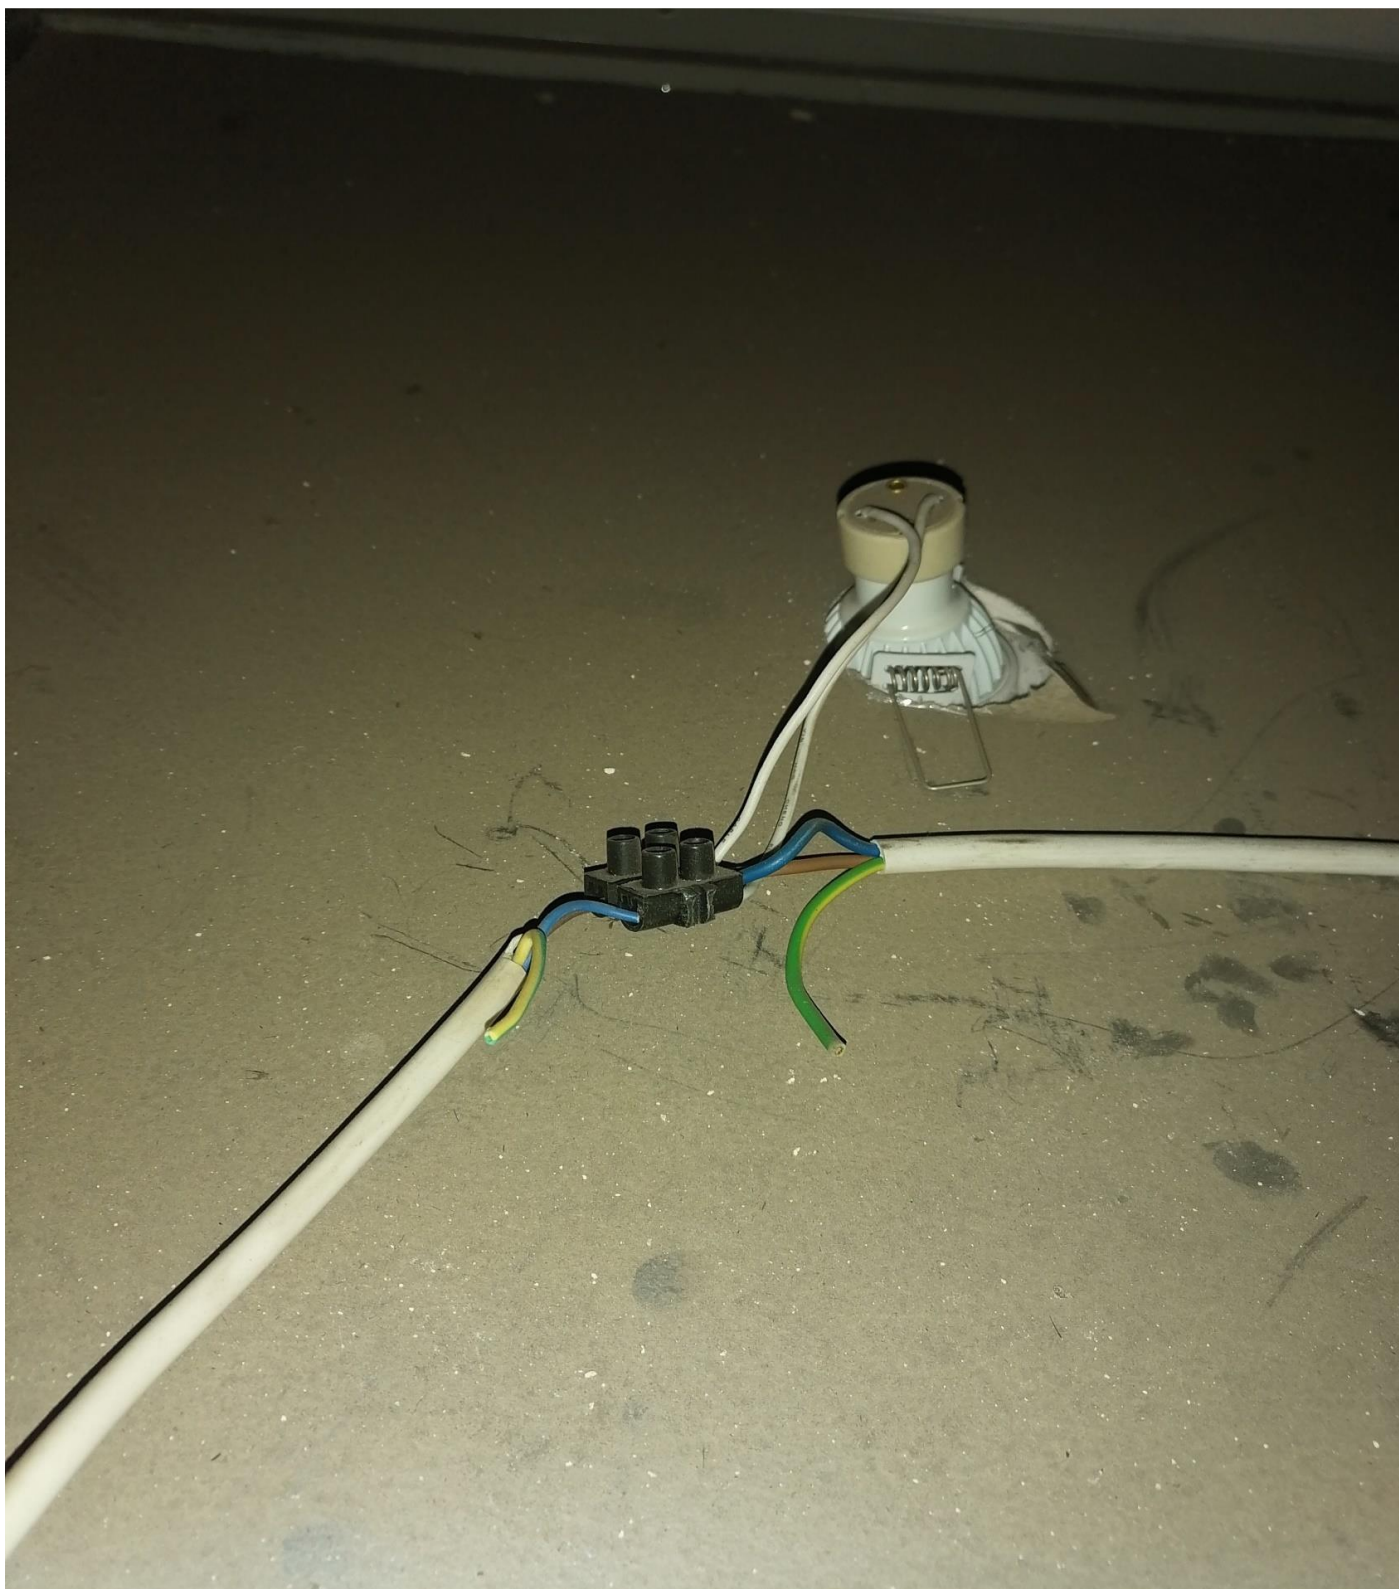
Fig 25 - Improper connections inside the ceiling void – Passage down lights

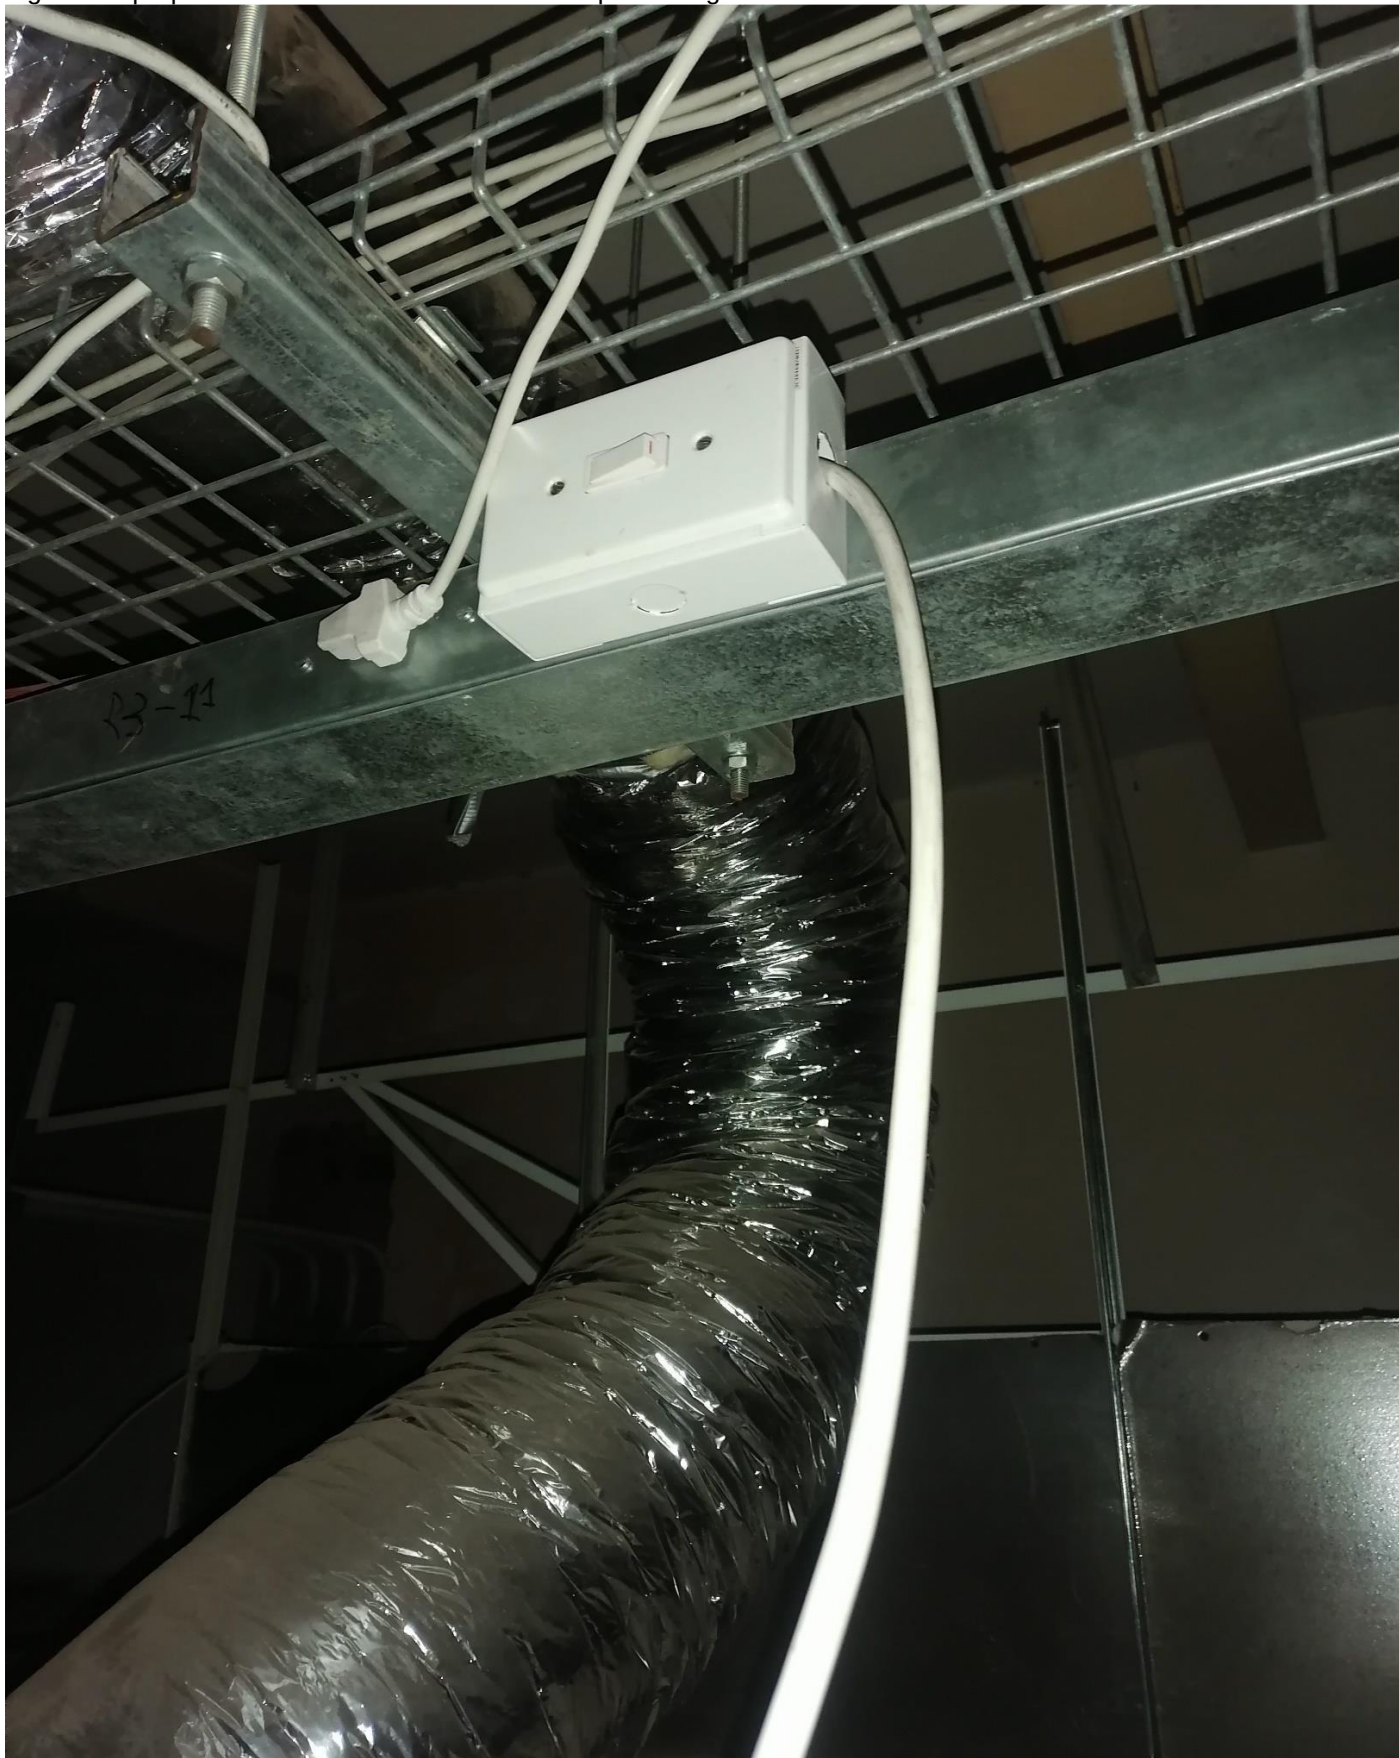
4. Improper cable terminations: This is mostly found on junction boxes mounted by the cable trunking side, connections were made without compression glands, allowing cable cords to be suspended by connections.

Fig 26 - Improper Cable termination – without compression glands

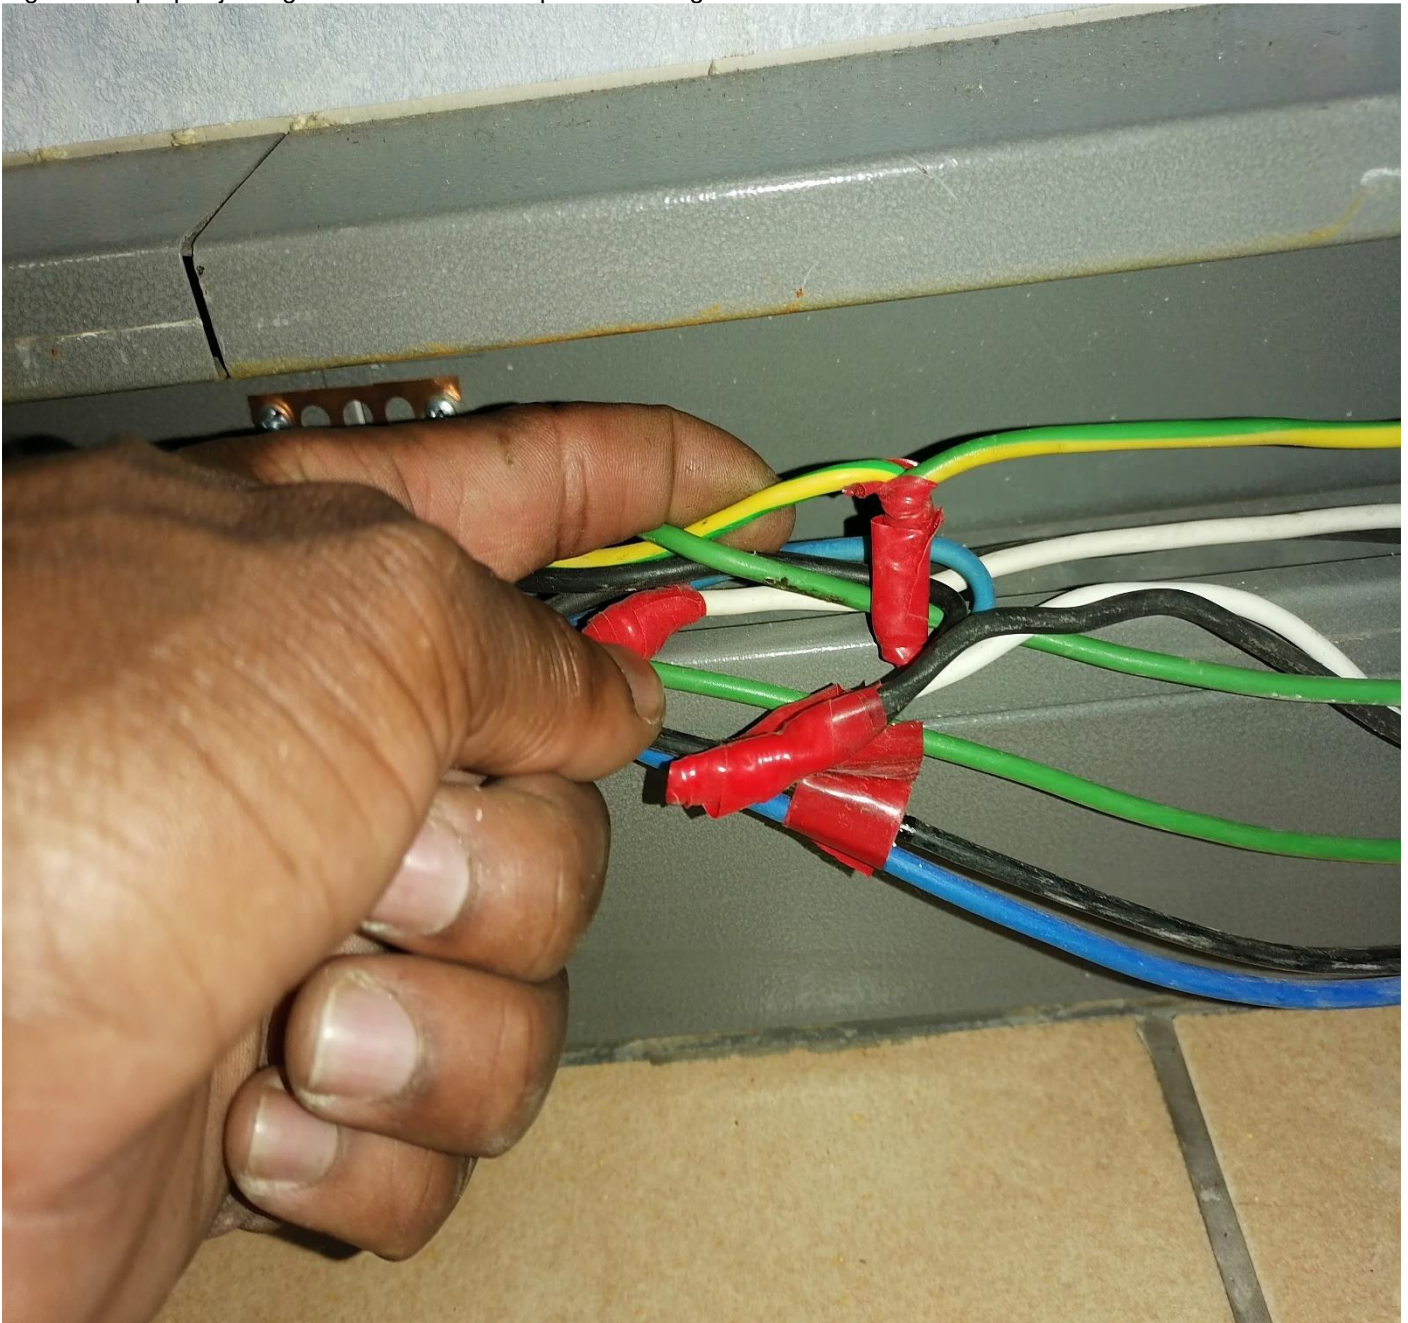
Fig 28 – Improper joining of cables inside the power skirting.
