| INSPECTION DATE: 02/02/2026<br>ASSET NO: TBC<br>TENANT NAME: Senzomix | FACILITIES MANAGEMENT-ANNUAL INSPECTION REPORT | |
| ANNUAL INSPECTION | PORT OF CAPE TOWN | |

Site Location: The building is located at the Port of Cape Town right alongside Duncan Road

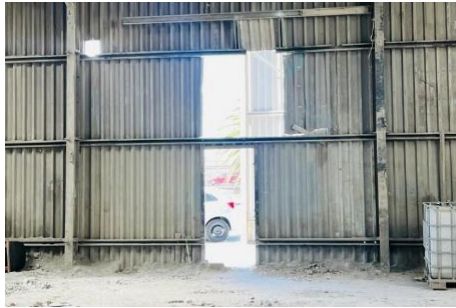
| AREA | IDENTIFIED FINDING | PICTURE/ EVIDENCE | ACTION TO BE UNDERTAKEN |
|---|---|---|---|
| <b>Interior</b> | Broken IBR wall sheets | | Remove and replace damaged IBR wall sheets with new IBR sheets to match the existing profile. |

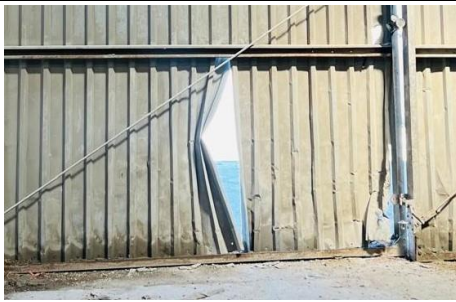
| AREA | IDENTIFIED FINDING | PICTURE/ EVIDENCE | ACTION TO BE UNDERTAKEN |
|---|---|---|---|
| | Bent IBR side wall Sheets | | |

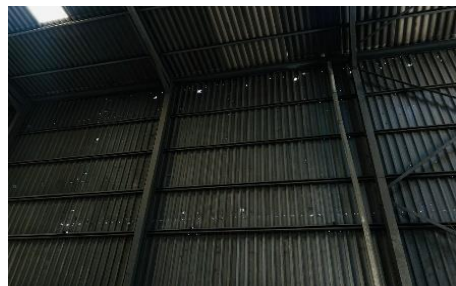
| AREA | IDENTIFIED FINDING | PICTURE/ EVIDENCE | ACTION TO BE UNDERTAKEN |
|---|---|---|---|
| | Holes on the IBR Sheets | | |

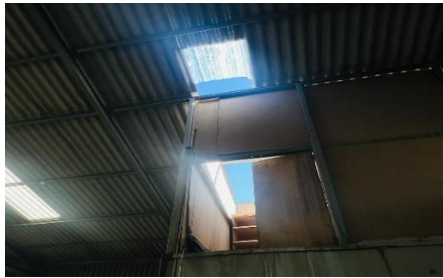
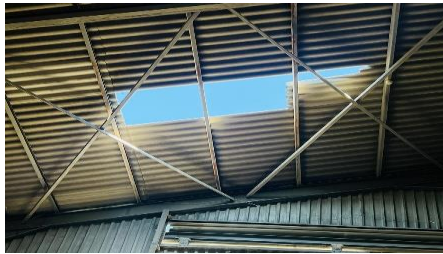
| <i>Interior continue...</i> | Broken IBR Roof sheets on the roof | | Remove and replace damaged IBR roof sheets and secure all roof fixings. |

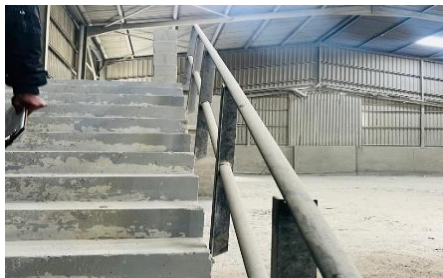
| | Loose handrails | | Secure and fasten loose handrails to ensure structural stability and user safety. |

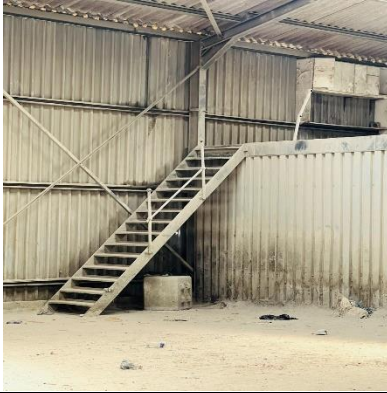
| <i>Interior continue...</i> | Loose handrails | | Secure and fasten loose handrails to ensure structural stability and user safety. |

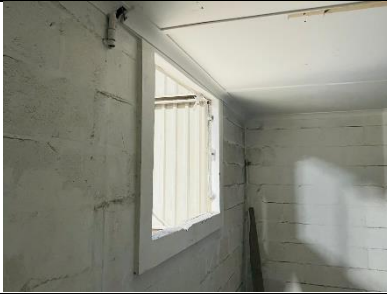
| | No window | | Supply and install a new window and ironmongery to match the existing installation. |

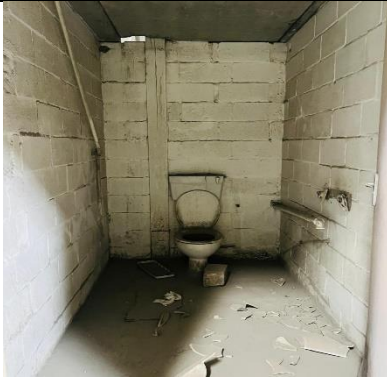
| | Toilet not working | | Investigate the cause of the defect and carry out the necessary plumbing repairs to restore functionality. |

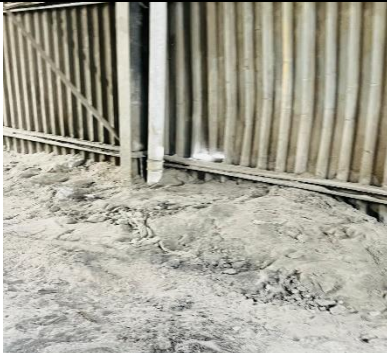
| <i>Interior continue...</i> | Cement on the floor | | Remove all cement debris and clean the affected area. |

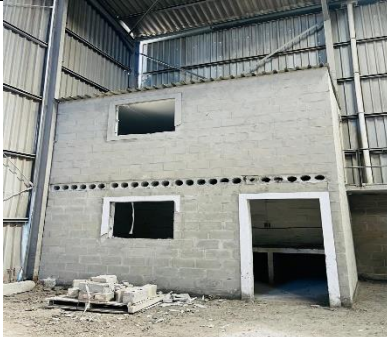
| | Building requires plastering, painting and installation of windows and doors | | Prepare all surfaces and repaint the building. Supply and install new windows and doors where required. |

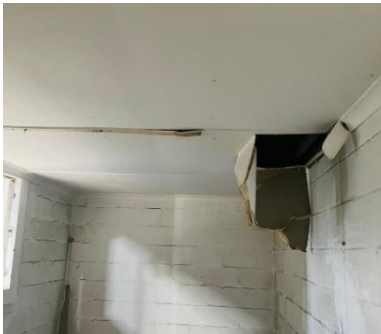
| | Broken ceiling boards | | Remove damaged ceiling boards and install a new ceiling complete with supporting grid where necessary |

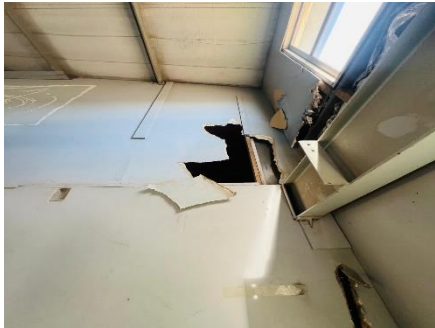
| <i>Interior continue...</i> | Partition wall vandalised | | Demolish damaged partition walls and construct new partition walls to match the existing layout |

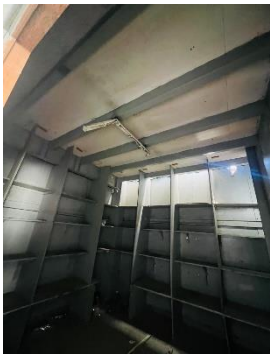
| | Broken and damaged Cupboards | | Remove damaged cupboards and supply and install new cupboards complete with fittings and hardware. |

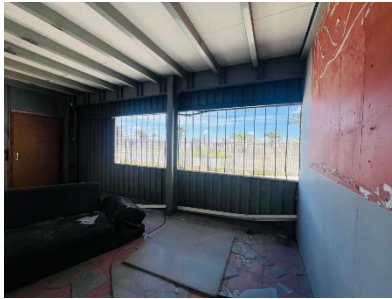
| <i>Interior continue...</i> | Damaged flooring observed | | Remove remaining damaged floor finishes and replace with new floor tiles, including all necessary preparation. |

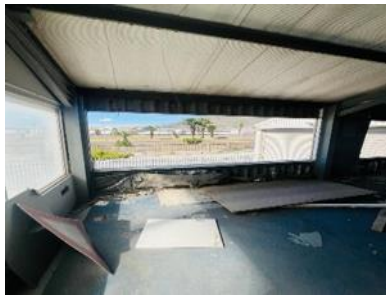
| | Missing office window | | Supply and install new office window complete with glazing and fittings. |

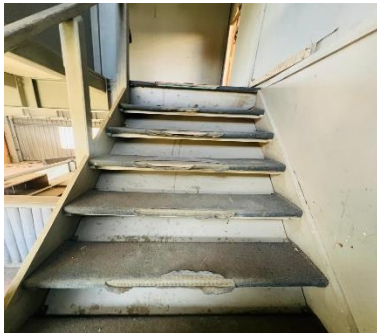
| | Staircase carpet in a poor condition | | Remove the damaged carpet and replace it with new heavy-duty commercial carpet suitable for staircases. |

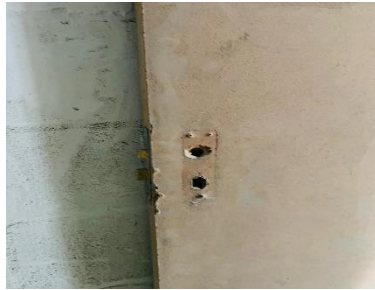
| <i>Interior continue...</i> | Missing door handle | | Supply and install new door handles complete with all necessary fixings. |

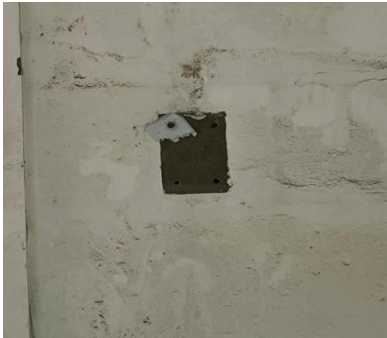
| | Electrical switch socket missing. | | Supply and install a new electrical switch socket and restore the affected electrical point. |

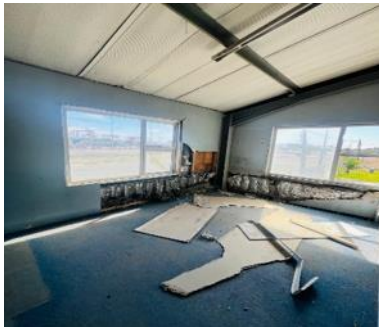
| | Partition wall vandalised | | Demolish damaged partition walls and construct new partition walls to match the existing layout |

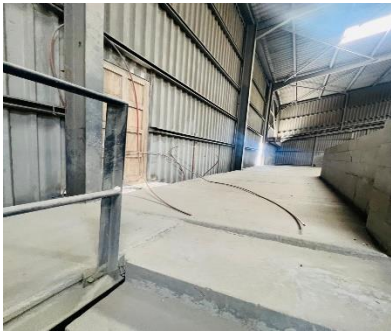
| <b>Exterior</b> | <i>Interior continue...</i> | Loose cables | | Secure, terminate and conceal loose electrical cables in accordance with applicable electrical standards. |

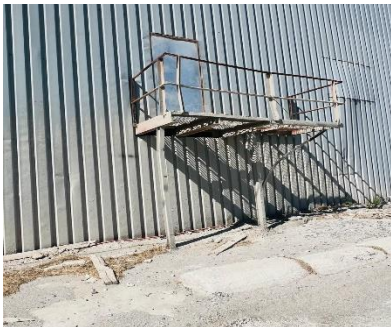
| | | Steel staircase bent and rusted | | Repair the damaged staircase, remove corrosion, apply anti-corrosion treatment and repaint with an approved protective coating. |

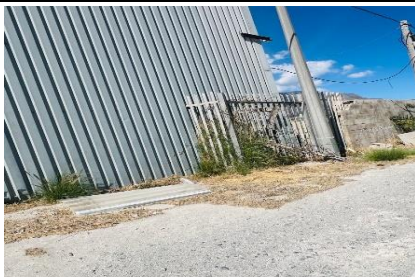
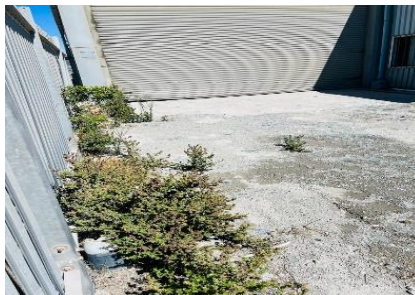
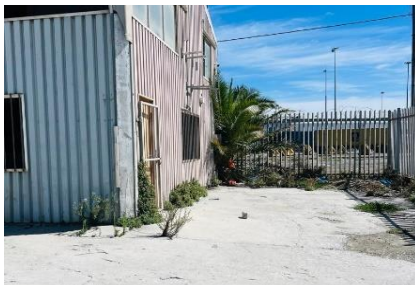
| <b>Exterior</b> | Overgrown vegetation observed. | | Clear all overgrown vegetation surrounding the building and dispose of the waste at an approved disposal site. |
