# Virtual Site Visit for Hercules to Magaliesburg Branch Line

02 July 2026

## 1.1 Overview of Hercules to Magaliesburg

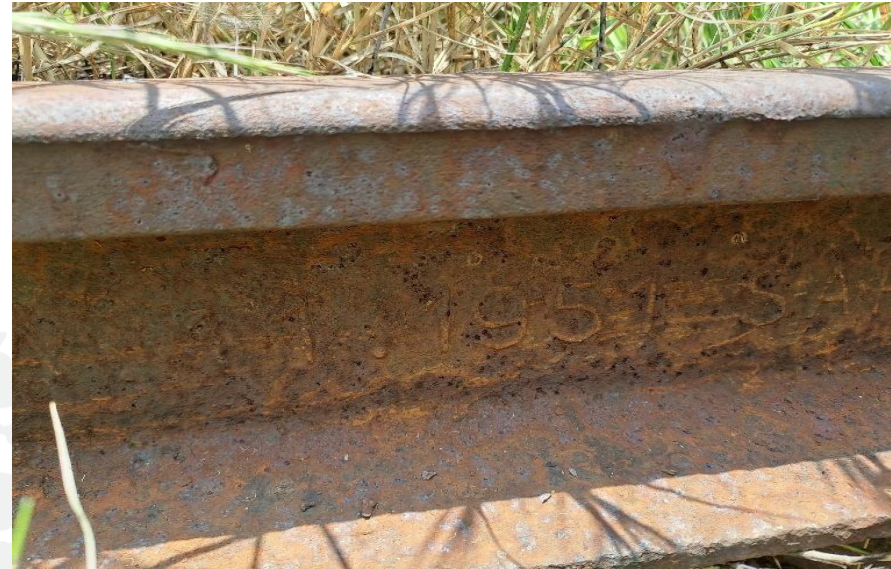
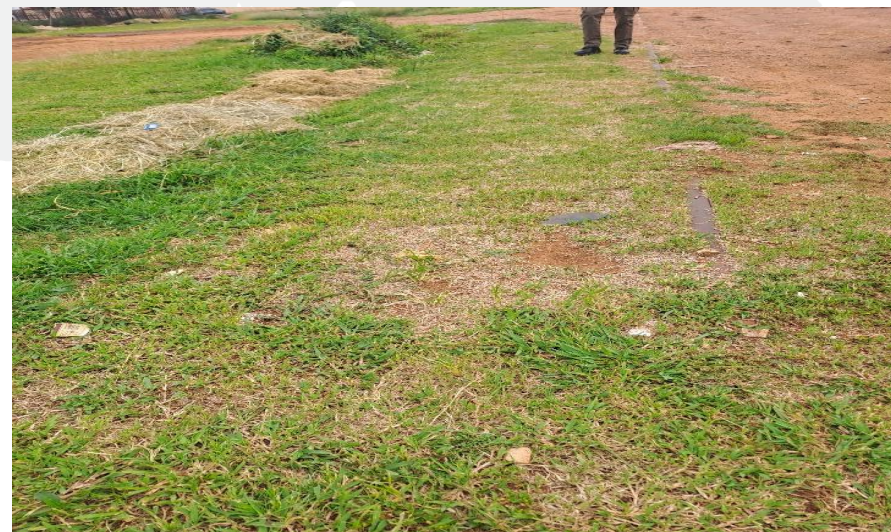
### Rails

- The rail profiles used are predominantly 30-40kg/m rail (based on markings were manufactured around 1951), with a small section consisting of 48kg/m around Hercules station.
- The majority of rails along the line are missing or removed.
- Remaining sections show signs of corrosion, misalignment, and partial burial, indicating long-term neglect and material theft.

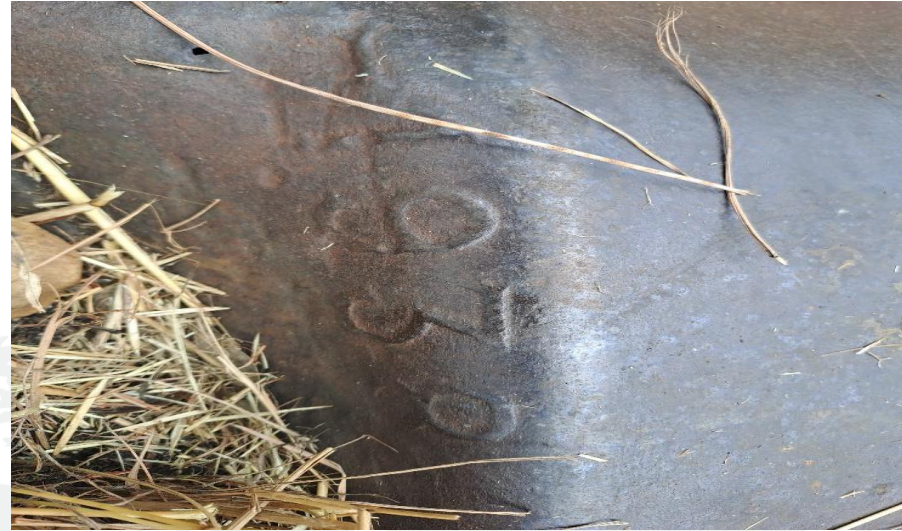
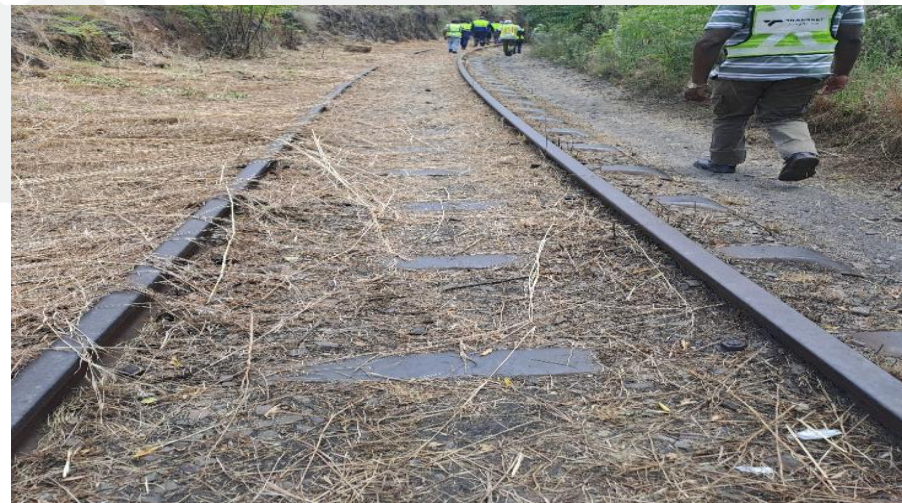
### Sleepers

- The line consists of steel (which based on markings were manufactured in 1938) and wooden sleepers.
- The sleepers are largely missing, with the few remaining areas severely decayed, structurally compromised and buried in soil and vegetation.

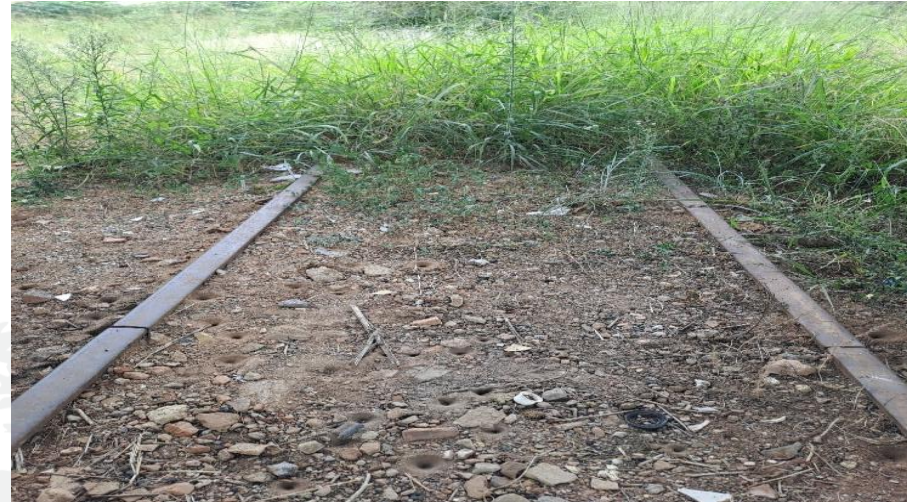
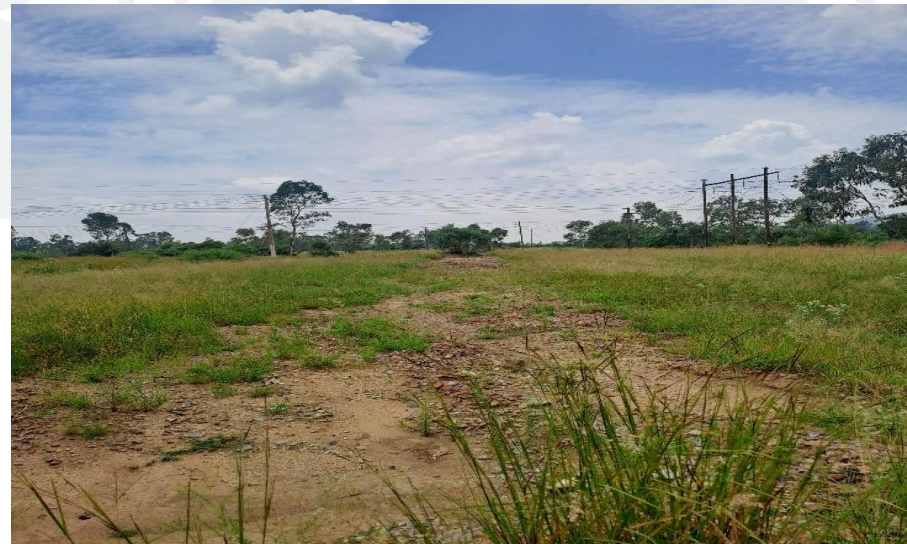
### Ballast

- The original ballast profile has been either removed or fouled with soil and vegetation.
- Generally, for the majority of the section the ballast profile and shoulder definition no longer exist.

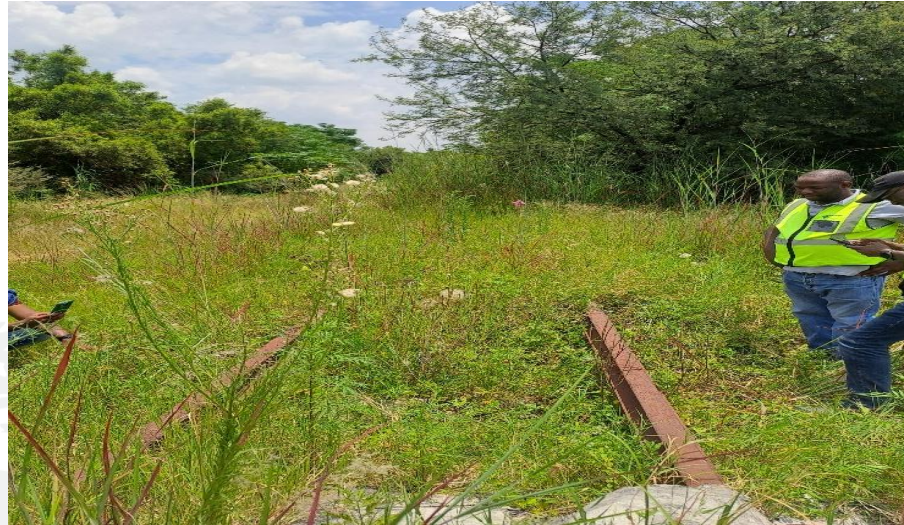
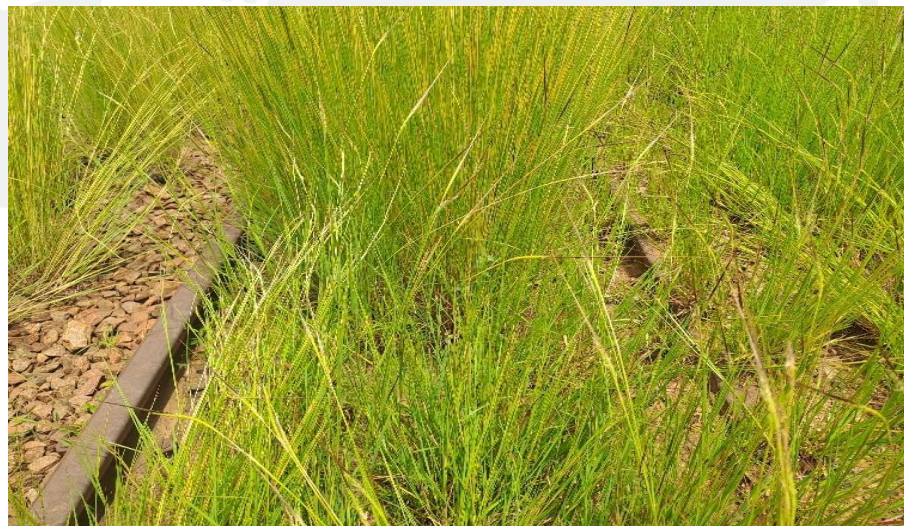
### Vegetation

- Vegetation along this section is extensive and unmanaged.
- Grasses, shrubs and trees have grown directly on the line, covering the rails, sleepers, ballast, formation and culverts.
- The encroaching trees pose a risk of root intrusion, which can undermine earthworks, damage culverts and accelerate erosion of embankments.

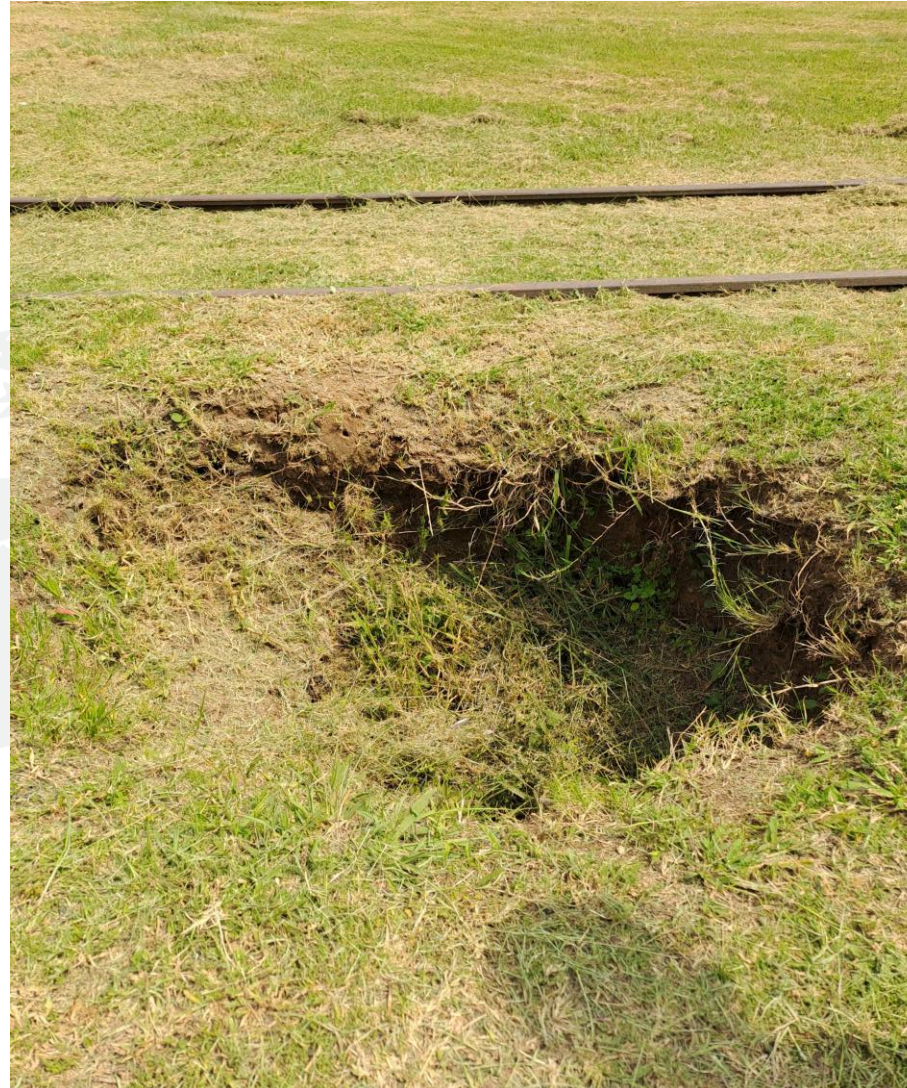
### Substructure and Drainage

- The railway formation remains partially intact on some sections of the line, however, its condition varies significantly along the route.
- Most sections generally have not retained their original profile and show signs of prolonged neglect, including surface erosion and vegetation encroachment.
- Other portions of the route have been physically disturbed or excavated, either for informal access routes, agricultural use, material recovery or development activities.
- Drainage along the section is generally ineffective or non-functional.
- Side and cut-off drains are blocked or overgrown with vegetation.

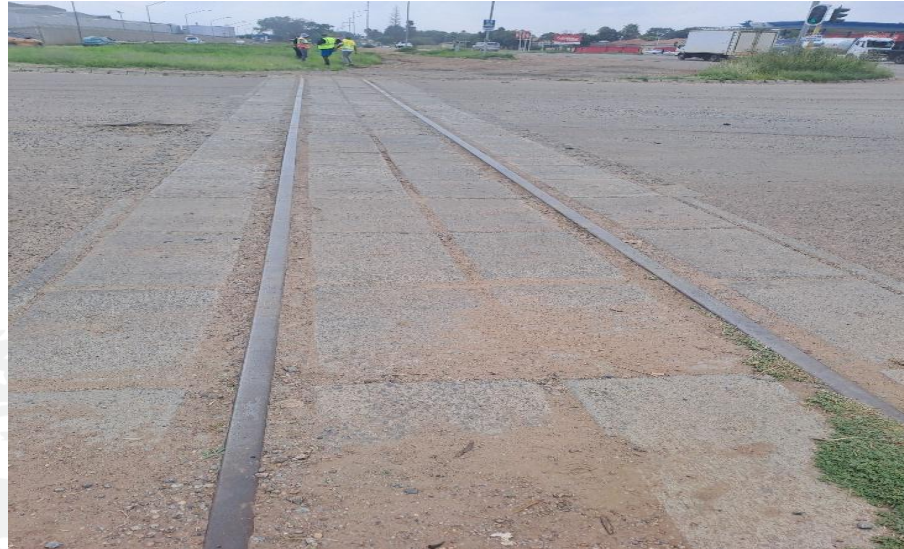
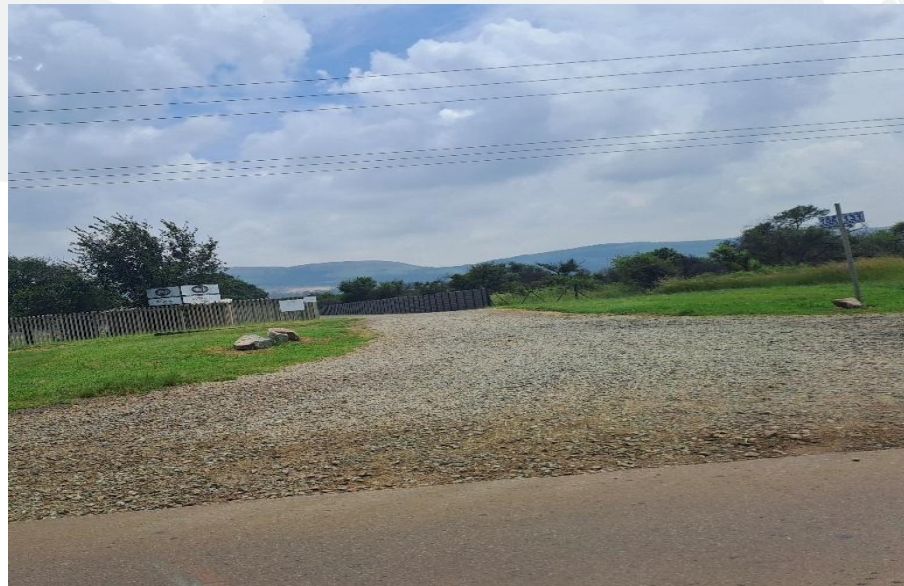
### Level Crossings

Some level crossings are fully integrated into road infrastructure, while others the infrastructure is still identifiable and others are illegal. From an operational perspective, these crossings would require full redesign, statutory approvals and coordination with road authorities to reinstate.

- In some locations, the rail infrastructure at level crossings has been completely removed, with road surfaces modified to accommodate vehicular traffic.
- Other areas, the rail infrastructure is still visible.
- Some illegal crossings were also observed. In all instances, no level-crossing protection was observed.
- There is no evidence of maintained sighting distances or controlled approaches in accordance with the safety standards.

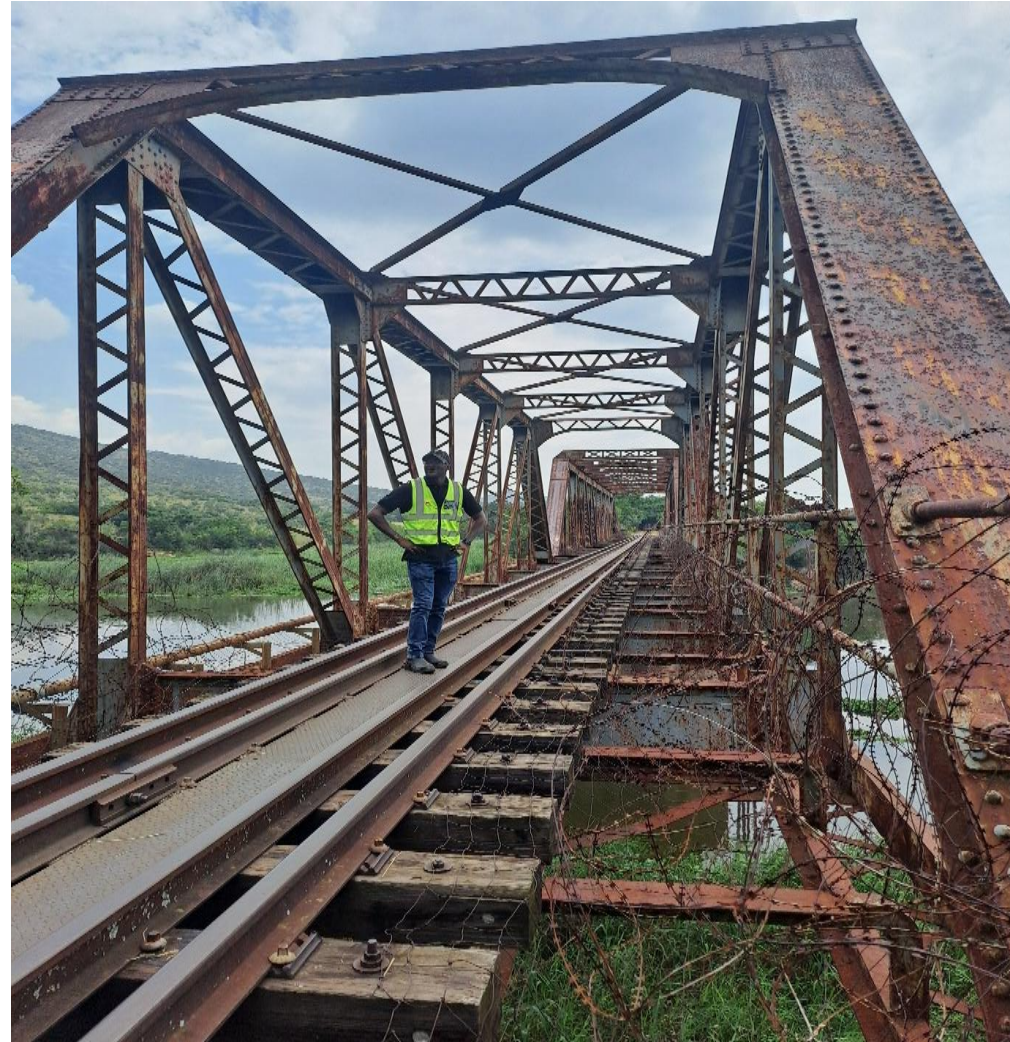
### Bridges and Culverts

- The structures along the line consist of 4 steel bridges (rail over river), 4 concrete arch bridges (rail over river) and 161 pipe culverts of diameter varying from 450 – 900mm and 71 box culverts varying from 1150 – 4000mm in size.
- A detailed assessment will be required to accurately determine the structural condition and serviceability of the bridges and culverts.

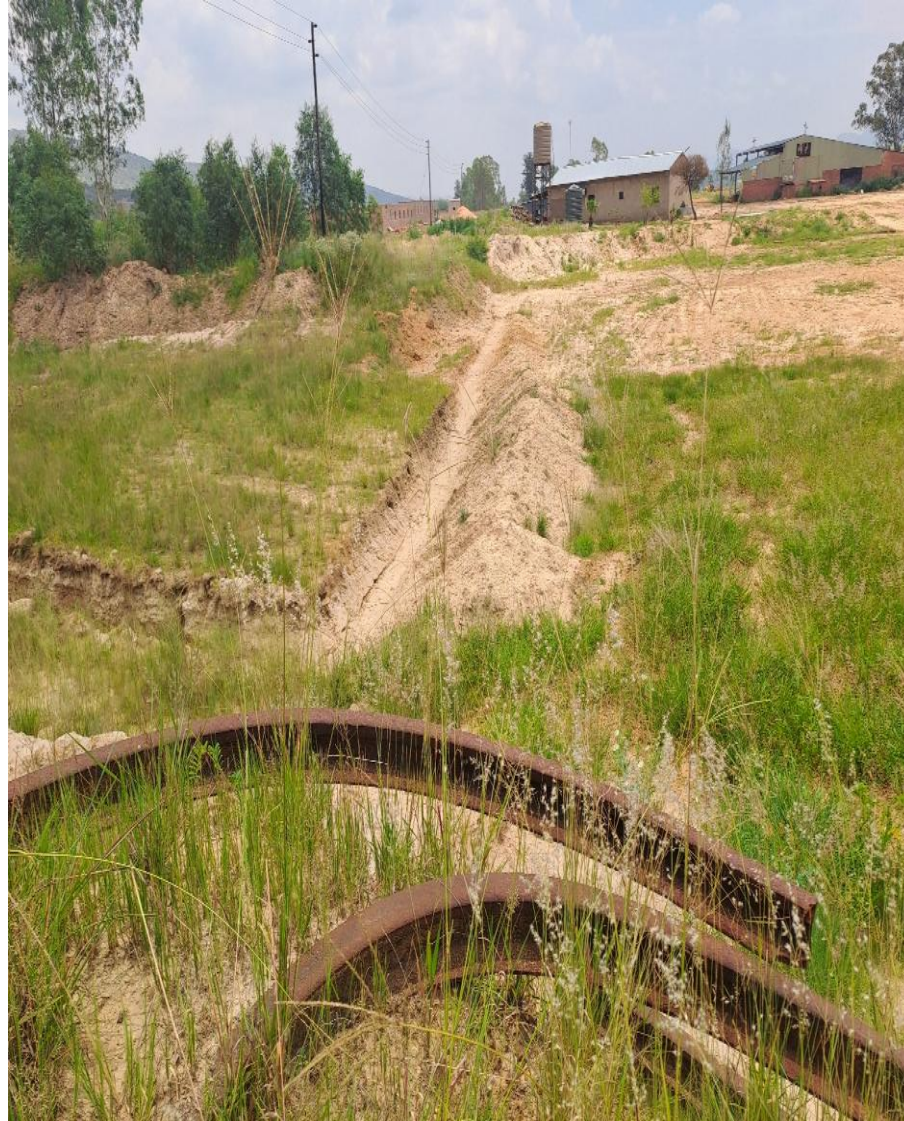
### Encroachment and Human Impact

- The line has been significantly compromised by widespread encroachment and human activity, resulting in a fragmented and discontinuous corridor.
- Portions of the rail alignment have been permanently converted to road infrastructure, while residential, industrial, agricultural and quarry developments have encroached the rail reserve.

- In several areas, track infrastructure has been removed, formations and embankments excavated and sections of the line repurposed for access roads and other land uses.

- These impacts have severely degraded the integrity of the corridor and created major challenges related to land ownership, servitude protection, environmental compliance, stakeholder engagement and relocation requirements.

- Consequently, any future reinstatement of the line would require not only substantial engineering reconstruction but also extensive legal, planning and social intervention.
