Report Name : Port of East London Grain Elevator
Substations Electrical Condition Assessment

Grain Elevator Substations Conditional Assessment

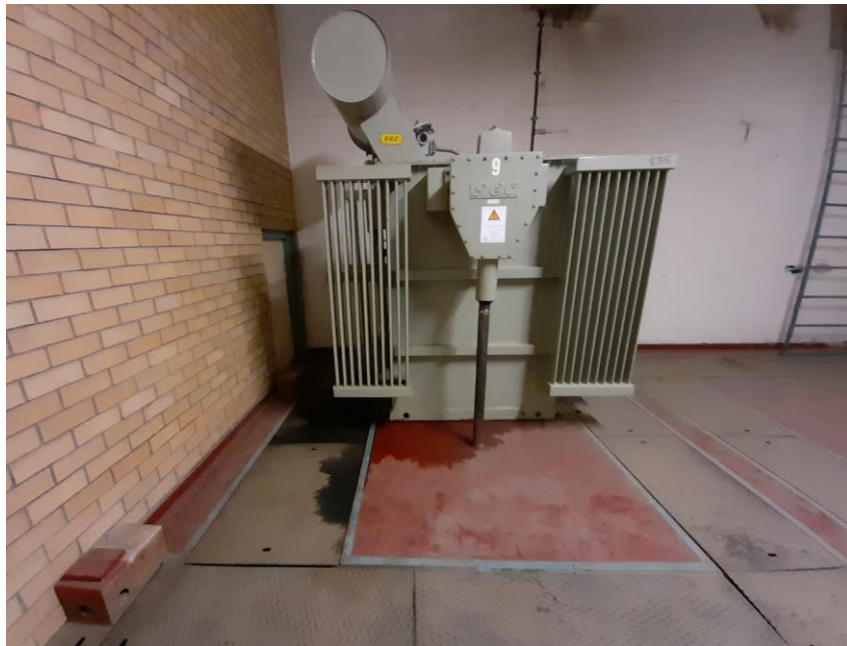
Figure 2 Distribution transformer with no oil containment provision

- For installations with oil Filled transformers, SANS 10142-2 requires that adequate provision shall be made for containing oil in case of leakages or spillages. Figure 2 shows an installation without an oil containment with some evidence of experienced leakages. The spill oil can also gain access to cable trenches which is in addition not acceptable, see *Figure 2*.

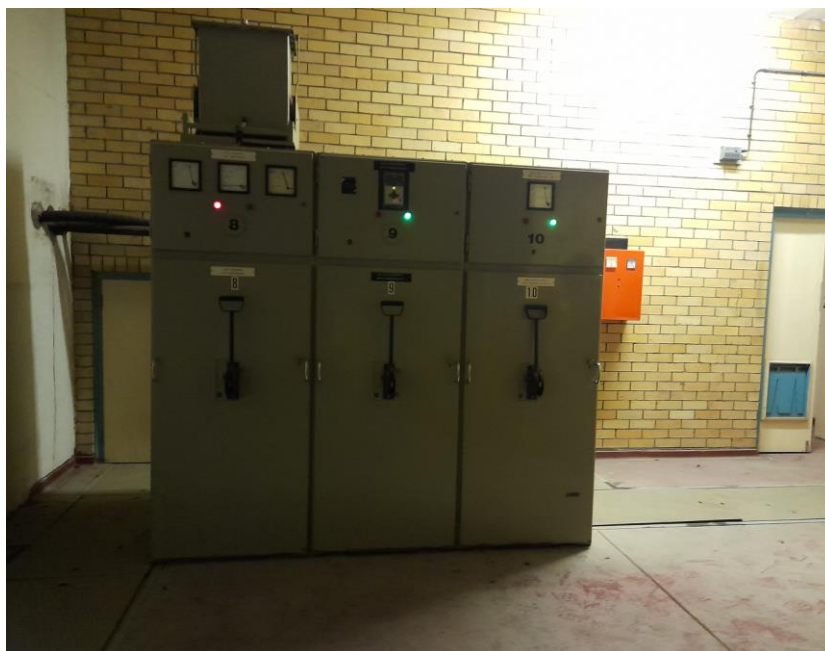
Figure 3 Medium Voltage Oil Insulated Switchgear

- The racking procedure for this type of switchgear may lead to poor contact which may cause internal arcing that may be harmful to the maintenance personnel when racking/operating the circuit breakers. See *Figure 3*. There is no record of switchgear type provision of internal arc protection system and arc quenching making them non-compliant with IEC 62271.

- The racking procedure for this type of switchgear may lead to poor contact which may cause internal arcing that may be harmful to the maintenance personnel when racking/operating the circuit breakers. See Figure 3. There is no record of switchgear type provision of internal arc protection system and arc quenching making them non-compliant with IEC 62271

- Supply and install gas insulated (GIS) Medium Voltage switchgear and match the existing VCB specification. The GIS shall incorporate for overload and earth fault protection in accordance to OHS Act of 1993, IEC62271-200, and SANS 10142-2. This MV panel shall be equipped with arc detection and quenching system, circuit breaker failure protection. This is the latest trend in the safety standard which has been the introduction of the IEC 62271-200 standard. See above section 4.1 for literature review on GIS.

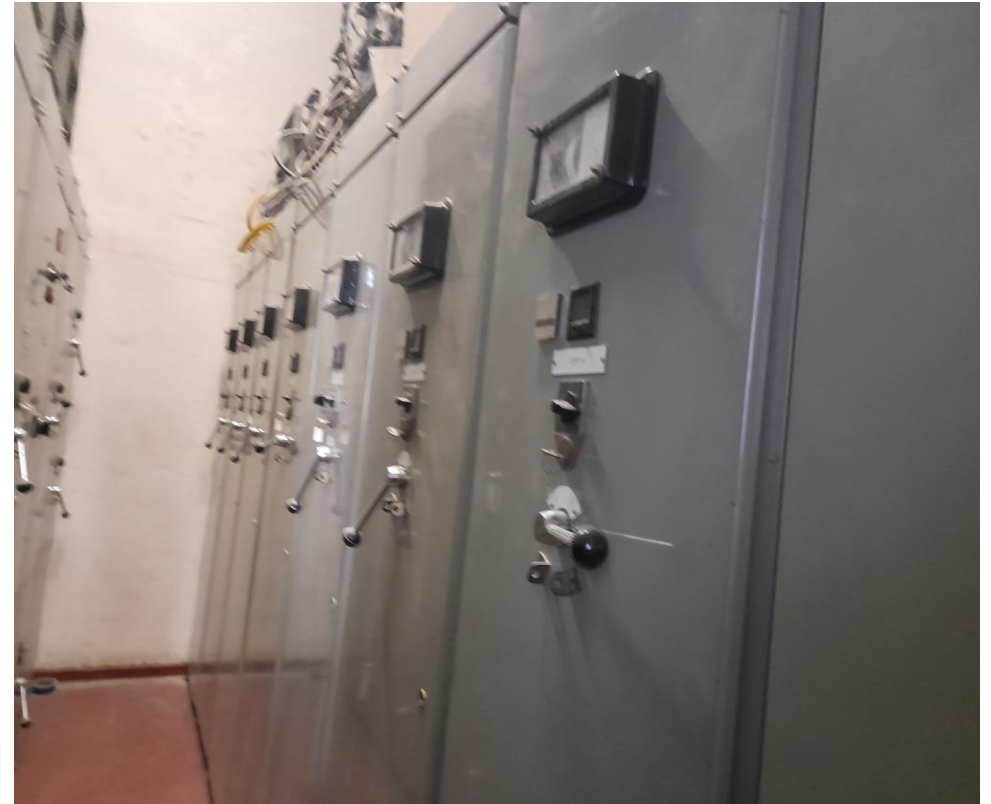
Figure 5 Old LV switchgear of fuse technology and working space

- There are no found records for routine tests and checks for the transformers.
- The LV board is an old type and it is made of fuses, see *Figure 5*. The LV supply is of the busbar system which is not best practice. Voltmeters and Ammeters are operational which makes an ease of analysing the day to day actual voltage and current demand. The LV board is fed from Transformer 2 and Transformer 1. The LV switchgear makes use of the fuse technology, which is not recommended as per the reasons discussed in Section 4.1.

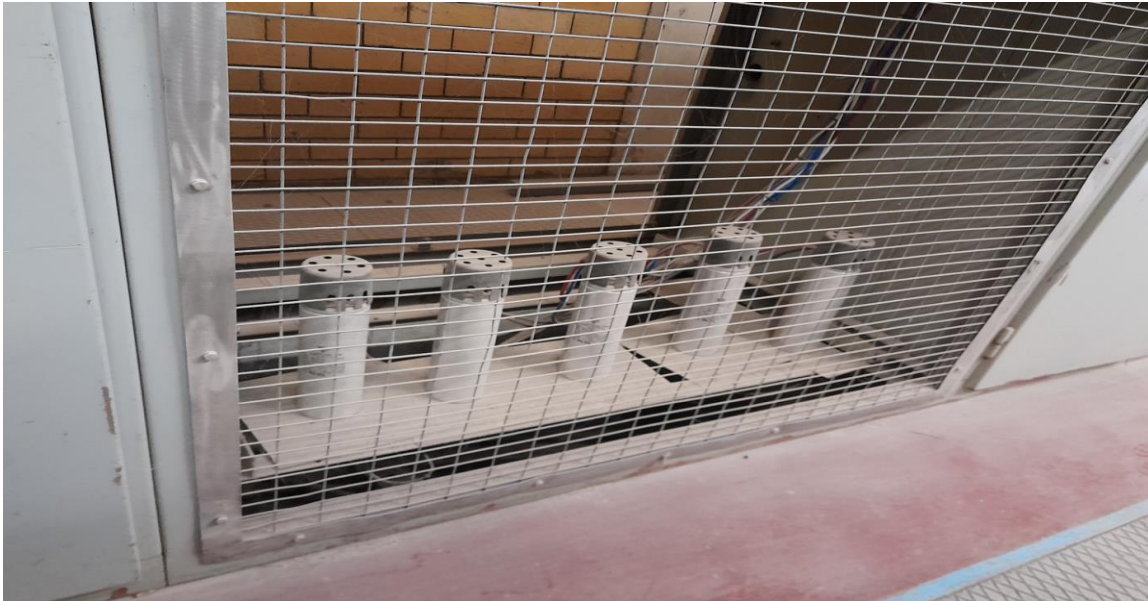
Figure 6 Old and Obsolete Power Factor Correction

- The substation uses very old and obsolete power factor correction equipment, see *Figure 6*.
- There are very old and obsolete resistance starters for bucket elevators, fans and chain elevators, are fed from oil circuit breakers in the LV distribution room. These units regularly burn out under load and replacement banks are not of the same resistance, see *Figure 7*.

- Installation of new power factor correction.
- Sort out the environmental operation of the switchgear which means the substation must get positively pressurized and install with filter fans and dehumidifiers so that the environment of the substation can become conducive to the switchgear installed. Sealing the substation is also recommended to prevent sea water mist and dust from entering the substation. Heat shrink the busbars including the terminations and all nuts and bolts on the switchgear.
