CATHODIC PROTECTION MAINTENANCE SURVEY OR TAMBO INTERNATIONAL AIRPORT SEPTEMBER 2025

REPORT NUMBER: PR0452

PROJECT : Cathodic Protection Maintenance Survey at
OR Tambo International Airport

TITLE : CP Maintenance Report – September 2025

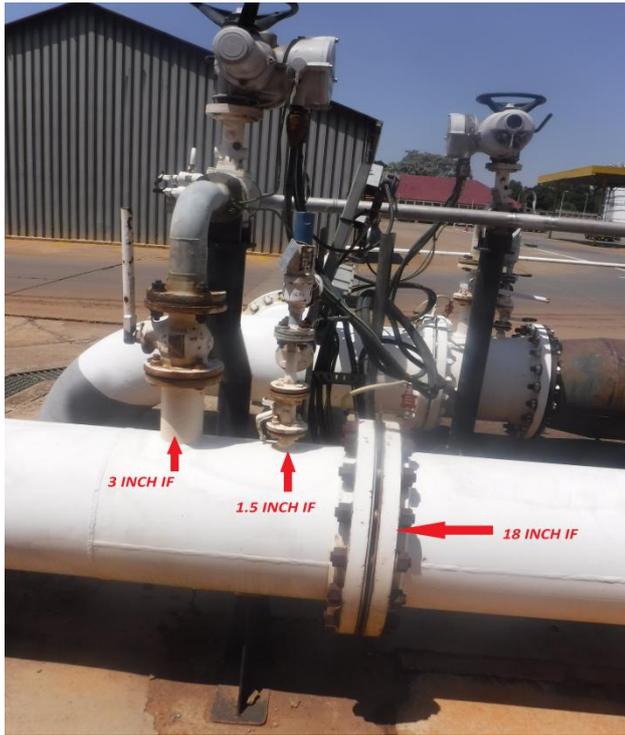
Figure 1: Insulating Flange kits on the 18 Inch feeder pipeline

The IF kits on the 18-inch feeder pipeline feeder pipeline were inspected and tested after access was granted into the fuel depot. No test was done on the 20 Inch as there was no IF kit. The IF kits that were tested are shown in Figure 1 below.

18 INCH / 20 INCH FEEDER PIPES - Insulating Flange testing at the Tank farm depot				
Description	18” Flange kit	3” Flange kit	1.5” Flange kit	20” Flange kit
Potential Upstream (DEAD SIDE) (Vcse)	-1.14V	-1.1V	-1.15V	-1.03V
Potential Downstream (LIVE SIDE) (Vcse)	-0.9V	-0.89V	-0.9V	-0.93V

The results showed current leak (shorting) from the newly installed bypass pipe which links the 18-inch feeder to the 20-inch feeder pipeline, and this is placing severe pressure on the groundbed at Bravo CP system (CP22).

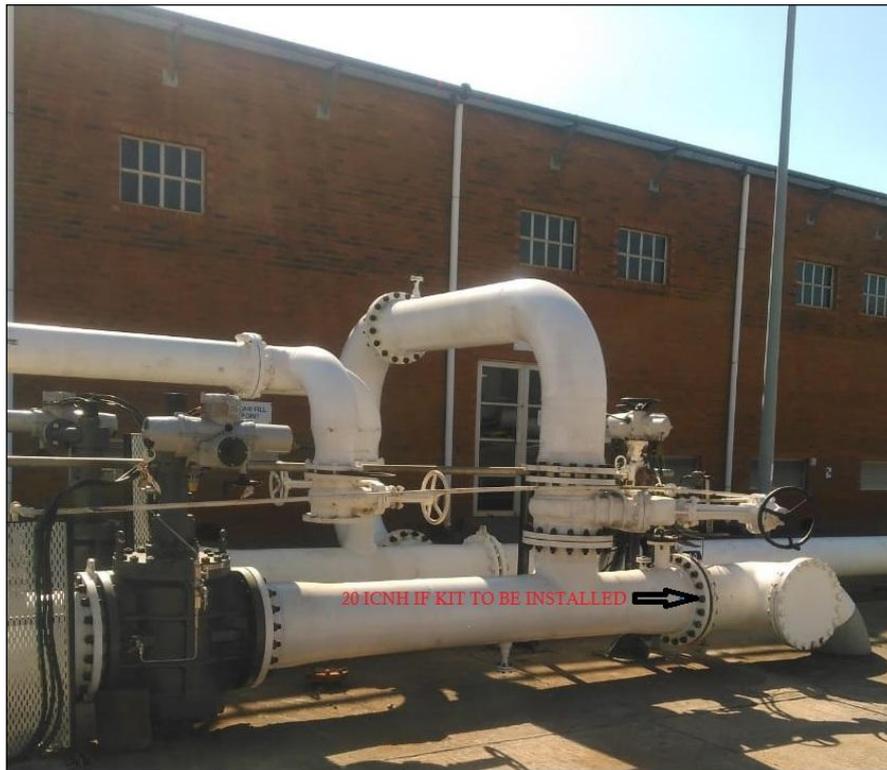
NOTE - THE CURRENT REMOVED IF KIT (INSULATING FLANGE KIT) DURING THE INSTALLATION OF THE NEW 18 INCH TO 20 INCH BYPASS PIPE HAS NEGATIVE IMPACT ON THE ENTIRE CP SYSTEM (GROUNDBED). THIS HAS TO BE CORRECTED URGENTLY TO REDUCE THE RISK OF CONSUMPTION ON THE SYSTEM.

Figure 2: 20 Inch flange with no IF kit after bypass installation

- Carry out further Bellows NDT inspection based on the approved program submitted last year.
- A new IF kit to be urgently installed at the IF (insulating flange) point on the 20-inch feeder.
- A new display monitor is required to be installed on the Bravo TRU system (CP22), as the current display is not visible and affects accuracy during data collection.

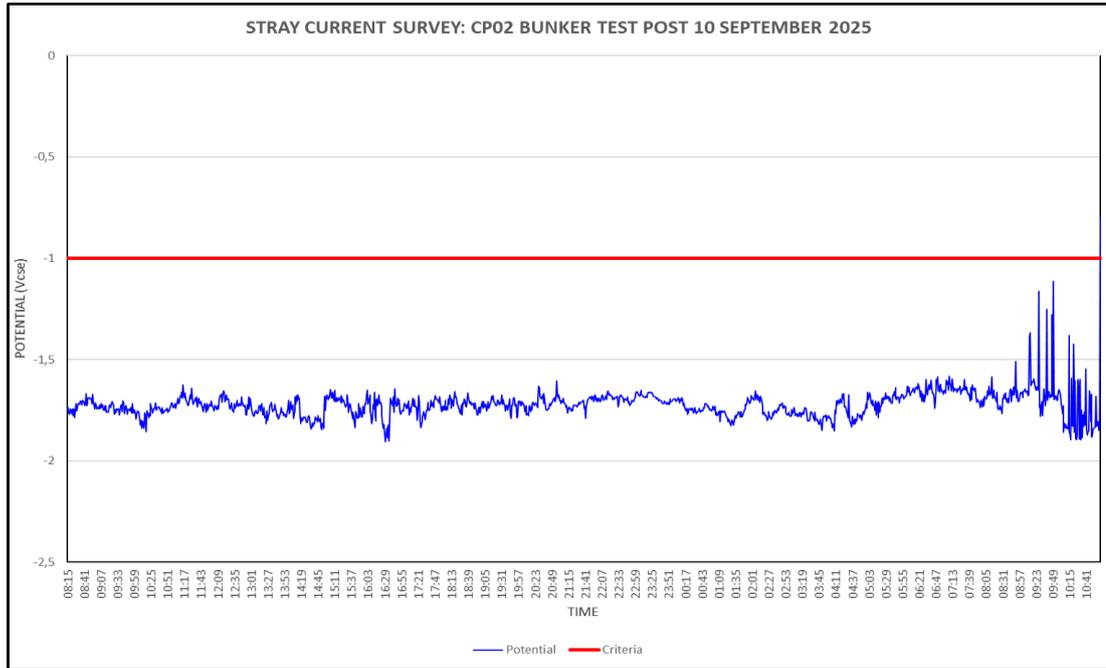
Figure 3: Stray current recording at CP02 bonding test post on the feeder pipes

The stray current results complied with the specified criteria and are represented graphically in Figure 3 to Figure 11 below:
