REQUEST FOR BID

10397088 – Scope of Work

Repair all non-compliance at no.1 Control room as per Scope Below:

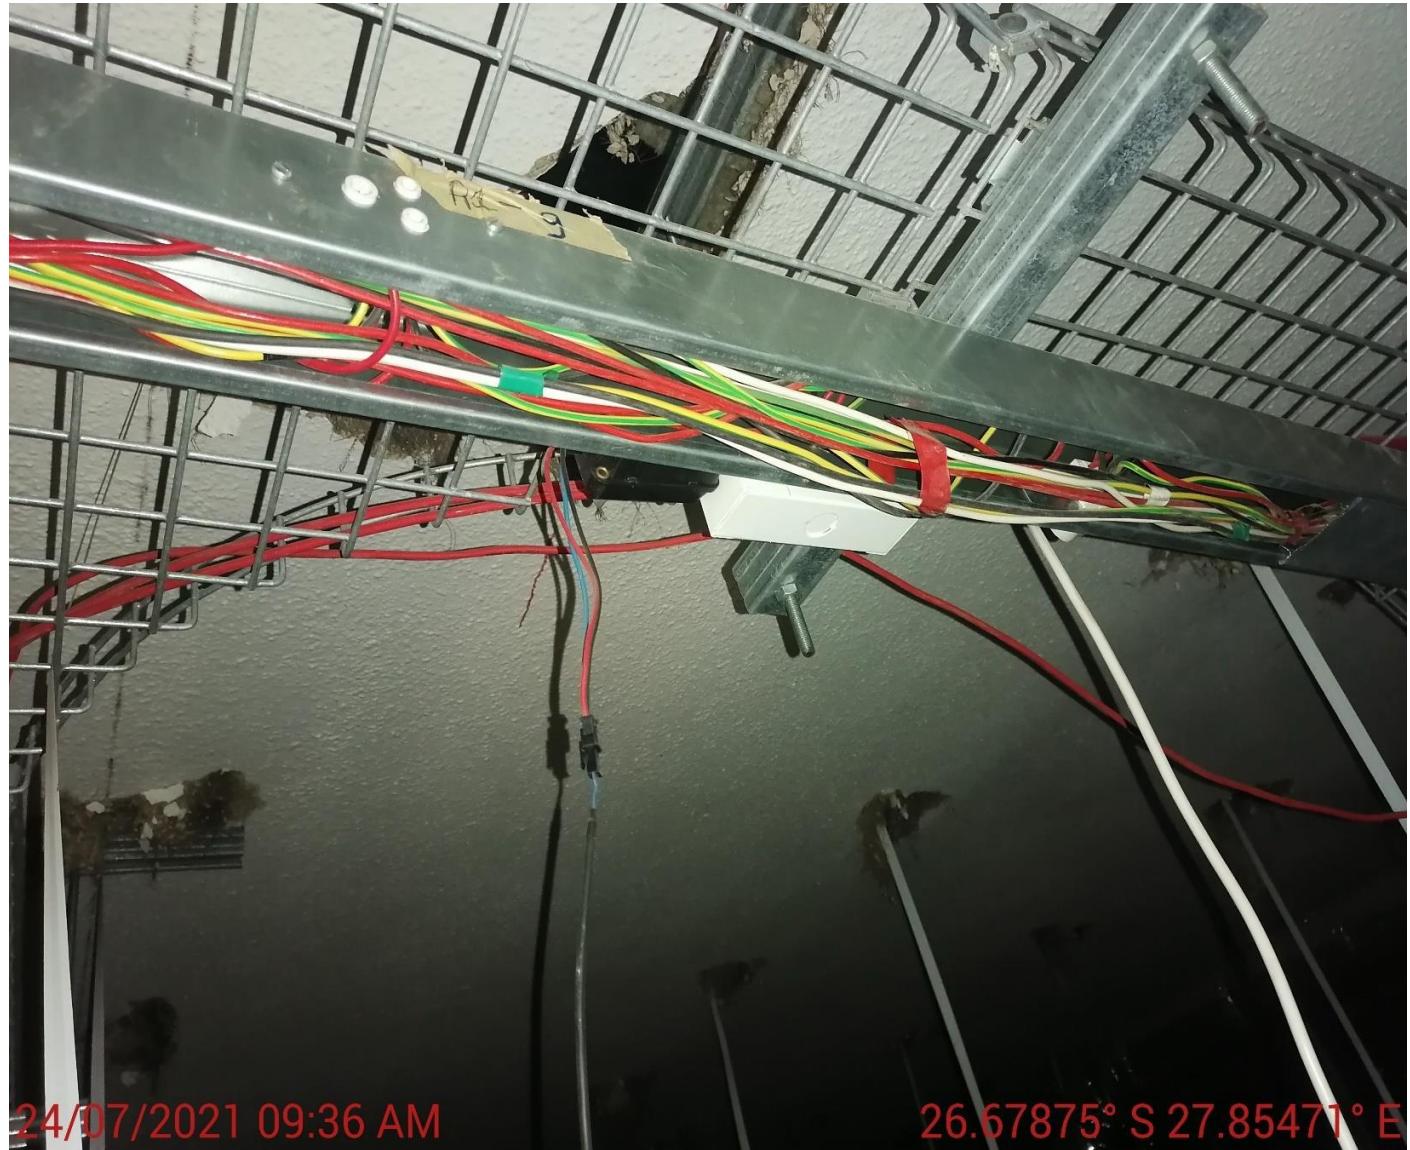
Fig 1 - Open trucking covers inside the ceiling exposing GP wires – Reception Ceiling Void

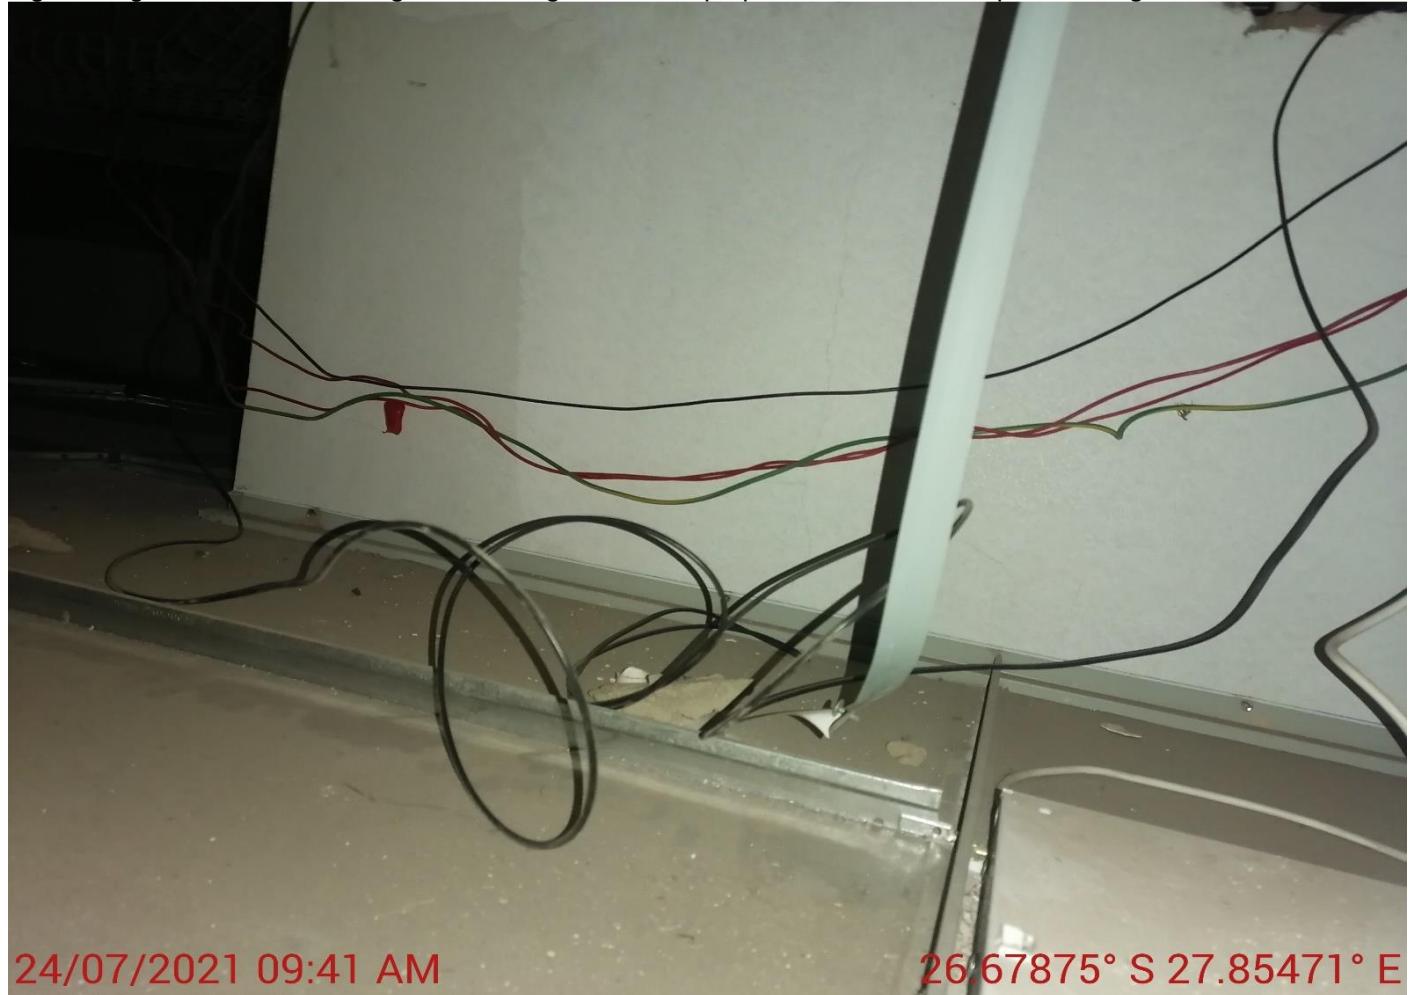
Fig 2 - Single core cables running in the ceiling without the proper enclosure – Reception Ceiling Void

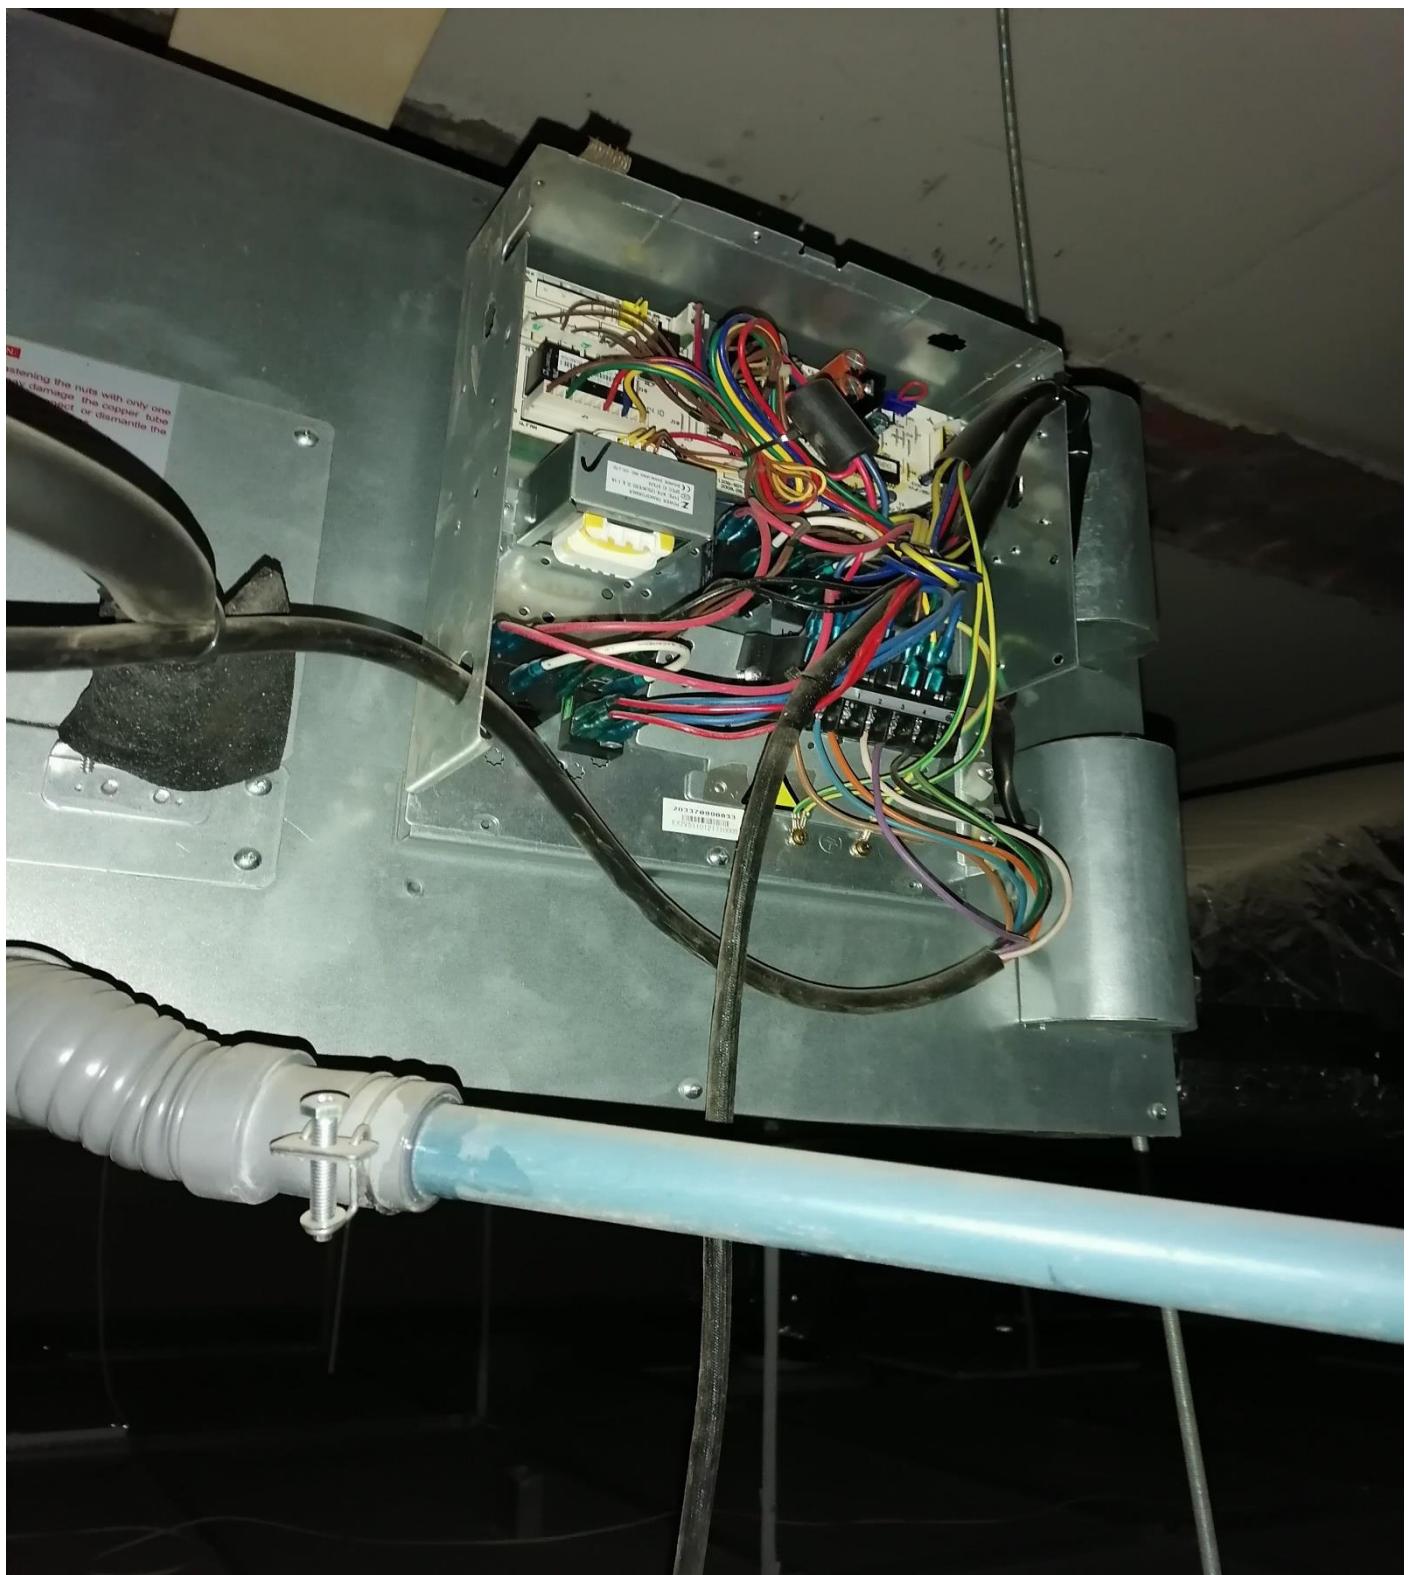
Fig 3 - Air con control box without cover exposing cables and connections. - in front of the Conference Room

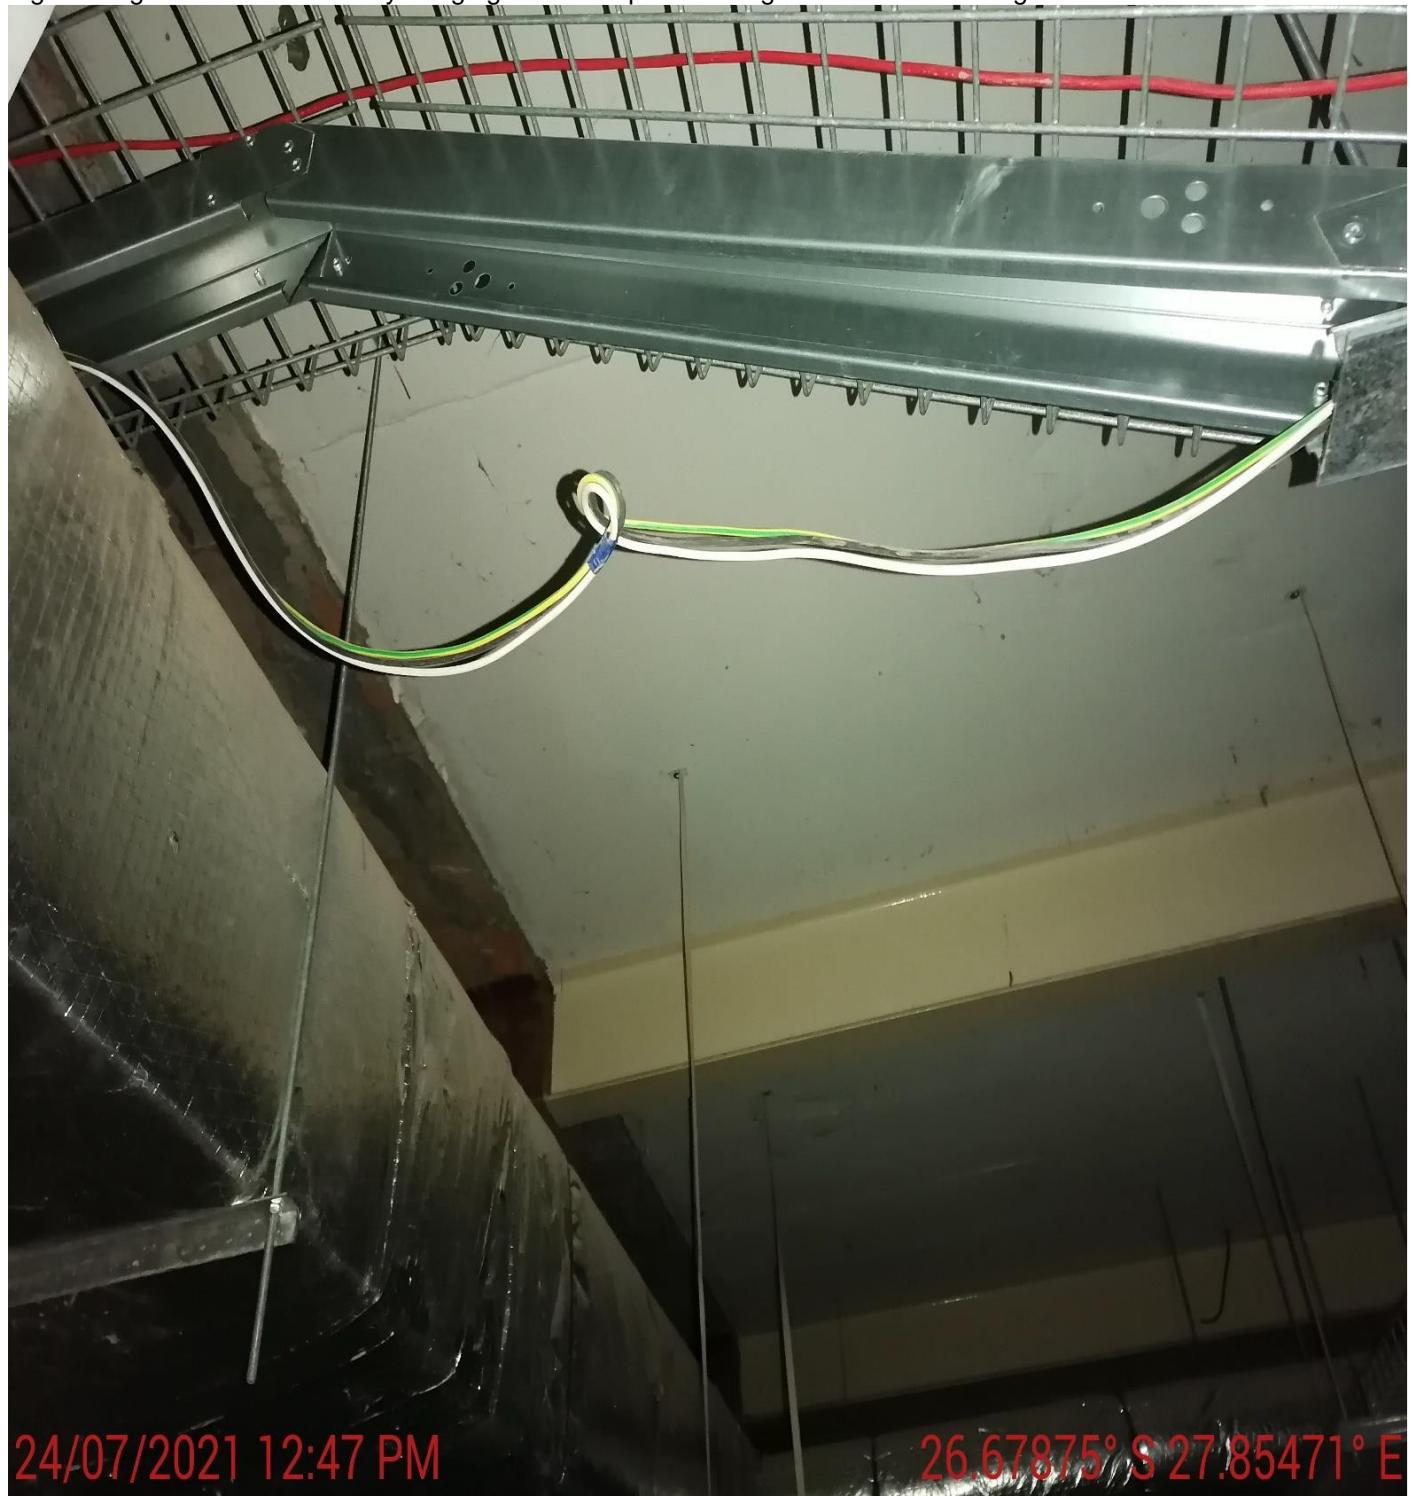
Fig 4 - Single core cables loosely hanging from the open trunking – Office 7 & 8 ceiling Void.

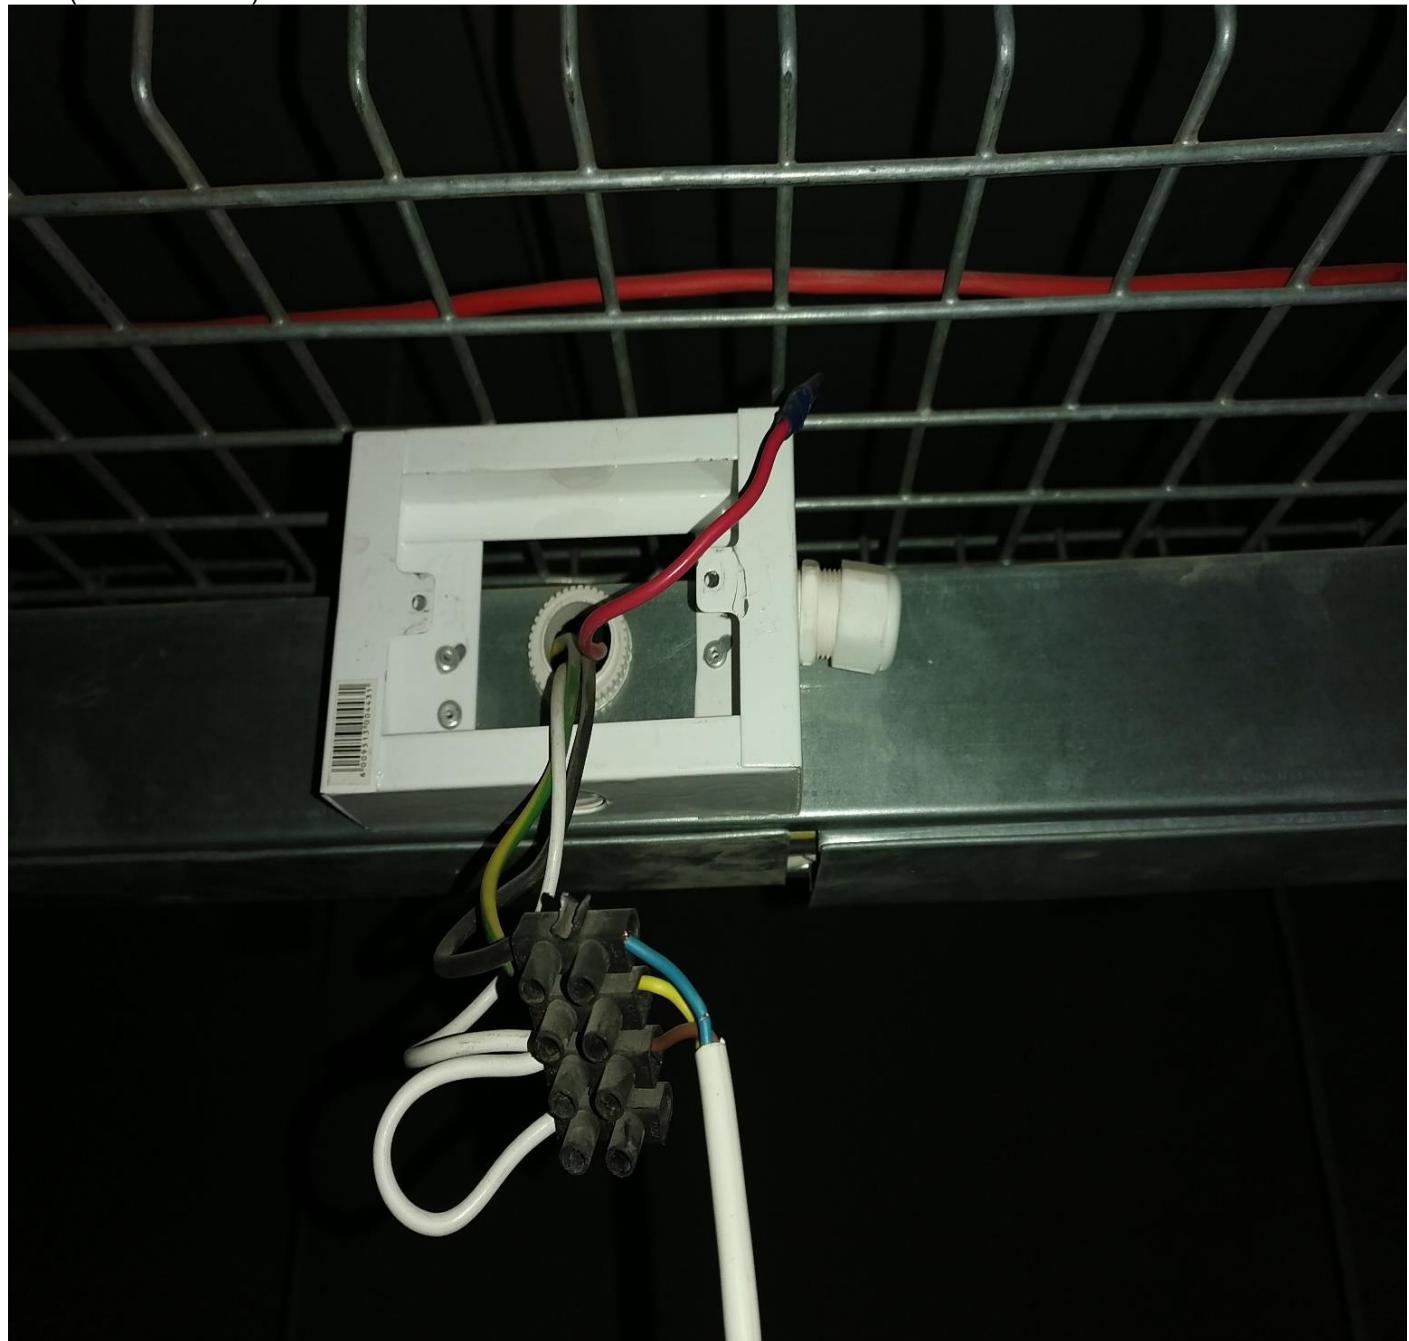
Fig 5 - Open junction boxes exposing connections and improper cable termination (without the use of glands) – Open Plan (Lavika's Office)

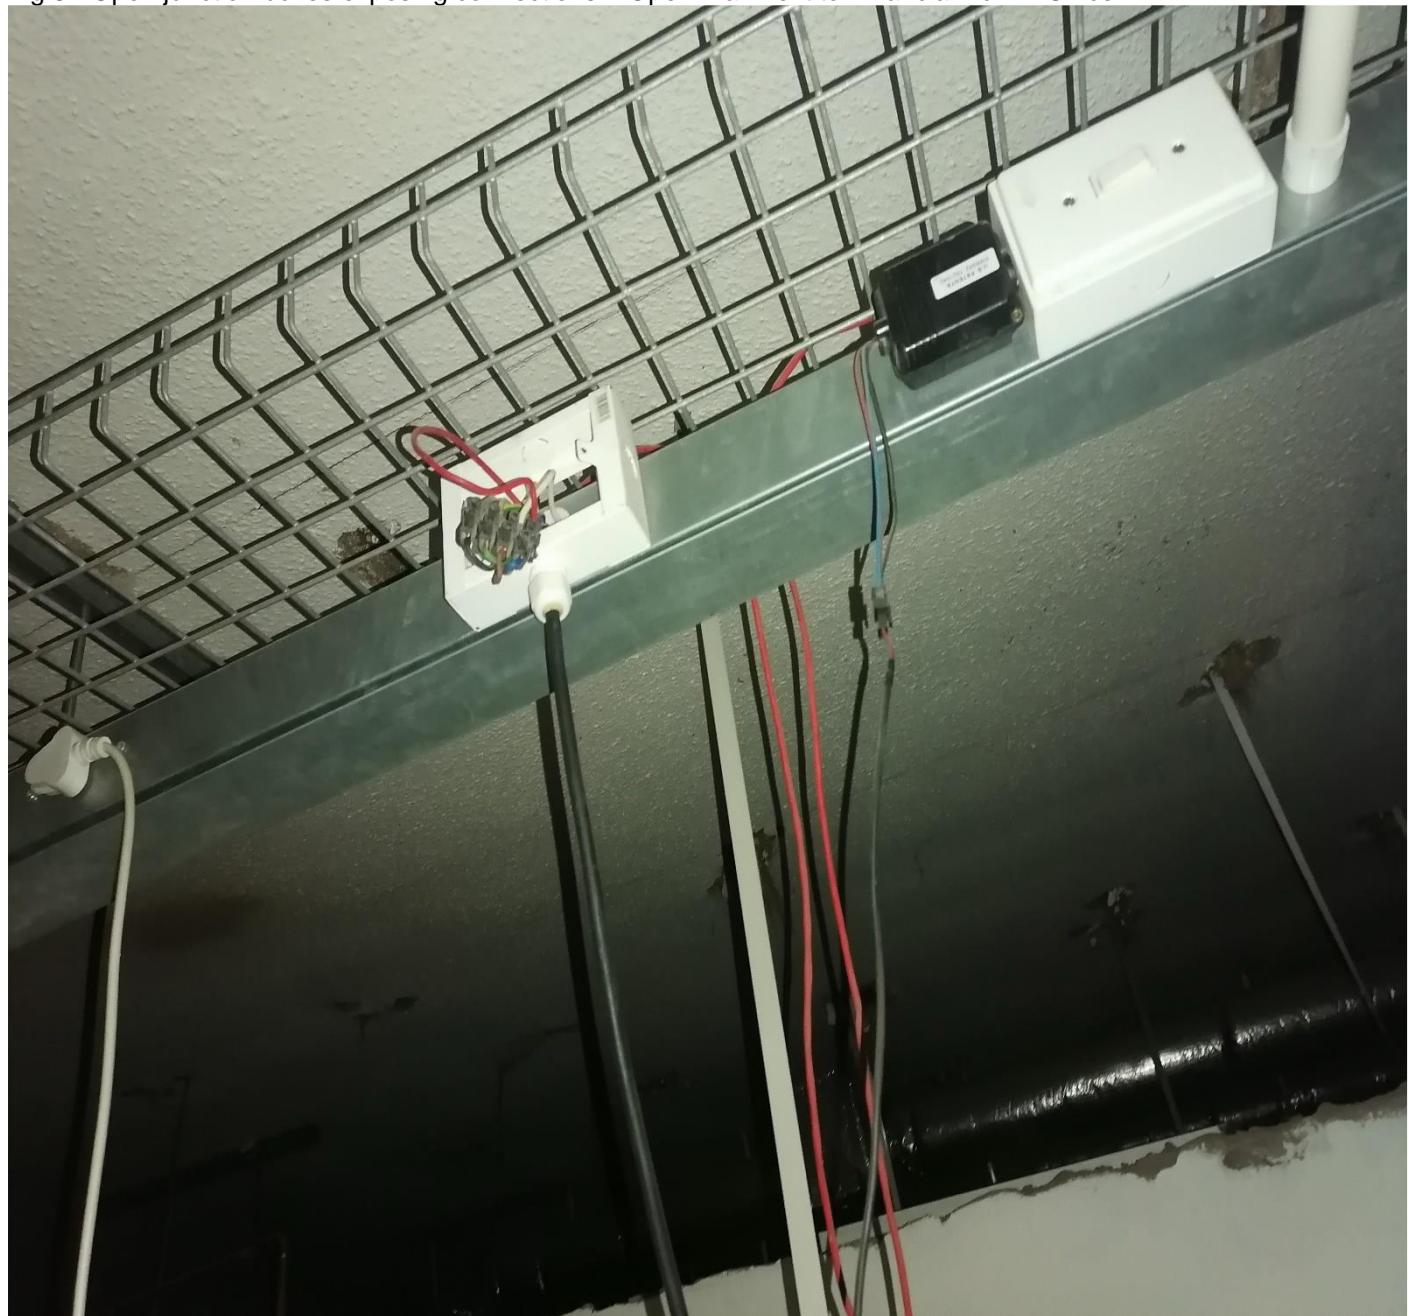
Fig 6 - Open junction boxes exposing connections – Open Plan next to Financial Admin Office

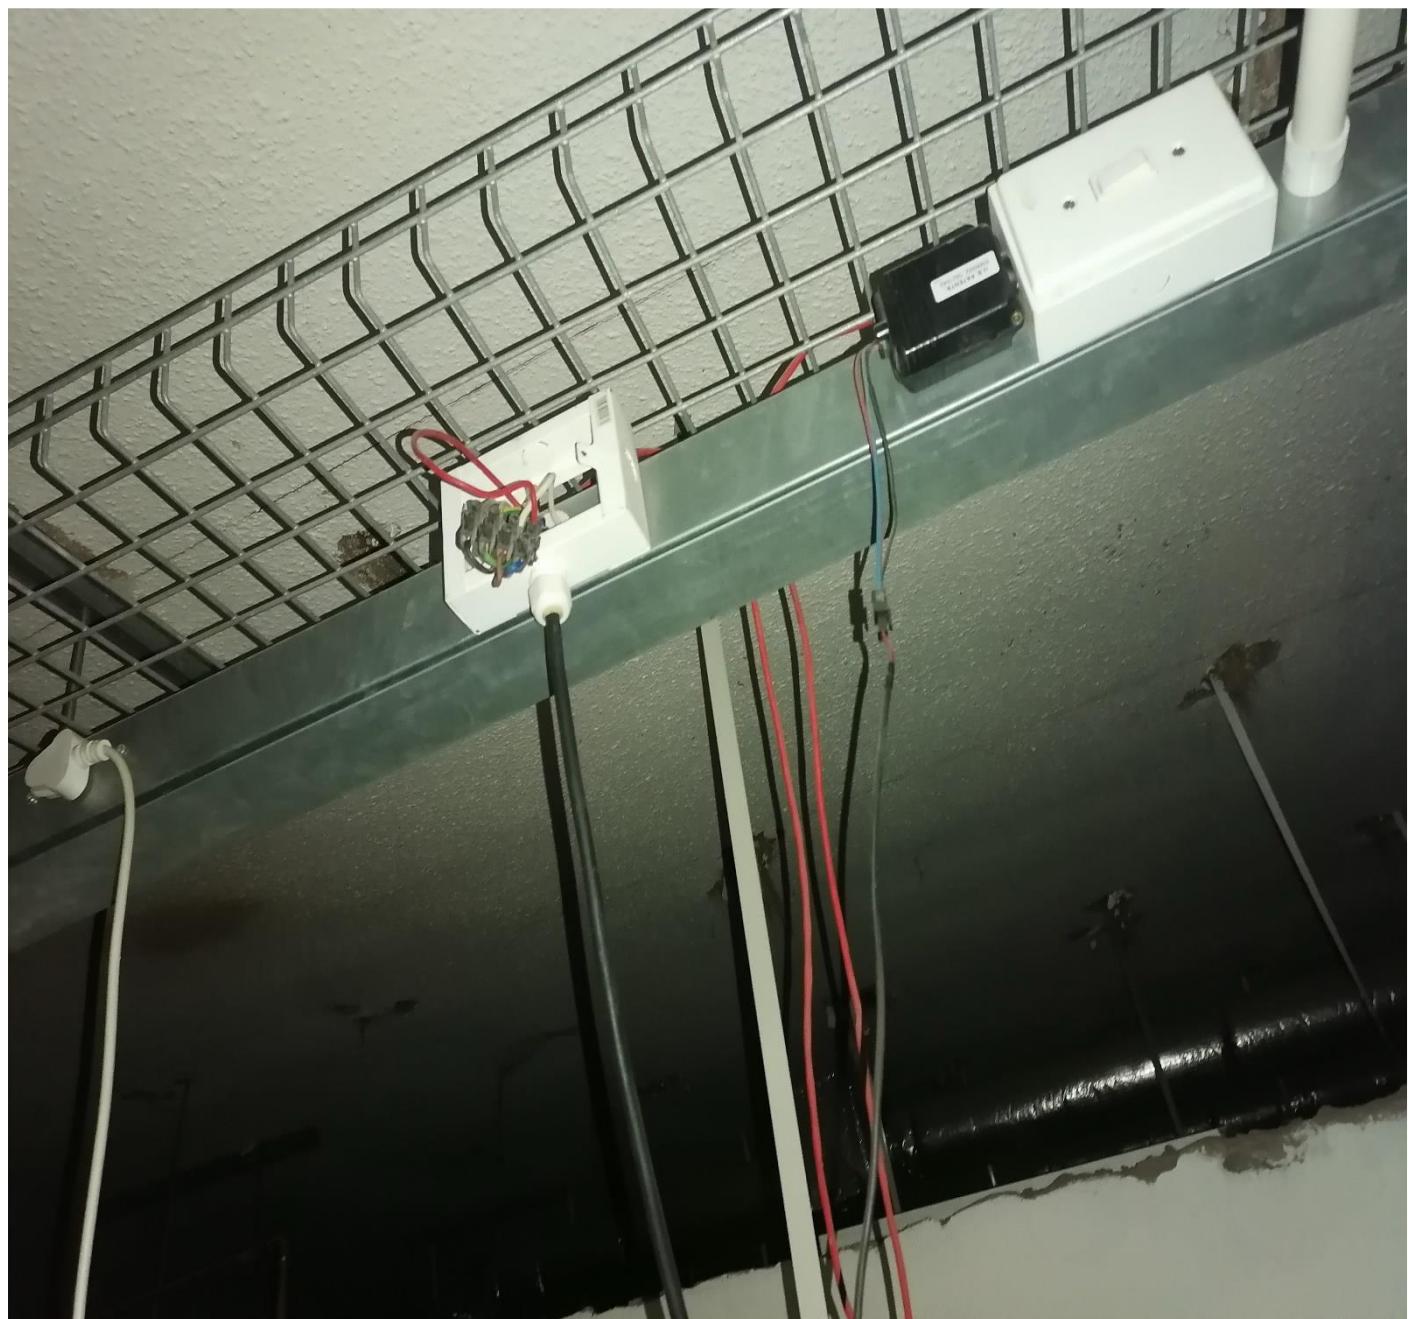
Fig 7 - Open junction boxes exposing connections – Open Plan next to Financial Admin Office

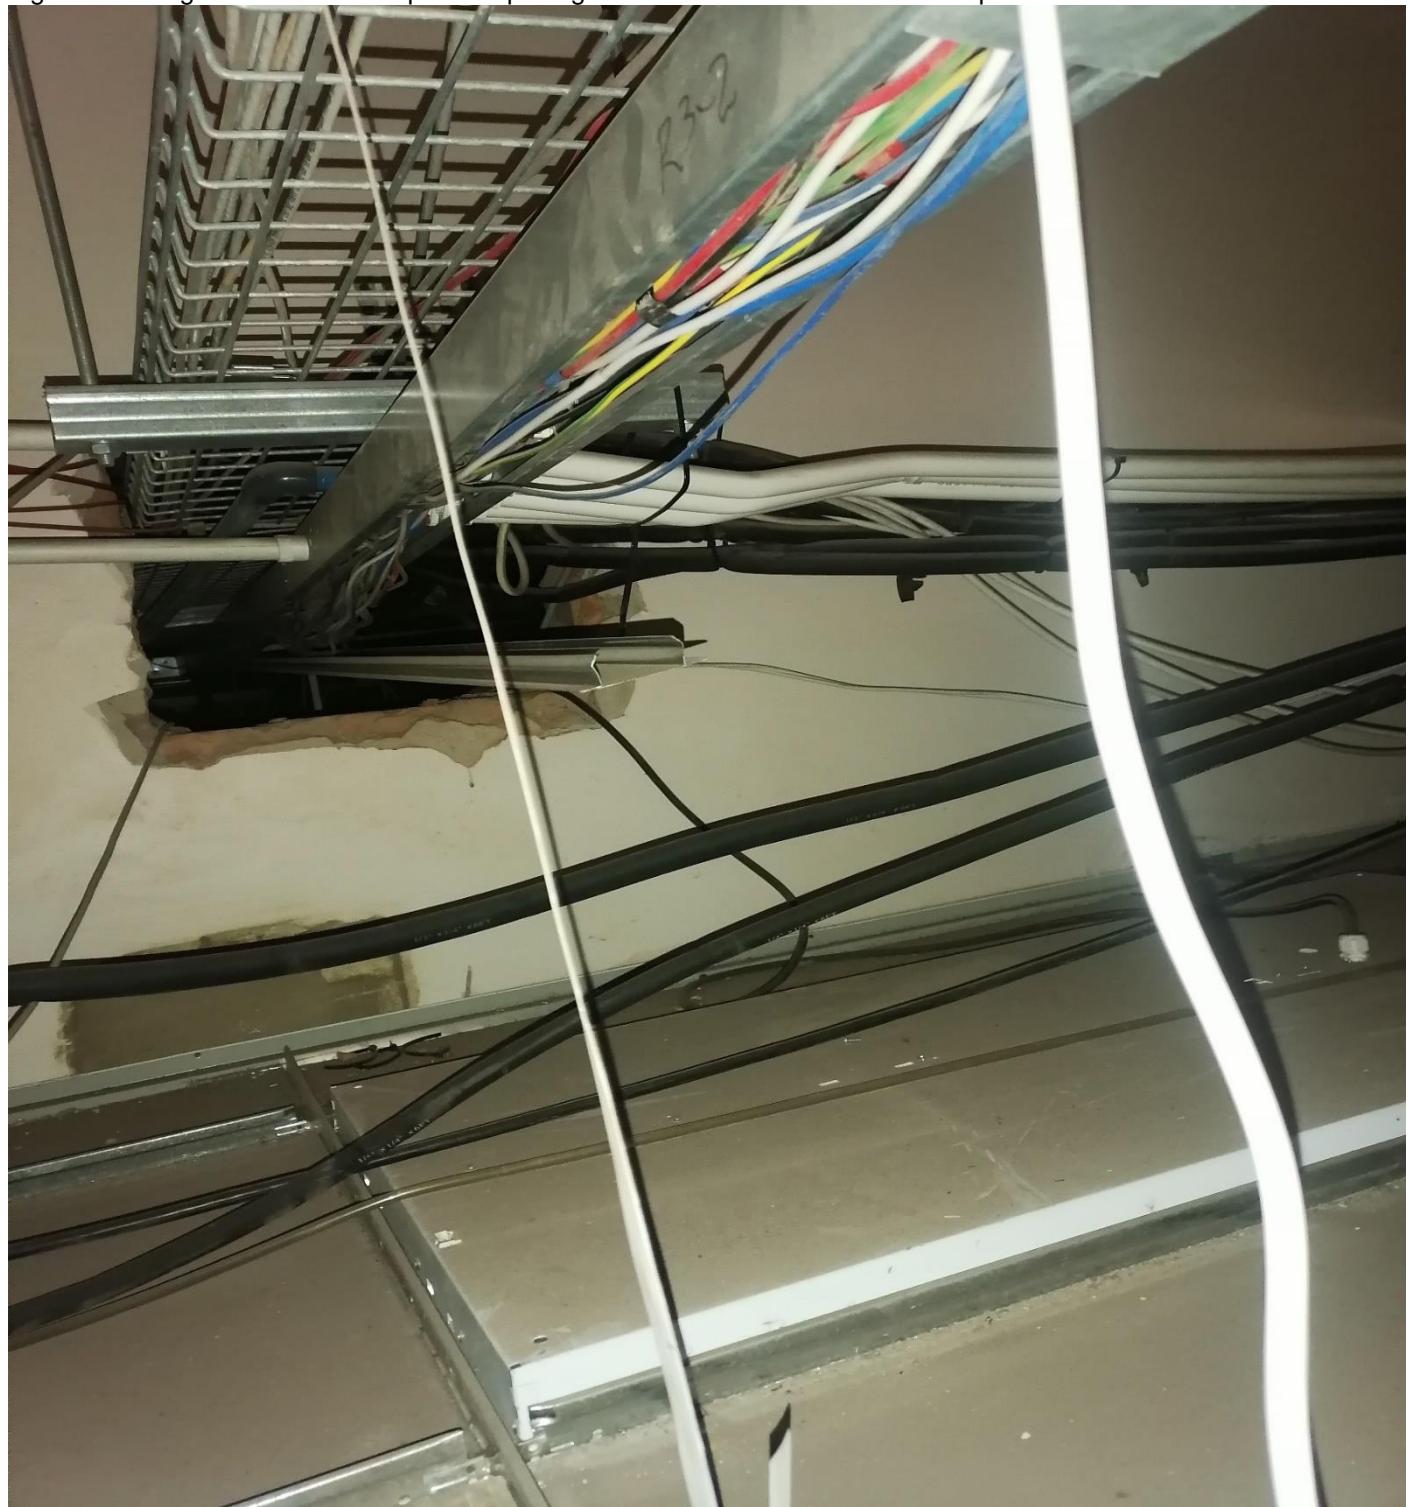
Fig 8 - Trunking with no covers in place exposing GP wires – Between Finance Dept and Control Room

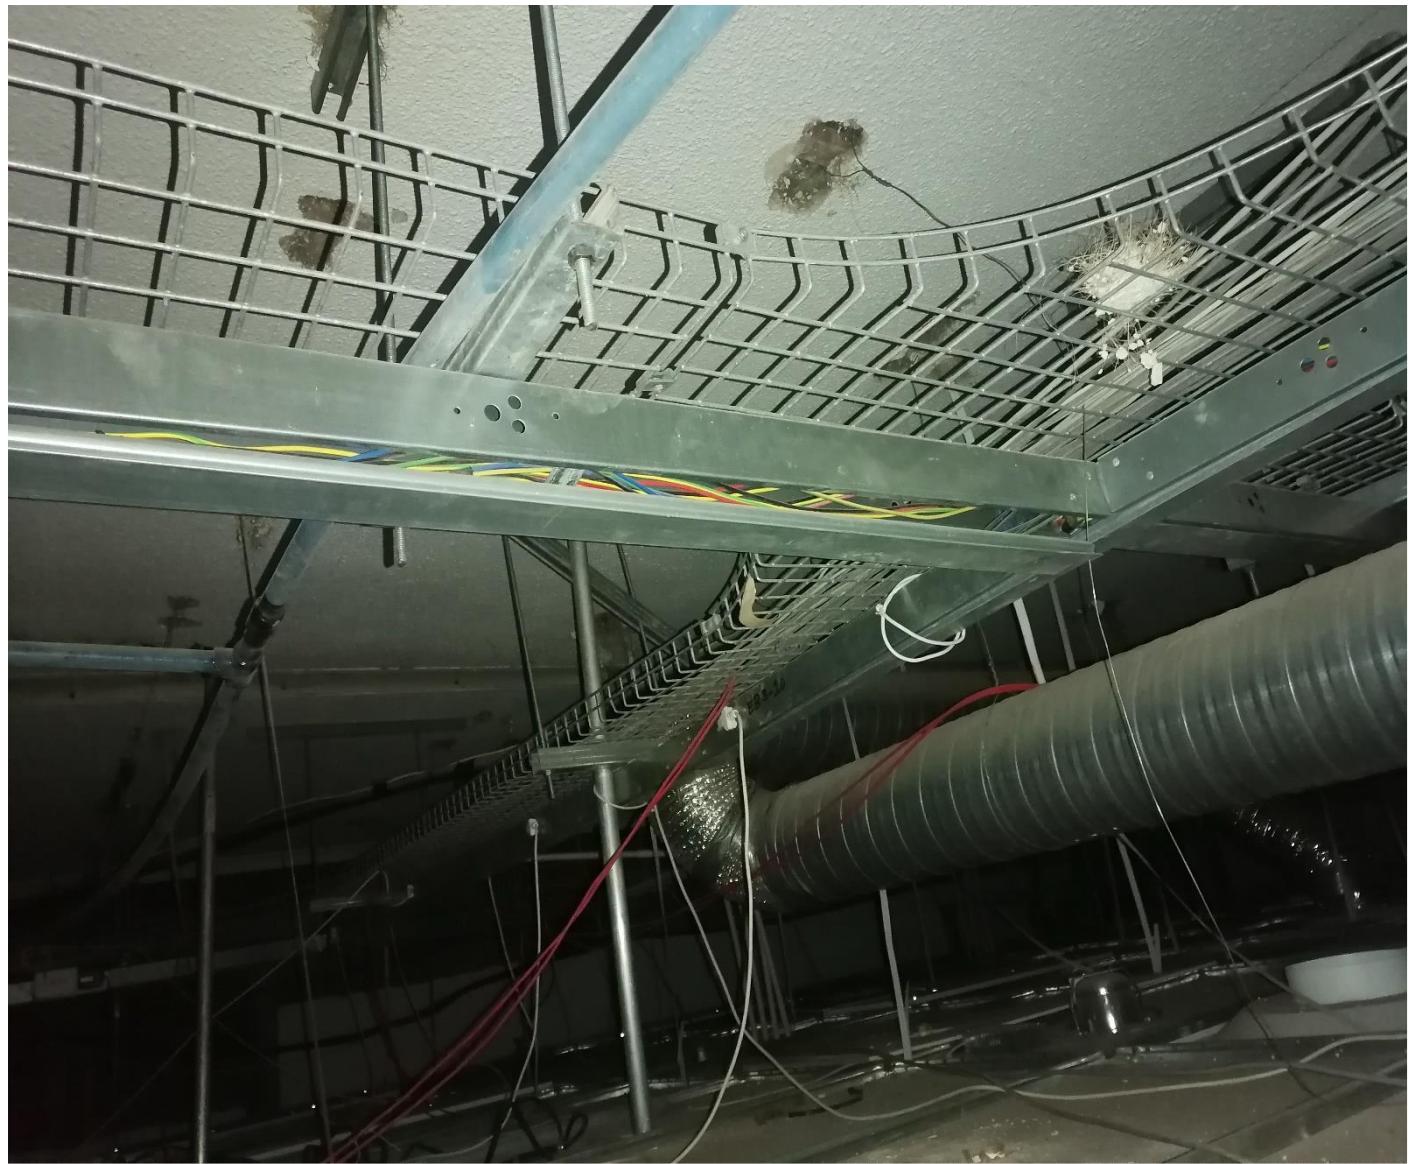
Fig 9 - Cable trunking with open covers - Entrance passage

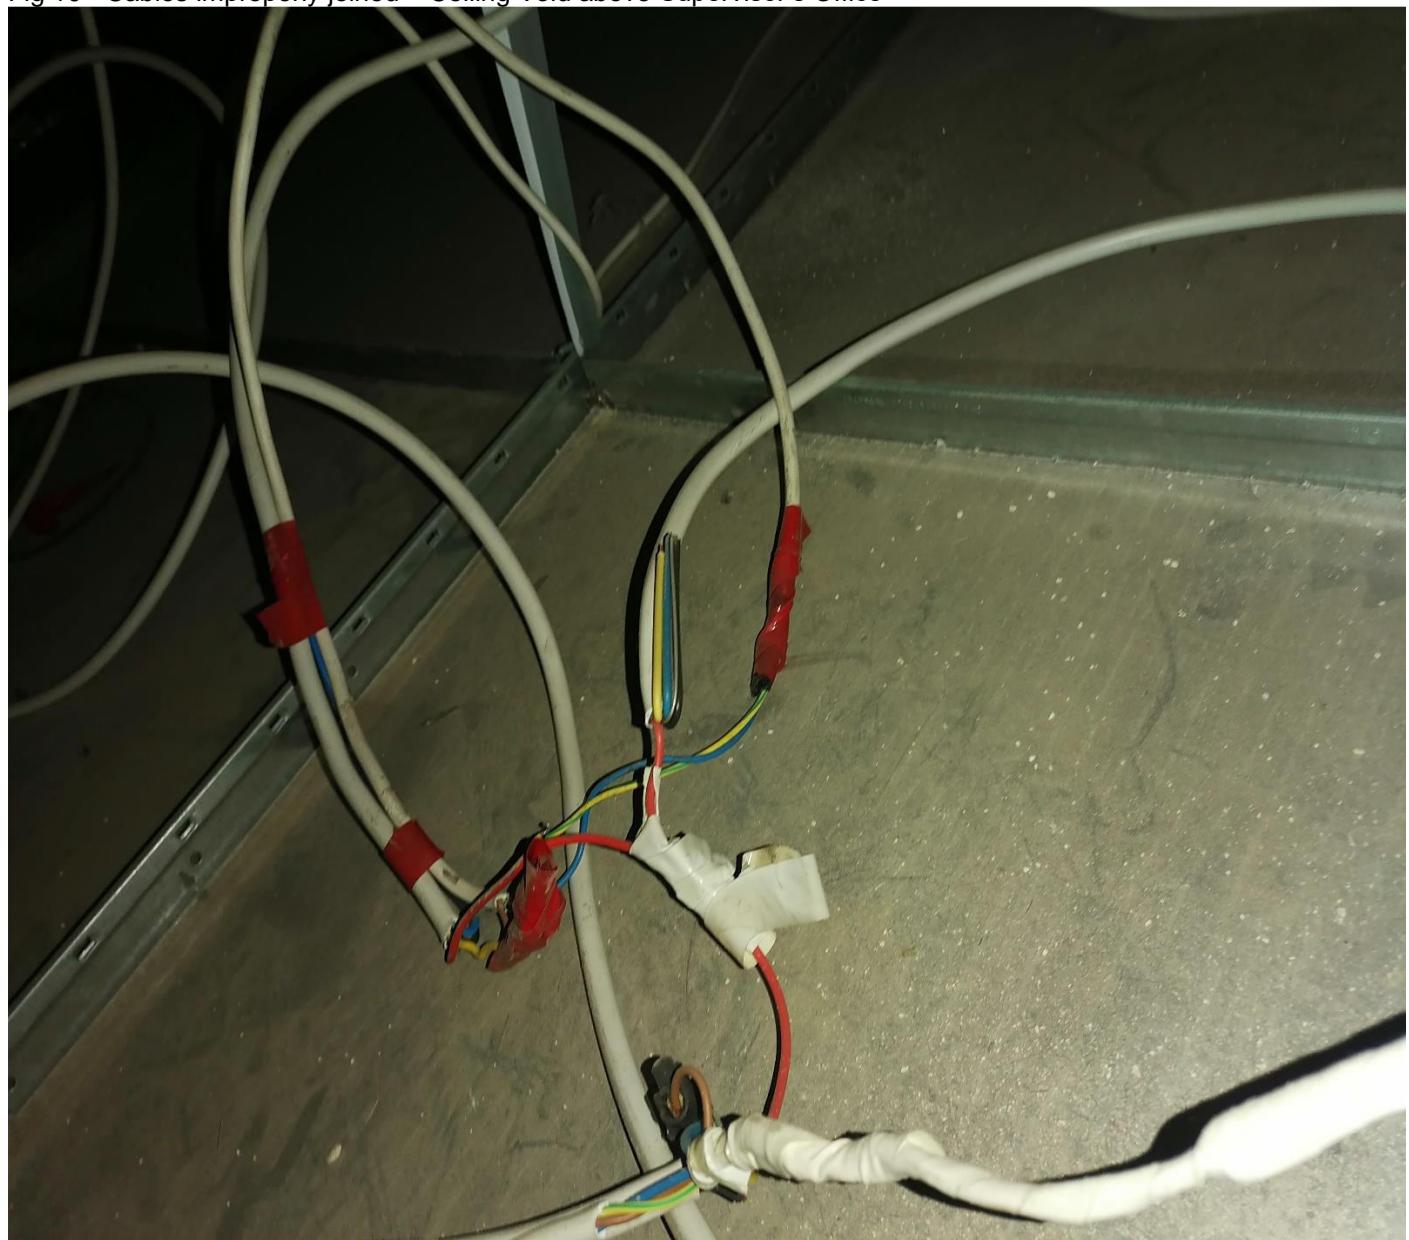
5. Improper cable joints: Open joints were randomly done inside the ceiling void, taped with insulating tape and left without protection. In some cases, such joints are suspected to have affected the resistance of the earth continuity conductor. The resistance of the earth continuity conductor on the following circuits were found to be above the limit:

Fig 10 - Cables improperly joined – Ceiling Void above Supervisor's Office

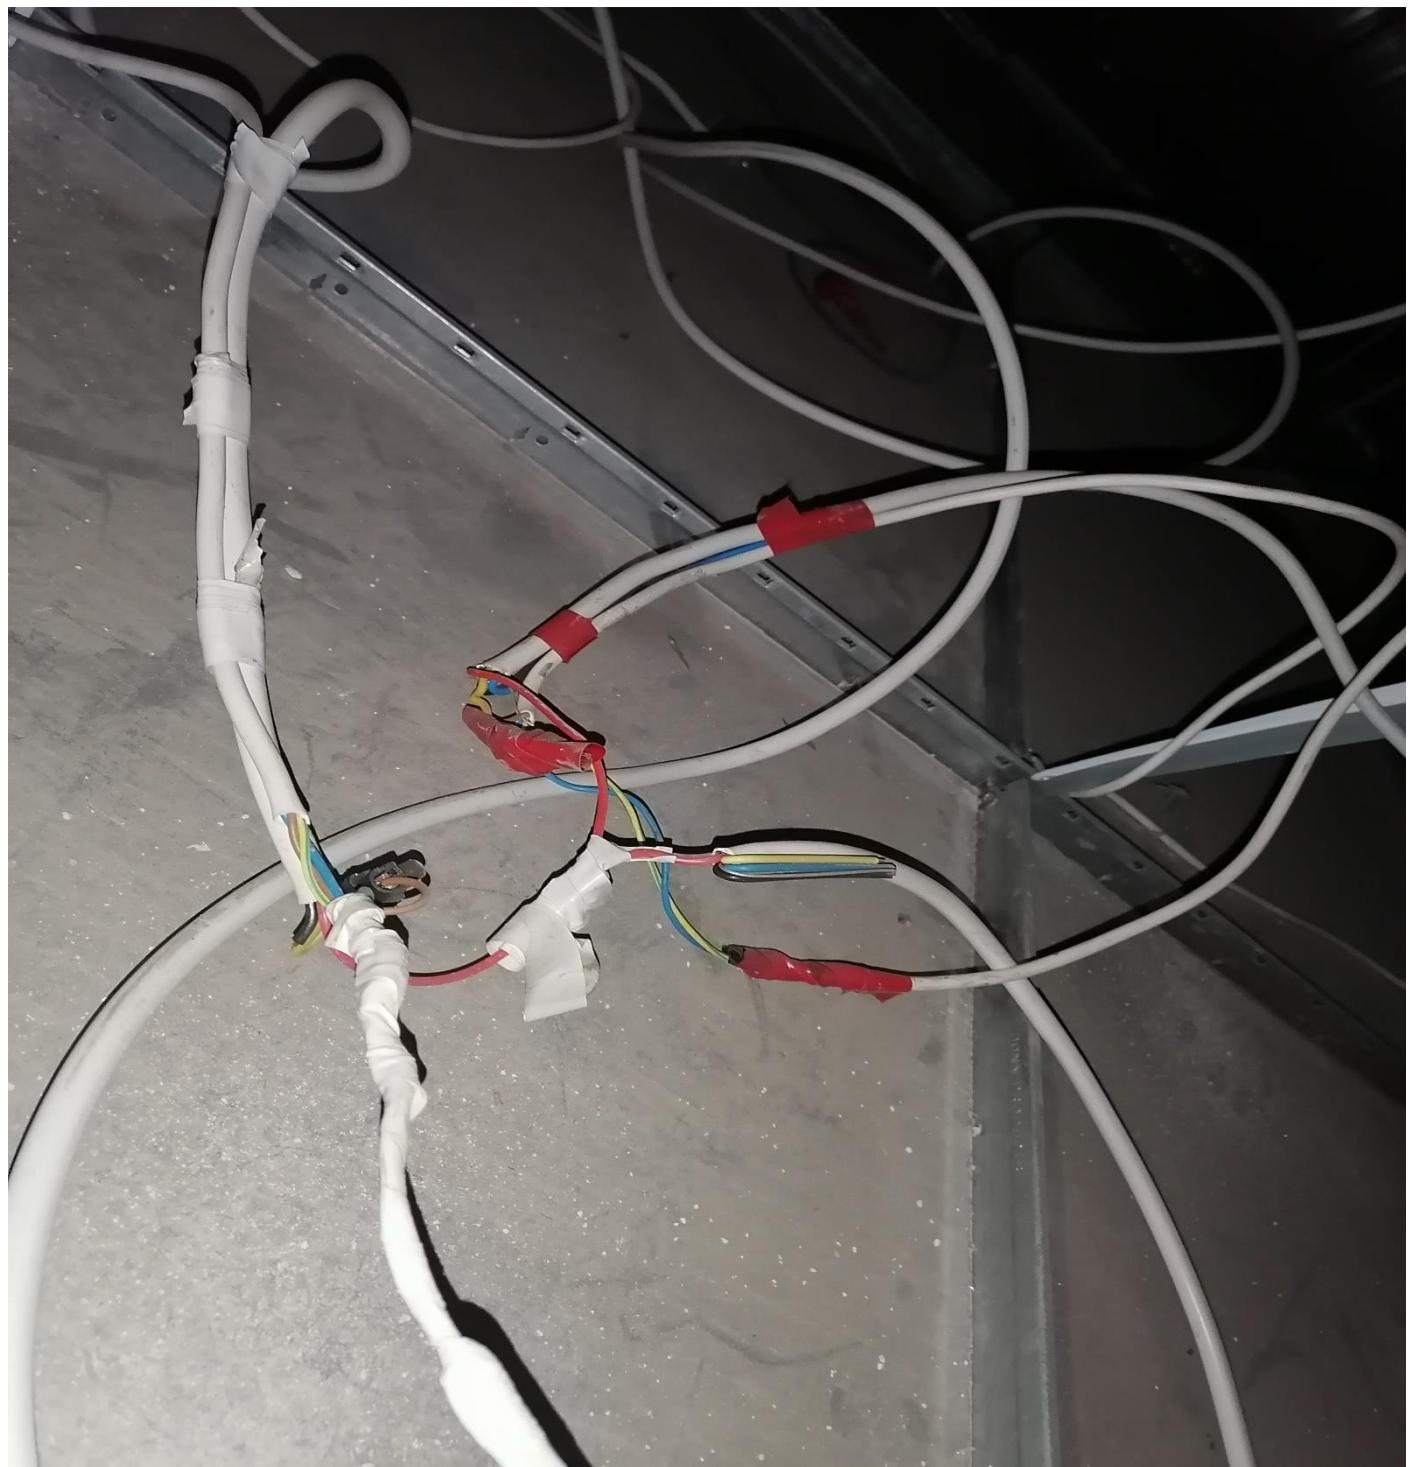
Fig 11 - Cables improperly joined - Ceiling Void above Supervisor's Office

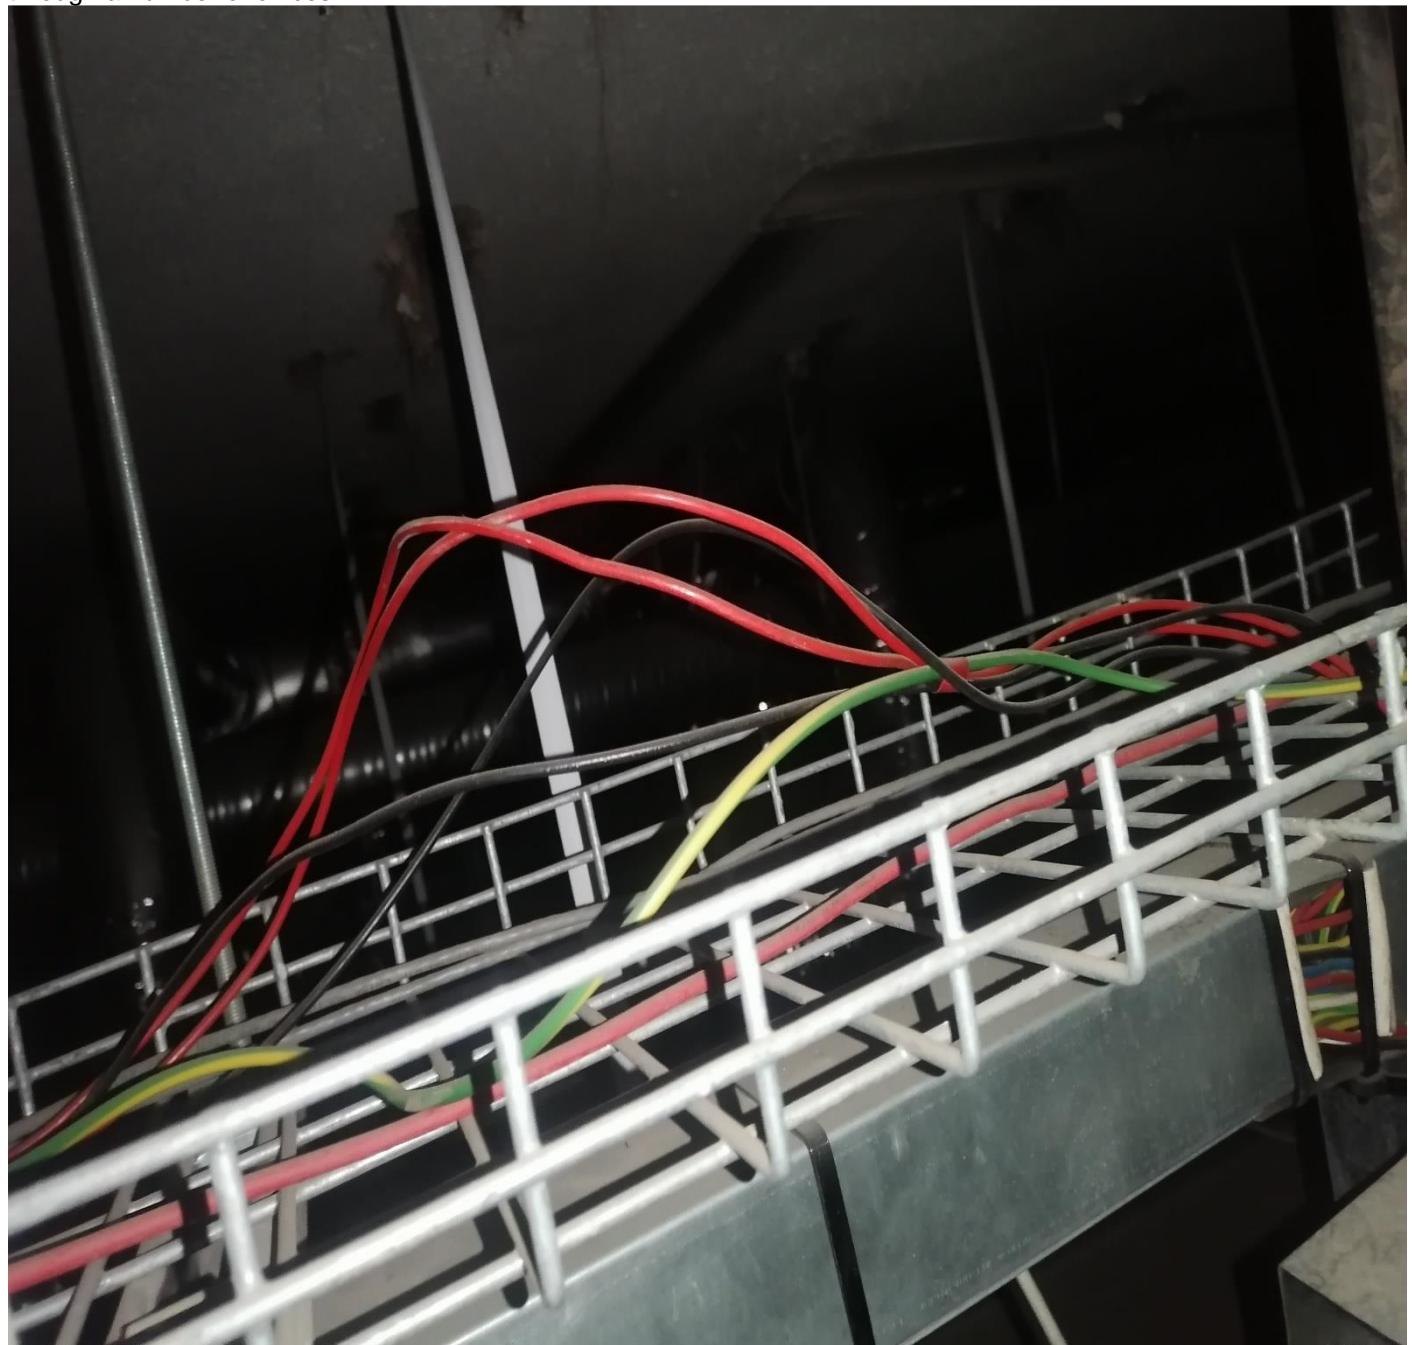
Fig 12 - General Purpose wires running in the cable tray instead of proper enclosed wireway – Cable tray running through a number of offices.
