REQUEST FOR BID

10397088 – Scope of Work

Repair all non-compliance at no.1 Control room as per Scope Below:

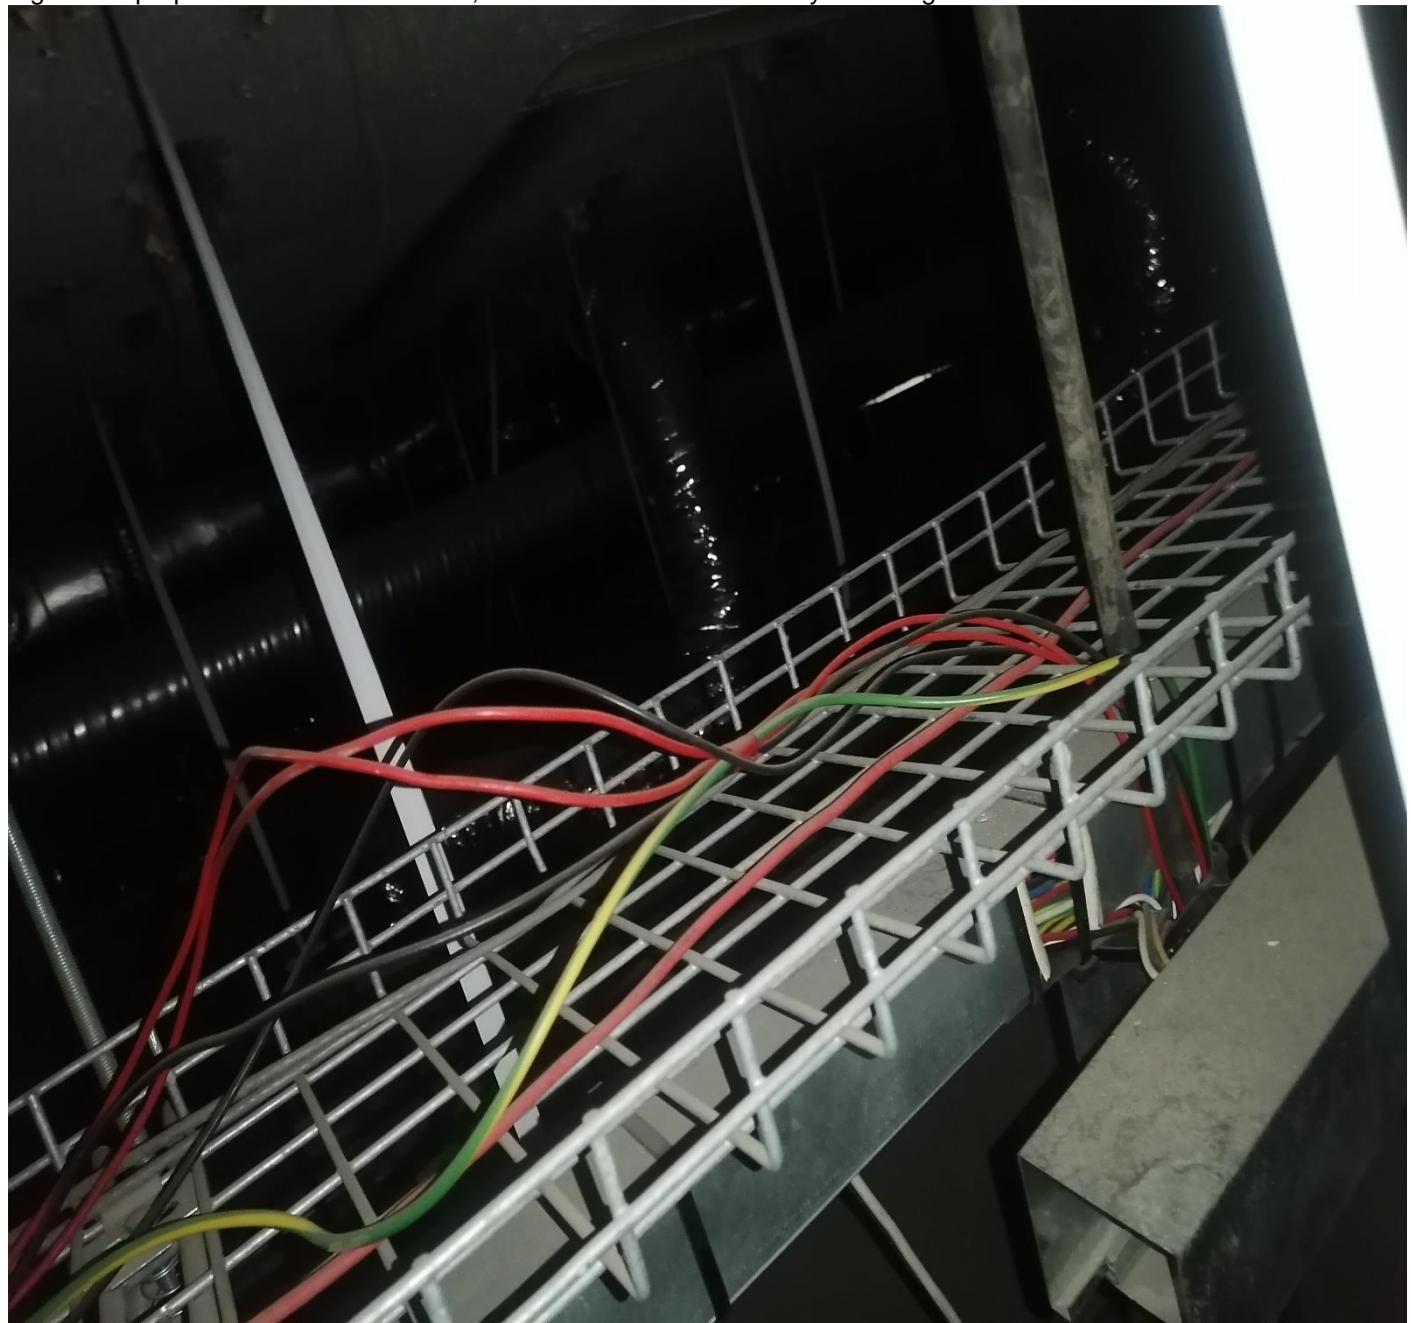
Fig 13 - Improper cable enclosure used, GP wires run on a cable tray - Passage

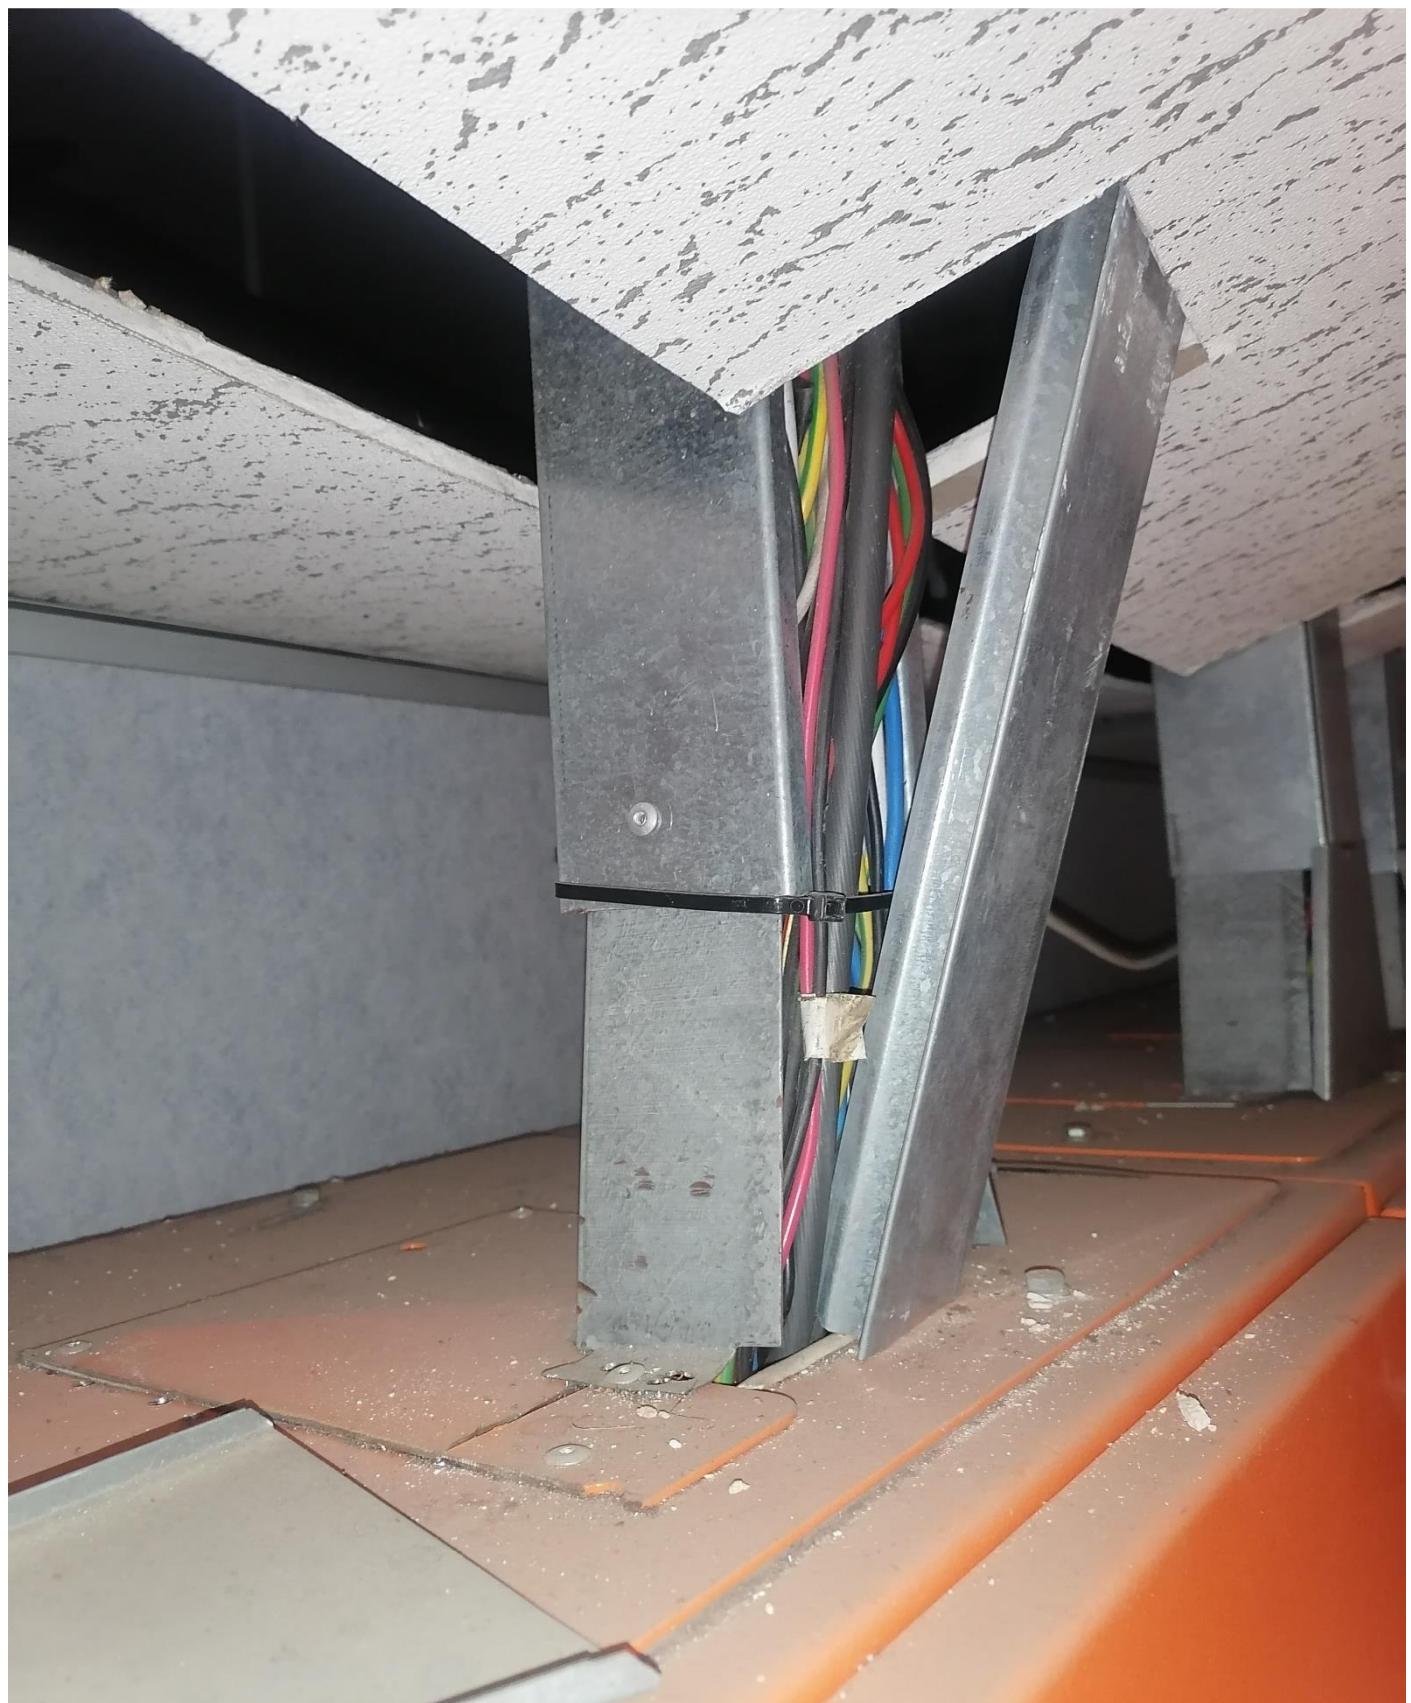
Fig 14 - Trunking not properly covered, cables held by a cable tie – Electrical Room

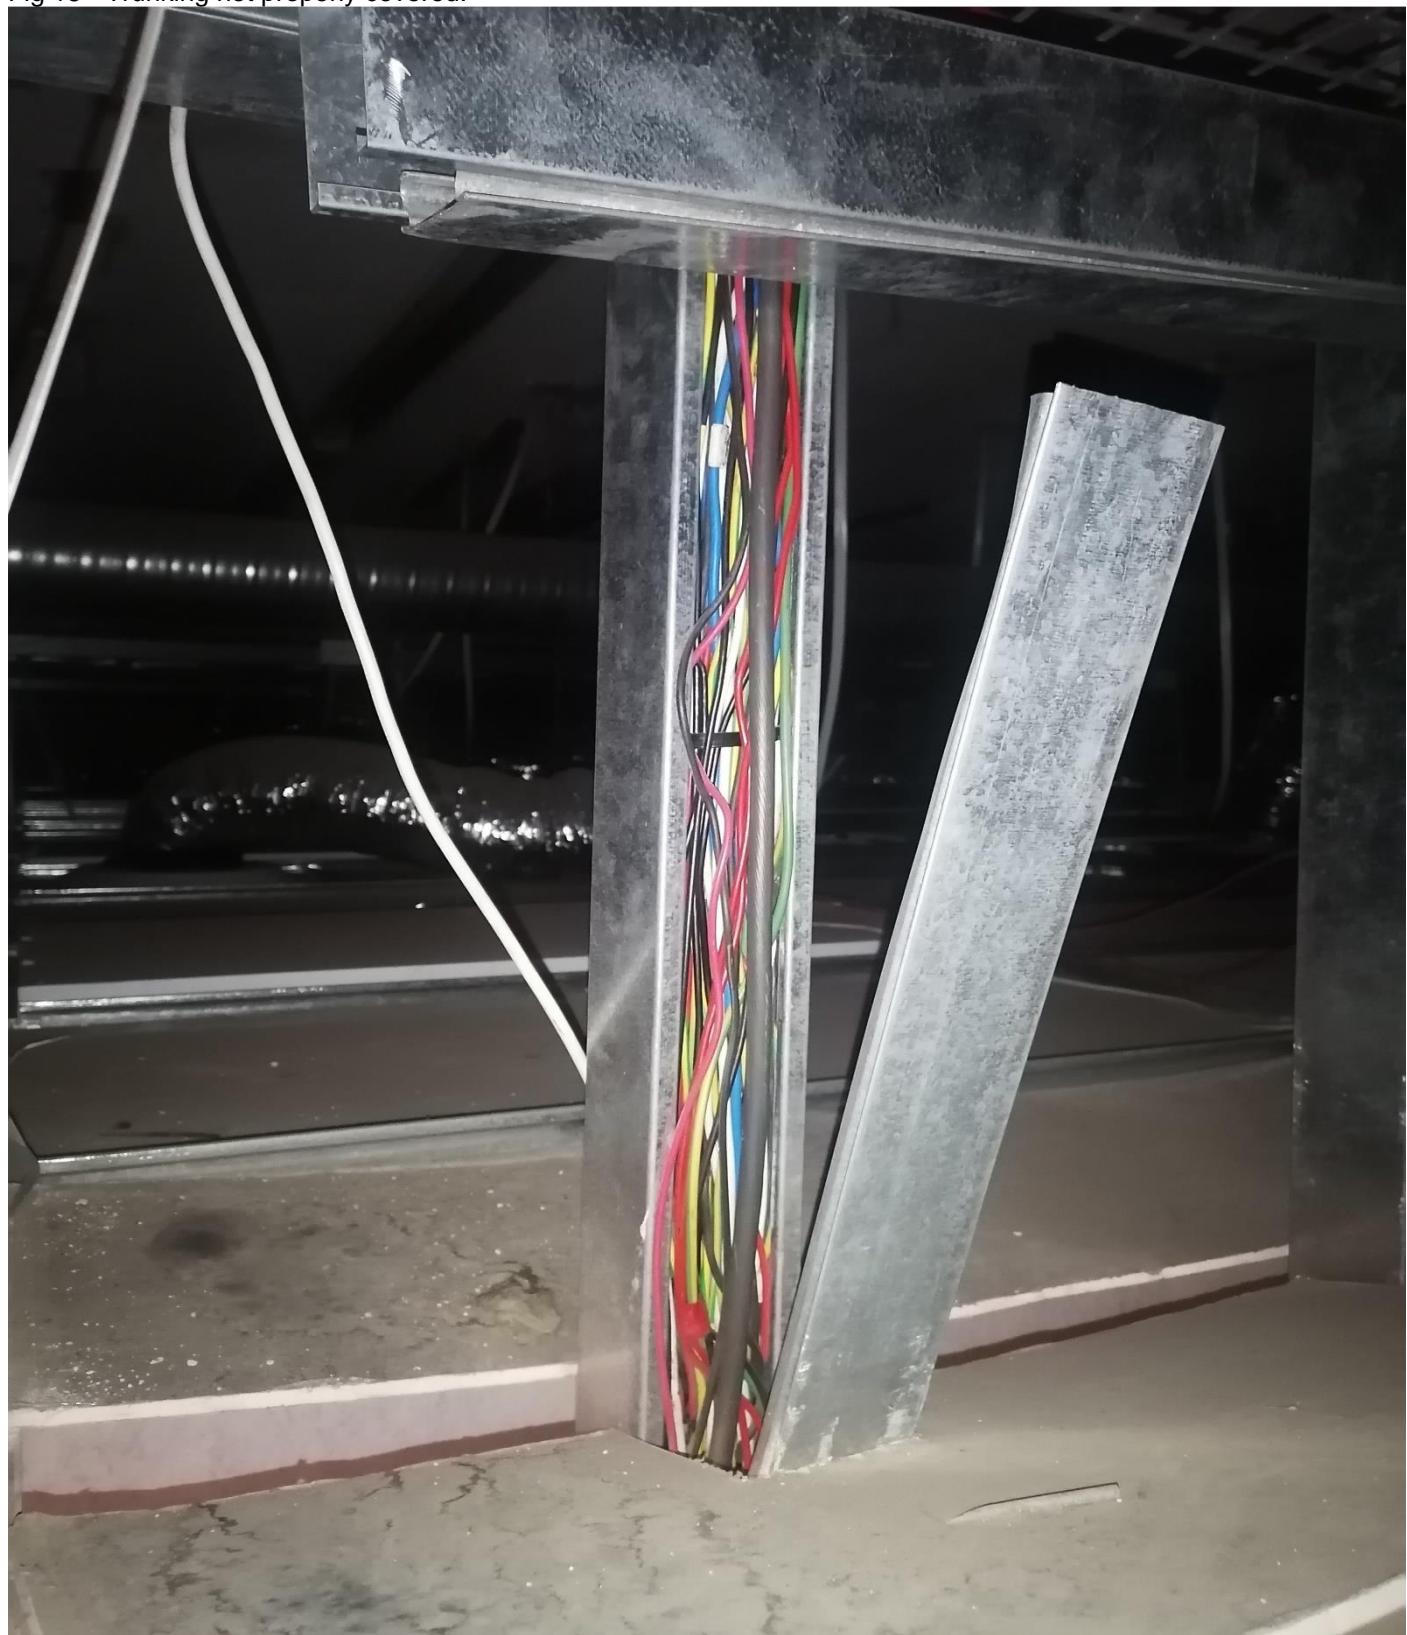
Fig 15 - Trunking not properly covered.

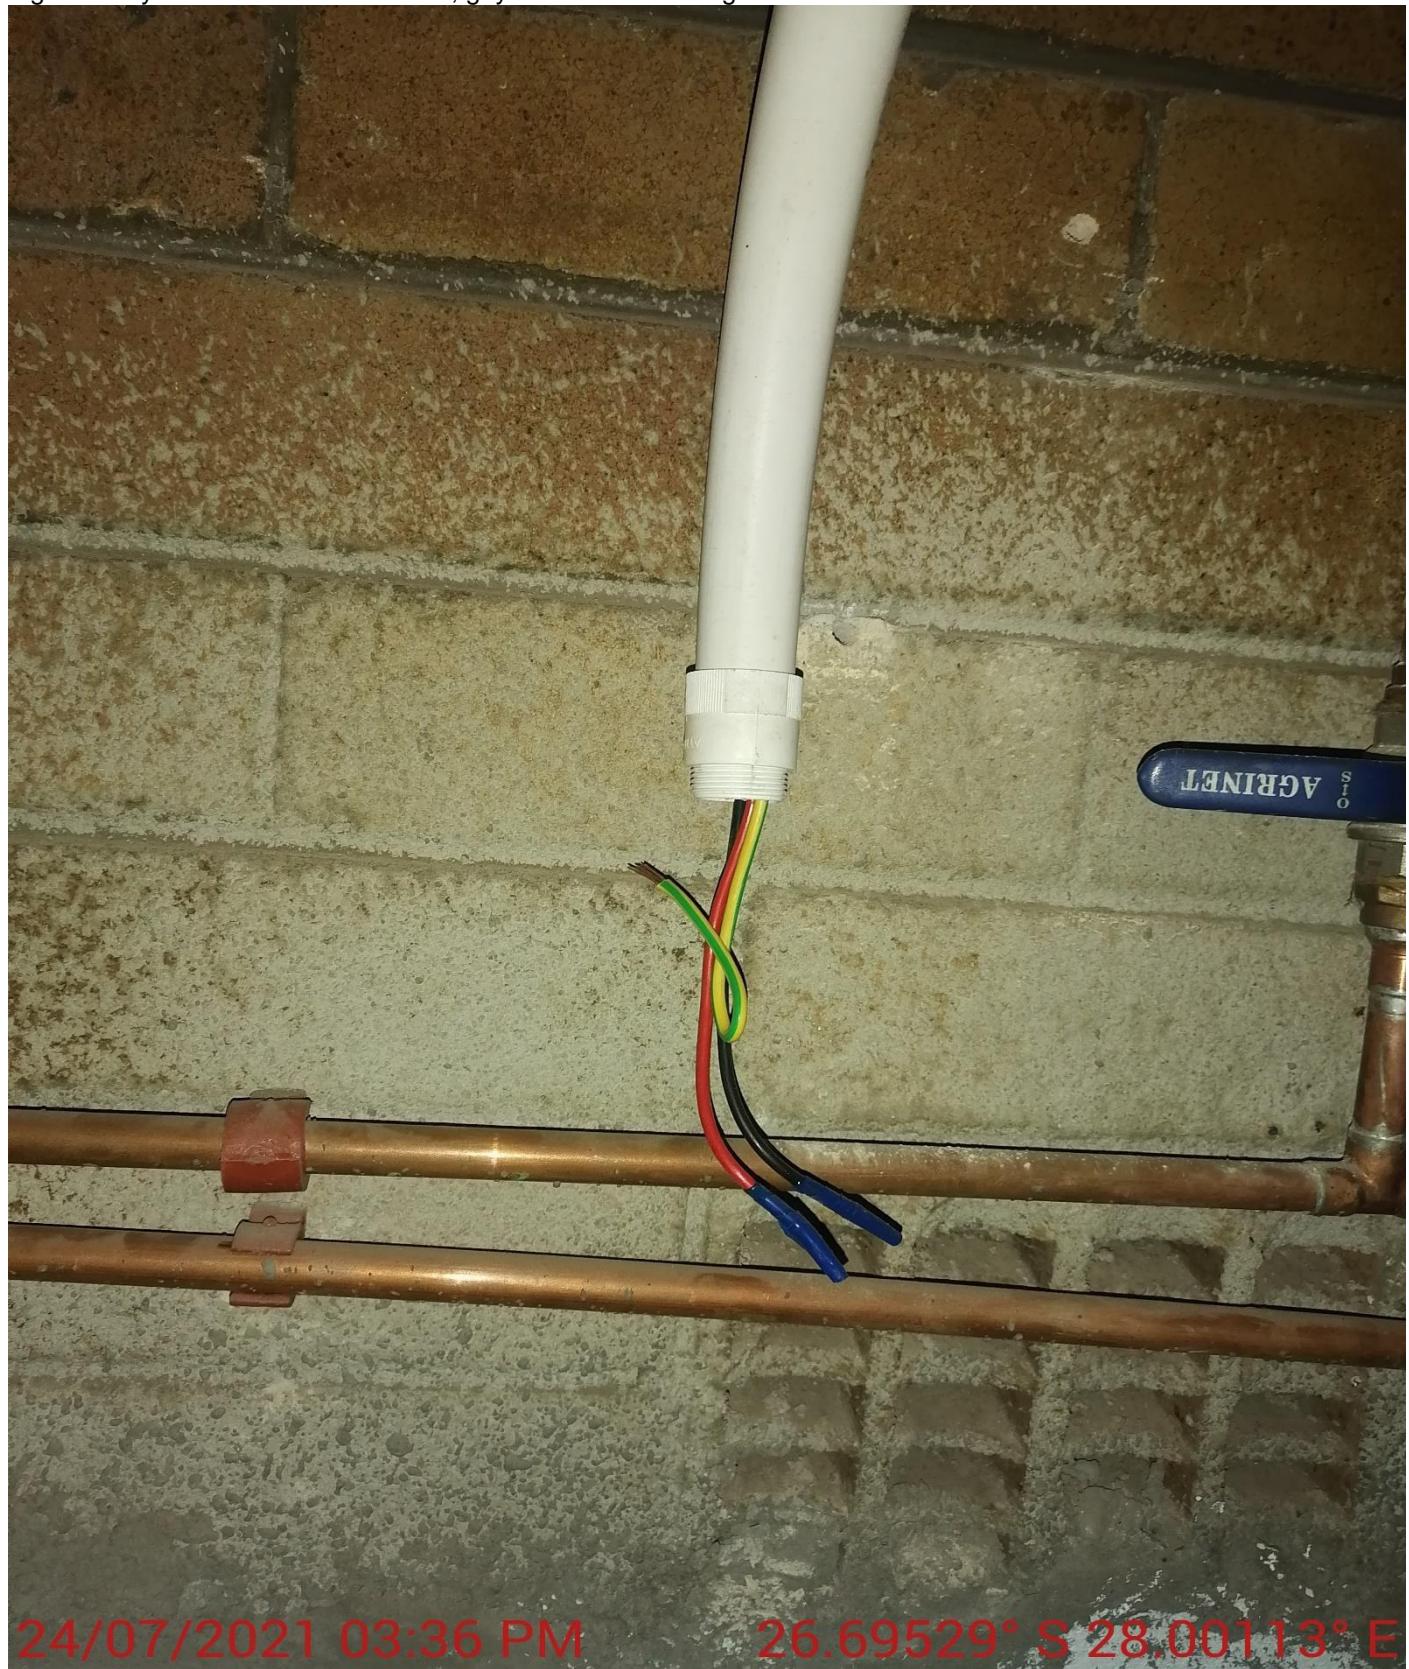
Fig 16 - Geyser cables not connected, geyser isolator missing – Female Toilets

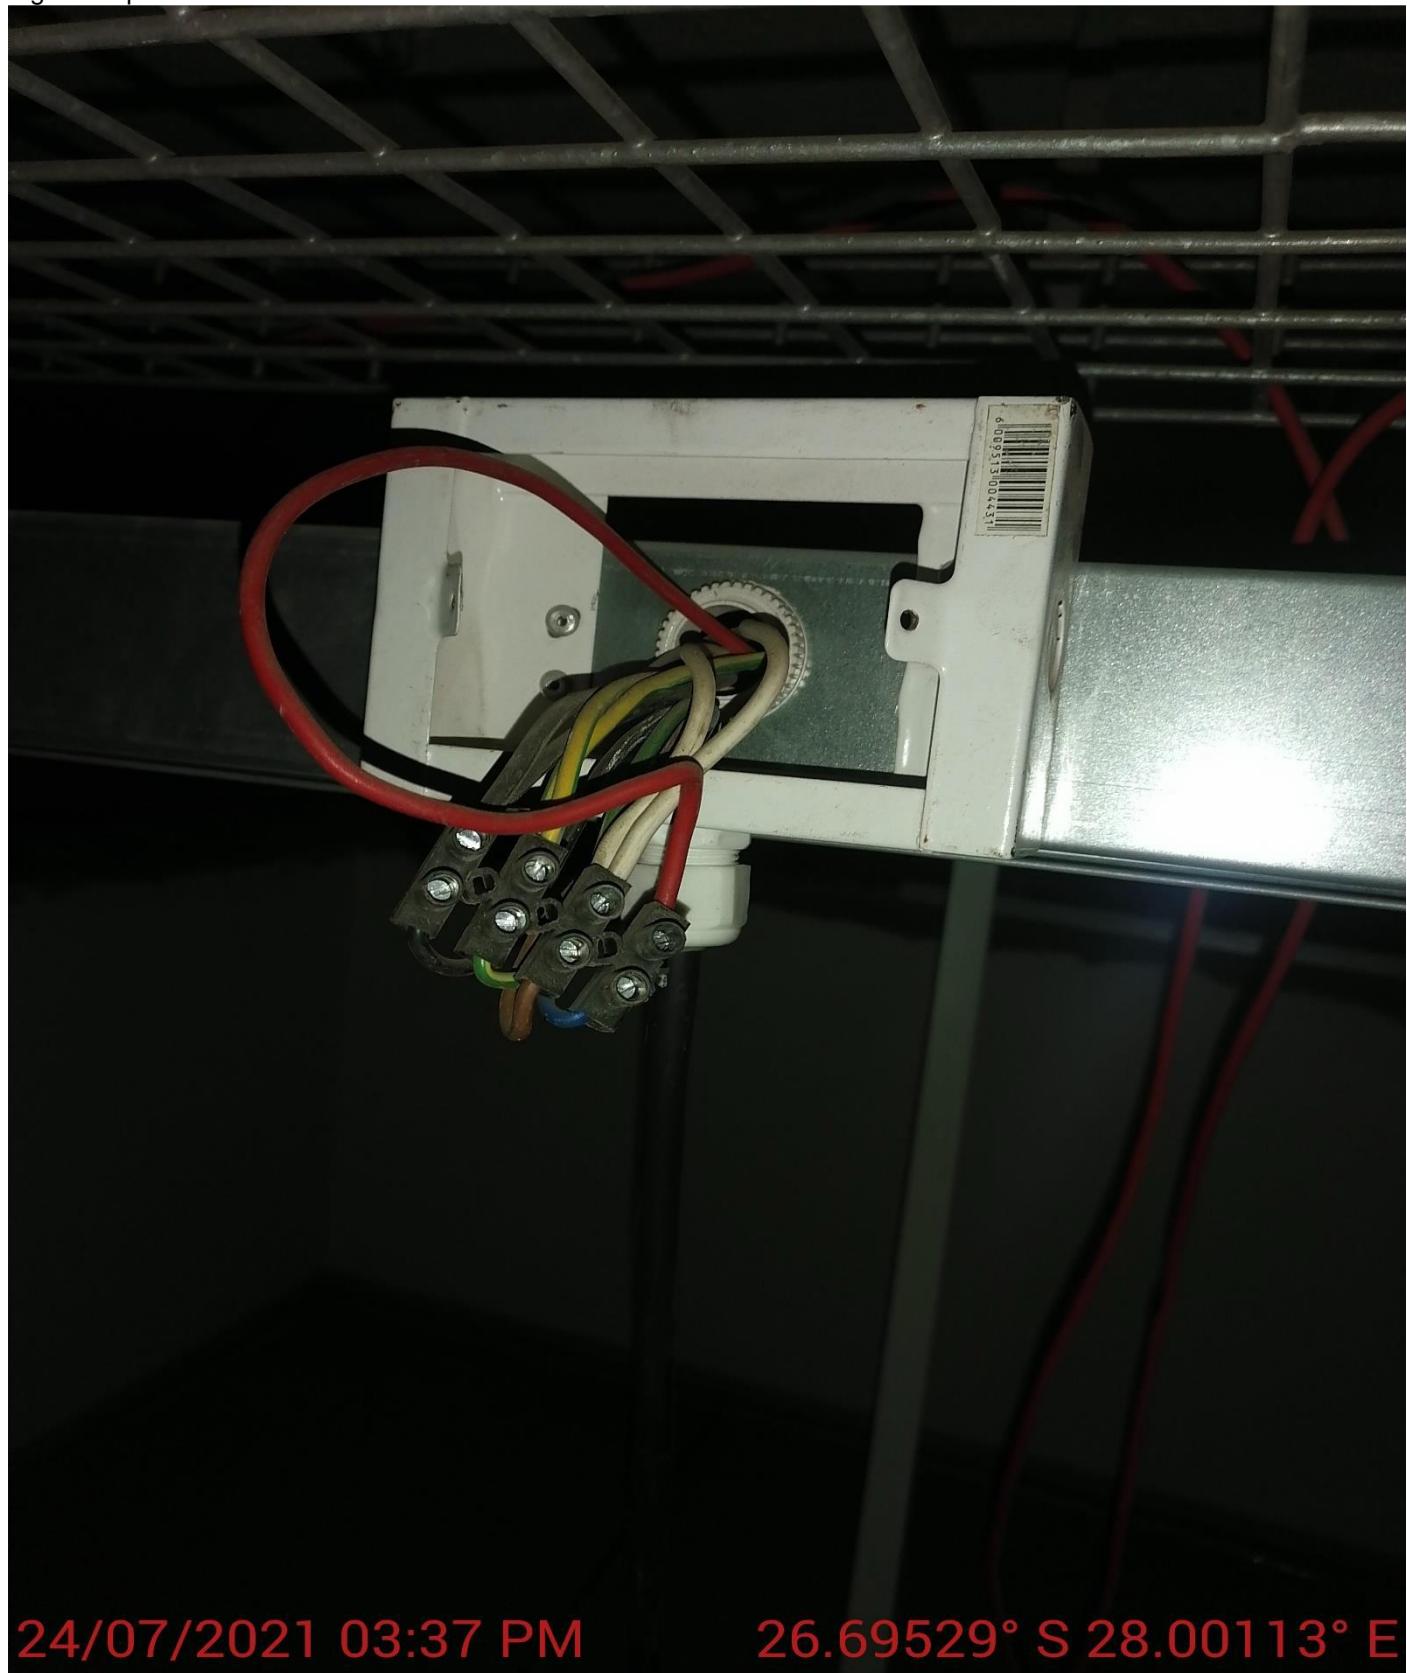
Fig 17 - Open Junction boxes

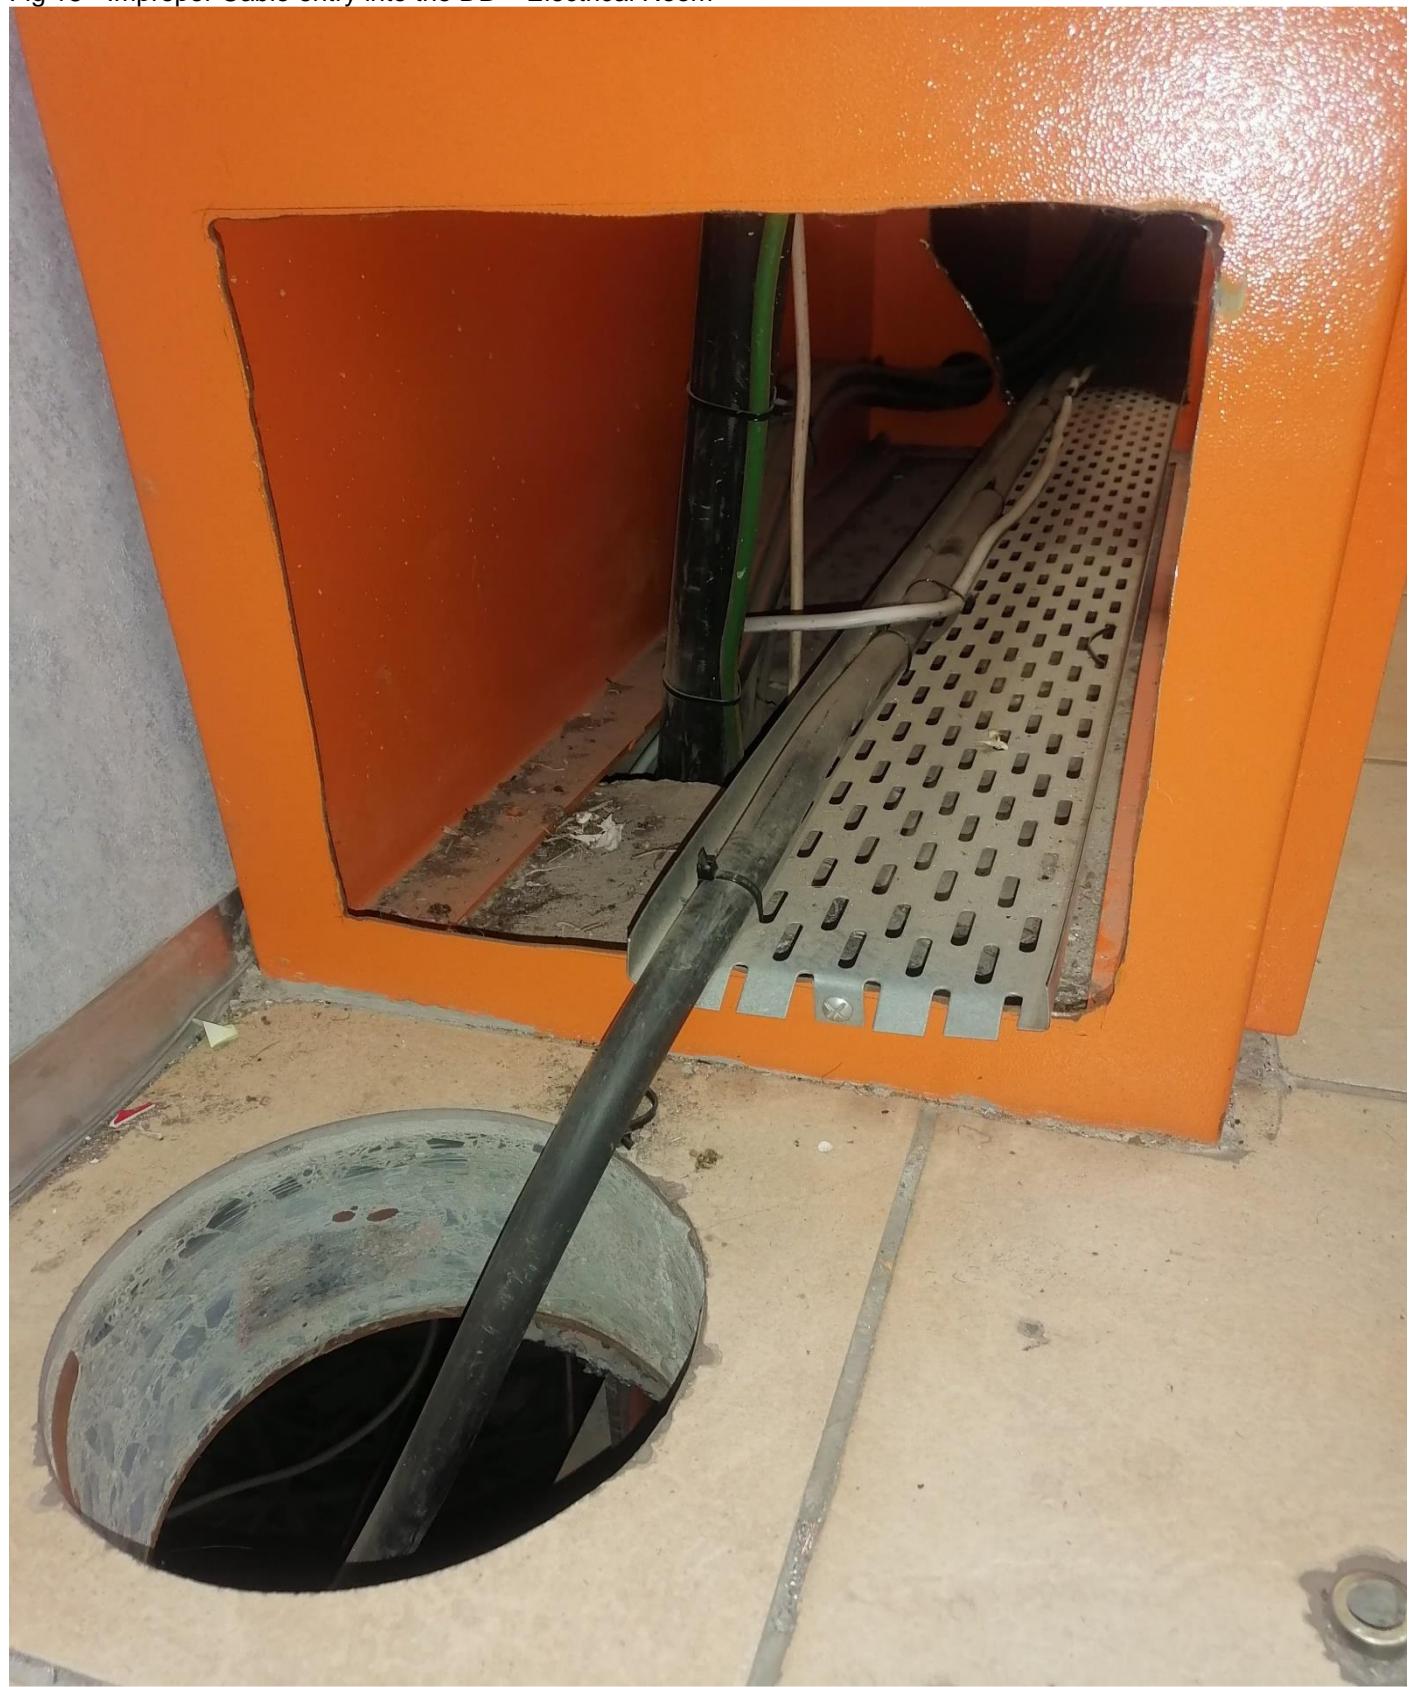
Fig 18 - Improper Cable entry into the DB – Electrical Room

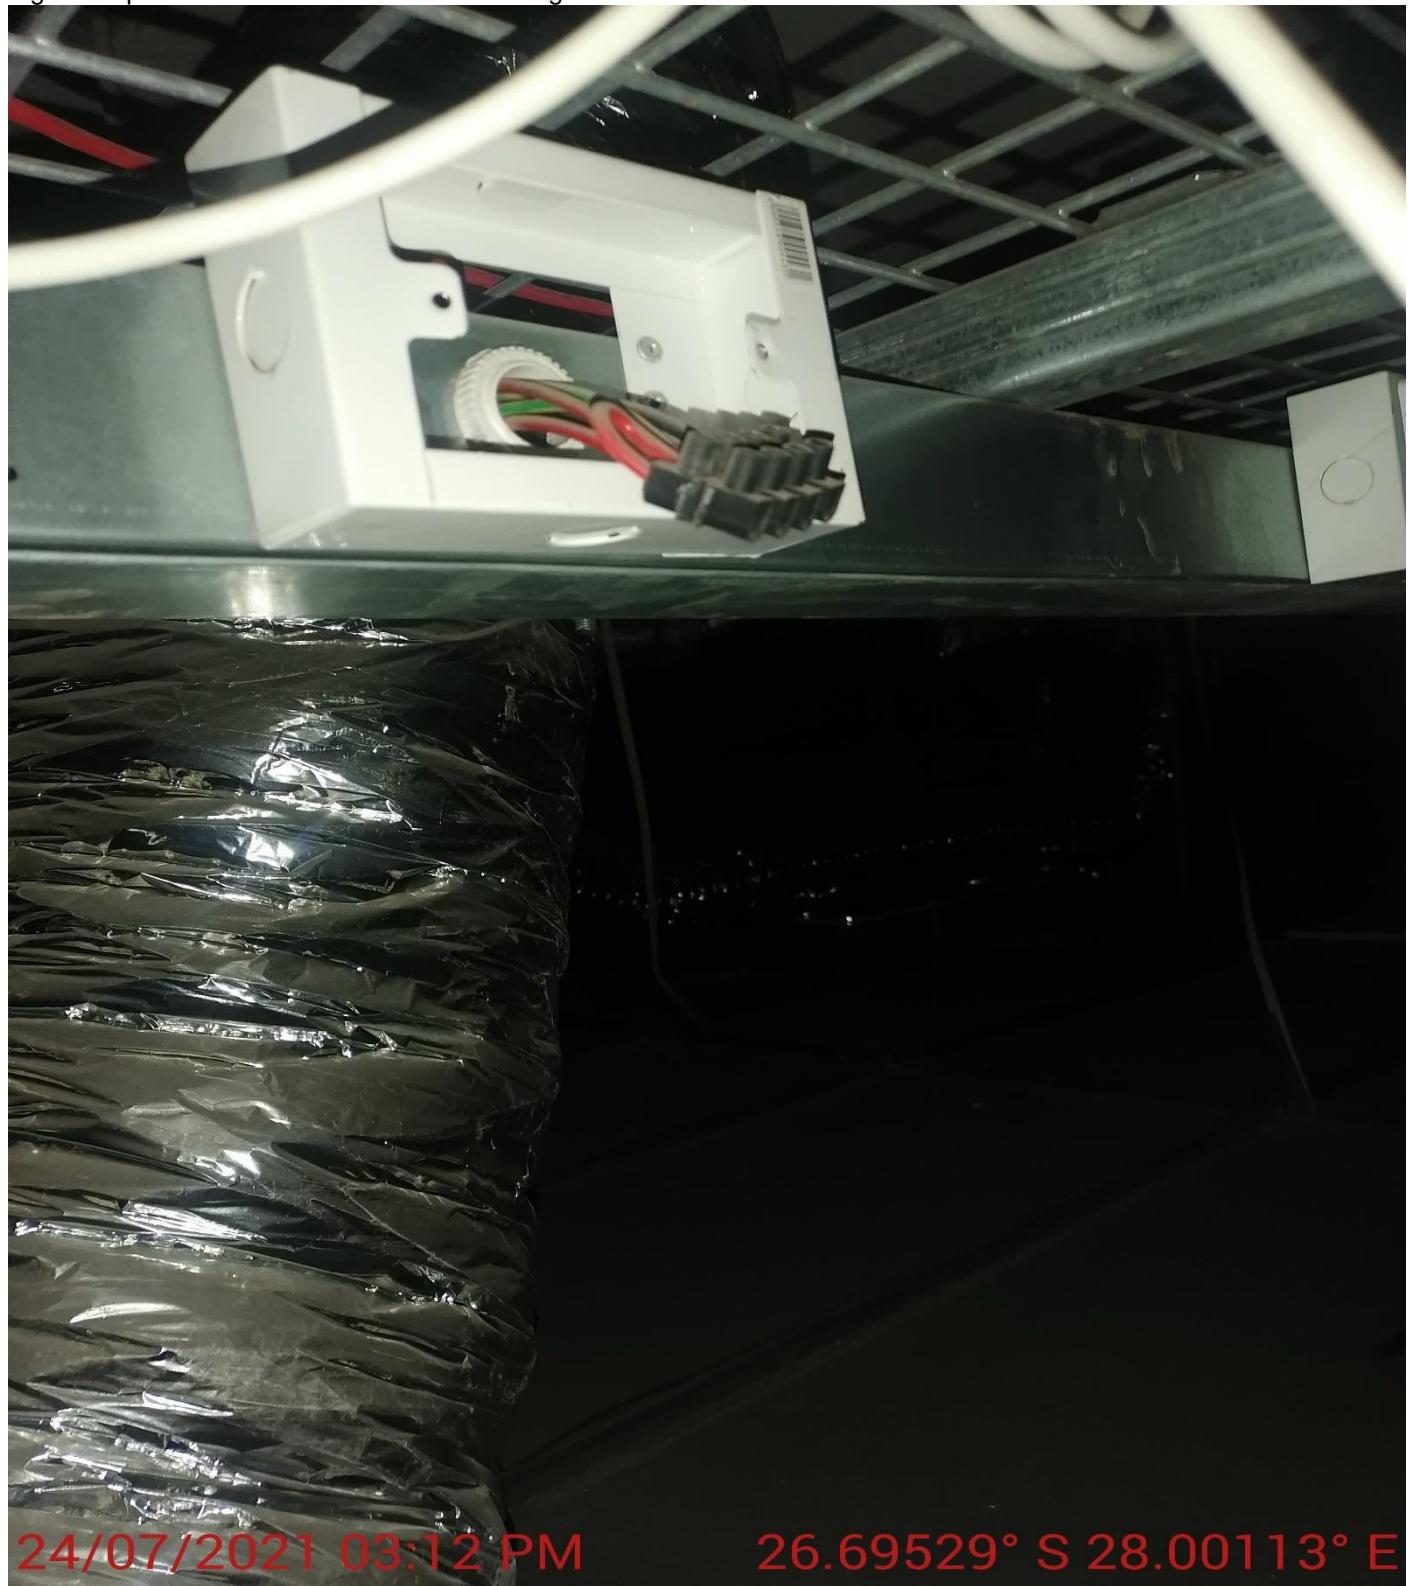
Fig 19 - Open Junction Boxes inside the ceiling void

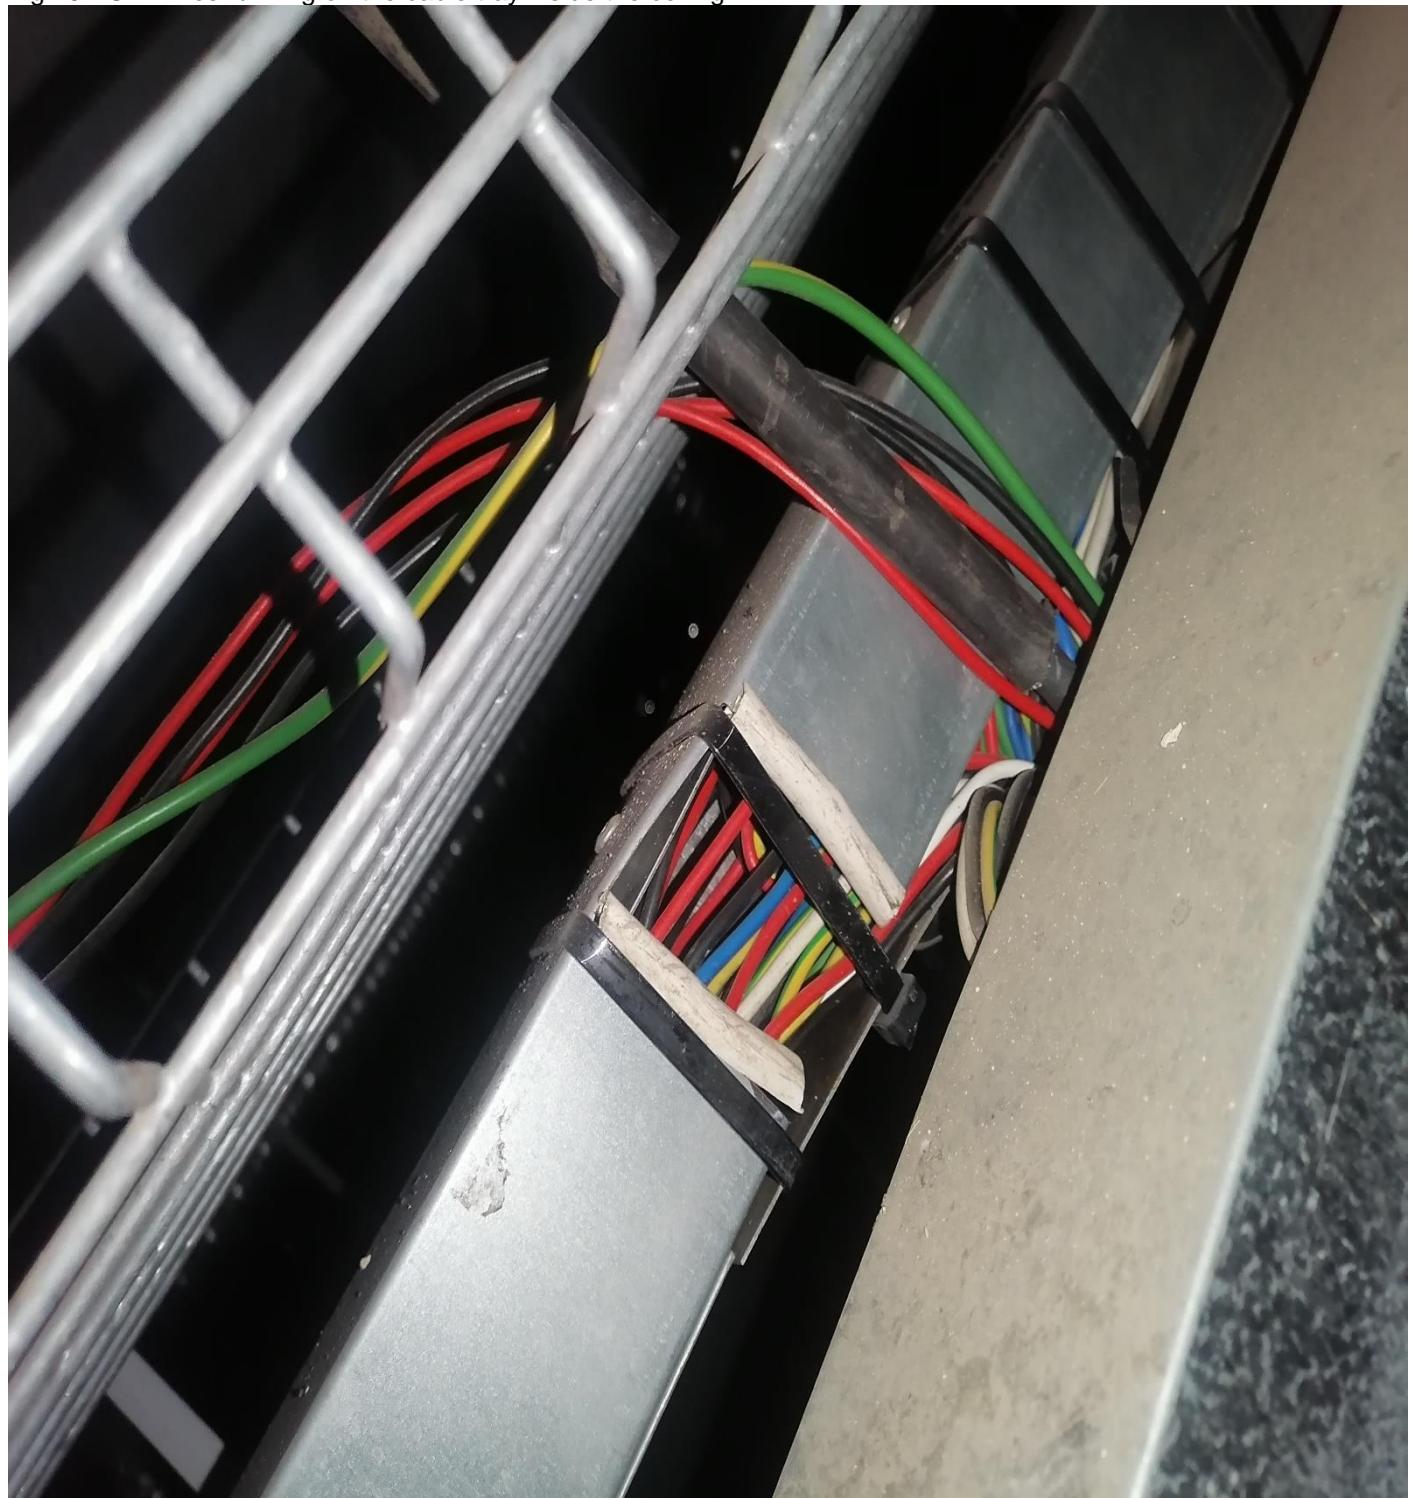
Fig 20 - GP Wires running on the cable tray inside the ceiling.

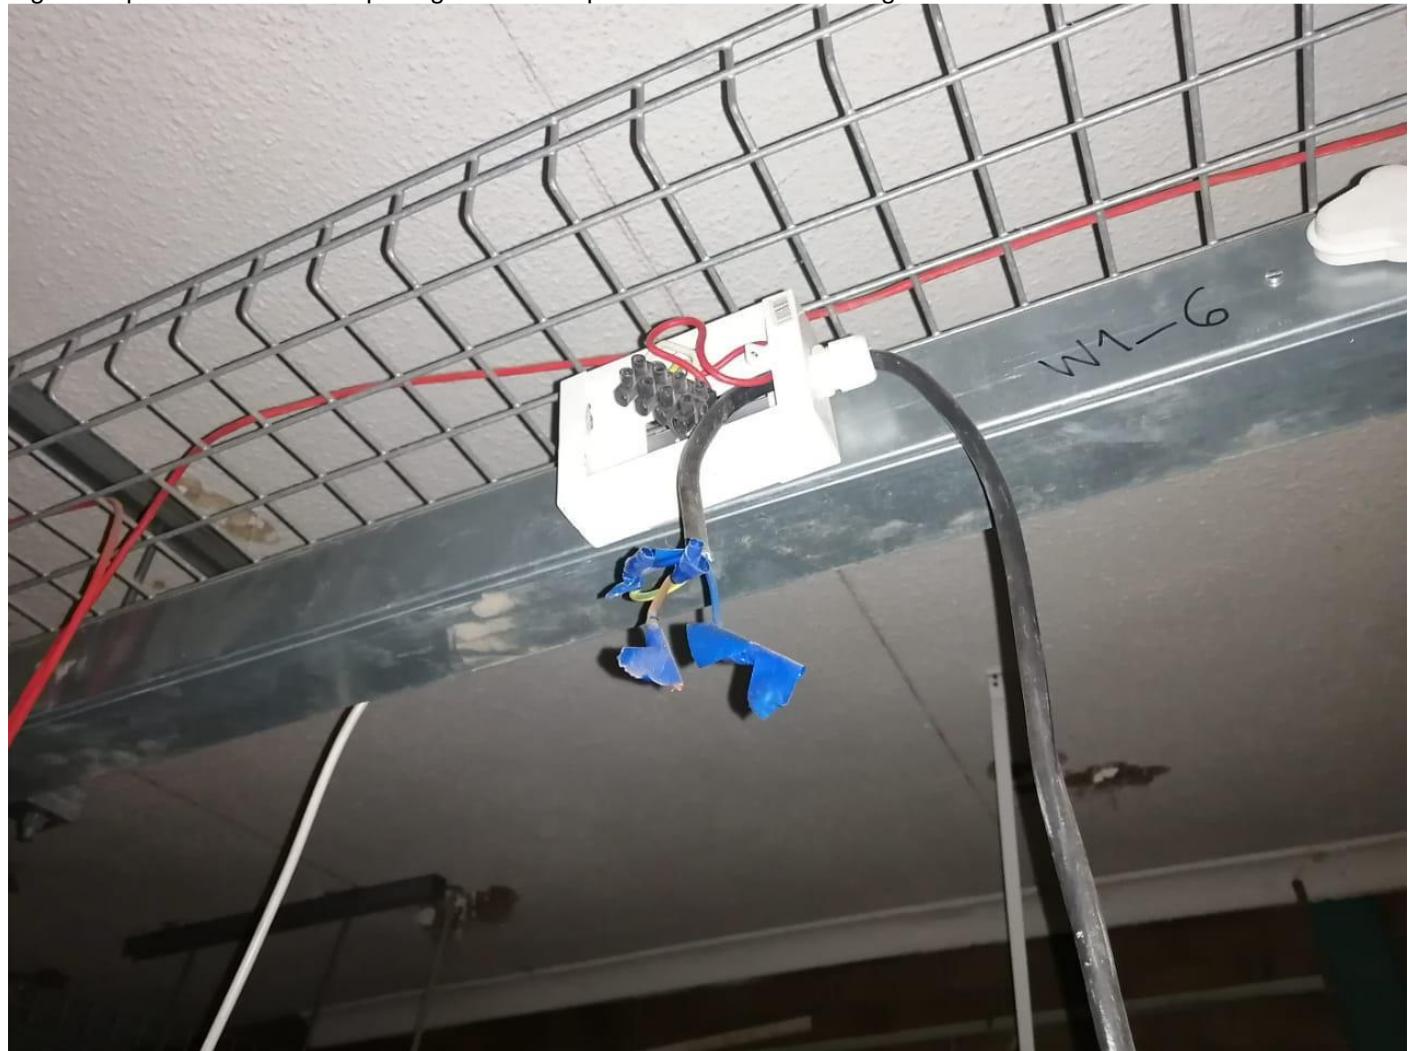
Fig 21 - Open Junction Box exposing conductive parts – Male Toilet Ceiling Void

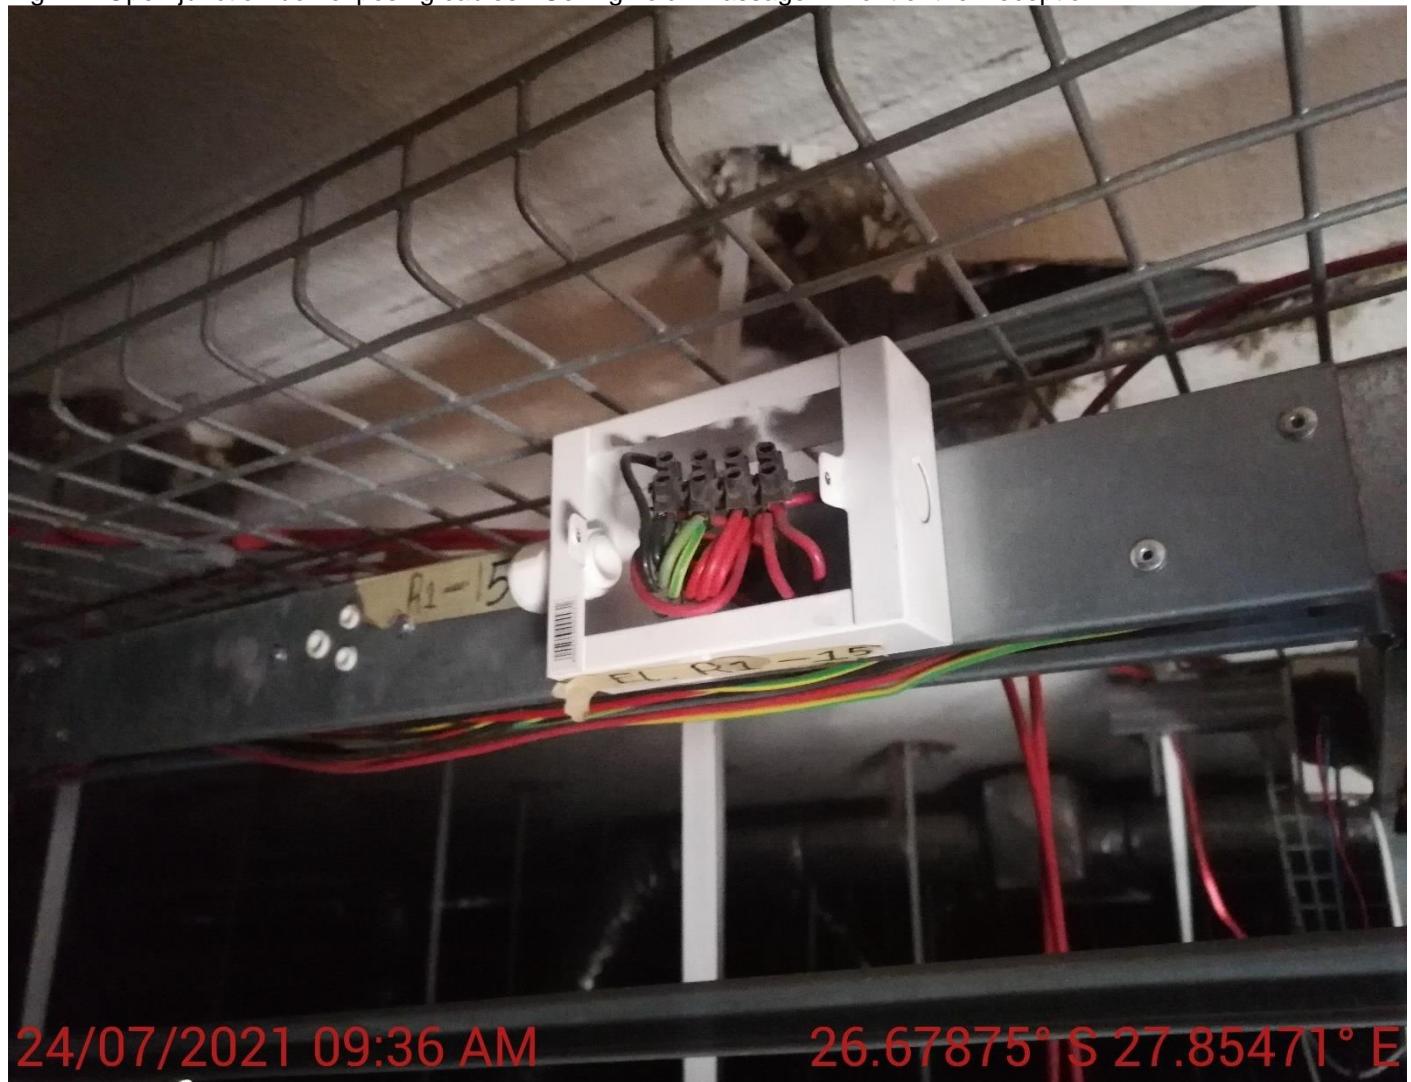
Fig 22 - Open junction box exposing cables – Ceiling void - Passage in front of the Reception

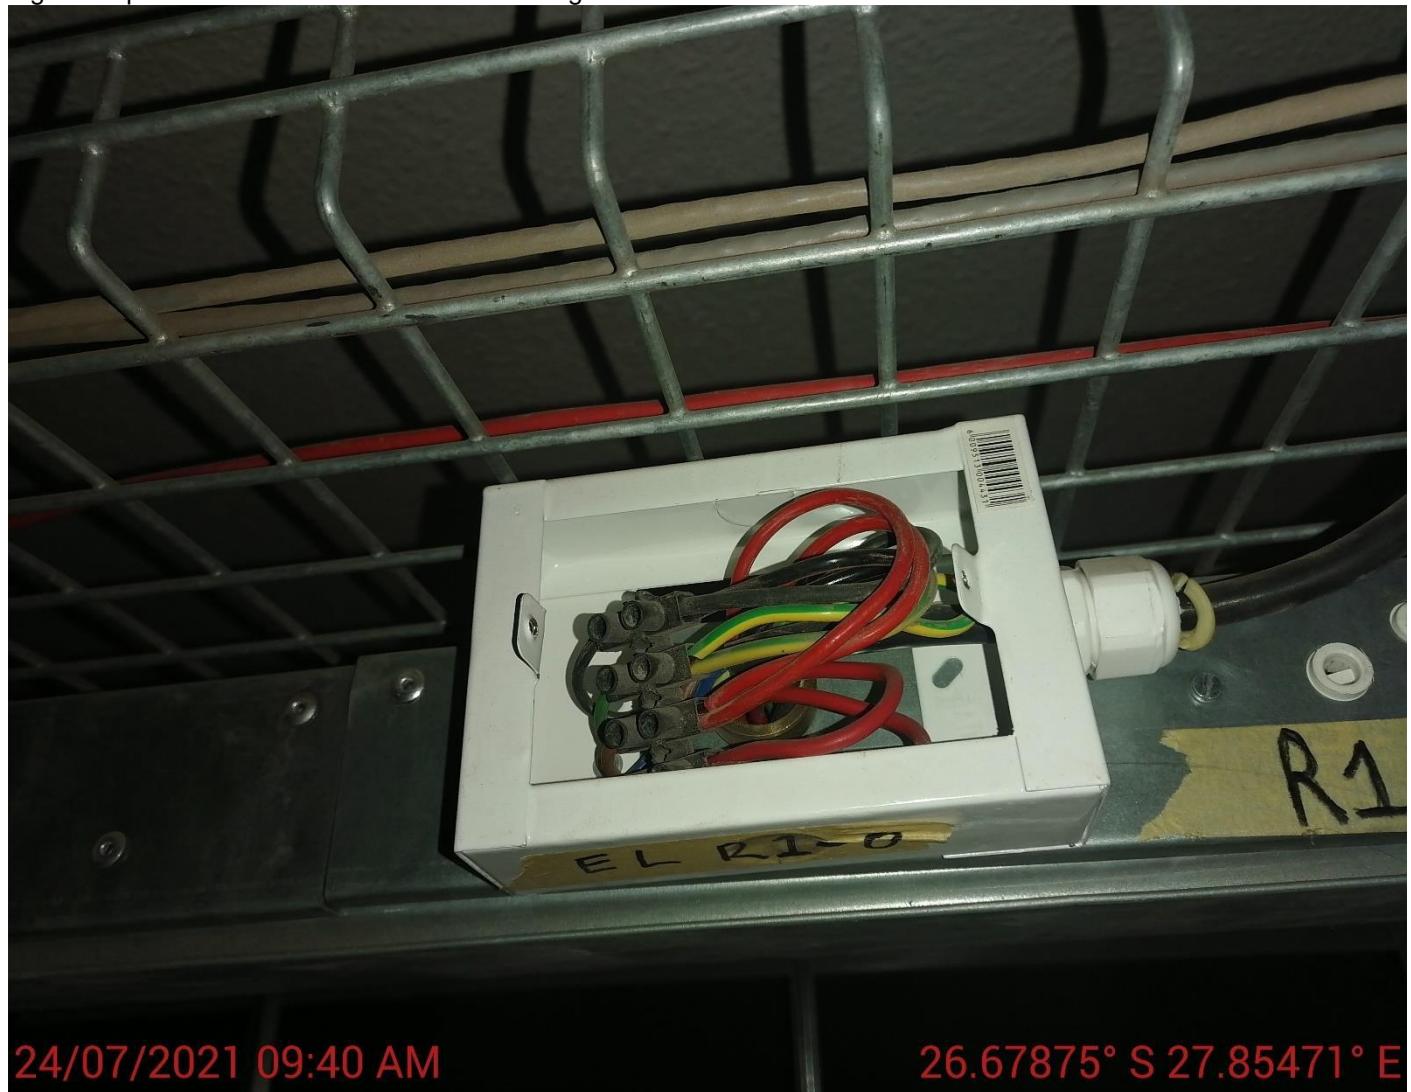
Fig 23 - Open Junction box – Tea Kitchen ceiling Void
