REQUEST FOR BID

10397088 – Scope of Work

Repair all non-compliance at no.1 Control room as per Scope Below:

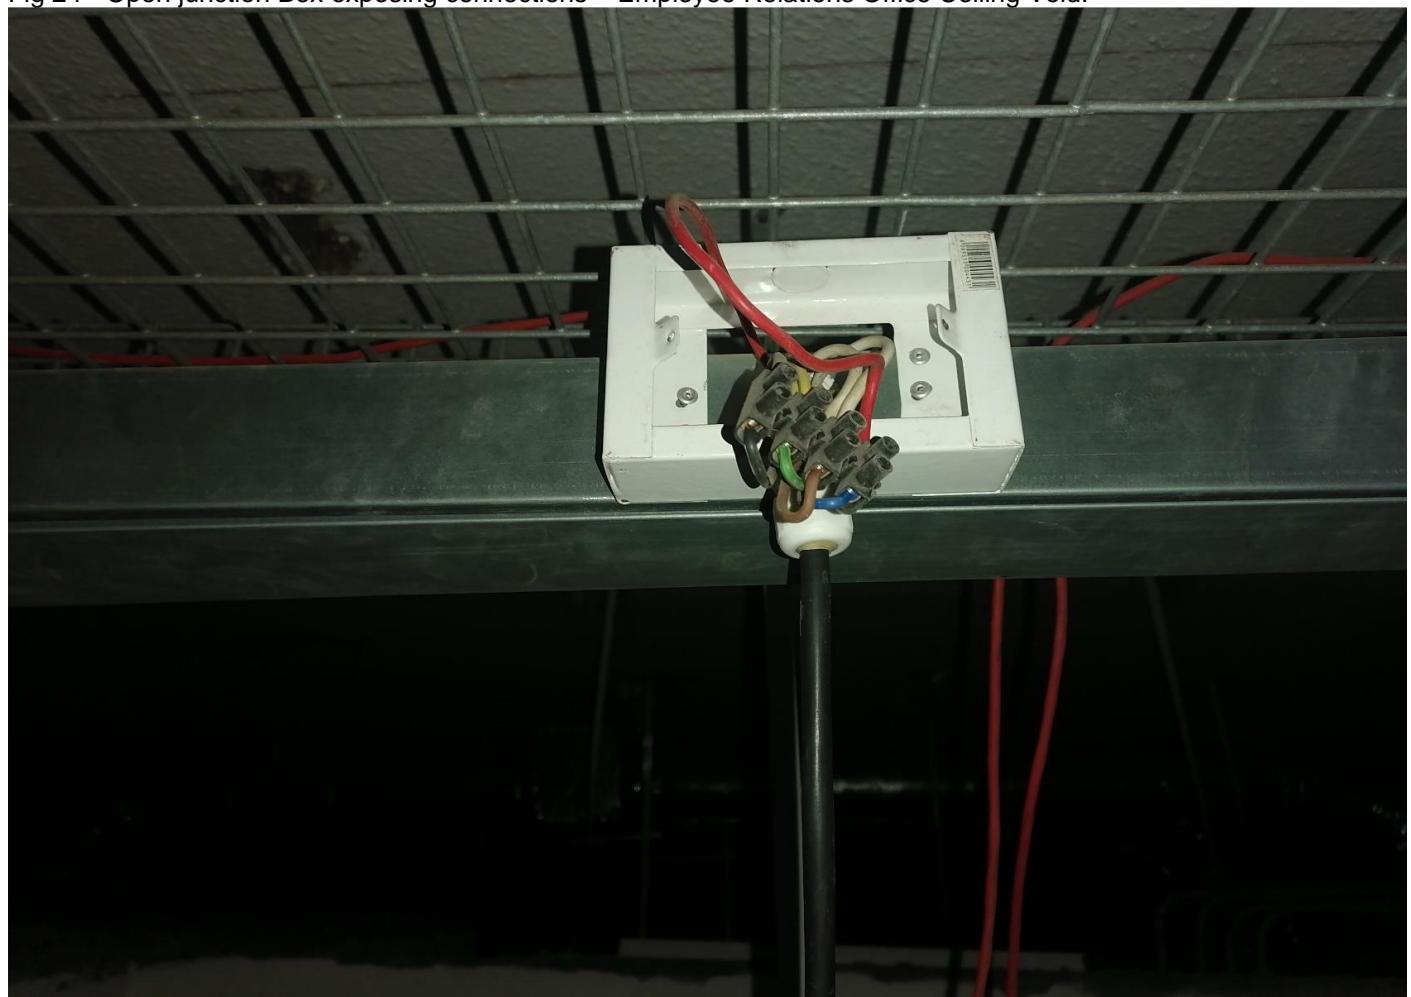
Fig 24 - Open junction Box exposing connections – Employee Relations Office Ceiling Void.

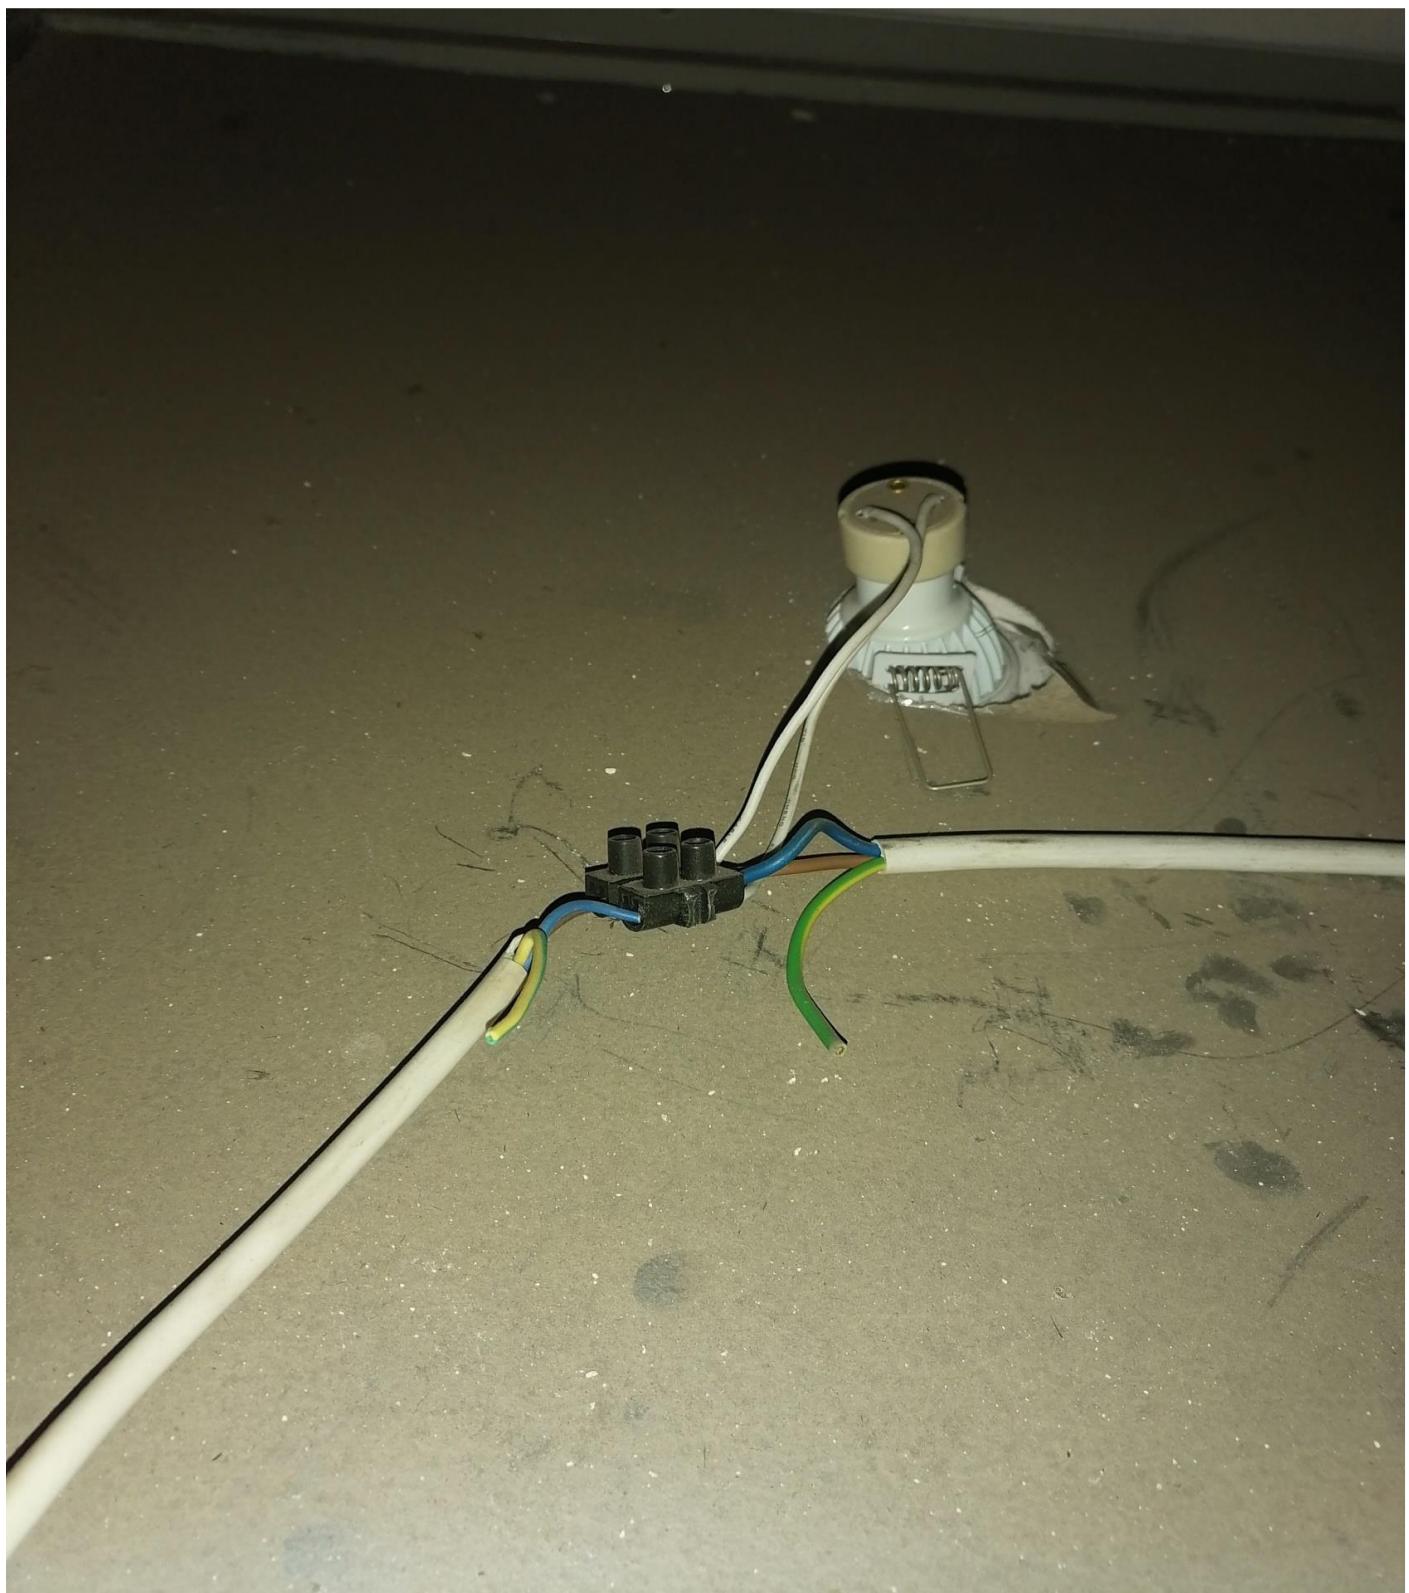
Fig 25 - Improper connections inside the ceiling void – Passage down lights

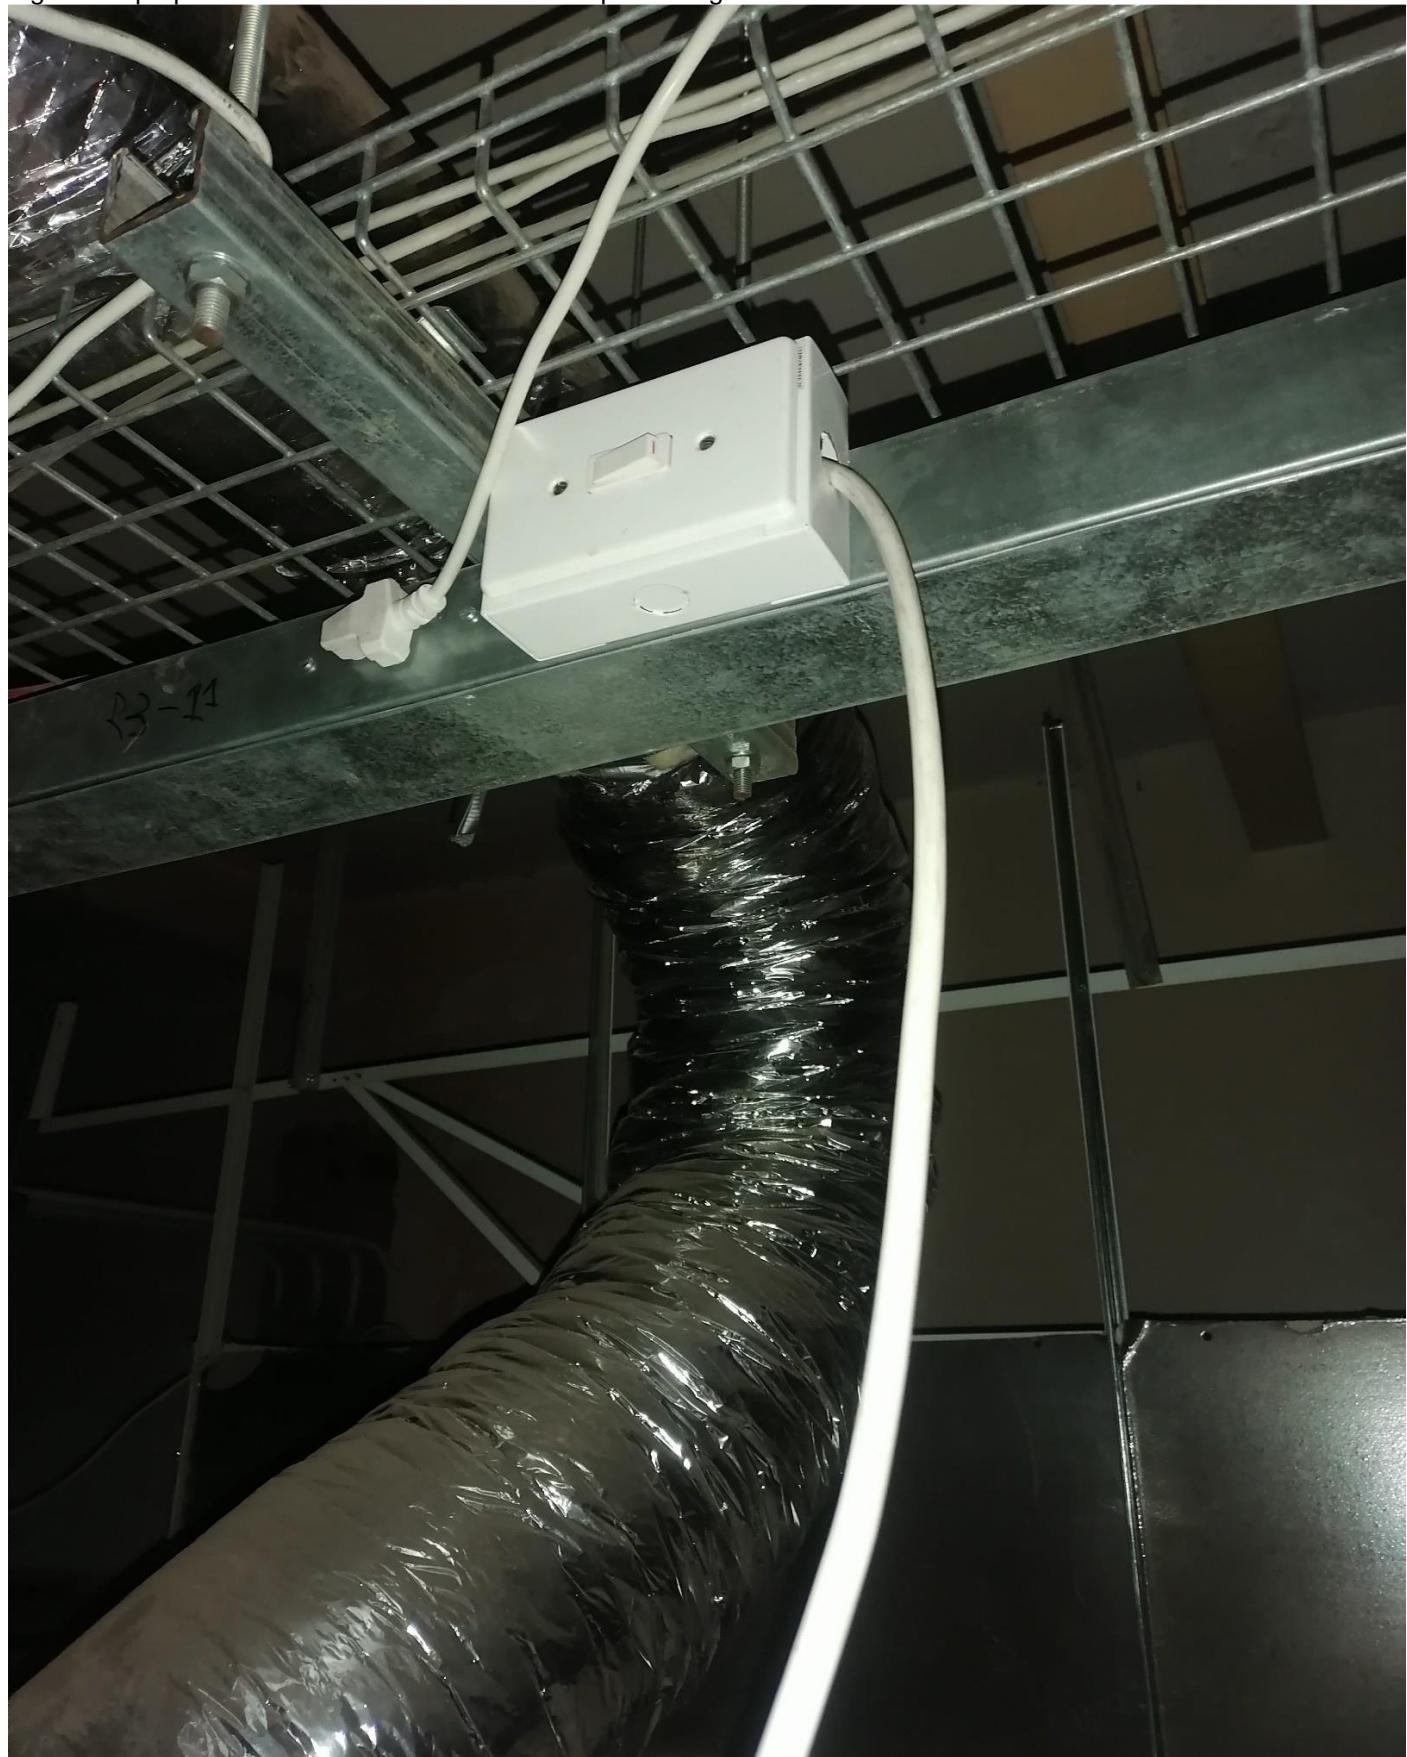
4. Improper cable terminations: This is mostly found on junction boxes mounted by the cable trunking side, connections were made without compression glands, allowing cabtyre cords to be suspended by connections.

Fig 26 - Improper Cable termination – without compression glands

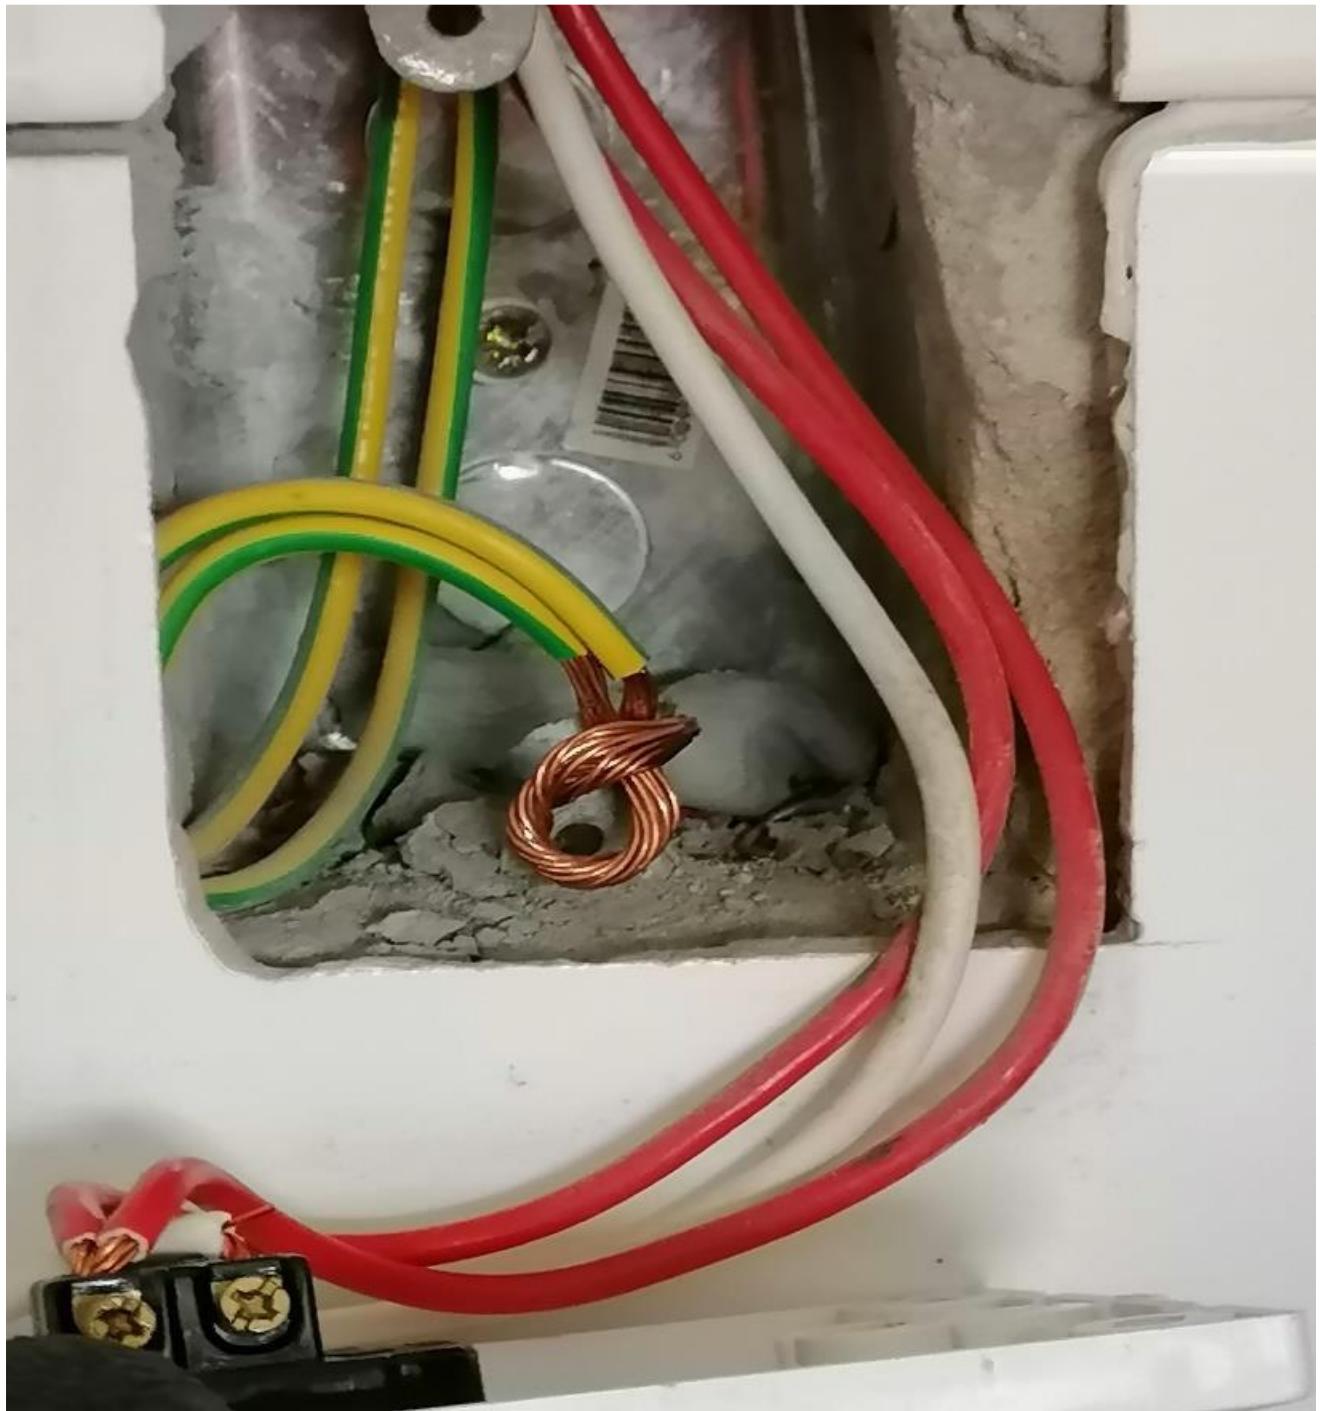
Fig 27 – Improper earth terminations on switch boxes.
Tea Kitchen Switch

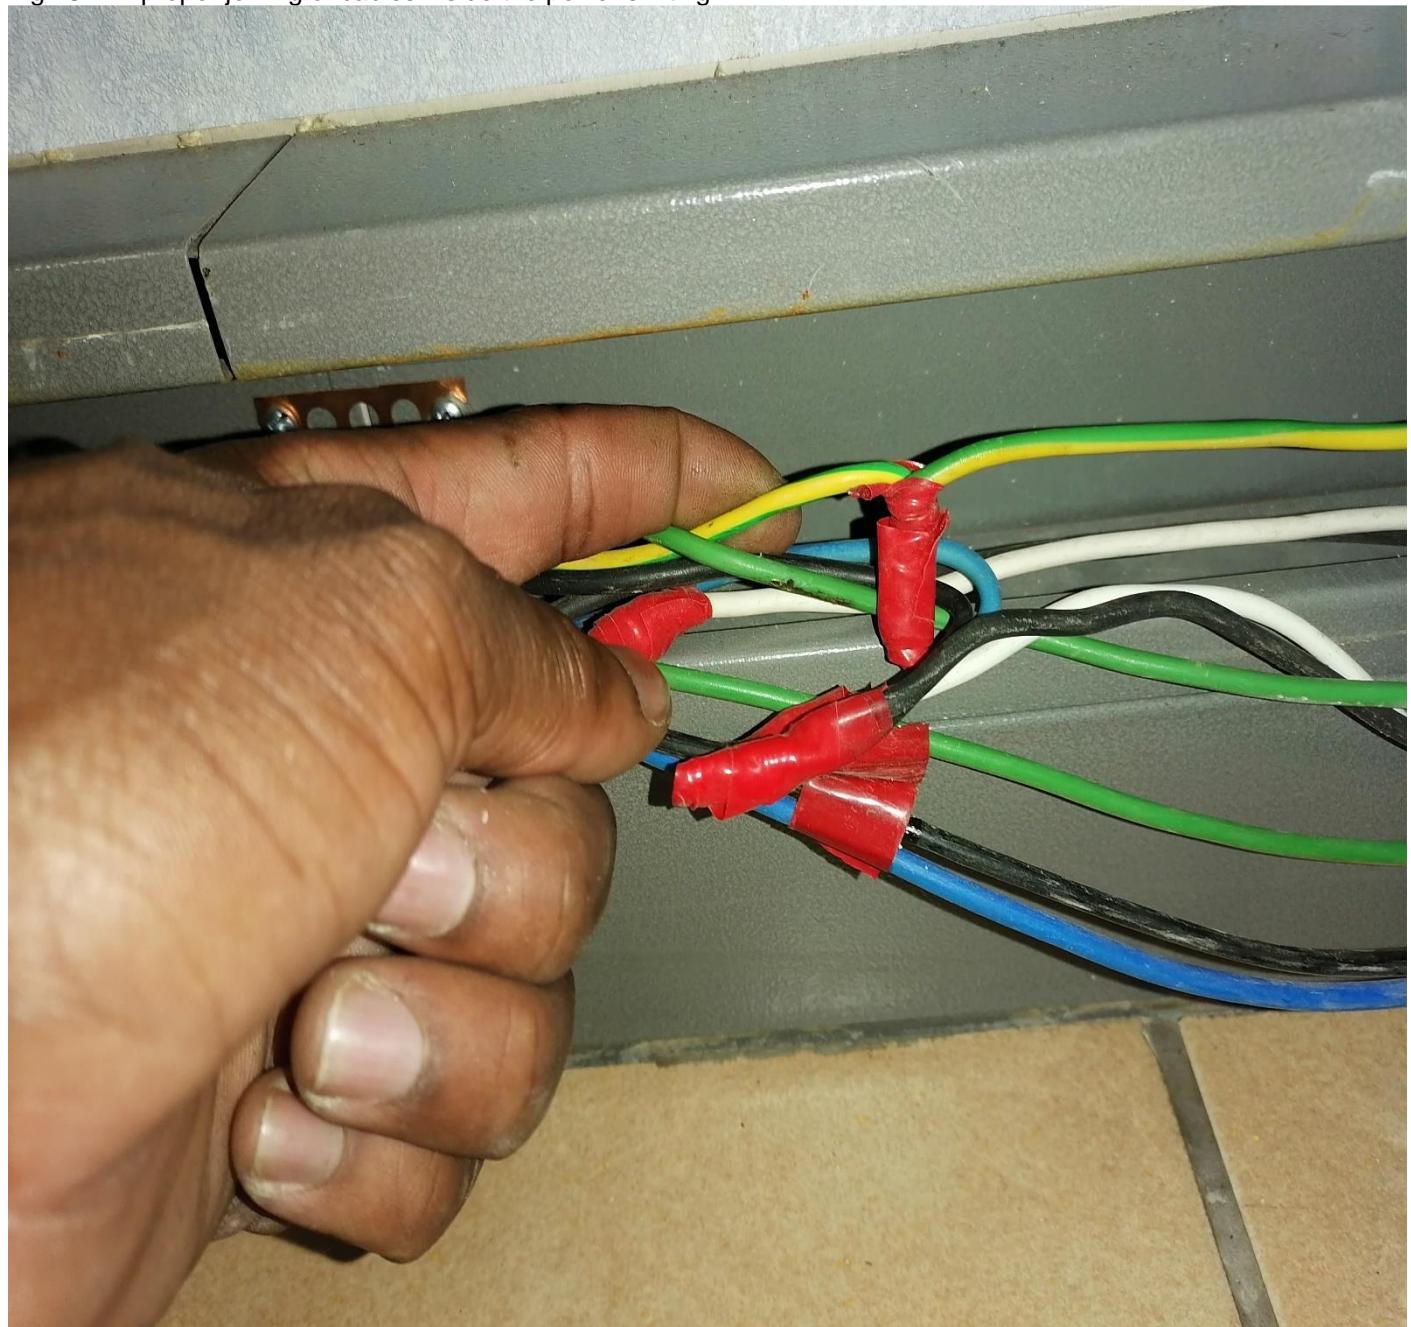
Fig 28 – Improper joining of cables inside the power skirting.
