**NATIONAL NUCLEAR REGULATOR (NNR)
NATIONAL NUCLEAR REGULATOR HEAD OFFICE BUILDING**

**PROVISION OF STRUCTURAL ENGINEERING SERVICES:
CONDITIONAL ASSESSMENT OF THE EXISTING HEAD OFFICE BUILDING
LOCATED AT: 420 WITCH-HAZEL AVE, ECO-PARK ESTATE,
CENTURION
0157**

PRELIMINARY VISUAL ASSESSMENT REPORT

SEPTEMBER 2021

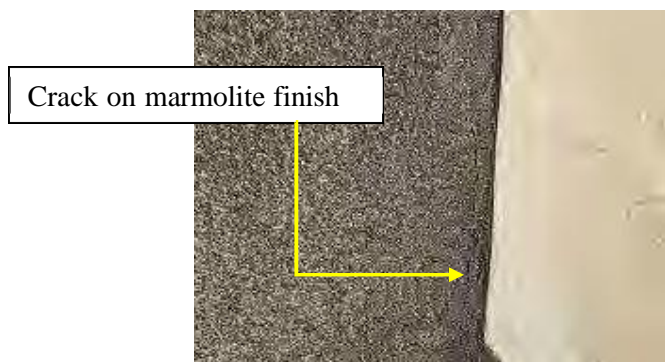
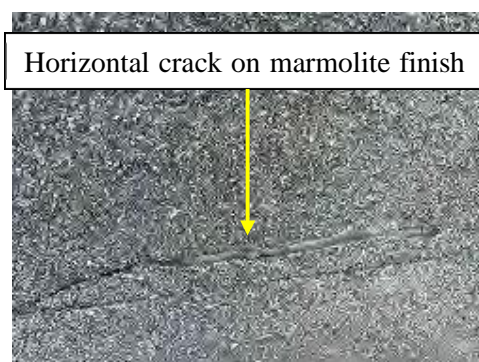
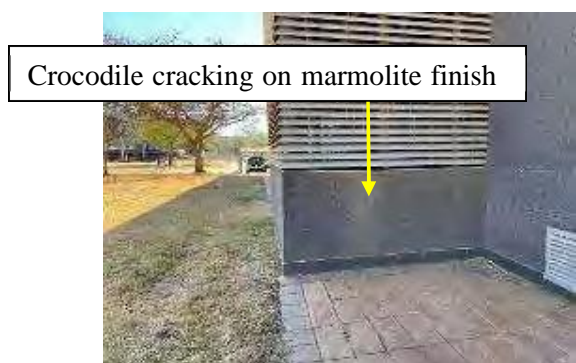
Figure 2: Showing minor crack of the existing marmolite finish

Figure 3: Showing minor cracking of the existing marmolite finish

Figure 4: Showing minor cracking of the existing marmolite finish

- c. Cracks within the marmolite finish appear to be due to general deterioration and lack of regular maintenance. These cracks on the marmolite finish are to be repaired by a specialist marmolite installer.

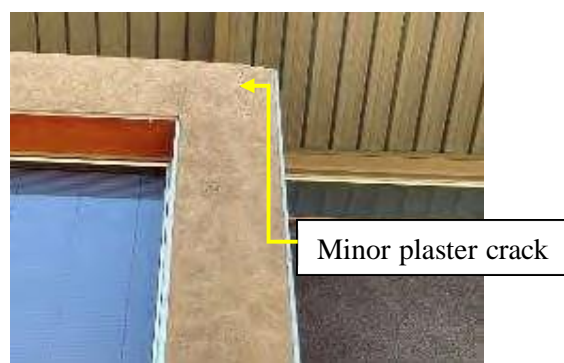
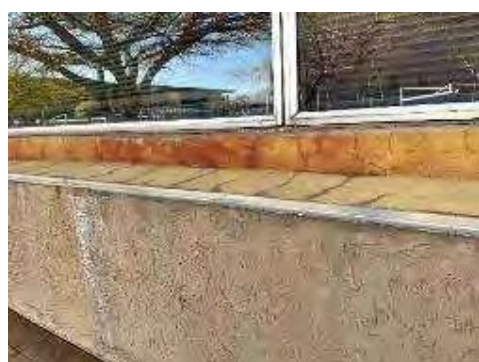
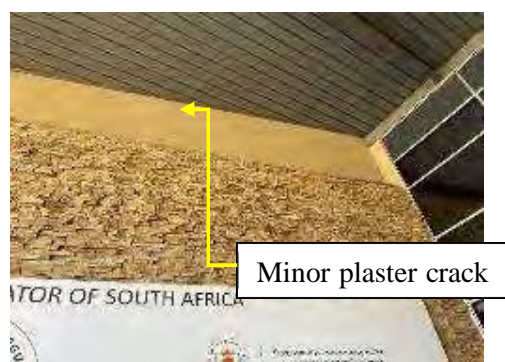
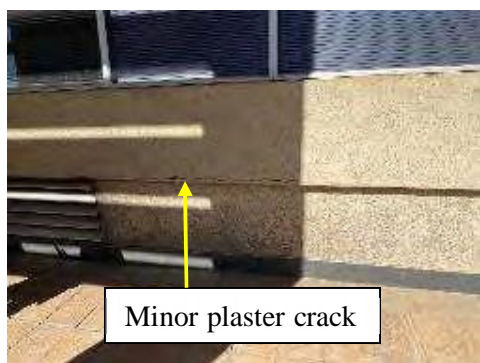
Figure 5: Showing plaster crack on the existing external wall

Figure 6: Showing plaster cracks on the existing external wall.

Figure 7: Showing plaster crack on the existing external wall.

Figure 8: Showing plaster crack on the existing external wall

- b. All plaster cracks and masonry cracks appear to be due to general deterioration and lack of regular maintenance. All plaster and masonry cracks must be repaired in accordance with the structural repair specification in *Annexure: A*

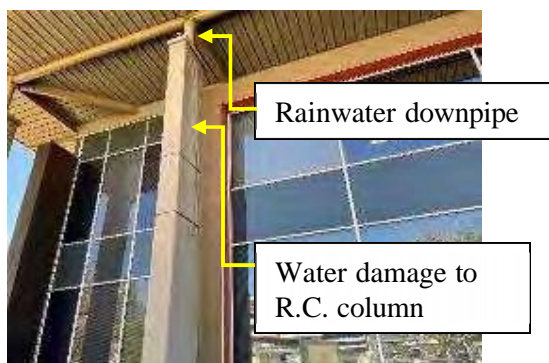
- c. Stormwater run-off from the rainwater gutters at roof level, is causing water seepage/ damage to the existing reinforced concrete columns.
- d. Access could not be gained to the roof area and therefore no comment could be made/given regarding the condition of the existing roof sheeting and rainwater gutters.

Figure 9: Showing the rainwater downpipe cast into R.C. column and water damage to the concrete column

- h. The rainwater downpipes within the R.C columns appear to be blocked and/or damaged. We recommend that the existing rainwater downpipes be high pressure cleaned and a CCTV camera investigation be undertaken to determine the integrity of the existing rainwater downpipes.

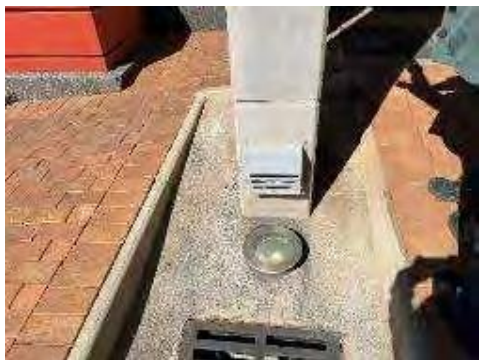
Figure 10: Showing rainwater downpipe grid inlets

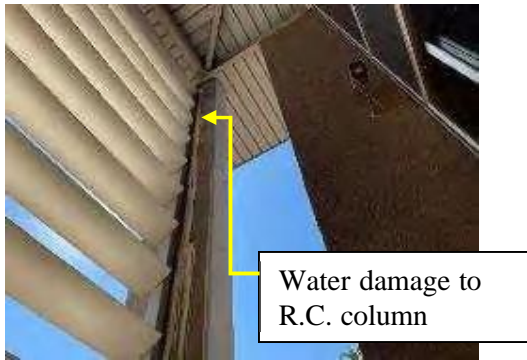
Figure 11: Showing water damage to the existing R.C. column

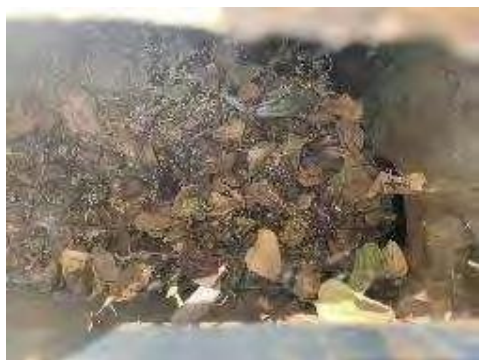
- e. Stormwater grid inlet and manholes at ground level were found to be blocked with silt and debris.
- f. Water damage to the fire escape staircase was observed.

Figure 12: Showing stormwater manhole blocked with silt and debris

- i. Existing stormwater reticulation, including all existing manholes, be high pressure cleaned.
- j. There are many existing office areas being used for storage and/or filing rooms. As per the structural design code, **SANS 10160-2:2011 Self Weight and Imposed Loads (Table 1 – Category B1)**, we assume that the existing slabs were designed for a live load of 2.5 kN/m² (250 kg/m²) of which is for ‘office areas for general use’. The current storage areas appear to have a stack height of approximately 3m which would make the live load requirement 7.5 kN/m² as per the live loading requirements of **Category B5 (SANS 10160-2:2011)**. This current loading situation, is in our opinion, in excess (more than 3 times) of the assumed designed live load of the existing slab and therefore could result in excess deflection and possible severe cracking of the existing slab. We strongly recommend that the stack height used in these storage areas be reduced to maximum 1m heights to maintain the overall structural integrity of the existing slab.

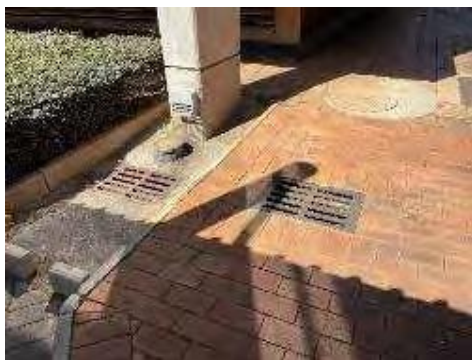
Figure 13: Showing existing stormwater grid inlets

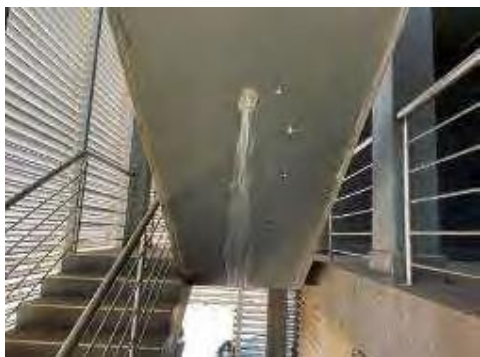
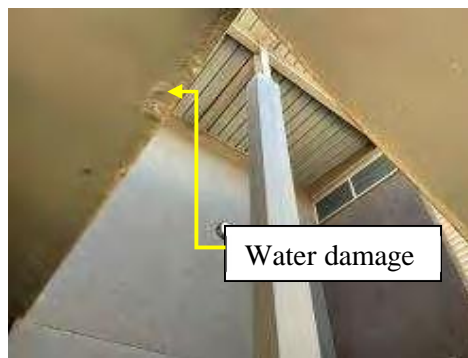
Figure 14: Showing water damage to the existing fire escape staircase

Figure 15: Showing water damage to the fire escape staircase

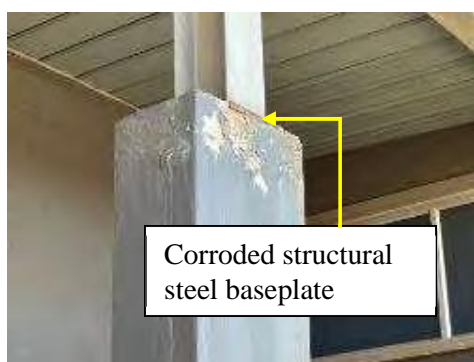
- g. Mild corrosion of the existing structural steel members at the fire escape staircase was observed.
- h. Moderate corrosion to a structural steel baseplate was observed by the fire escape staircase.

Figure 16: Showing corroded structural steel baseplate

- d. The corrosion to the structural steel members is to be repaired in accordance to our structural specification as detailed in *Annexure: B*
- e. Cracks in the existing concrete surface bed slab in the basement must be repaired as per the repair specification in *Annexure: C*

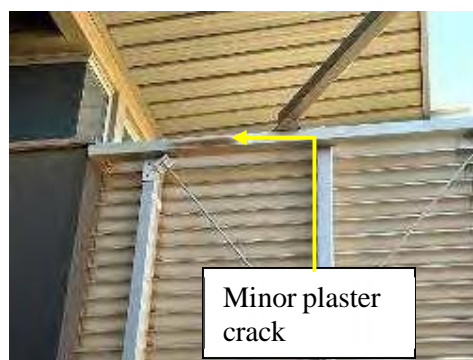
Figure 17: Showing corroded structural steel member

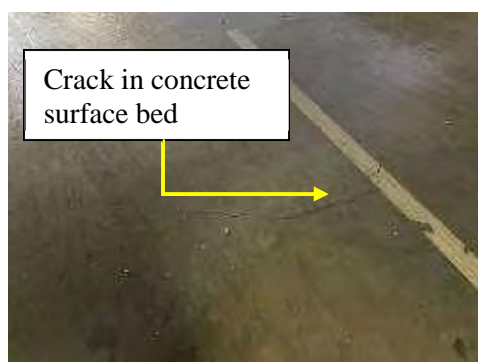
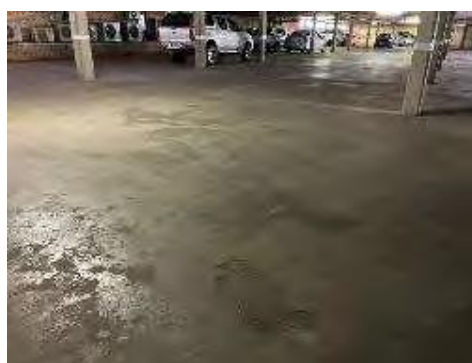
- i. The existing surface bed slab at basement level was found to have minor cracks.
- j. Water damage and structural cracking to the internal walls of the transformer room was observed.

Figure 18: Showing cracking of the existing concrete surface bed slab at basement level

Figure 19: Showing damage to existing concrete surface bed slab at basement level

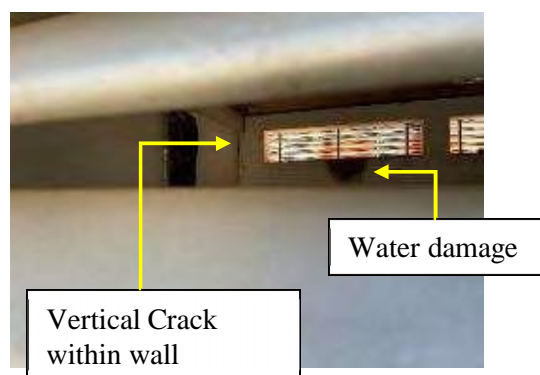
Figure 20: Showing water damage and structural cracking to the internal walls in the transformer room

- f. Concrete spalling at various locations should be repaired as per the repair specification in *Annexure: D*
- g. Masonry walls located within the transformer have water damage due to water ingress from the screens above. The vertical crack is to be repaired as per the repair specification in *Annexure: E*

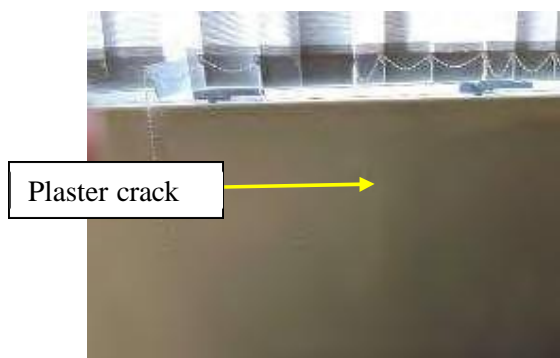
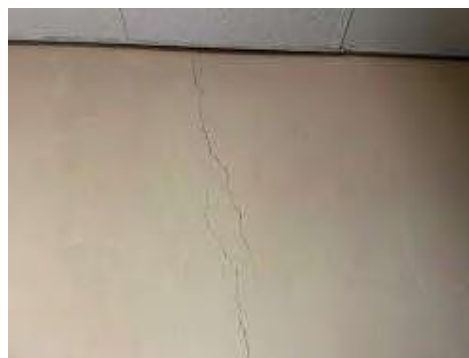
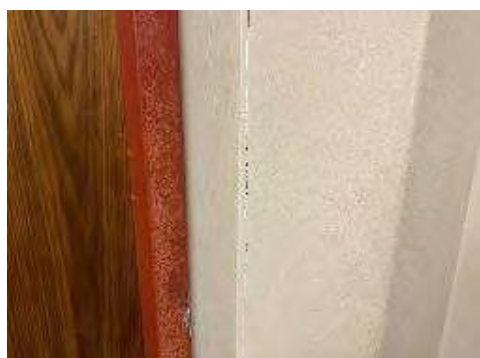
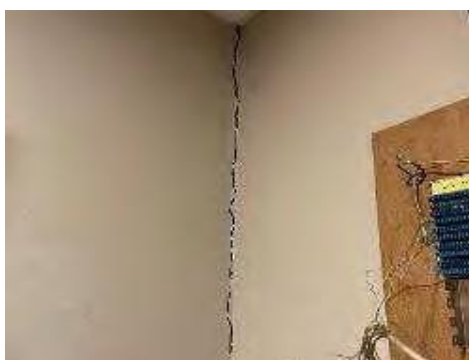
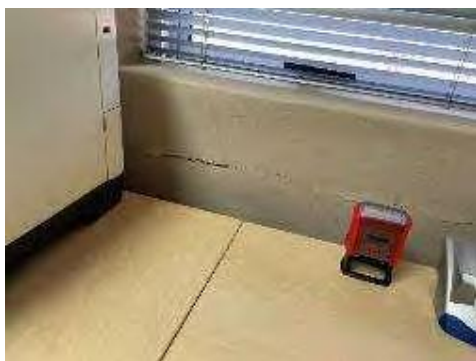
Figure 21: Showing minor plaster crack on the existing wall

Figure 22: Showing minor plaster crack on the existing wall

Figure 23: Showing minor plaster crack on the existing wall

Figure 24: Showing moderate plaster crack on the existing wall

Figure 25: Showing minor horizontal plaster crack on the existing wall

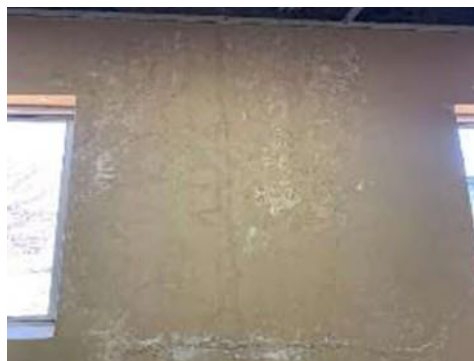
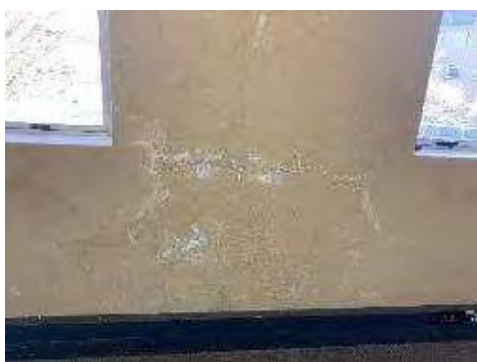
Figure 26: Showing water damage to the existing internal office wall

Figure 27: Showing water damage to existing internal office walls

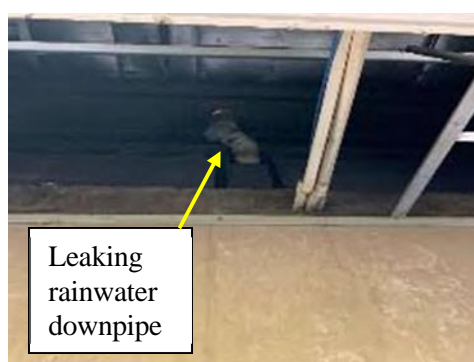
Figure 28: Showing leaking/damaged rainwater downpipe

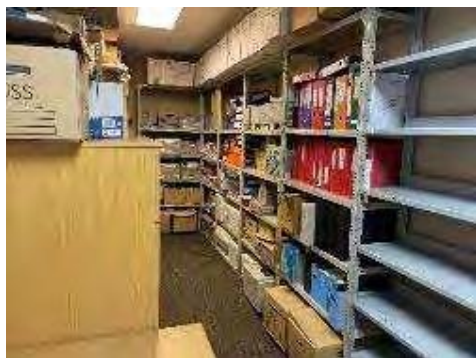
Figure 29: Showing existing office being utilized as a filing room/storage

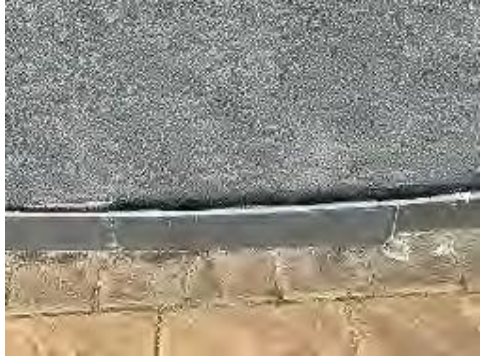
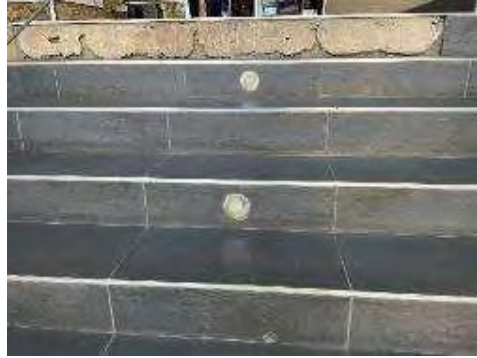
Figure 30: Showing delamination of the tiled skirting on the existing wall

Figure 31: Showing damage to the exterior tiling

- k. All damaged ceiling boards to be removed and replace with new. All to match existing on site.
- l. All damaged and cracked tiles are to be removed and replaced. All to match existing on site.
- m. All internal walls to be prepared to receive two coats of paint.

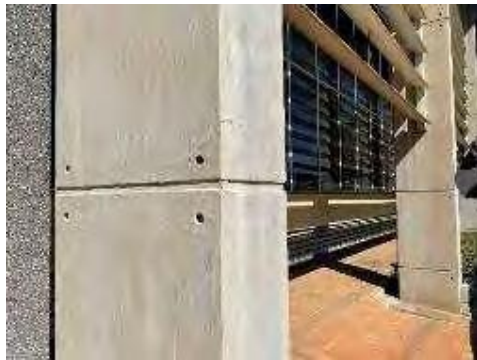
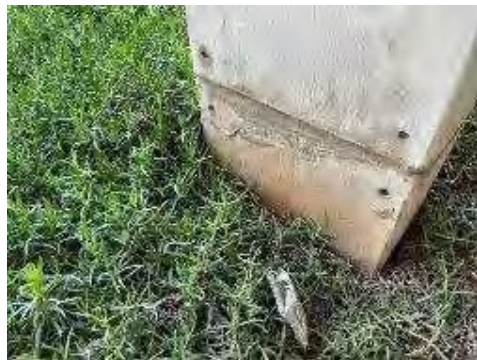
Figure 32: Showing minor spalling on the finish of the existing

Figure 33: Showing minor spalling on the finish of the existing

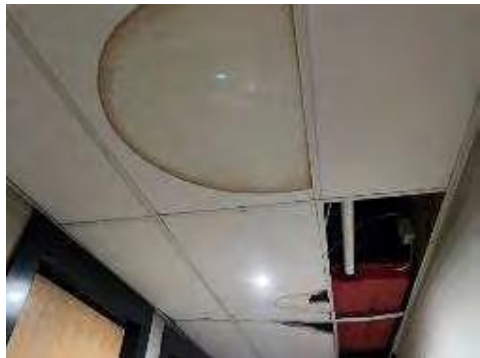
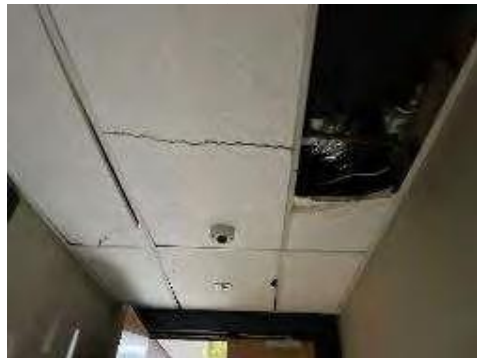
Figure 34: Showing water damage to existing ceiling boards

Figure 35: Showing cracked/damaged ceiling boards
