REQUEST FOR BID CIDB

10397088 – Scope of Work

Repair all non-compliance at no.1 Control room as per Scope Below:
Pricing to include all spares required and labor.

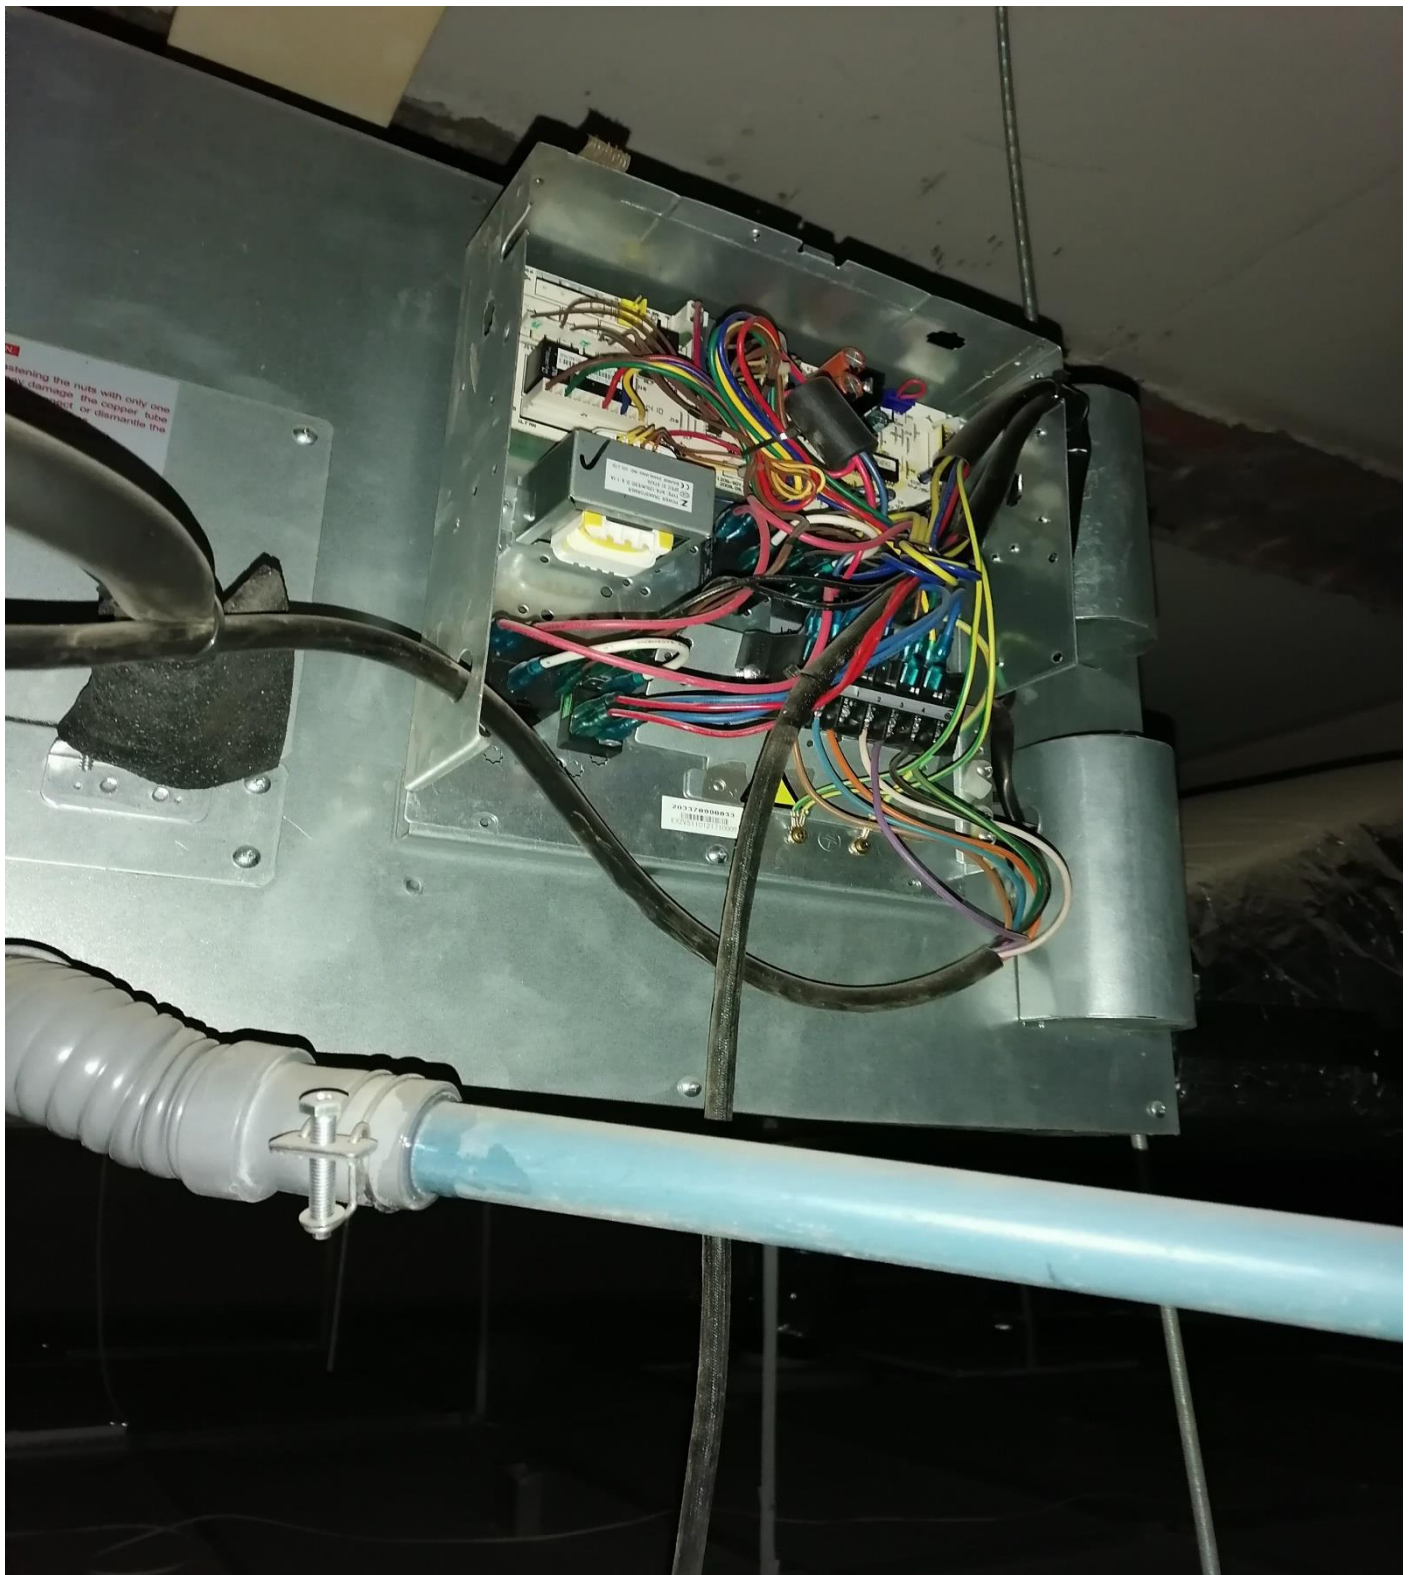
Fig 3 - Air con control box without cover exposing cables and connections. - in front of the Conference Room

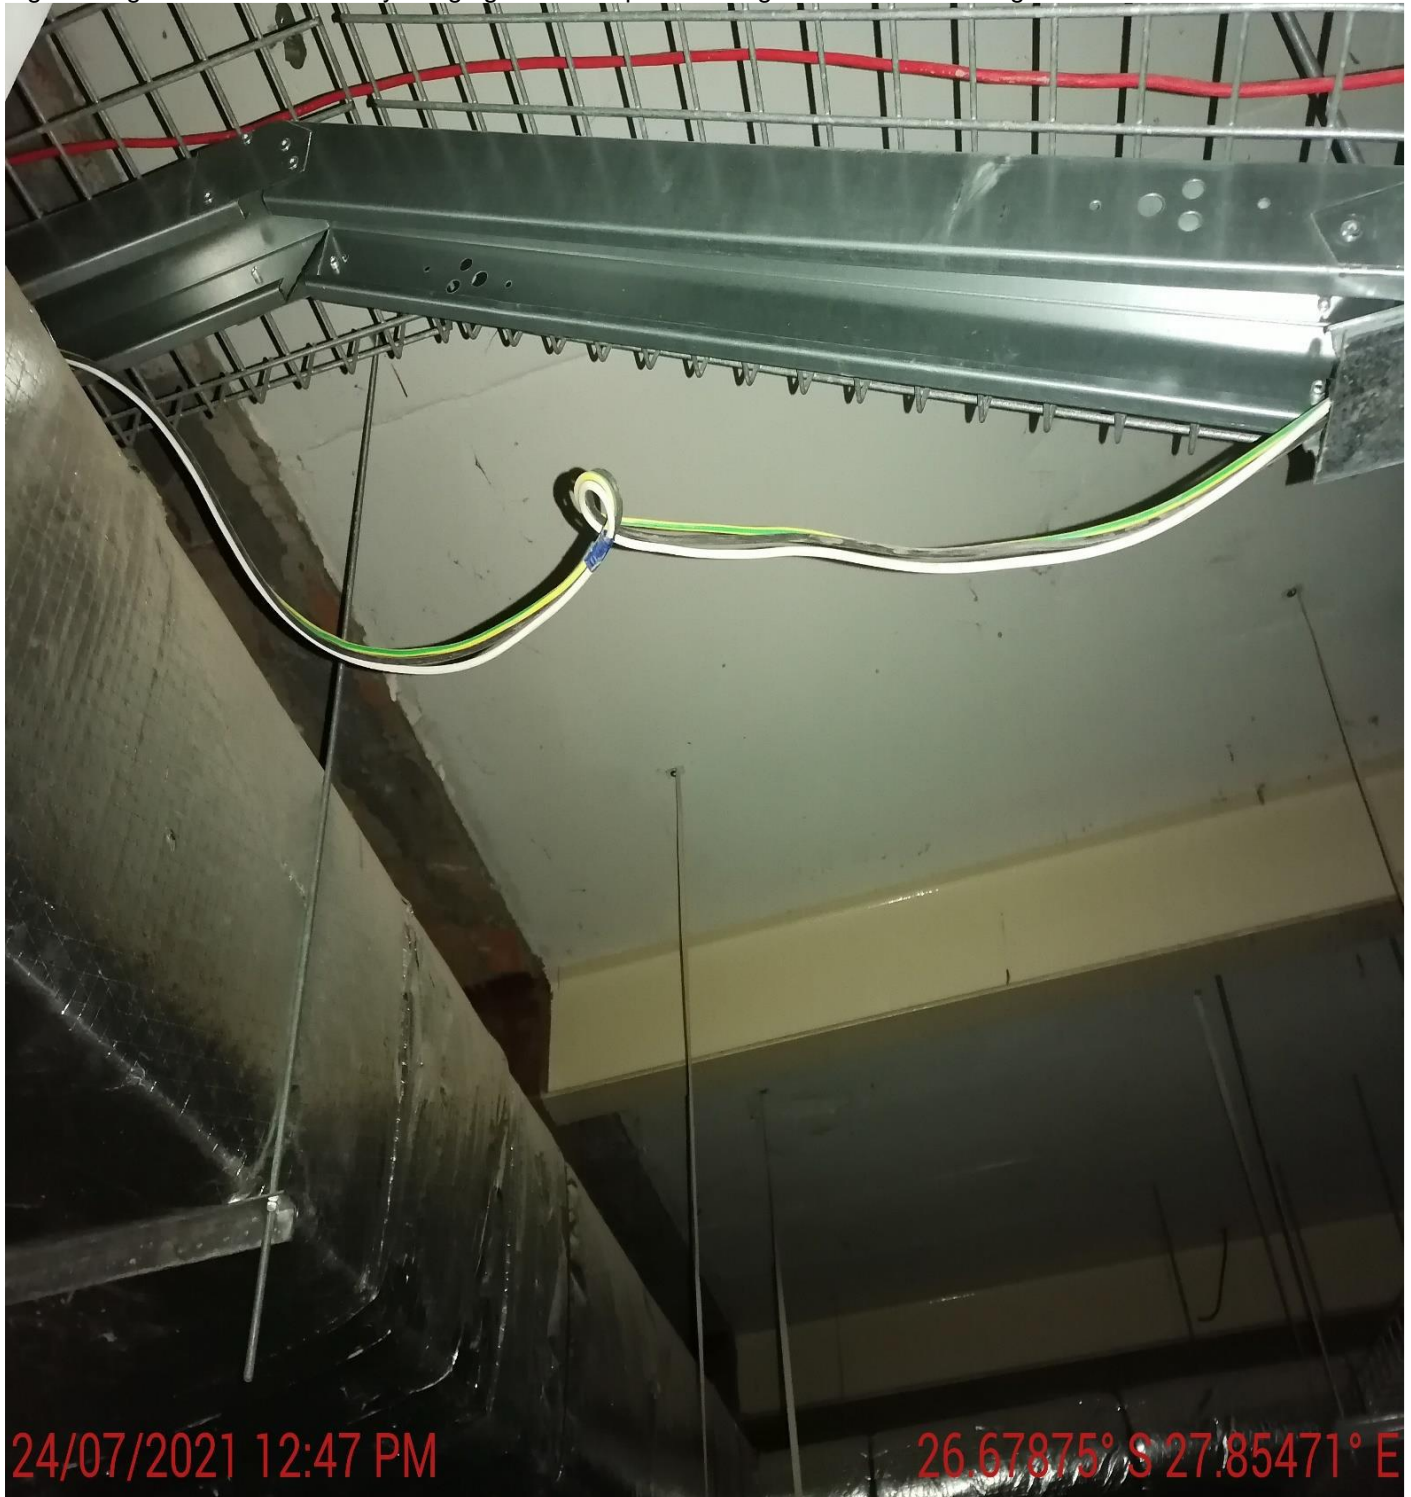
Fig 4 - Single core cables loosely hanging from the open trunking – Office 7 & 8 ceiling Void.

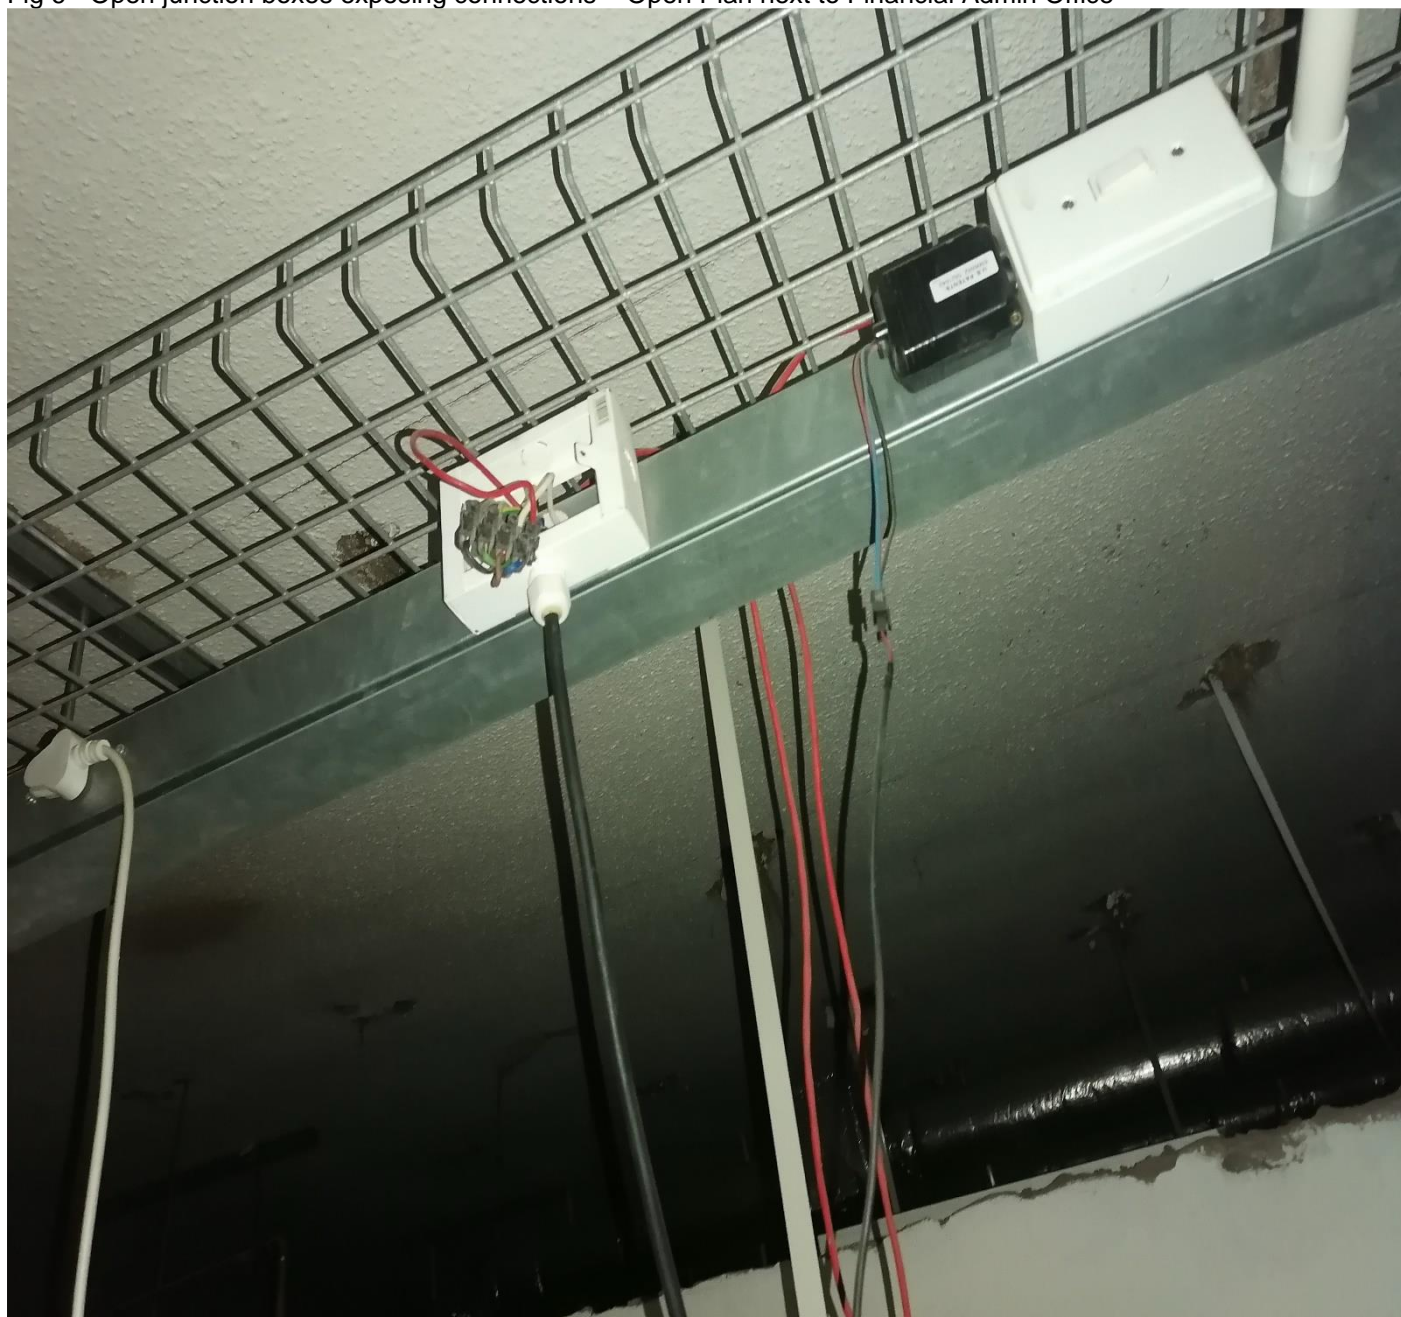
Fig 6 - Open junction boxes exposing connections – Open Plan next to Financial Admin Office

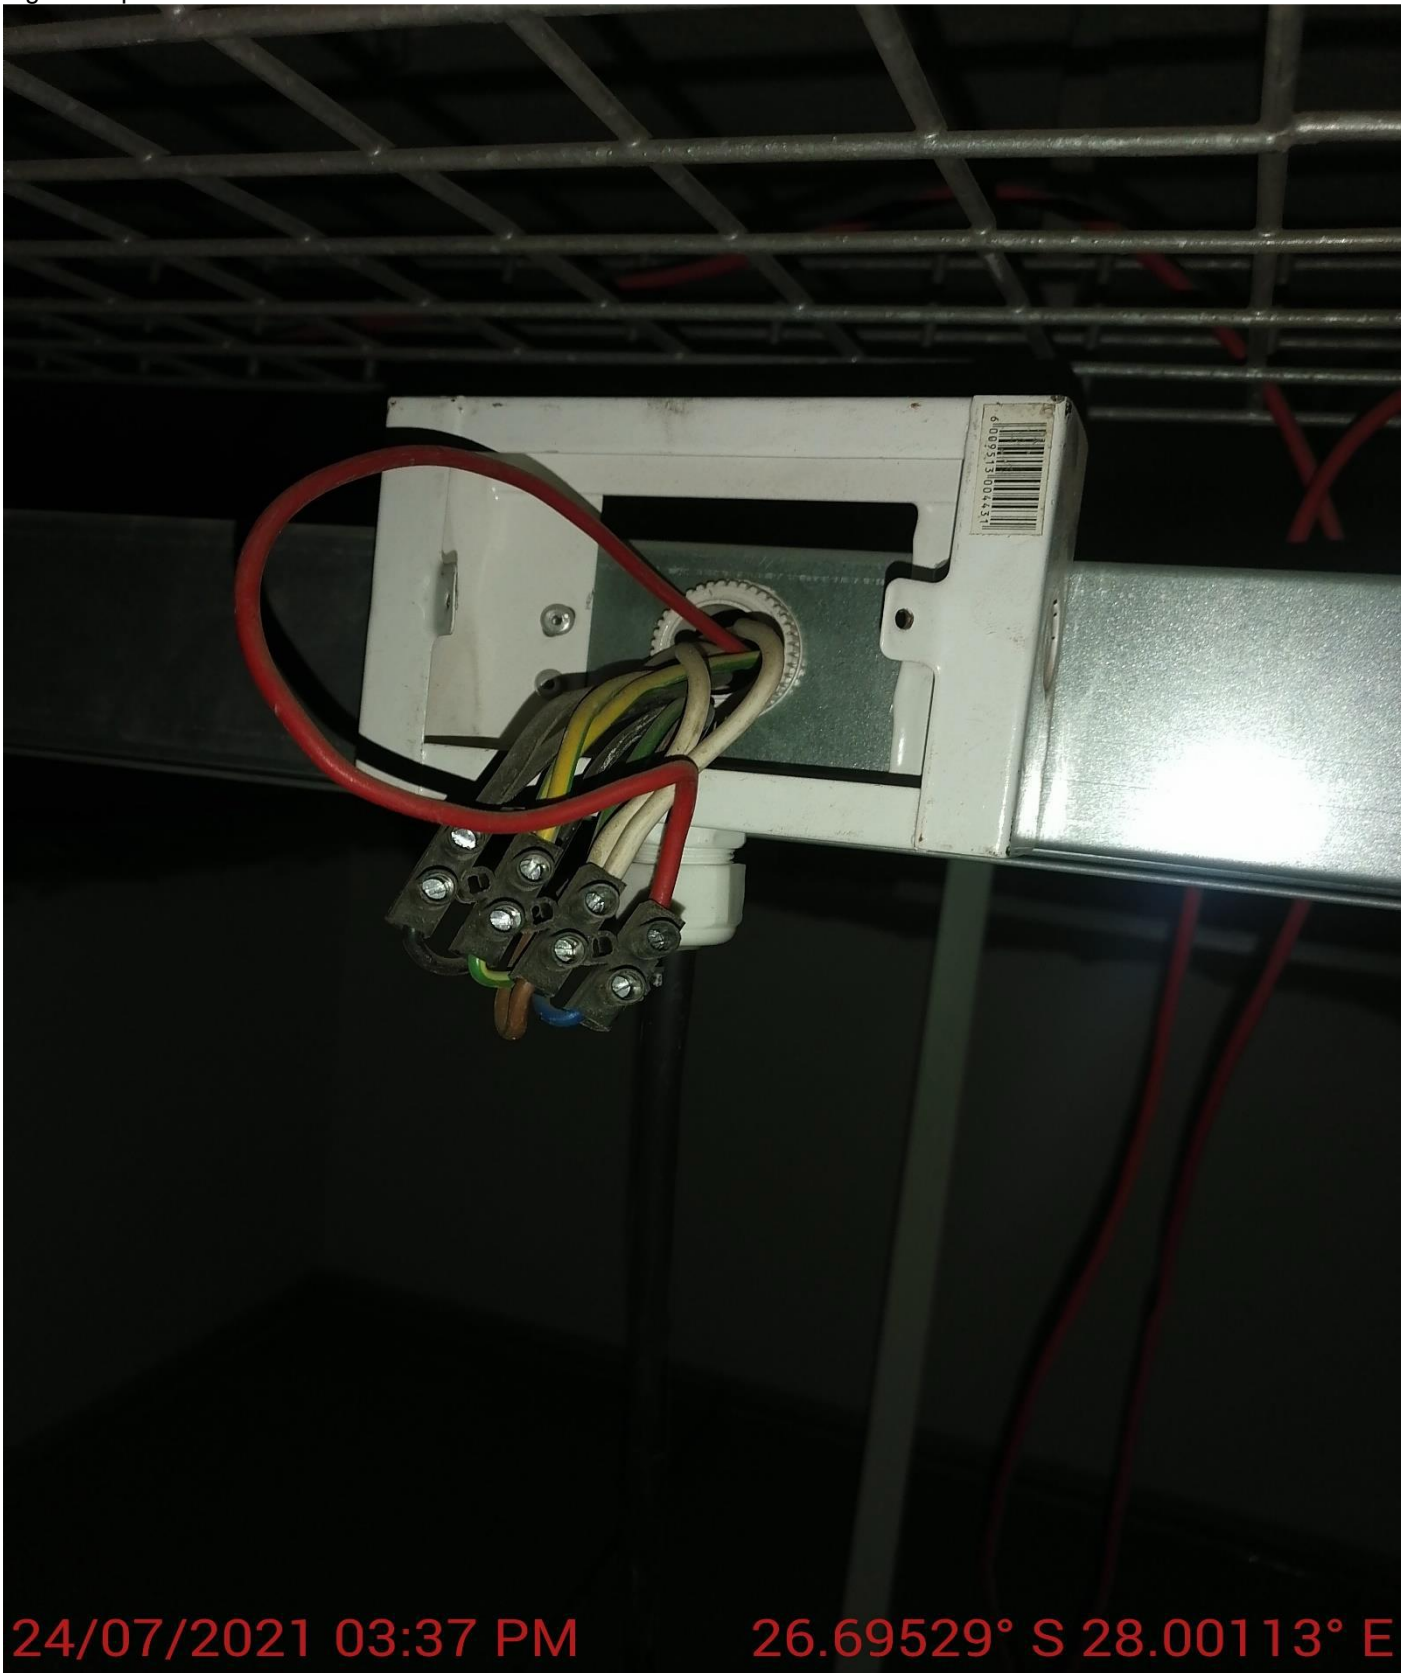
Fig 17 - Open Junction boxes

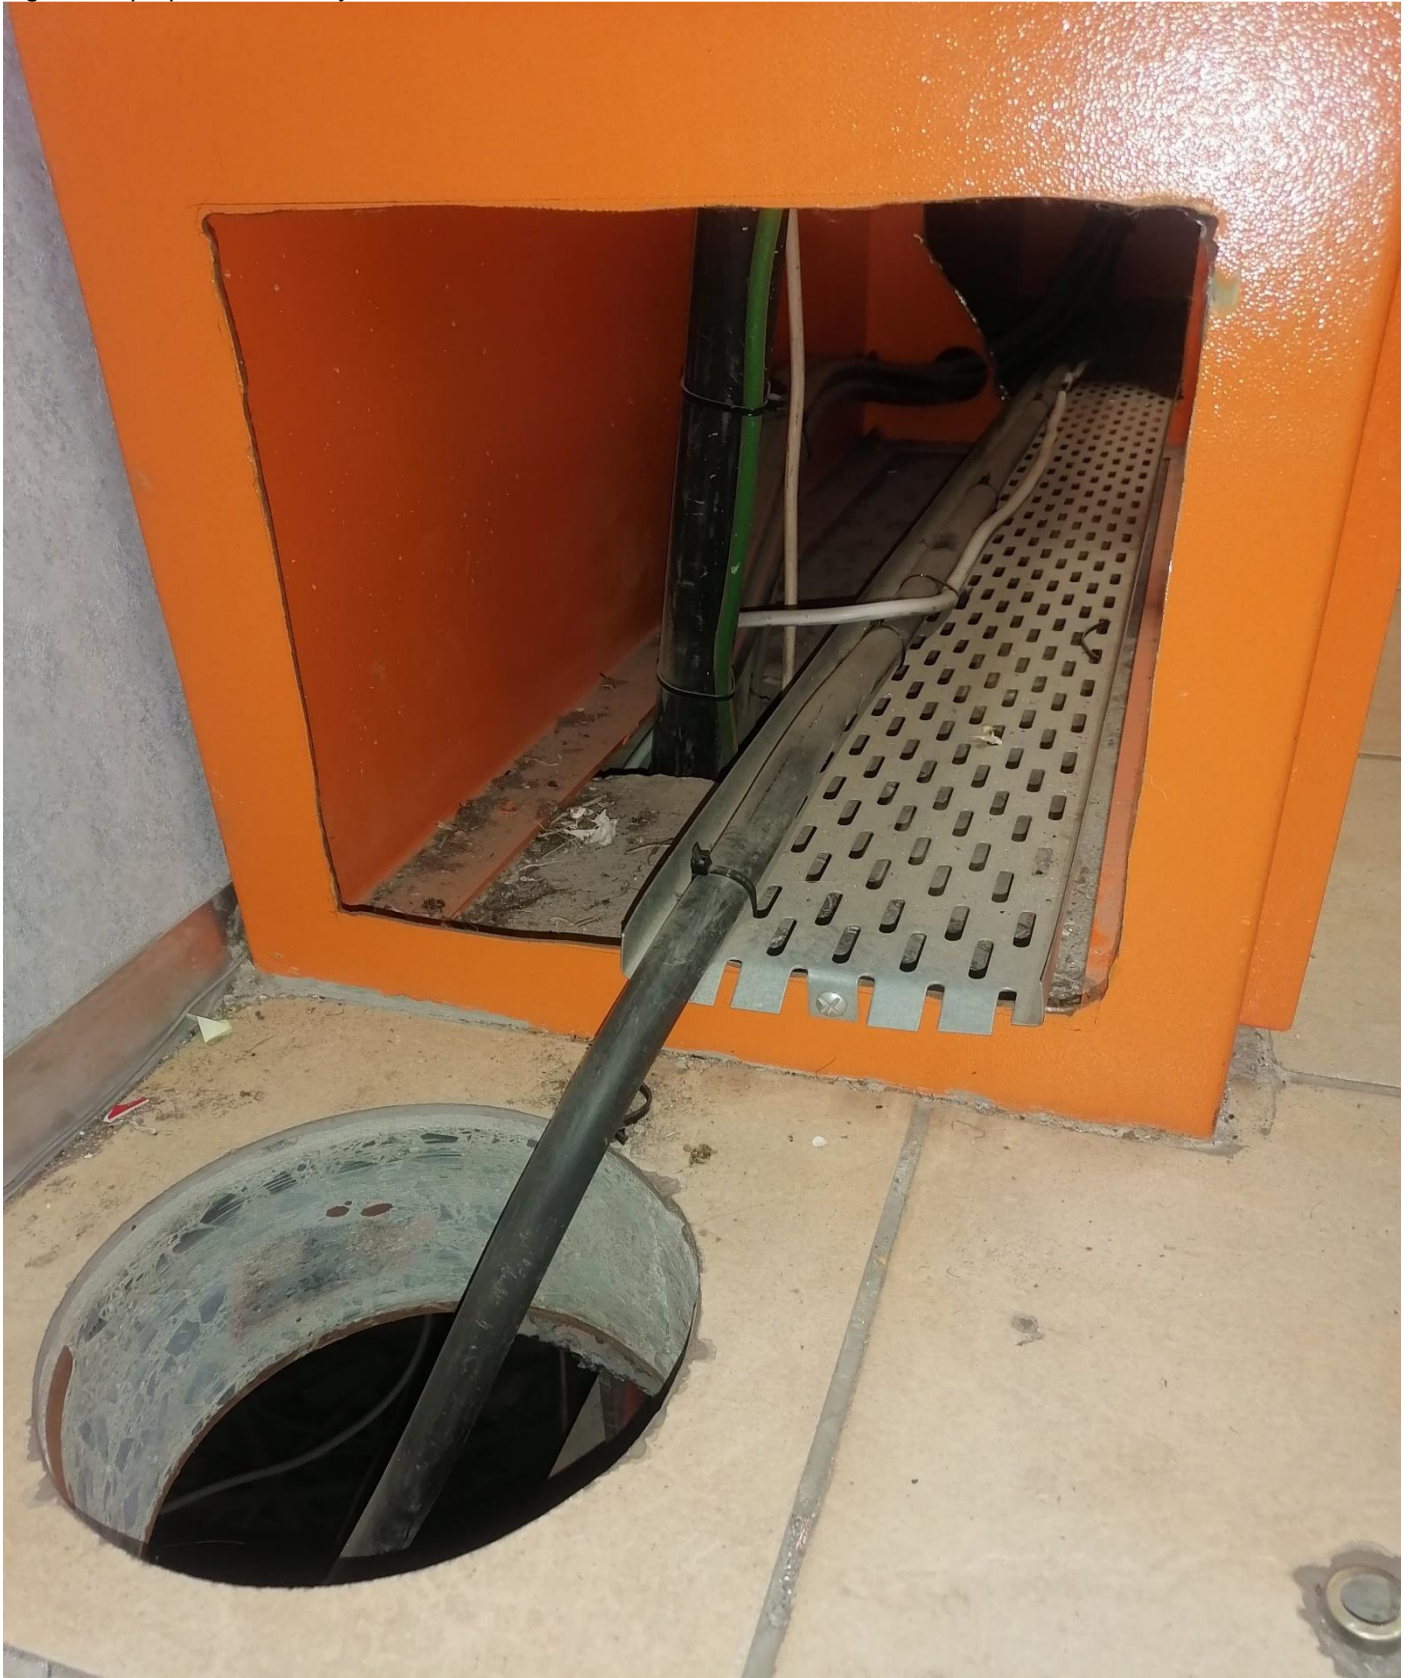
Fig 18 - Improper Cable entry into the DB – Electrical Room

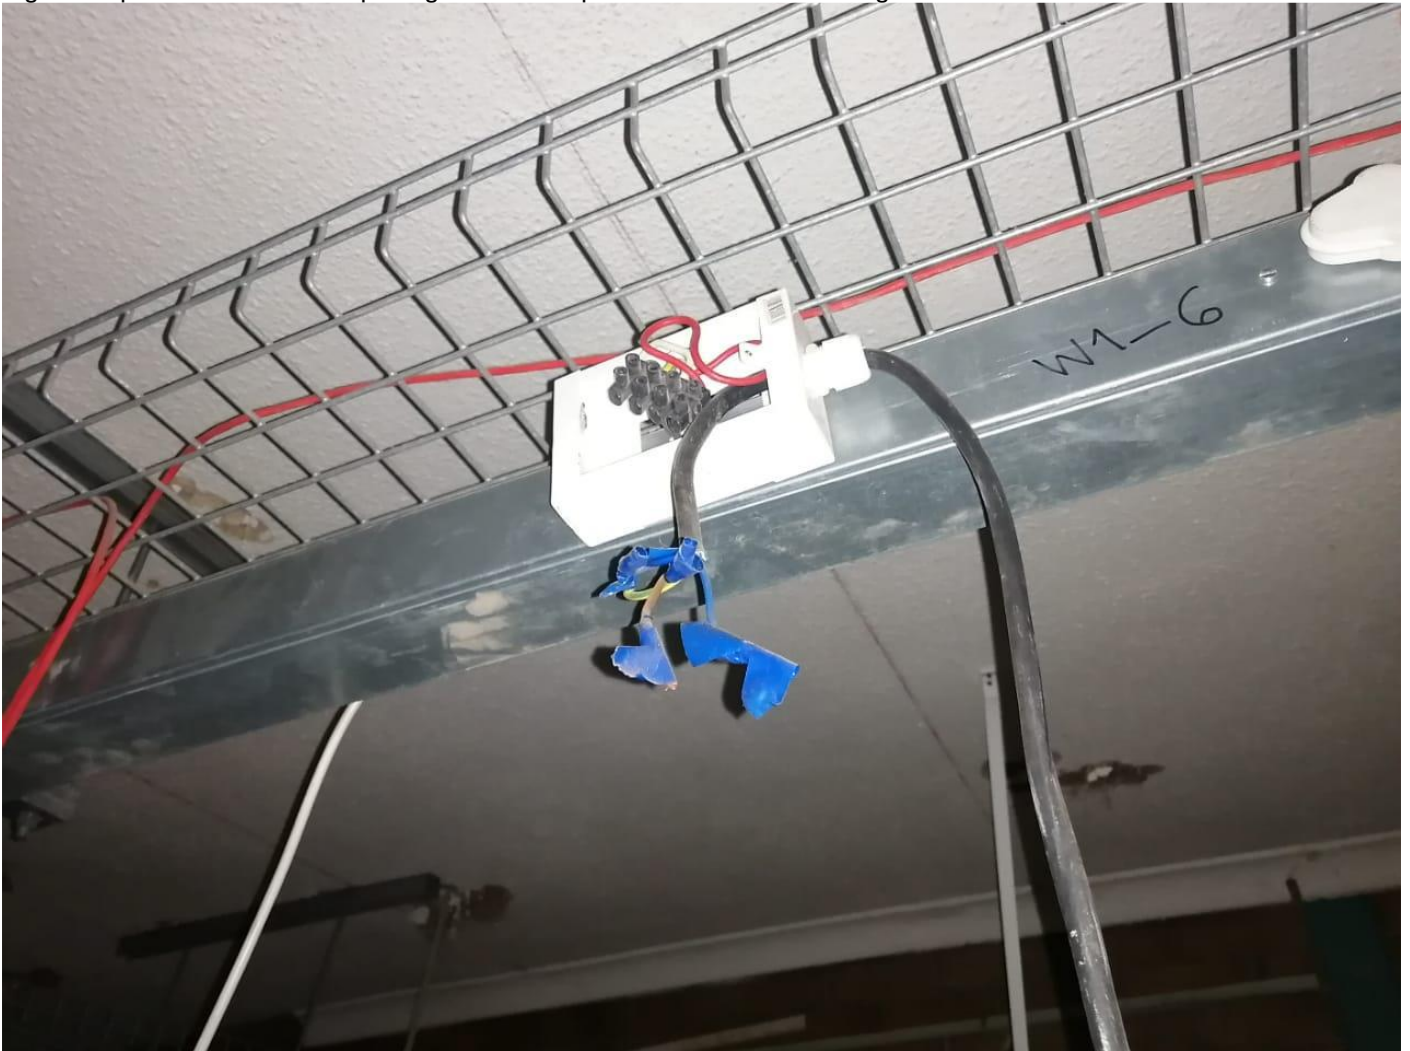
Fig 21 - Open Junction Box exposing conductive parts – Male Toilet Ceiling Void

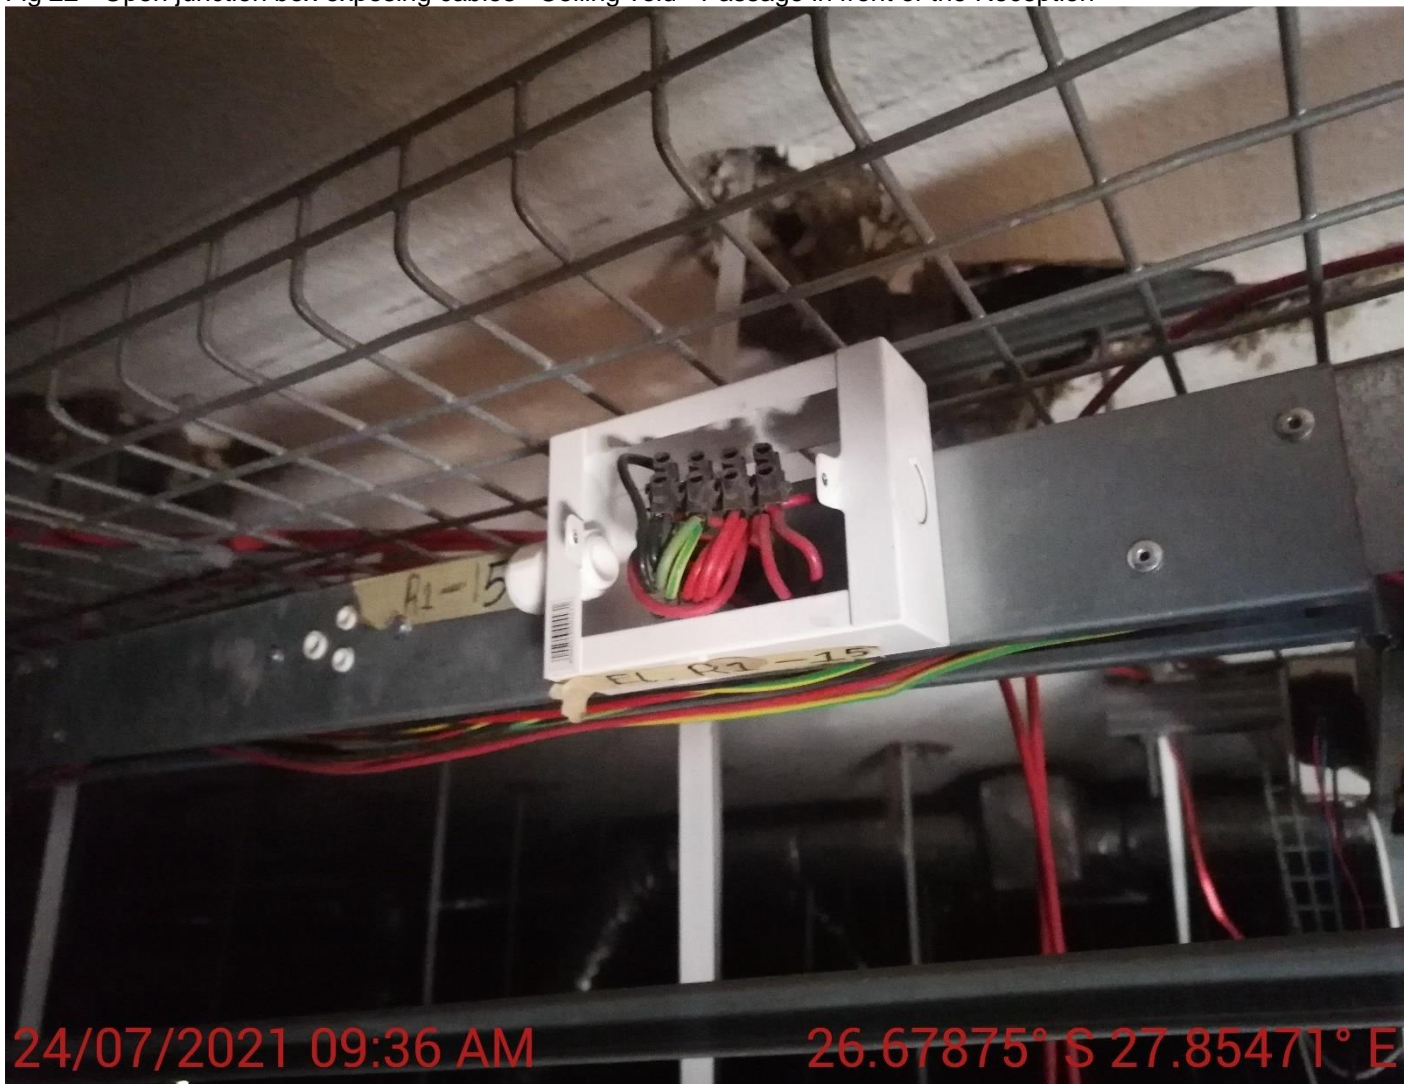
Fig 22 - Open junction box exposing cables– Ceiling void - Passage in front of the Reception

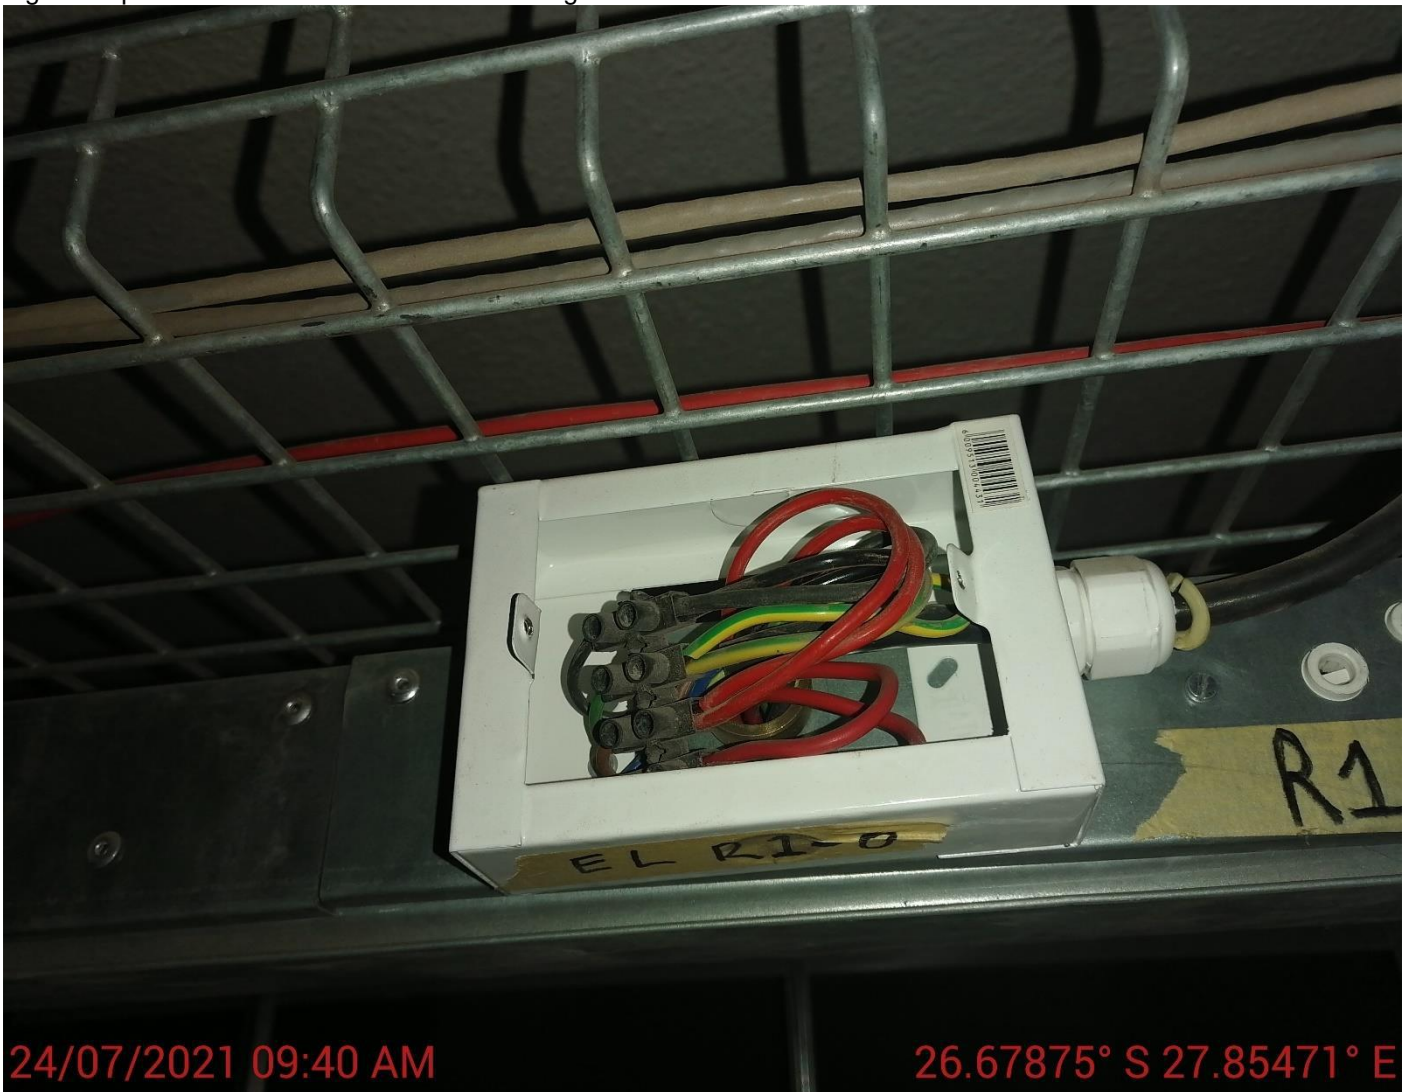
Fig 23 - Open Junction box – Tea Kitchen ceiling Void
