CONDITION ASSESSMENT REPORT FOR THE KZN ~~ROWING~~ ASSOCIATION

Project Name : Condition Assessment (Ex-Lampro Shopfitters CC
(PTY)LTD)

Owner : Transnet National Ports Authority

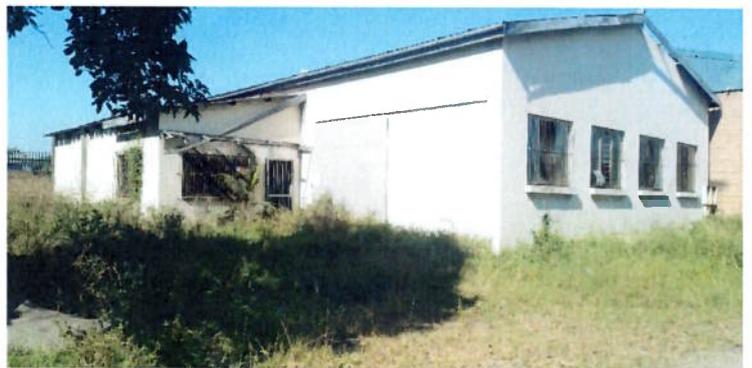
Figure 3: Building Exterior

- The area of land in this building is 569 m²
- The exterior of this building is in fair condition
- The entire roof structure is covered by asbestos of which need to be changed.
- The roof has drainage system, but it is starting to fall apart some parts have no gutters now.

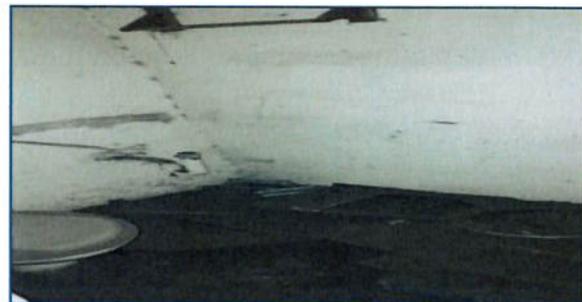
Figure 4:ablutions

- The bathroom in this building is poor the toilet is damaged and there is no sign of water pipe inlet.

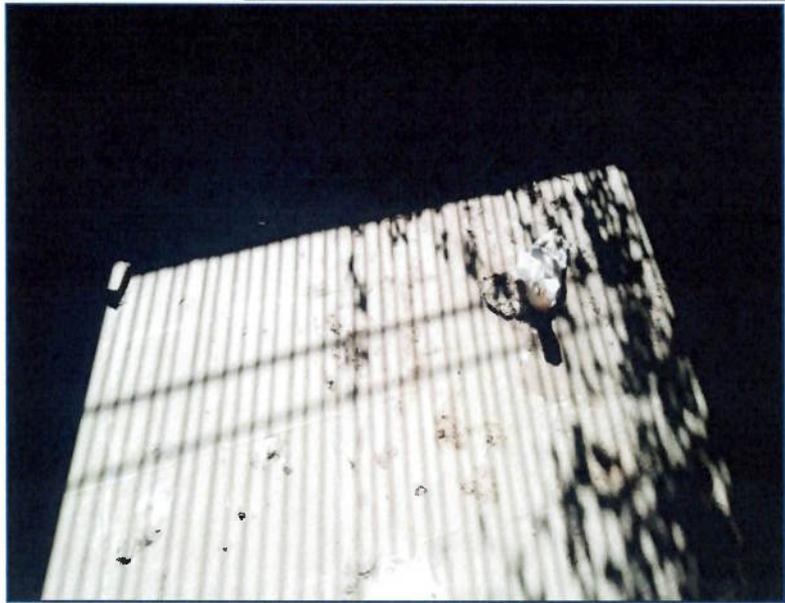
Figure 5:floor

- The condition of the floor in this building is in fair condition, upkeep and maintenance required.

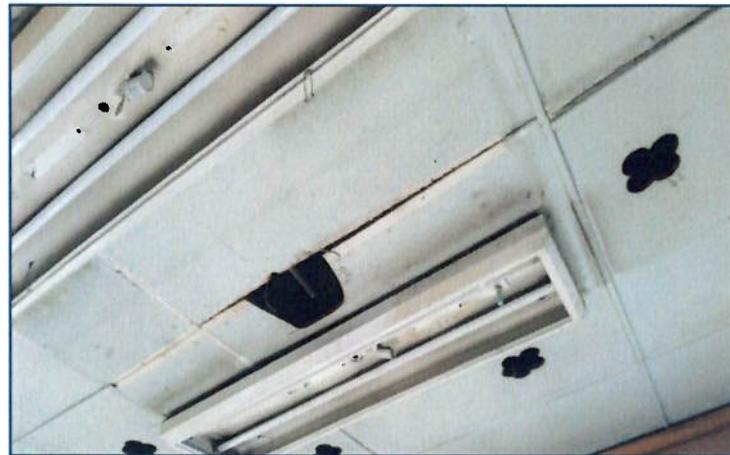
The ceiling in this building is in poor condition. Attention required.

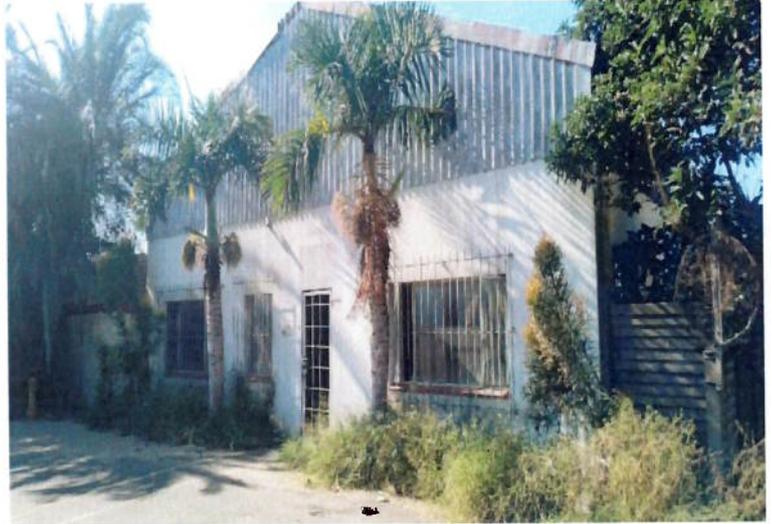
Figure 3: Building Exterior

- The area of land in this building is 575 m²
- The exterior of this building is in fair condition
- The entire roof structure is covered by metal sheets and some of them are now corroded, these need to be changed.
- The roof and the entire property do not have drainage.

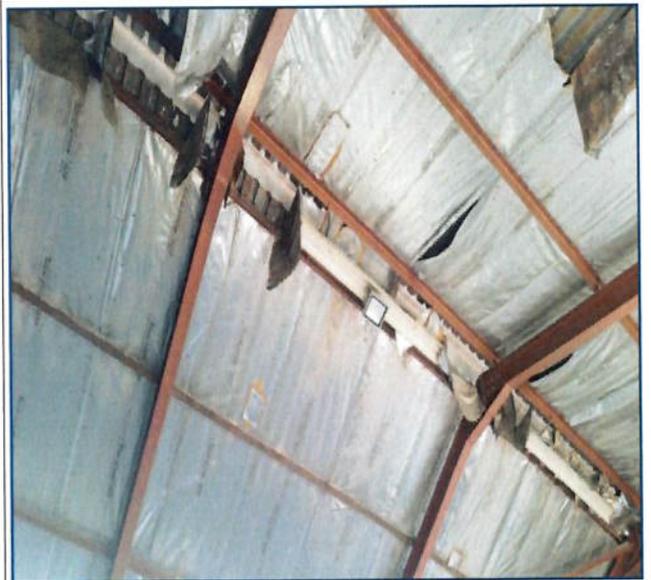
Figure 4: roof

- The membrane for this roof is falling needs to be replaced.
- The steel portal frames are still in good condition.

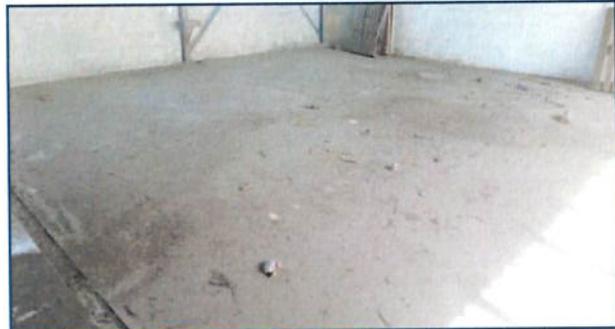
Figure 5: floor

- The condition of the floor in this building is good, Upkeep required.
- A large opening is present at the rear of the building, reportedly caused by a truck that lost control and impacted on the structure.

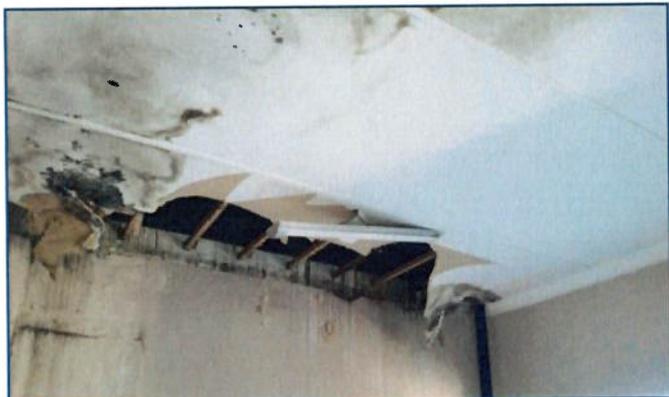
Figure 6: ceiling

- The ceiling in this building is in poor condition, repairs are required.

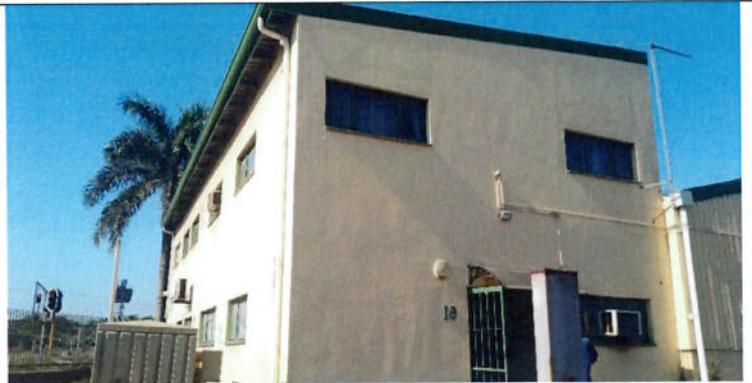
- The area of land in this building is 1703 m2
- The exterior of this complex is fair condition. Minor maintenance is required.
- The entire roof structure is covered by metal sheets of which are not visible to assess. The second floor has wooden flooring which does not look safe, this might be the result of some moisture entering the room and should be rectified.
- The roof has a drainage system, as well as the entire property

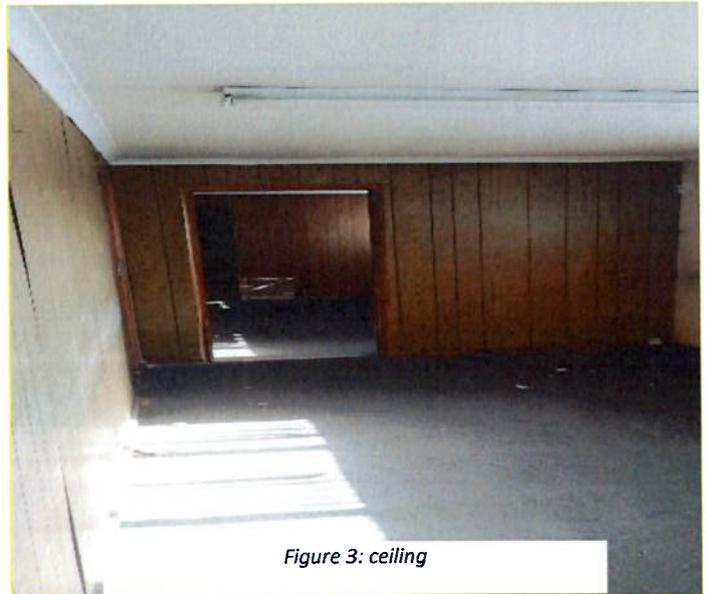
- The ceiling in this building is in fair condition

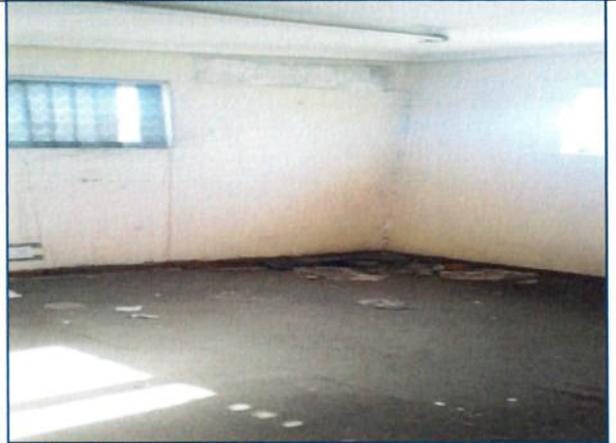
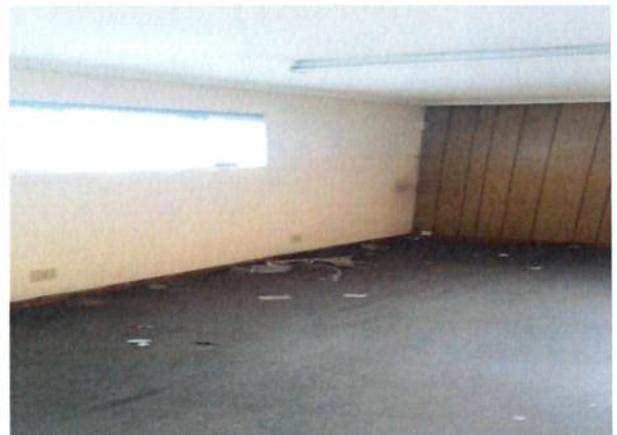
- Broken windows were observed
- The finishing on this floor is in poor condition, it needs attention

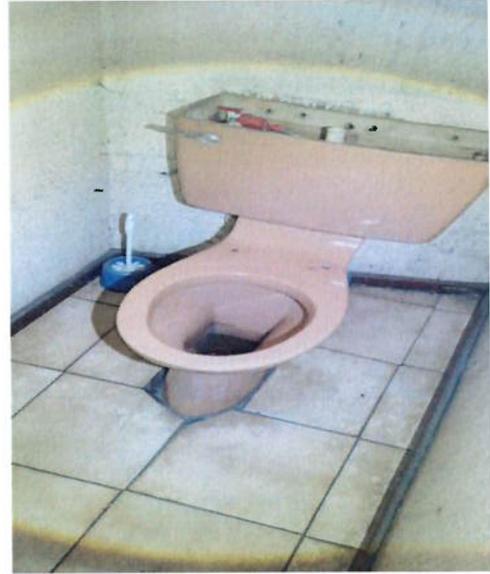
Figure 6: ablutions

- Ablution facility in poor condition and requires maintenance
- The floors are in fair condition and require upkeeping

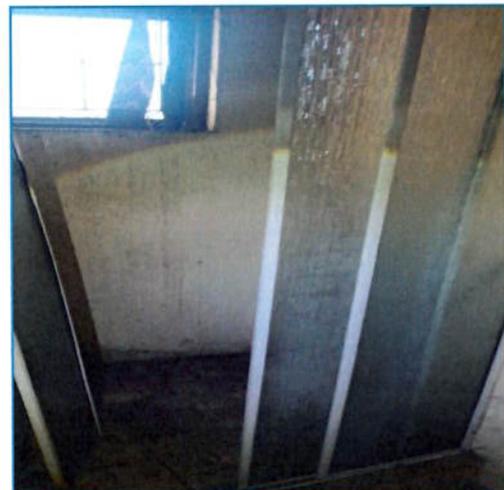
Figure 7: shower

- The water pipes in this building are damaged.
- The wall is in fair condition

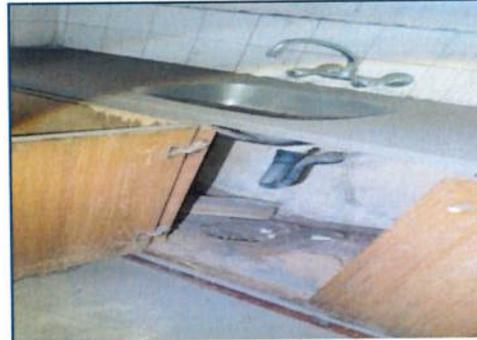
Figure 8: plumbing

The ground floor kitchen sink is damaged and plumbing issues have been observed. No water in taps.

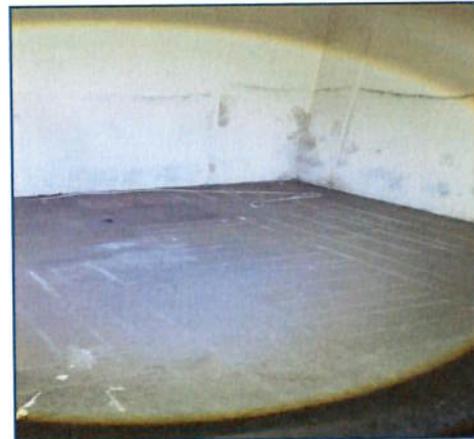
Figure 9: floor

- The floors in this room are not in poor condition. Carpets in poor condition.
- Maintenance and upkeep required.

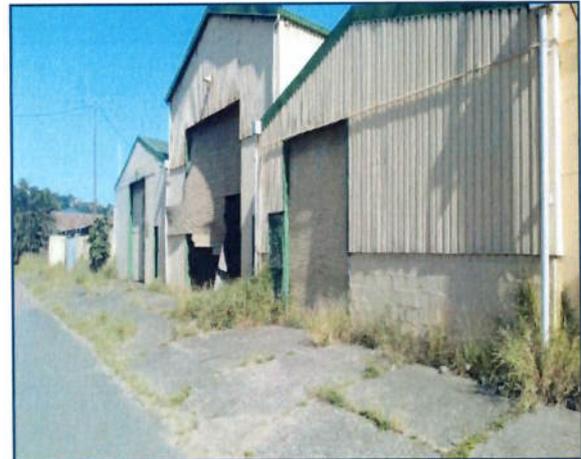
Figure 10:workshop exterior

The exterior walls of this workshop are in fair condition. Upkeep required.

The doors are in poor condition, the roller door is totally damaged, and it needs to be replaced.

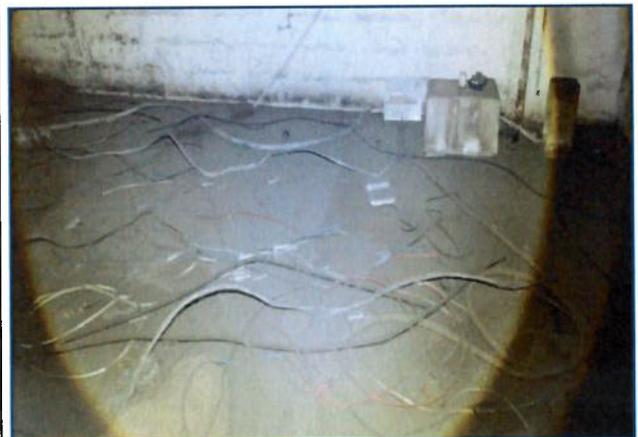
Figure 11:workshop floor

The floors in this building are in poor condition. Upkeep and maintenance required.

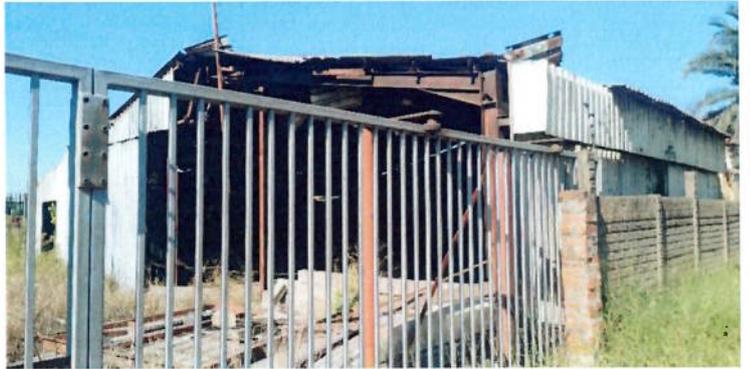
Figure 3: Building Exterior

- The area of land in this building is 624 m²
- The exterior of this building is very bad condition most.
- The entire roof structure is covered by metal sheets and most of them are now corroded, and they need to be changed.
- The roof has no drainage system, as well as the entire property.

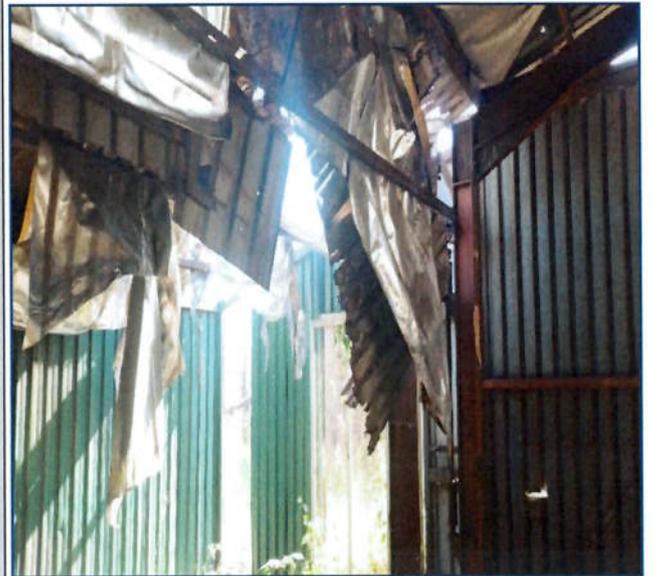
Figure 4: roof

- The roof of this building is falling apart, and the metal sheets have corroded.

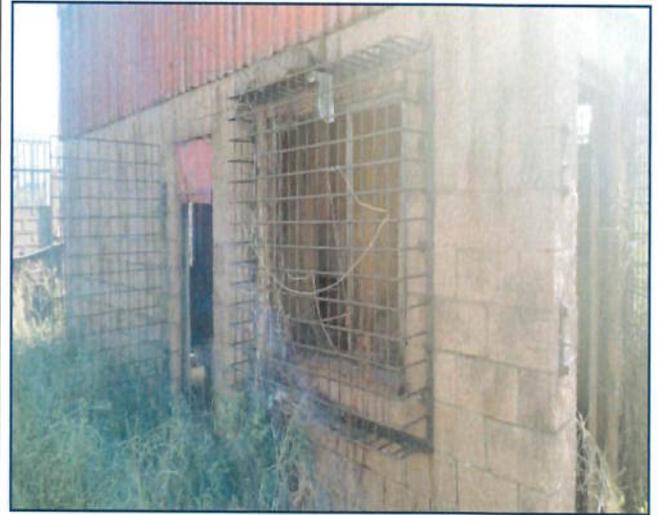
Figure 5:building 2 exteriors

The condition of this building is not in a very bad condition the walls just need some minor changes. There is overgrown vegetation

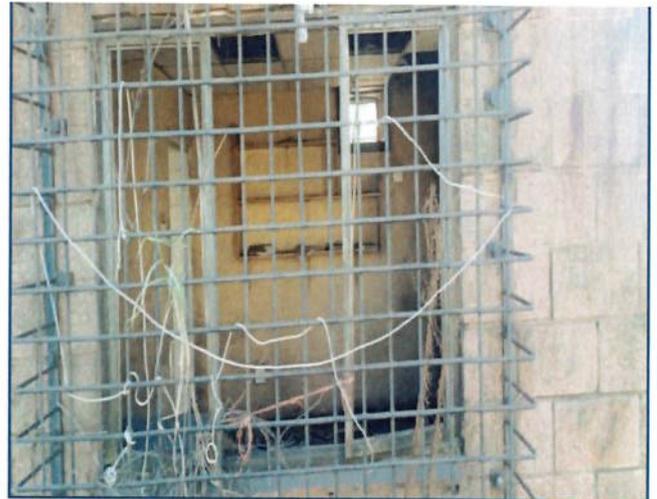
Figure 6:building 2 windows

The windows are not in very bad condition. There are missing glasses in the windows for this building

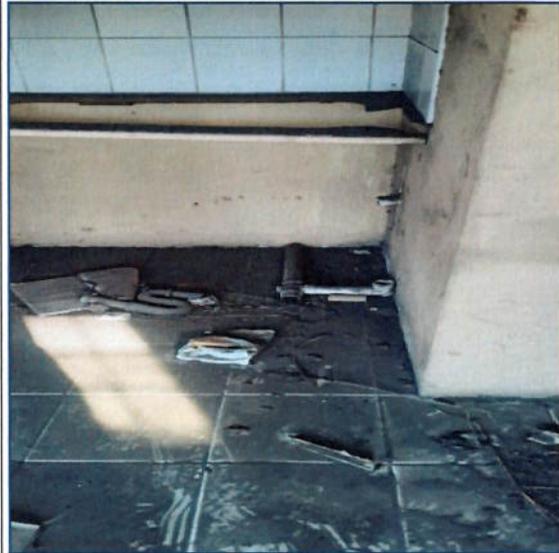
Figure 7:building 2 floor

The floors of this building are not in a bad condition; they just need to be cleaned they are filled with dirt and dust due to the windows being broken.

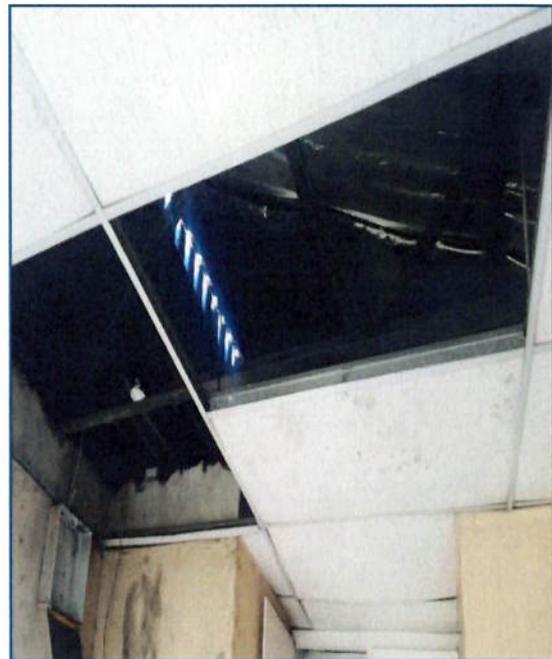
Figure 8:building 2 ceiling

The ceiling for this building is not in bad condition but the roof has leaks.

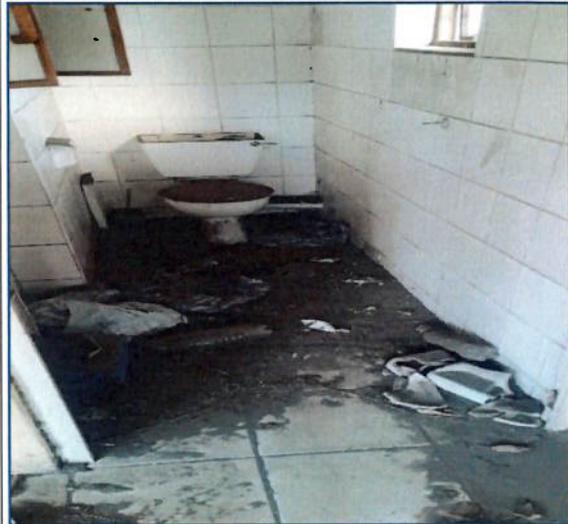
Figure 9:building 2 ablutions

The ablutions to this building are not in bad condition, there are some pipes available, only a few objects are missing from the toilet and there was no sign of water from the toilet.

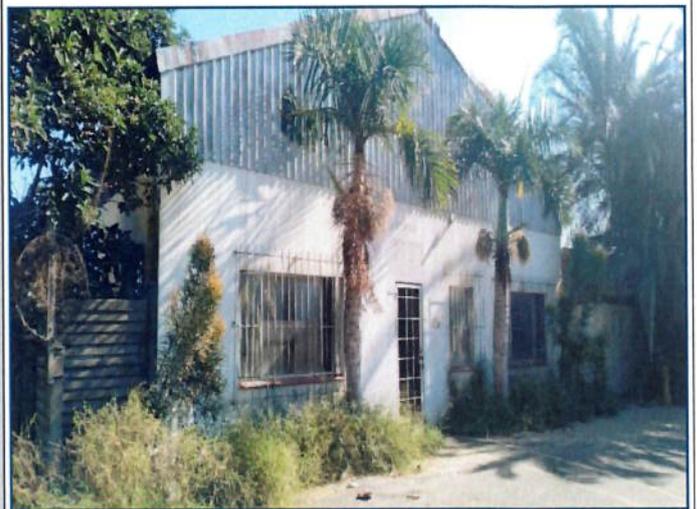
Figure 3: Building Exterior

- The area of land in this building is 575 m²
- The exterior of this building is not in bad condition
- The entire roof structure is covered by metal sheets and some of them are now corroded, and they need to be changed.
- The roof has no drainage system, as well as the entire property.

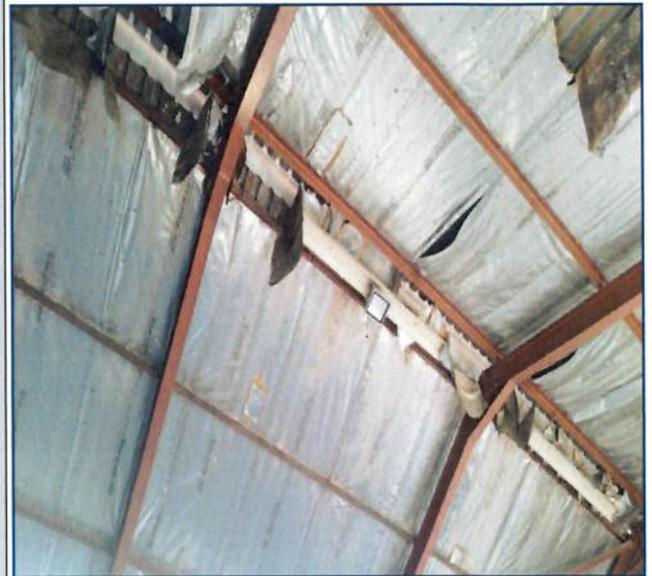
Figure 4: roof

- The membrane for this roof is falling needs to be replaced.
- The steel portal frames are still in good condition.

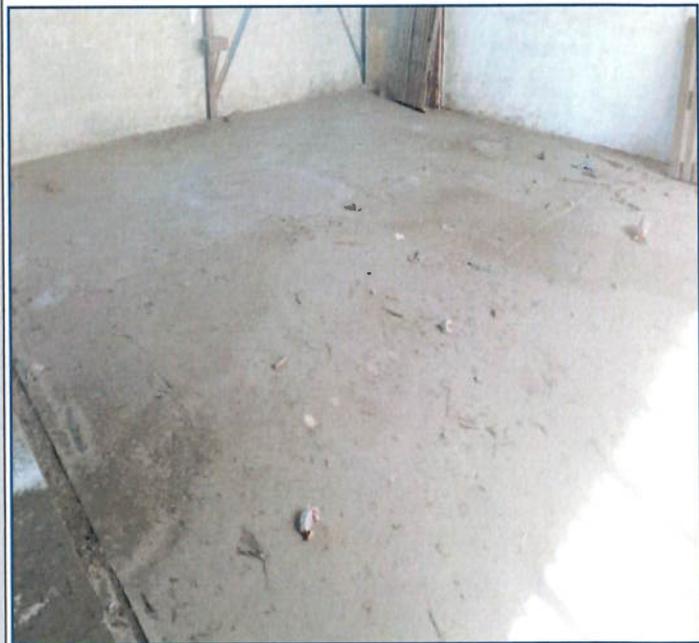
Figure 5:floor

The condition of the floor in this building is not in very bad condition, it needs to be cleaned so it can get back to its condition

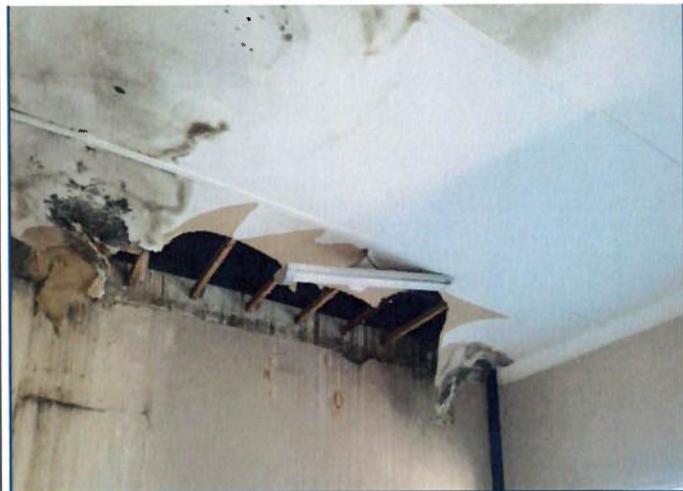
Figure 6:ceiling

The ceiling in this building is not in good condition, it needs to be changed or fixed because some of the panels from it are missing.

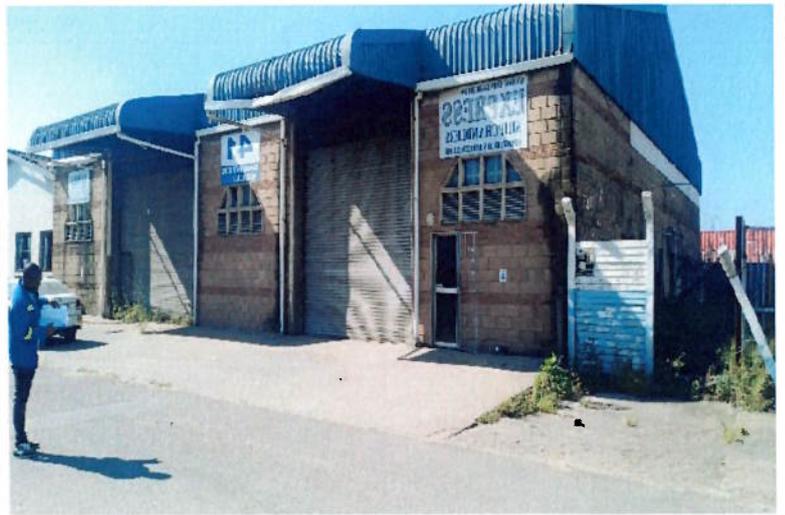
Figure 3: Building Exterior

- The area of land in this building is 582 m²
- The exterior of this building is not in bad condition
- The entire roof structure is covered by metal sheets, and they are not in very bad condition. It is just that the wooden second floor is damp and does not feel safe to walk on of which might be the result of the roof having some holes in where rain is entering.
- The roof has drainage system, but it is starting to fall apart some parts have no gutters now.

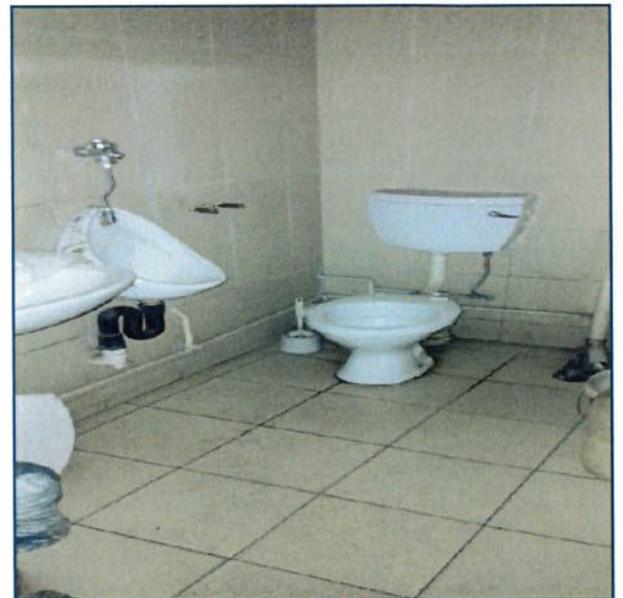
Figure 4: Plumbing

- The bathroom in this building is in a good condition the toilet is not damaged even the walls on the bathroom are still looking clean

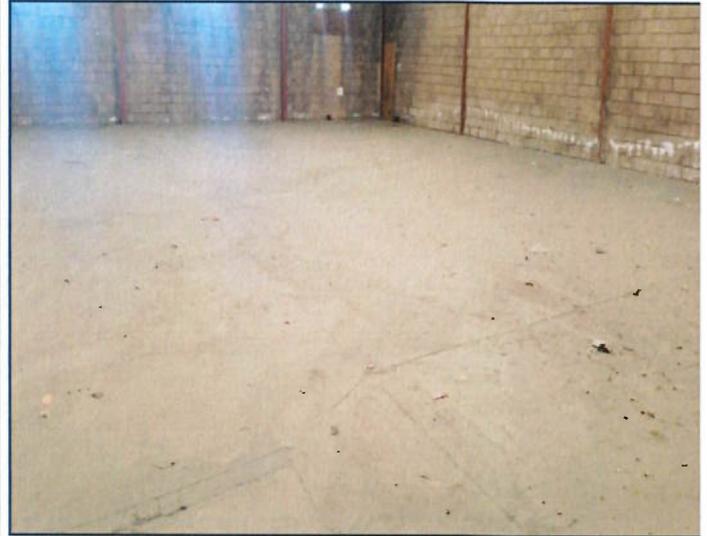
Figure 5: floor

- The condition of the floor in this building is not in very bad condition, it needs to be cleaned so it can get back to its condition

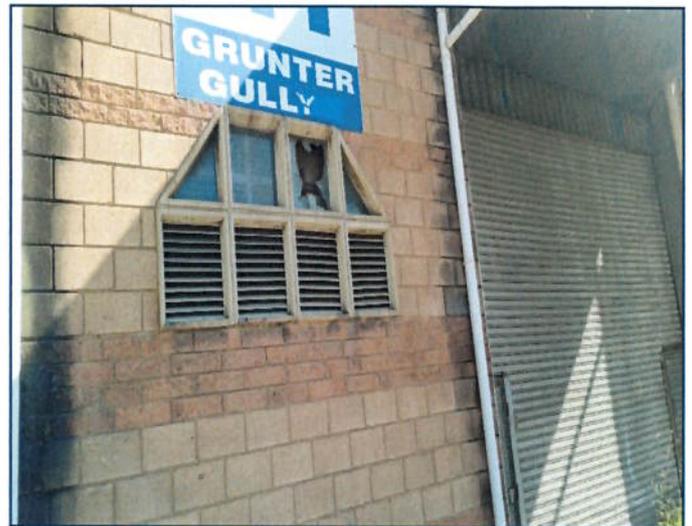
Figure 6: windows

- The windows in this building are still in good condition, only a few of them are broken.
