Title: **ERIC Roofs
Conditional Assessment**

Unique Identifier: **363-ERE-AABZ4-D00221-2**

This document describes the findings and recommendations which relates to the investigation of the ERIC (Eskom Research and Innovation Centre) roof structures.

An inspection of the site infrastructure was undertaken by Eskom Real Estate team on 1 September 2021

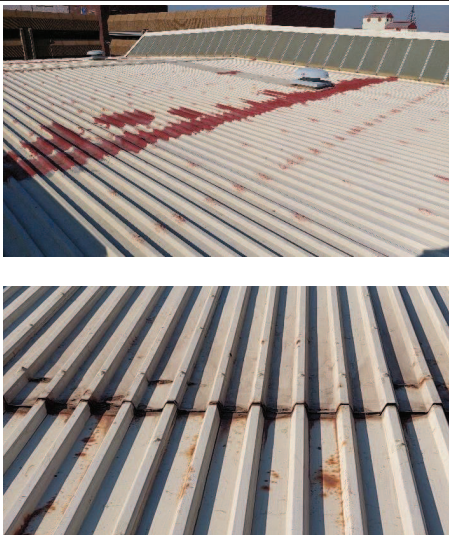
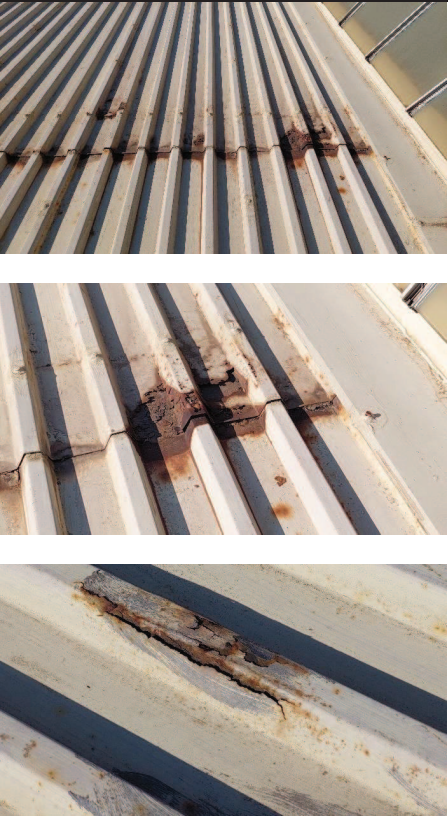
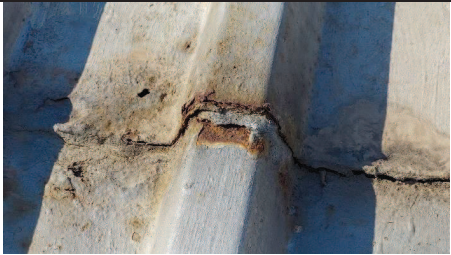
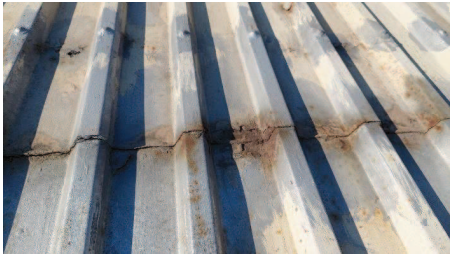
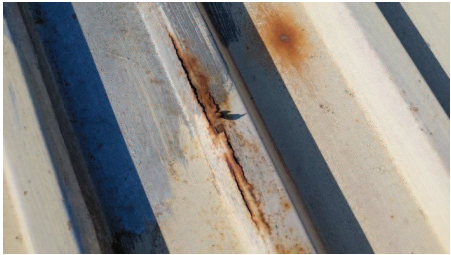
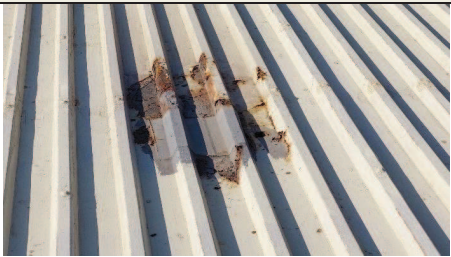
Classification: Unsatisfactory <ul style="list-style-type: none">• Previous repairs have been done to the IBR sheeting roof.• These repairs are at certain spots and are effective for a short period.• Points along the red marked areas are where leaks are present.• IBR sheeting has deteriorated and corroded in many areas.• The full IBR sheeting needs replacement• The East side of Block E roof has recently replaced IBR sheeting which is white in colour. This does not need replacement.

The full IBR sheeting needs replacement across the warehouse area except for the East side of Block E roof which was recently replaced with IBR sheeting that is white in colour. Approximate perimeter is 317m and the area is **3522 m²** for sheeting.

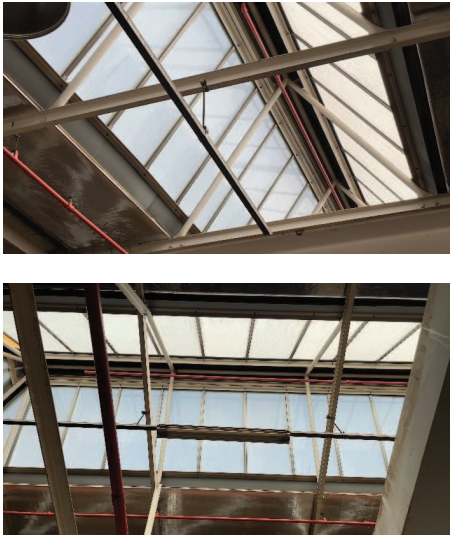
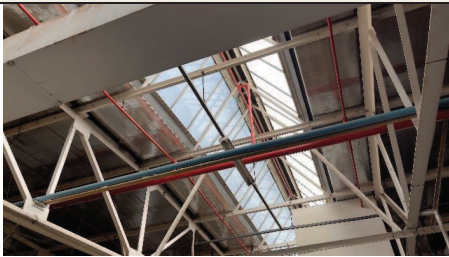
Block E Skylights

<p>Classification: Acceptable (this clarification is based on what could be seen from below the roof, further inspection recommended from above)</p> <ul style="list-style-type: none">• From the various visual inspections conducted for the skylights it was found that the skylights are still in relatively good condition.• The skylight seals are to be redone as these will end up being removed during the roof refurbishment.• As part of the roof refurbishment, it is recommended that the skylights be cleaned and inspected thoroughly as a detailed inspection could not be done due to safety issues around accessibility.

It is recommended that the successful Contractor, perform a detailed inspection of all the skylights as well as a structural integrity assessment for the roof support structure at Block E. The outcome of that assessment will justify/motivate for the replacement of the skylights.

With the roof sheeting replacement project soon to be underway it is recommended that the skylight seals be redone as this will get damaged during the sheeting replacement. As part of the roof refurbishment it is recommended that the skylights be cleaned.

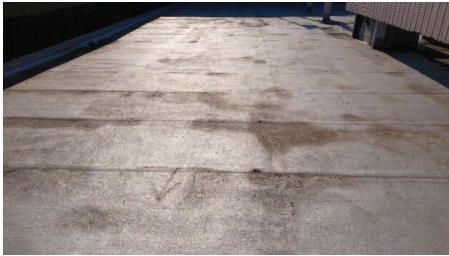
Block D – Flat accessible slab with waterproofing

<p>Classification: Acceptable</p> <ul style="list-style-type: none">• Block D waterproofing is in good condition.• While there are patches and pooling present, there have been no reports of leaks.
Block C East – Flat accessible slab with waterproofing

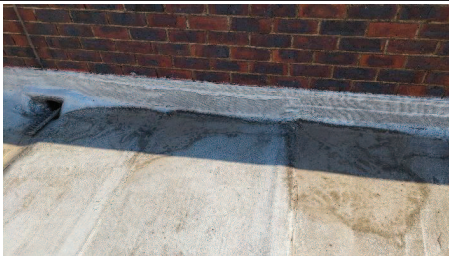
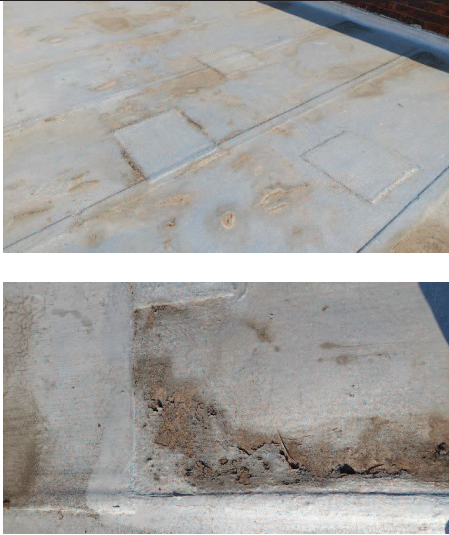
<p>Classification: Unsatisfactory</p> <ul style="list-style-type: none">• Leaks are present due to deterioration.• Patches have been done but there are still leaks especially toward the sides.• Replacement of water proofing for Block C East roof is recommended.

Leaks are present due to deterioration. Patches have been done but there are still leaks especially toward the sides. Replacement of water proofing for Block C East roof is recommended. The total area is **1140 m²** of floor waterproofing excluding the two plant rooms below.

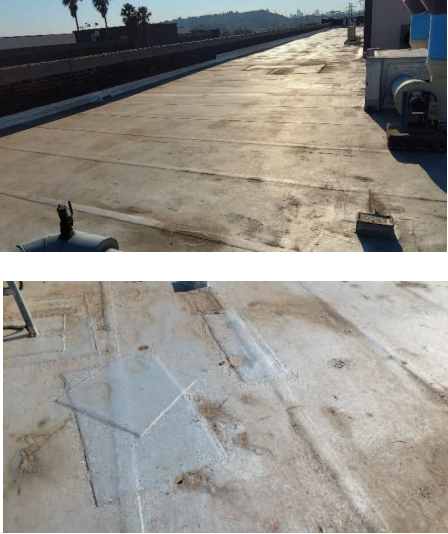
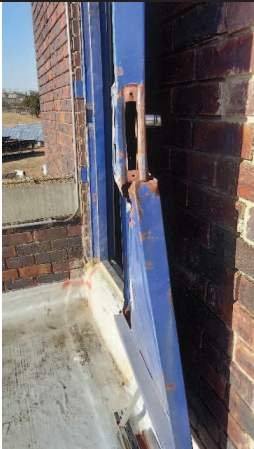
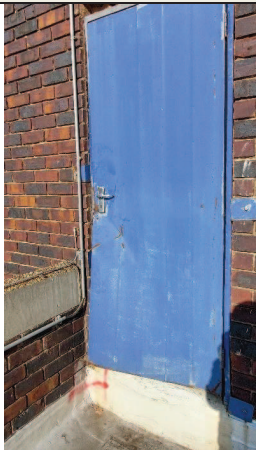
<p>Classification: Acceptable</p> <ul style="list-style-type: none">Block B waterproofing is in good condition.The West end of Block B has experienced a leak previously in heavy rainfall. It is suspected that this is at a point where some of the plant in that location is mounted.Instead of a full waterproofing replacement, it is recommended that the West end be flooded and tested to identify the root cause of the leak and then repair that portion only.
		<ul style="list-style-type: none">Damage to the access door on this block is noted. It is recommended that all the access doors be checked and repaired/replaced where required.

Block B waterproofing is in good condition. The West end of Block B has experienced a leak previously in heavy rainfall. It is suspected that this is at a point where some of the plant in that location is mounted. Instead of a full waterproofing replacement, it is recommended that the West end be flooded and tested to identify the root cause of the leak and then repair that portion only.

All access doors are to be inspected for repair or replacement where required.

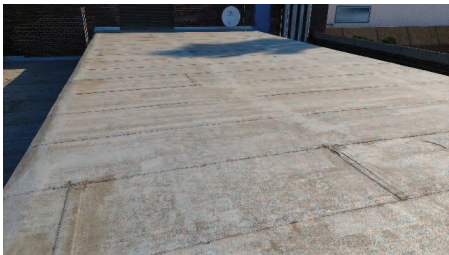
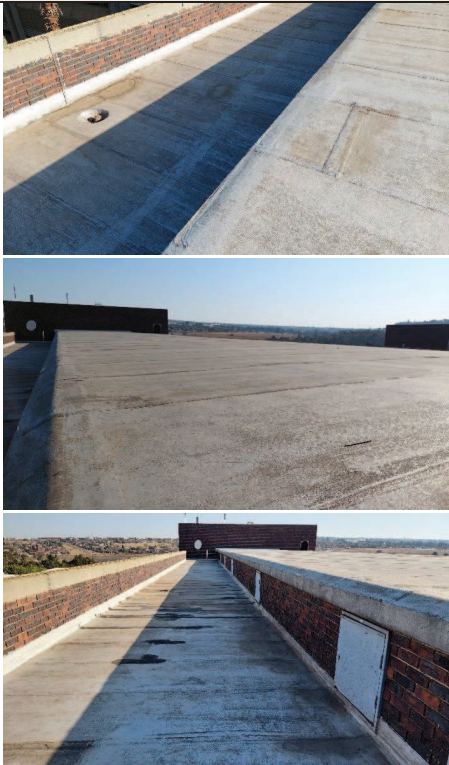
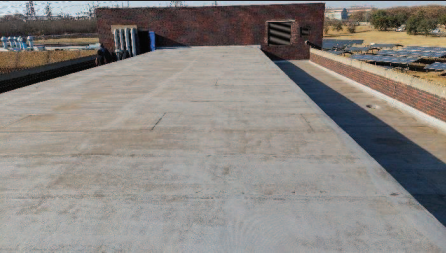
Links G, H, J and K

<p>Classification: Acceptable</p> <ul style="list-style-type: none">• All links have waterproofing that is in good condition.• Previously water would collect on the links due to the drainage downpipe points getting clogged with leaves and debris, but this issue has since been resolved as trees have been cut to lower heights than the links
