## Summary - List of Buildings Checked for Disability Compliance at Rosherville

## **Disability Enablement Project – List of Buildings to Comply**

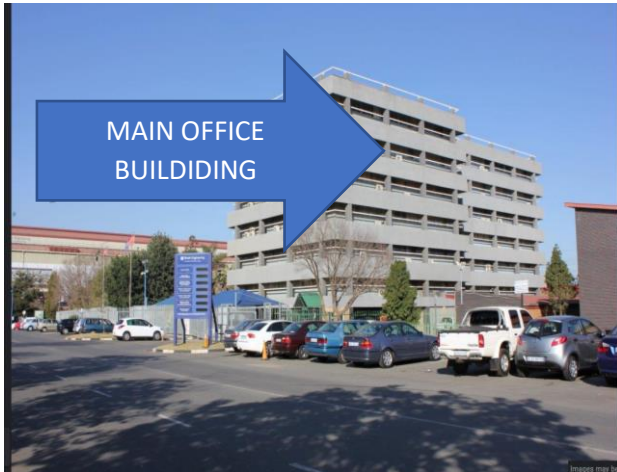
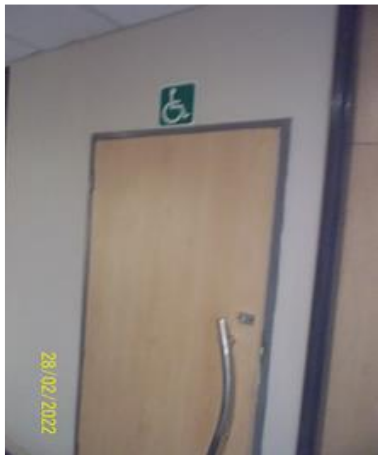
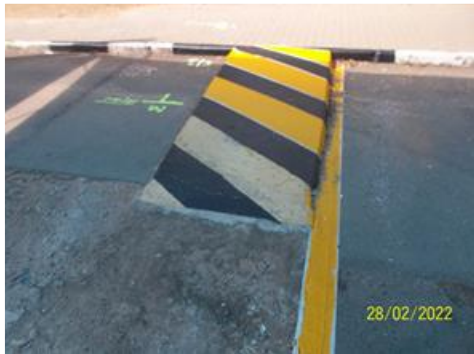
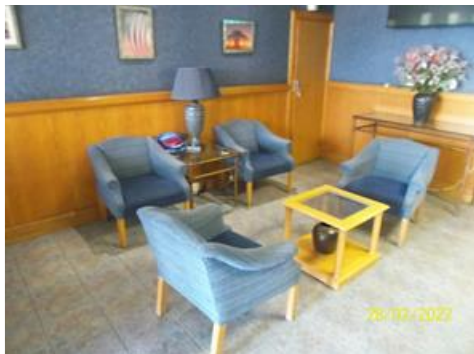
Item No	Building Descriptions And Cost (Incl. VAT)	Building m <sup>2</sup>	Number of Floors	Building Identification Pic on Google Earth	Defects	Recommendations
1	Main Office Building / HQ Building	13867m <sup>2</sup>	6 Storeys

<p><b>Signage</b></p> <ul style="list-style-type: none"> <li>The parking inside the office area does not have any international blue signage other than the sign provided on the road surface.</li> <li>Sign with pictogram indicating the location of the toilets according to SANS 10400 S (4.2) are provided however the sign is too high and the wrong colour.</li> <li>There is a lack of legal pictogram / symbolic signs leading to elevators.</li> <li>There is a lack of pictogram / symbolic signs leading to elevators.</li> </ul> <p><b>Hearing</b></p> <ul style="list-style-type: none"> <li>No hearing induction loop or other amplifying devices fitted provided.</li> </ul> <p><b>Entrance</b></p> <ul style="list-style-type: none"> <li>No entry phone for deaf users installed.</li> </ul> <p><b>Parkings</b></p> <ul style="list-style-type: none"> <li>The parking area inside the office area does have the metal frame work however the shade netting is missing.</li> <li>The closest public parking transport stop (Taxi rank) is ±500 meters from the entrance. With reference to <b>CLASSIFICATION OF PERSONS WITH DISABILITIES</b> this distance exceeds the minimum traveling distance.</li> <li>Drop kerbs constructed from concrete in the road way (pavement) is provided. Some areas are very rough and needed to be stream lined so that wheelchairs do not get stuck and the person fall over.</li> </ul> <p><b>Handrails</b></p> <ul style="list-style-type: none"> <li>The ramp provided is not provided with railings on both sides.</li> </ul> <p><b>Lighting</b></p> <ul style="list-style-type: none"> <li>Unobstructed pathways are provided however no lighting is provided as the paths is in the open. This must be on the regular maintenance plan.</li> </ul> <p><b>Reception</b></p> <ul style="list-style-type: none"> <li>Only chairs with arms are provided in the reception area.</li> </ul> <p><b>Access</b></p> <ul style="list-style-type: none"> <li>The entire ground floor is assessable. Except the one office has a step which is not conducive for the use of wheelchair patrons.</li> </ul> <p><b>Doorways, Doors and Door Handles</b></p> <ul style="list-style-type: none"> <li>A manual system is also provided and installed at a high of 1500mm on the left side of the door opening. This device is too high and needs to be lowered to allow a person in a wheelchair easy reach to the device.</li> </ul> <p><b>Ramp</b></p> <ul style="list-style-type: none"> <li>The ramp provided is not provided with railings on both sides.</li> </ul> <p><b>Staircase</b></p> <ul style="list-style-type: none"> <li>The staircases leading from the various lobby areas is not suitable for disabled people as the width between the railings is not according the required width as per the SANS codes.</li> <li>No stair cases at the IT Area.</li> </ul> <p><b>Toilet Facilities</b></p> <ul style="list-style-type: none"> <li>The toilet for wheelchair patrons on the ground and the fifth floor. The traveling distance exceeds the prescribed distances as prescribed.</li> </ul> <p><b>IT AREA</b></p>	<p><b>Doorways, Doors and Door Handles</b></p> <p>The main door has an opening mechanism that once you get close to the door open automatically. A manual system is also provided and installed at a high of 1500mm on the left side of the door opening. This device is too high and needs to be lowered to allow a person in a wheelchair easy reach to the device.</p>

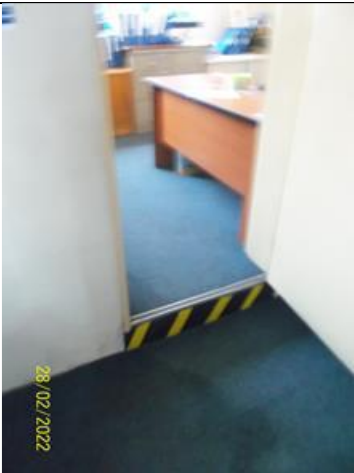
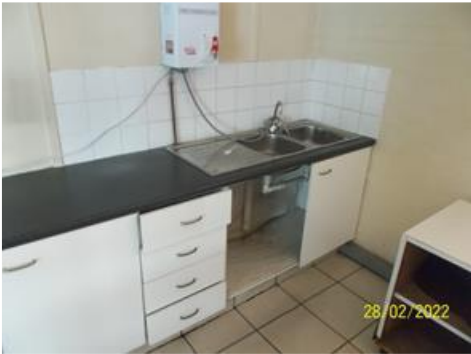
<ul style="list-style-type: none"> <li>• <b>No provision provided.</b> There are no toilet facilities in this building and the adjacent buildings facilities needs to be utilized by disabled people. It exceeds minimum distances</li> <li>• Grab rails at the ground floor cubical do comply to SANS 10400 S (4.12).</li> <li>• No pull cord is provided in the bathroom.</li> </ul> <p><b>Hearing</b></p> <ul style="list-style-type: none"> <li>• No hearing induction loop or other amplifying devices fitted provided.</li> </ul> <p><b>Touch</b></p> <ul style="list-style-type: none"> <li>• All The hydro boil equipment installed or other hot areas must be marked with symbolic signs.</li> </ul> <p><b>Height</b></p> <ul style="list-style-type: none"> <li>• The hydro boil equipment installed is at a height which may cause problems and injury should patrons in wheel chairs trying to get boiling water, it is therefore important to lower the hydro boil equipment to ensure that wheelchair patrons may easily rich the lever on the machine.</li> </ul> <p><b>Kitchen</b> <b>IT AREA</b></p> <ul style="list-style-type: none"> <li>• No dedicated kitchen is provided for patrons making use of wheelchairs in the working area of this building. The current kitchen can easily be converted into a disabled kitchen with as there is sufficient space whilst the shelving and equipment can be lowered to cater for wheelchair patrons.</li> </ul>

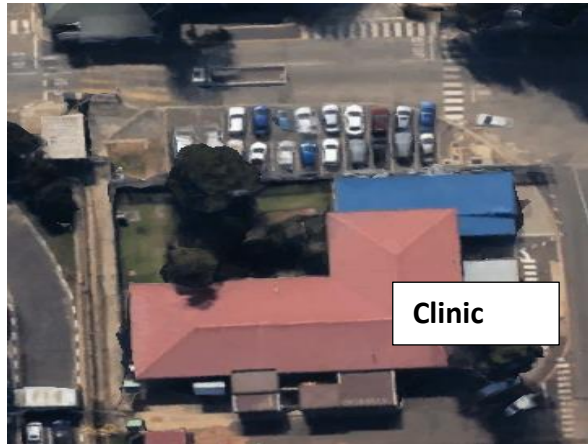
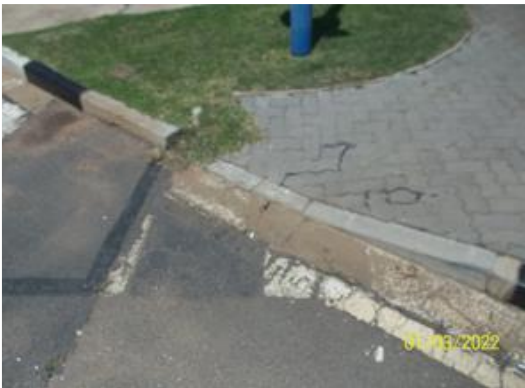
2	Clinic / Health Building	480m <sup>2</sup>	Single Storey

<p><b>Signage</b></p> <ul style="list-style-type: none"> <li>• The street parking has been supplied with the international signs and colour as well as the sign on the road surface at the main parking area. These are the only area with international signage and larger parking spaces. If patrons park at these parking the traveling distances exceeds 45m.</li> <li>• The old assembly point signage is still on the wall and needs to be removed as it provides conflicting information to the people who leave the clinic during an evacuation situation. Make sure a path is provided so that people in wheelchairs evacuation is not jeopardize as a result of the uneven route which needs to be taken to get to safety.</li> <li>• All The hydro boil equipment installed or other hot areas must be marked with symbolic signs.</li> <li>• There is a lack of pictogram / symbolic signs leading to all areas.</li> </ul> <p><b>Hearing</b></p> <ul style="list-style-type: none"> <li>• No hearing induction loop or other amplifying devices fitted provided.</li> </ul> <p><b>Entrance</b></p> <ul style="list-style-type: none"> <li>• No entry phone for deaf users installed.</li> <li>• No security checkpoint installed at the entrance of the building there is only the security control point when entering the premises which do cater for wheelchair access as well as for disabled patrons entering with vehicles.</li> <li>• A speaker warning entry system is installed however the location of the device is higher than 1200mm. Speaker is 1300mm high.</li> </ul> <p><b>Parkings</b></p> <ul style="list-style-type: none"> <li>• Two parking bays are situated in front of the building in the street. The width is 2400mm. Some of the disabled parking areas width is the same as a normal parking space who do not accommodate a space for a wheelchair to be lowered from a vehicles roof and allowing a disable</li> </ul>	<p><b>Signage</b></p> <ul style="list-style-type: none"> <li>• Sign with pictogram indicating the location of the toilets according to SANS 10400 S (4.2) must be provided and the sign must be visible to all disabled patrons.</li> <li>• Standardization of symbolic safety signs.</li> </ul> <p><b>Parkings</b></p> <ul style="list-style-type: none"> <li>• Disabled parking spaces need to be wider than a normal parking space width.</li> </ul> <p><b>Toilet Facilities</b></p> <ul style="list-style-type: none"> <li>• Disabled toilet next to TSS receipt and dispatching building are available should disabled patrons need to use ablution facilities. The doorway is wide enough to allow a wheelchair to enter and to turn around.</li> </ul>

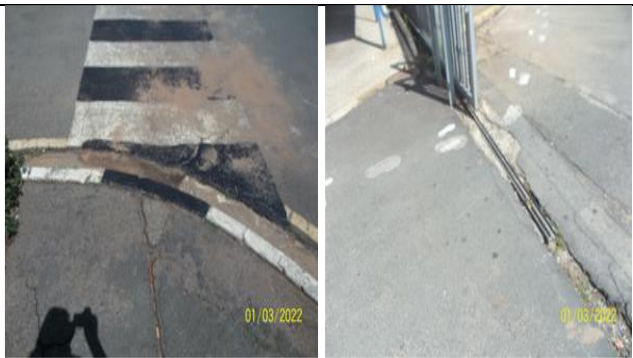
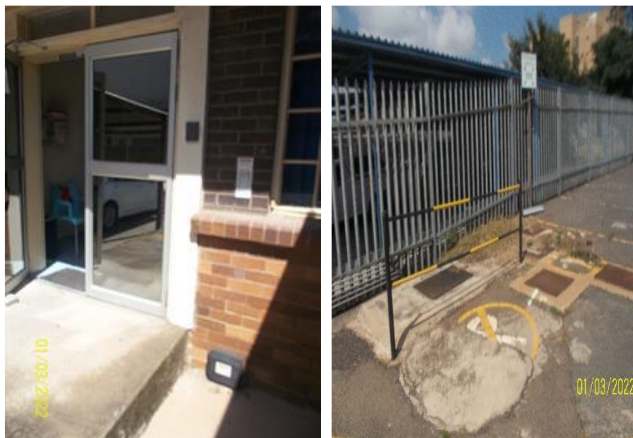
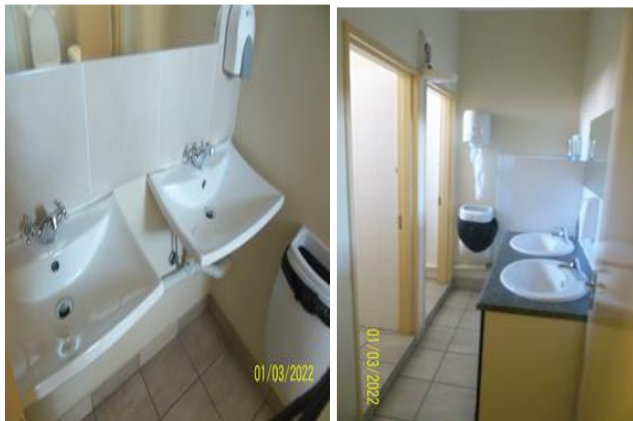
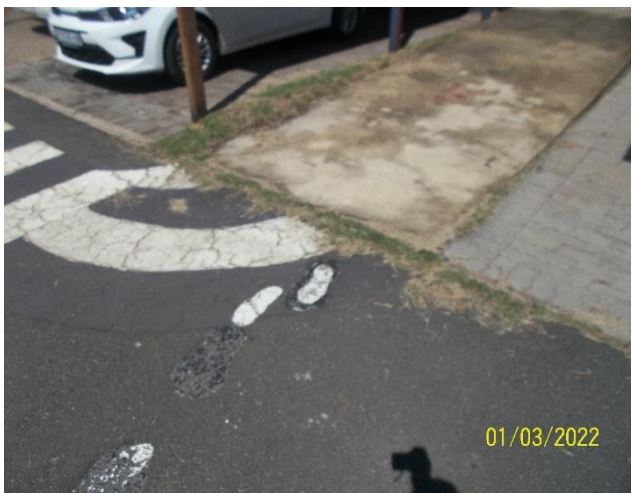
patron access to his wheel chair. Disabled parking spaces need to be wider than a normal parking space width.

- There are no dropped of area provided and marked for people who visited the clinic whether you are normal or disabled.
- Drop curbs constructed from concrete in the road way (pavement) is provided. The curb leading from the parking area in the street towards the security access point is dropped however the curb is too small and overgrown with vegetation which needs to be changed and vegetation removed so as to provide easy and safe traveling for disabled patrons.

- The curb leading to the small gate for utilization by wheelchair patrons are not dropped and needs to be changed for easy traveling with wheelchairs.

- Unobstructed pathways are provided except where you need to go through the main gate the gate railing is loose which could hinder the smooth traveling of wheelchair patrons. No lighting is provided as the paths are in the open.

- The curb close to the toilet cubical also do not have a slopped curb which needs to be changed as a matter of urgency as there is a wheelchair patron in one of the adjacent buildings.

- The closest public parking transport stop (Taxi rank) is  $\pm 500$  meters from the entrance. With reference to **CLASSIFICATION OF PERSONS WITH DISABILITIES** this distance exceeds the minimum traveling distance.

- . The steps do not have any handrails on the sides of the steps as per SANS 10400 S (4.10).
- There is no safe landing provided at the top of the ramp before entering through the entrance door as per SANS 10400 S (4.8).
- No 1200mm<sup>2</sup> level platforms at the top of the ramp as per SANS 10400 S (4.8).
- The ramp provided is not provided with railings on both sides.

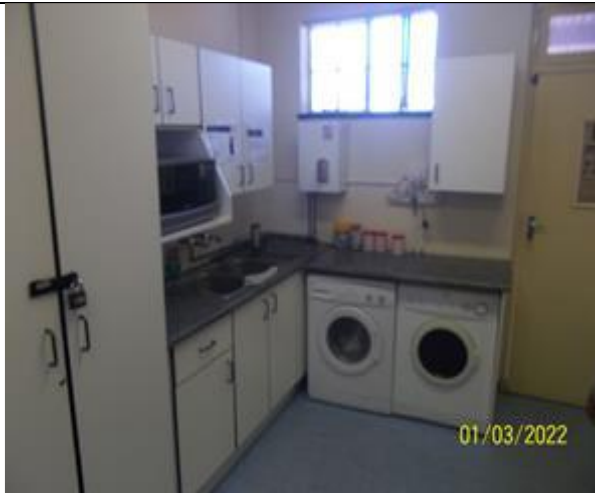
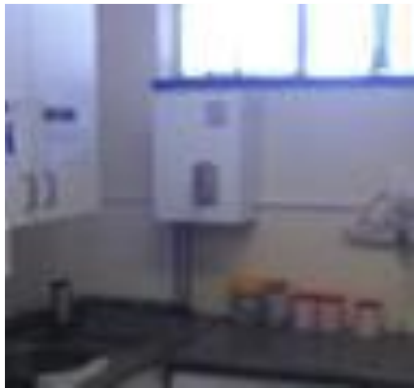
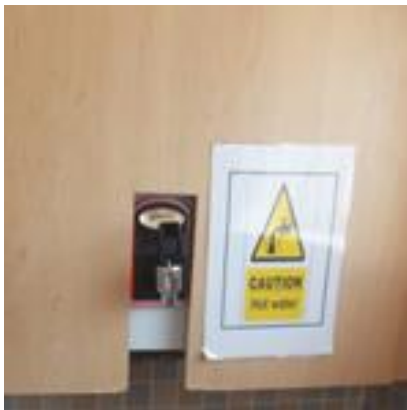
- Normal basins with the wrong tap fittings for wheelchair patrons provided.
- Only normal toilet facilities are provided inside the structure. There is however a disabled toilet next to TSS receipt and dispatching building are available should disabled patrons need to use the toilet. As a medical facility the clinic needs to have its own facilities. Normal toilet provided.
- No pull cord is provided in the bathroom.

- The travel distance is within the required 45m as per SANS 10400 S (4.12). However, the toilet cubical is situated on the outside of the building and wheelchair patrons must follow the route on the outside which do not always comply with the requirements as per SANS 10400 S as the route follow forms part of the road and pavement infra structure. The wheelchair patrons are not only reliant on the road and pavement condition but must also content with the weather and possible road and pavement repair and maintenance conditions.
