## REQUEST FOR BID CIDB

### 10397088 – Scope of Work

Repair all non-compliance at no.1 Control room as per Scope Below:  
Pricing to include all spares required and labor.

Work to be done at Rand Water Zuikerbosch

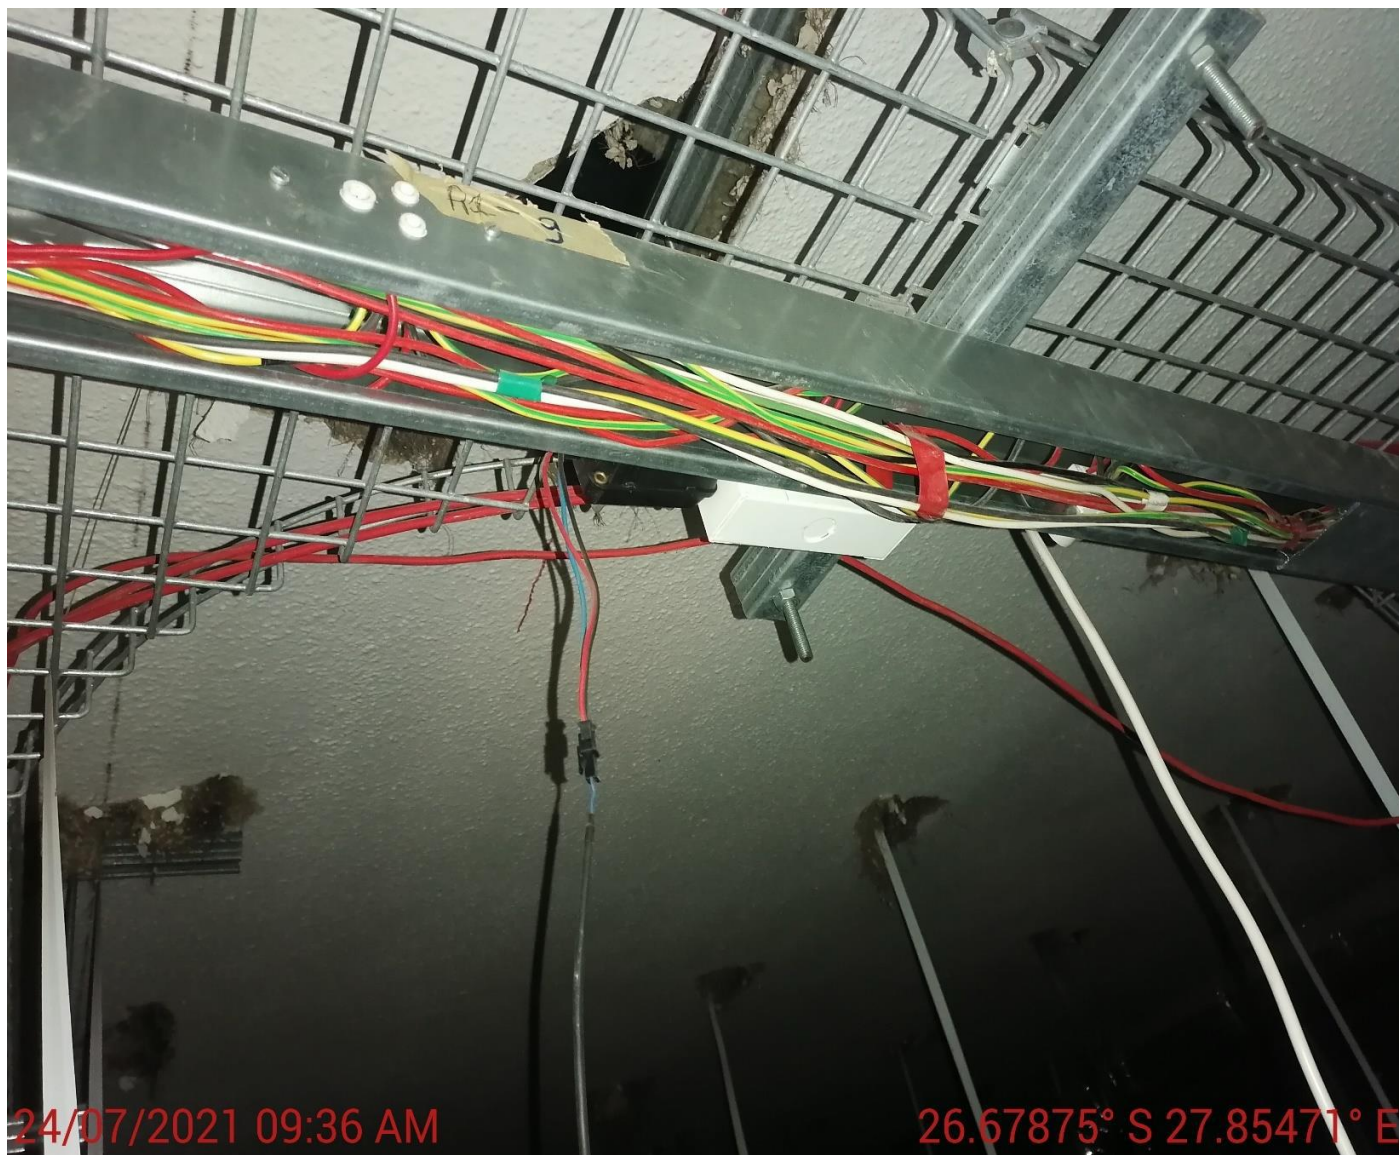
Fig 1 - Open trucking covers inside the ceiling exposing GP wires – Reception Ceiling Void

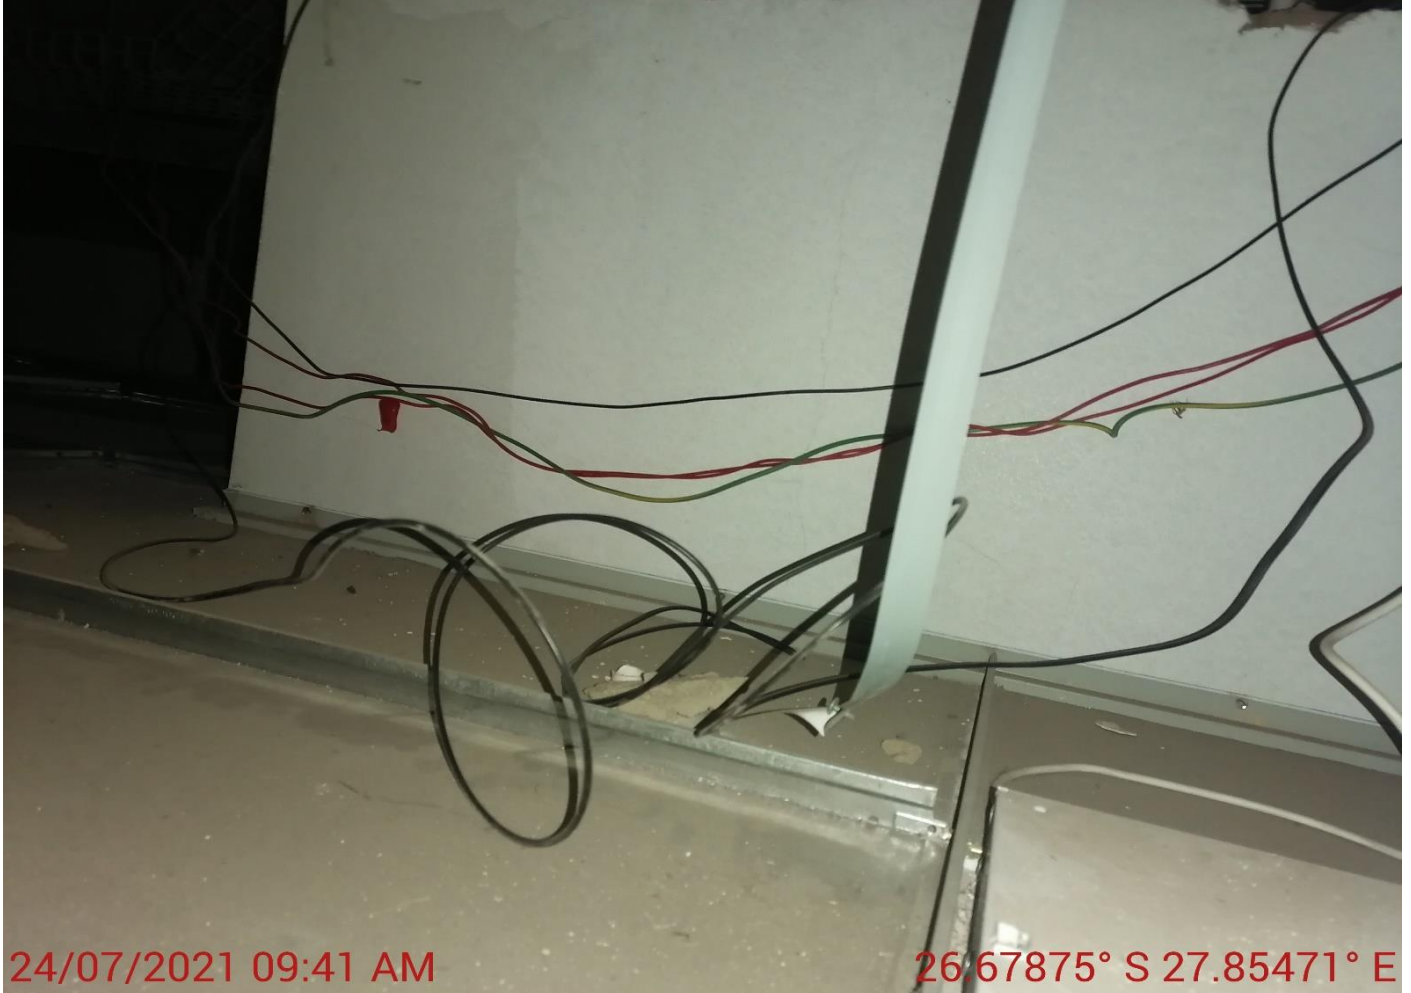
Fig 2 - Single core cables running in the ceiling without the proper enclosure – Reception Ceiling Void

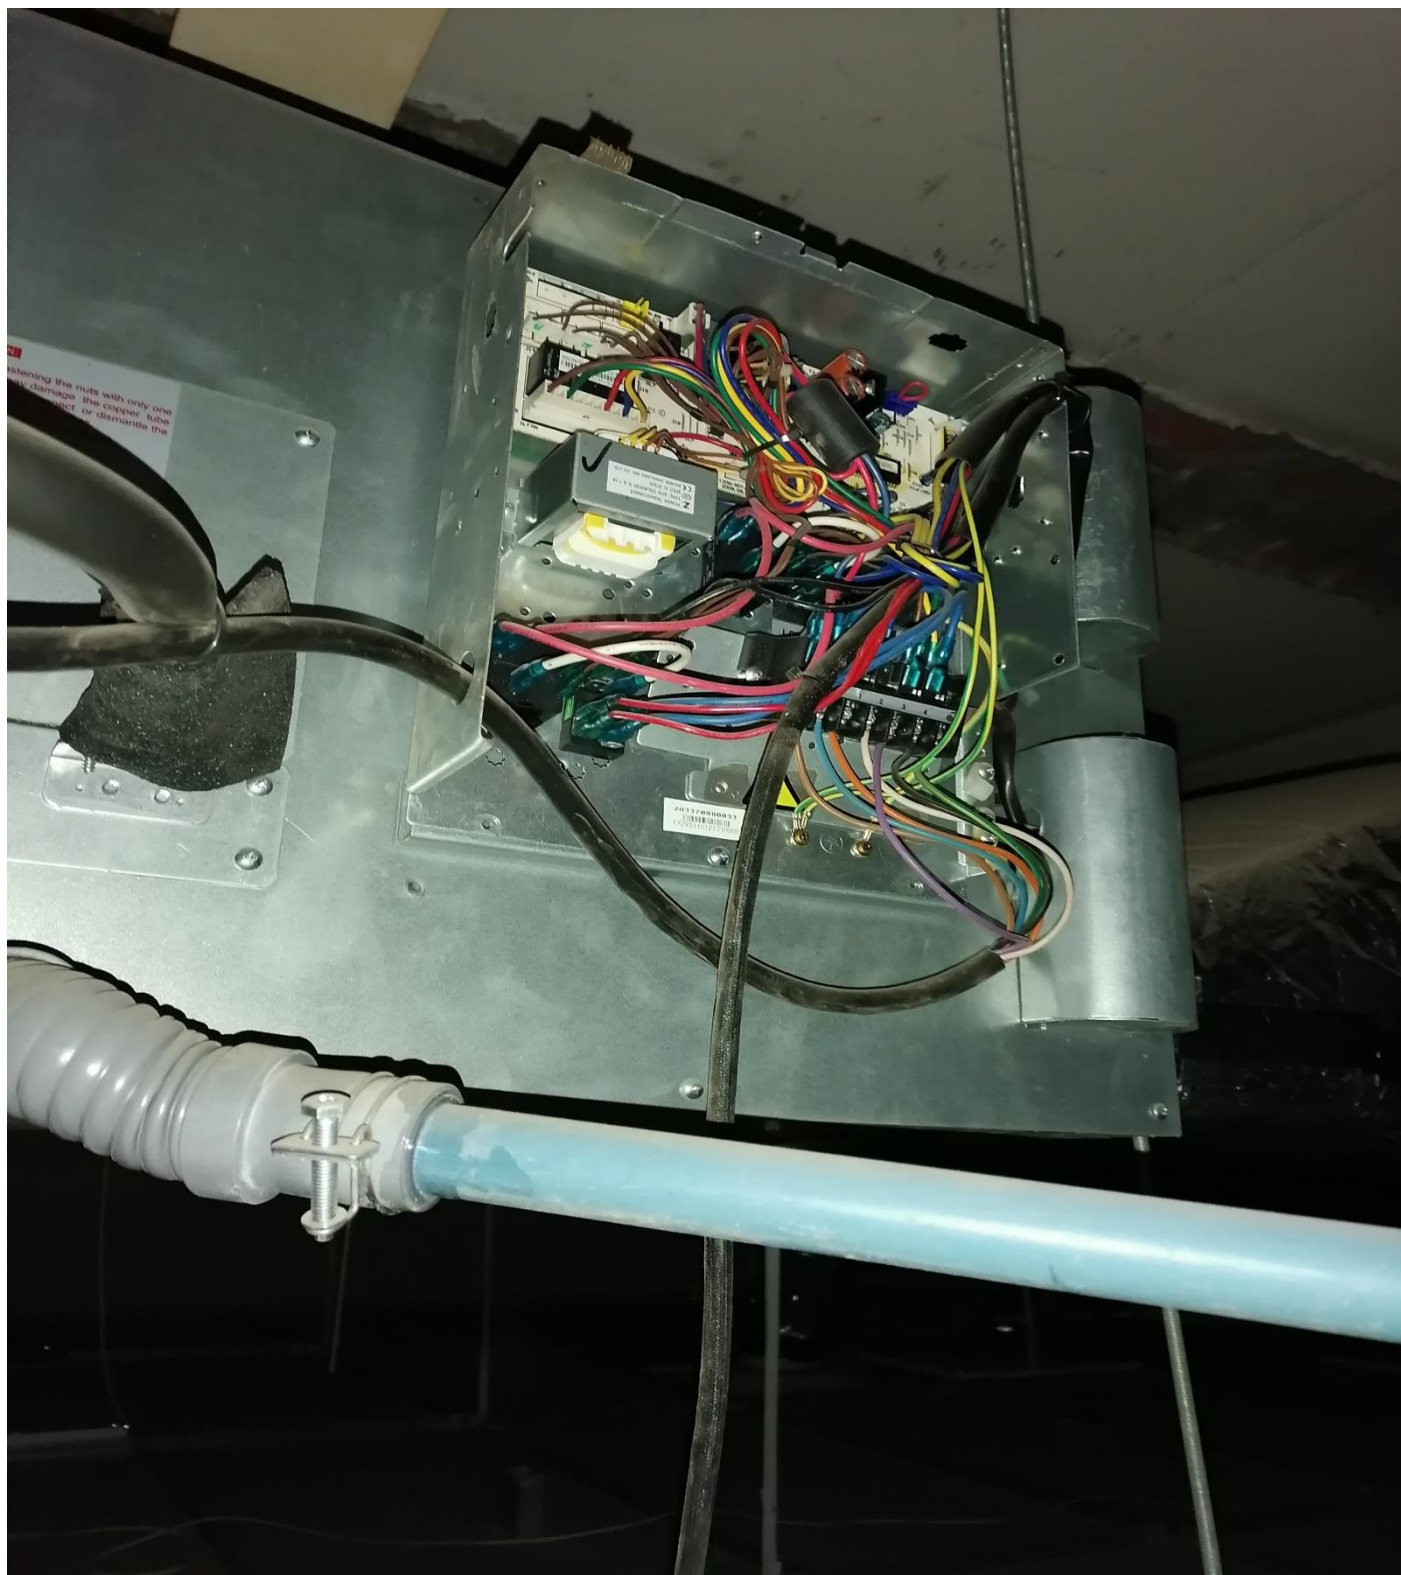
Fig 3 - Air con control box without cover exposing cables and connections. - in front of the Conference Room

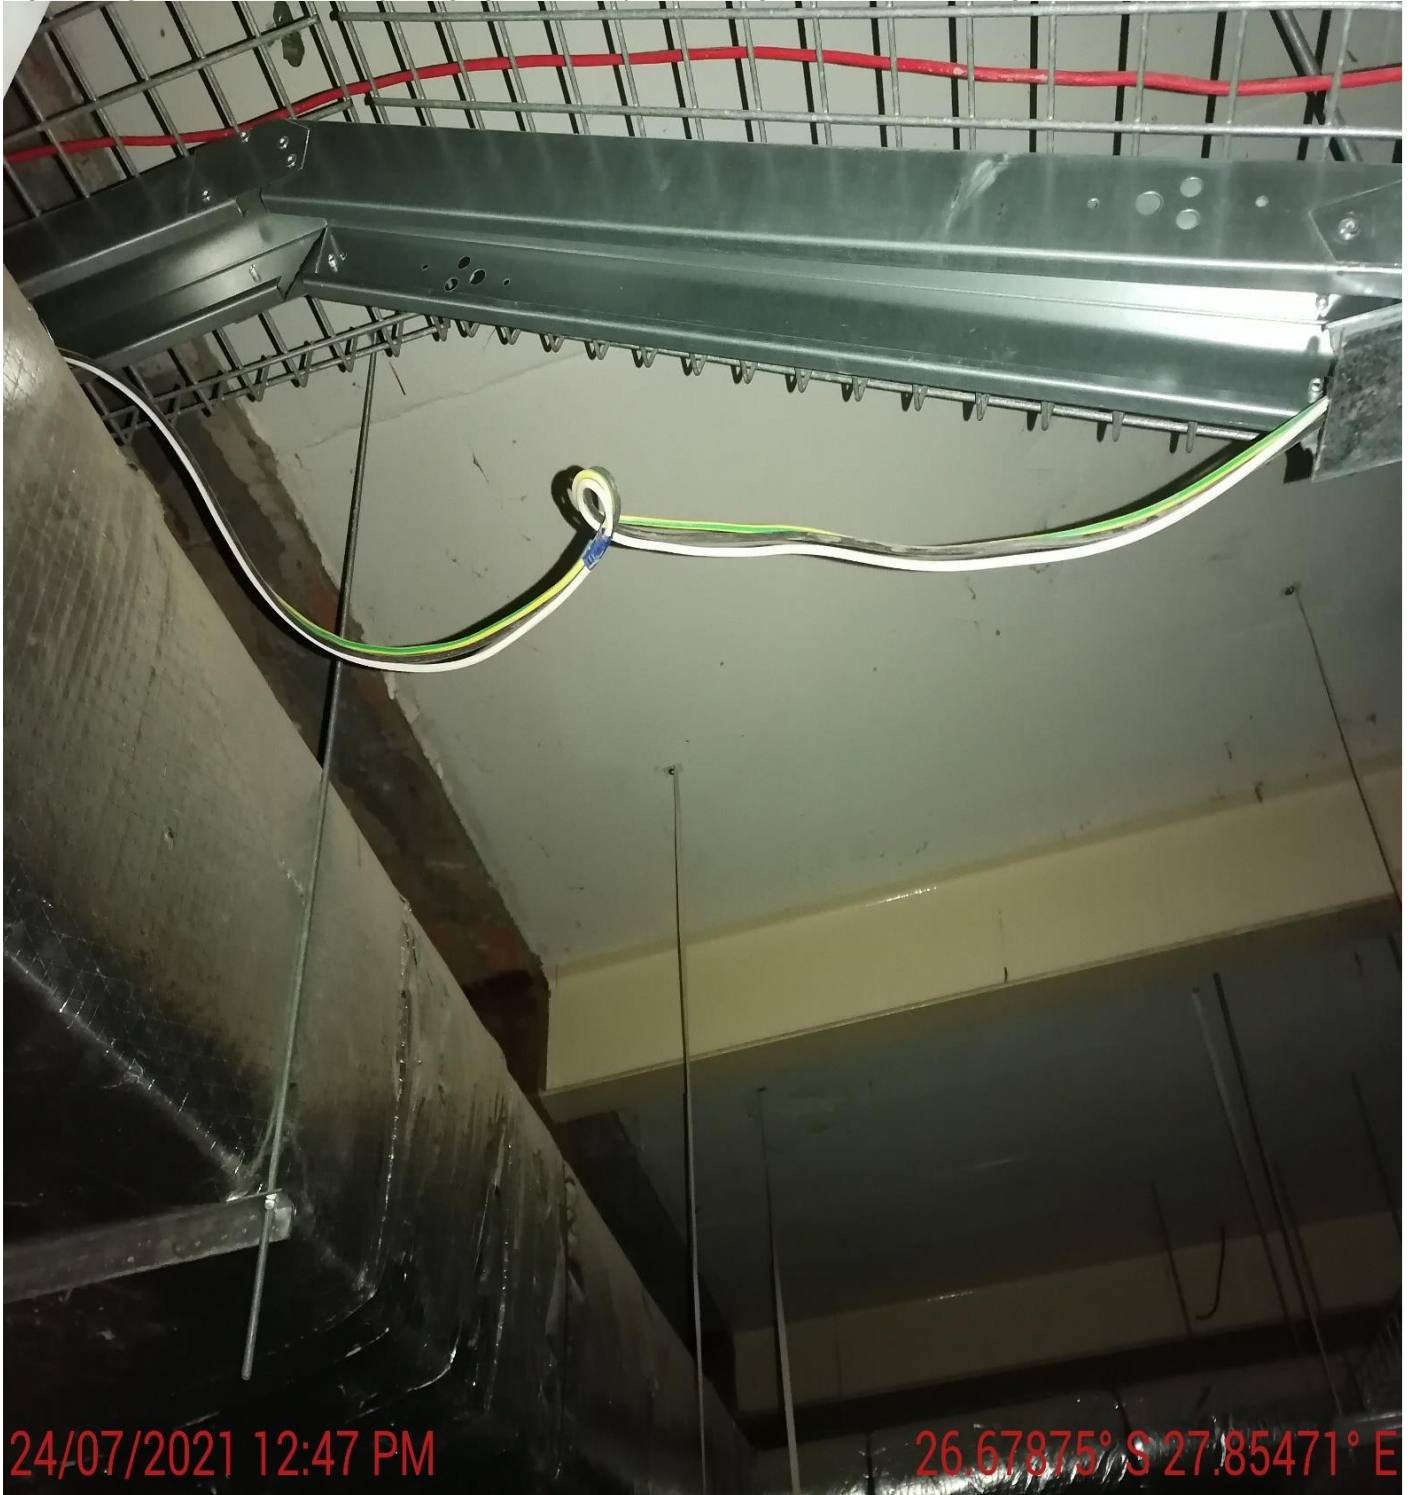
Fig 4 - Single core cables loosely hanging from the open trunking – Office 7 & 8 ceiling Void.

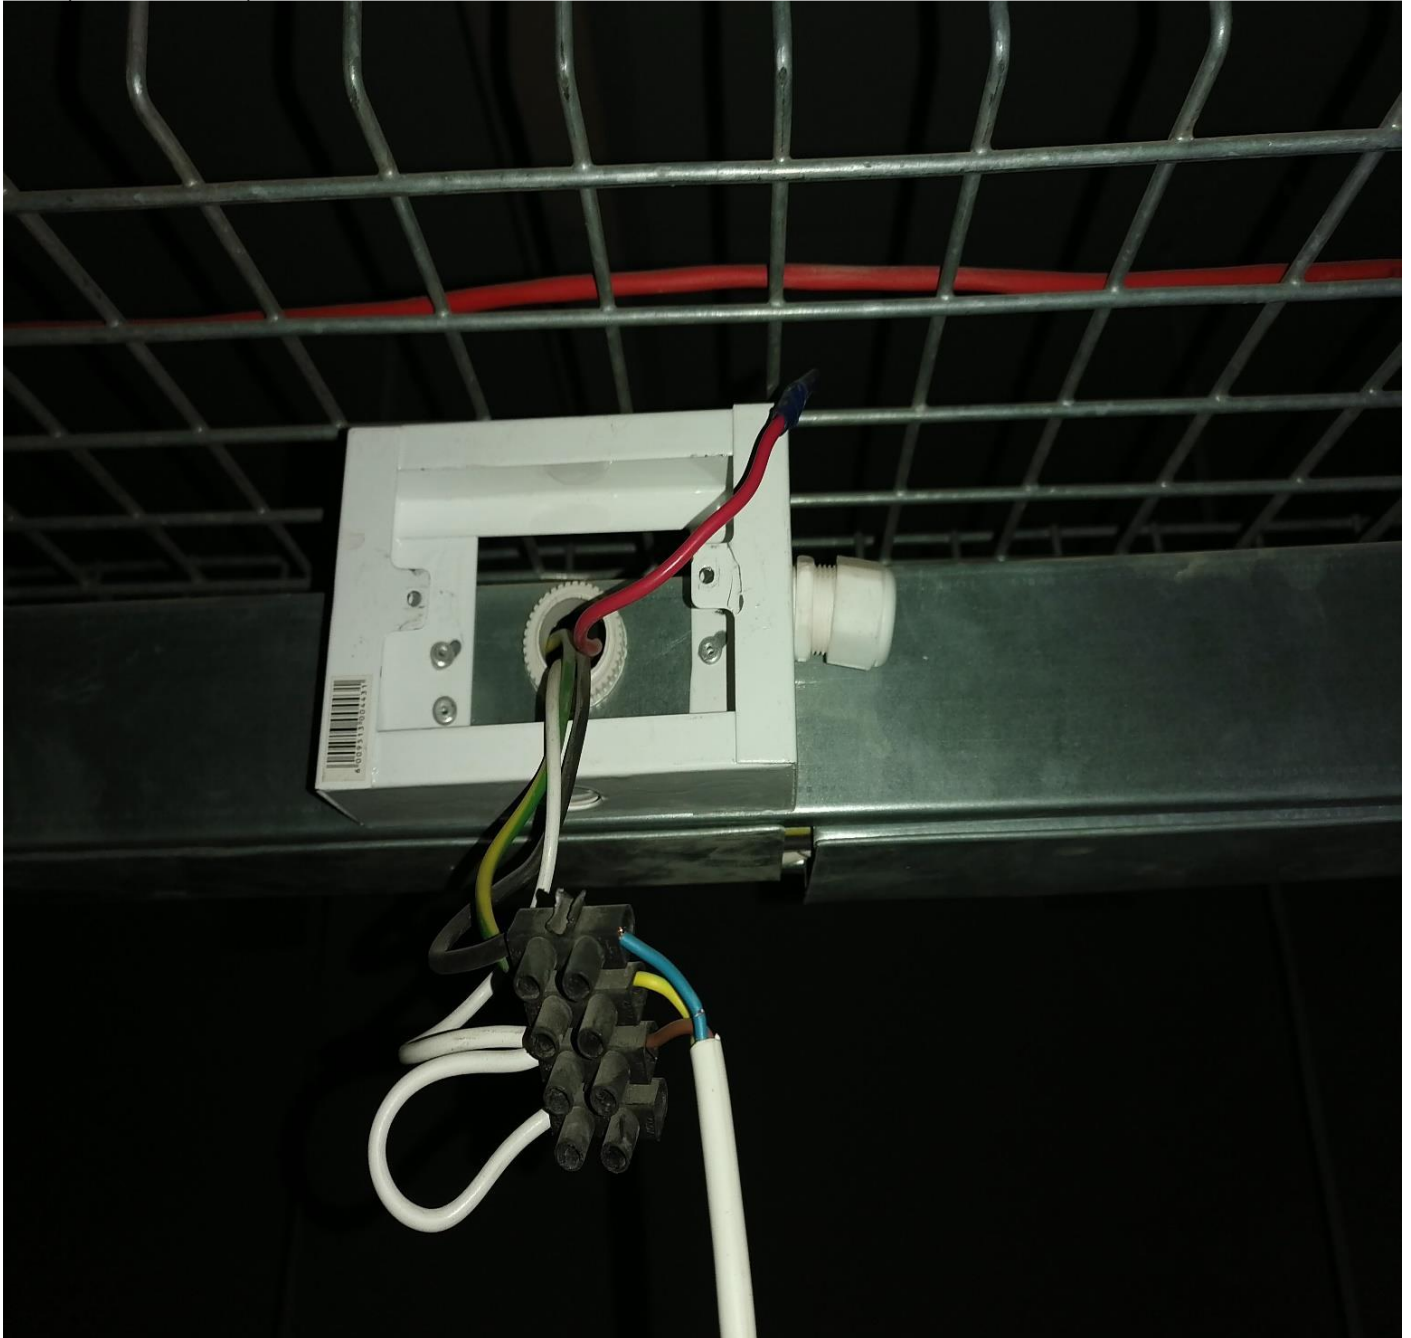
4. Improper cable terminations: This is mostly found on junction boxes mounted by the cable trunking side, connections were made without compression glands, allowing cable cords to be suspended by connections.

Fig 5 - Open junction boxes exposing connections and improper cable termination (without the use of glands) – Open Plan (Lavika's Office)

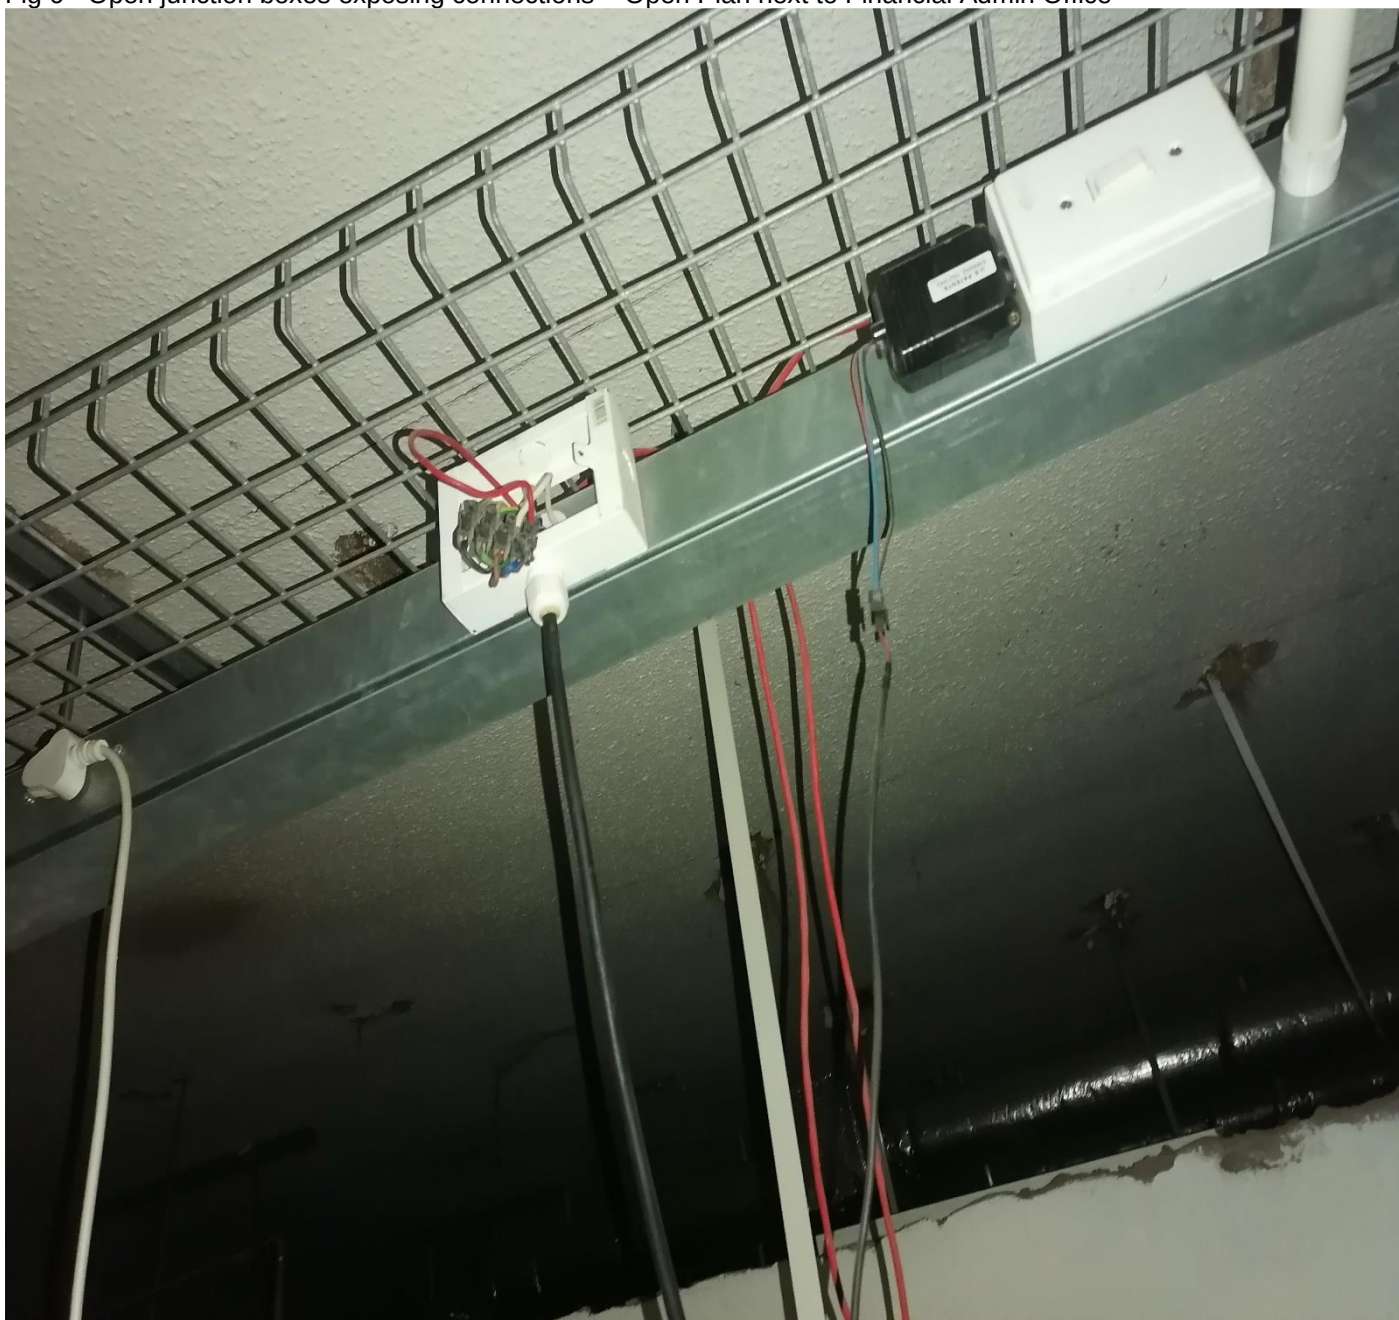
Fig 6 - Open junction boxes exposing connections – Open Plan next to Financial Admin Office

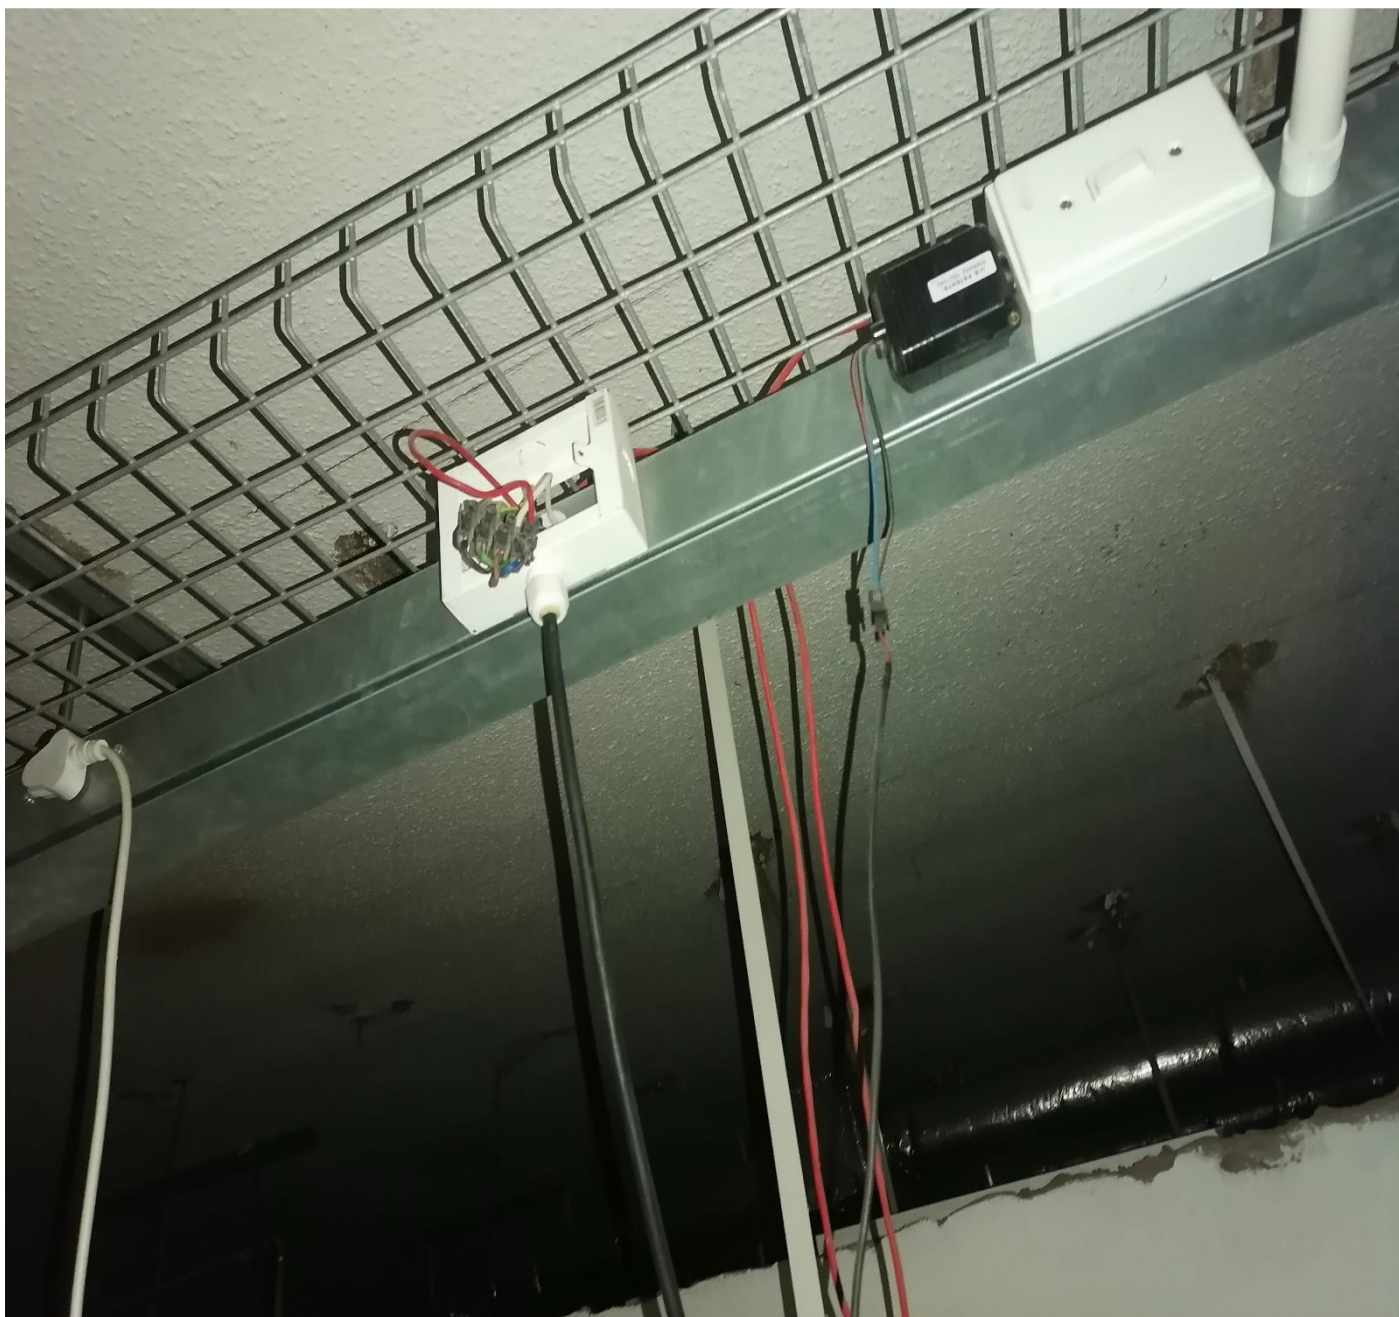
Fig 7 - Open junction boxes exposing connections – Open Plan next to Financial Admin Office

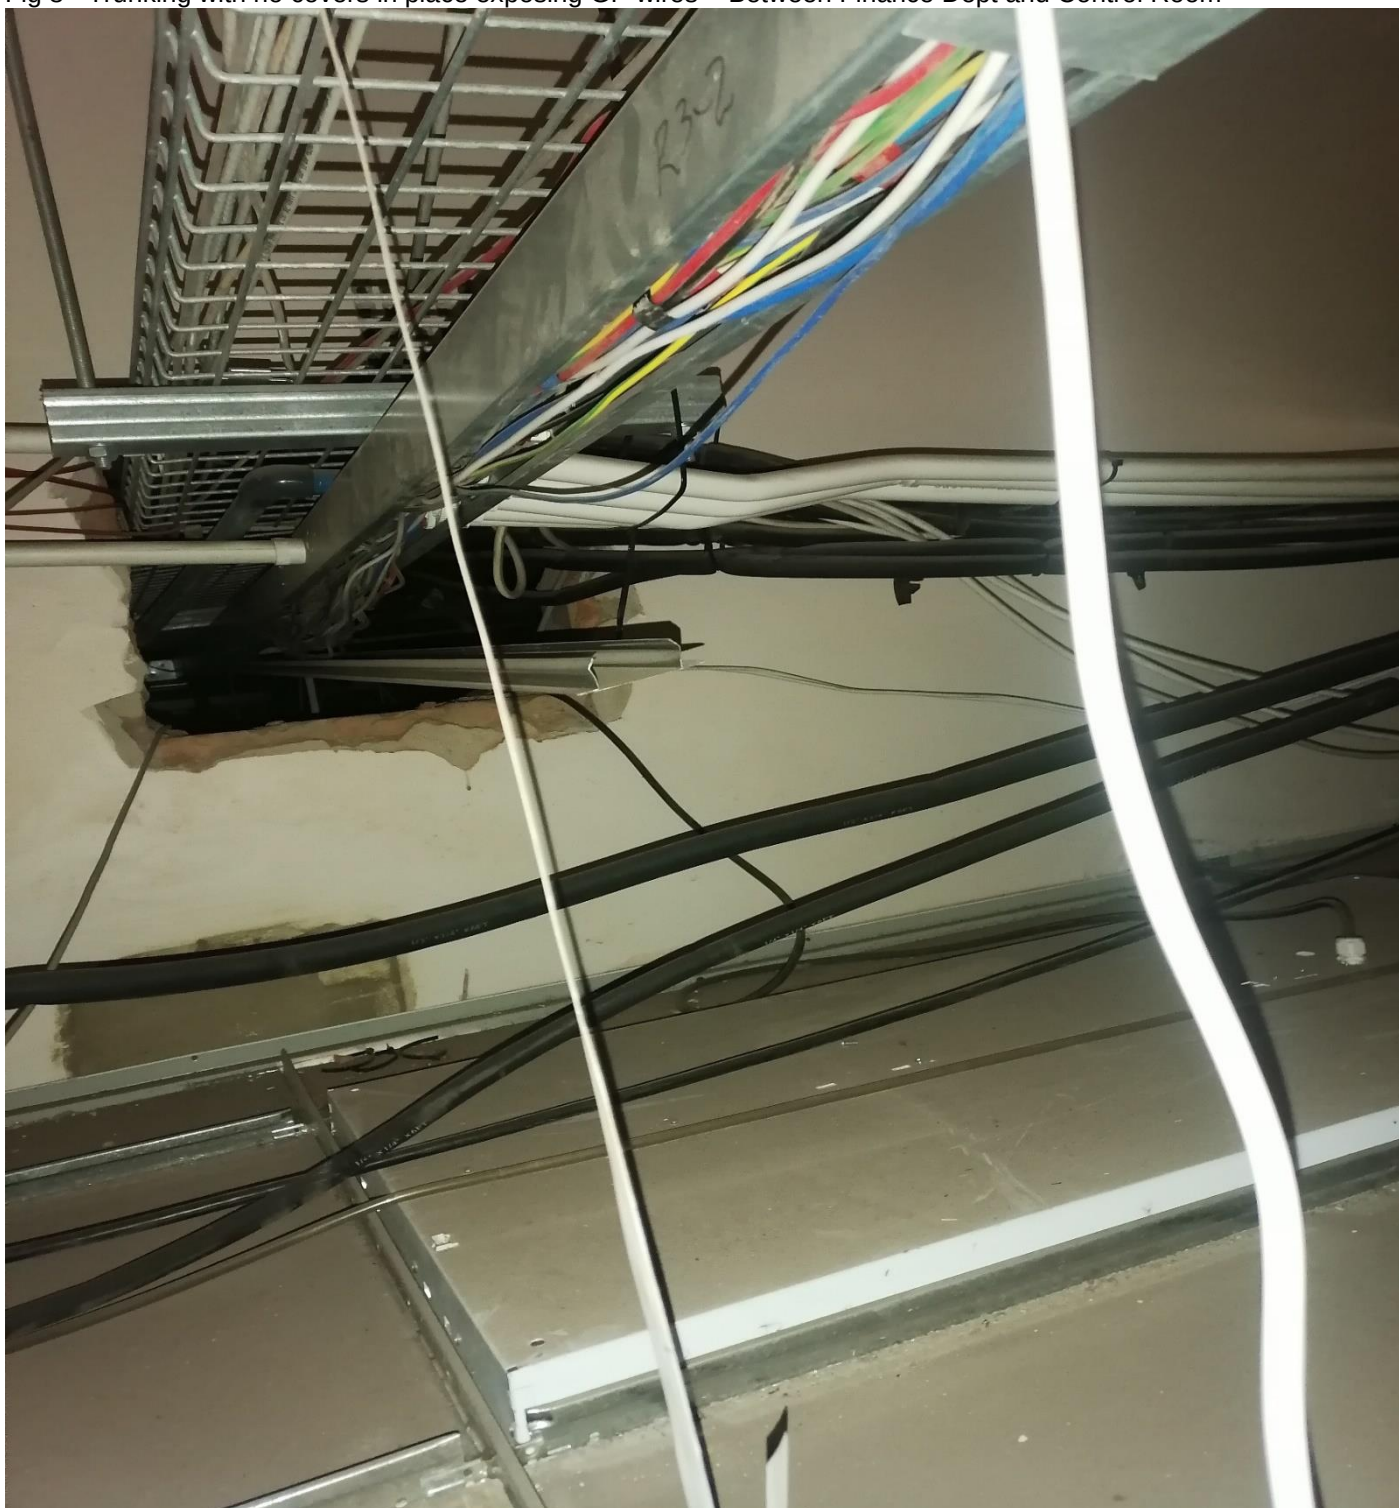
Fig 8 - Trunking with no covers in place exposing GP wires – Between Finance Dept and Control Room

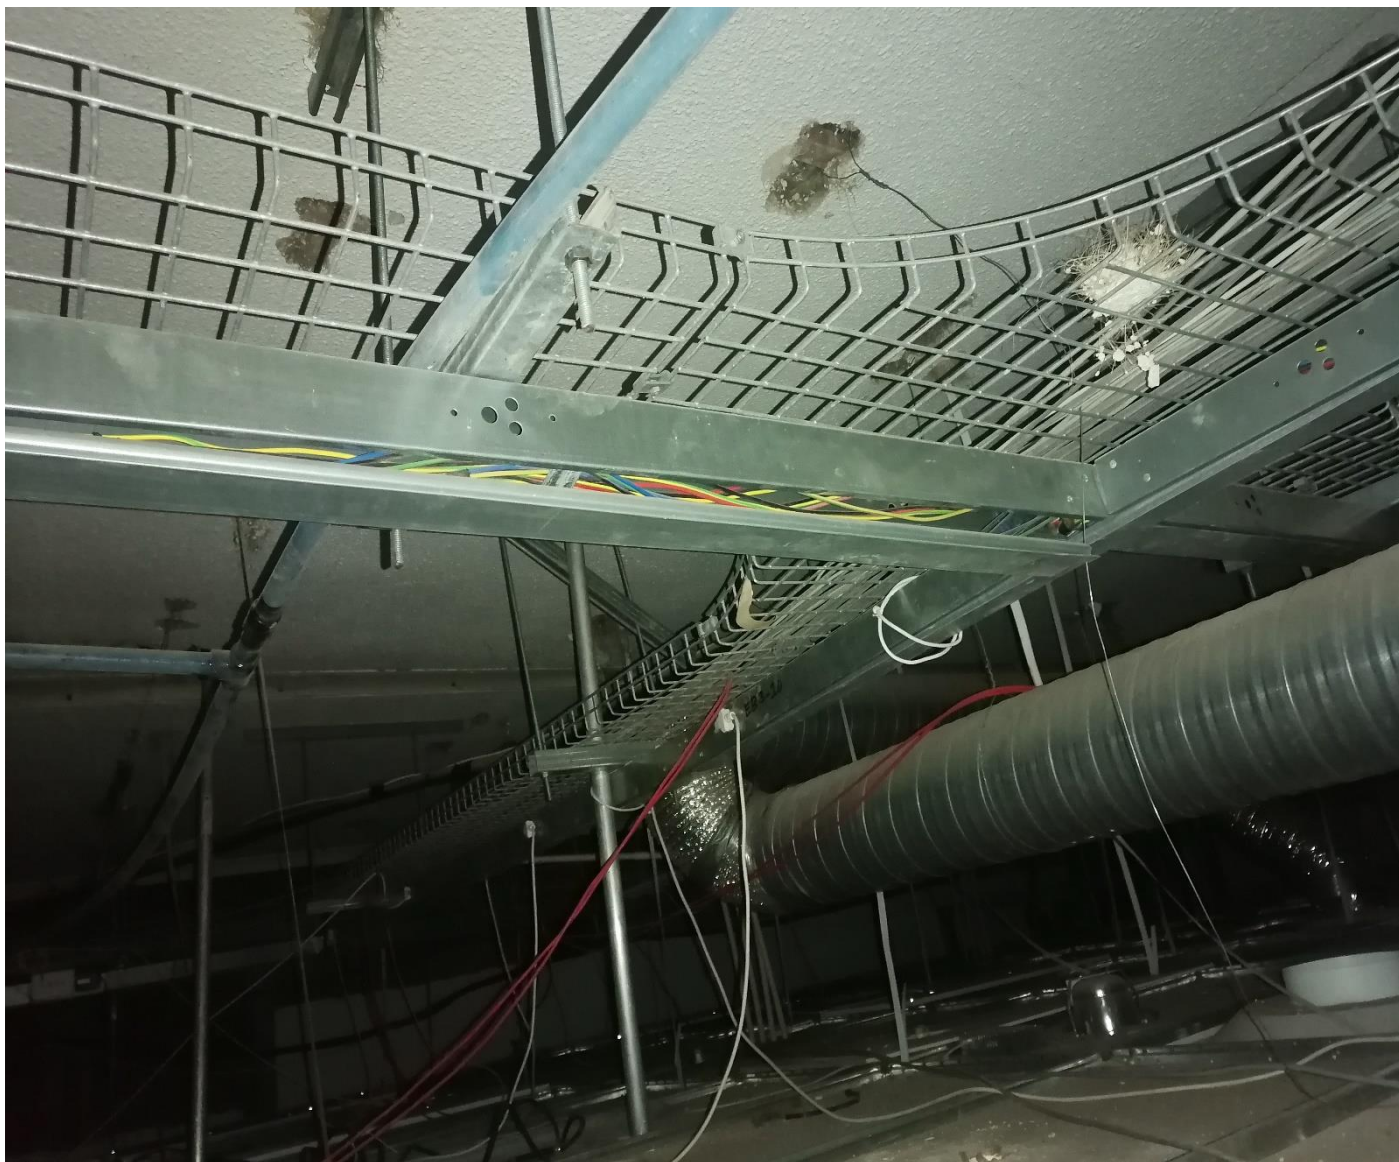
Fig 9 - Cable trunking with open covers - Entrance passage

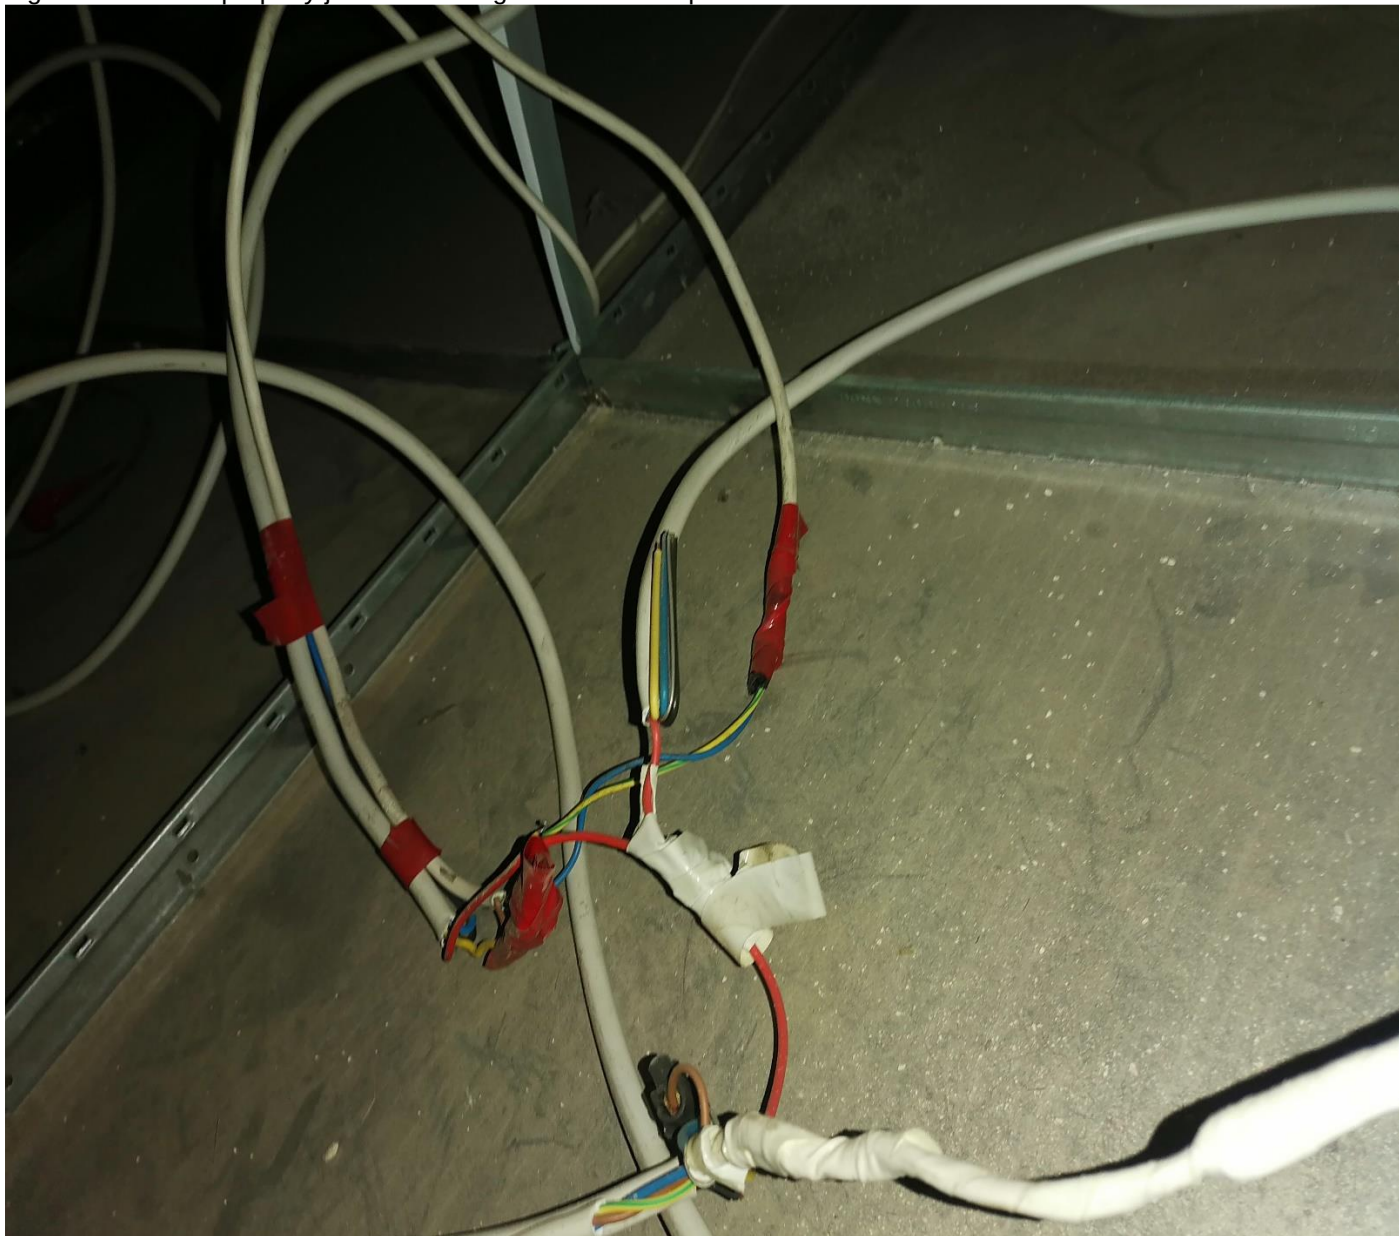
5. Improper cable joints: Open joints were randomly done inside the ceiling void, taped with insulating tape and left without protection. In some cases, such joints are suspected to have affected the resistance of the earth continuity conductor. The resistance of the earth continuity conductor on the following circuits were found to be above the limit:

Fig 10 - Cables improperly joined – Ceiling Void above Supervisor's Office

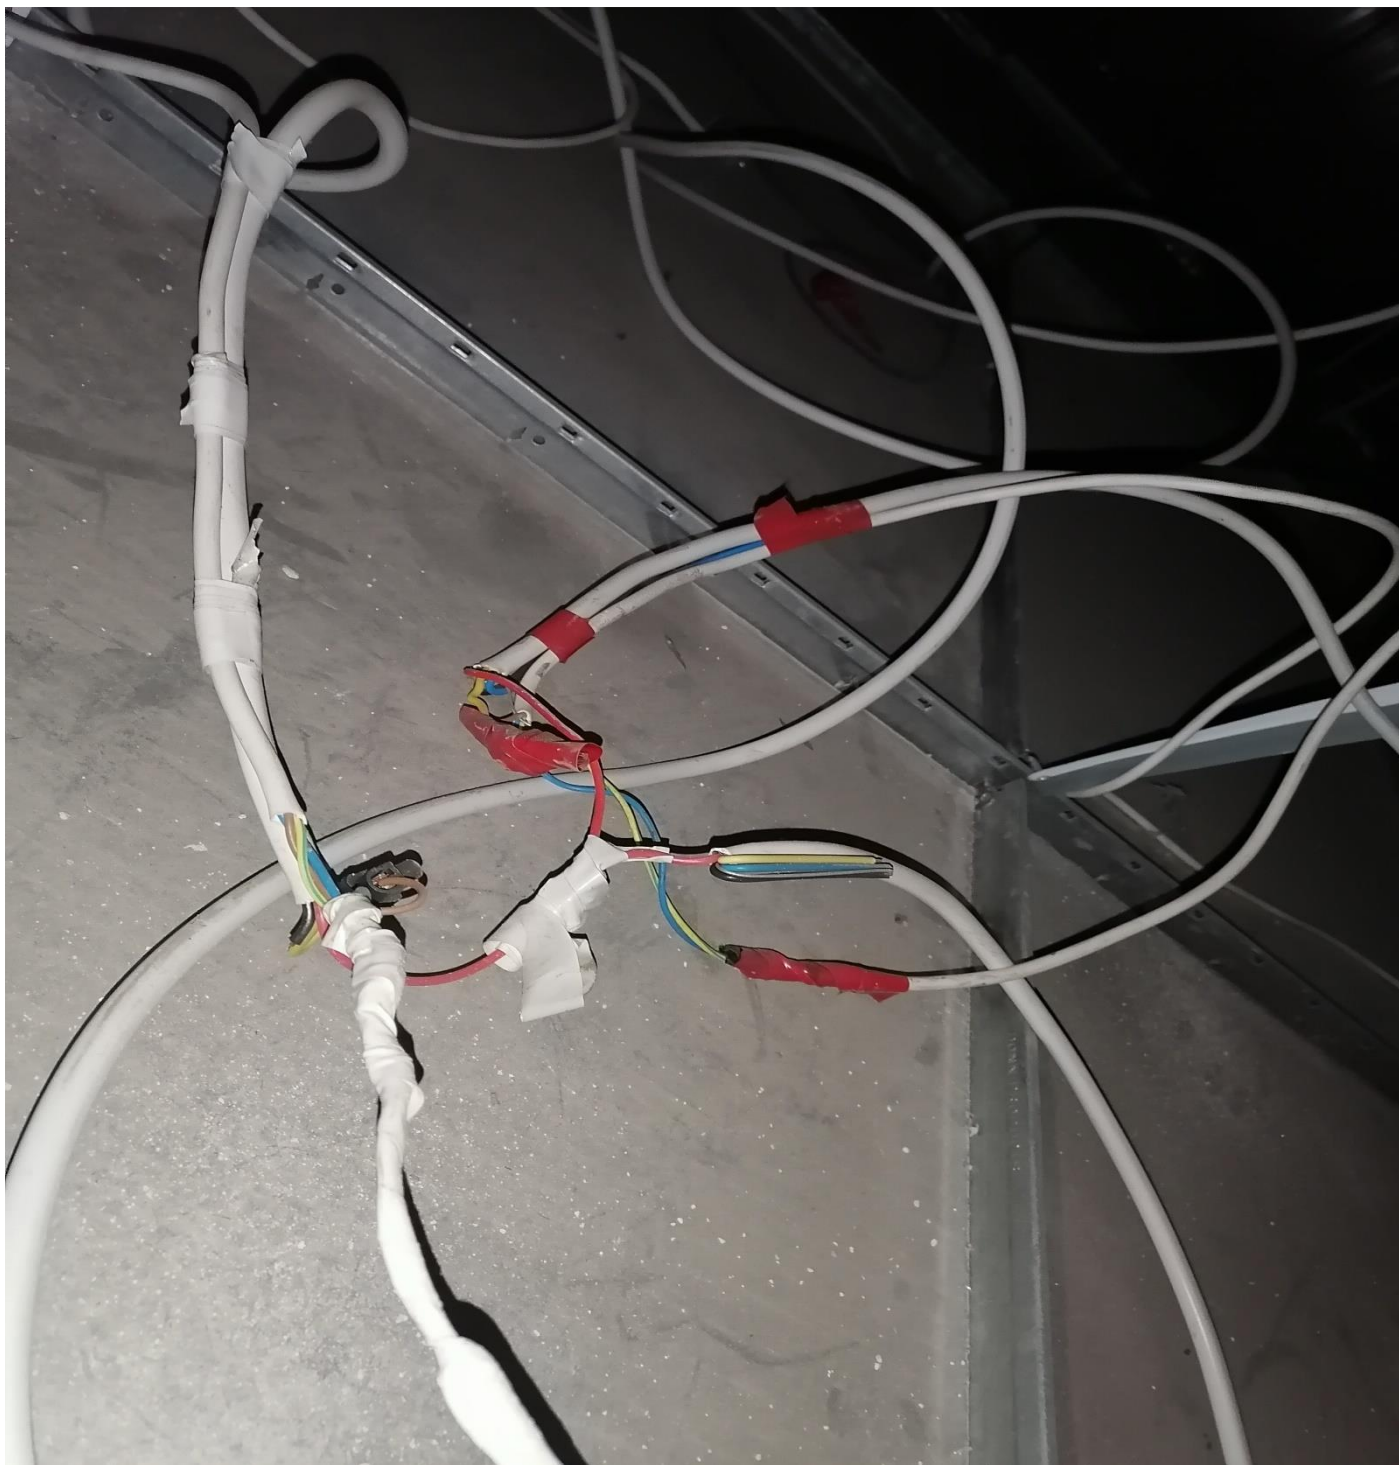
Fig 11 - Cables improperly joined - Ceiling Void above Supervisor's Office

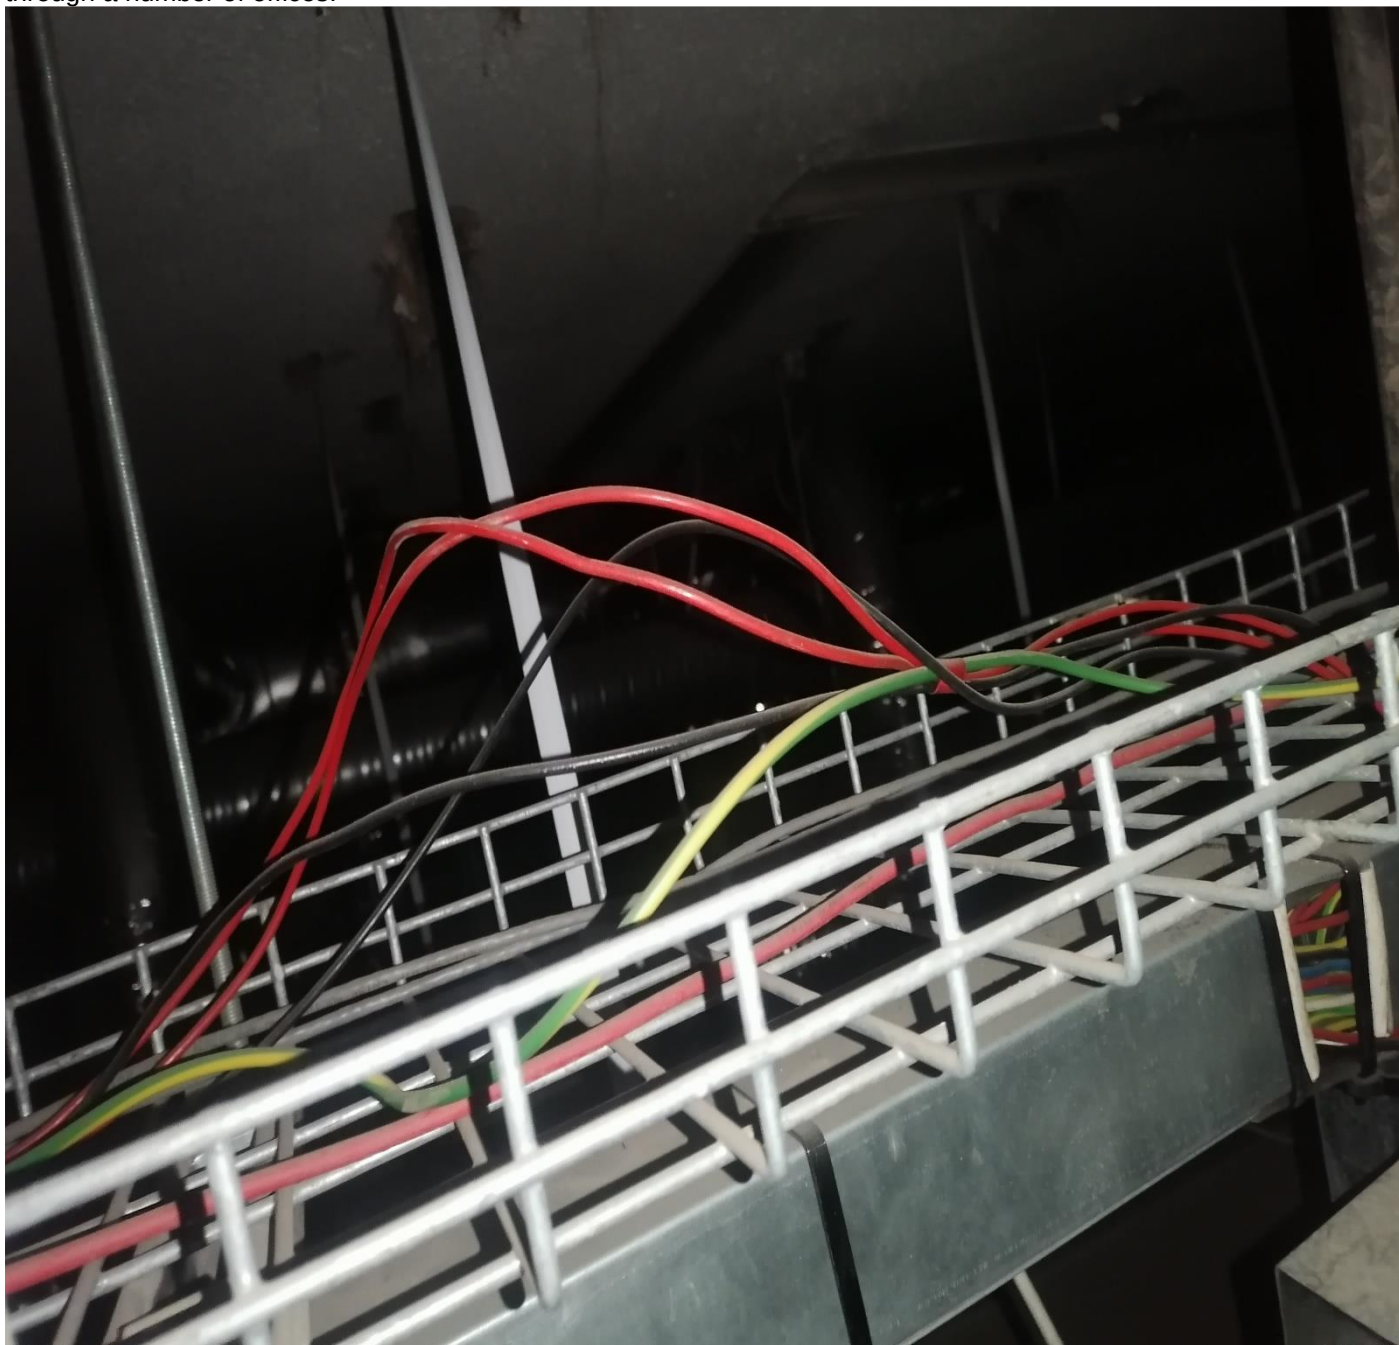
Fig 12 - General Purpose wires running in the cable tray instead of proper enclosed wireway – Cable tray running through a number of offices.
