## REQUEST FOR BID CIDB

### 10397088 – Scope of Work

Repair all non-compliance at no.1 Control room as per Scope Below:  
Pricing to include all spares required and labor.

Work to be done at Rand Water Zuikerbosch

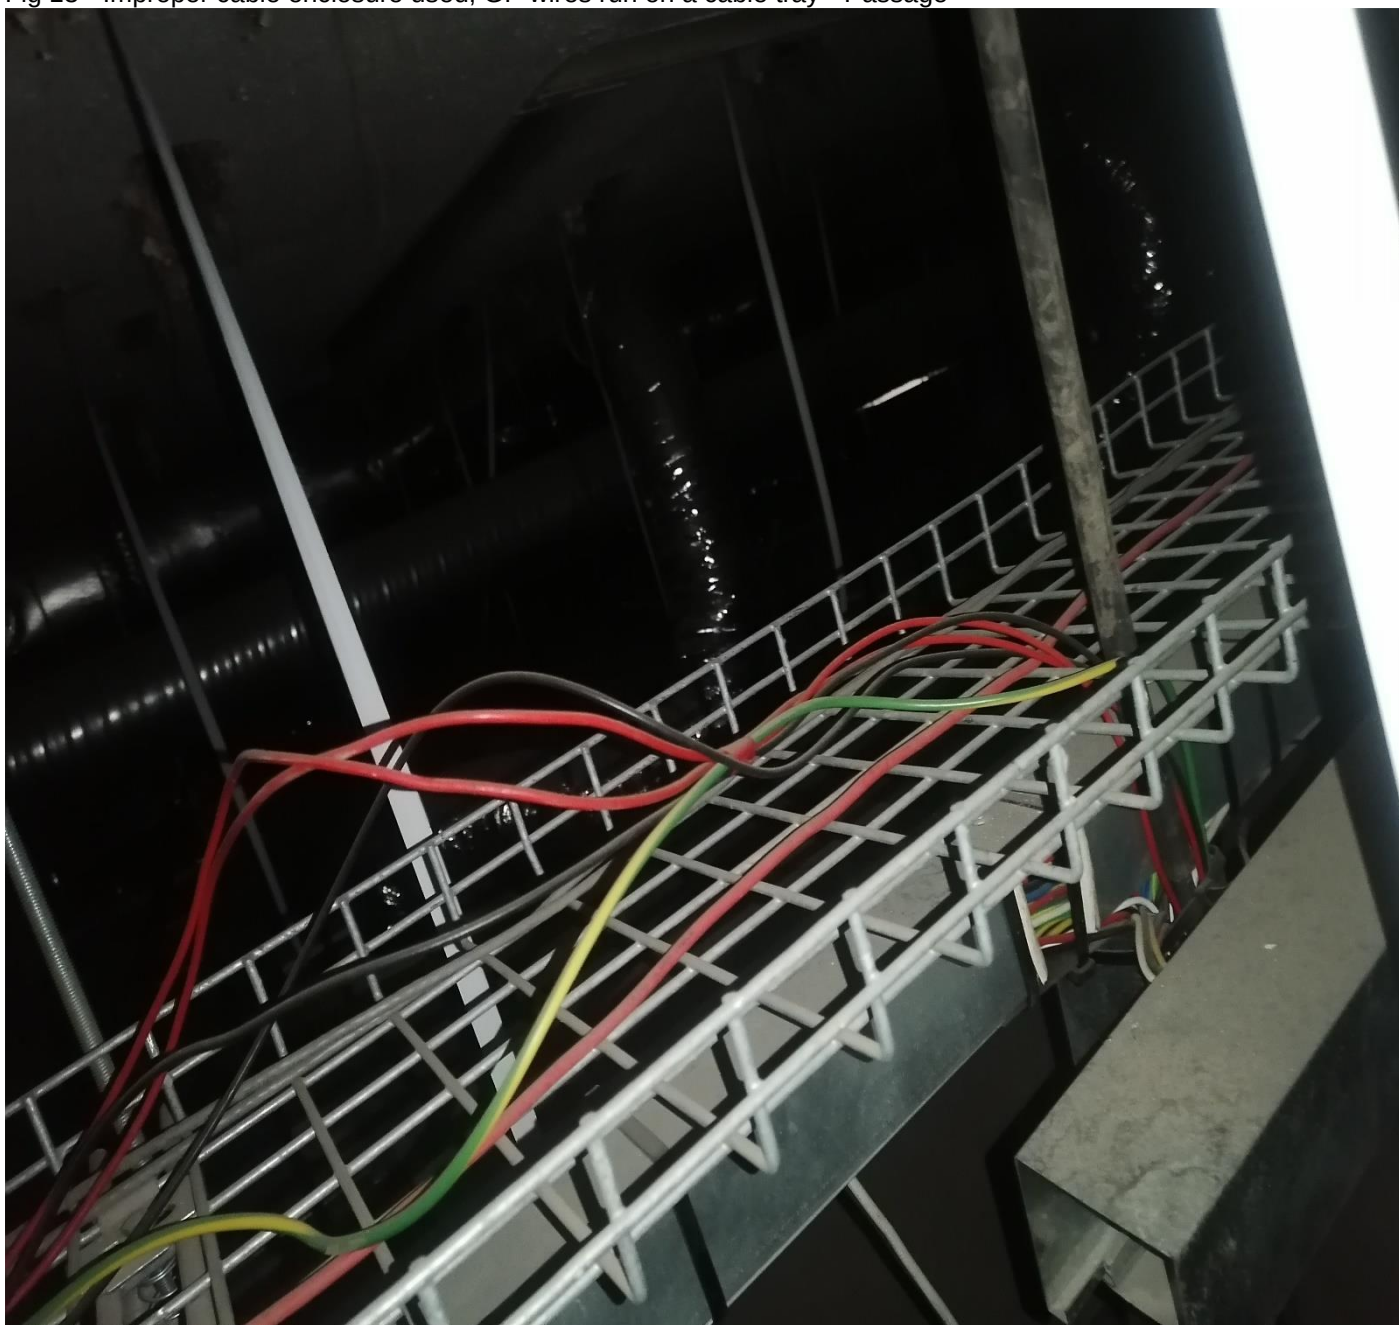
Fig 13 - Improper cable enclosure used, GP wires run on a cable tray - Passage

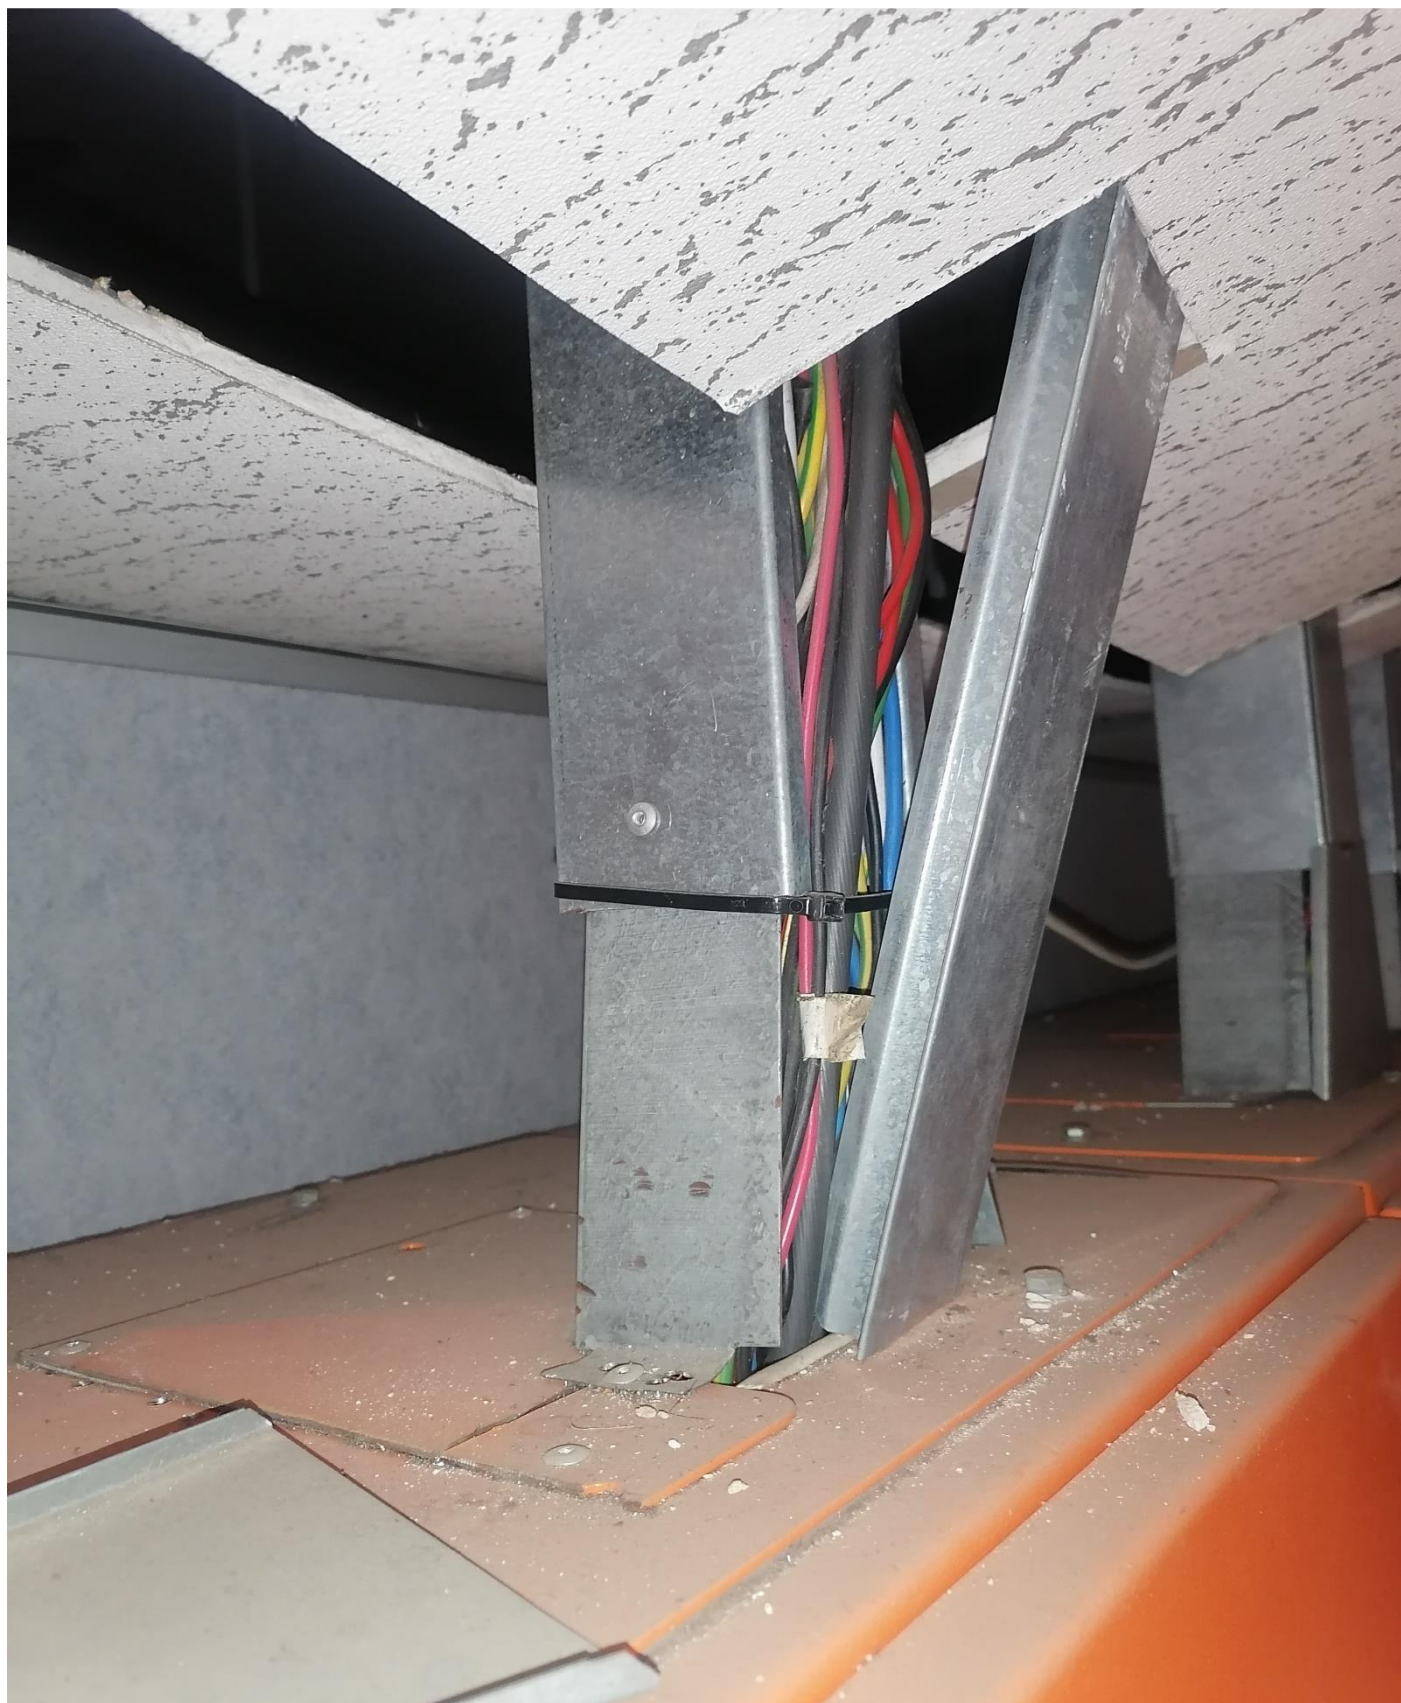
Fig 14 - Trunking not properly covered, cables held by a cable tie – Electrical Room

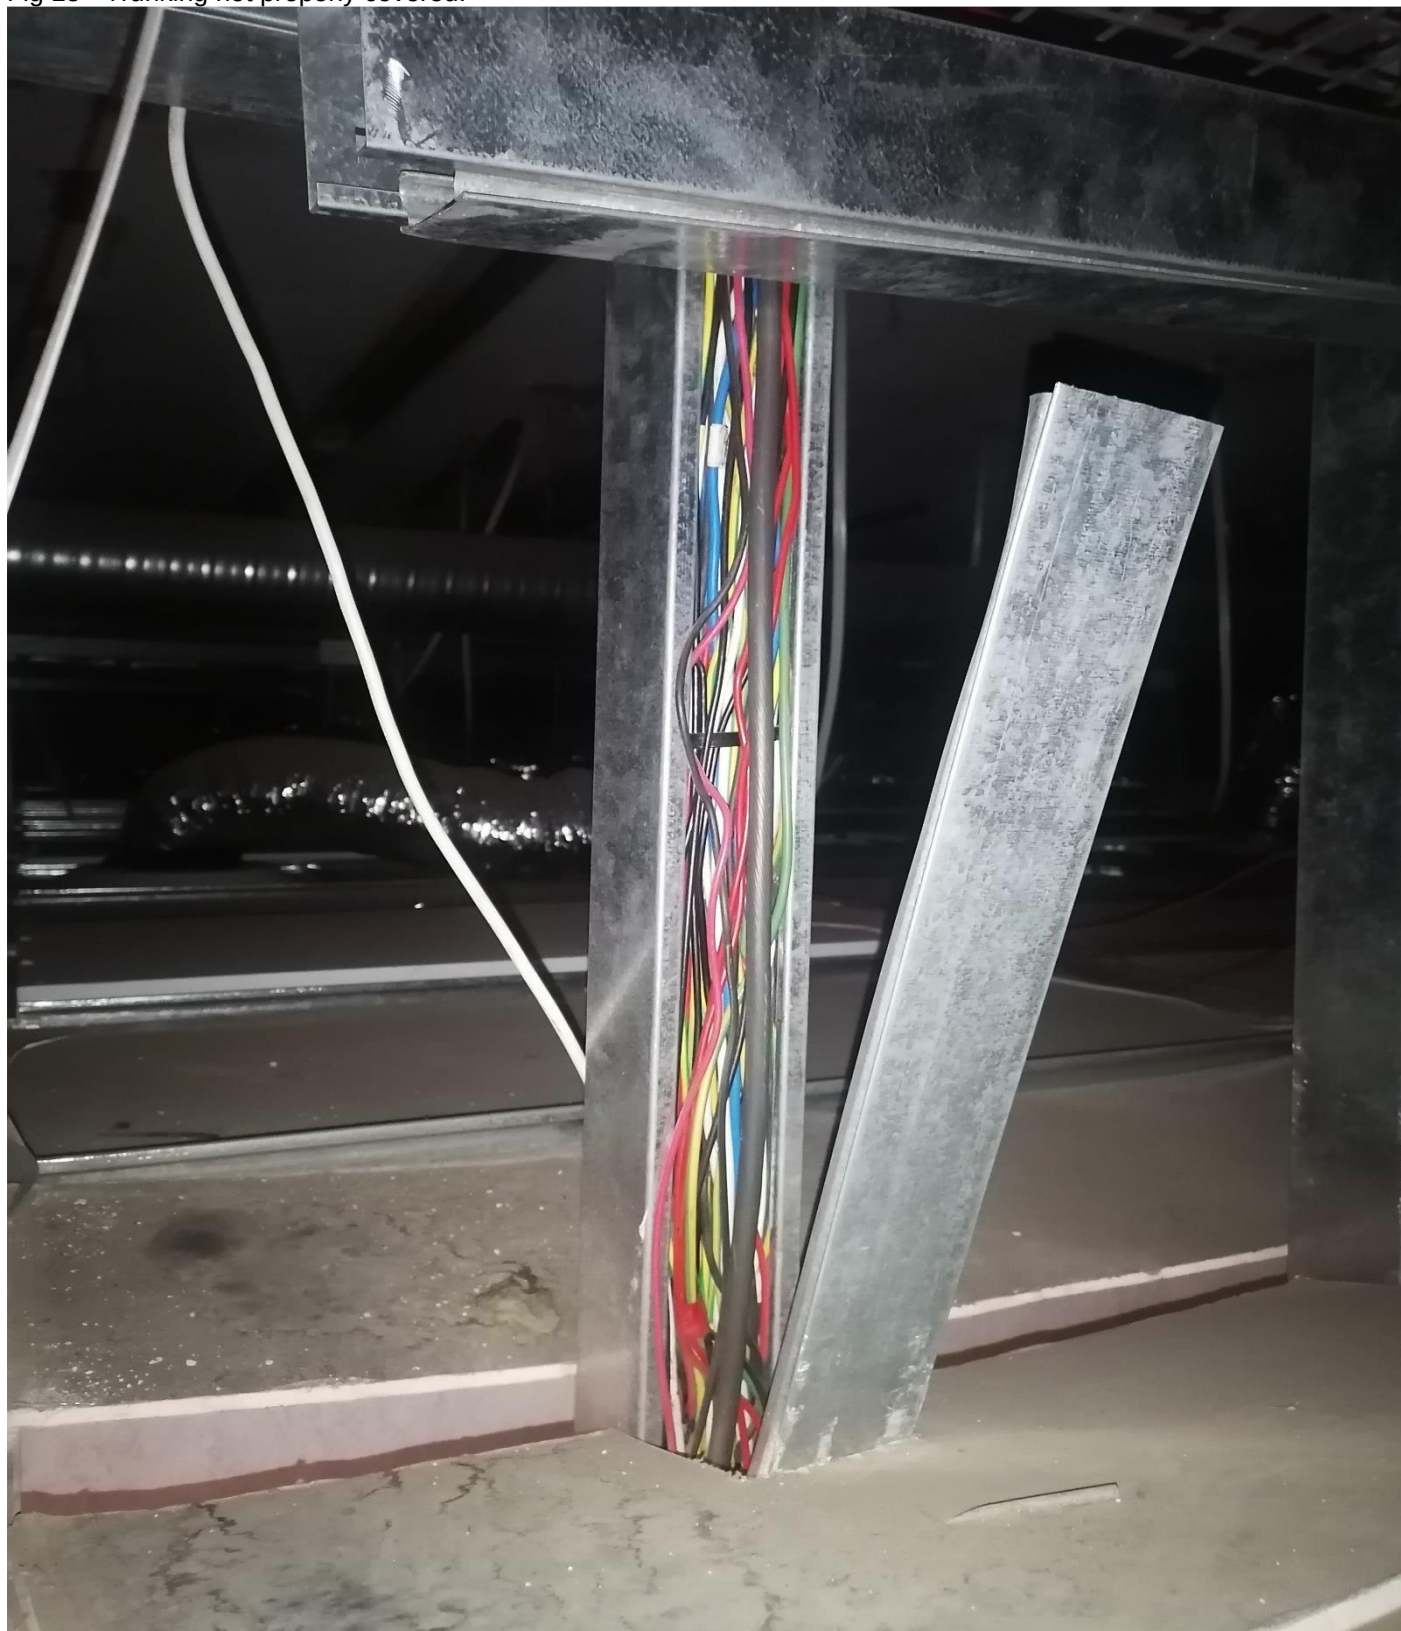
Fig 15 - Trunking not properly covered.

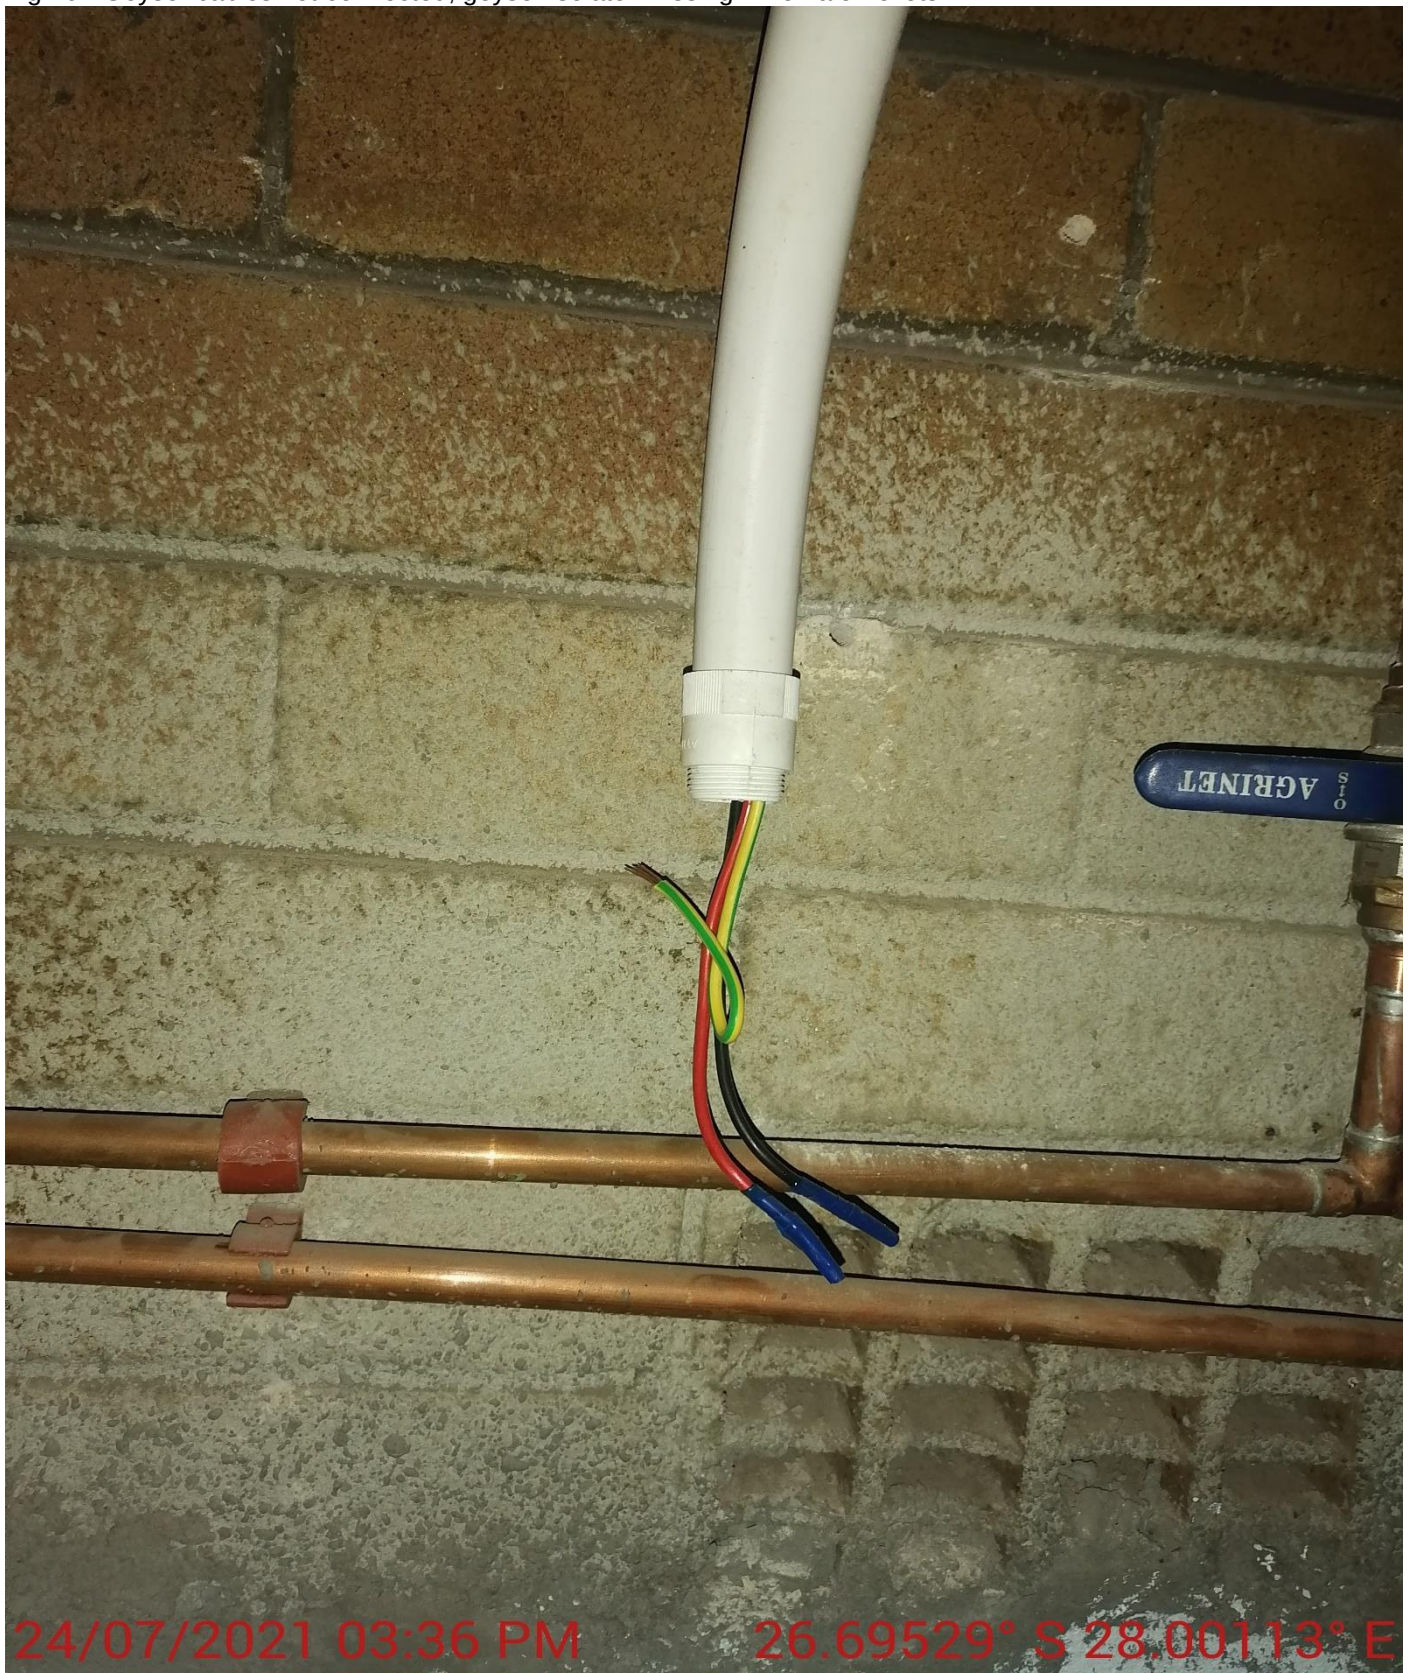
Fig 16 - Geyser cables not connected, geyser isolator missing – Female Toilets

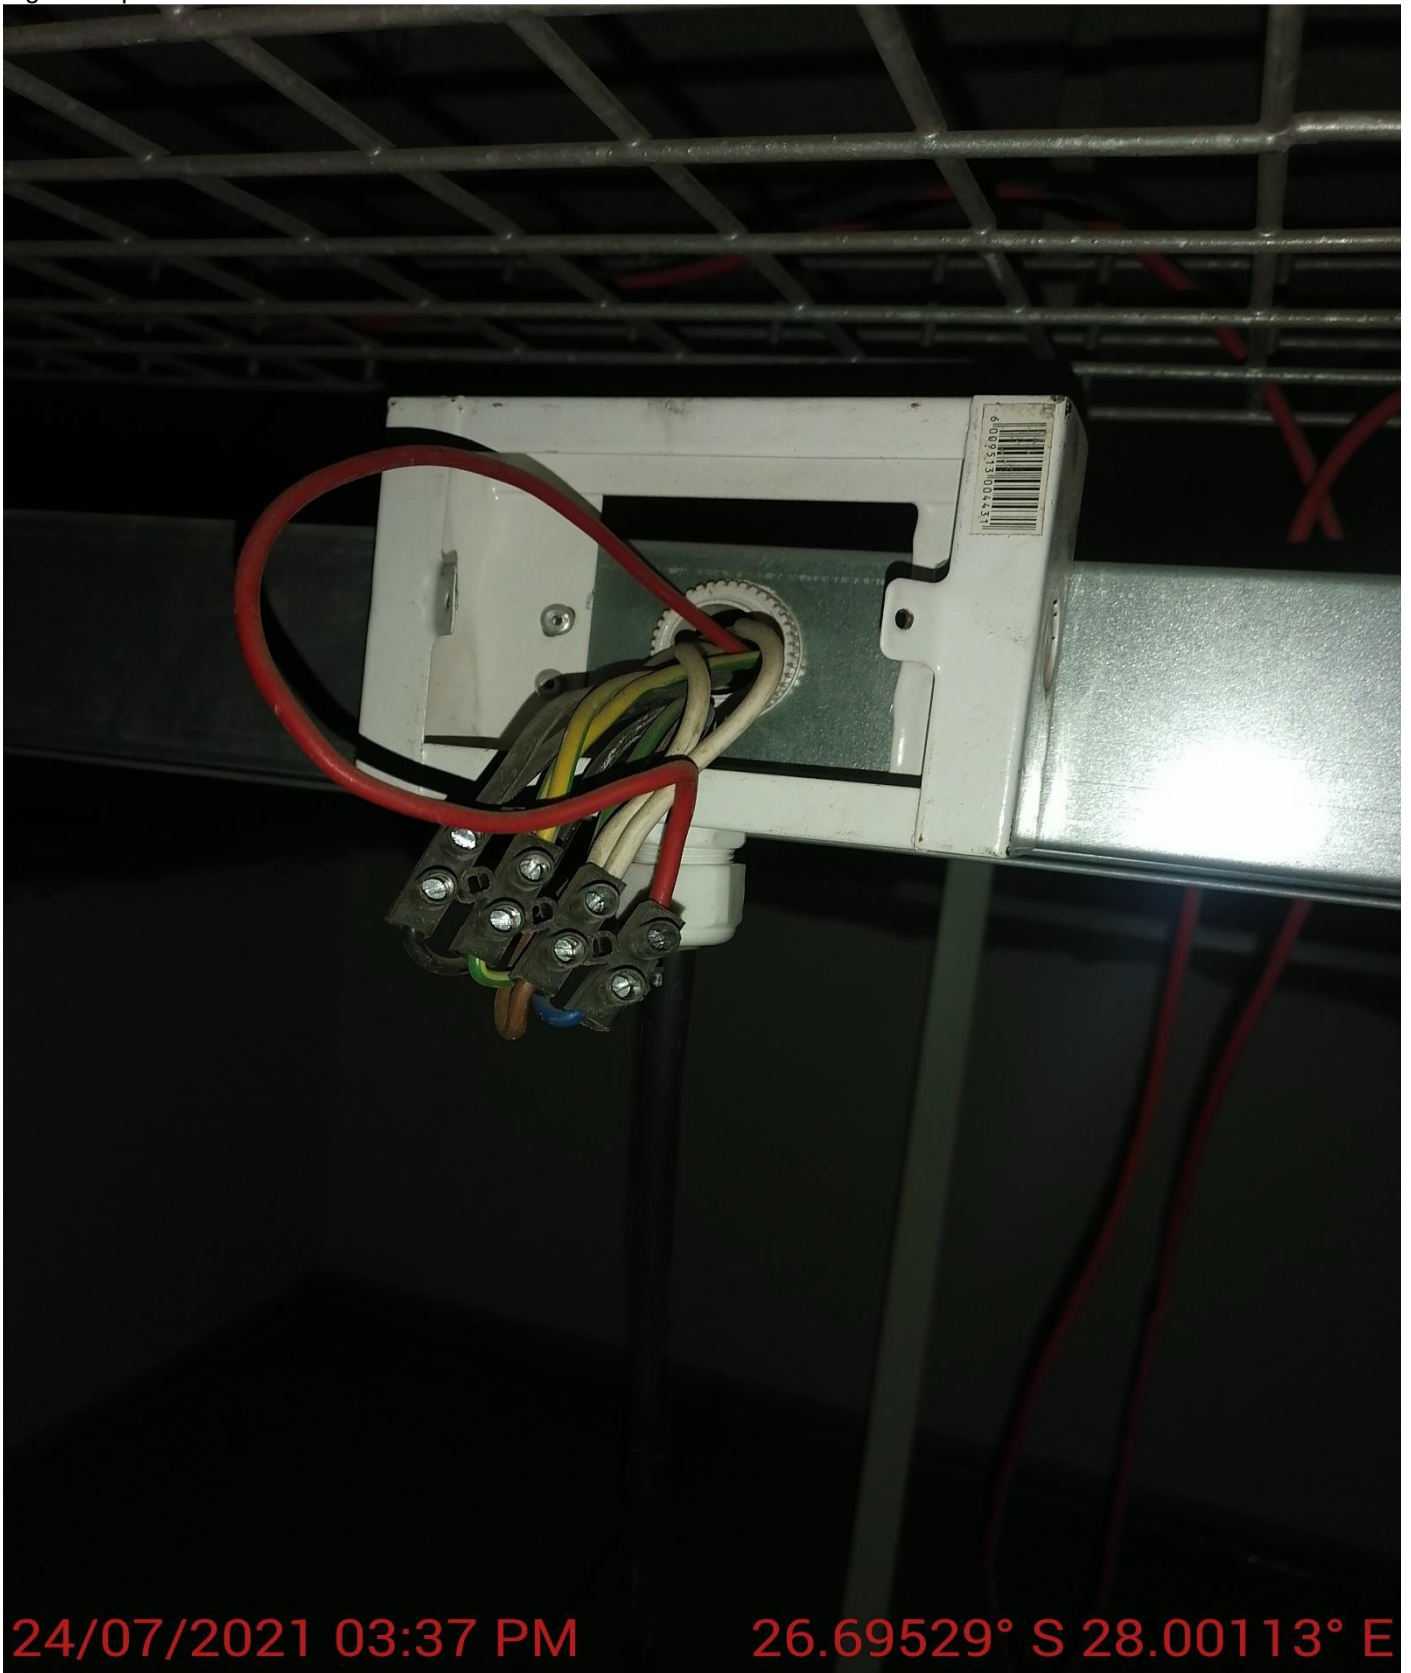
Fig 17 - Open Junction boxes

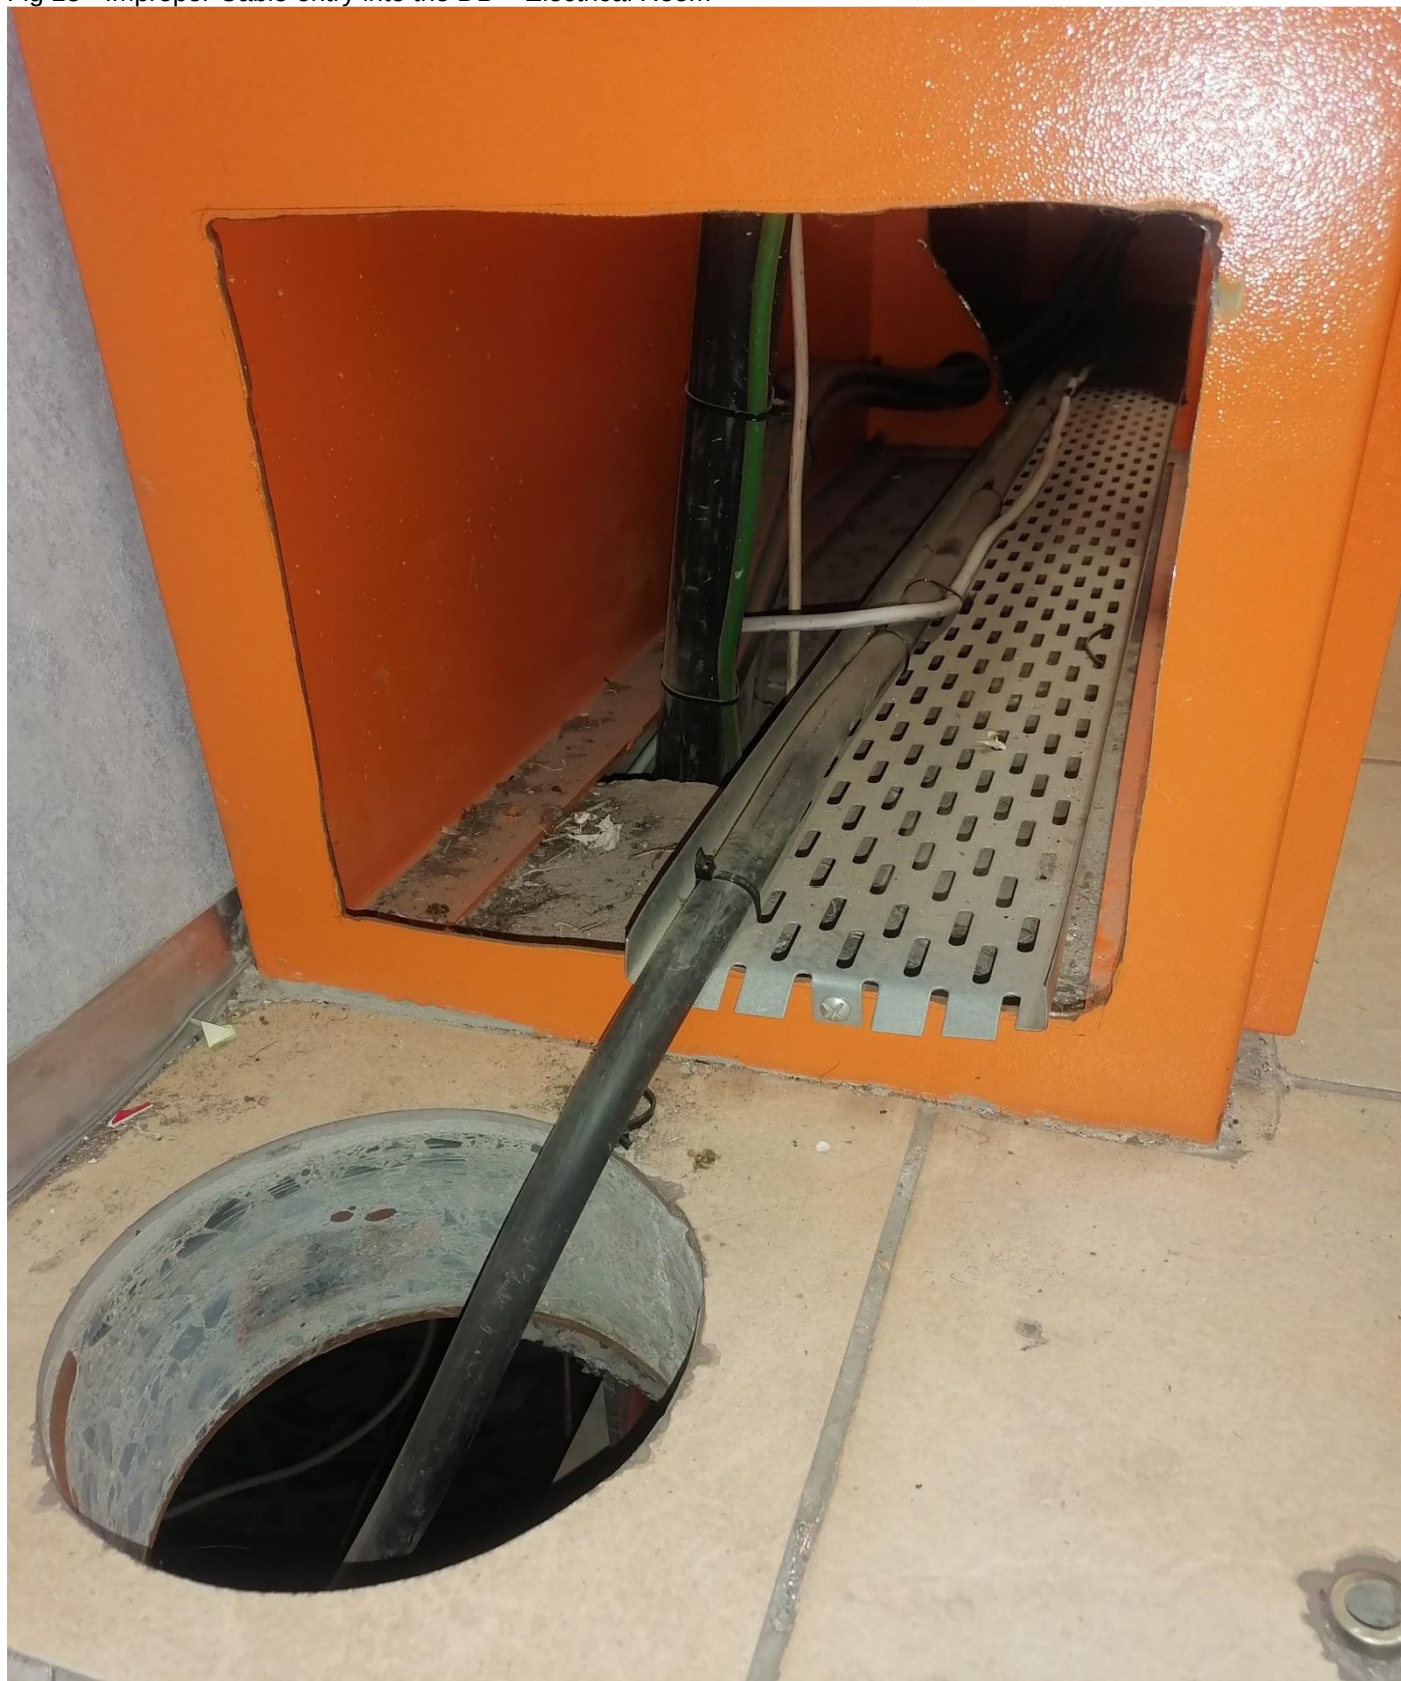
Fig 18 - Improper Cable entry into the DB – Electrical Room

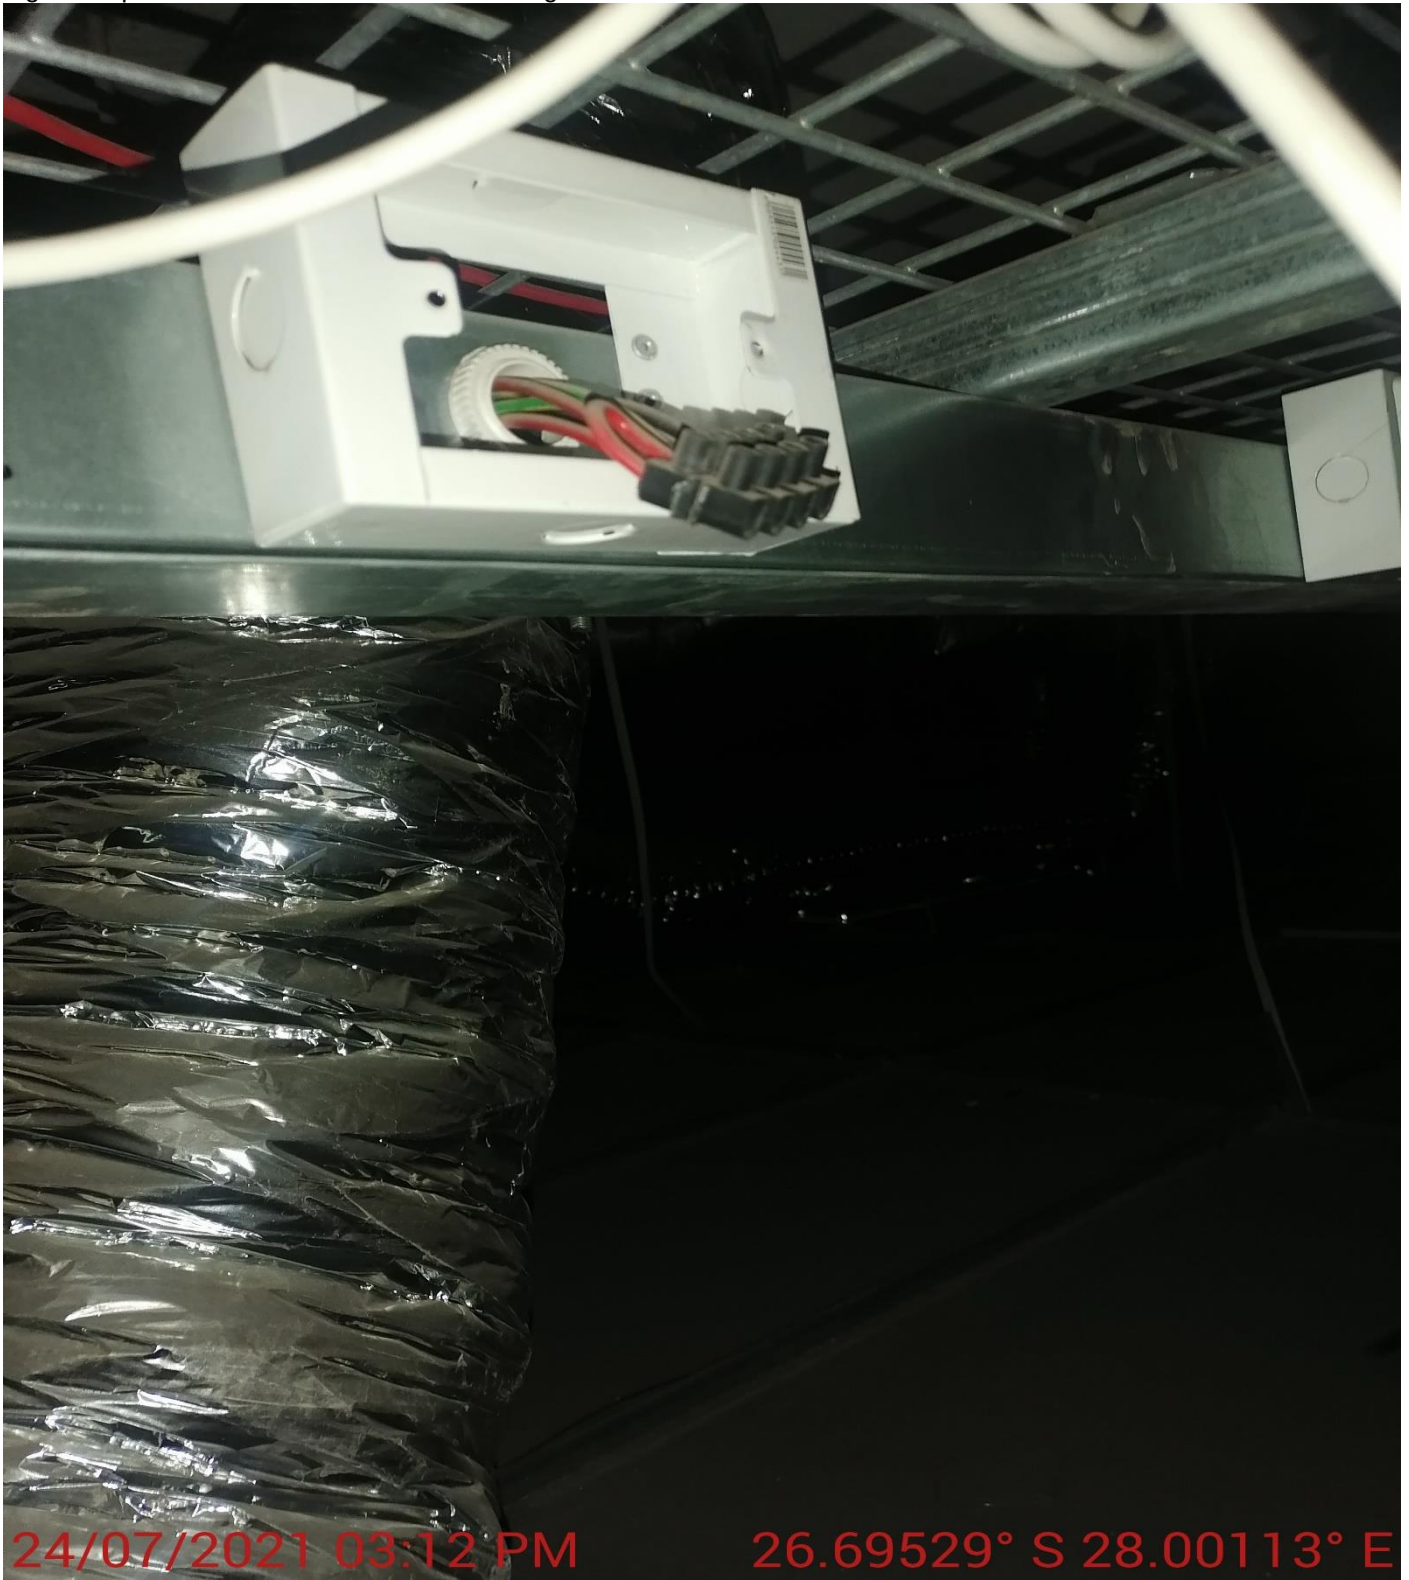
Fig 19 - Open Junction Boxes inside the ceiling void

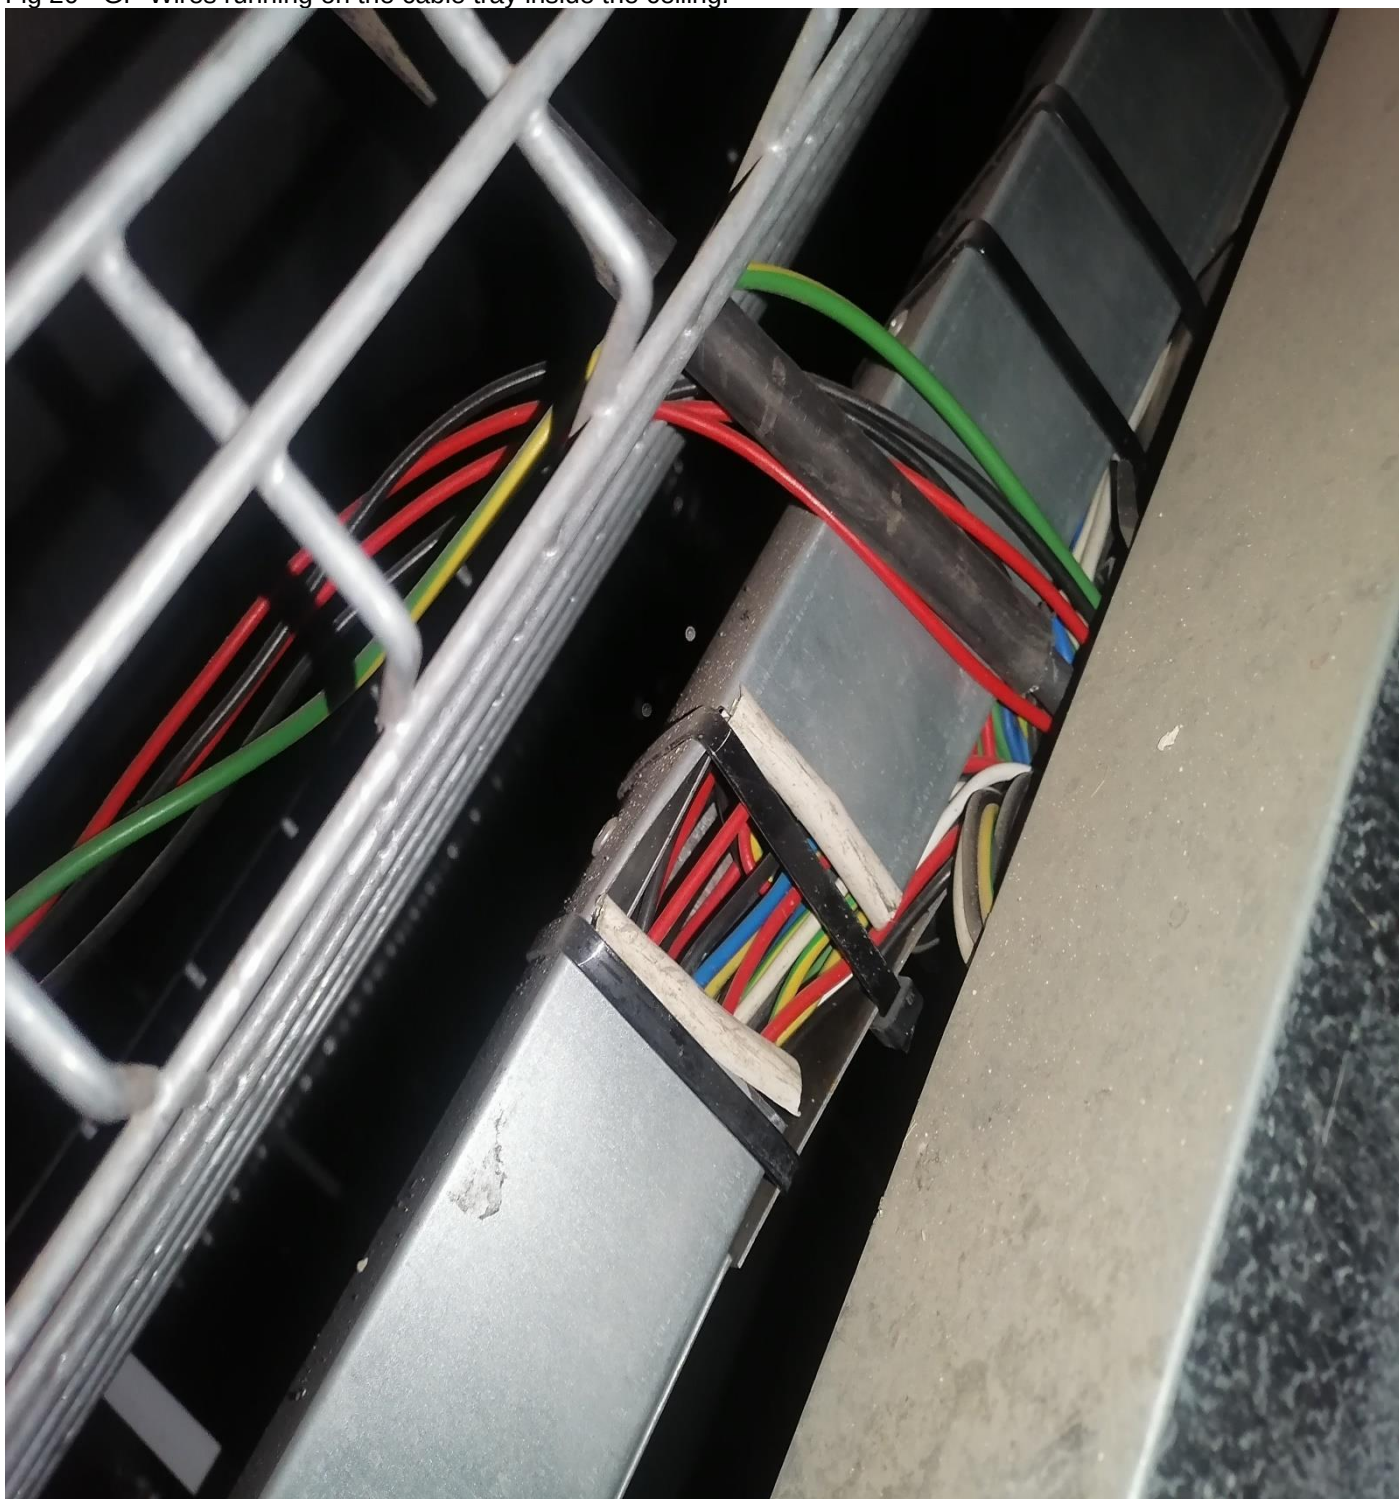
Fig 20 - GP Wires running on the cable tray inside the ceiling.

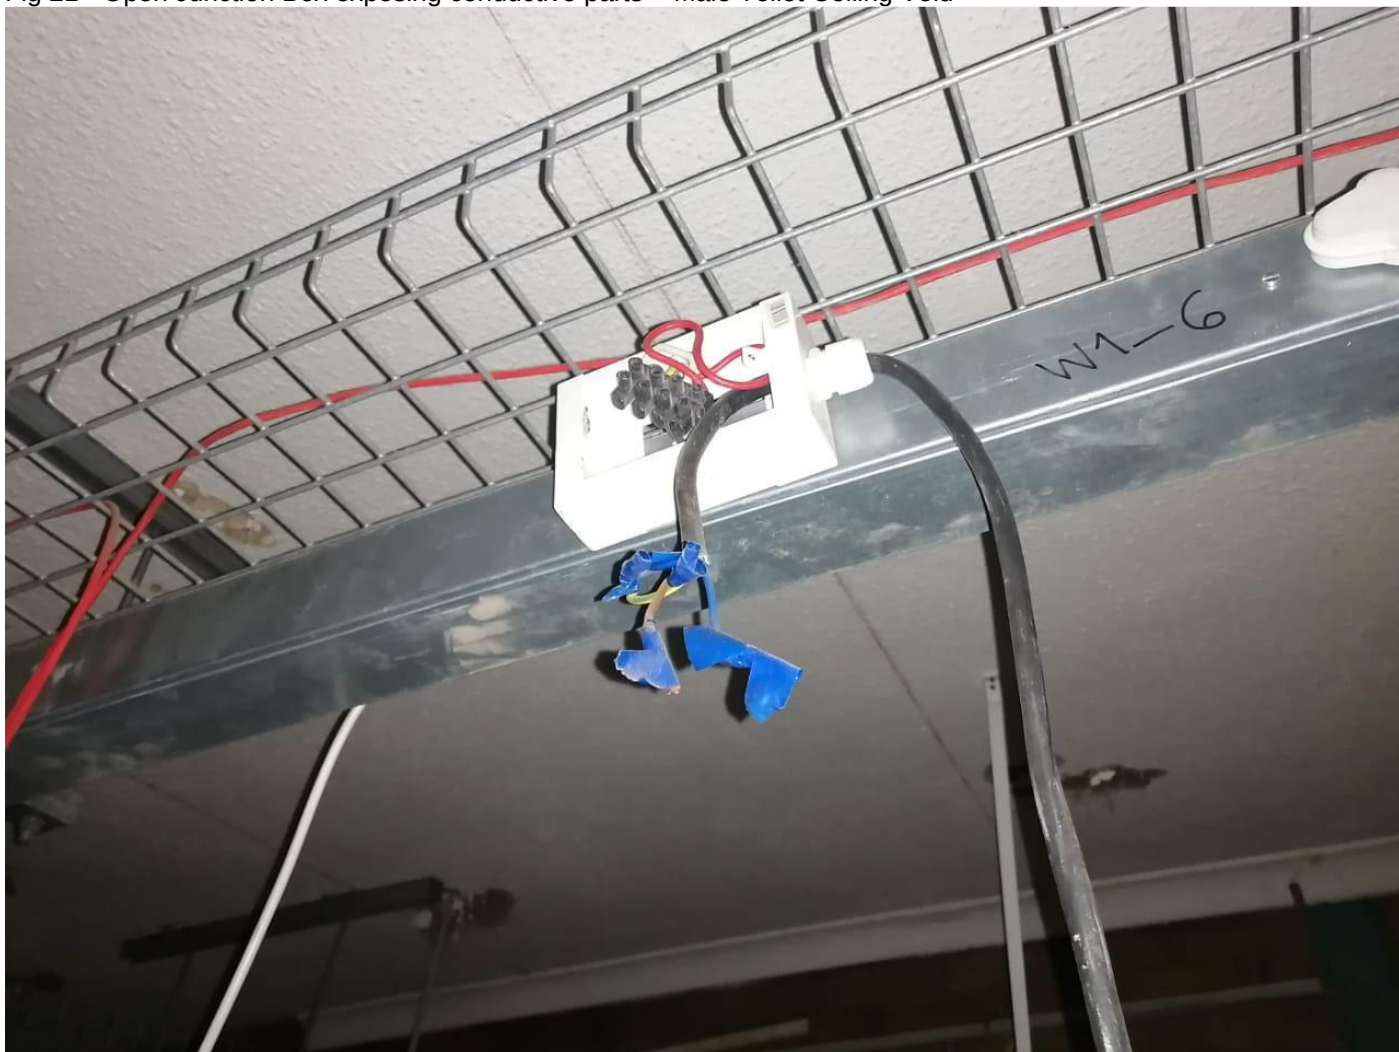
Fig 21 - Open Junction Box exposing conductive parts – Male Toilet Ceiling Void

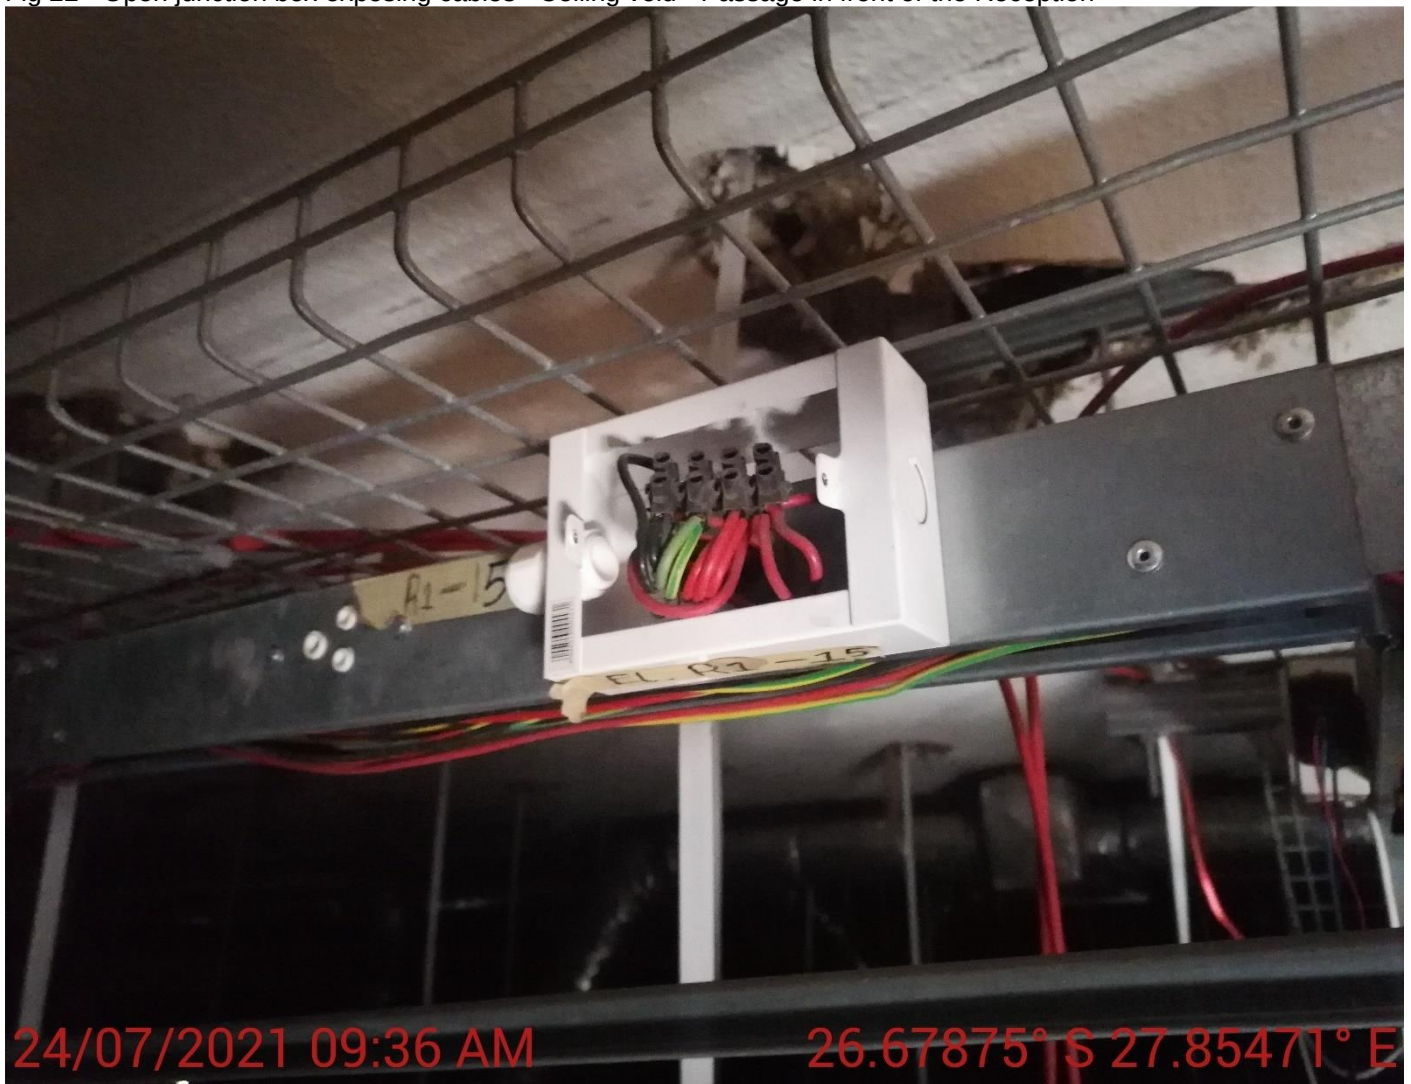
Fig 22 - Open junction box exposing cables– Ceiling void - Passage in front of the Reception

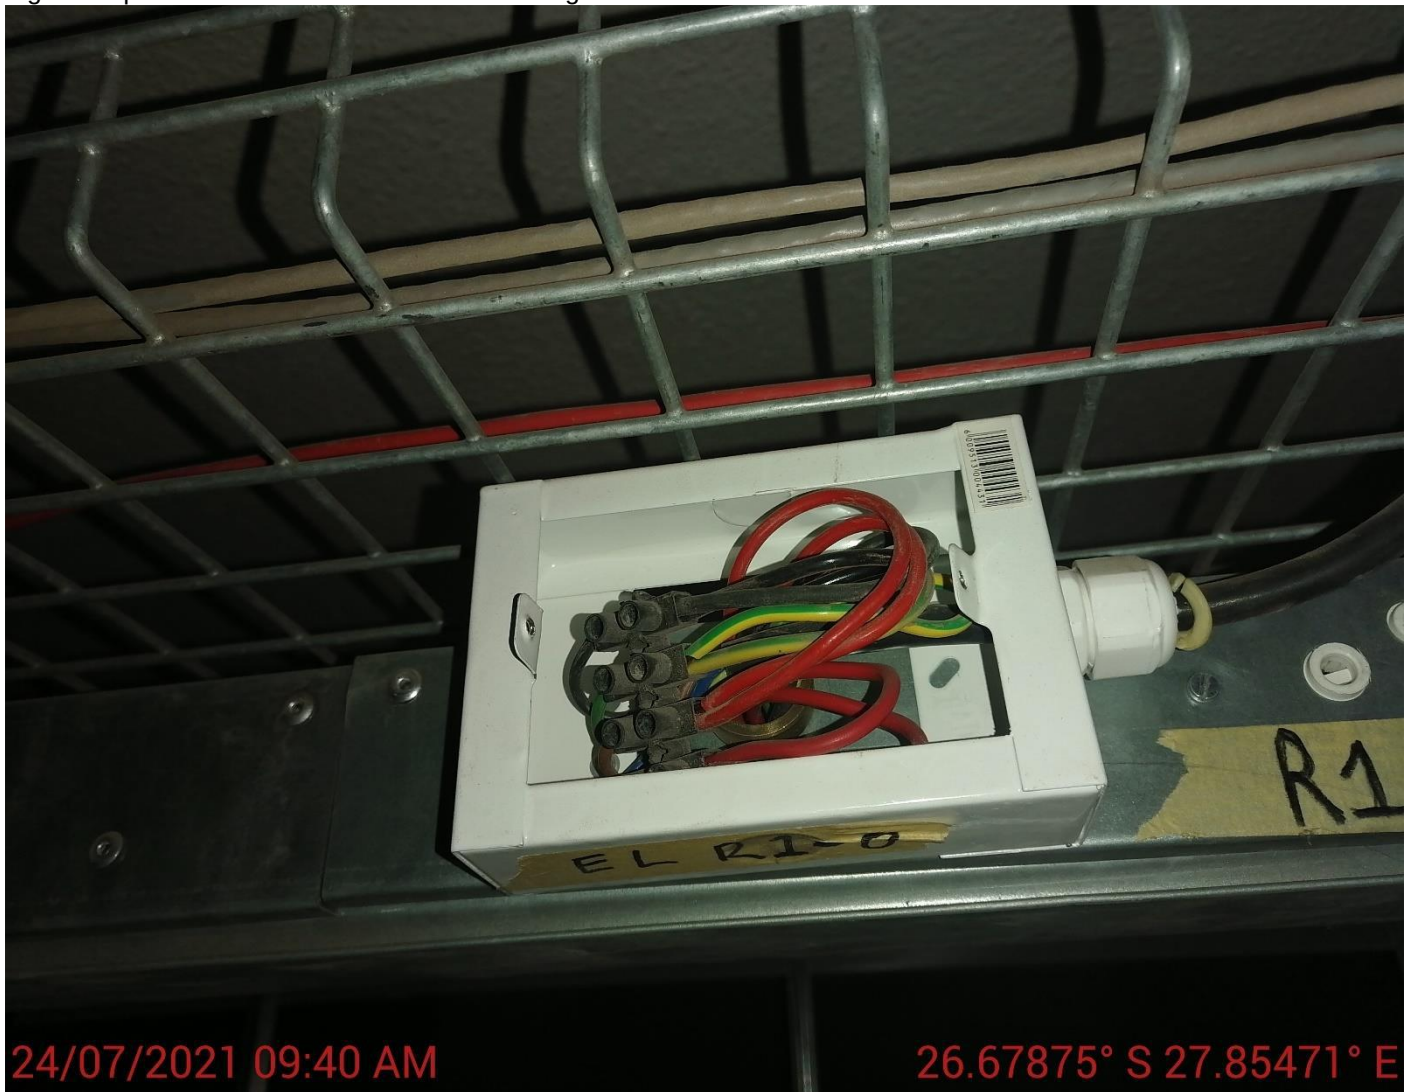
Fig 23 - Open Junction box – Tea Kitchen ceiling Void
