## REQUEST FOR BID CIDB

### 10397088 – Scope of Work

Repair all non-compliance at no.1 Control room as per Scope Below:  
Pricing to include all spares required and labor.

Work to be done at Rand Water Zuikerbosch

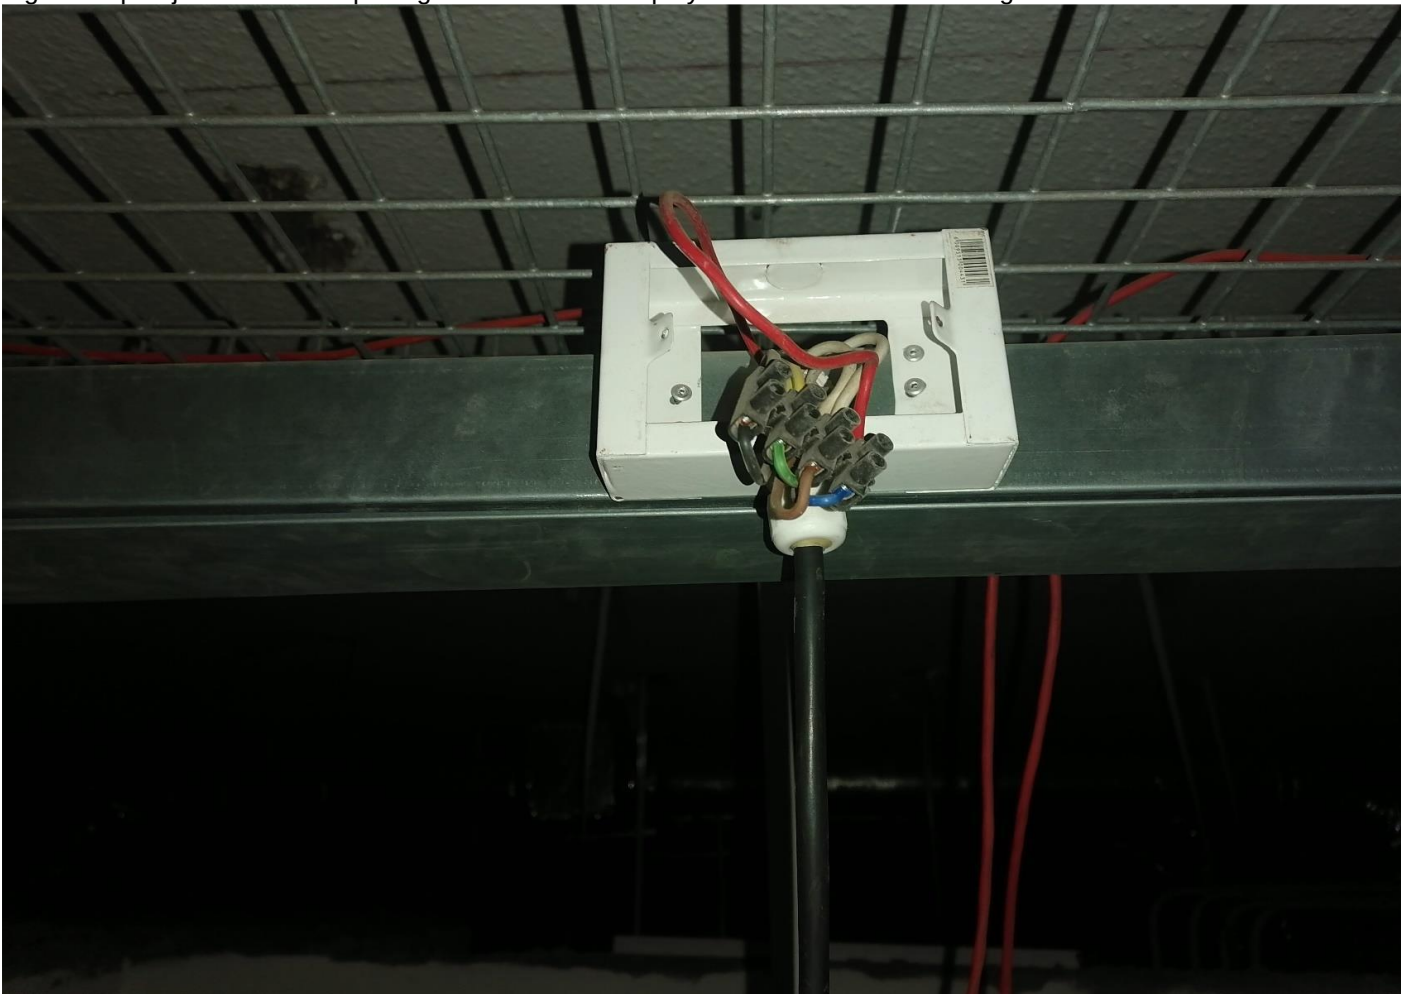
Fig 24 - Open junction Box exposing connections – Employee Relations Office Ceiling Void.

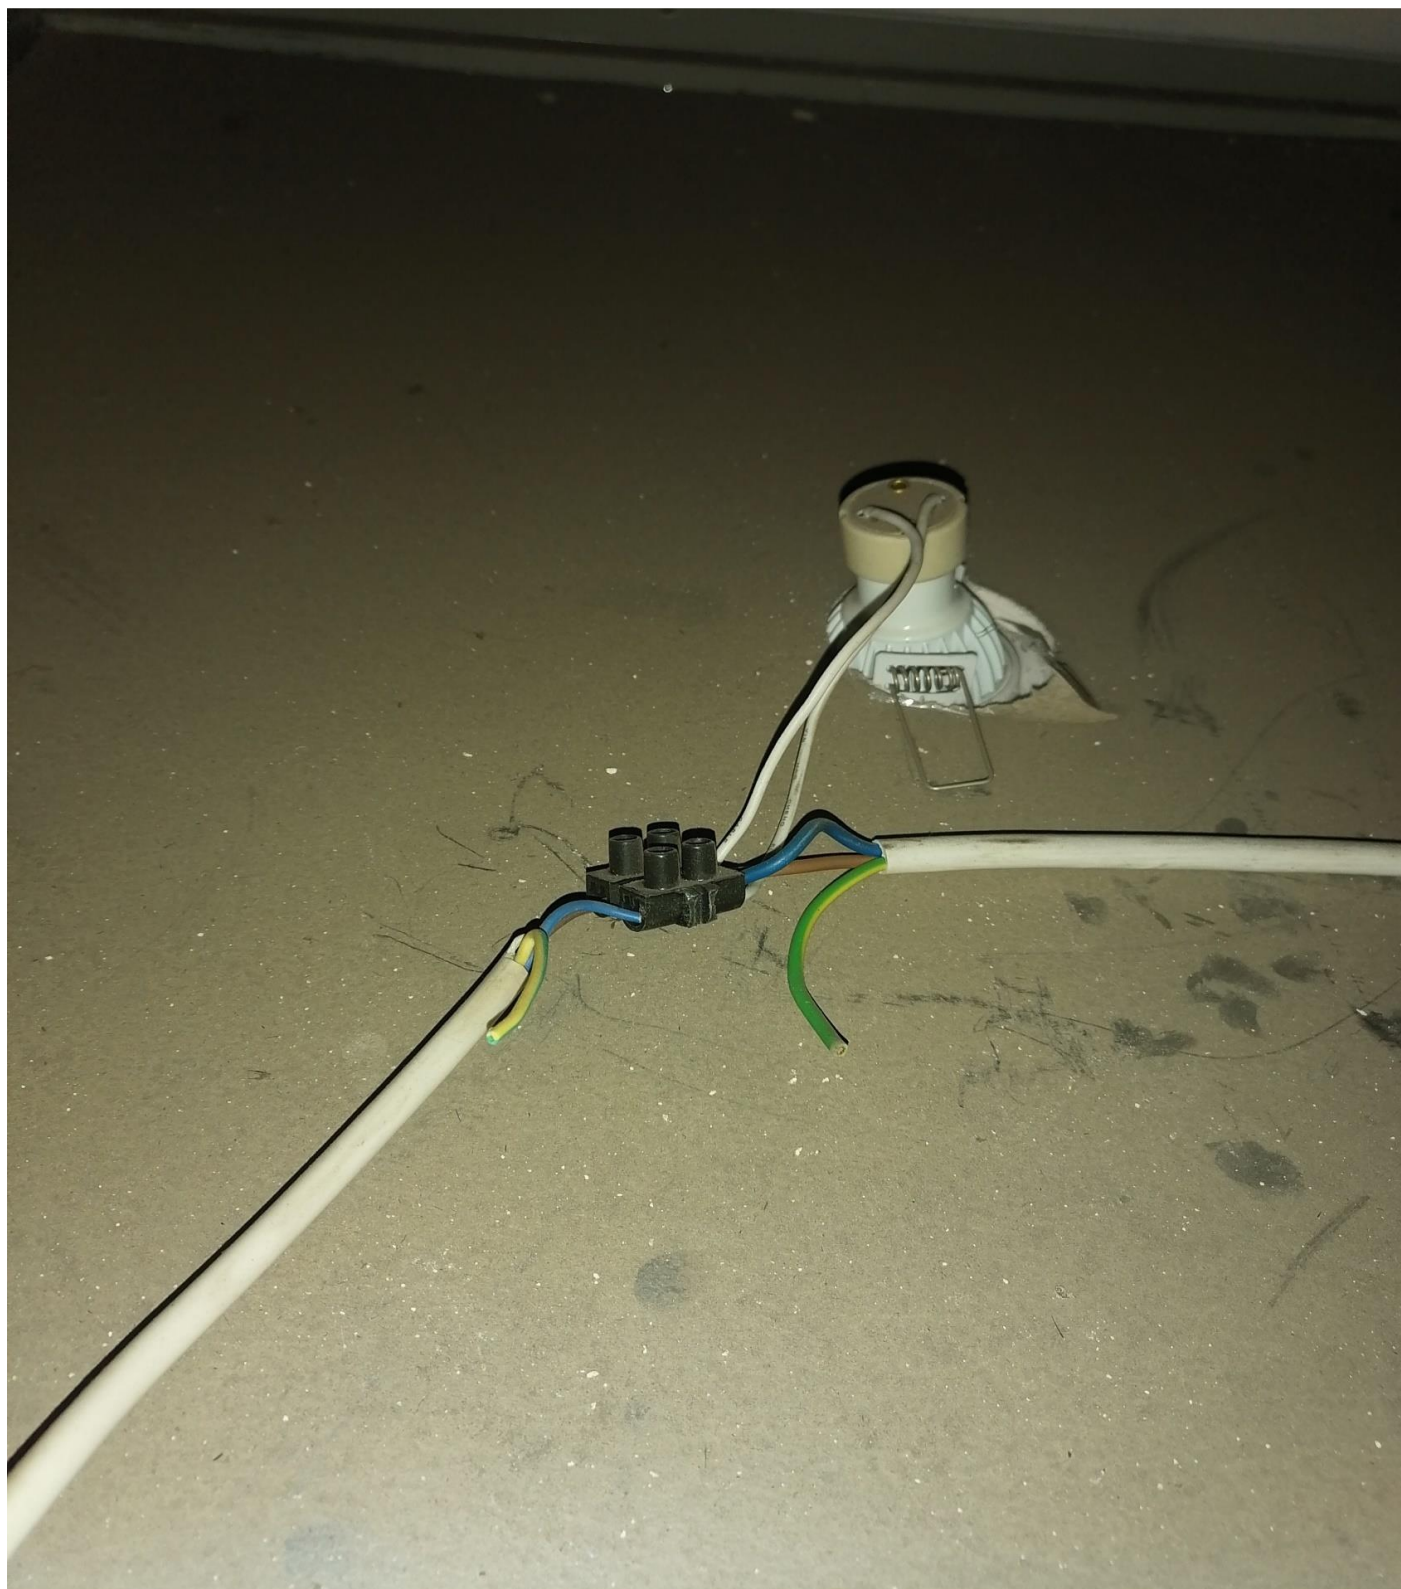
Fig 25 - Improper connections inside the ceiling void – Passage down lights

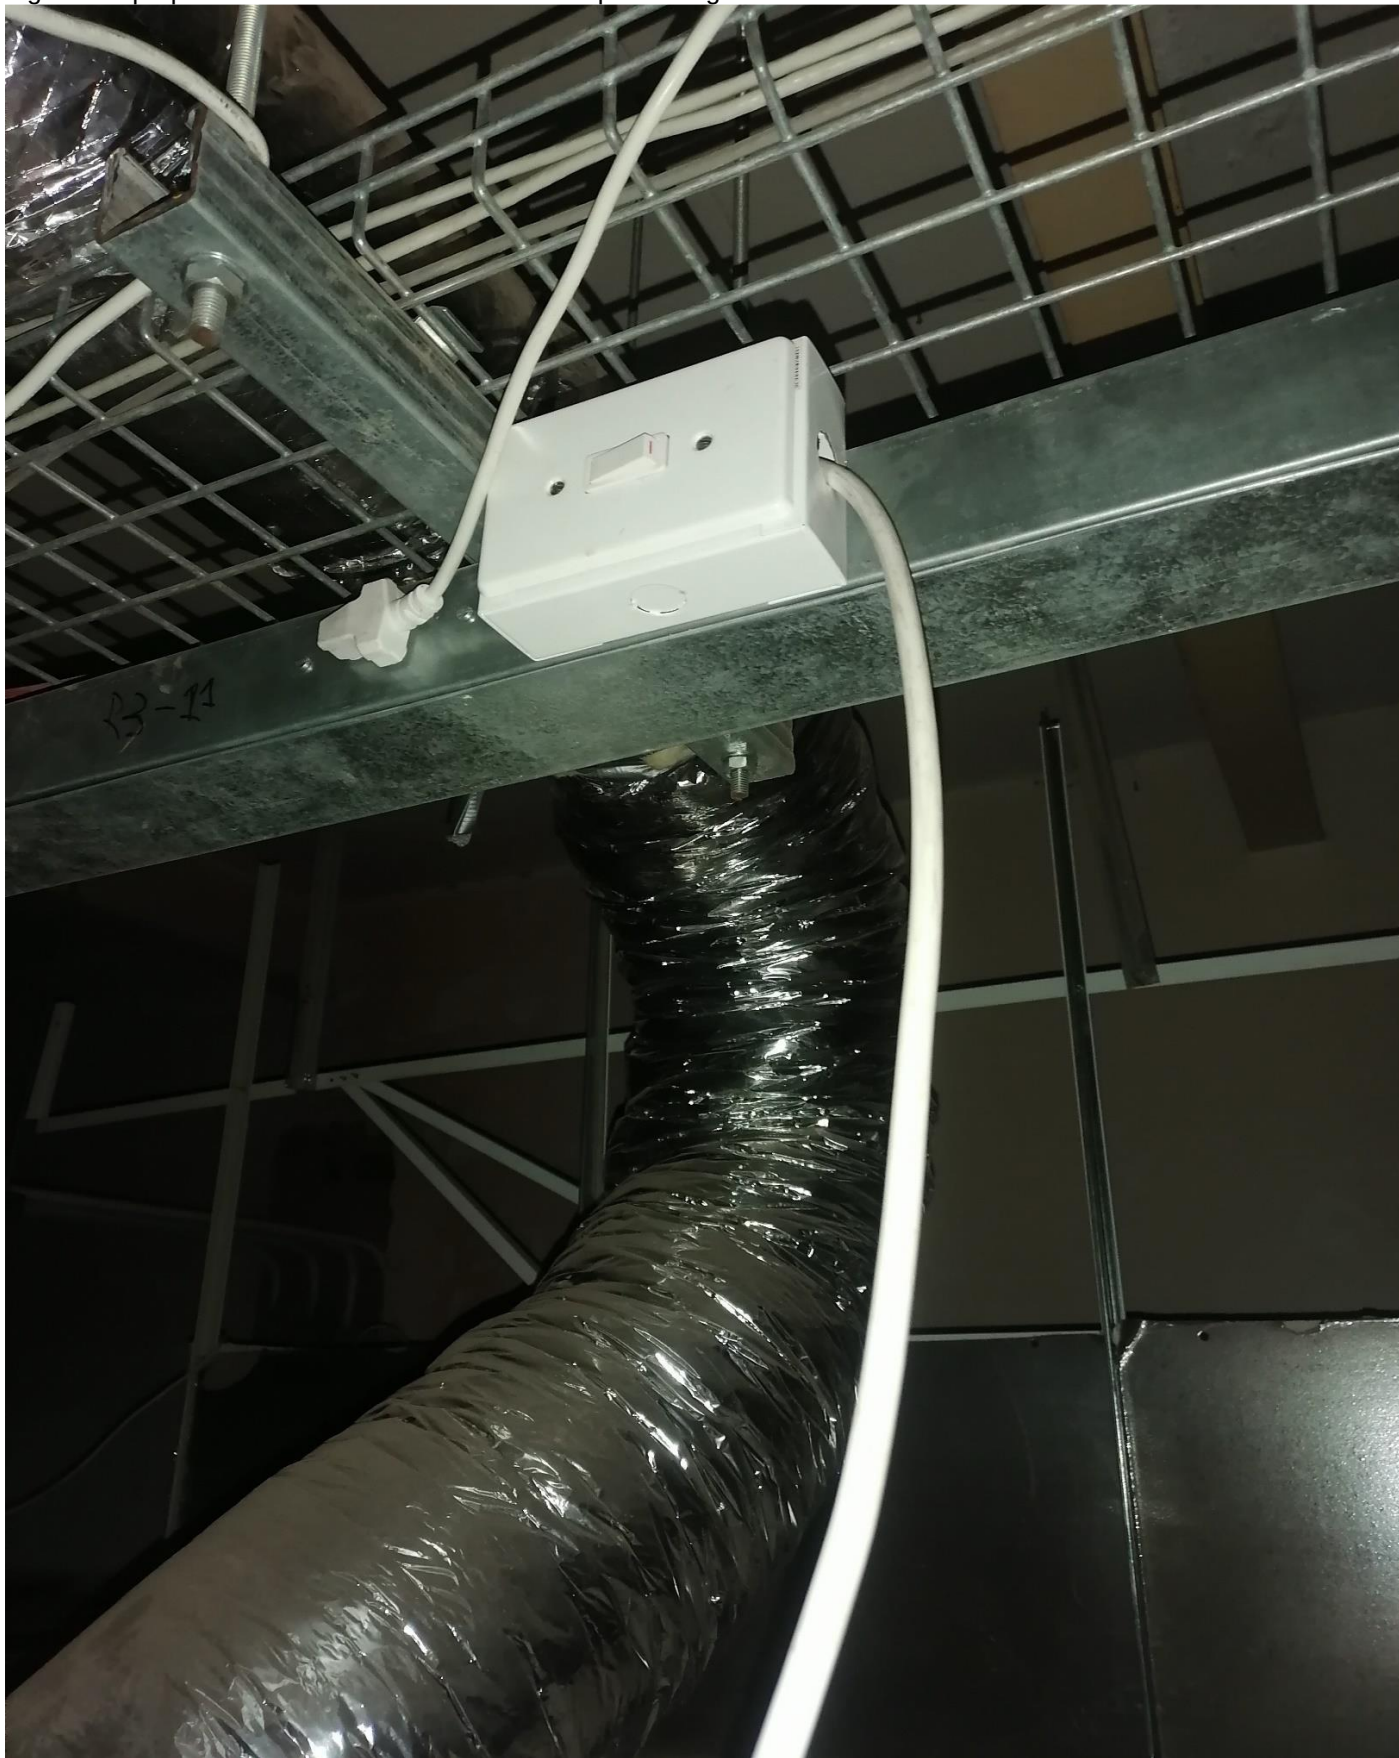
Fig 26 - Improper Cable termination – without compression glands

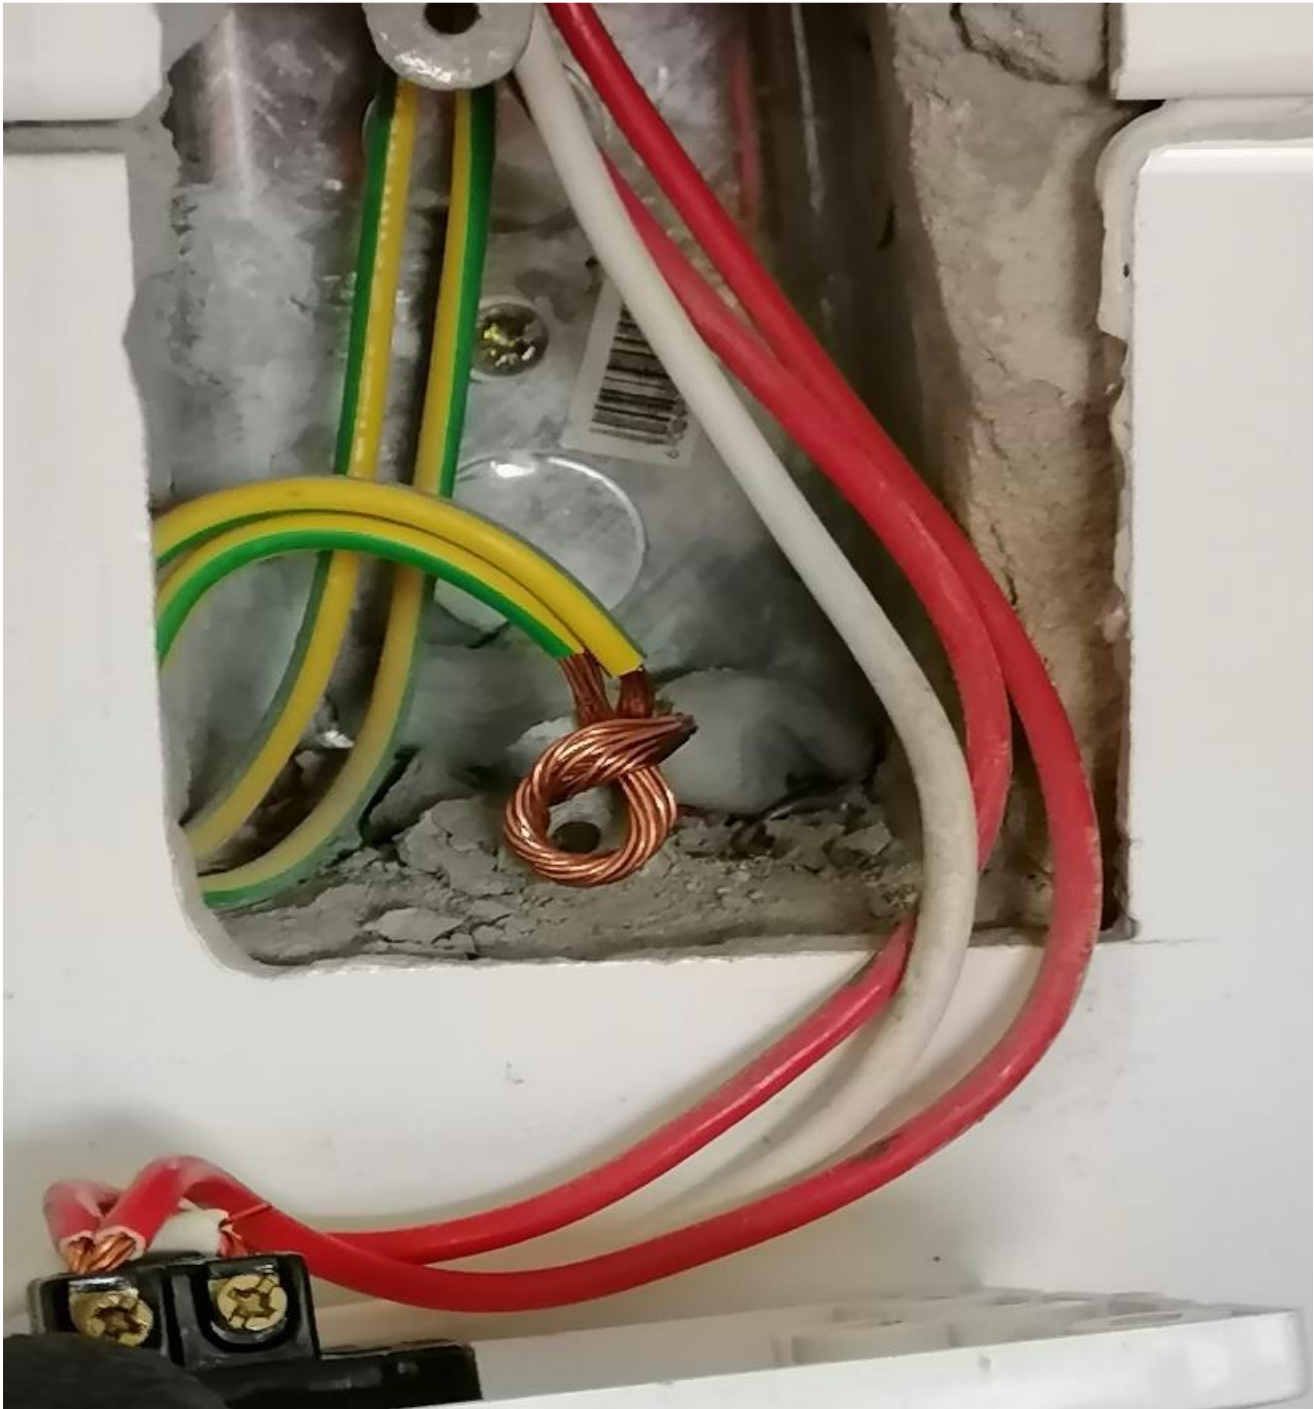
Fig 27 – Improper earth terminations on switch boxes.  
Tea Kitchen Switch

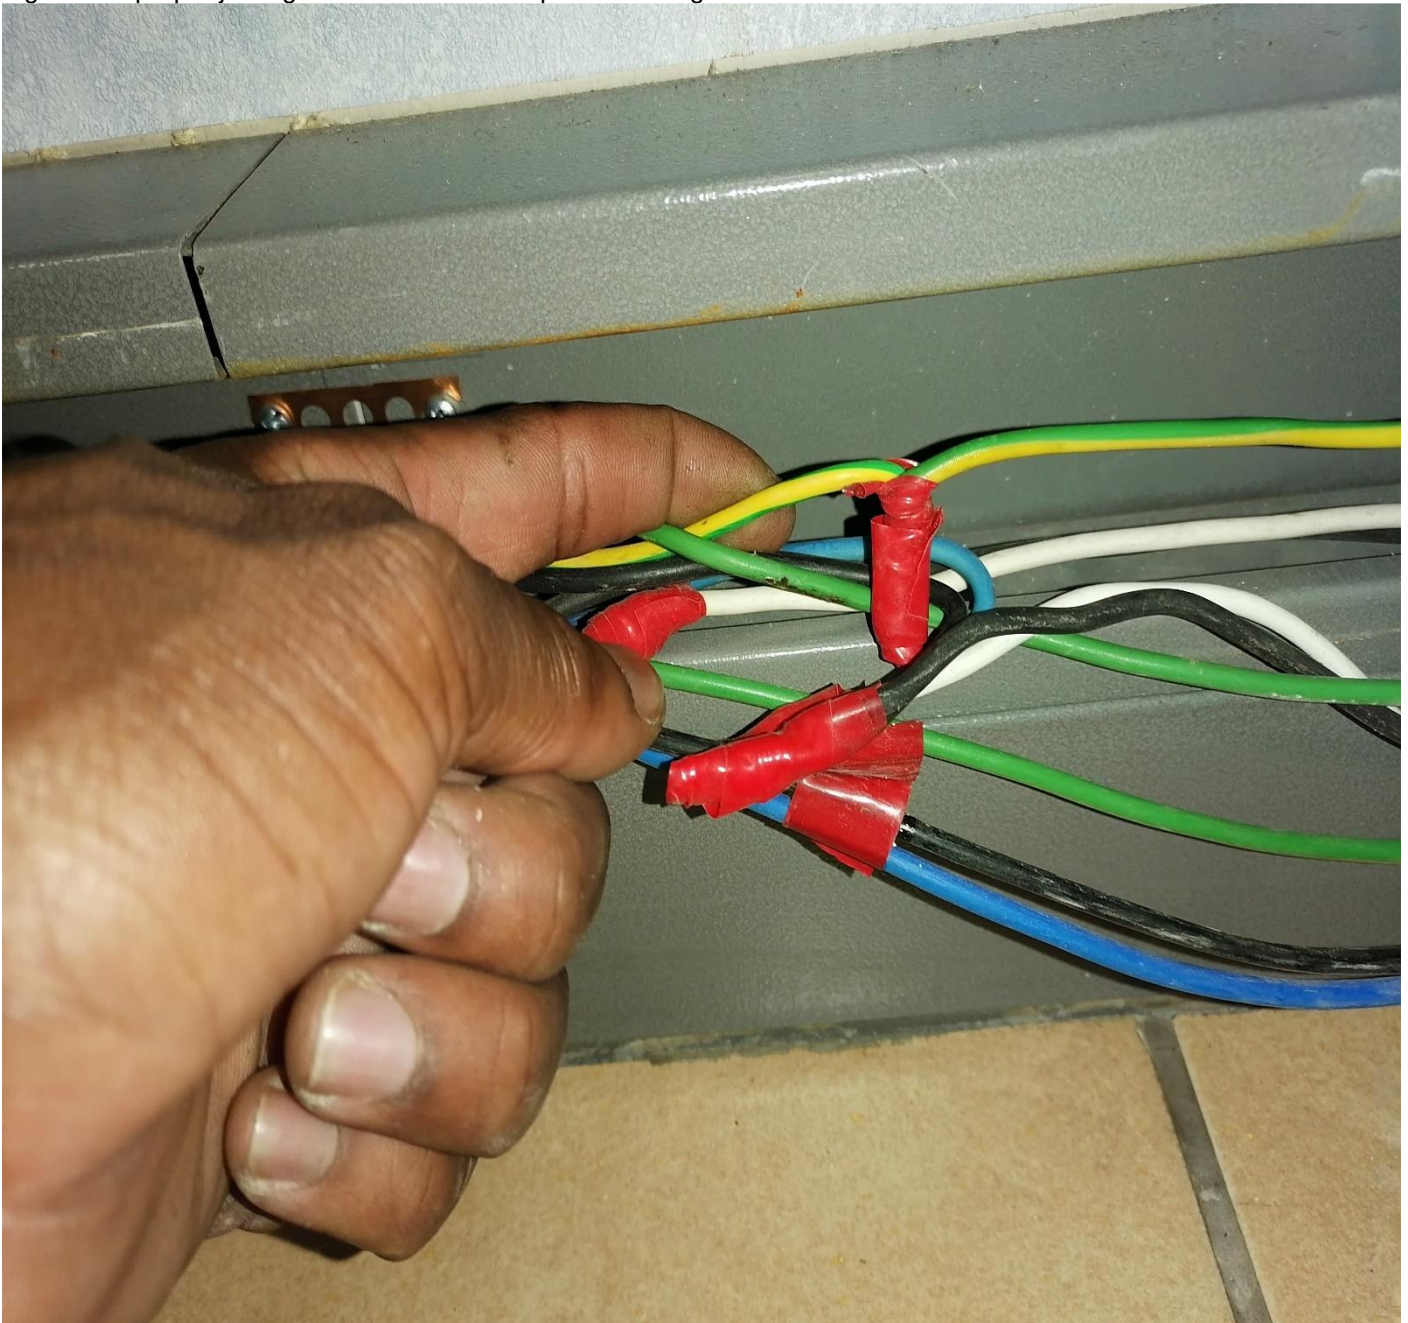
Fig 28 – Improper joining of cables inside the power skirting.
