## REQUEST FOR BID CIDB

### 10397088 – Scope of Work

Repair all non-compliance at no.1 Control room as per Scope Below:  
Pricing to include all spares required and labor.

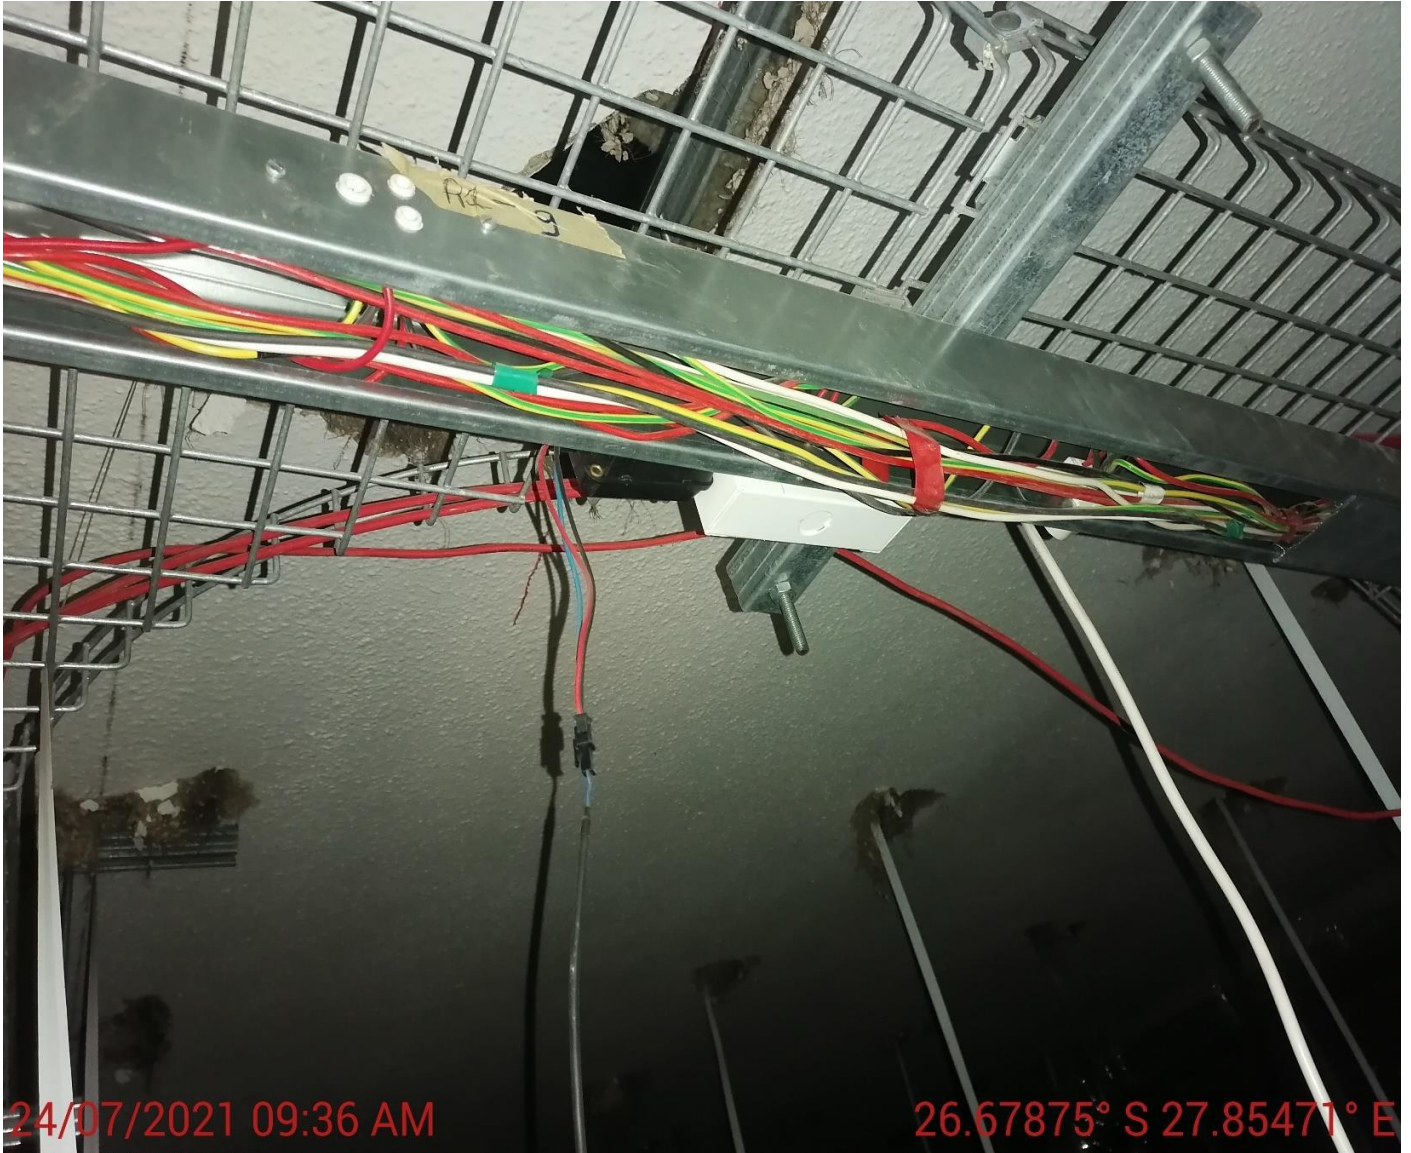
Fig 1 - Open trucking covers inside the ceiling exposing GP wires – Reception Ceiling Void

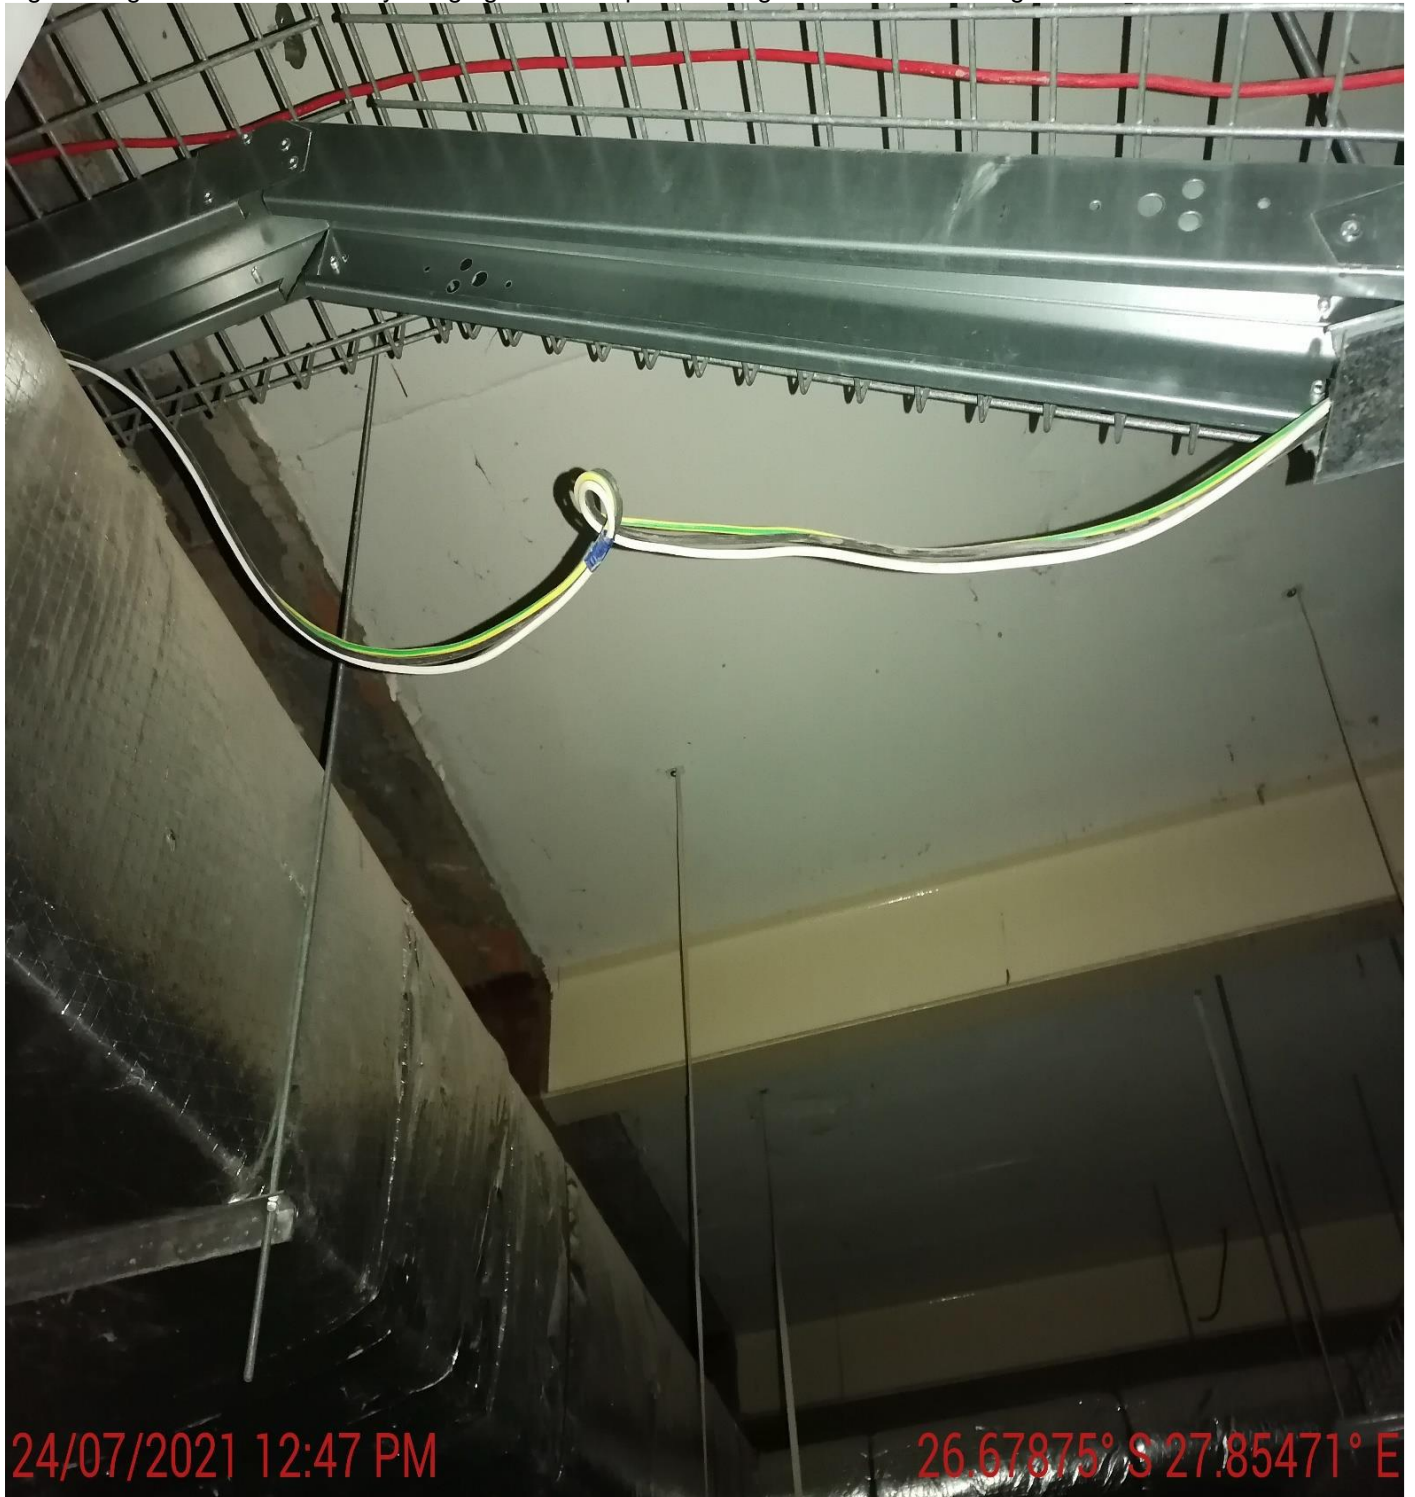
Fig 4 - Single core cables loosely hanging from the open trunking – Office 7 & 8 ceiling Void.

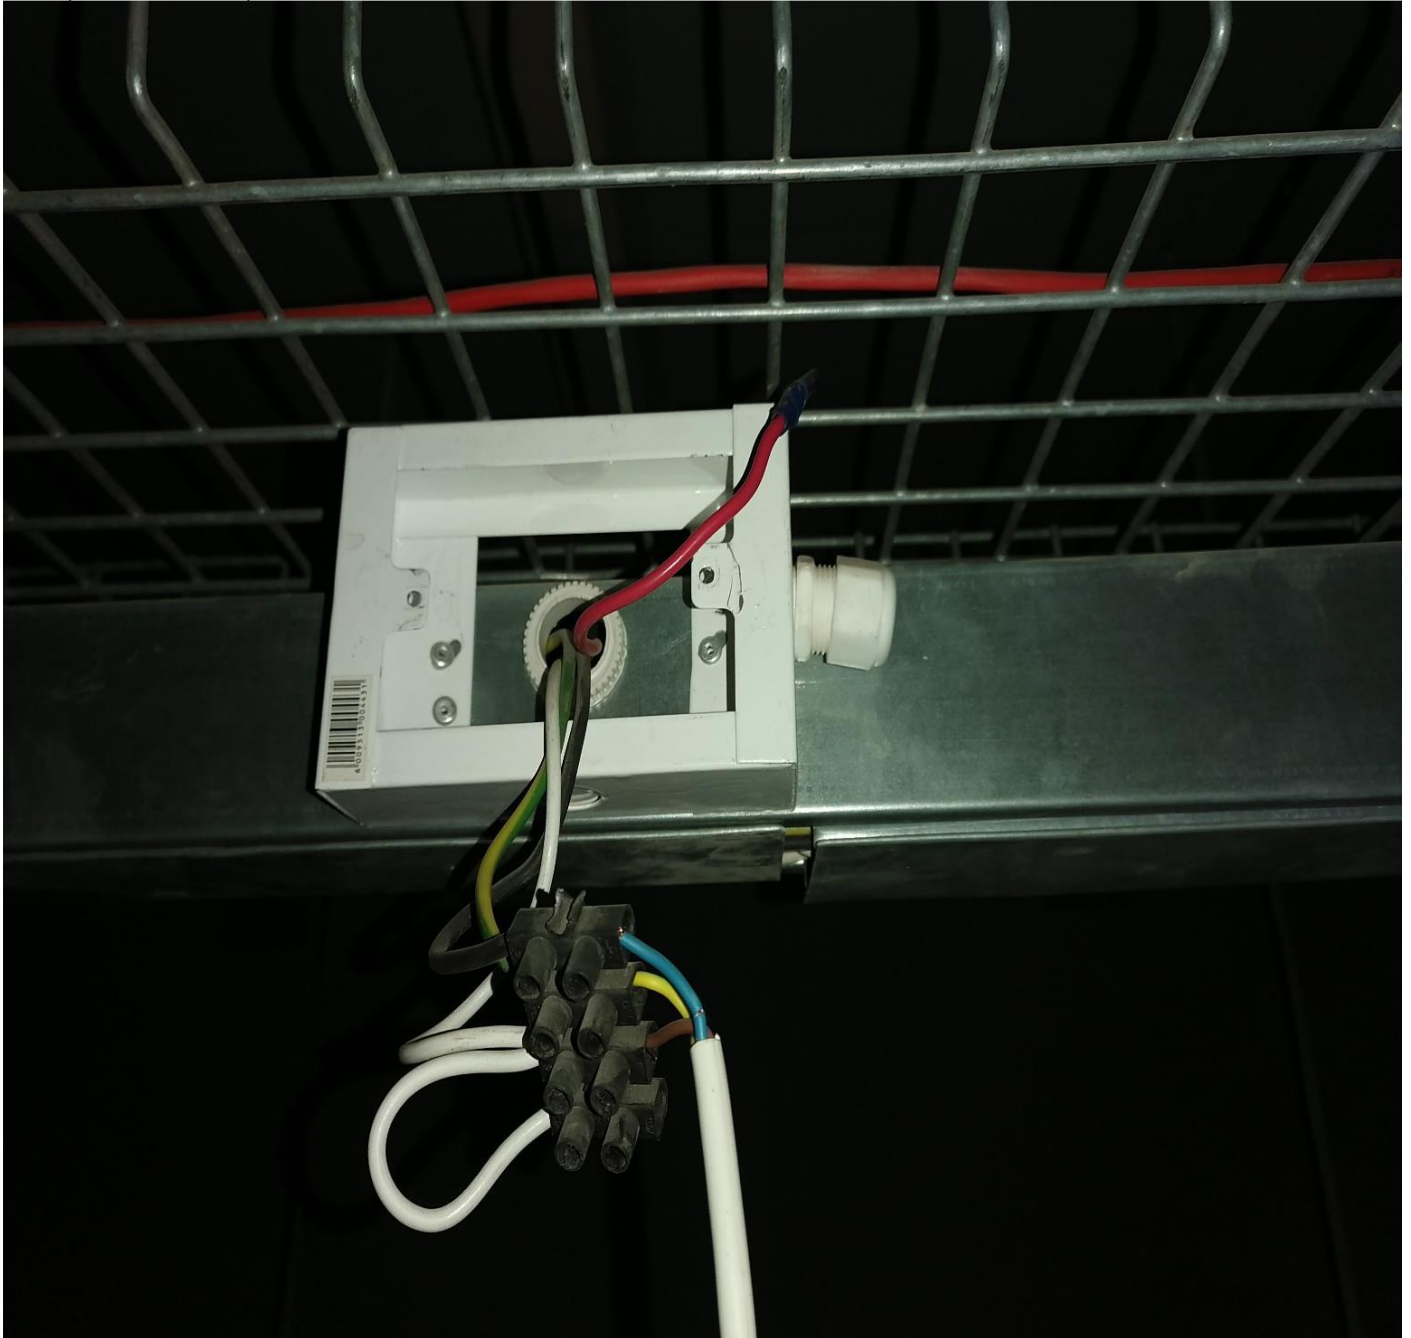
Fig 5 - Open junction boxes exposing connections and improper cable termination (without the use of glands) – Open Plan (Lavika's Office)

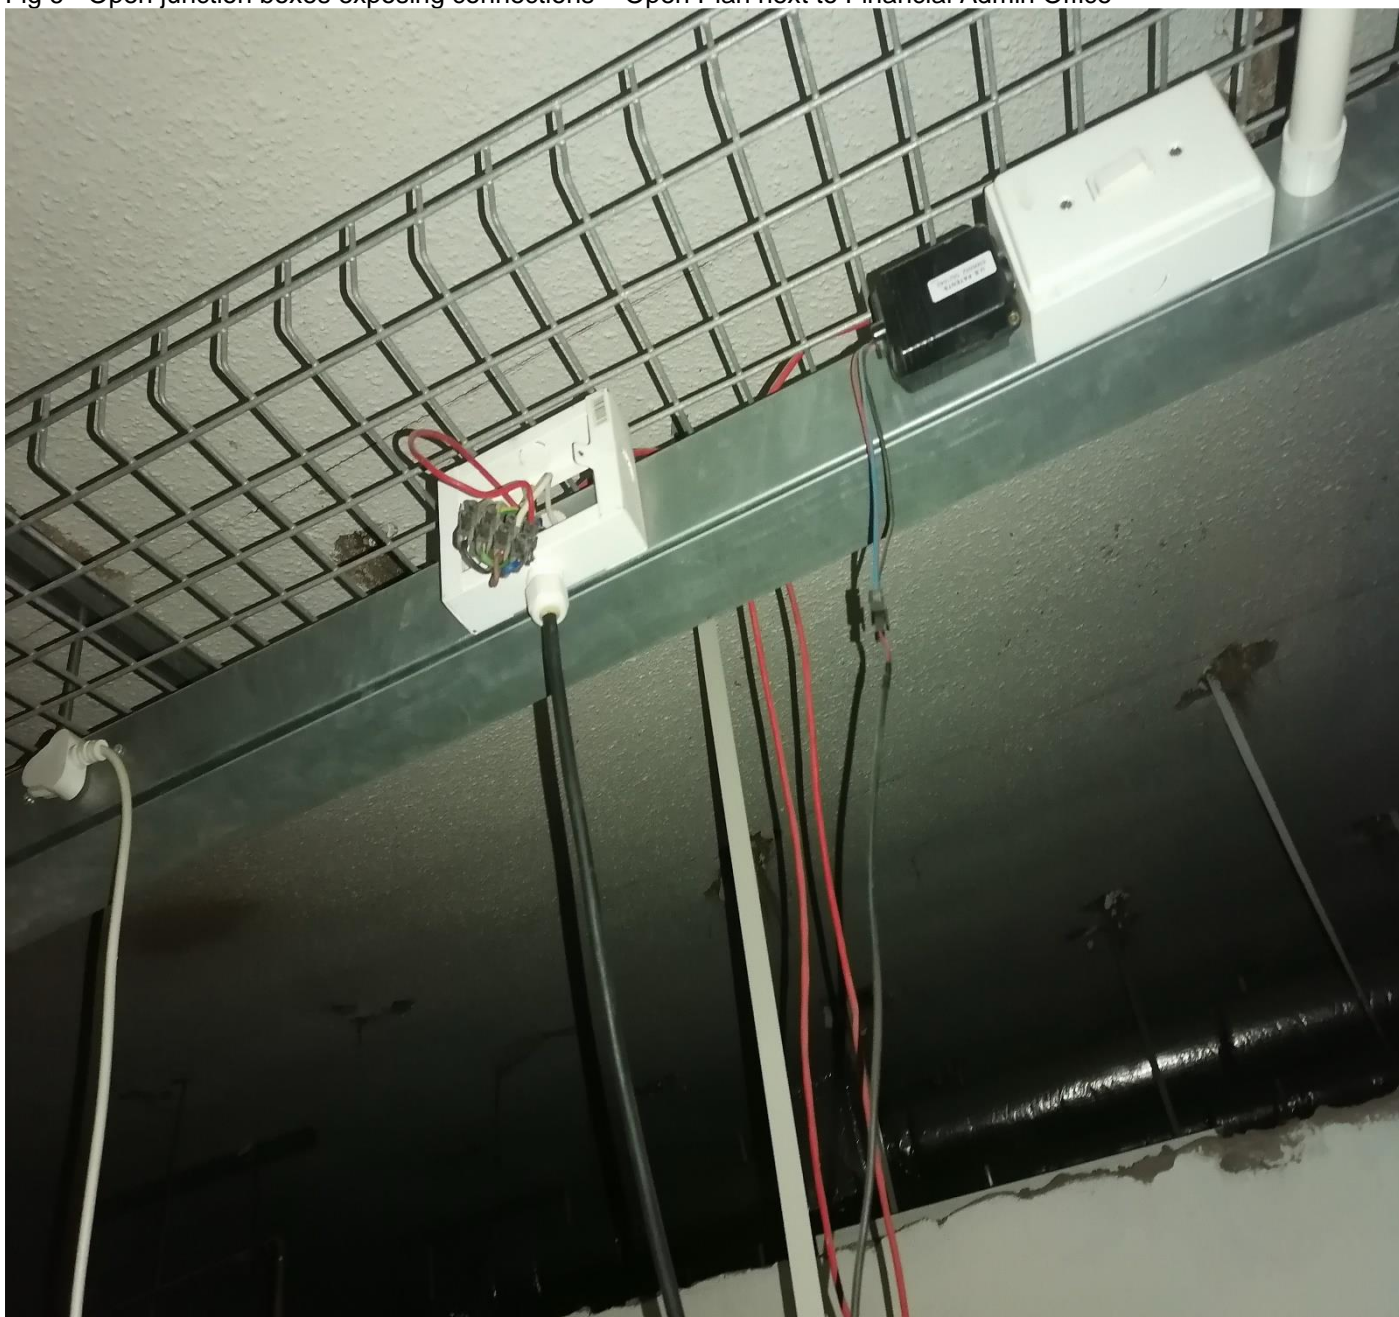
Fig 6 - Open junction boxes exposing connections – Open Plan next to Financial Admin Office

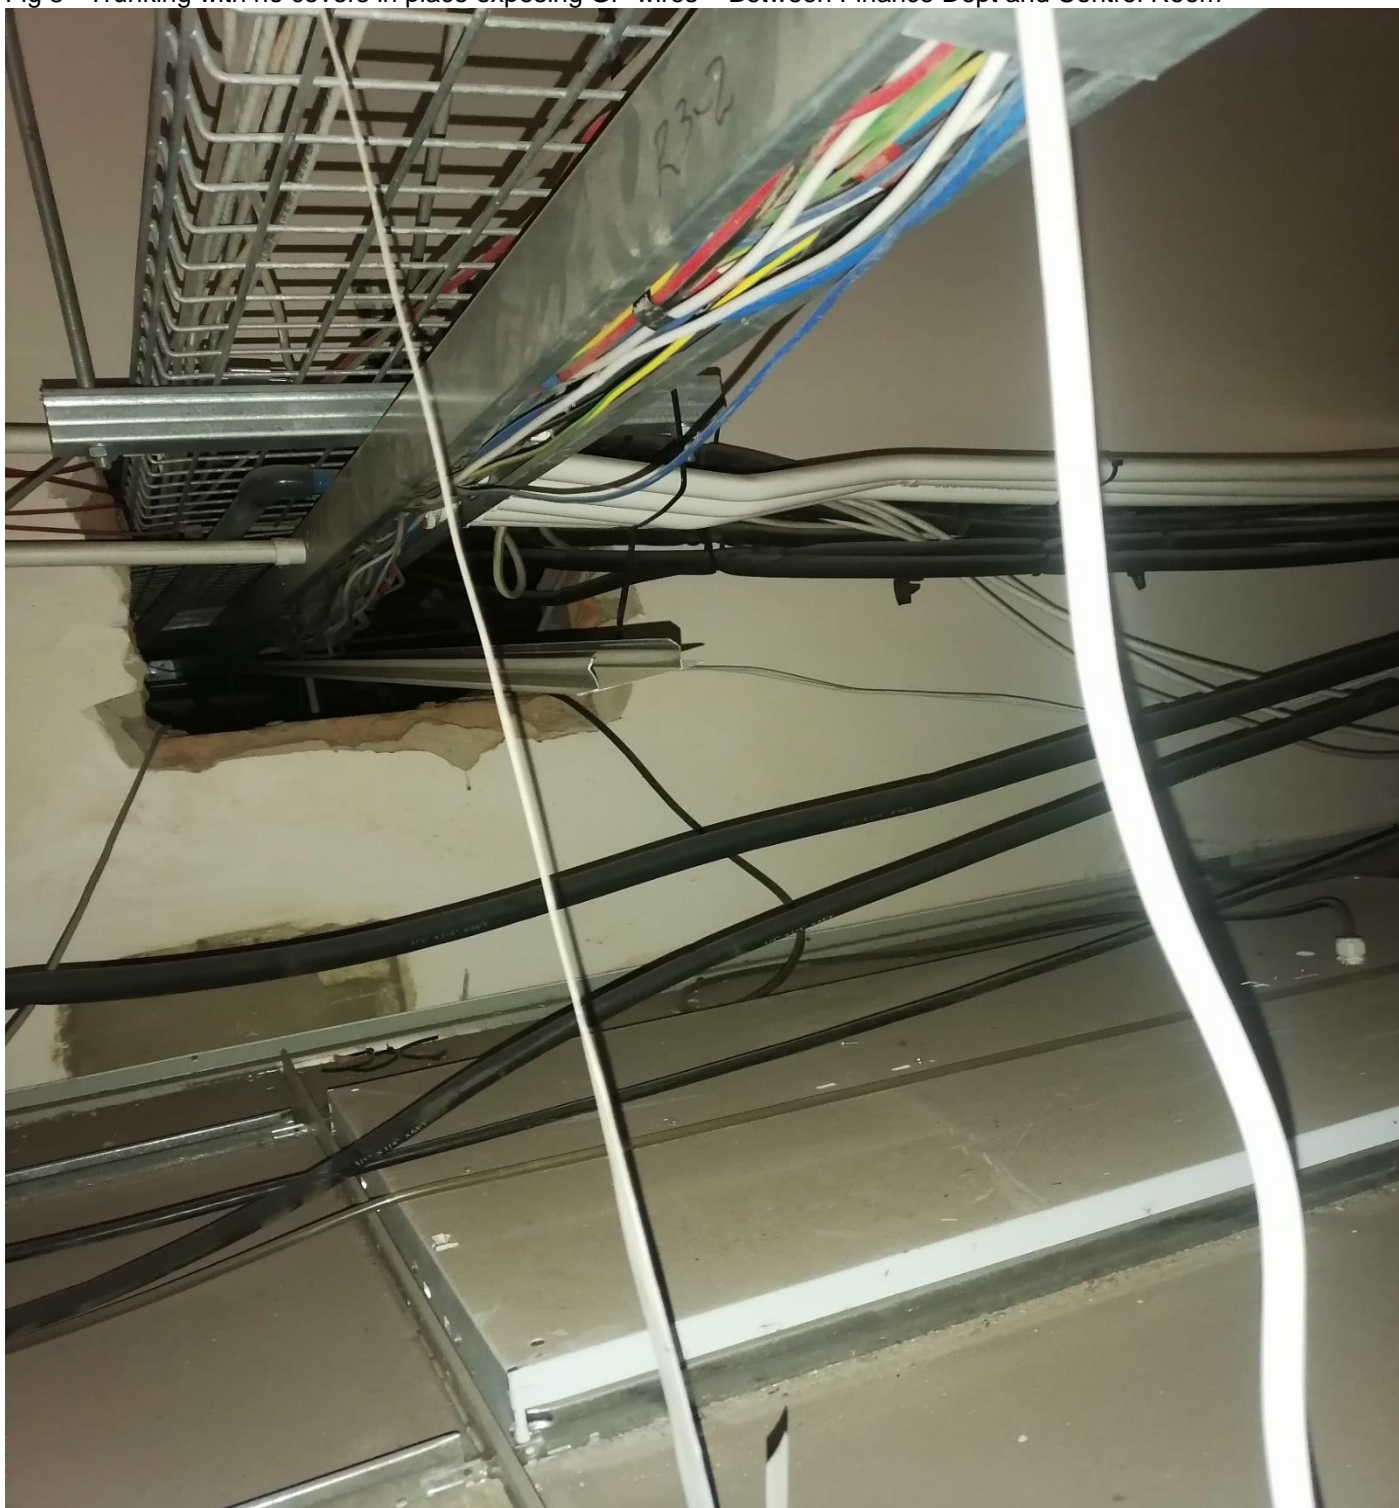
Fig 8 - Trunking with no covers in place exposing GP wires – Between Finance Dept and Control Room

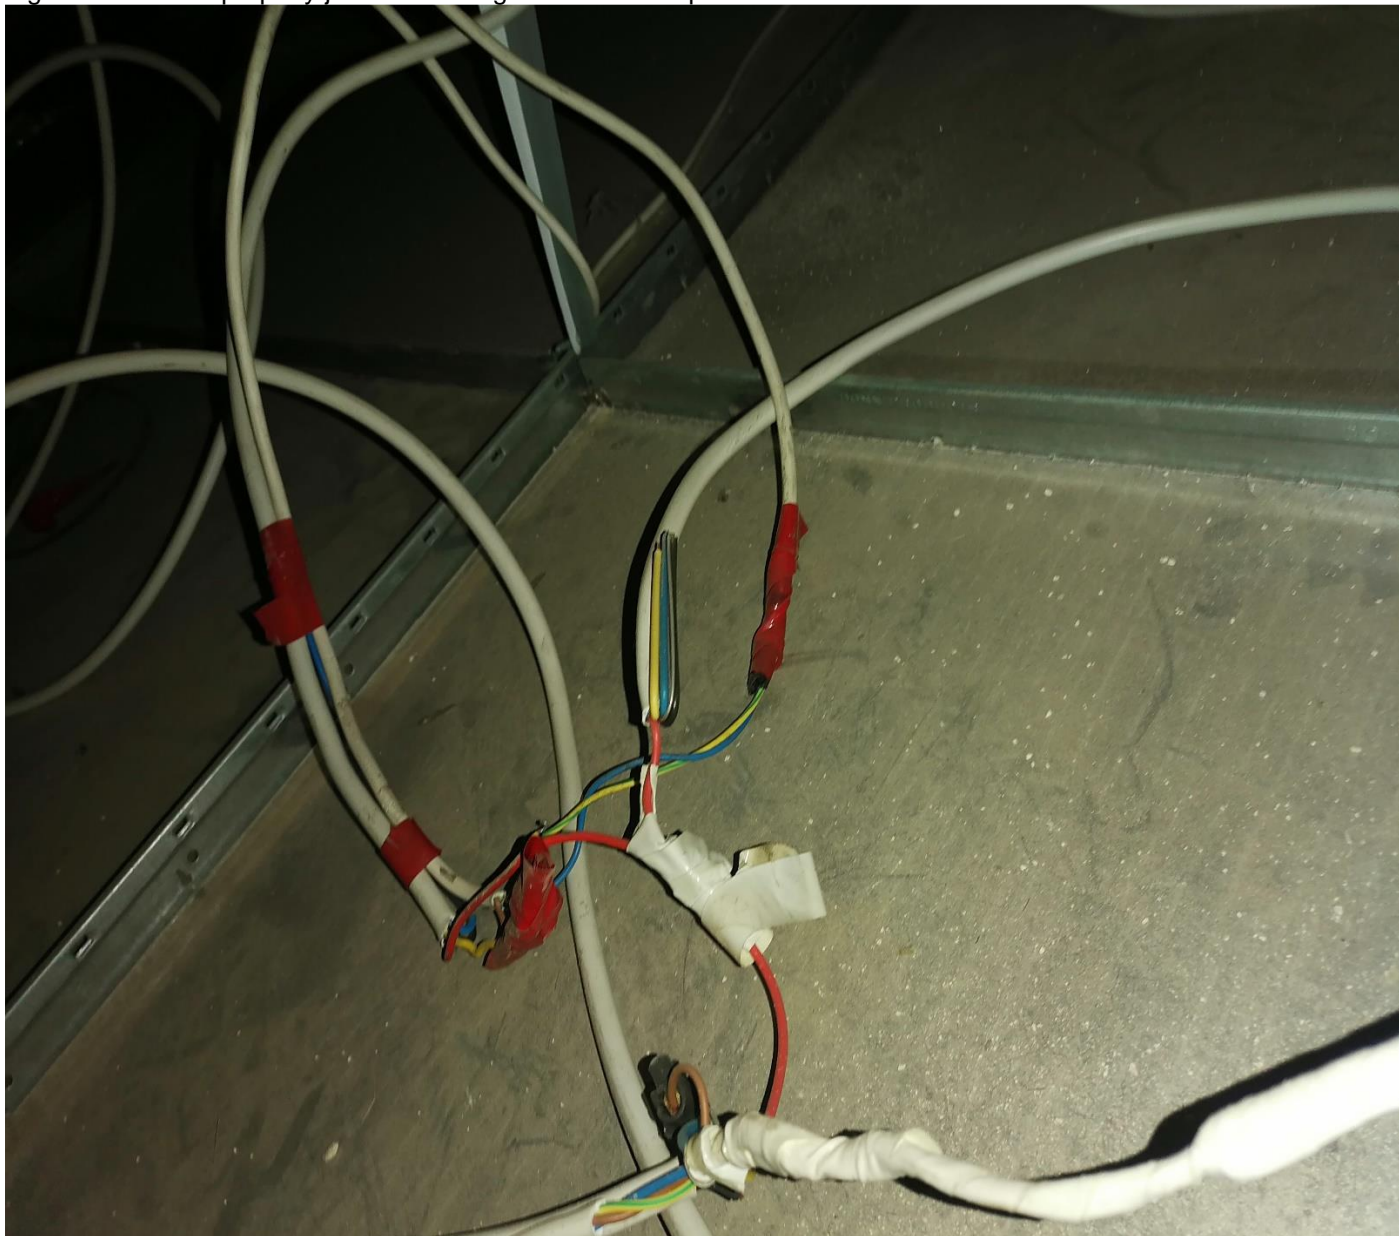
5. Improper cable joints: Open joints were randomly done inside the ceiling void, taped with insulating tape and left without protection. In some cases, such joints are suspected to have affected the resistance of the earth continuity conductor. The resistance of the earth continuity conductor on the following circuits were found to be above the limit:

Fig 10 - Cables improperly joined – Ceiling Void above Supervisor's Office

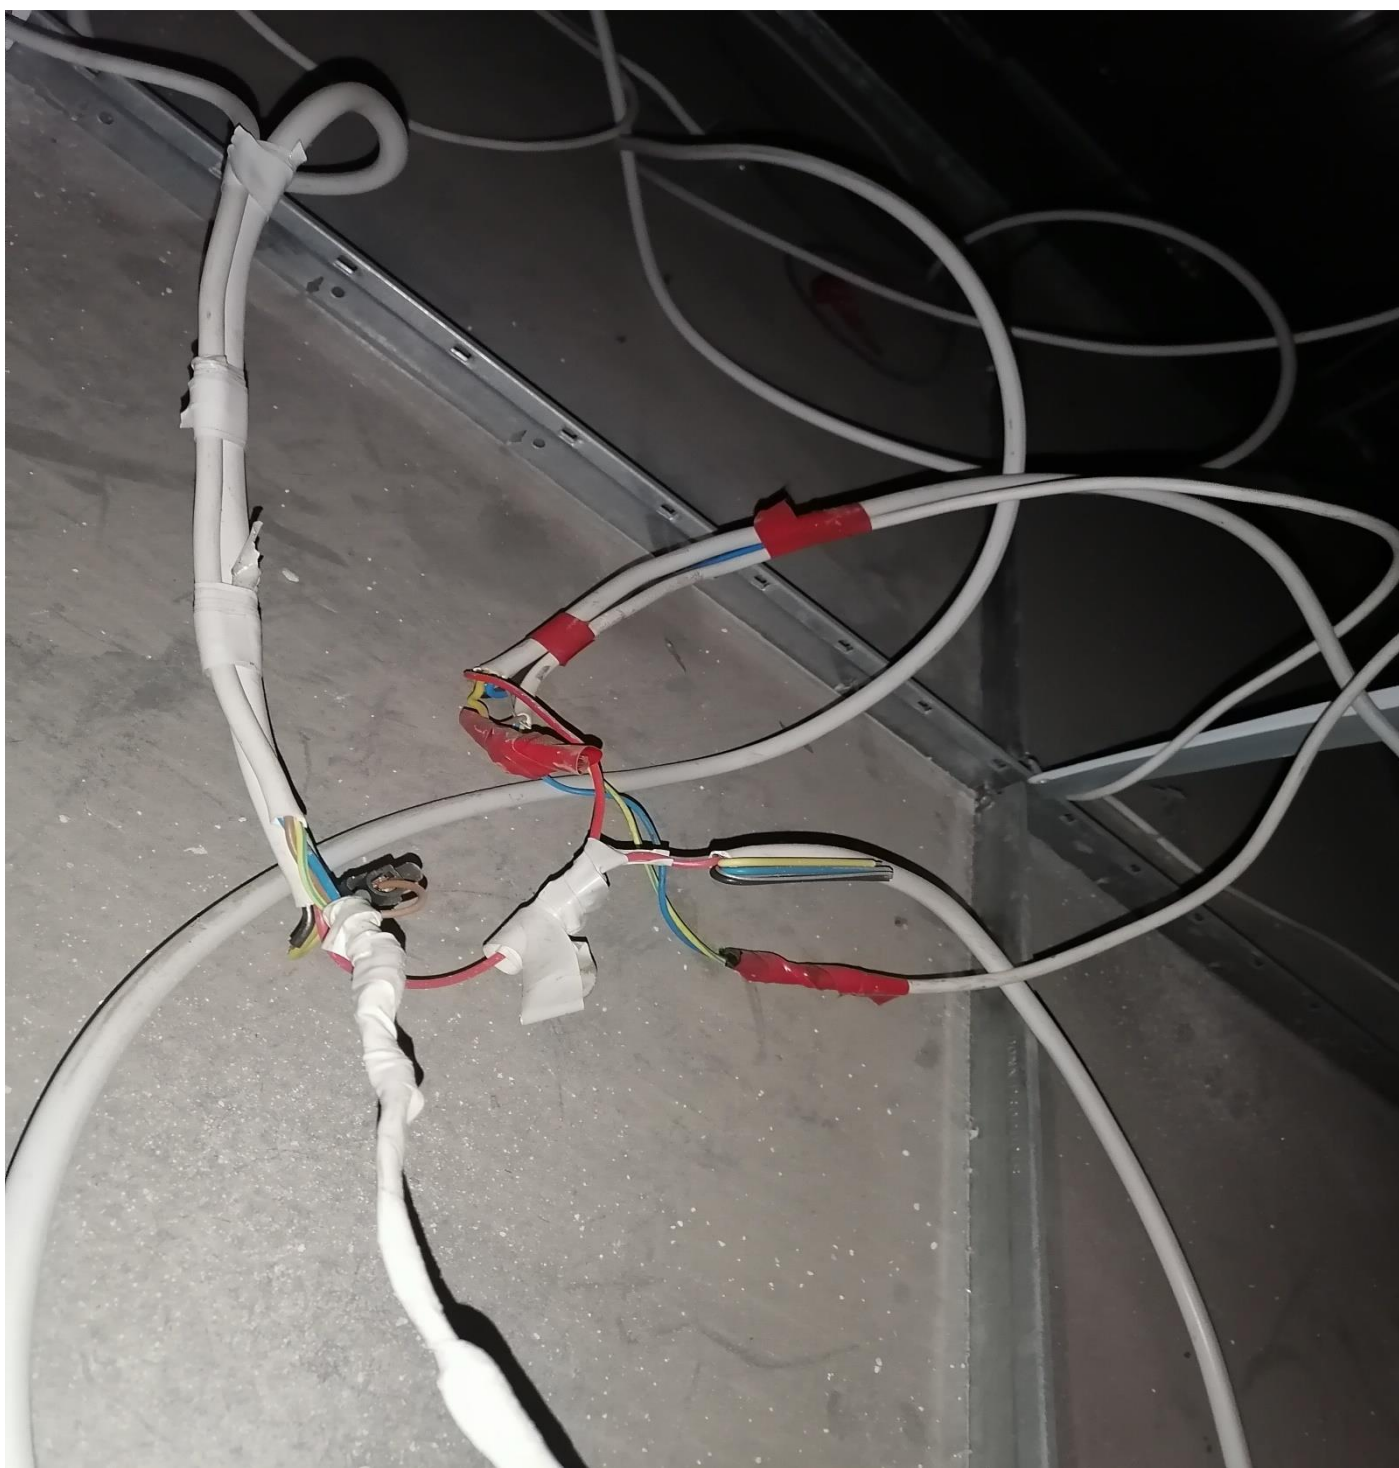
Fig 11 - Cables improperly joined - Ceiling Void above Supervisor's Office

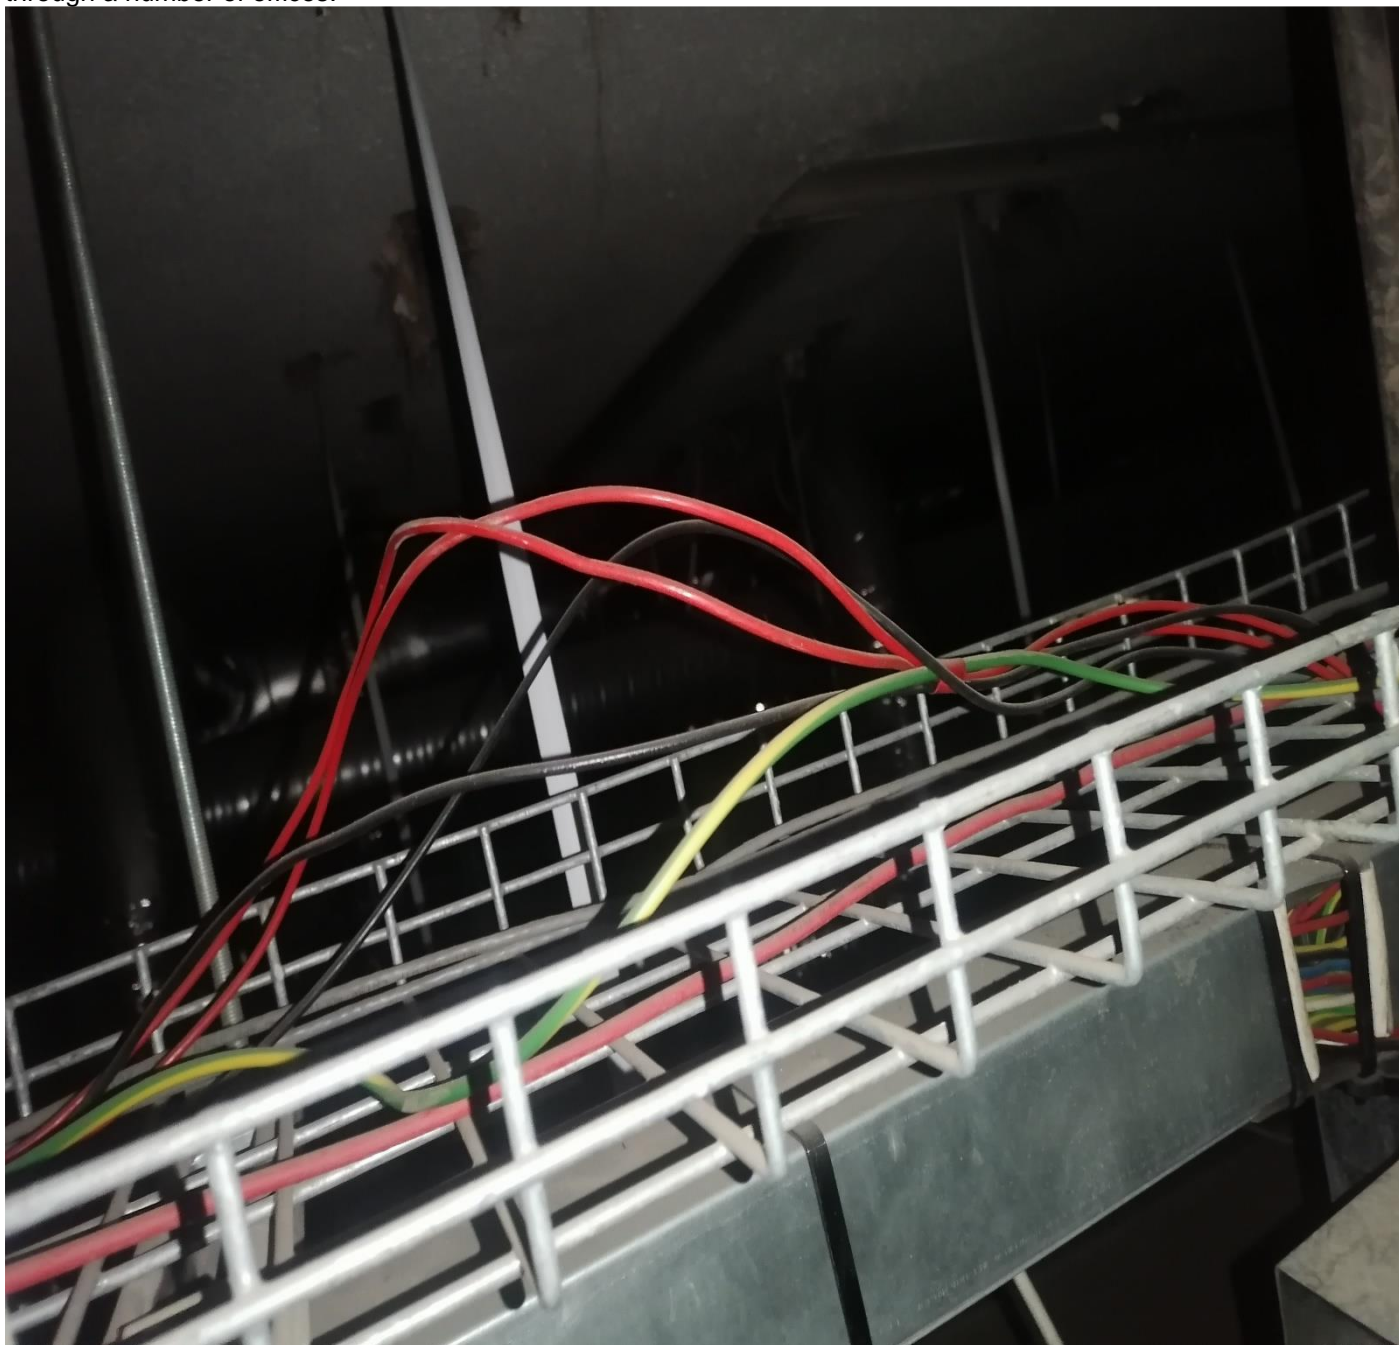
Fig 12 - General Purpose wires running in the cable tray instead of proper enclosed wireway – Cable tray running through a number of offices.

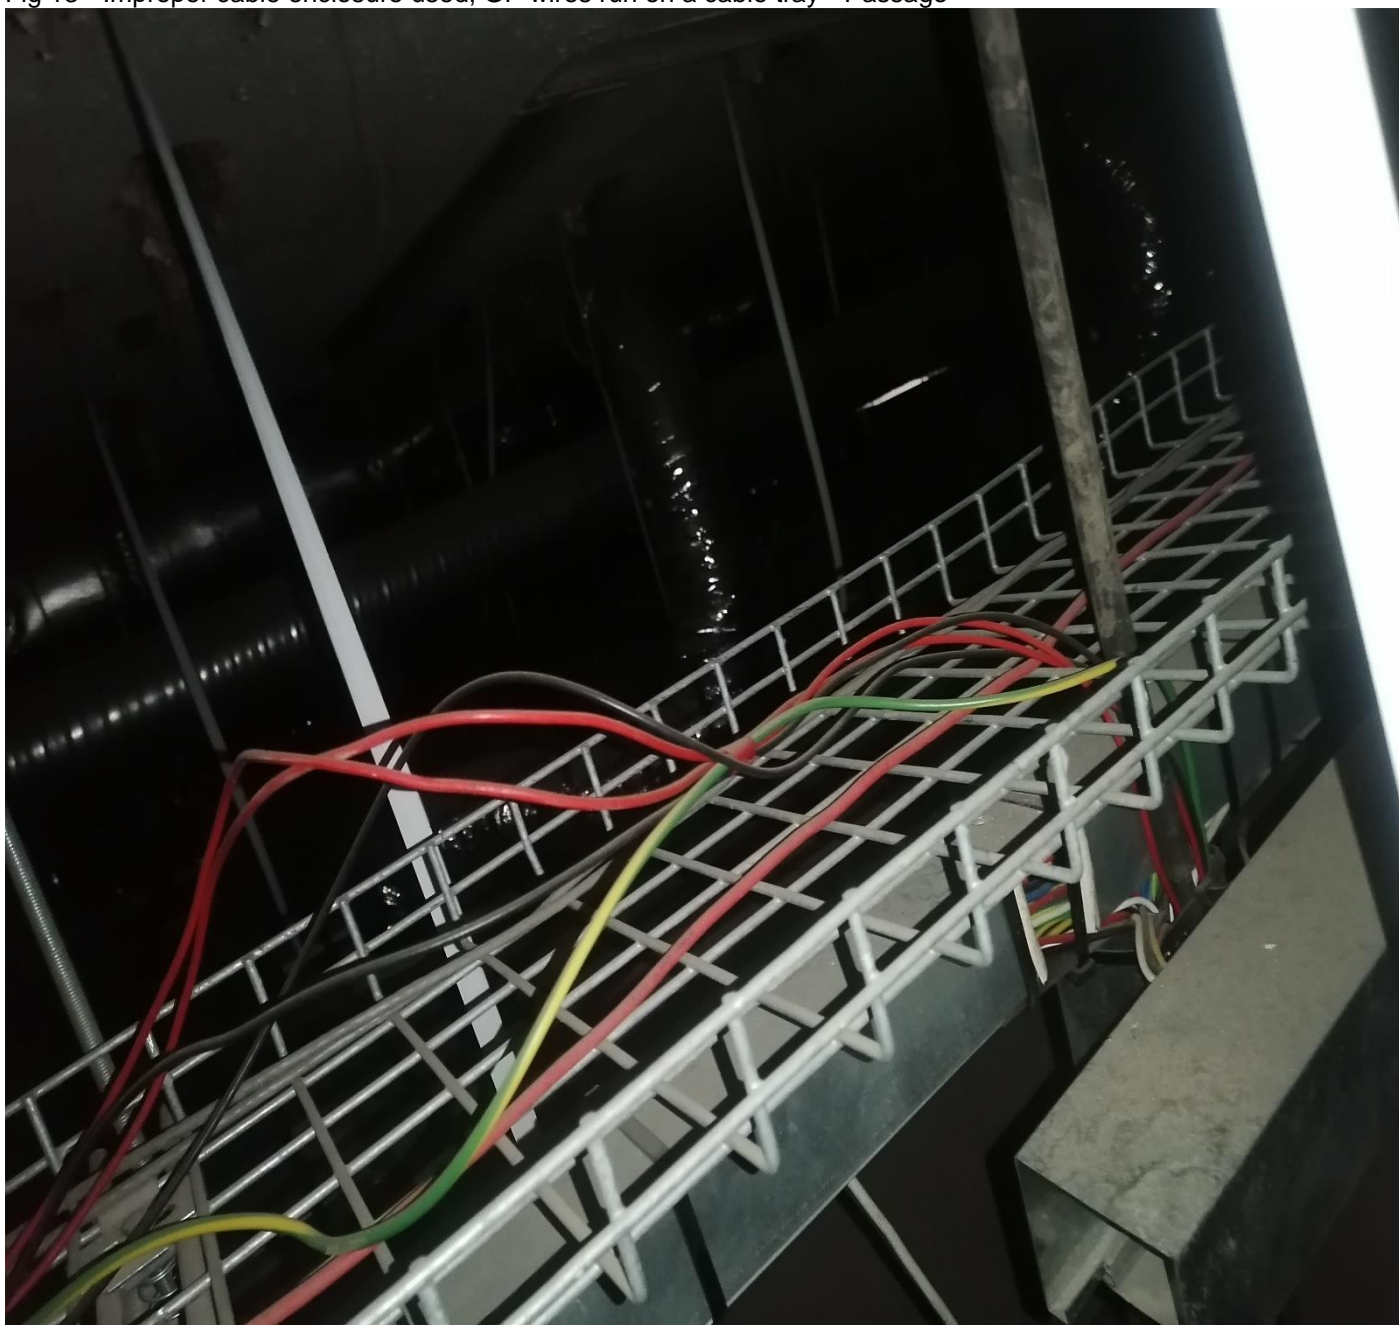
Fig 13 - Improper cable enclosure used, GP wires run on a cable tray - Passage

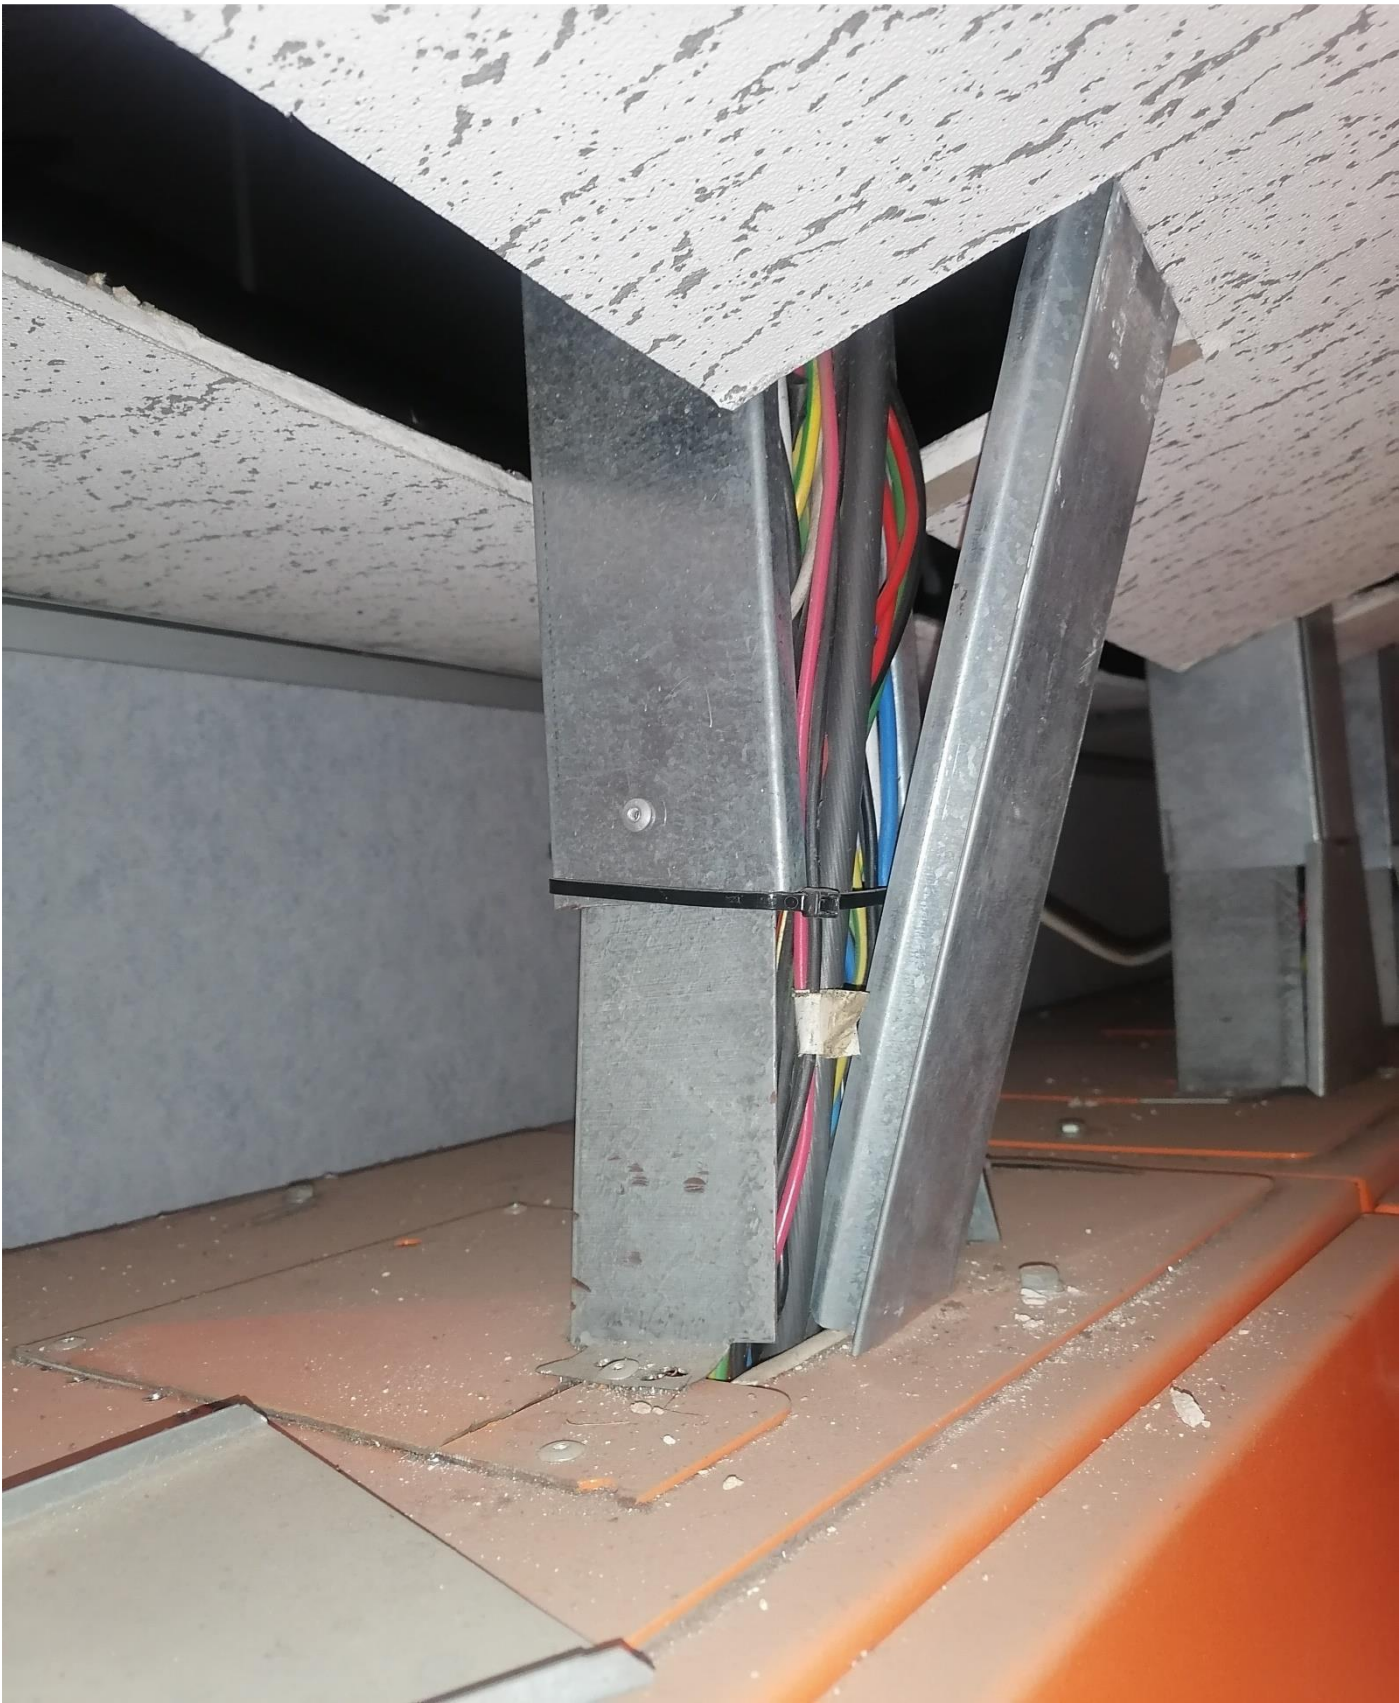
Fig 14 - Trunking not properly covered, cables held by a cable tie – Electrical Room

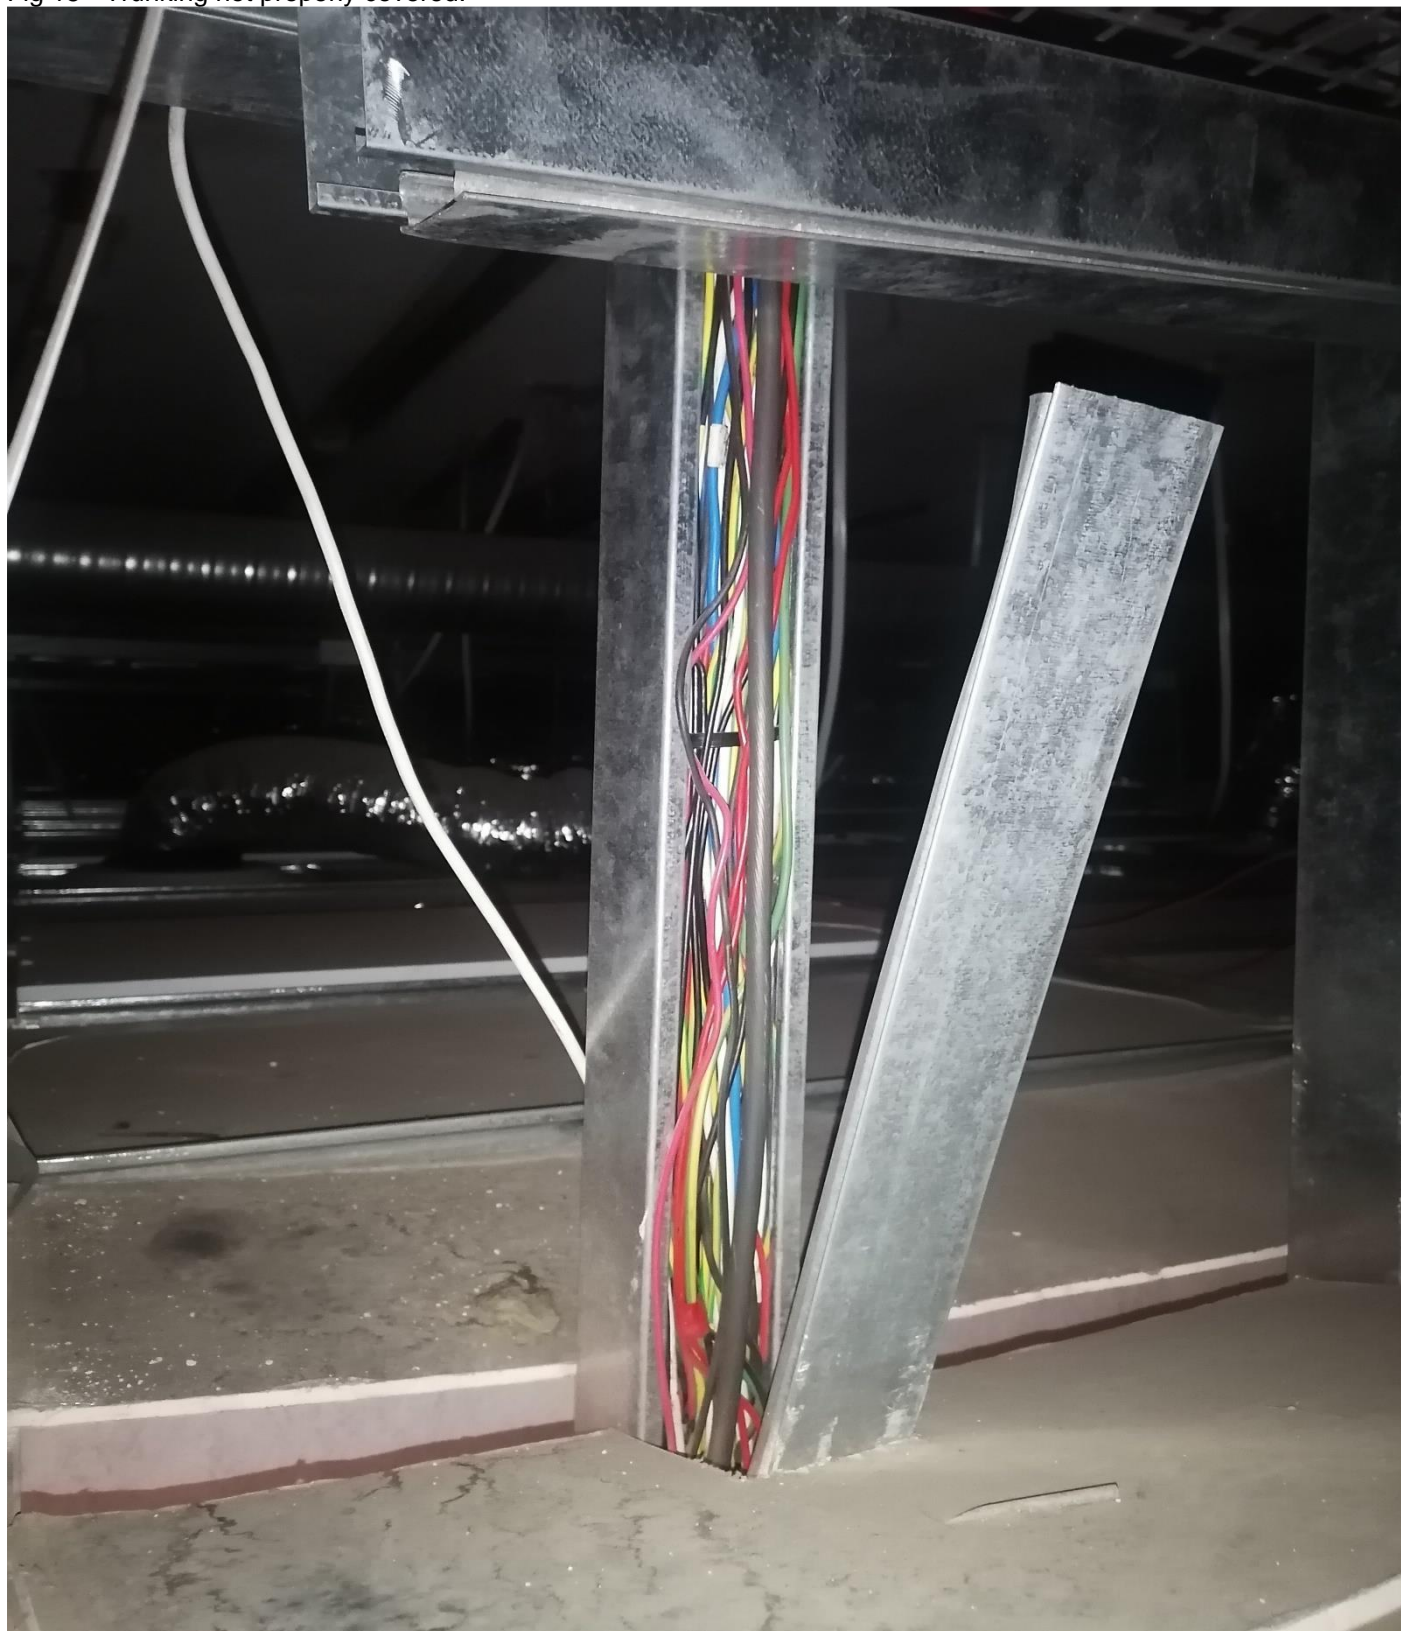
Fig 15 - Trunking not properly covered.
