## REQUEST FOR BID CIDB

### 10397088 – Scope of Work

Repair all non-compliance at no.1 Control room as per Scope Below:  
Pricing to include all spares required and labor.

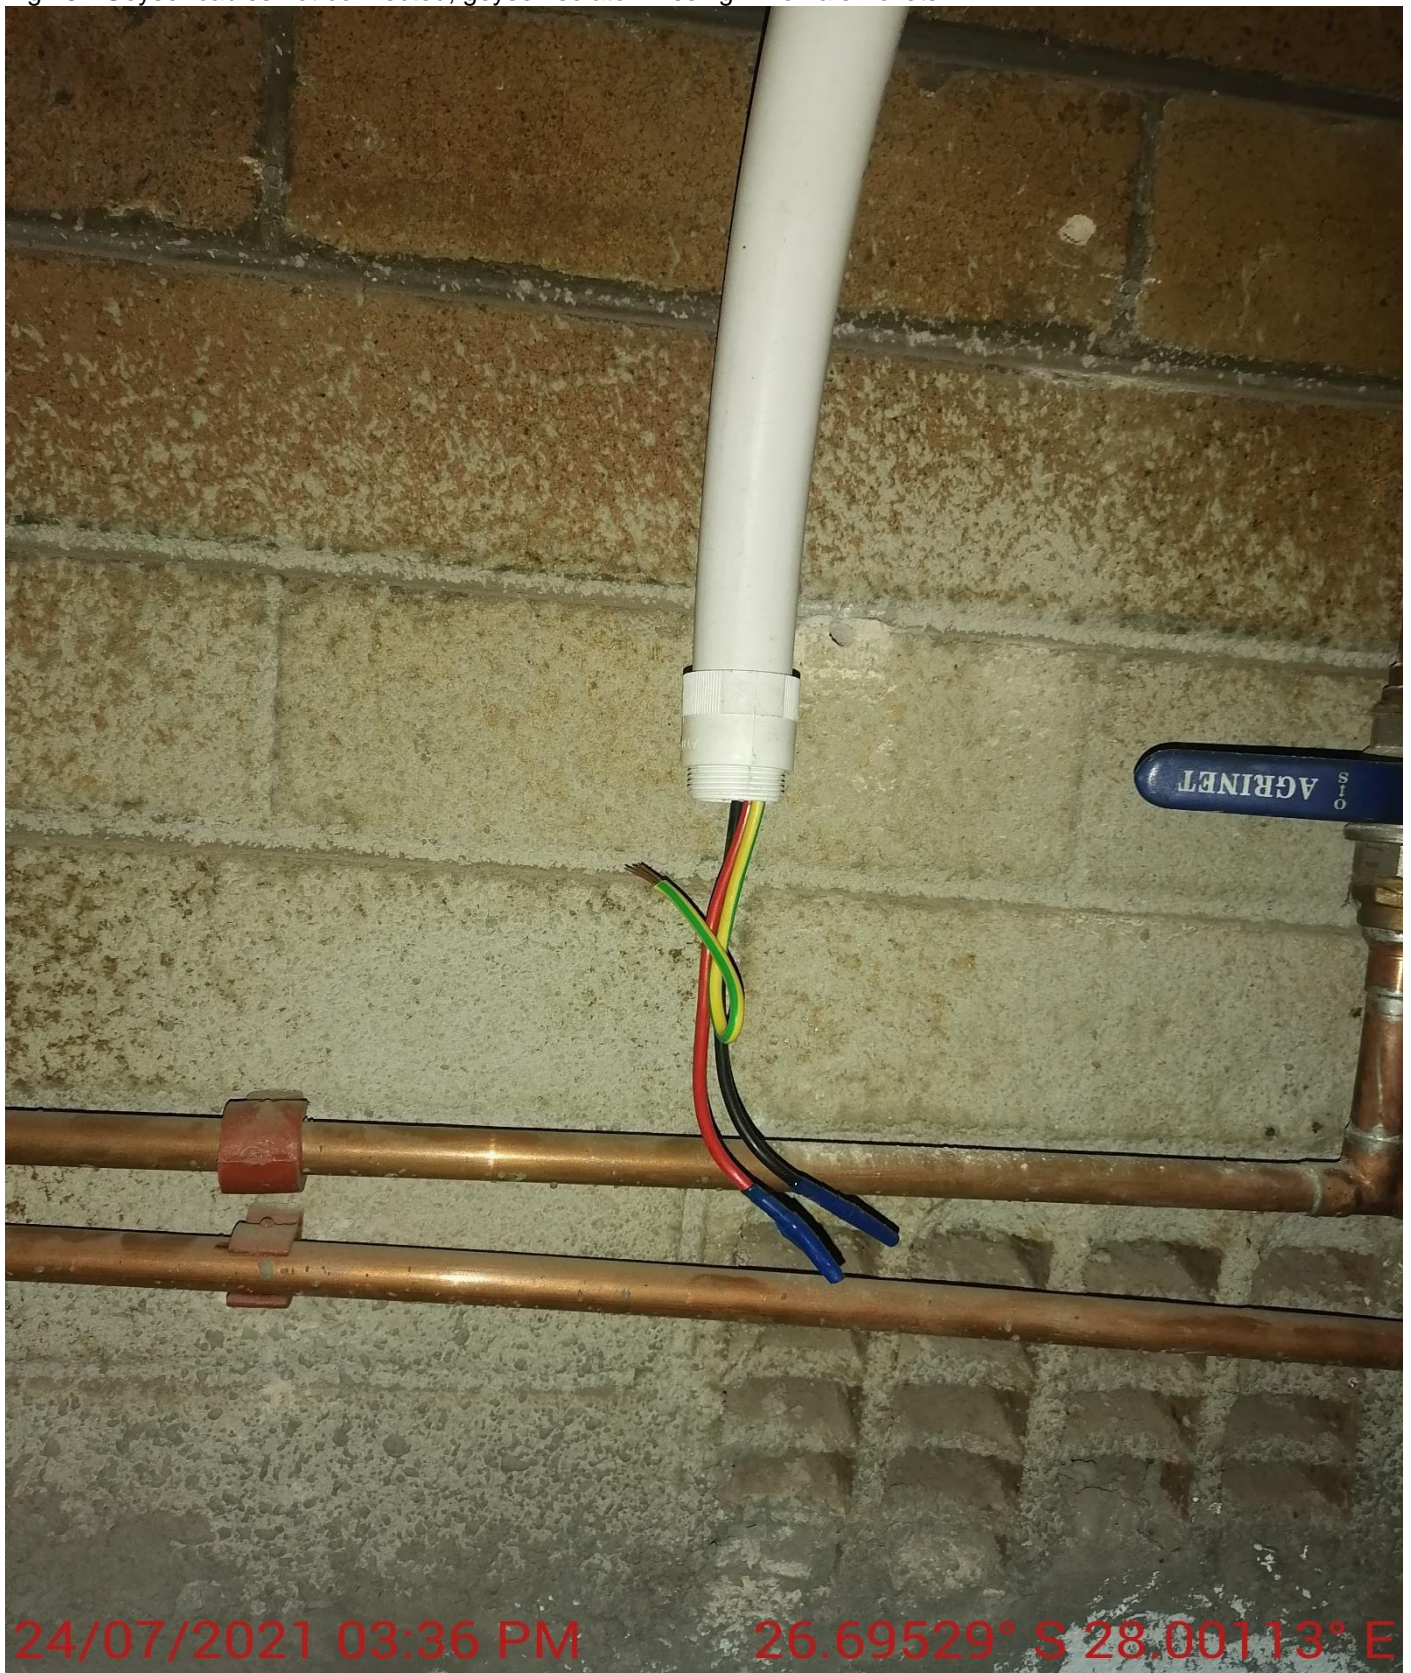
Fig 16 - Geyser cables not connected, geyser isolator missing – Female Toilets

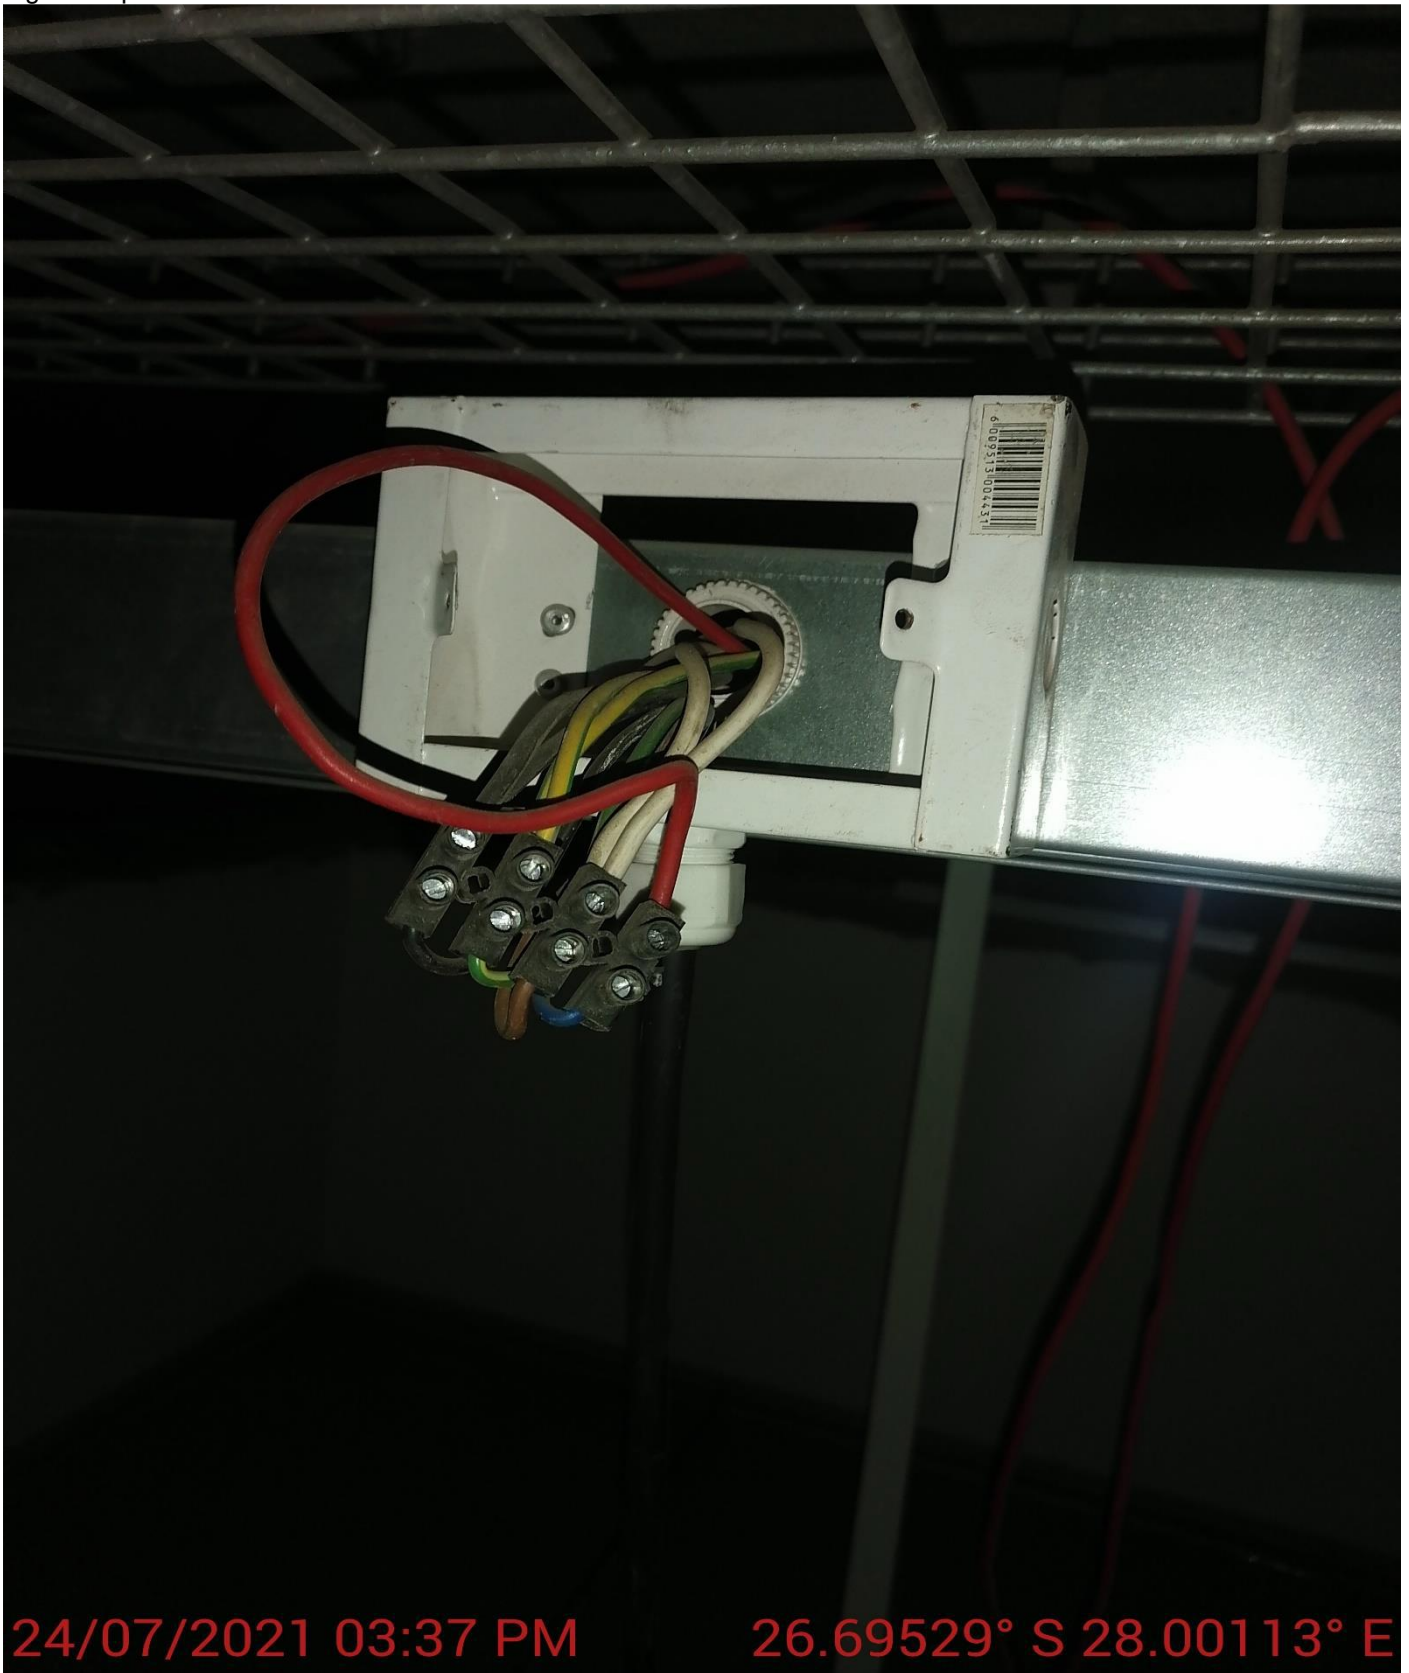
Fig 17 - Open Junction boxes

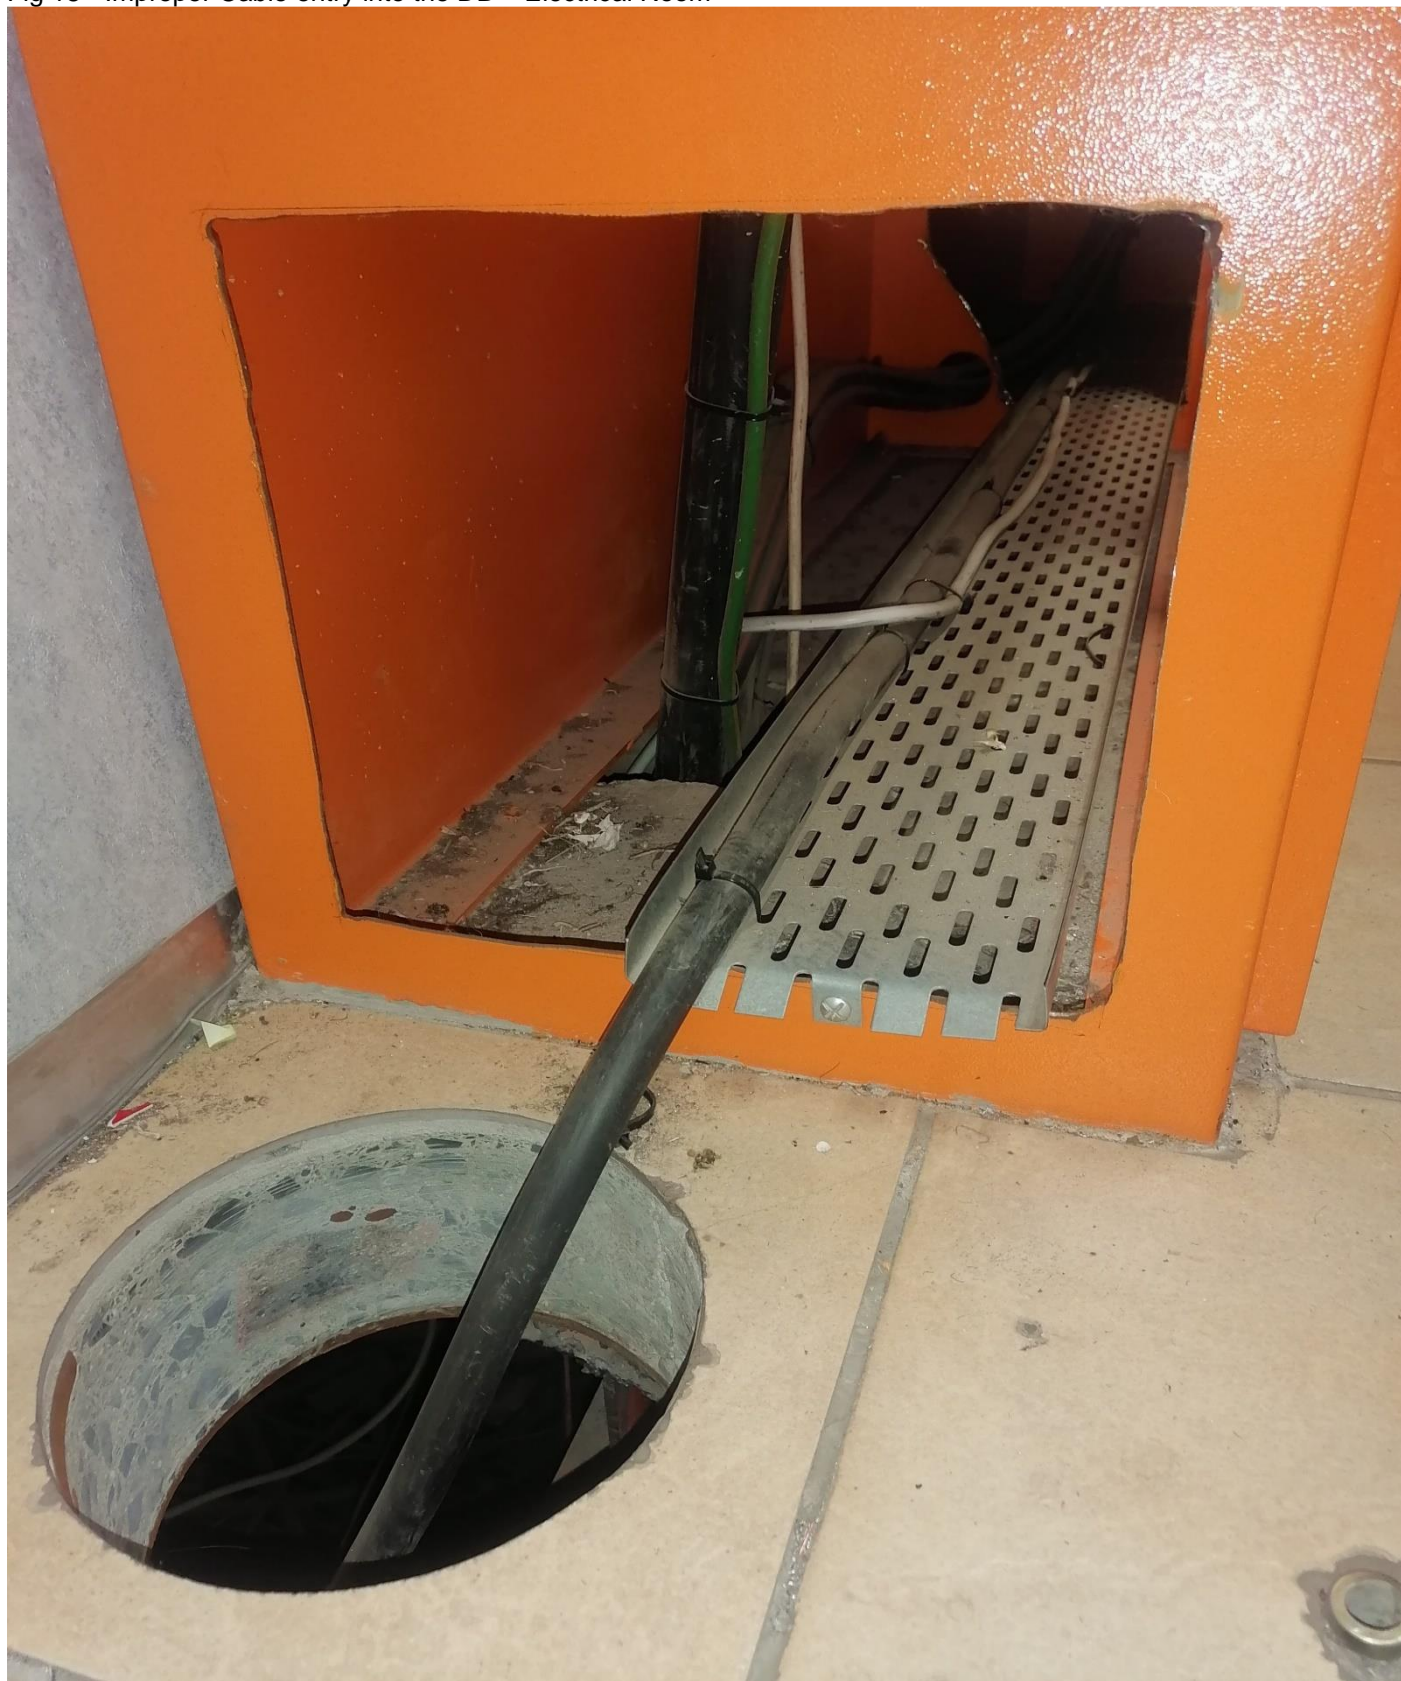
Fig 18 - Improper Cable entry into the DB – Electrical Room

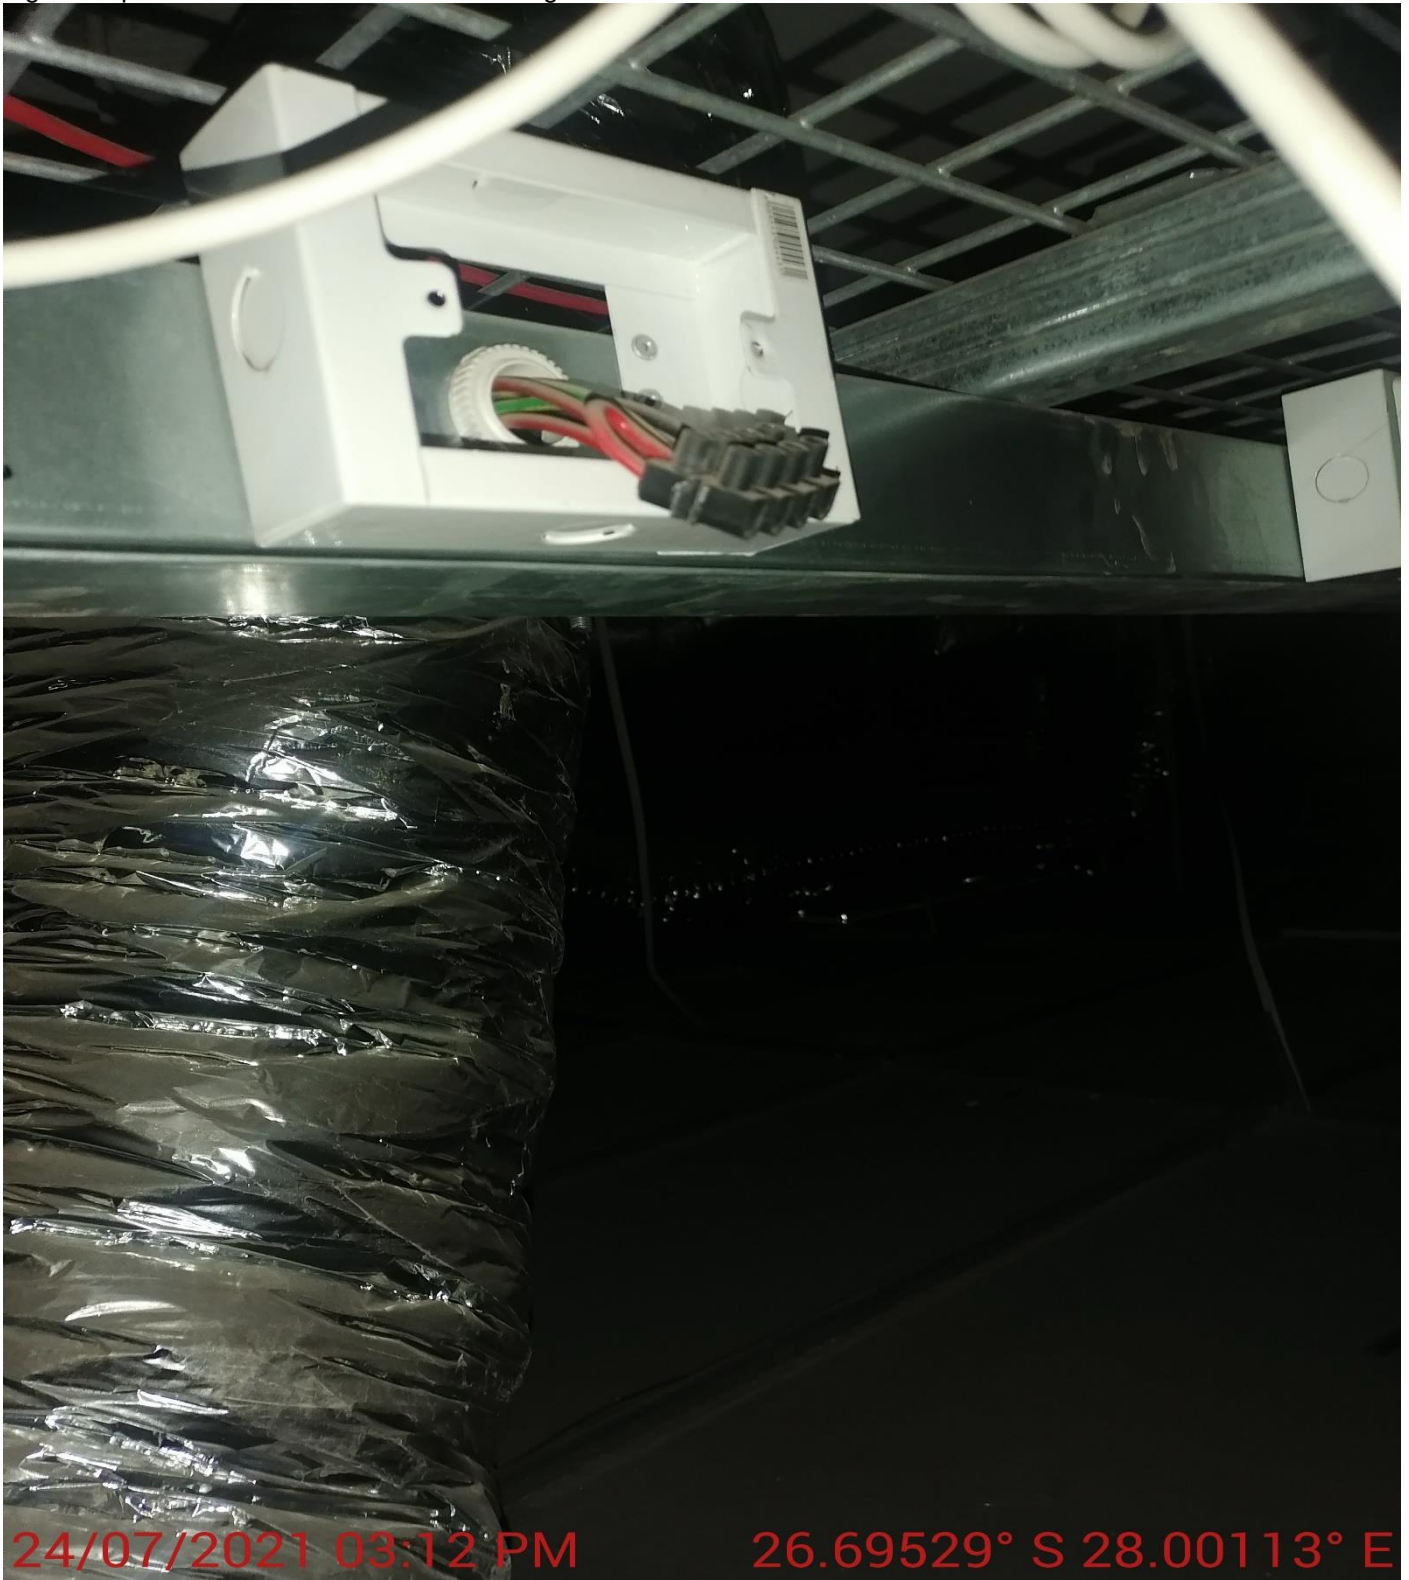
Fig 19 - Open Junction Boxes inside the ceiling void

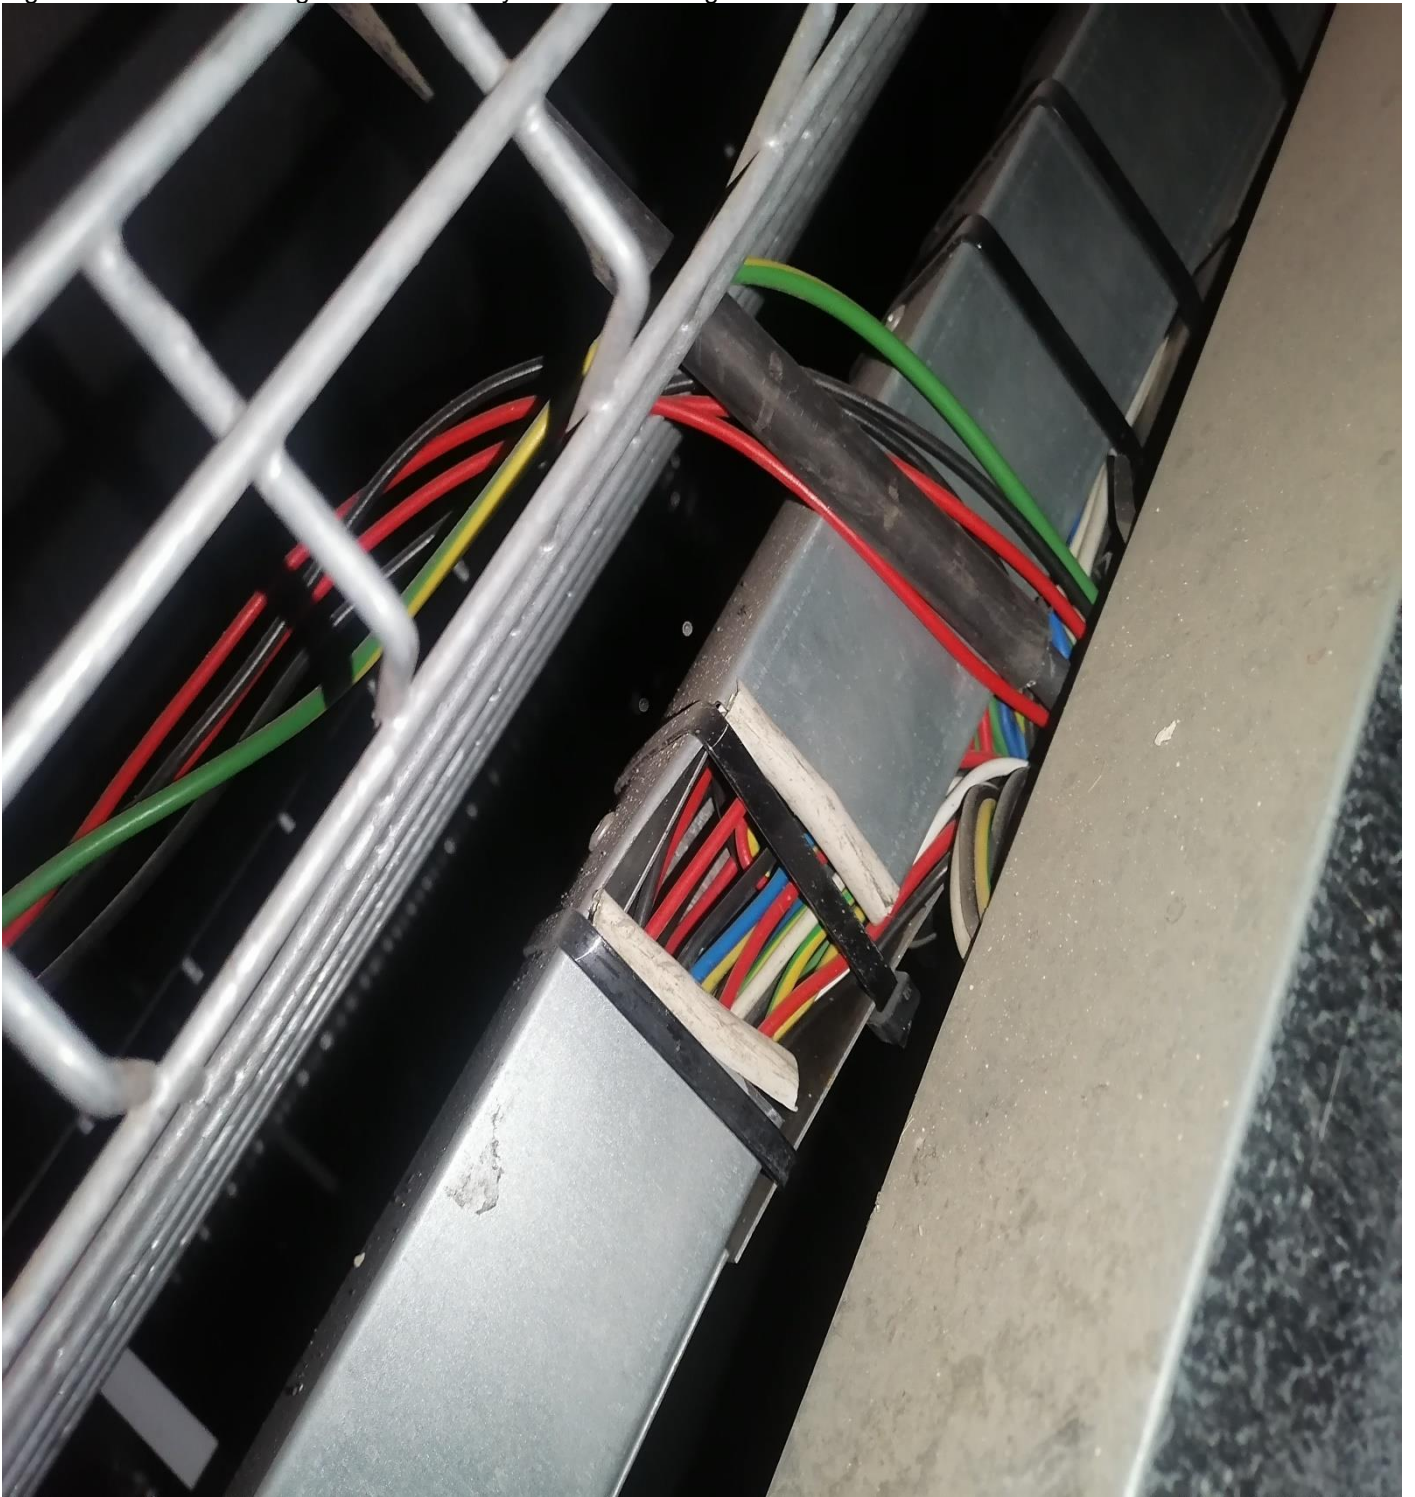
Fig 20 - GP Wires running on the cable tray inside the ceiling.

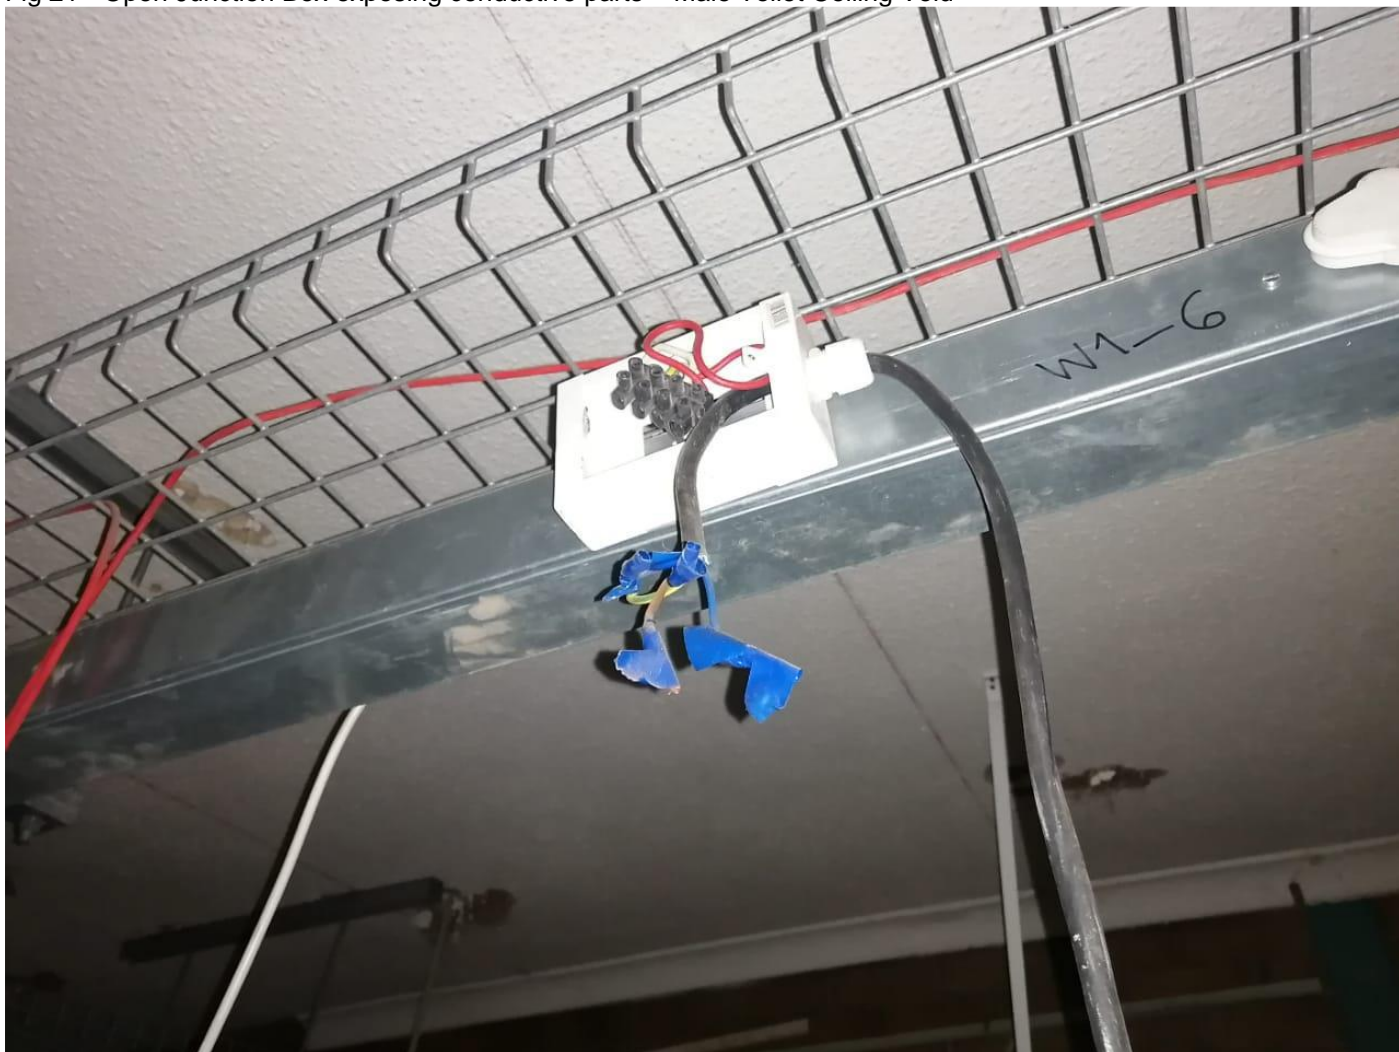
Fig 21 - Open Junction Box exposing conductive parts – Male Toilet Ceiling Void

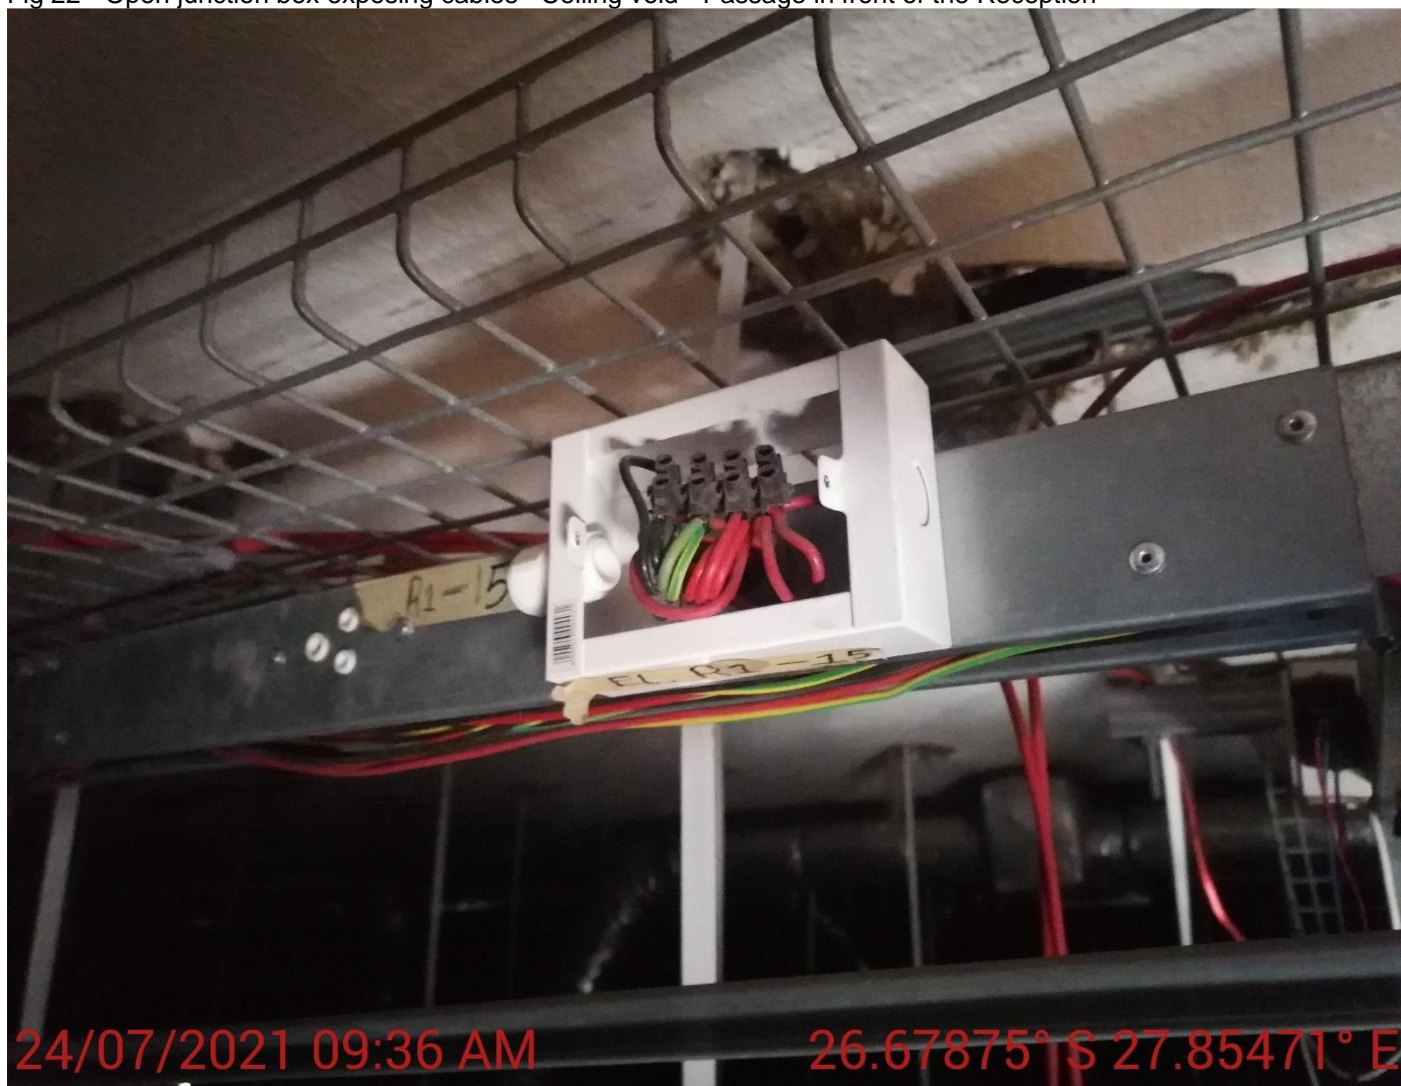
Fig 22 - Open junction box exposing cables– Ceiling void - Passage in front of the Reception

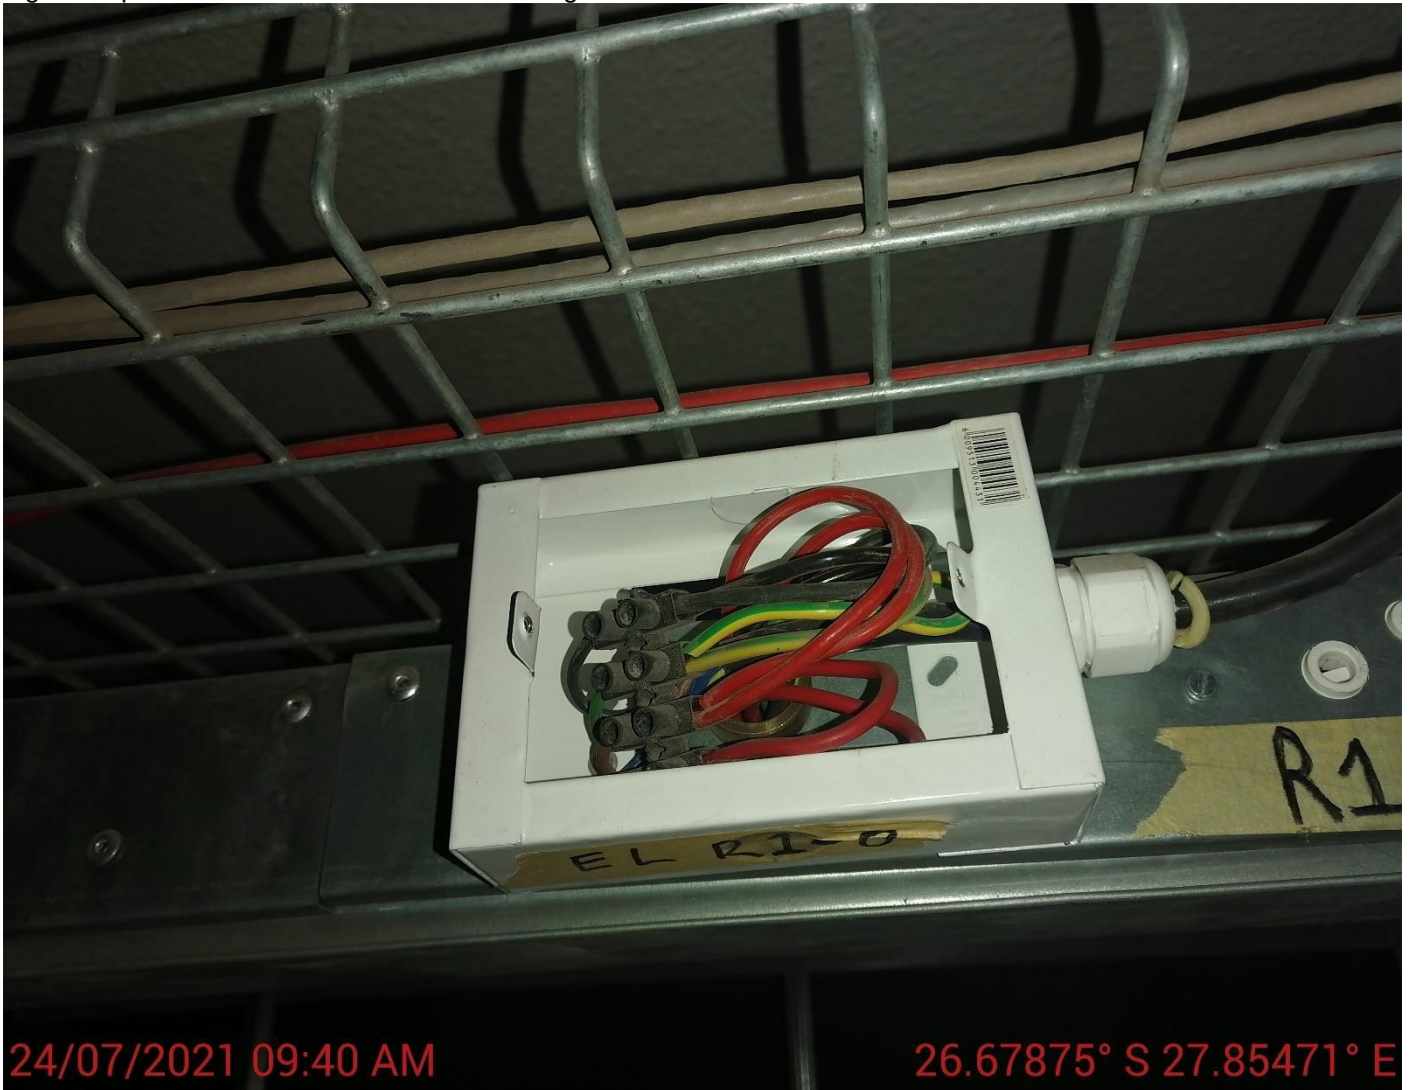
Fig 23 - Open Junction box – Tea Kitchen ceiling Void

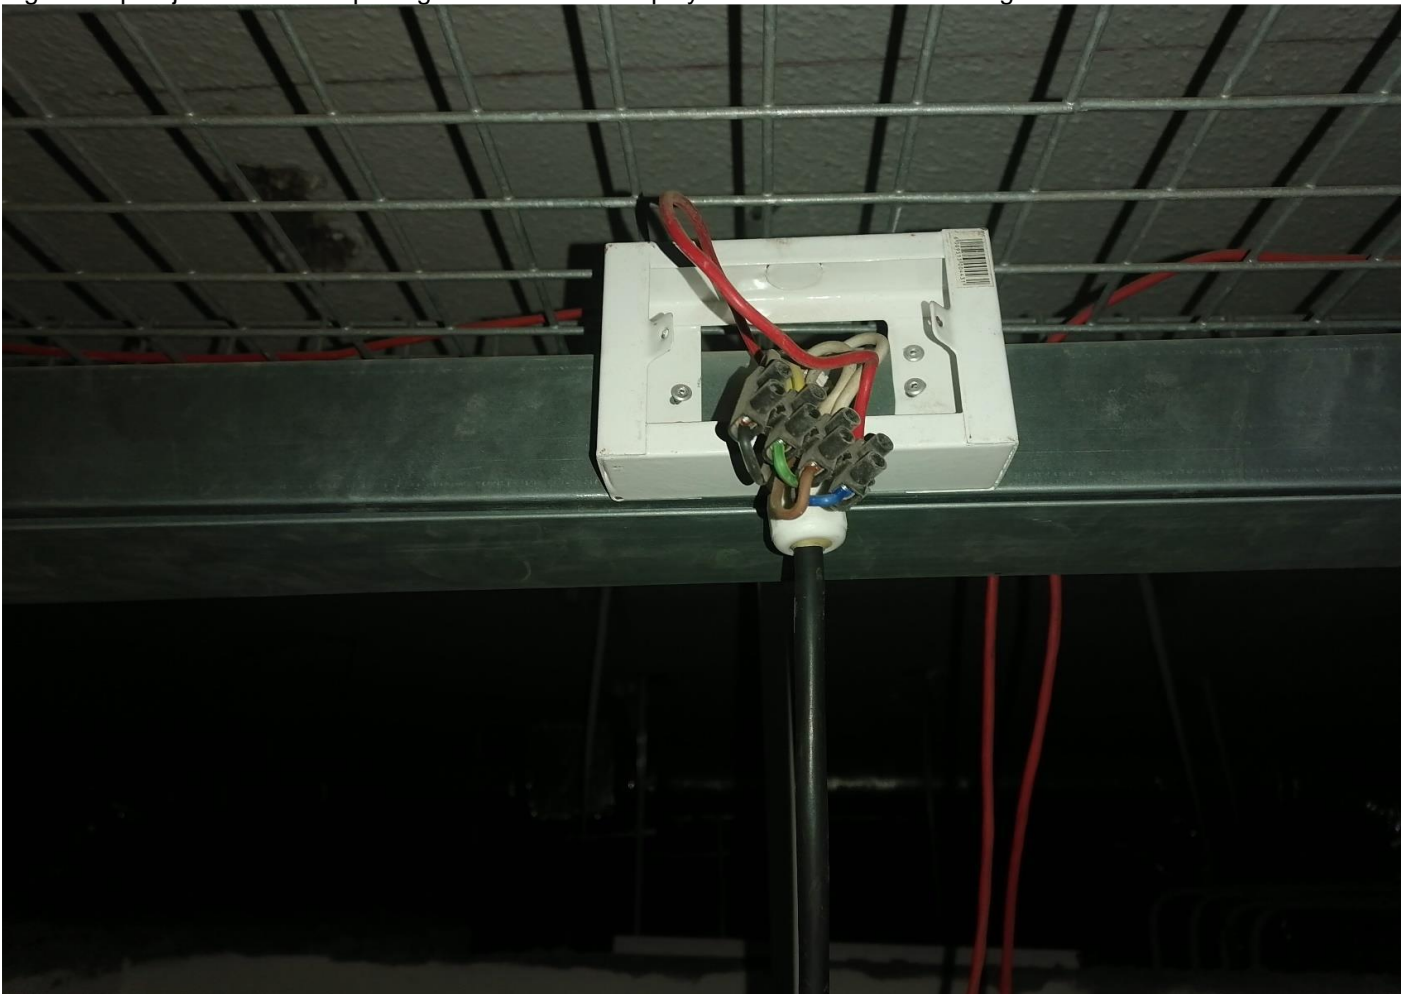
Fig 24 - Open junction Box exposing connections – Employee Relations Office Ceiling Void.

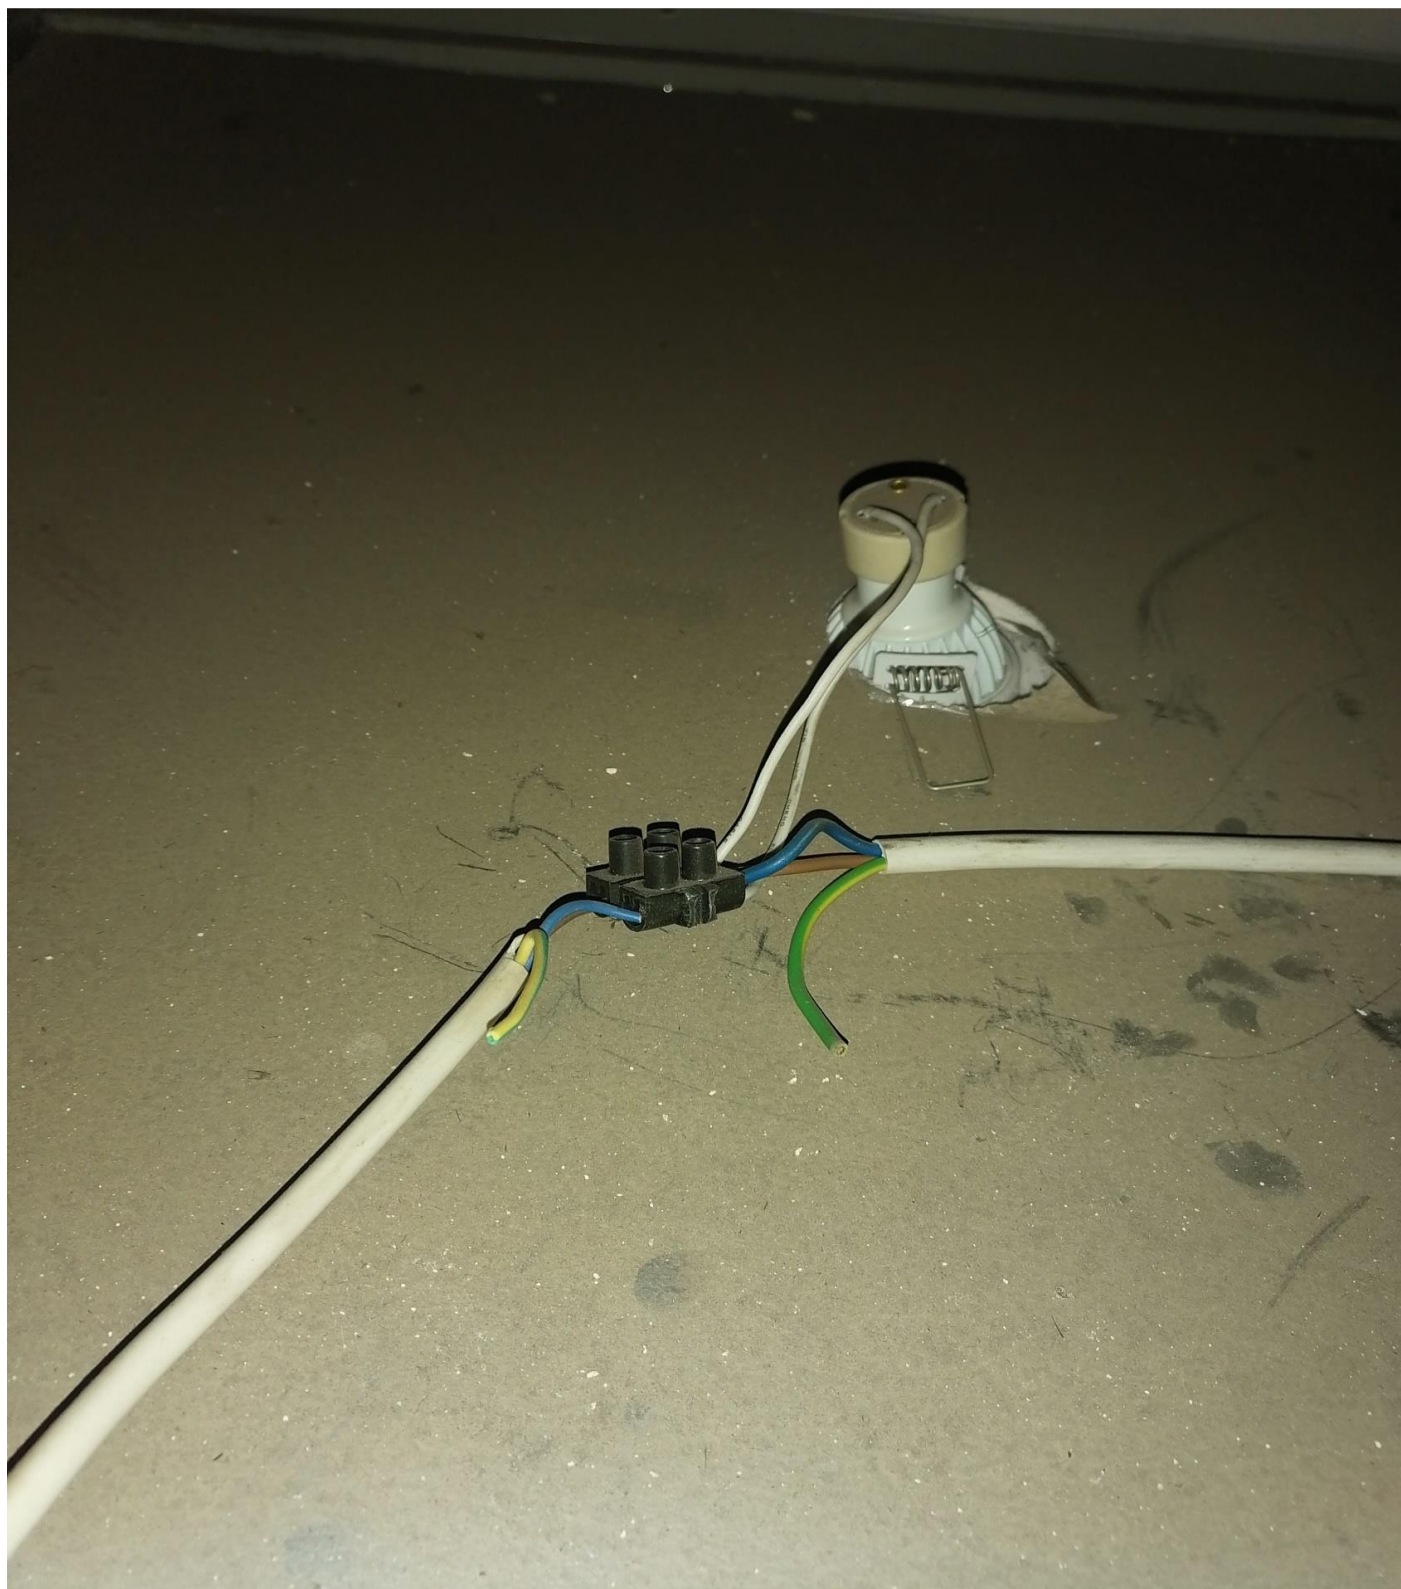
Fig 25 - Improper connections inside the ceiling void – Passage down lights

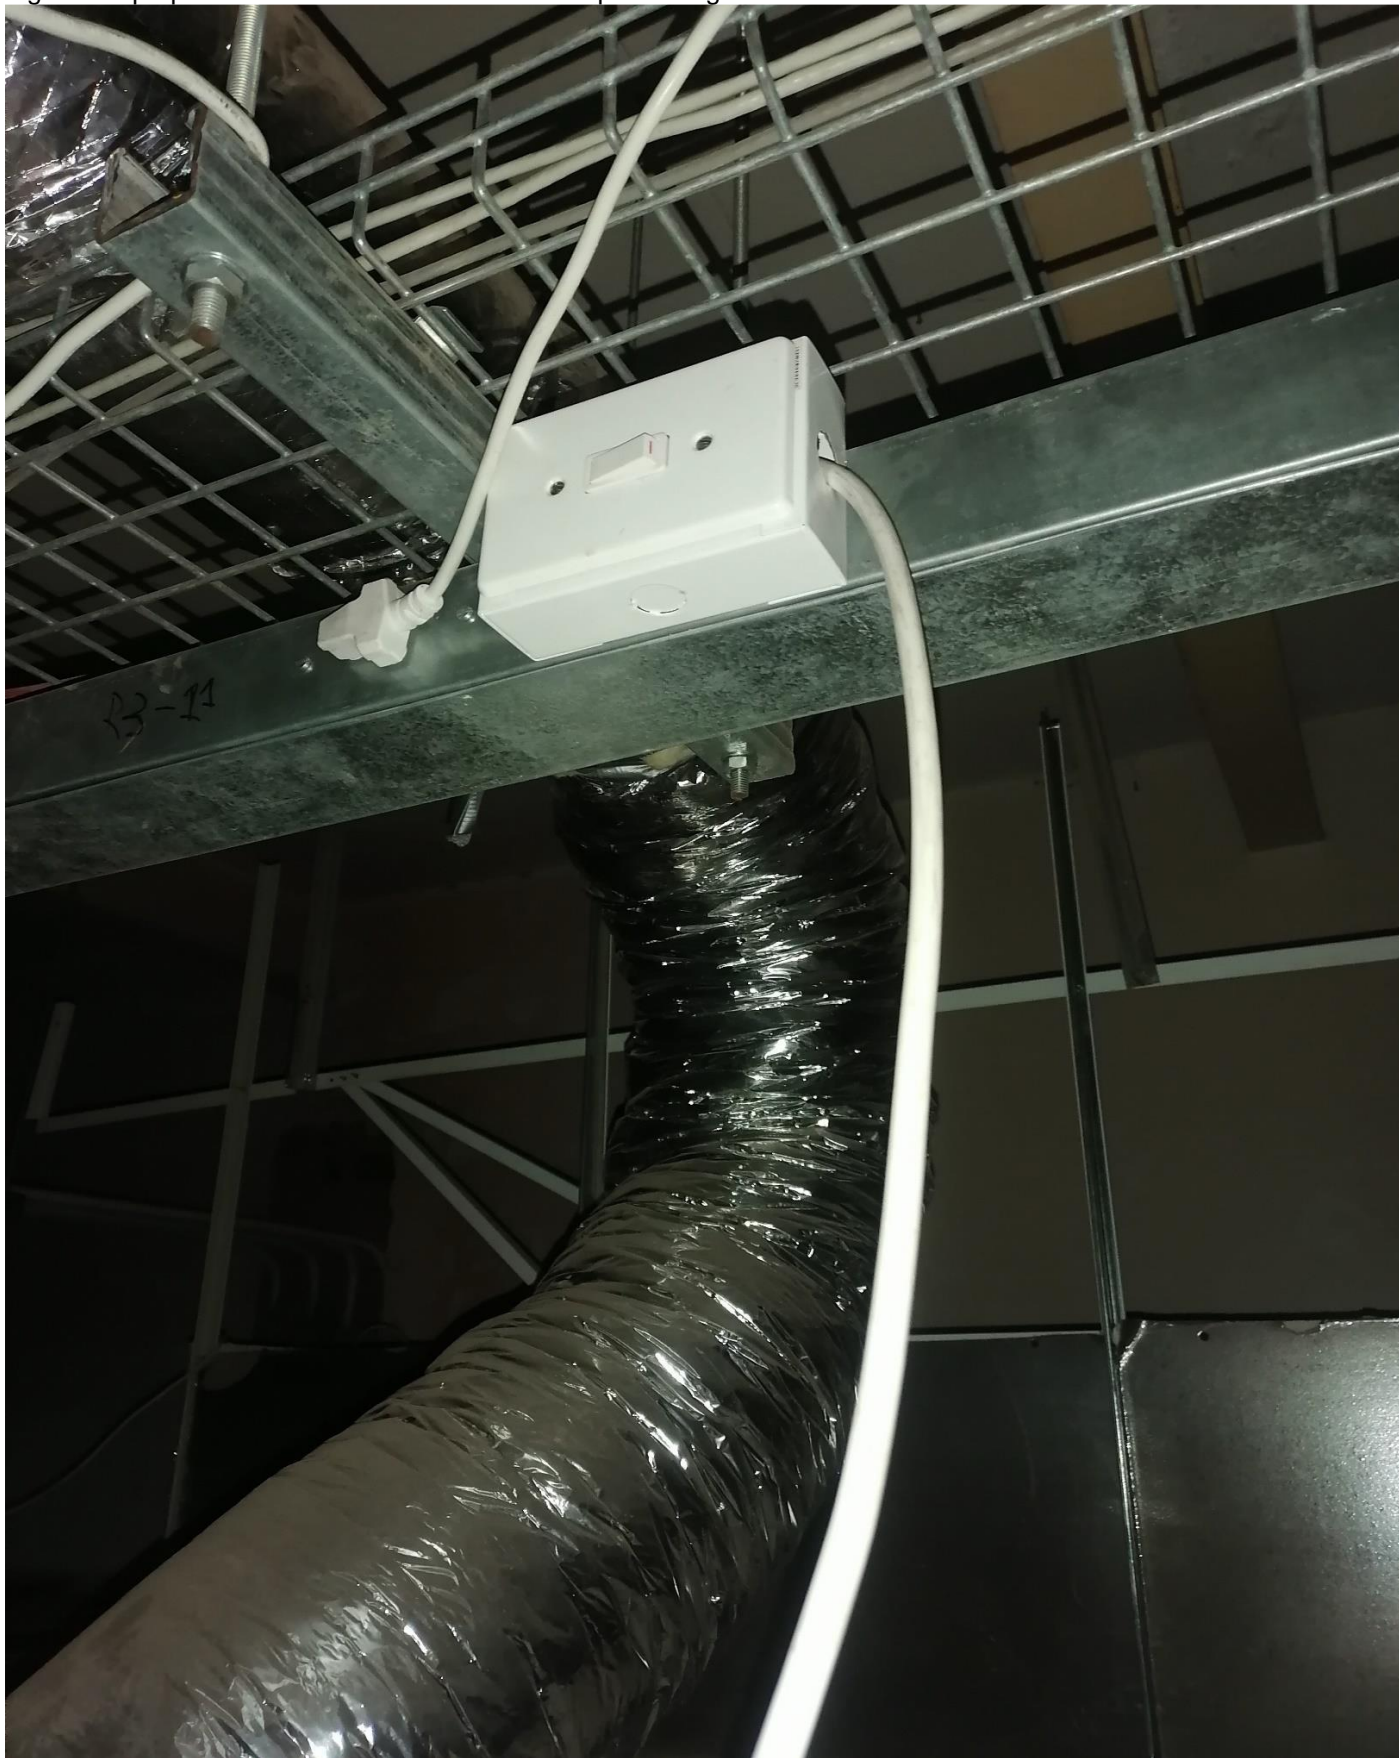
4. Improper cable terminations: This is mostly found on junction boxes mounted by the cable trunking side, connections were made without compression glands, allowing cable cords to be suspended by connections.

Fig 26 - Improper Cable termination – without compression glands
