## REQUEST FOR BID CIDB

### 10397088 – Scope of Work

Repair all non-compliance at no.1 Control room as per Scope Below:  
Pricing to include all spares required and labor.

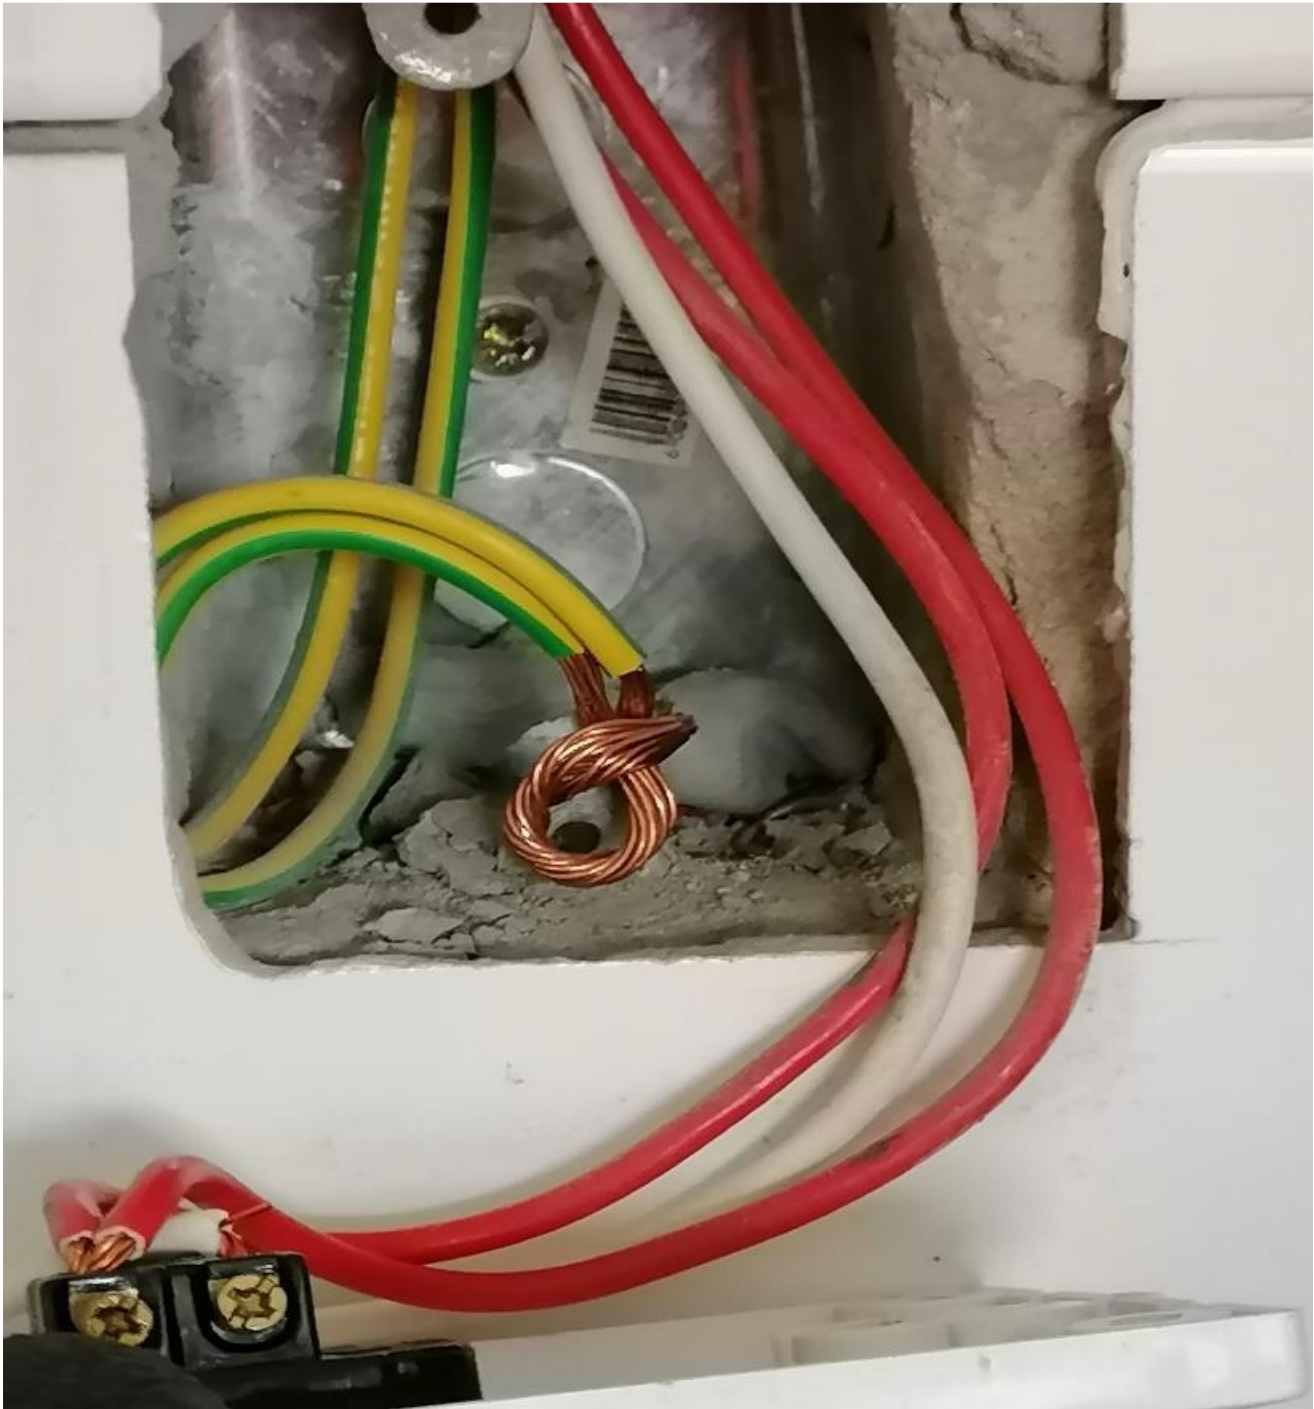
Fig 27 – Improper earth terminations on switch boxes.  
Tea Kitchen Switch

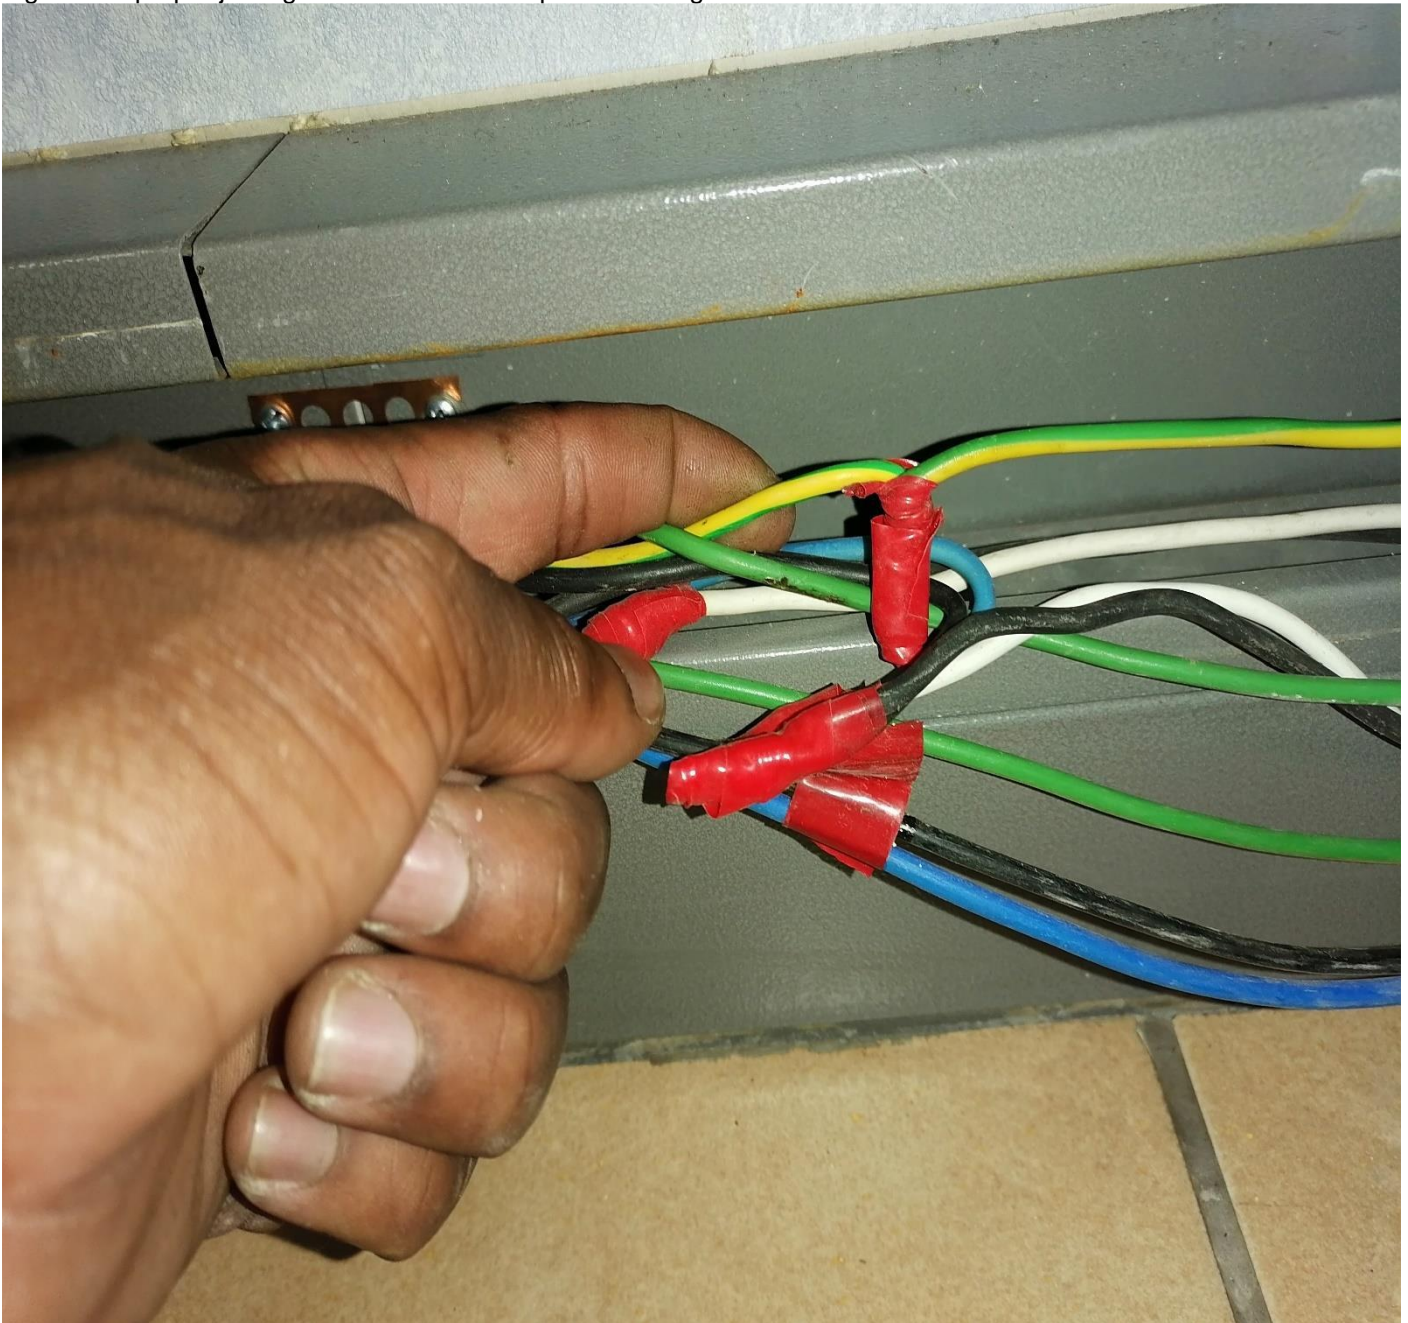
Fig 28 – Improper joining of cables inside the power skirting.
