| Eskom | Scope of Work | Transmission |

Title: **FOUNDATIONS
REHABILITATION -
NORTH EAST GRID** Unique Identifier: **240 - 47411023**
 Alternative Reference Number: **LES-GP-159**

| Eskom | Foundations Rehabilitation - North East Grid | Transmission |

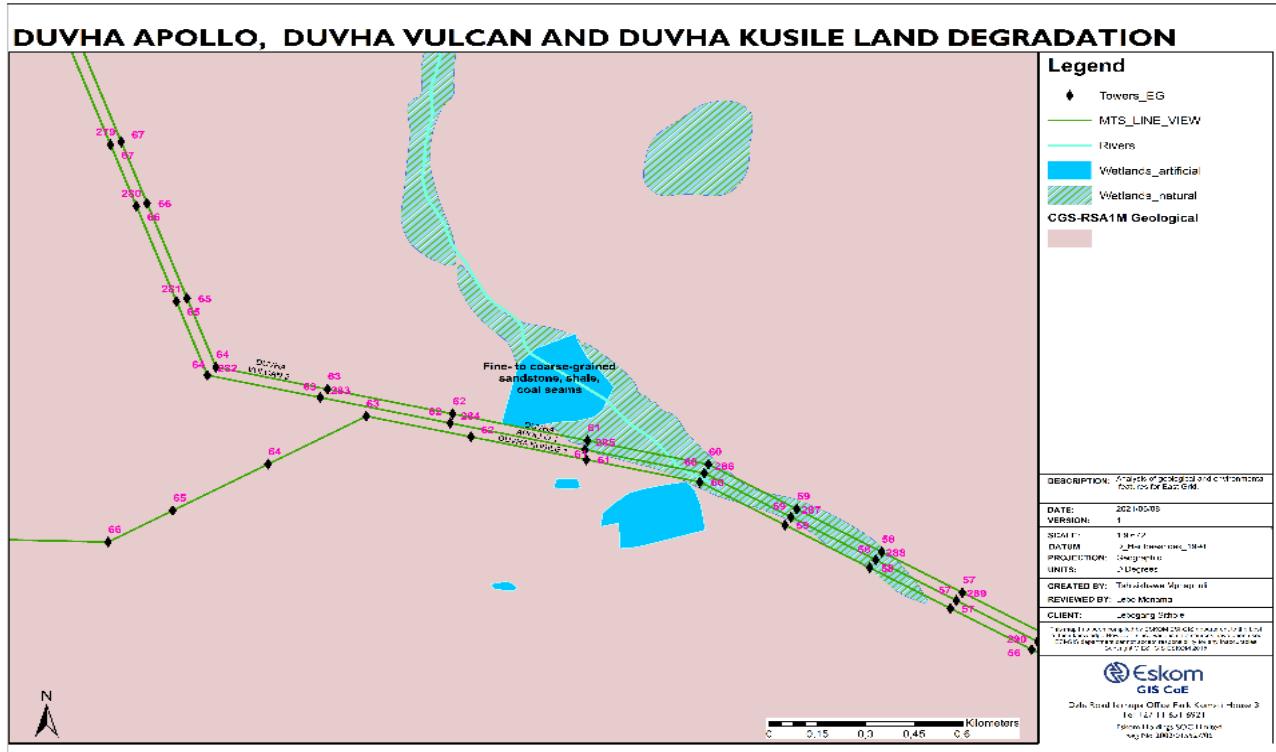
Figure 1: Watercourses next to Duvha- Apollo, Duvha – Vulcan and Duvha – Kusile Lines

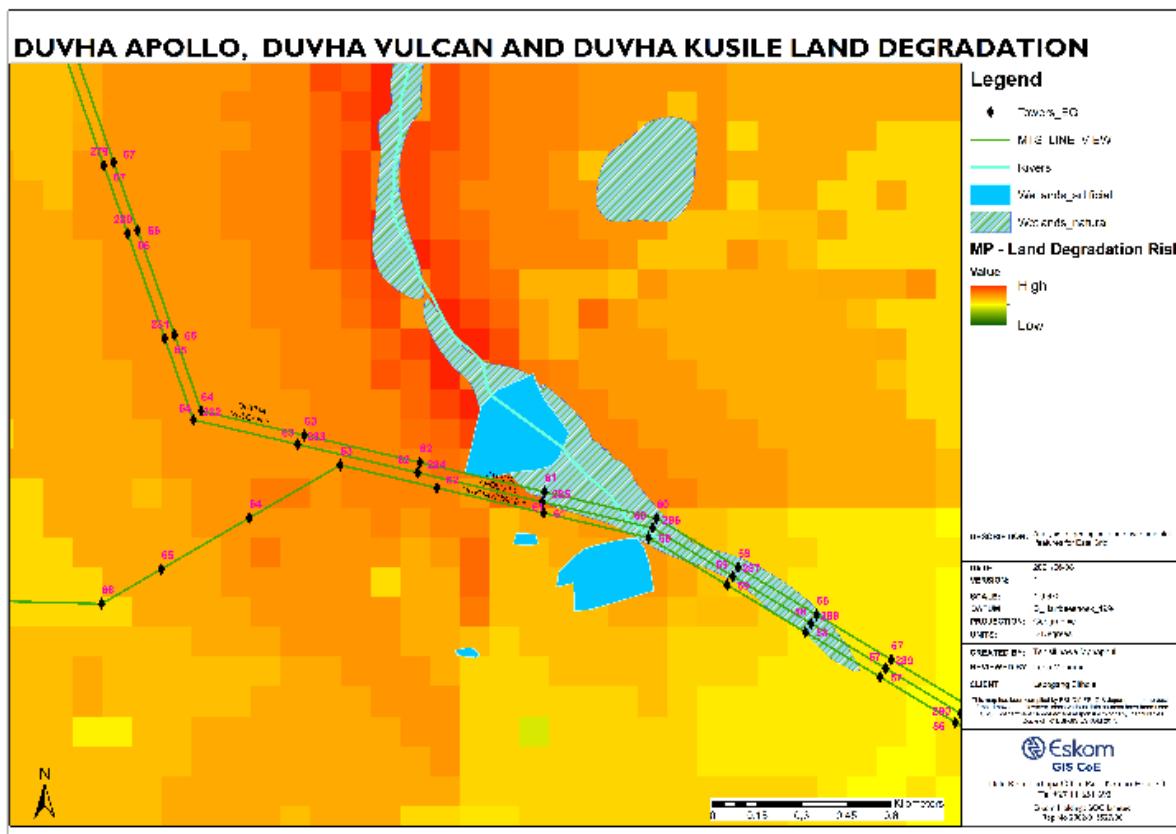
Figure 2 : Erosion Risk to Duvha- Apollo, Duvha – Vulcan and Duvha – Kusile Lines

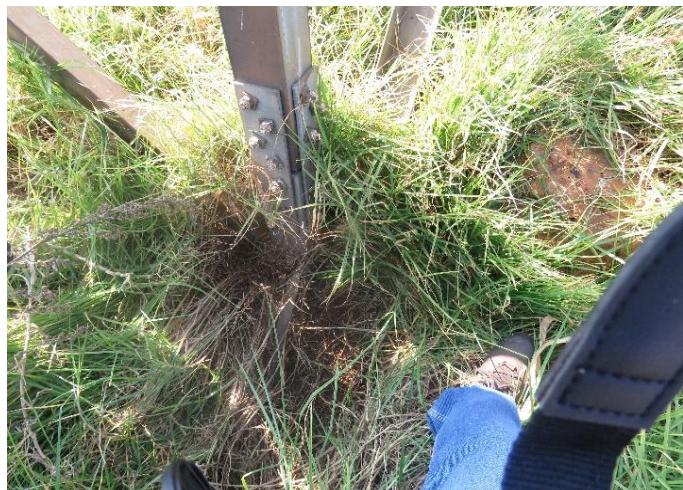
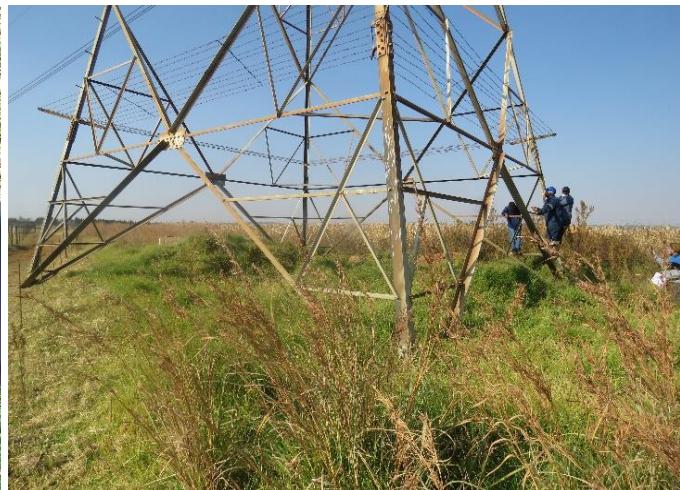
2.1 KUSILE - MINERVA NO1 400KV LINE TOWER 150

The tower foundations are covered by dense vegetation as shown on figure 6. The tower legs are at a huge risk of corrosion since the stub are directly exposed to soil. The recommendation is to remove the vegetation around the tower and expose the foundation to inspect the stubs.

Figure 3: Foundations covered in vegetation

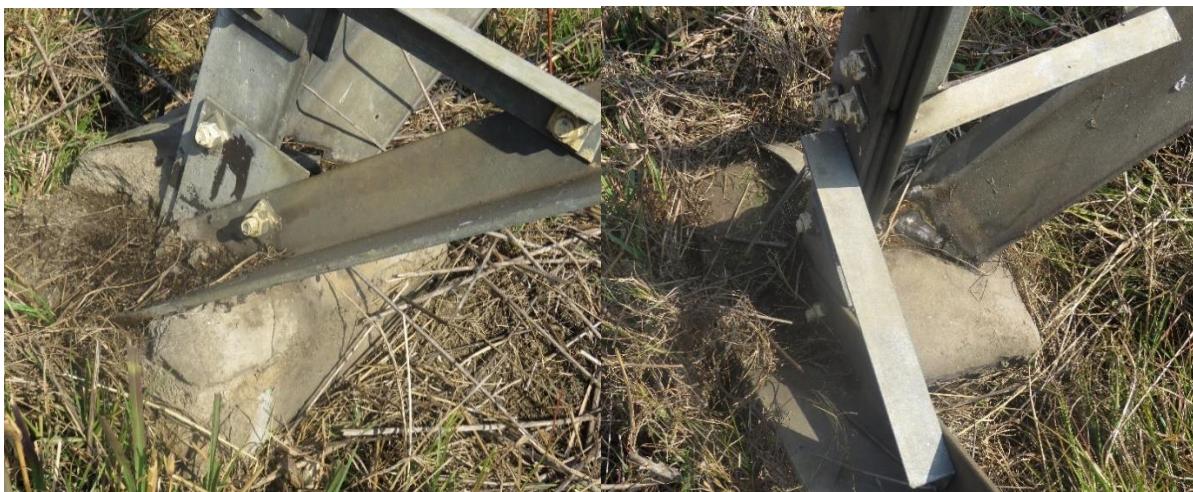
2.2 KUSILE - MINERVA 1 400KV LINE TOWER 121

The foundations are buried underground which is a violation of TRMSAAC6 which states that foundations should protrude a minimum of 250mm above ground level. The concrete on the foundations is breaking away as shown on the figure below. The bitumen paint on the foundations stubs is also cracking which will result in the corrosion of steel members and slight corrosion was detected. Mitigation is repair the concrete, treat the corrosion and increase the encasement to 250mm above ground.

Figure 4: Cracked foundations

| | Lucile - Minerva No1 400kV | | Mitigation |
|---|---|---|---|
| 2 | Kusile Minerva No1 400kV Line | Twr 121 | Crack Repair |

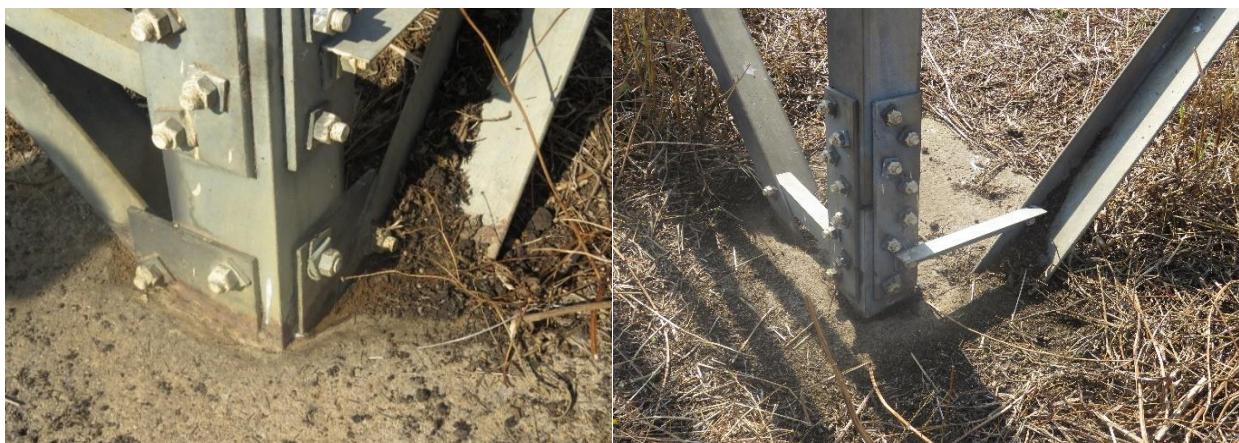
2.3 KUSILE - MINERVA1 400KV LINE TOWER 119

The foundation is buried, and the stub has started corroding, the corrosion around the stub is severe as shown on Figure 5. The foundations have no watershed and the water ponds around the stubs which causes the corrosion. There is also no protective coating around stubs. Mitigation is treating the corrosion and encase the legs in concrete.

Figure 5: Corrosion on the stub

| | Lucile - Minerva No1 400kV | | Mitigation |
|---|---|---|---|
| 3 | Kusile Minerva No1 400kV Line | Twr 119 | Corrosion Assessment and Encasement |

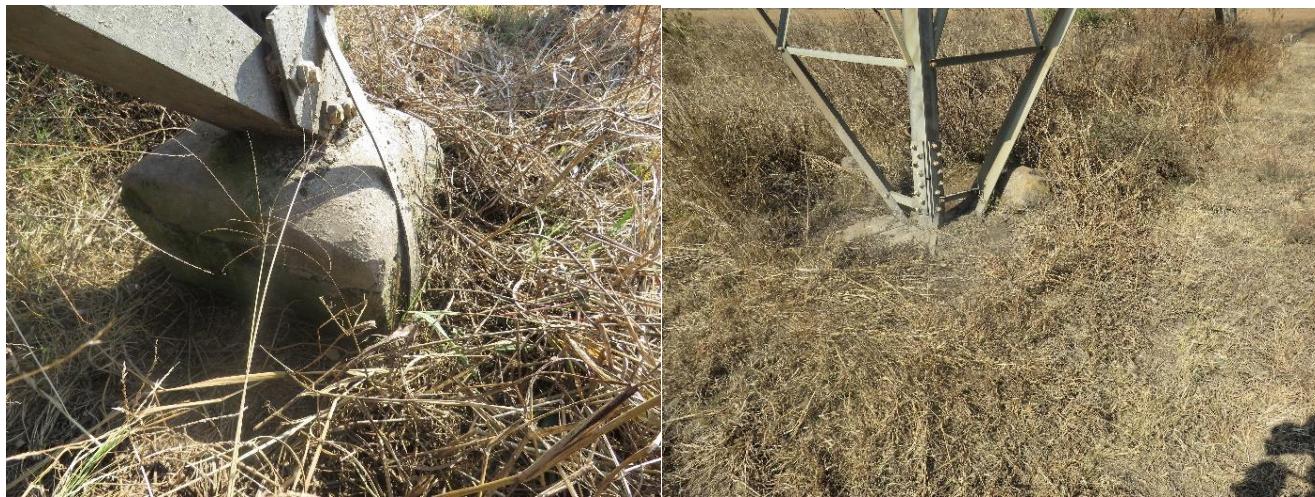
2.4 KUSILE - MINERVA NO1 400KV LINE TOWER 117

The tower has cracked foundations and the one leg of the tower is buried underground as shown on figure 6. Unwanted silting refers to the build-up of sediment in structures required to channel water away from sensitive areas. When this happens, water overflows and cause erosion around and under soil erosion structures, leading to subsidence and eventual failure. Silting needs to be remedied by simply cleaning out the sediment and placing it in areas where it will not re-enter the system. The cracking to be mitigated by encasing with new concrete.

Figure 6: Concrete cracks and buried foundation

| | Lucile - Minerva No1 400kV | | Mitigation |
|---|---|---|---|
| 4 | Kusile Minerva No1 400kV Line | Twr 117 | Crack Repair and Encasement |

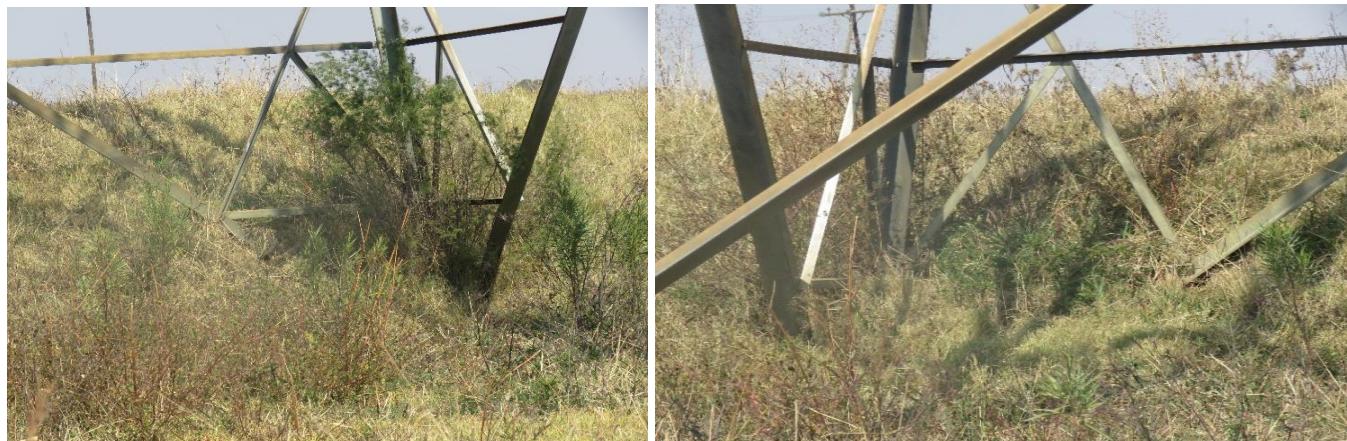
2.5 KUSILE- MINERVA NO1 400KV LINE TOWER 112

Dense vegetation around the tower, the foundations are covered with soil and cannot be inspected. Vegetation to be cleared and the tower foundations inspected for any corrosion.

Figure 7: Dense vegetation around the tower

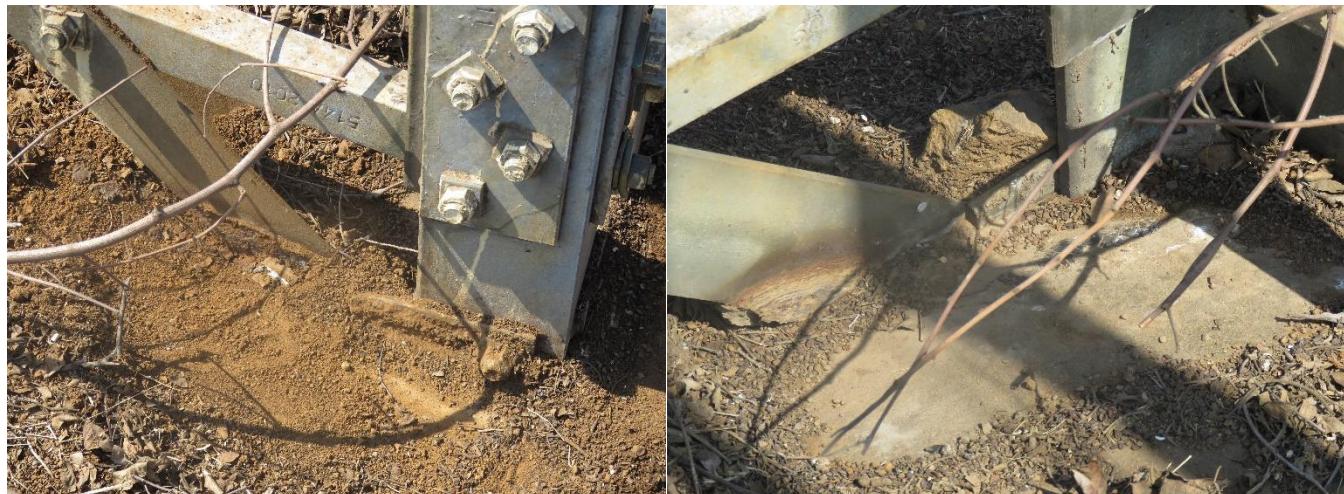
2.5.1 KUSILE- MINERVA1 400KV LINE TOWER 111

Tower 111 of the Kusile – Minerva Line has severe corrosion, there's evidence of material loss on the stub and brace members of the tower. The foundation is buried into the ground as shown in the images below, there is no bitumen paint and the foundation cap has no watershed, which promotes corrosion.

Figure 8: Corrosion on the stub and leg

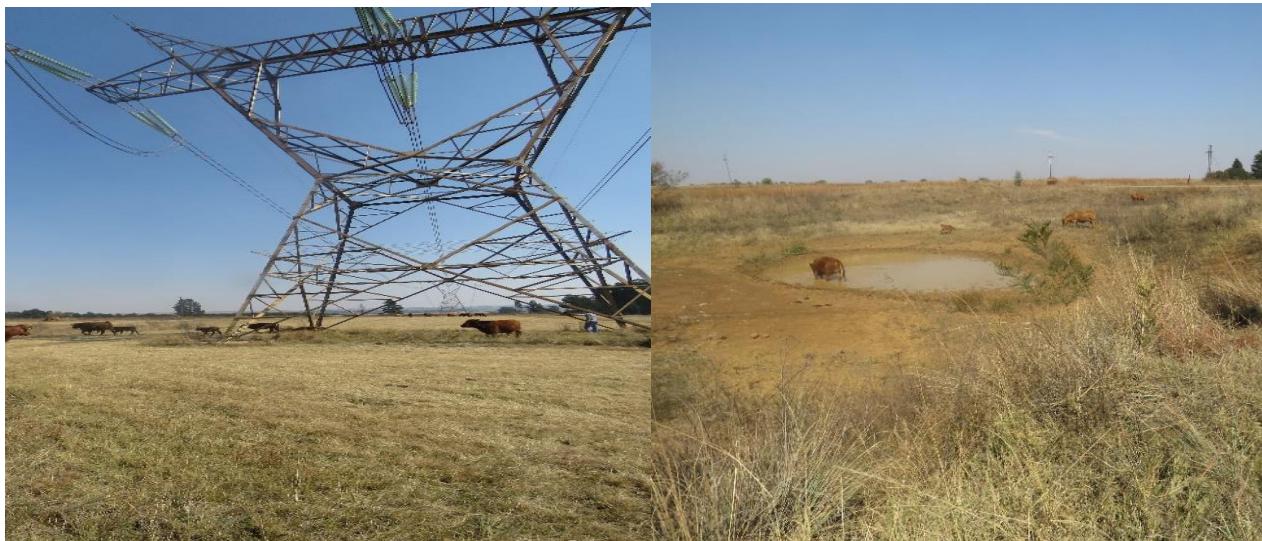
2.5.2 KUSILE - MINERVA NO1 400KV LINE TOWER 113

There is a man – made catchment next to tower used by the cattle to drink water as shown of figures below. The catchment is not a direct threat to the tower currently, however if left unattended it will expand to a point where it affects the foundations of the tower. The recommendation is for the Grid to engage the landowner to consider relocating the catchment away from Eskom's servitude.

Figure 9: Water catchment under the Eskom servitude
CONTROLLED DISCLOSURE

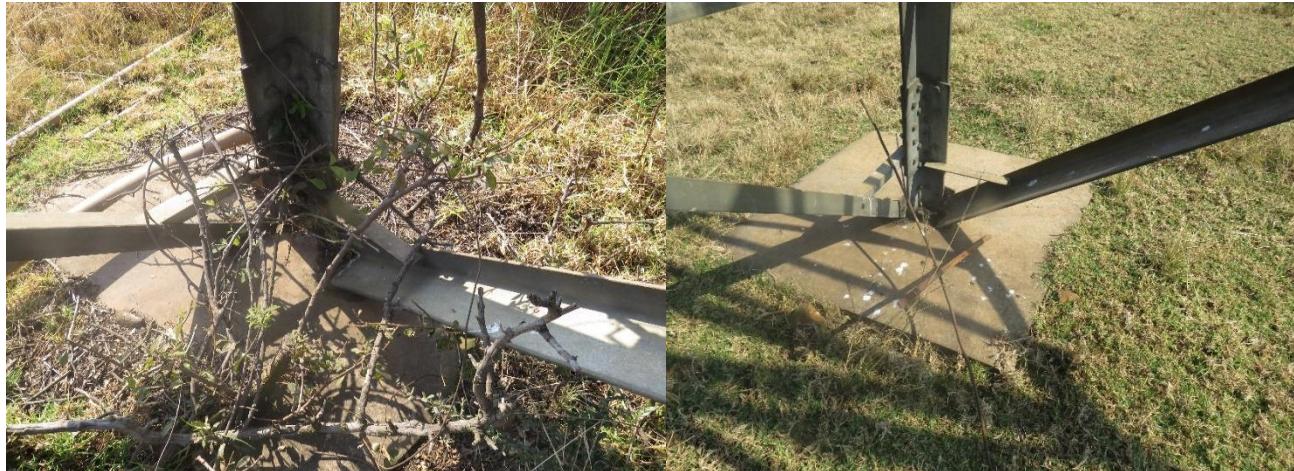
2.6 KUSILE - MINERVA1 400KV LINE TOWER 115

The foundations of this tower are buried but there are no signs of corrosion on the stubs, the tower must be closely monitored and the vegetation removed.

Figure 10: Buried foundations

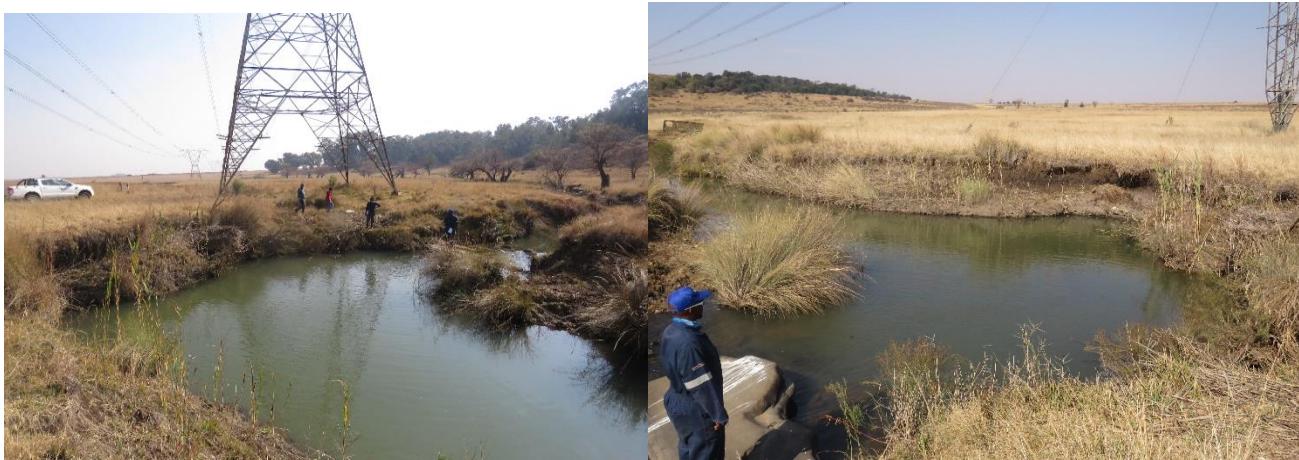
2.7 KENDAL - APOLLO 400KV TOWER 93 & KENDAL – MINERVA 400KV TOWER 87

Tower 93 of the Kendal – Apollo Line and Kendal – Minerva Tower 87 are located next to a stream as shown on the figures below. The embankment of the stream is eroding away which directly affects the foundations of the tower. From the pictures below it is evident that the erosion path is moving towards the stay foundations for tower 87 and the foundations for the self- support tower for tower 93. The mitigation is to install gabion walls following the countering of the stream embankment as shown on figure 14 and 15. The gabion wall will act as a retaining wall to prevent further soil erosion.

Figure 11: Stream next to the towers

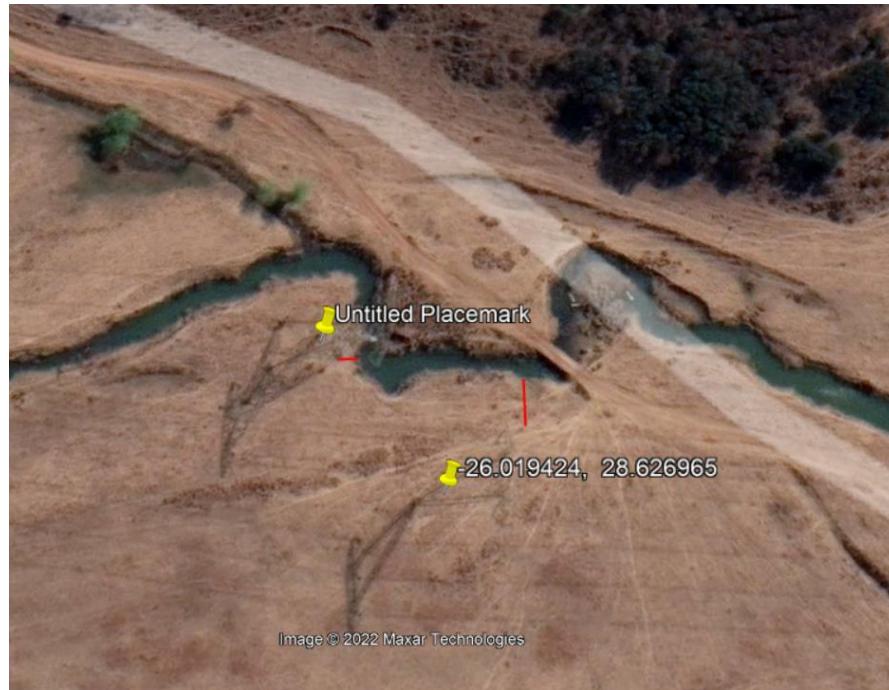
Figure 12: Erosion on the stream embankments towards the foundations (Google Earth imagery)

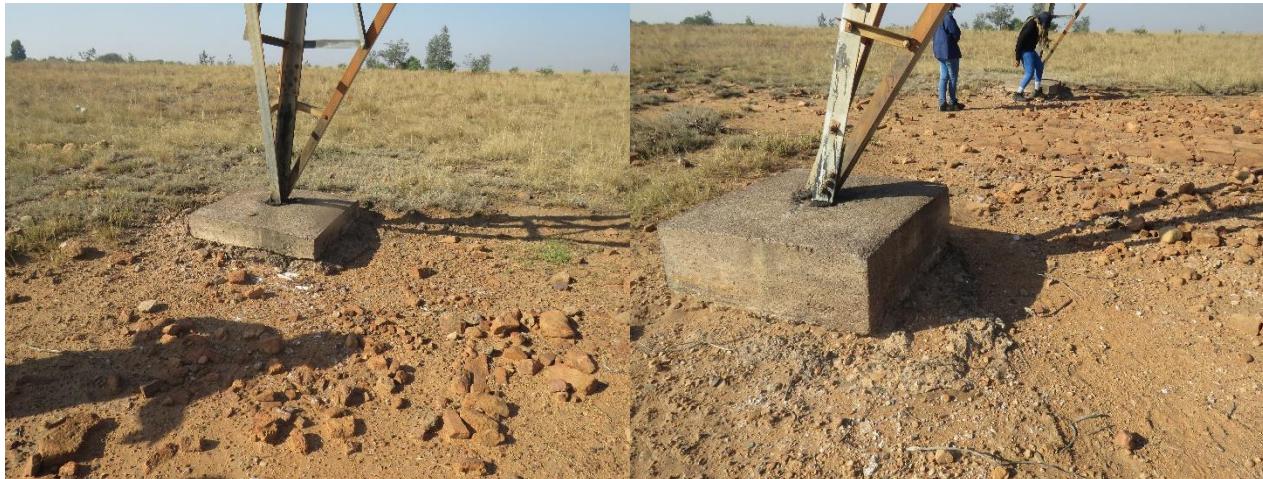
2.8.1 Duvha – Vulcan 1400kv Line Tower 101

Figure 17: Scouring of foundations

See section 3.4 for mitigation

Tunnelling and scouring occurs where water erodes and undermines structures. It is evidenced by voids on the upstream side of retaining structures and subsidence or cracking of the soil erosion structure. This can be remedied by replacement of soil with stabilised material to prevent further scouring.

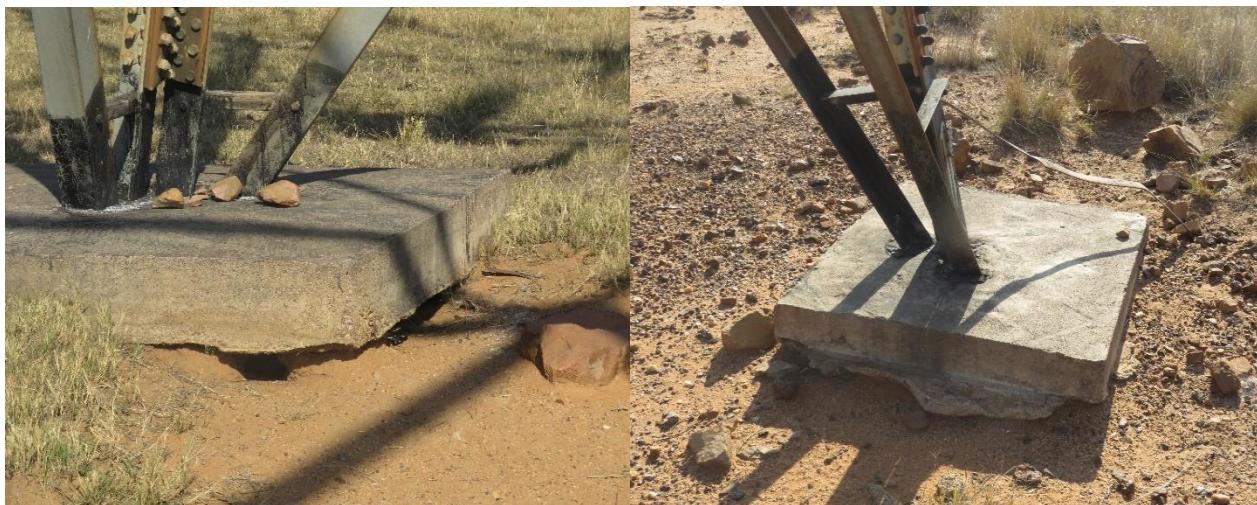
2.8.2 Hendrina – Vulcan 1 400kV Line Twr195

Figure 18: Scouring of foundation

See section 3.4 for mitigation

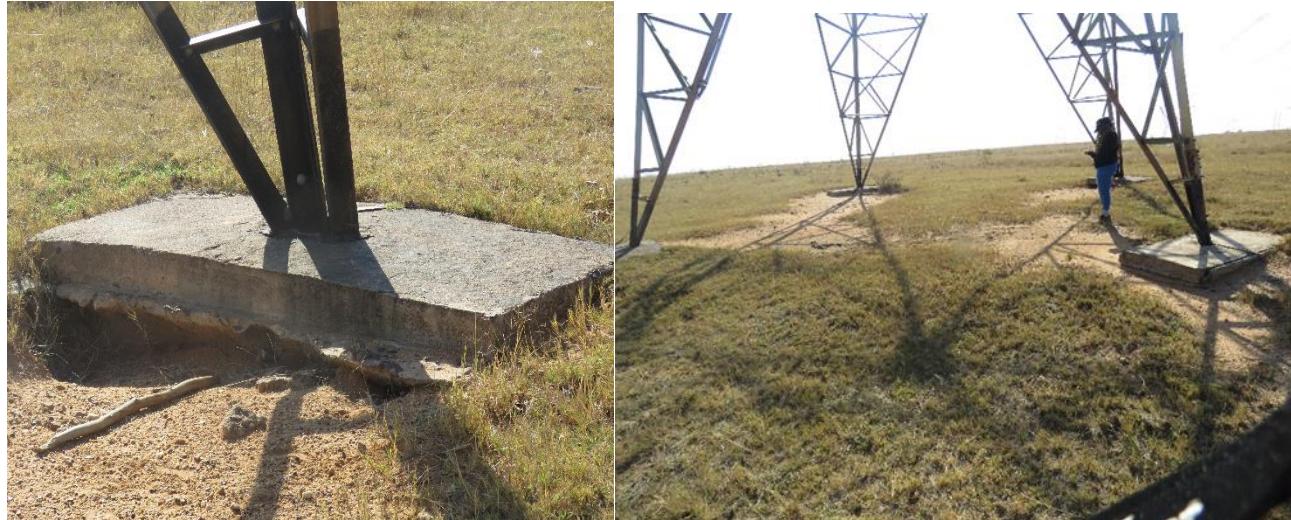
2.8.3 Hendrina - VULCAN1:400kV Line Twr195

Figure 19: Scouring of foundation

See section 3.4 for mitigation

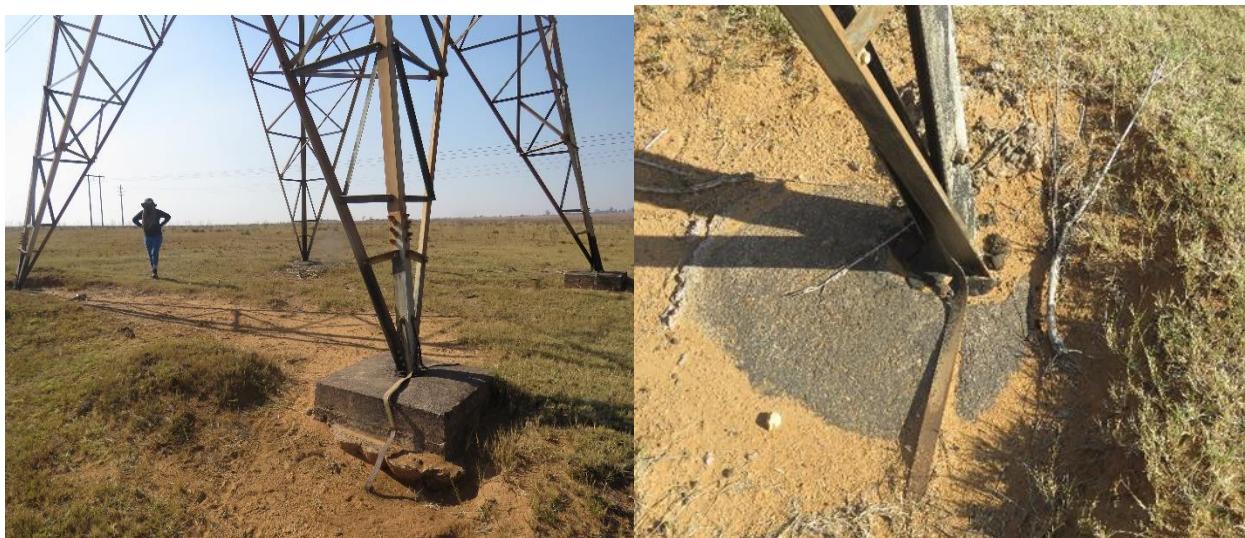
2.8.4 Duvhan- Vulcan1:400kV Line Twr104

Figure 20: Scouring of foundation

See section 3.4 for mitigation

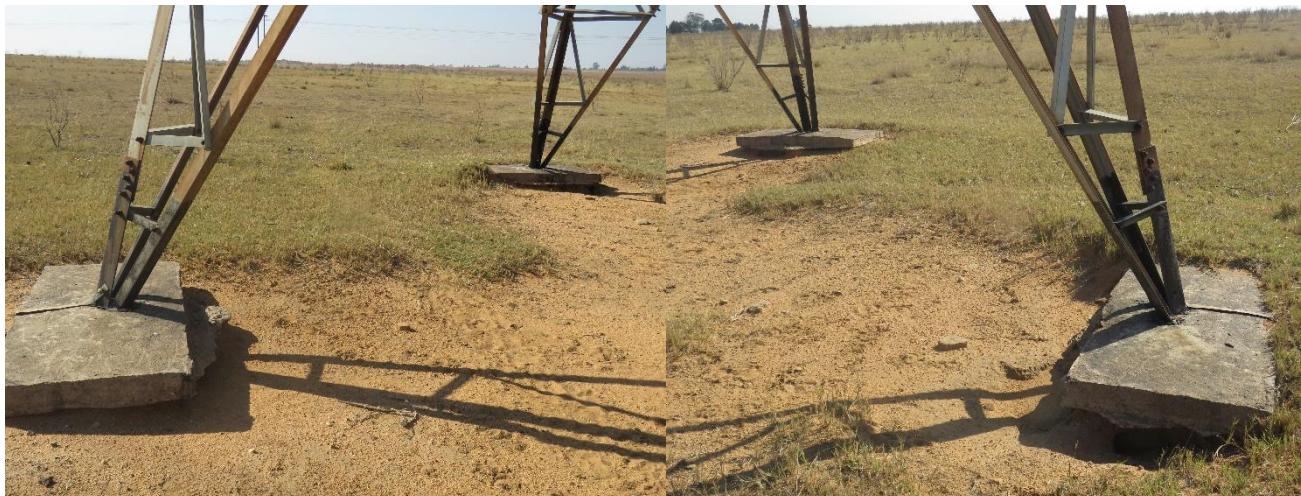
2.8.5 Hendrina - Vulcan 1:400kV Line Twr197

Figure 21: Scouring of foundation

See section 3.4 for mitigation

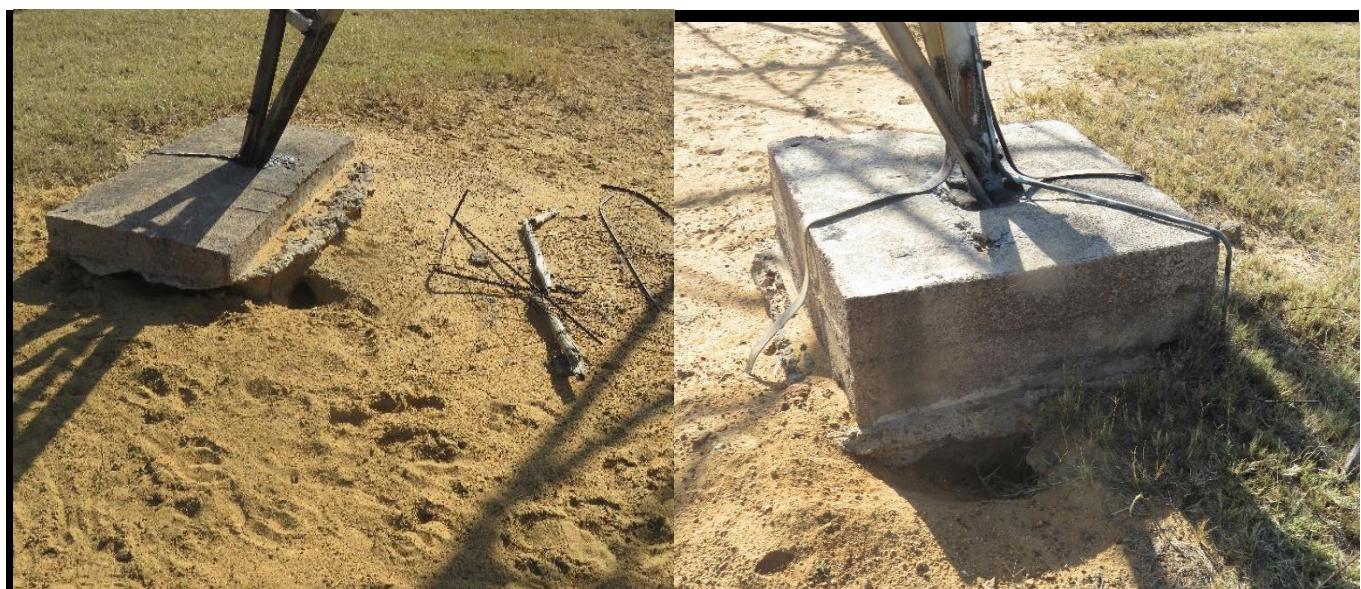
2.8.6 Hendrina – Vulcan 1:400kV Line Twr198

Figure 22: Scouring of foundation

See section 3.4 for mitigation

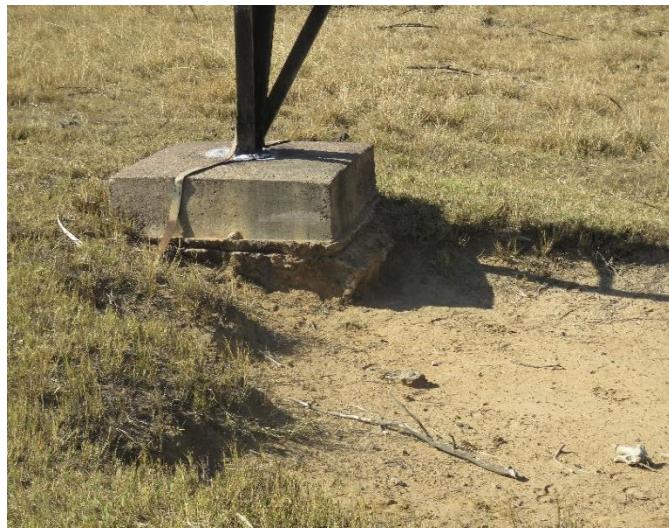
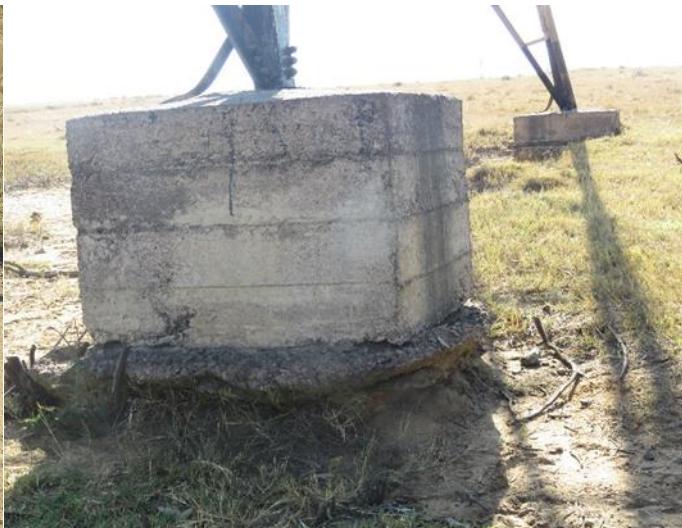
2.8.7 Duvha - Vulcan 1:400kV Line Twr106

Figure 23: Scouring of foundation

See section 3.4 for mitigation

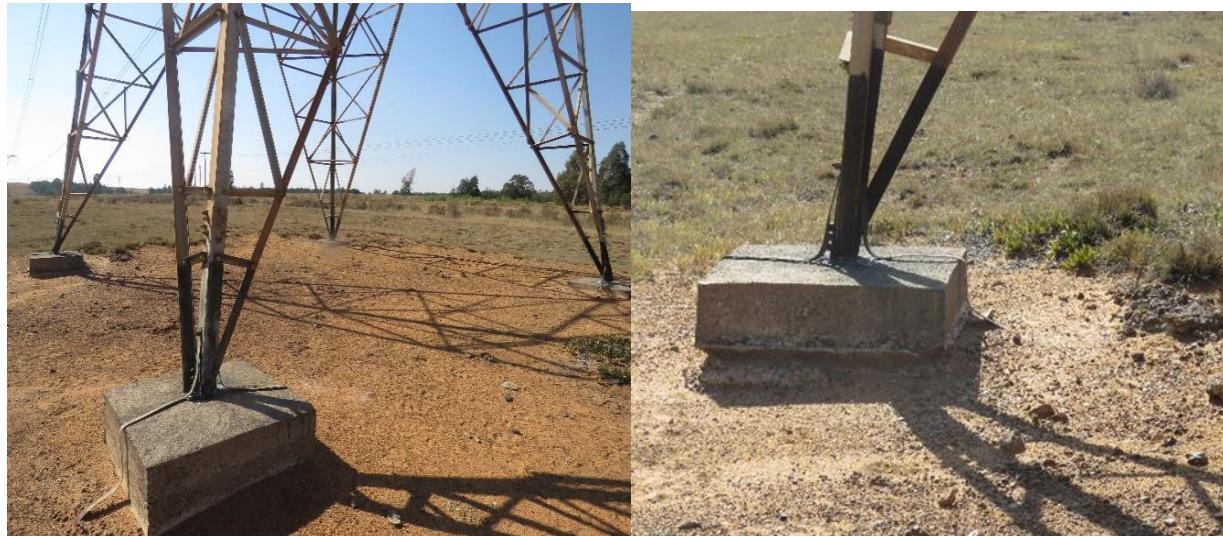
2.8.9 Duvha - Vulcan 1:400kV Line Twr107

Figure 24: Scouring of foundations

See section 3.4 for mitigation

| | Lucile - Minerva No1 400kV | | Mitigation |
|---|---|---|---|
| 7 | Duvha Vulcan1:400kv Line | Twr107 | Backfilling and Hydroseeding Corrosion Assessment and Encasement |

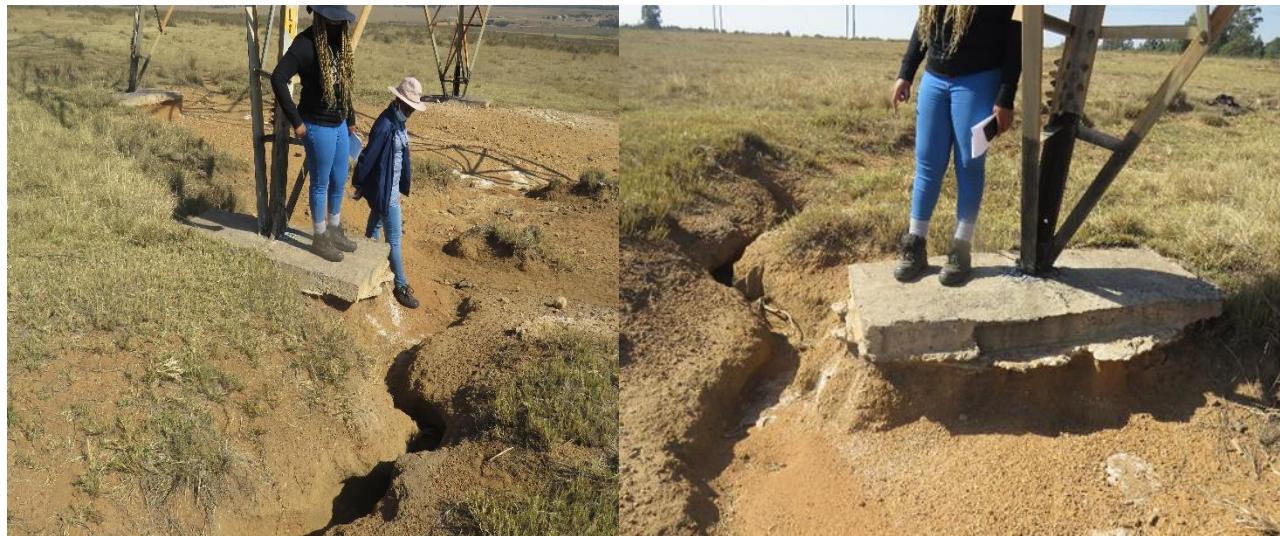
2.8.10 Hendrina - Vulcan 400kV Twr 200

Figure 25: Scouring of foundations

See section 3.4 for mitigation

| | Lucile - Minerva No1 400kV | | Mitigation |
|---|---|---|---|
| 4 | Hendrina Vulcan 1 400kV | Twr 200 | Backfilling and Hydroseeding Corrosion Assessment and Encasement |

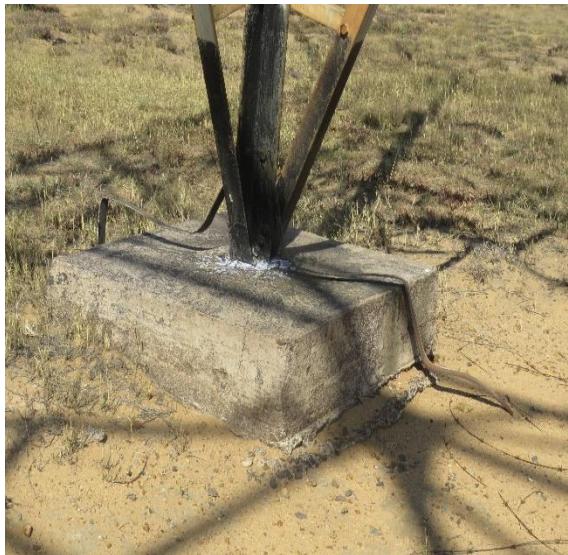
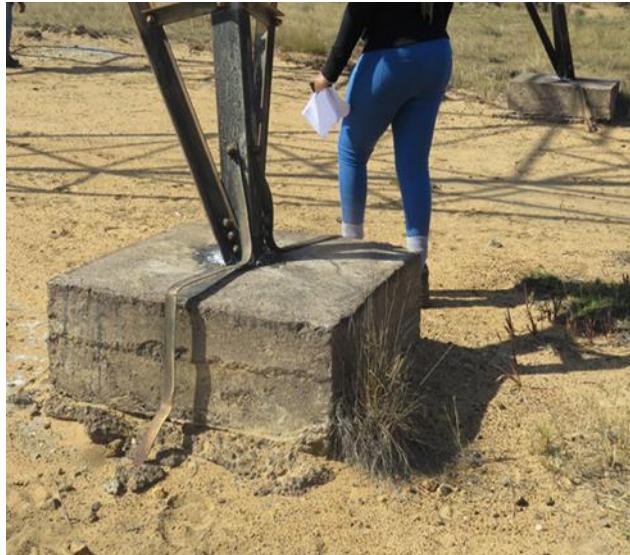
2.8.11 Duvha Vulcan 1 400kV Twr108

Figure 26 : Scouring of foundation

See section 3.4 for Mitigation

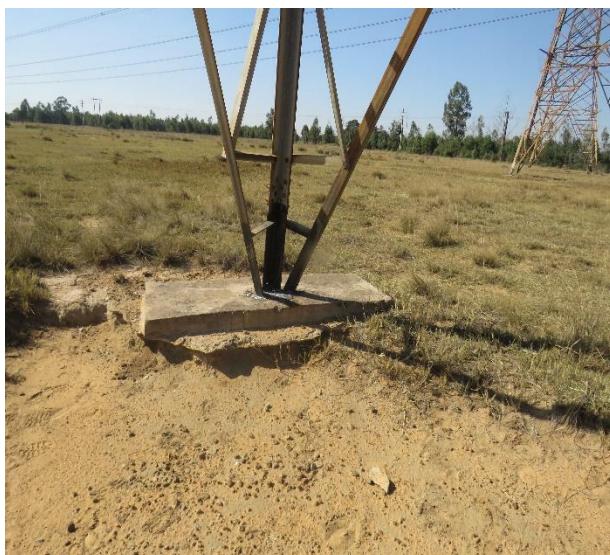
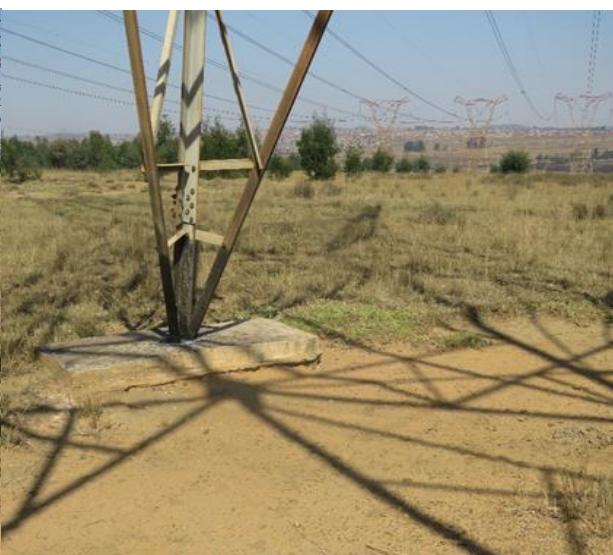
2.8.12 Hendrina - Vulcan 1 400kV Twr 201

Figure 27 : Scouring of foundations

See section 3.4 for Mitigation

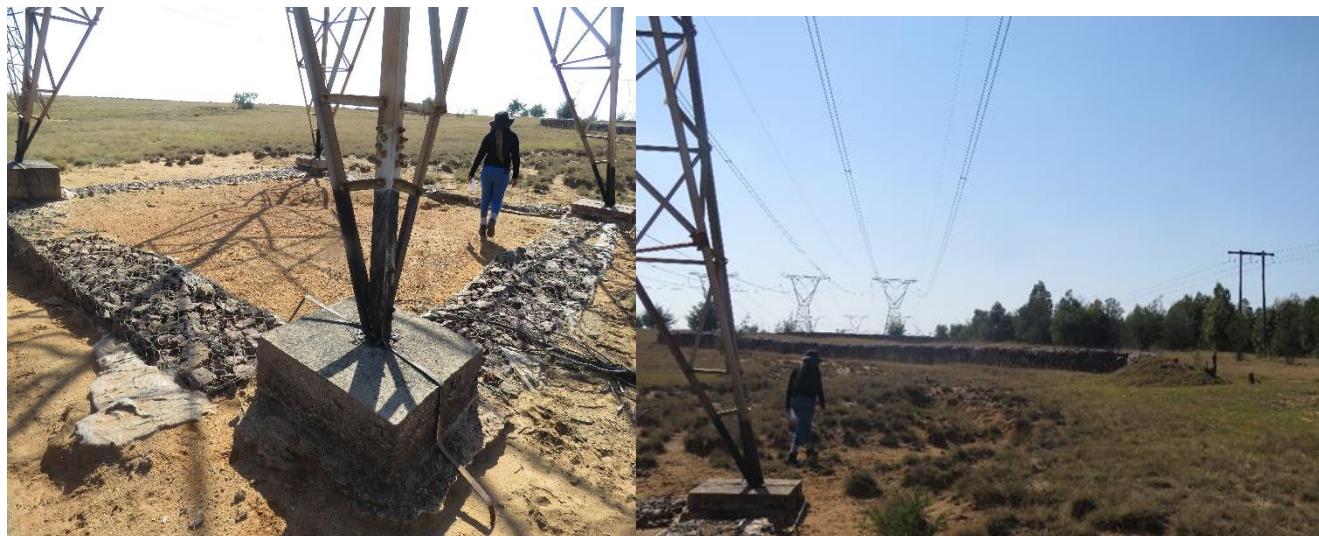
2.8.13 Duvha Vulcan 1:400kV Twr 109

Figure 28: Existing Gabion Wall

See section 3.4 for Mitigation

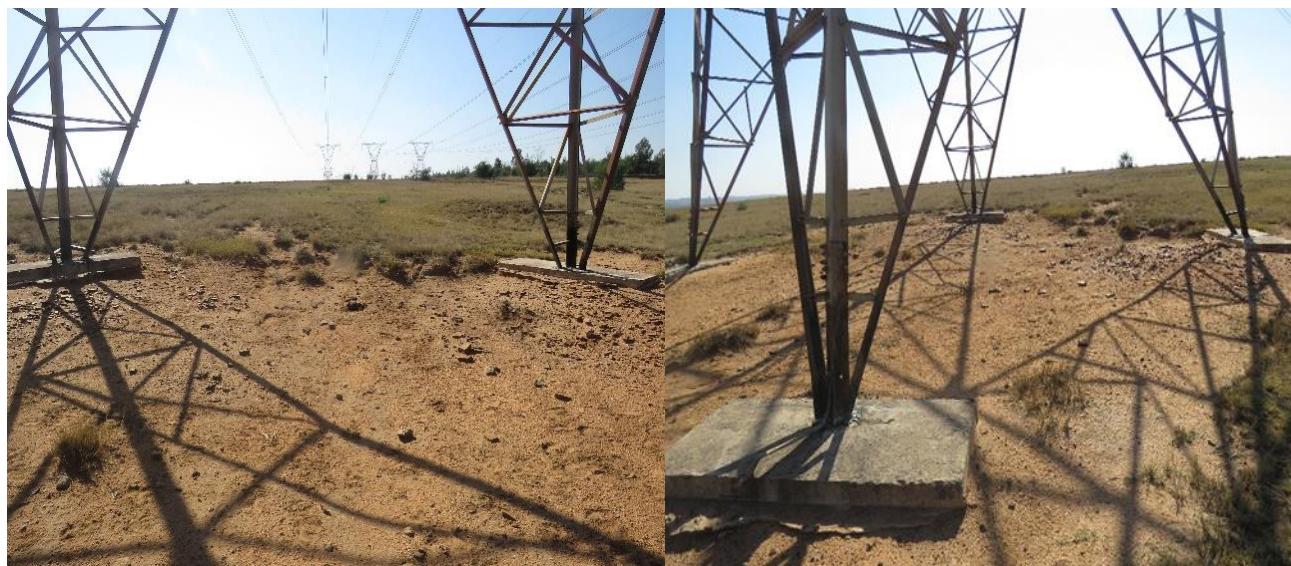
2.8.14 Hendrina Vulcan - 400kV Twr 202

Figure 29: Scouring of foundations

See section 3.4 for Mitigation

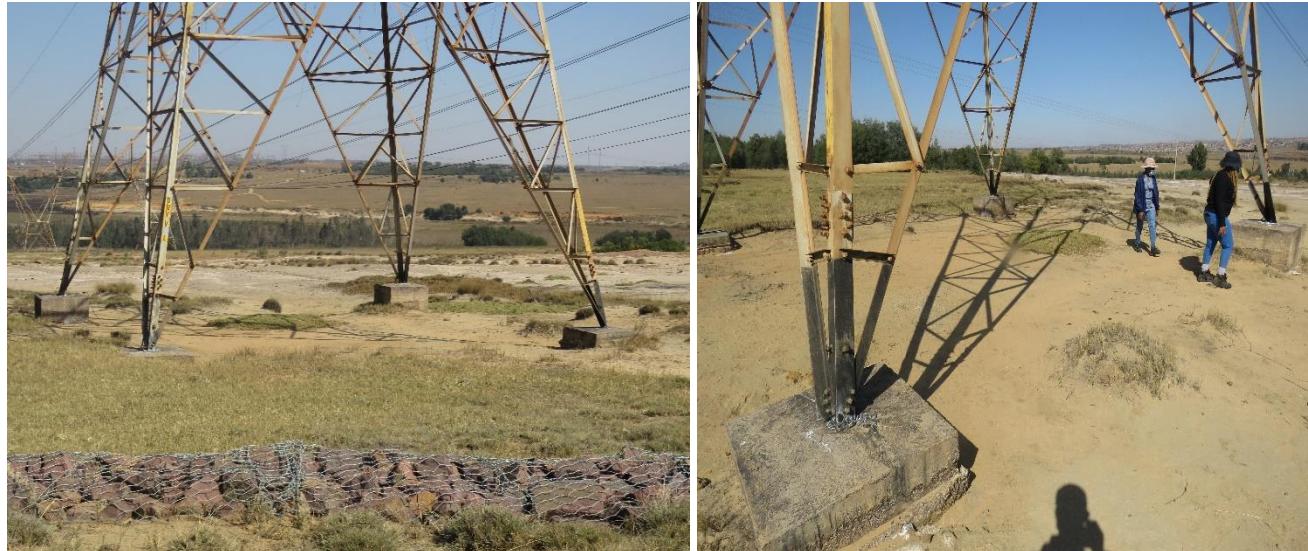
2.8.15 Duvha Vulcan 1 400kV Twr 110

Figure 30: Scouring of foundations

See section 3.4 for Mitigation

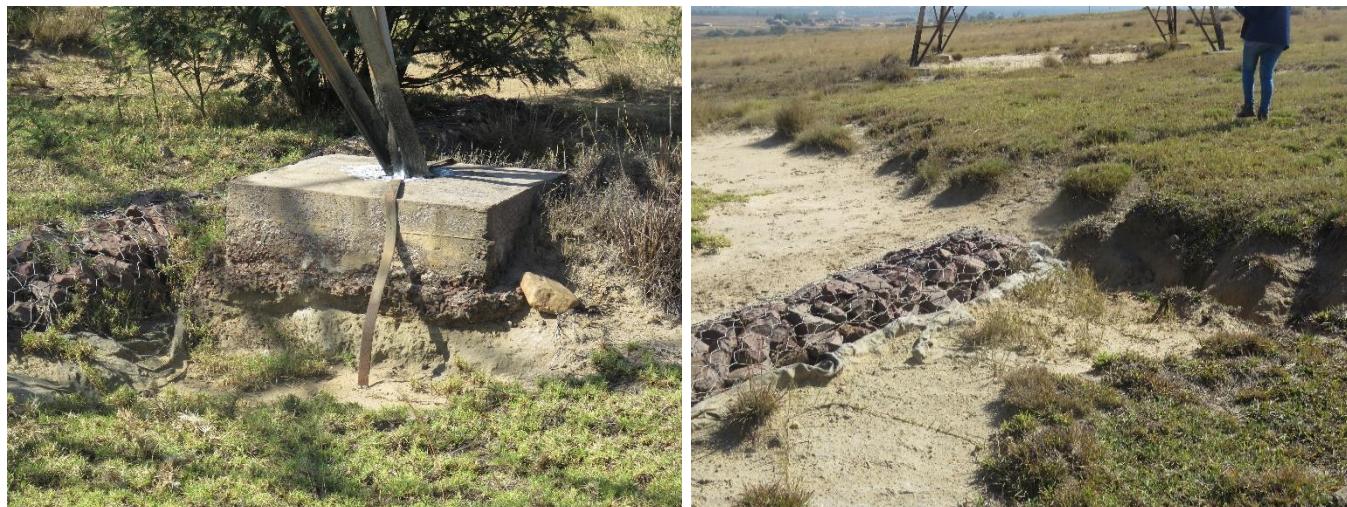
2.8.16 Hendrina Vulcan 400kV Twr 203

Figure 31: Scouring of foundations

See section 3.4 for Mitigation

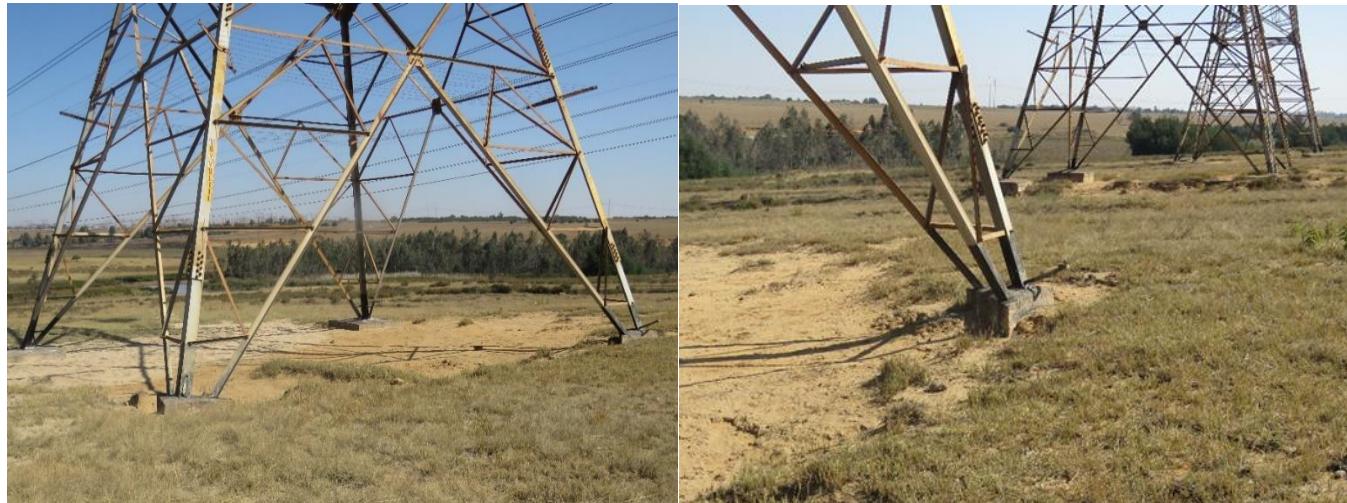
2.8.17 Duvha - Vulcan 1 400kV Twr 111

Figure 32: Scouring of foundations

See section 3.4 for Mitigation

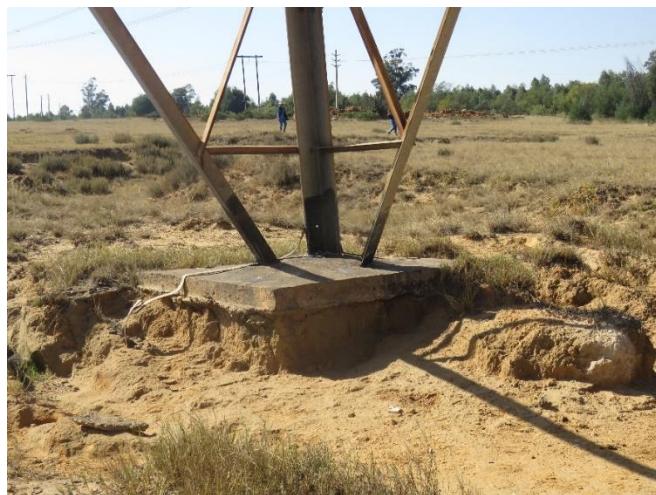
2.8.18 Hendrina - Vulcan 400kV Twr 204

Figure 33: Scouring of foundation

See section 3.4 for Mitigation
