TRANSNET NATIONAL PORTS AUTHORITY
TERMINAL OVERSIGHT AUDIT
INSPECTION REPORT

SITE: 18 DAVEY ROAD, MAYDON WHARF,
DURBAN

LESSEE: EX-MAYDON WHARF PORT TERMINALS

DATE: 25/03/2025

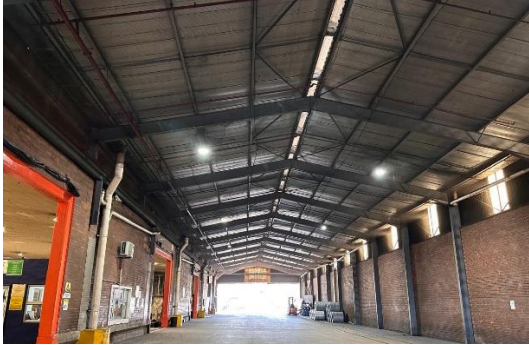
Element	Condition	Image
Roof / Ceiling	GOOD: The roof is in good condition with no visible signs of water leaks, holes, deformation, or corrosion. The structural integrity remains intact, and no immediate maintenance or repairs are required at this stage. Regular inspections should continue to ensure its longevity and performance.

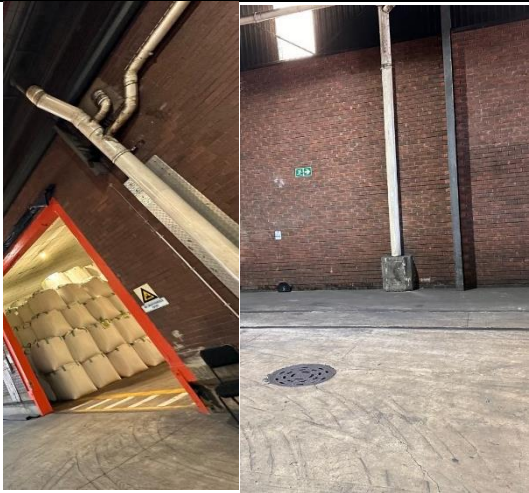
Gutters & downpipes	GOOD: The rainwater and stormwater downpipes are in good condition with no visible signs of leaks, holes, deformation, or other defects. They are functioning as intended, ensuring proper water drainage. Regular inspections and maintenance should be continued to sustain their efficiency.

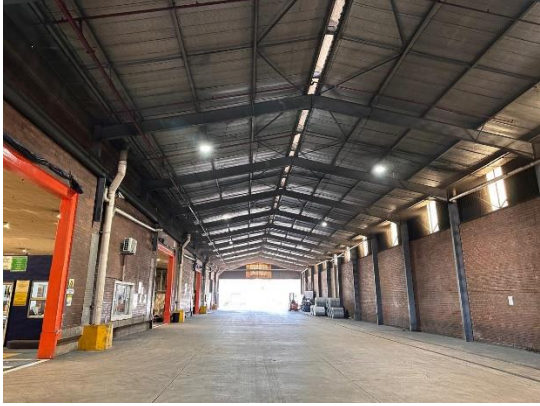
<p>Walls</p>	<p>GOOD: The non-load-bearing clay brick wall is in good condition, with no visible signs of water leaks, dampness, cracks, deformation, or deterioration. The structural integrity remains intact, and no immediate maintenance is required.</p>

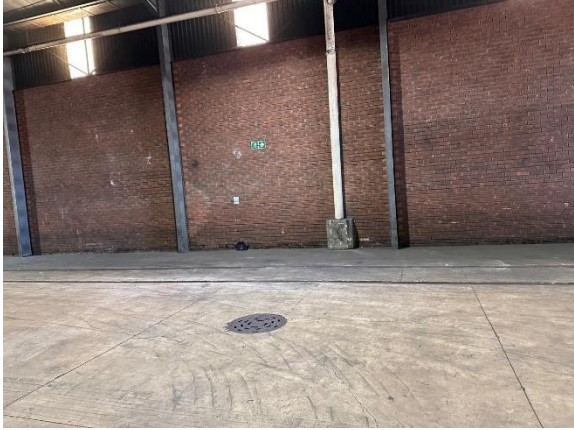
<p>Beams , Columns</p>	<p>GOOD: The beams and columns, forming part of the portal steel frame structure, are in good condition with no major signs of water ingress, corrosion, or visible deformation. The structural integrity is intact, and no immediate maintenance is required.</p>

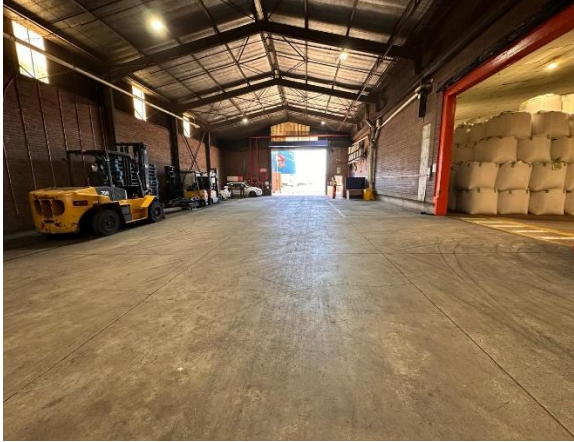
<p>Slabs</p>	<p>GOOD: The concrete floor slab is in good condition overall; however, there are visible cracks, primarily in areas where construction joints were insufficient, indicating excessive pressure. While the structural integrity remains intact, it is recommended to monitor the cracks and</p>

consider remedial measures if they widen or affect functionality. Regular maintenance and proper joint placement should be considered in future works to prevent similar occurrences.	
Doors, Windows	GOOD: The doors and windows are in good condition with no visible damage or functional issues. However, during the inspection, the main shutter doors were already open, preventing a full assessment of their operational functionality.	N/A
Drainage	GOOD: The drainage system is in good condition, with no visible signs of ponding. The presence of drains connected to stormwater downpipes indicates that excess water is efficiently directed to existing manholes and the rest of the drainage network. Regular maintenance and inspections should continue to ensure ongoing functionality.

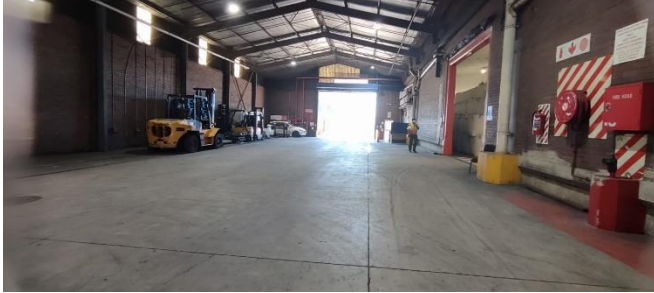
<p>Housekeeping / other</p>	<p>GOOD: Housekeeping around the intake building leading to the break bulk warehouse is in excellent condition. There are no debris, obstructions, or hazards that could impact operational safety. Continuous maintenance and monitoring are recommended to sustain these high standards and ensure a safe and efficient working environment.</p>

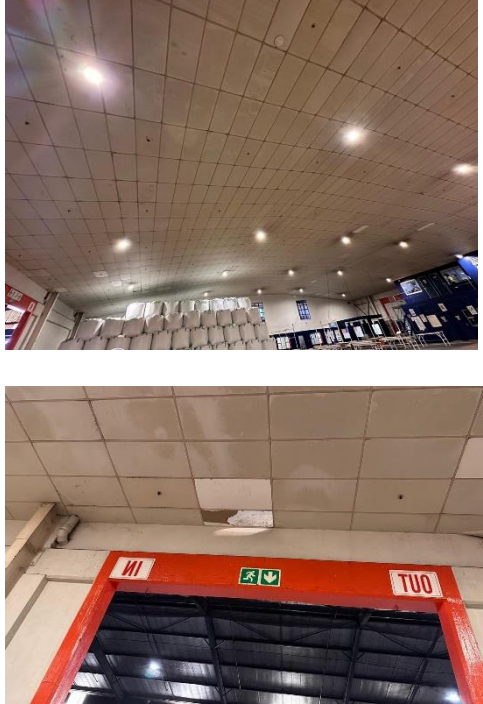
Element	Condition	Image
<p>Roof / Ceiling</p>	<p>GOOD: The assessment of the suspended ceiling confirms that it is in good condition, with no signs of water ingress or major damage. All panels remain intact, contributing to the overall structural integrity of the ceiling. However, one or two panels require replacement to maintain consistency and aesthetics.</p>

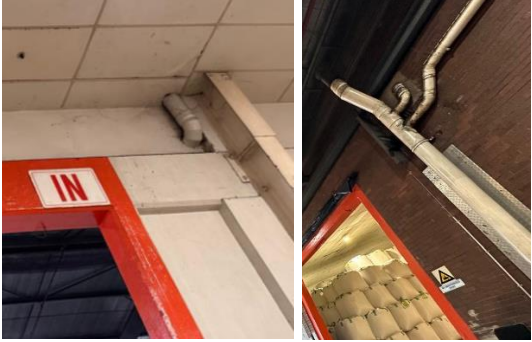
<p>Gutters & downpipes</p>	<p>GOOD: The assessment of the drainage downpipes confirms that the stormwater drainage system for the warehouse is directly linked to that of the adjacent structures, namely the Intake Building and the loading passage, where the main downpipes are located. The downpipes are in good condition, with no signs of leaks or any form of disrepair. The system appears to be functioning effectively, ensuring proper water drainage.</p>

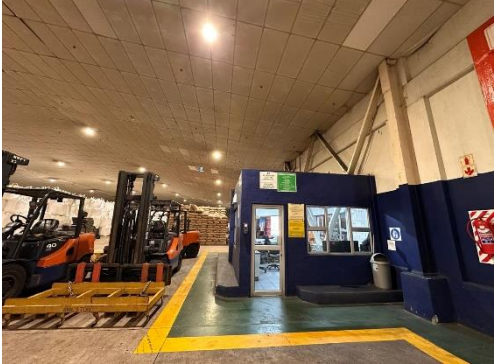
<p>Walls</p>	<p>GOOD: No visible signs of water leaks, dampness, cracks, deformation, or deterioration. The structural integrity remains intact.</p>

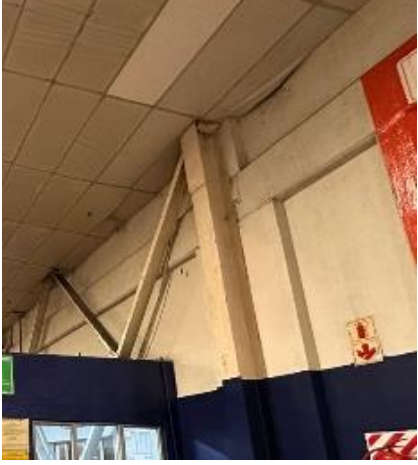
<p>Beams, columns</p>	<p>GOOD: The structure consists of a steel portal frame. The beams are not visible as they are concealed by the suspended ceiling. The columns are integrated into the brick wall and have been painted to match the rest of the structure, providing a seamless appearance. There are no signs of corrosion or deformation on the steel columns, indicating that they remain in good condition.</p>

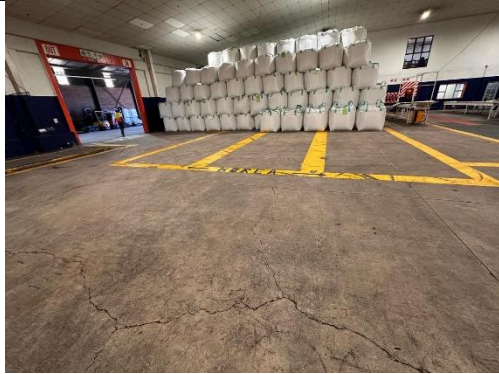
Slabs	GOOD: The concrete floor slab is in good condition overall; however, there are visible cracks, primarily in areas where construction joints were insufficient, indicating excessive pressure. While the structural integrity remains intact, it is recommended to monitor the cracks and consider remedial measures if they widen or affect functionality.

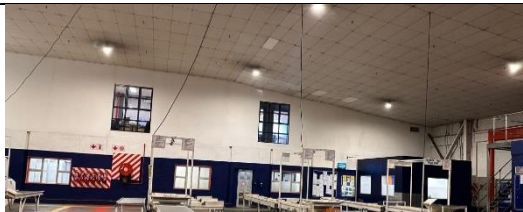
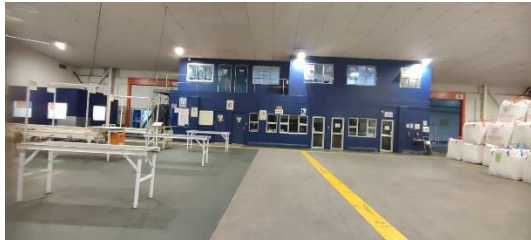
Doors, Windows	GOOD: The assessment of the windows and doors within the warehouse and office blocks indicates that most of the windows are linked to the office spaces and the admin building. Both the windows and doors are in good condition, showing no visible signs of damage or deterioration. They appear to have been recently refurbished, enhancing their functionality and overall aesthetic appeal.

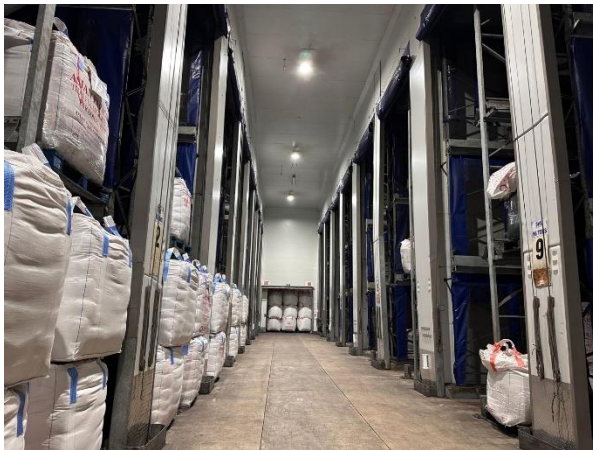
Figure 2: The interior of the cold storage showing racks and passages

The floors are generally in good condition. While much of the floor area is covered by storage racks, the visible sections in the drive-in passages show that the concrete floor remains intact. Small cracks observed are attributed to insufficient joints during the construction phase but do not pose immediate structural concerns. Regular monitoring is recommended to ensure long-term durability.

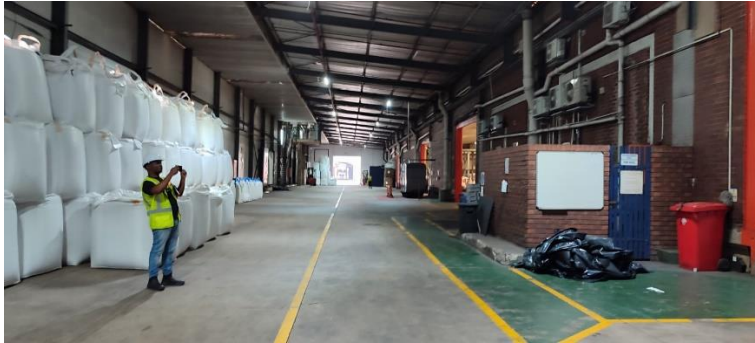
Figure 3: A view of the Loading Passage

The inspection of the loading passage confirms that it is a dedicated structure separating the warehouse and the cold storage room, serving as a key area for loading operations. The passage shares walls and stormwater downpipes with adjacent buildings, which appear to be in

good condition. Additionally, ablution facilities and a changing room are present at the East-end corner of the building, providing necessary amenities for workers. The overall condition of the loading passage is satisfactory, with no visible structural concerns.

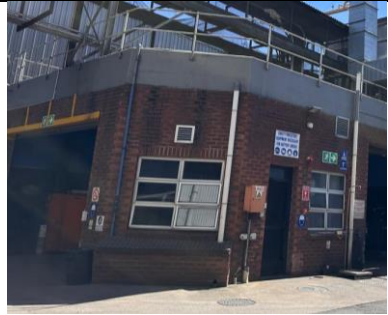
Element	Condition	Image
Walls	GOOD: brick wall is in good condition and structurally sound. There are no visible signs of cracks, damage, or deterioration, indicating the walls are well-maintained. The overall integrity of the structure is intact, ensuring stability and safety.

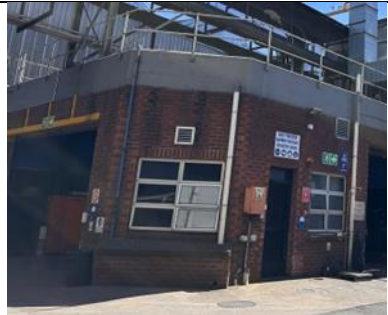
Windows/Doors	GOOD: Windows and doors in the engine room confirms that they are in good and sound condition. There are no visible signs of deterioration, damage, or wear. The fixtures appear to be well-maintained, contributing to the overall integrity and security of the engine room

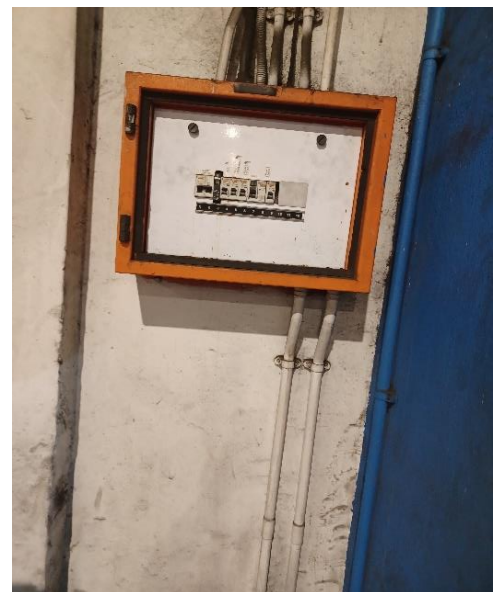
Element	Condition	Image
Low voltage distribution	<ul style="list-style-type: none"> Various distribution boards in the facility some of these need attentions as their covers are either loose or missing especially in the warehouse area. A COC for each DB will be given to our property department. The lighting is in good condition. 	See next page

Figure 6: DB missing a door

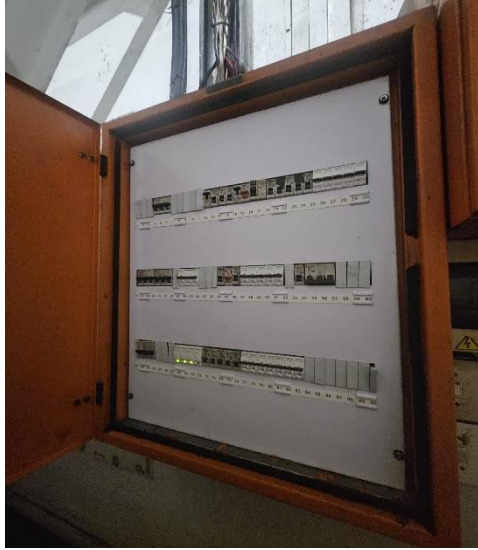
Figure 7: DB in good condition

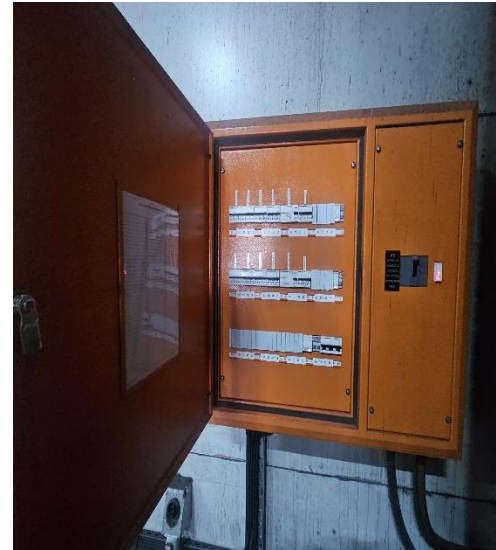
Figure 8: DB in good condition
