Title: **ESSELEN SUBSTATION
SINKHOLE REHABILITATION
SCOPE AND SPECIFICATION**

Unique Identifier: **Ess22P15-SE-E87**

Documentation Type: **Report**

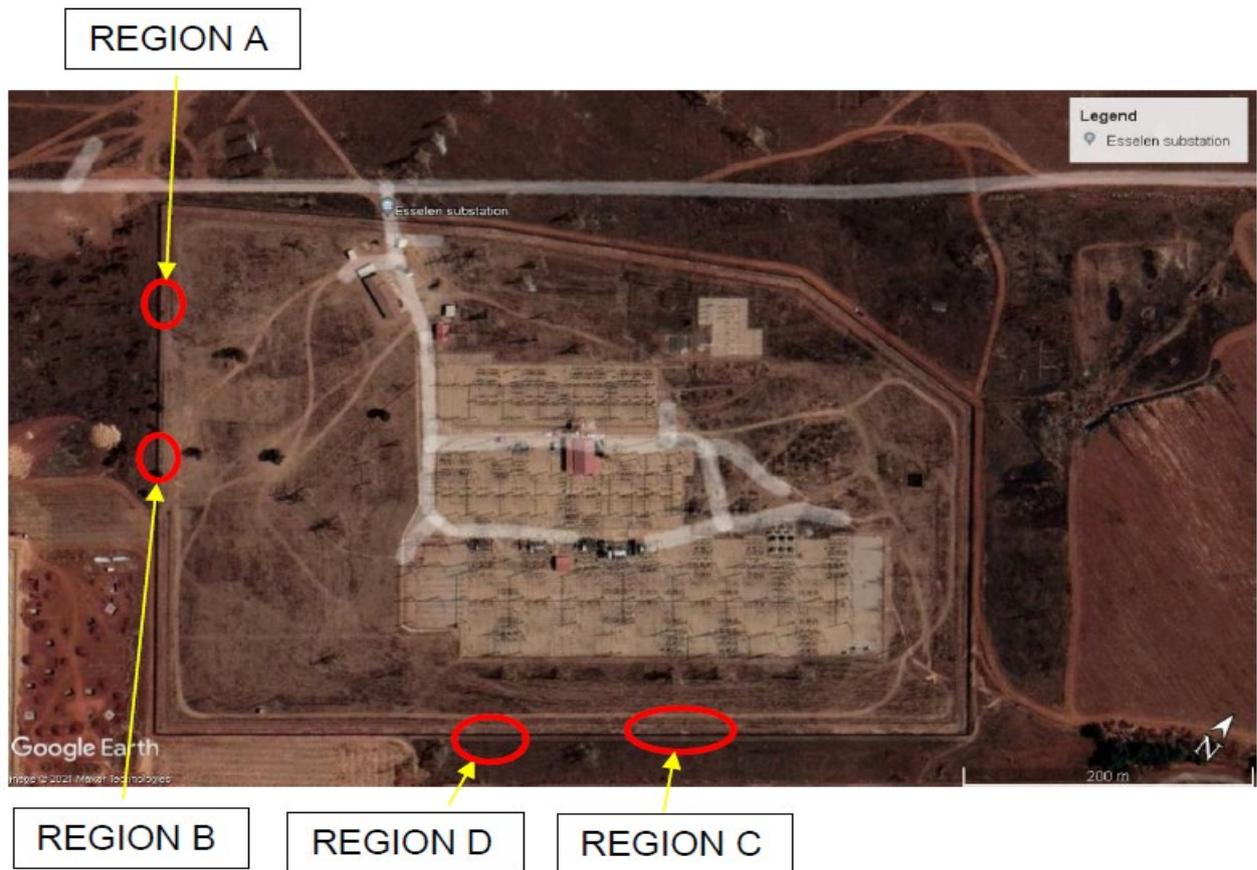
Figure 1: Sinkholes in various regions

Sinkholes manifested in the perimeter fence of the substation in the western and southern flank. The sinkholes are formed due to poor storm water management in the periphery of the substation along the fence area in the western and southern flank of the substation. It should also be noted that there are large tension cracks in the southern flank in Region C (refer to figure 1) indicating that more sinkholes will develop.

There are four (4) regions with localised sinkholes; thus, each Region has been named A, B, C and D. The regions are depicted in the image below:

The sinkholes have been identified to be along the fence. The sinkholes that have developed at the substation are all located at the outer barrier fence. Typically, there is a sinkhole between the outer barrier fence and the lethal fence; and then there are more sinkholes outside the outer barrier fence adjacent to the sinkhole inside.

Additionally, there are tension cracks at Region C, indicating more imminent sinkholes to be formed.

Region	Sinkhole	Diameter (m)	Depth (m)	Volume (m ³)	Description	Total Volume (m ³)
A	1	7,5	2,5	60	This should be taken as a single sinkhole.	229
	2	8,45	2,5	169		
	3	2,5	2,5	16	Isolated sinkhole and should rehabilitated.	16
B	1	3,4	0,5	7	Isolated sinkhole and should rehabilitated.	7
	2	5	2	49	These sinkholes are actually two sinkholes in close proximity.	49
C	1	7,6	2,5	57	Isolated sinkhole and should rehabilitated.	57

Region	Sinkhole	Diameter (m)	Depth (m)	Volume (m ³)	Description	Total Volume (m ³)
	2	16	2,5	72	Tension crack has collapsed to a depth of 1 meter.	72
	3	12	2,5	390	Isolated sinkhole and should rehabilitated.	390
	4	6,9	2,5	52	Isolated sinkhole and should rehabilitated.	52
D	1	6	4	144	Isolated sinkhole and should rehabilitated. In close proximity to ESS/JUP3 Tower	144
Total volume to be filled						1015

The sinkholes formed at the Esselen Substation shall be rehabilitated by using a combination of materials as specified in [6]; i.e. dump rock, bulkfill and self-compacting concrete to cover up and fill the formed cavities. The areas that have tension cracks formation shall be induced to collapse to at least a depth of one meter (1 m) to form sinkholes that will be backfilled with the specified material. The throats of the sinkhole will be choked with dump rock, apply self-compacting concrete and bulk fill material.

- b. The contractors' competent person shall determine safe working distance and correct position to erect security fences during construction.
4. Pre-collapse all the sinkholes, including walls between them and tension cracks around them, to form one big sinkholes. This should be done in accordance to [Table 1](#) description.

5. Pre-collapse all areas with tension cracks to a minimum depth of at least 1m to reach bedrock.
6. The sidewalls should be excavated at 45 degrees to the horizontal. Stability must be ensured prior to continuing with the works.
