### CONDITION ASSESSMENT REPORT FOR THE KZN ROWING ASSOCIATION

Project Name : Condition Assessment (Ex- Cargo Lash and Trading  
CC

Author : Nduduzo Mkhize

Owner : Transnet National Ports Authority

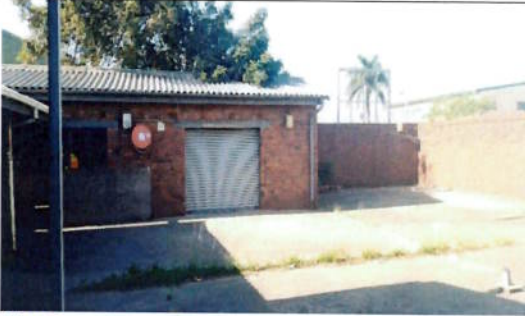
<p><b>Building 1</b></p> <ul style="list-style-type: none"> <li>• The area of land in this building is 543 m<sup>2</sup></li> <li>• The exterior of this complex is in fair condition.</li> <li>• The entire roof structure is covered by asbestos of which must be changed.</li> </ul>

<p>Figure 3; external wall</p> <p>Figure 3</p>
<ul style="list-style-type: none"> <li>• The floors of this building are in very good condition.</li> <li>• The internal walls for this building are in a very good condition however surface scratches are present likely due to furniture which may require repainting for aesthetic purposes</li> </ul>

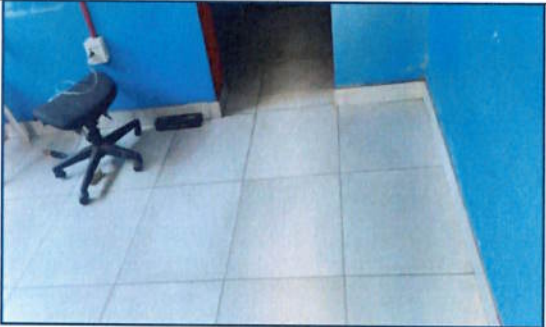
<p>Figure 4:floor</p>
<ul style="list-style-type: none"> <li>• The ablution facilities are in good condition and there is a presence of water in this building.</li> </ul>

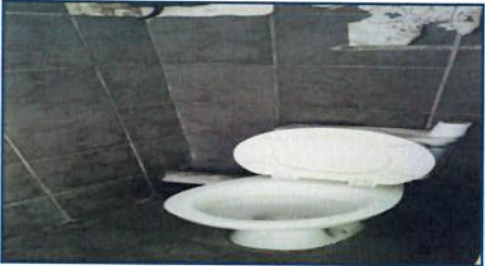
<p>Figure 5:ablution</p>
<ul style="list-style-type: none"> <li>• This is the only toilet not in use, possibly due to a flushing malfunction.</li> </ul>

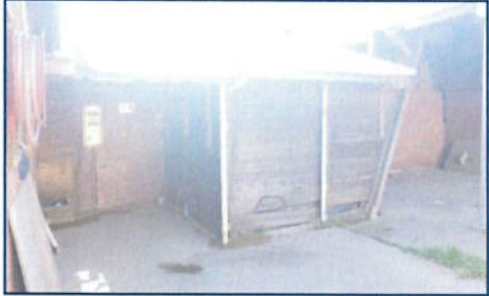
<ul style="list-style-type: none"><li>This section of the site has a wooden structure/ shelter. The shelter is in very bad condition</li></ul>

<i>Figure 7:shelter 1 exterior</i>
<ul style="list-style-type: none"><li>The floor for this shelter is fair condition. A lot of dirt present is a potential fire hazard</li></ul>

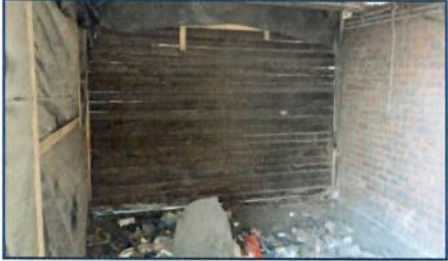
<i>Figure 8: interior</i>
<ul style="list-style-type: none"><li>This carport is in fair condition requiring minor maintenance.</li><li>There are no gutters for this carport and there are no down pipes present.</li></ul>

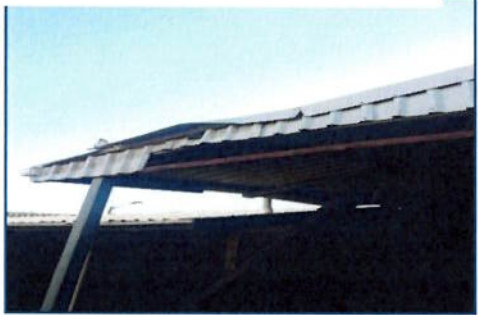
<i>Figure 9:shelter 2</i>
<ul style="list-style-type: none"><li>Asbestos present on side panels, these need to be replaced with another material.</li></ul>
