REHABILITATION OF BERWICK 341 ASBESTOS MINE

CONTRACT: MTK 03/2024

SITE INFORMATION

C4 SITE INFORMATION

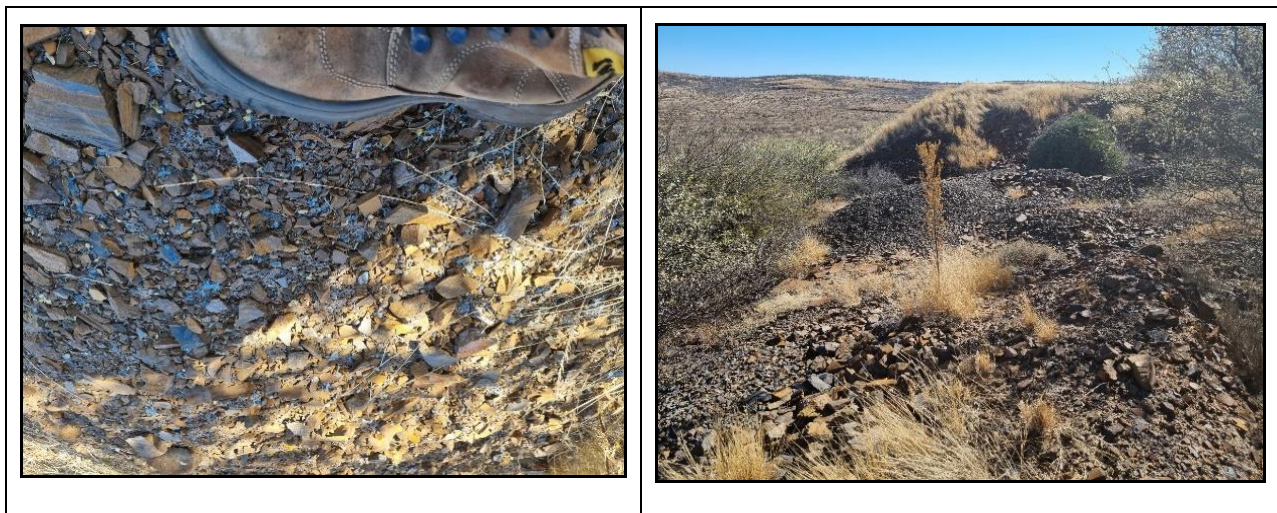
Land use of the surrounding environment is largely wilderness area. Berwick 341 area has a semi-arid natural vegetation which makes it prone to winds that can carry asbestos fibres to the nearest communities. Asbestos rock dumps and fine asbestos fibres were identified in the vicinity of the site as shown in **Figure 2**.

Figure 2: Asbestos fibres and rock dumps

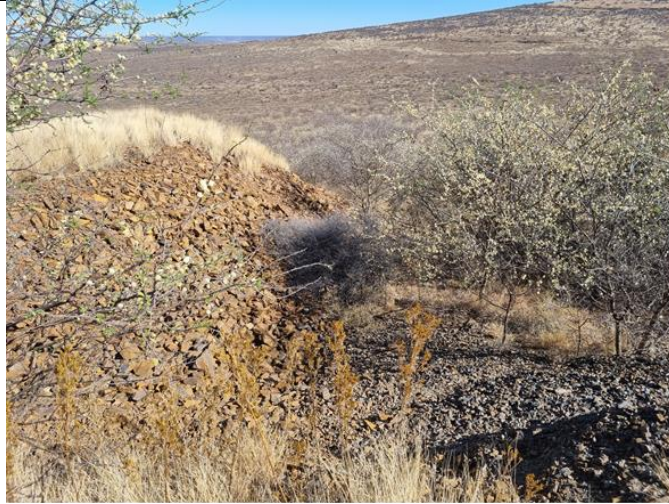
There are dumps that contain loose asbestos fibers which can easily be airborne as can be seen in **Figure 3**. The prevalence of these materials is indicative of level of contamination and the long-term health risk due to potential asbestos fiber release.

Figure 3: Partially vegetated Asbestos dump with fibres that can easily be carried away by water or wind.

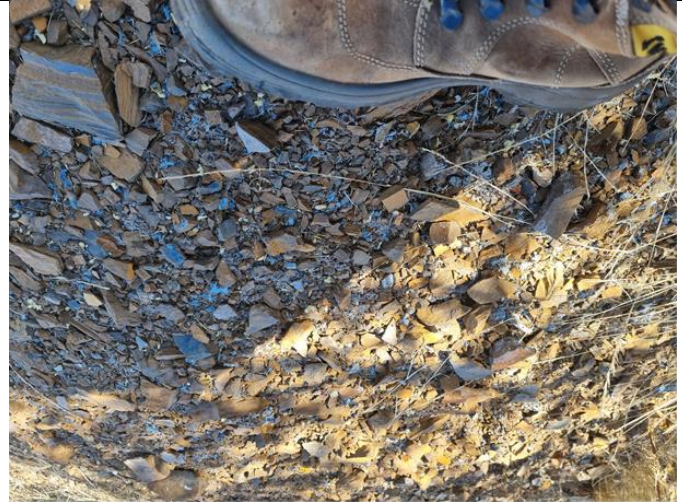
Figure 4: Asbestos containing discard with loose fibres.

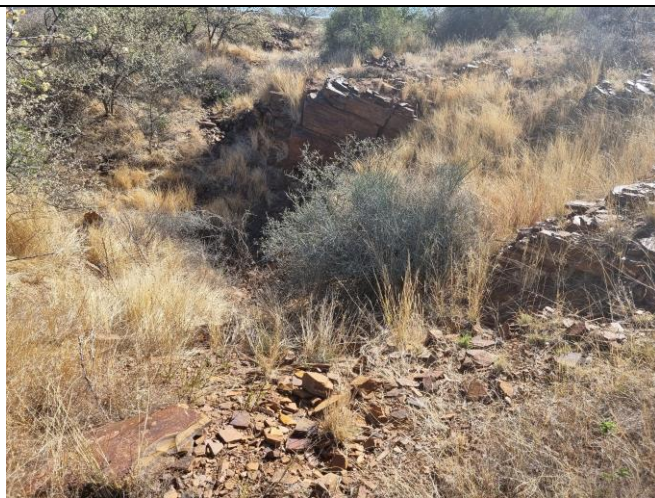
The following **Figure 5 - 8** shows wide spread of waste rocks and fine asbestos discard which is indicative of contamination and poses a long-term health risk due to potential asbestos fiber release.

Figure 5: Unrehabilitated asbestos shafts.

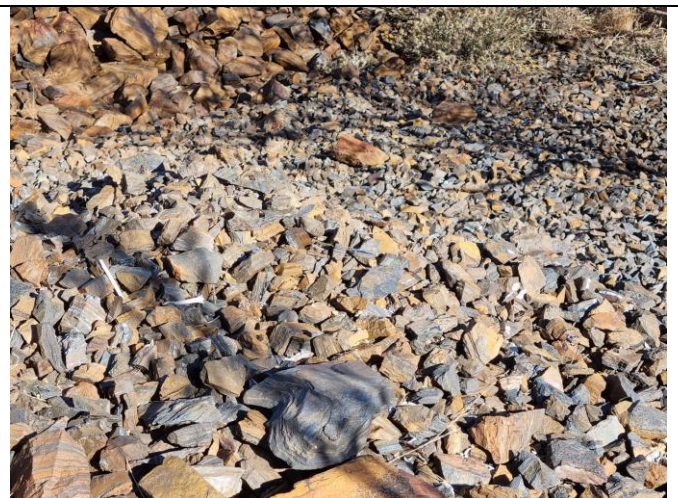
Figure 6: Waste rock strewn across most of the area.

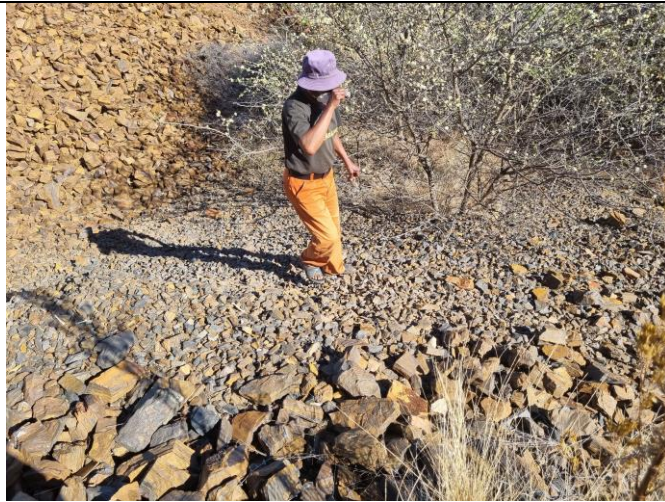
Figure 7. Further waste rock on water drainage path.

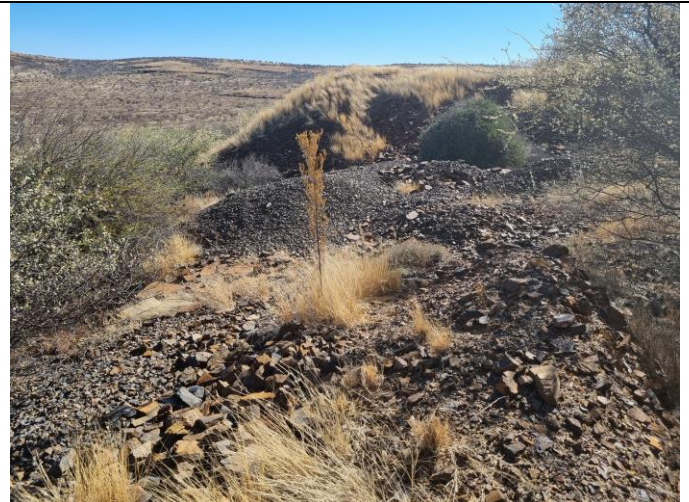
Figure 8: Asbestos containing discard from trenches.
