**COMPLETION OF CONSTRUCTION OF
ETHANDAKUKHANYA 24HR COMMUNITY
HEALTH CENTRE (CHC), MKHONDO
LOCAL MUNICIPALITY**

Architects Due Diligence Report:
TECHNICAL ASSESSMENT

AUGUST - 2025

Prepared for:
National Department of Health

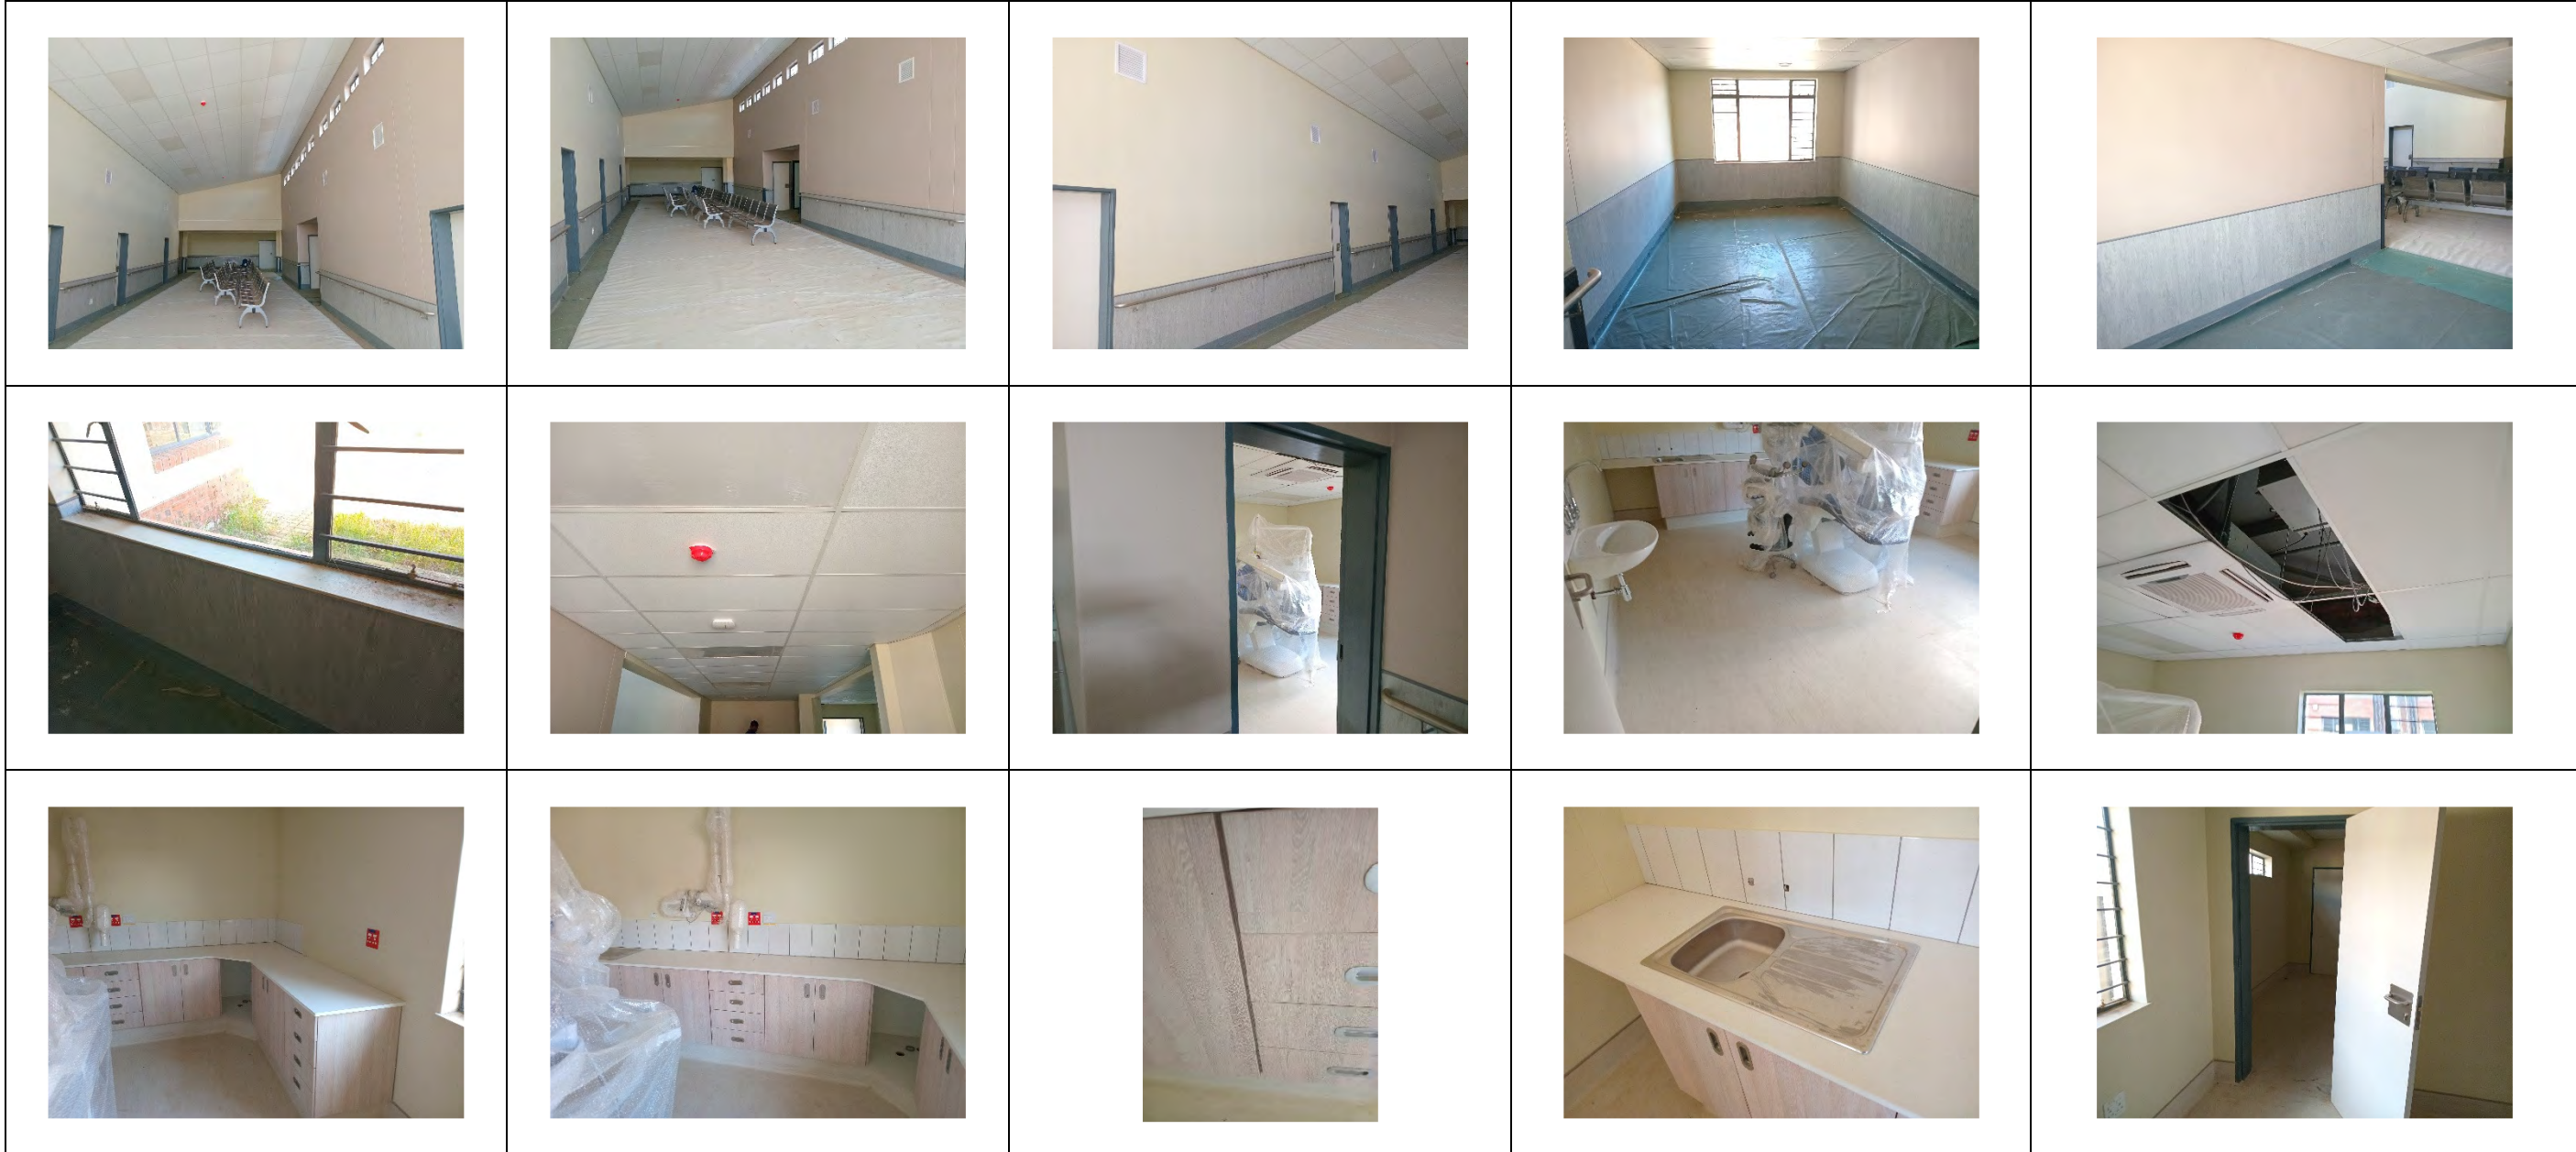
Block letter	G		
Block name	Health Support Services (HSS)

Block ID	G							
Block name	Health Support Services (HSS)							
Recorded Status Quo / Scope of Work completed / remaining Internal								
Room name	Floors	Walls	Suspended Ceiling grid / tiles	Doors & Frames	Windows & Frames	Joinery	Sanitary fittings & Accessories	Other Remediation
Terminal & Pregnancy Services RM 023	<ul style="list-style-type: none"> Vinyl floor covered Cleaning needed 	<ul style="list-style-type: none"> Painting done Final paint touches required 	<ul style="list-style-type: none"> Bed curtains & rails to be installed Water leak stained panels One panel area is open (TB Room only) T joint corners a joining end points to be fixed 	<ul style="list-style-type: none"> Bottom of door to be fixed (Minor defect possible from liquid) Repaint required 	<ul style="list-style-type: none"> Window cleaning Opening gear to be serviced 	<ul style="list-style-type: none"> Drawers not aligned in installed cupboard – must be corrected 	<ul style="list-style-type: none"> Adjustment to the basin mixers No sink installed Accessories to be installed Installation of ss sink to be completed. 	Water damage ceiling panels to be replaced

Counselling room RM 024	<ul style="list-style-type: none"> Vinyl floor covered Cleaning needed 	<ul style="list-style-type: none"> Painting of 2 different colour tones noted – End user to confirm 	<ul style="list-style-type: none"> T joint corners joining, end points to be fixed Water leak stained panels 	<ul style="list-style-type: none"> Kick plates needed Reclean / Repaint needed (Remove insect webs) 	<ul style="list-style-type: none"> Window cleaning Opening gear to be serviced 	<ul style="list-style-type: none"> Cleaning of door panels required 	<ul style="list-style-type: none"> Accessories to be installed 	Water damage ceiling panels approx. 7 to be replaced
Mental Health & Social Services RM 025	<ul style="list-style-type: none"> Vinyl floor covered Cleaning needed 	<ul style="list-style-type: none"> Painting of 2 different colour tones noted – End user to confirm Painting small touch around basin 	<ul style="list-style-type: none"> T joint corners joining, end points to be fixed Water leak stained panels 	<ul style="list-style-type: none"> Kick plates needed Reclean / Repaint needed (Remove insect webs) 	<ul style="list-style-type: none"> Window cleaning Opening gear to be serviced 	<ul style="list-style-type: none"> Cleaning of door panels required 	<ul style="list-style-type: none"> Accessories to be installed 	Water damage ceiling panels approx. 6 to be replaced

Nutrition Support Services RM 026	<ul style="list-style-type: none"> Vinyl floor covered Cleaning needed 	<ul style="list-style-type: none"> Painting of 2 different colour tones noted – End user to confirm Painting /Seal needed around basin 	<ul style="list-style-type: none"> T joint corners joining, end points to be fixed Water leak stained panels 	<ul style="list-style-type: none"> Kick plates needed Reclean / Repaint needed (Remove insect webs) 	<ul style="list-style-type: none"> Window cleaning Opening gear to be serviced 	<ul style="list-style-type: none"> Cleaning of door panels required 	<ul style="list-style-type: none"> Accessories to be installed 	Water damage ceiling panels approx. 6 to be replaced

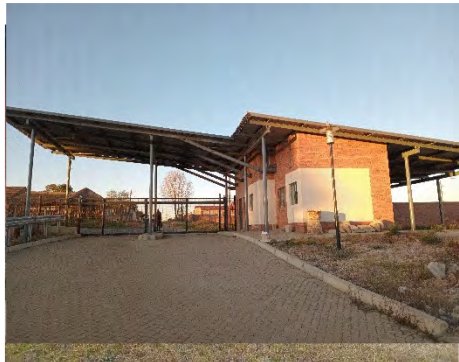
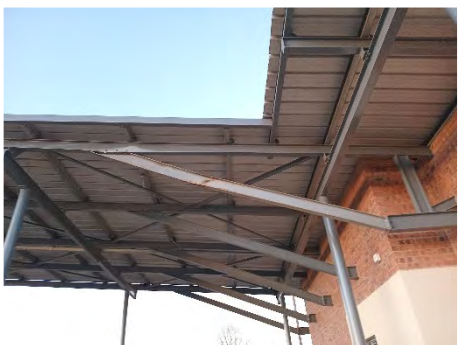
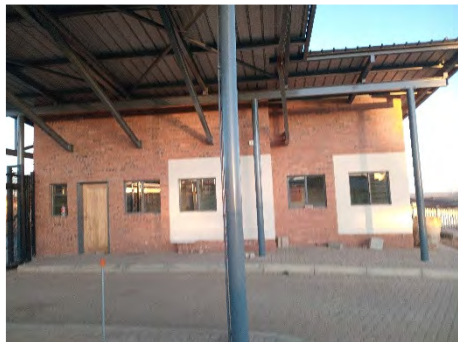
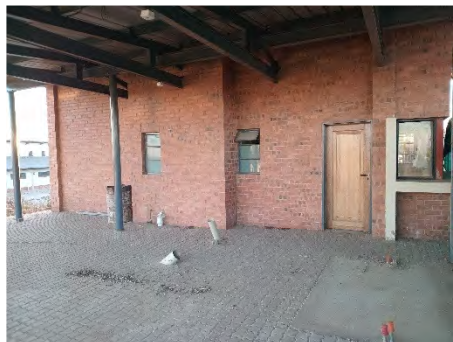
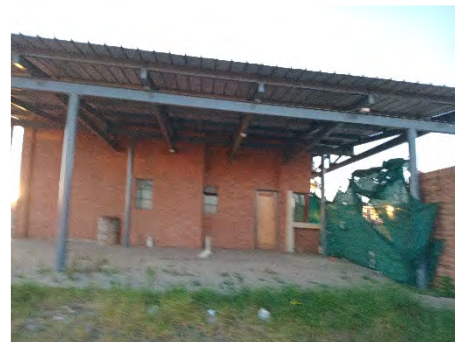
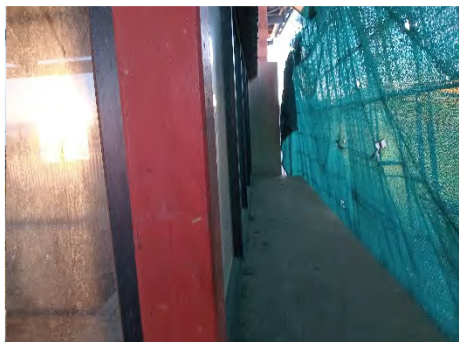
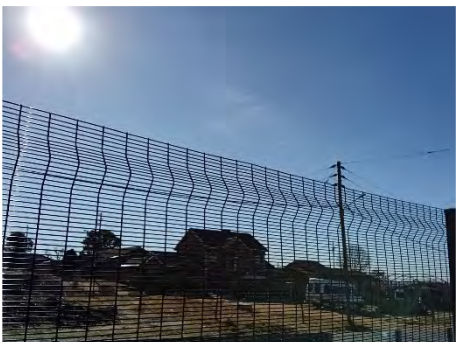
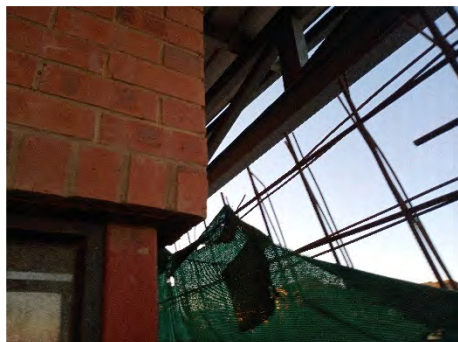
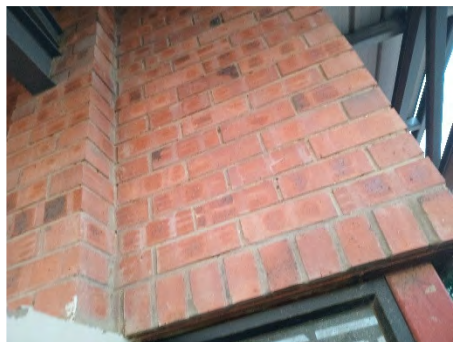
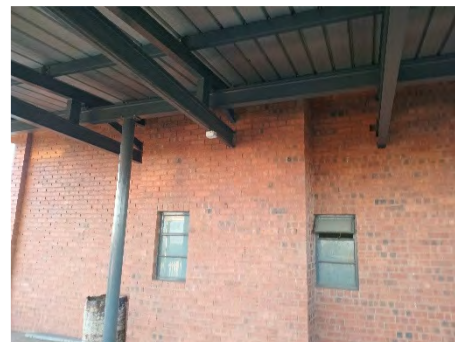
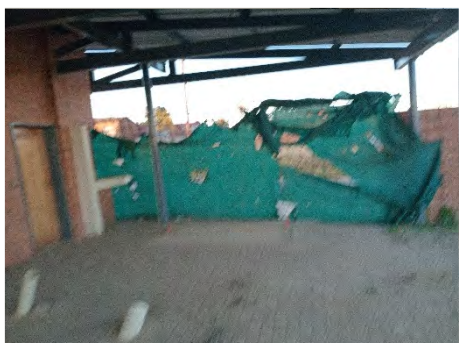
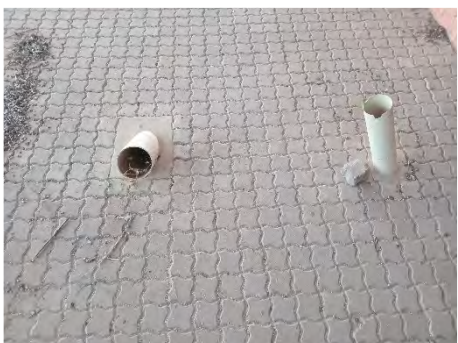
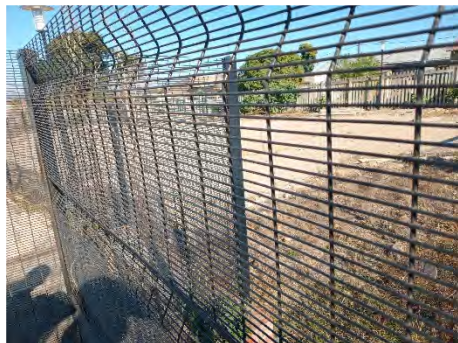
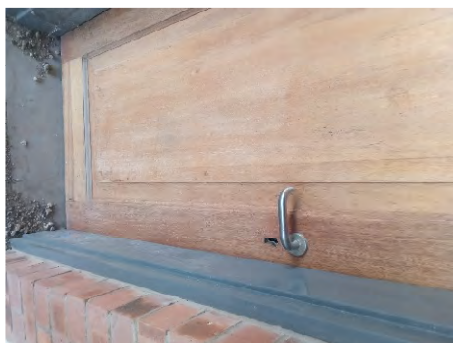
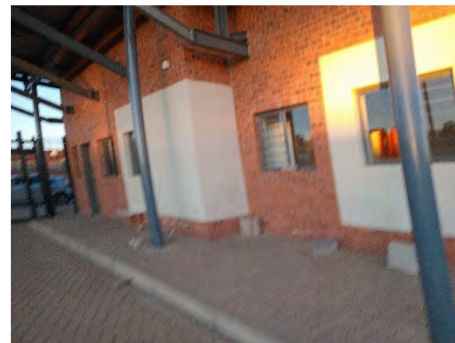
Completion of Ethandakukhanya CHC – Architects Due Diligence data capturing summary		
Block letter		Key plan
Area name	Landscape, Roadways and Walkways	
Recorded Status Quo / Scope of Work completed / remaining		
External		
Area	Notes	
Walkways	<ul style="list-style-type: none"> External walkway paving is incomplete, and the paving around the columns of the carports needs completion. Cleaning and maintenance of the culvert at the gate entrance are required. Paving is stained in certain areas across the facility around the buildings because of raining drops on the paving aprons – sand blasting required for cleaning of the stains. Small sections at the Main Entrance need rectification and replacement of kerbs (5). The paving and kerbs need to be cleaned of dirt and tire marks at the Accommodations Parking area. Small invasive plants in the area are to be removed using chemicals on the walkways and Driveway.
