## ANNEXURE A- DAMAGED PICTORIALS FOR THE KZN CORRIDOR -(PREQUALIFICATION OF CONTRACTORS)

### CLUSTER ONE (Umlazi Corridor- Umlazi Montclair and Clairwood Station Cluster 1)

#### ANNEXURE A: PICTORIALS

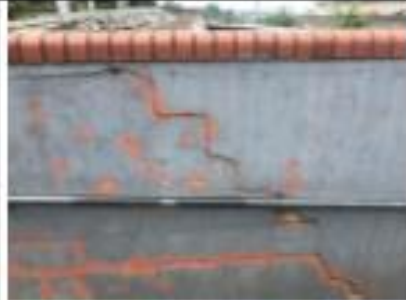
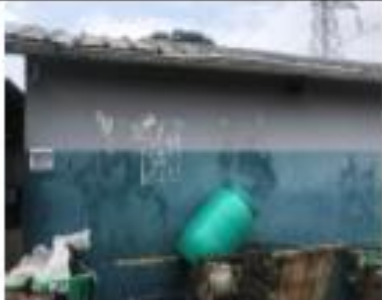
| Umlazi Station | | |

| | | Cracked retaining wall, and walls that needs repainting. |

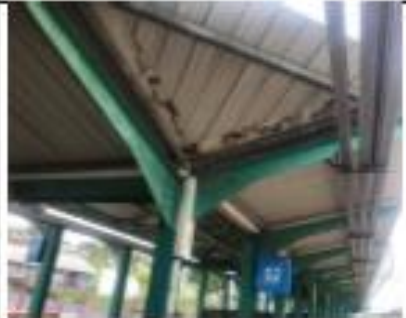
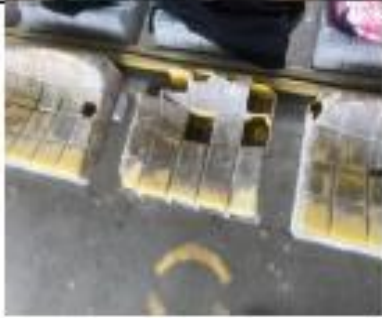
| | | Rusty metal sheets, steel structure and damaged chairs |

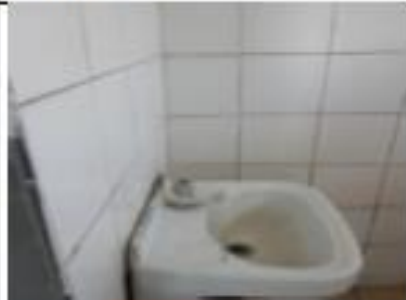
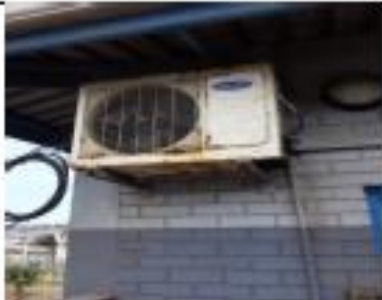
| | | Vandalized toilets sinks with no taps. Rusty and faulty air conditioning system |

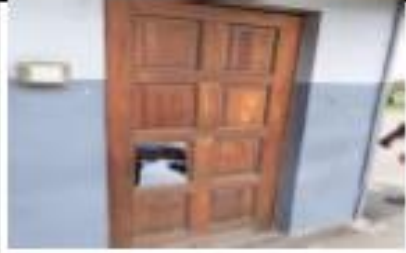
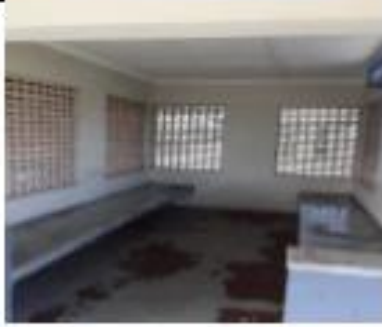
| | | Damaged door and flooring in the waiting rooms that needs refinishing. |

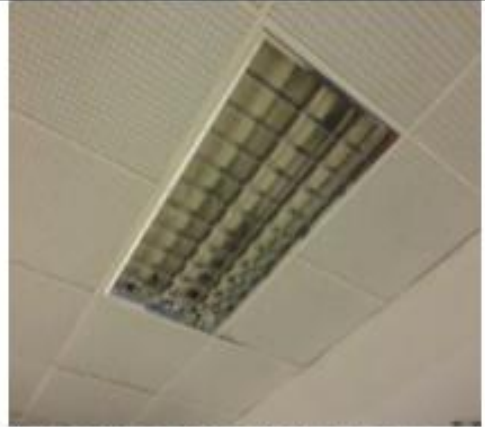
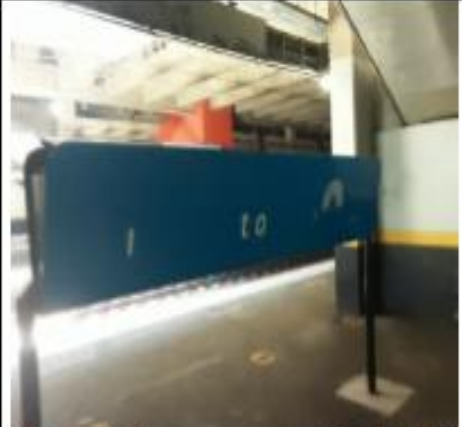
| Durban Station | | |

| | | Missing lights and signage that is no longer visible. |

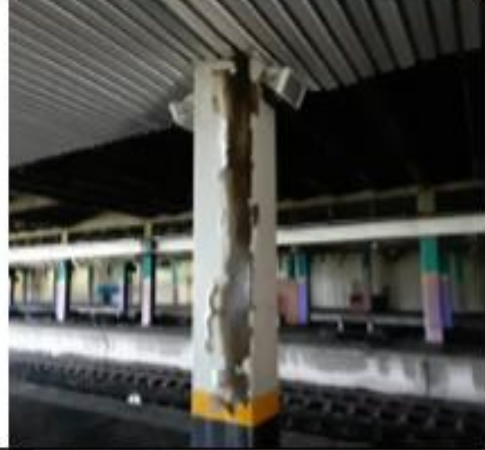
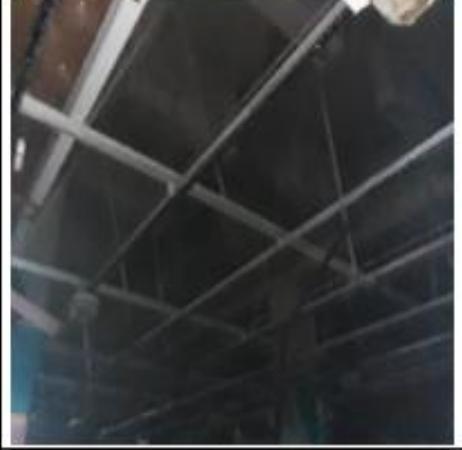
| | | Missing ceiling sheets and a leak that causes paint to peel. In this column. |

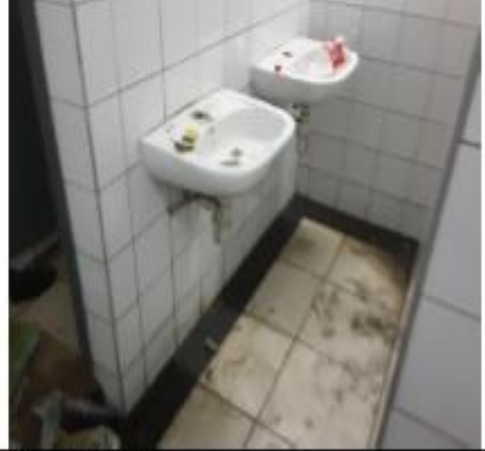
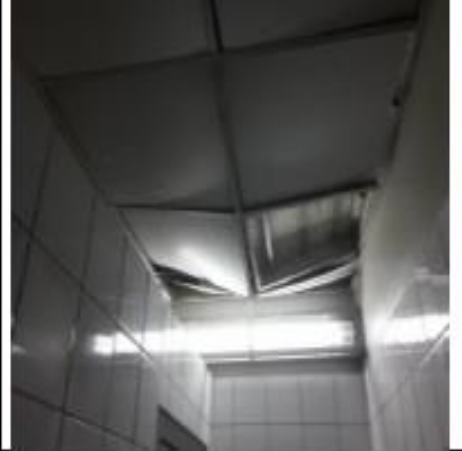
| | | Missing plumbing system in the toilets and damaged ceiling. |

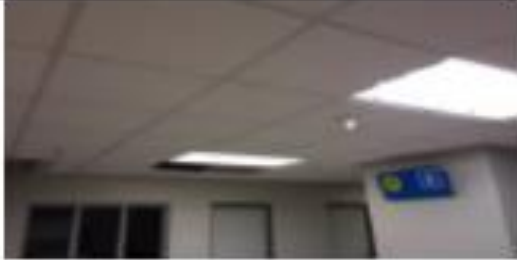
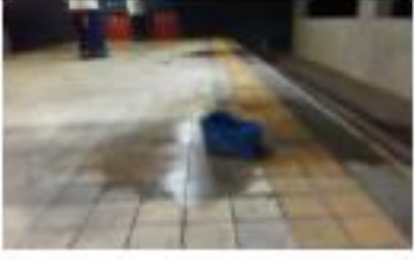
| Bridge City Station | | |

| | | Damaged ceiling and roof leaks. |

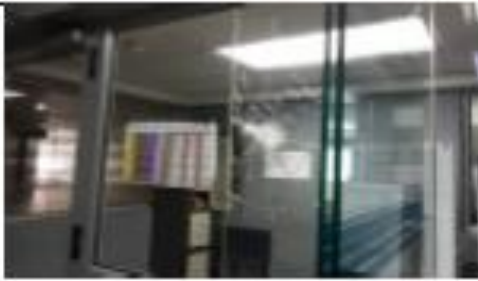
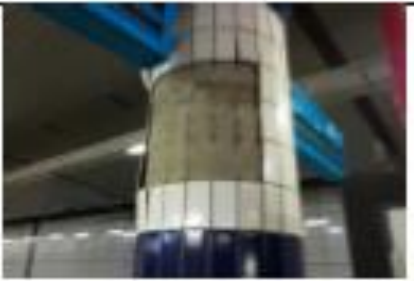
| | | Cracked glass door panel and peeling column tiles |

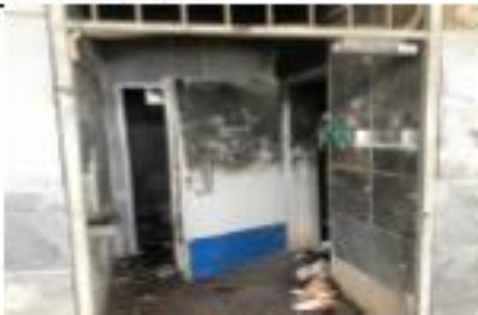
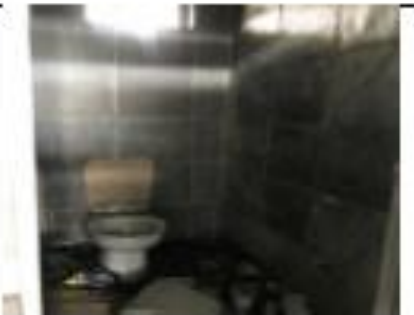
| Thembalihle Station | | |

| | | Burnt rooms and toilets with missing plumbing system. |

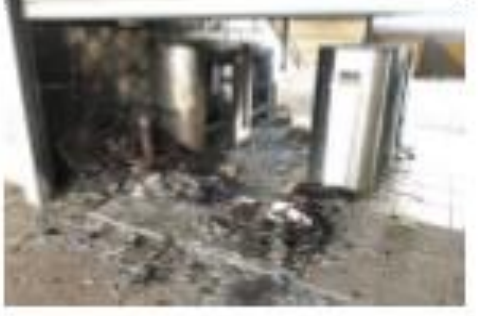
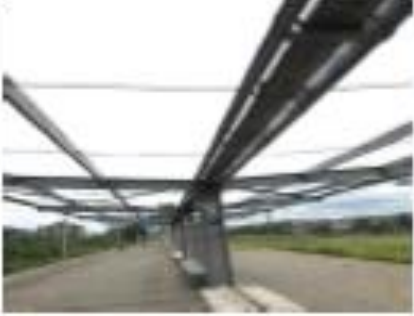
| | | Roof structure with missing metal sheeting's. Burnt turnstiles |
