# **MEYERTON WASTEWATER TREATMENT PLANT:**

## **Preliminary Structural & Visual Assessment**

30 September 2022

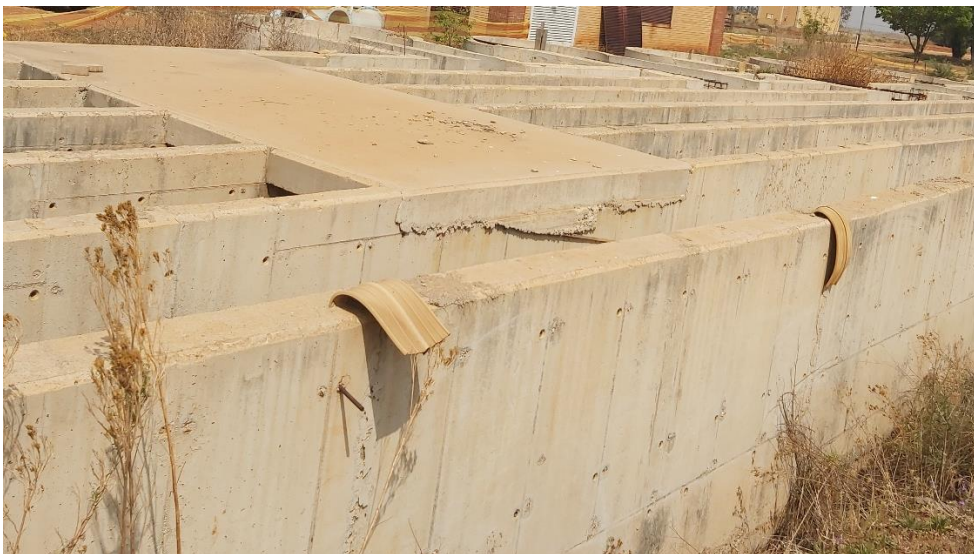
A special focus, in terms of likely distress due to the inadequacy of the foundation was conducted on the as-built structure, however, no settlement cracks were observed on the perimeter of the structure during the site inspection as shown in Figure 3 below.

**Figure 3 - Perimeter View of the Header of Works**

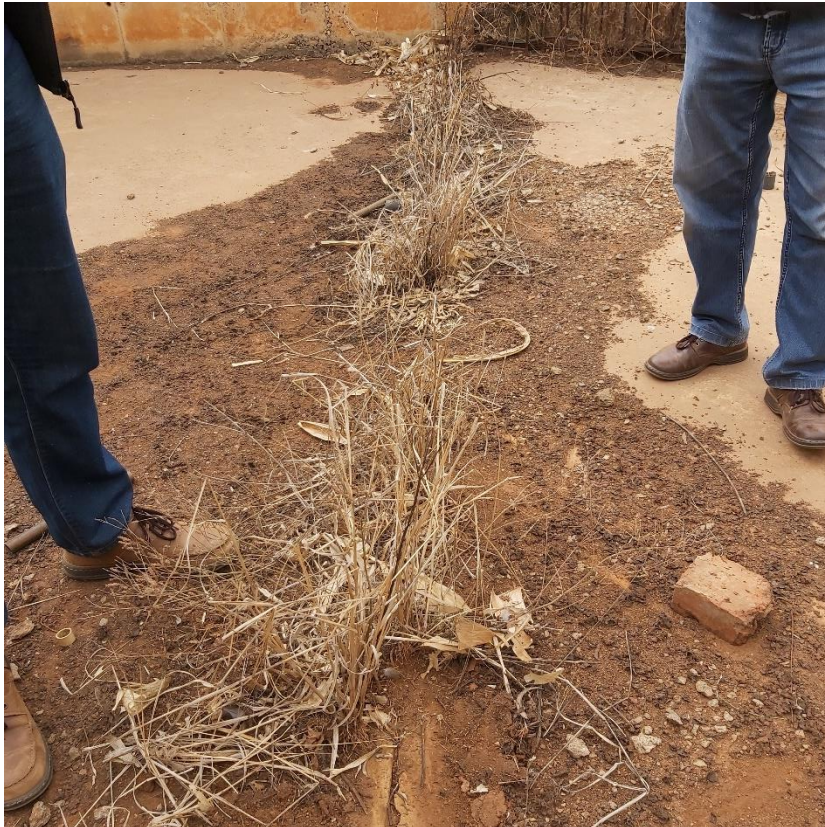
The 300mm surface bed generally displayed no major defects throughout the structure: however, a significant gap was identified in what was observed to be an expansion joint, as indicated on drawing number J40073/010-201 Rev 0 and outlined in red in Figure 2. Vegetation had in fact begun to grow through the joint, as shown in Figure 4.

**Figure 4 - Vegetation outgrowth through expansion joint on the surface bed**

Further investigation, by specialists, is required to determine the accuracy of construction of the joint, and a resealing using an approved sealant would be required to prevent the outflow of raw sewage underneath the structure.

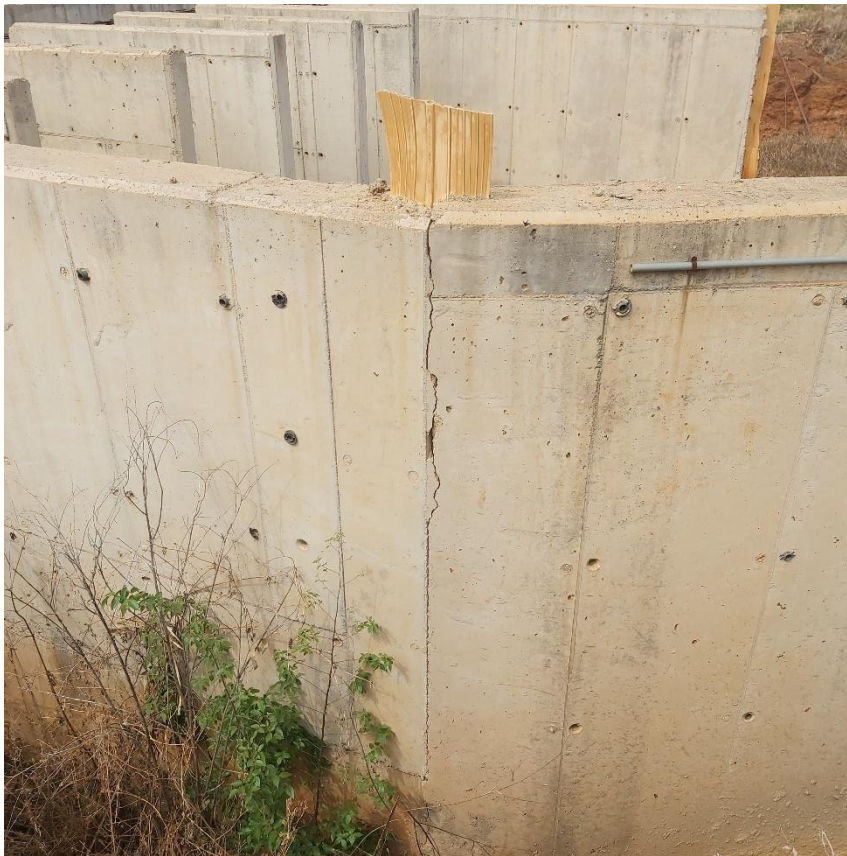
**Figure 5 - Crack along a specified expansion joint on the RC Wall**

In Figure 5, a crack along the wall at the specified expansion joint, further investigation must be conducted to confirm the suitability of construction, as per construction drawings and the sealing to prevent sewage outflow. In addition, Figure 5 shows that none of the ferrule tube holes has been closed post stripping of the shutters, whereas some of the tie-rods we cast without a ferrule tube and are thus stuck in the concrete walls.

Remedial work will be required, by the incoming contractor, to prevent any deterioration of the structure due to corrosion of the exposed tie-rods.

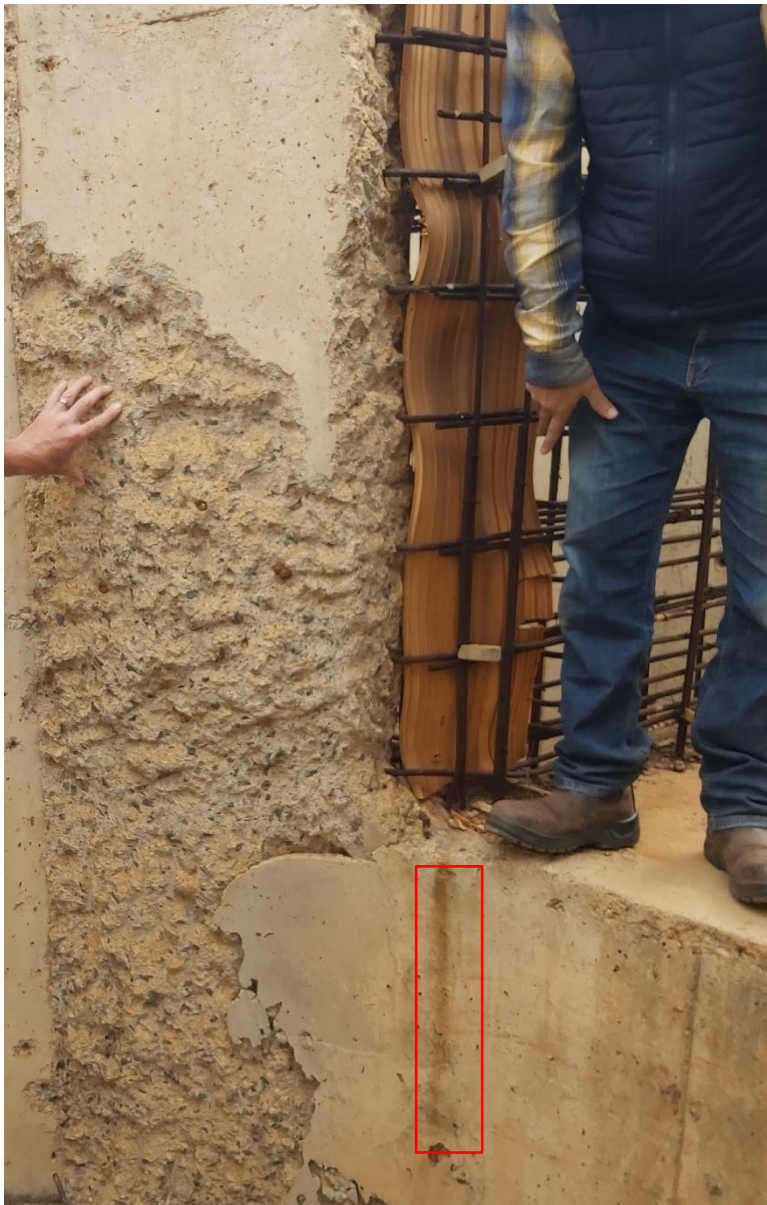
**Figure 6 - Signs of concrete remedial works on the Jet Air Grit Trap Walls**

In Figure 6, it is evident that substandard shuttering had taken place resulting in a shutter(s) moving during casting, hence the contractor started to remediate by removing the excess concrete; however, the contractor did not complete the works before leaving the site. In addition, exposed rebars and a dilapidated water-stop can be observed in Figure 6, and the face of the walls indicates rebar corrosion over time, through the ferric oxide stains, outlined in red on the figure, as the structure has been exposed to weather elements since construction ceased.

The integrity of the reinforcement will have to be evaluated, by specialist, to determine the level of corrosion of the rebars as opposed to the original diameter in each instance. All damaged water-stops are to be replaced, by the incoming contractor, before concrete casting can continue.

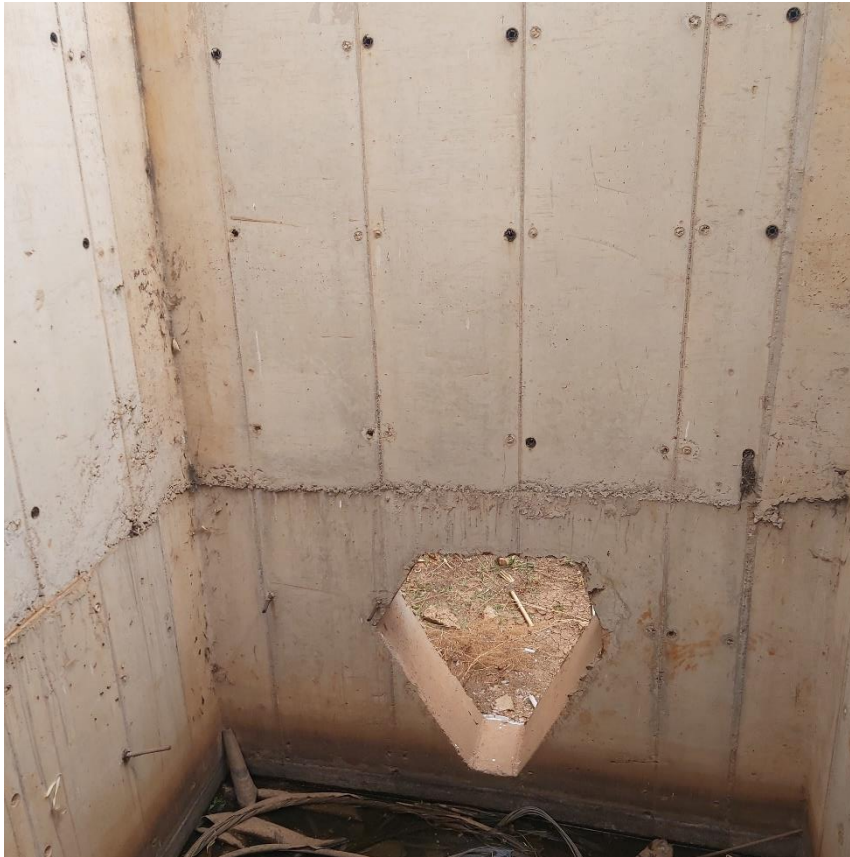
**Figure 7 – Sub-standard wall casting and jointing observed around the perimeter of the structure**

In Figure 7, sub-standard workmanship can be observed around the perimeter of the structure, with emphasis on the kicker wall that is that is cast on top of the surface bed. There is evidence of sub-standard joint preparation, and the poor finishing can be observed around the perimeter of the structure at the base of all perimeter walls.

In addition, a cast-in tie rod can be observed in Figure 7, whereas in most sections, unsealed ferrule holes can be observed around the structure.

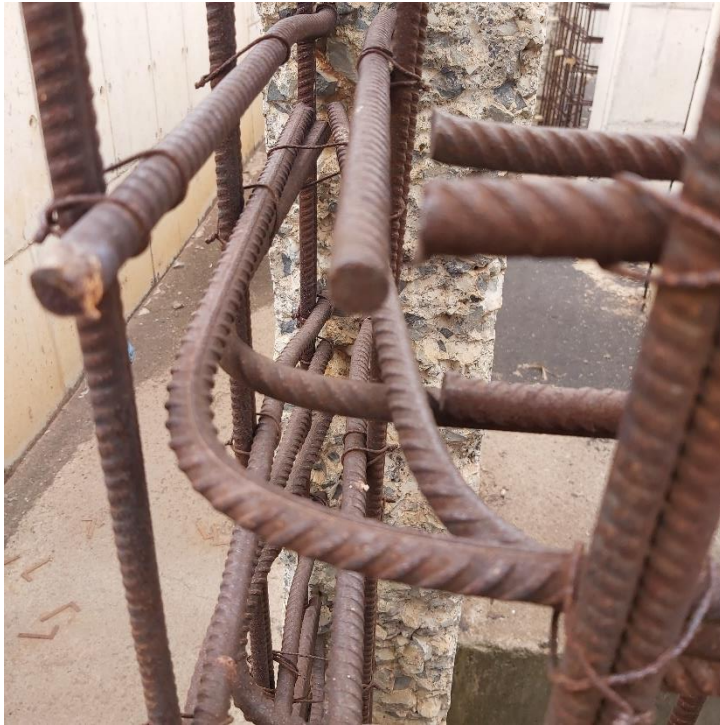
**Figure 8 - Incorrect placement of reinforcement bars**

In Figure 8, It is evident that the reinforcement placement on this existing wall, does not confirm to the reinforcement arrangement drawings, as there are discrepancies in how the rebar was arranged, which will hinder the effective distribution of loads throughout the wall. In addition, Inadequate concrete cover is also observed, and this is of major concern in a sewage retaining structure, in view of the acidic properties of raw sewage.

Specialist investigations are required to provide rebar protection recommendations to ensure that the structure can meet the minimum design lifespans.

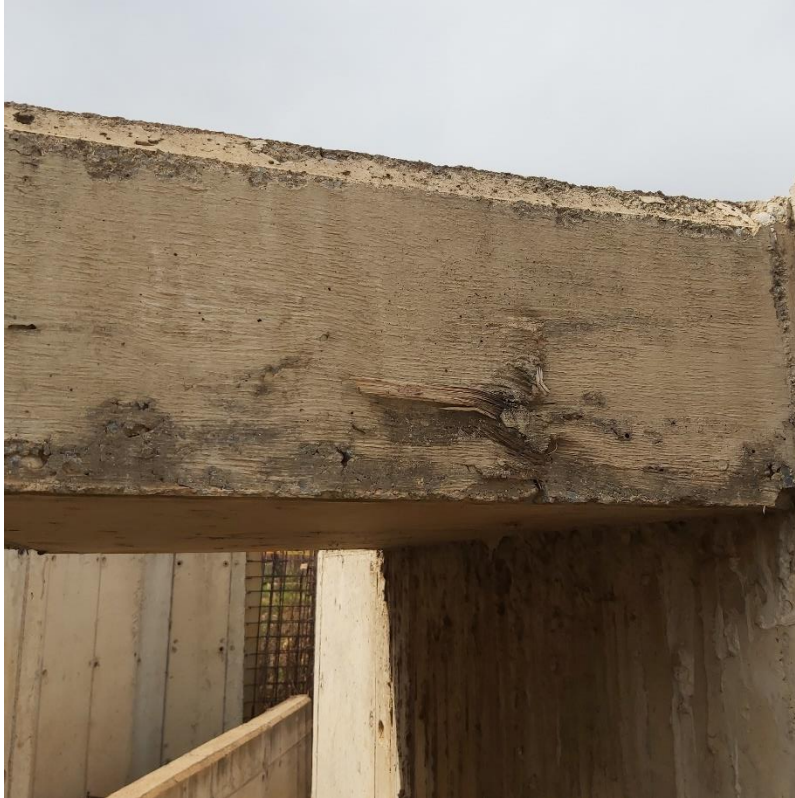
The 200mm thick suspended platform slabs display the extent of the lack of workmanship and quality control. Platform slabs were misaligned and show signs of the segregation of concrete at joints, due to bleeding of the concrete during casting. Organic (timber) material was observed to have been cast into the slabs which is also of concern, especially considering the inherent negative impact on the long-term durability of concrete sections with cast-in organic material that was decay-prone.

**Figure 9 - Timber material cast into concrete within the platform suspended slabs**

In Figure 9, a piece of timber material can be observed within the suspended slab. As highlighted above, this presents long-term durability concerns as the organic material will decay over time, thus leaving a cavity within the concrete section, and rendering it vulnerable to ingress of sewage water, thus shortening the design lifespan of the element.

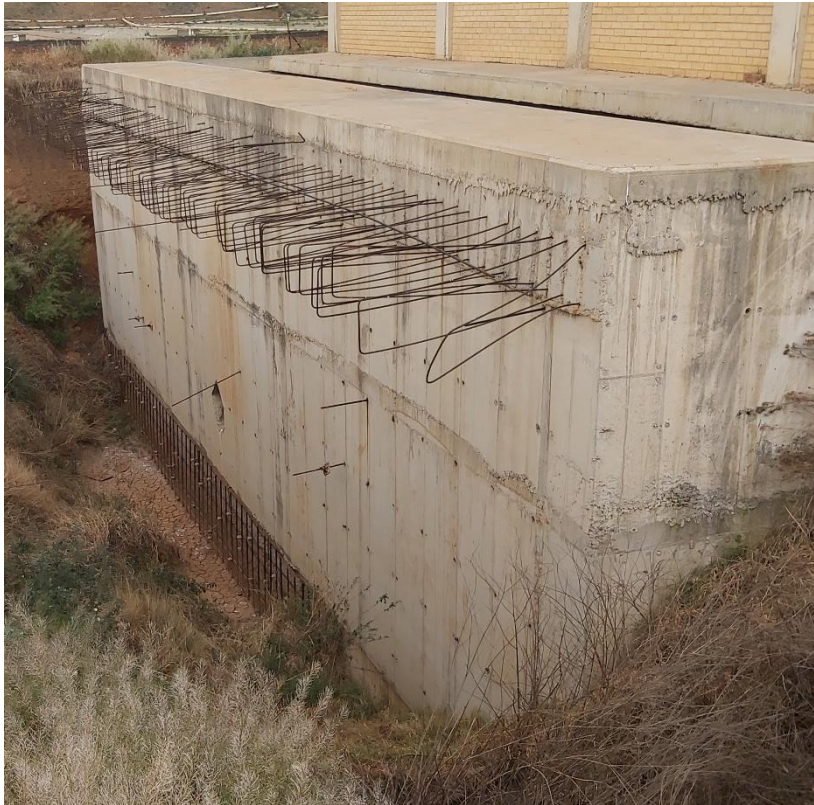
**Figure 12 - Basement of the Raw Water Pump Station**

Exposed rebar can be observed in Figure 12, as per the construction drawings. From the construction drawings, it is evident that this was intended to serve as continuity reinforcement for the suspended slab on the adjacent chamber: however, since construction ceased, the rebars have been exposed to all weather elements.

A detailed investigation on the extent of corrosion of the rebars is required, to determine the suitability of the reinforcement, in terms of the design specifications.

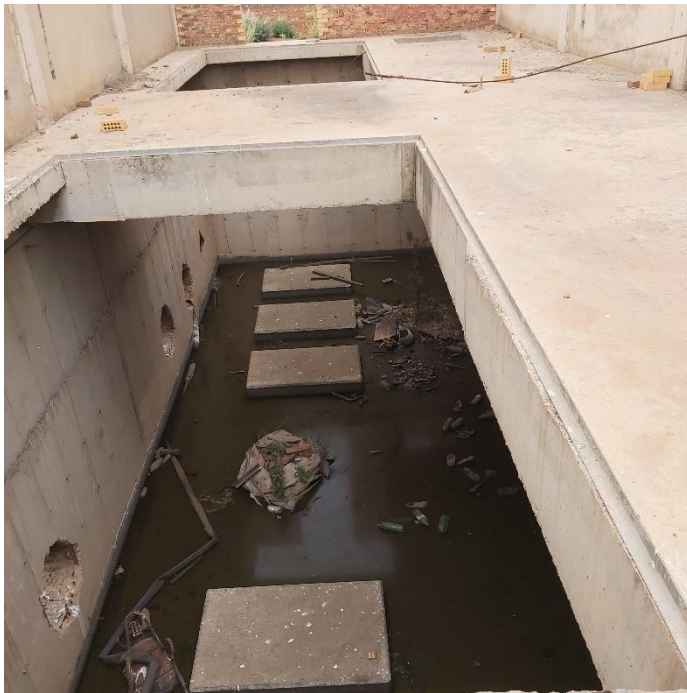
**Figure 13 - Ponding water on the basement surface bed of the raw water pump station**

A thorough investigation must still be undertaken once, adequate access inside the structure has been arranged.

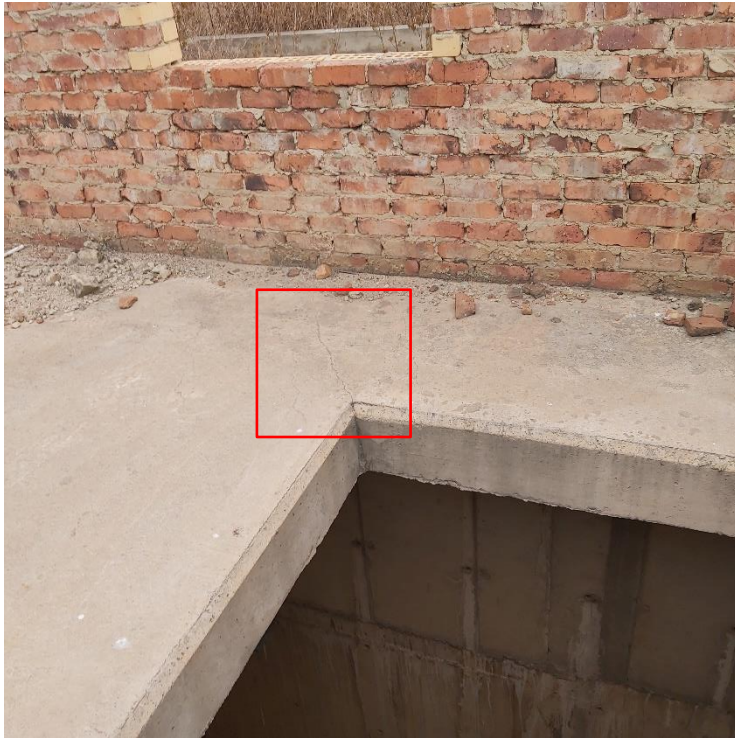
The platform suspended slabs displayed no major structural distress, however, cracks were observed spreading from the corners of the open sections of the suspended slab, as shown in Figure 14

**Figure 14 - Cracks propagating from the corners of open sections of the slab**

A detailed investigation is necessary, to verify, firstly, the presence of reinforcement, at the corners of the open sections, of the suspended slab. Secondly, to ensure that the reinforcement used, conforms to the specified reinforcement on the construction drawings.

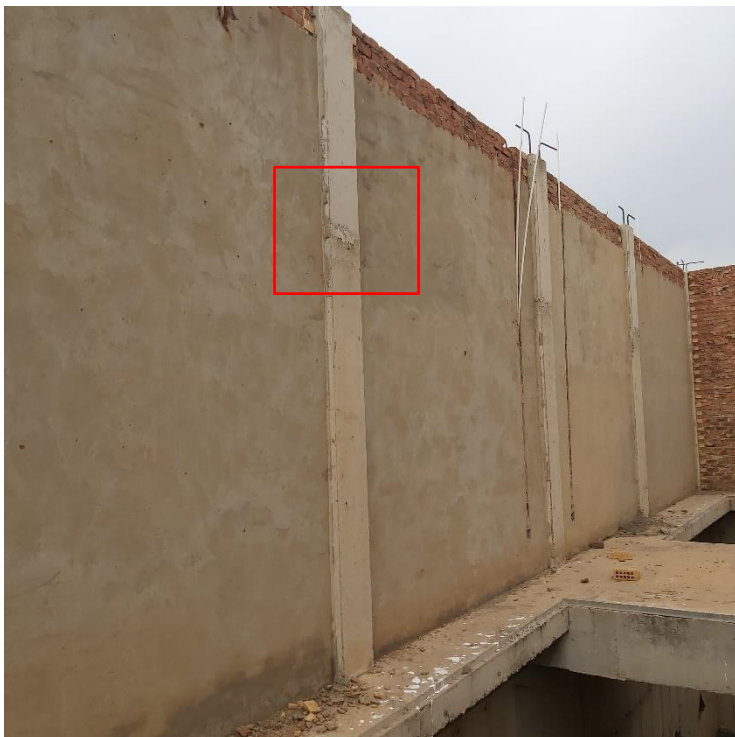
The reinforcement concrete columns displayed no significant deformations/defects during the inspection. However, poor workmanship was observed on interfaces between the consecutive cast-sections: there are signs of bleeding that occurred during casting, possibly due to inadequate shuttering and sealing.

**Figure 15 - Concrete Columns for Raw Water Pump Station**

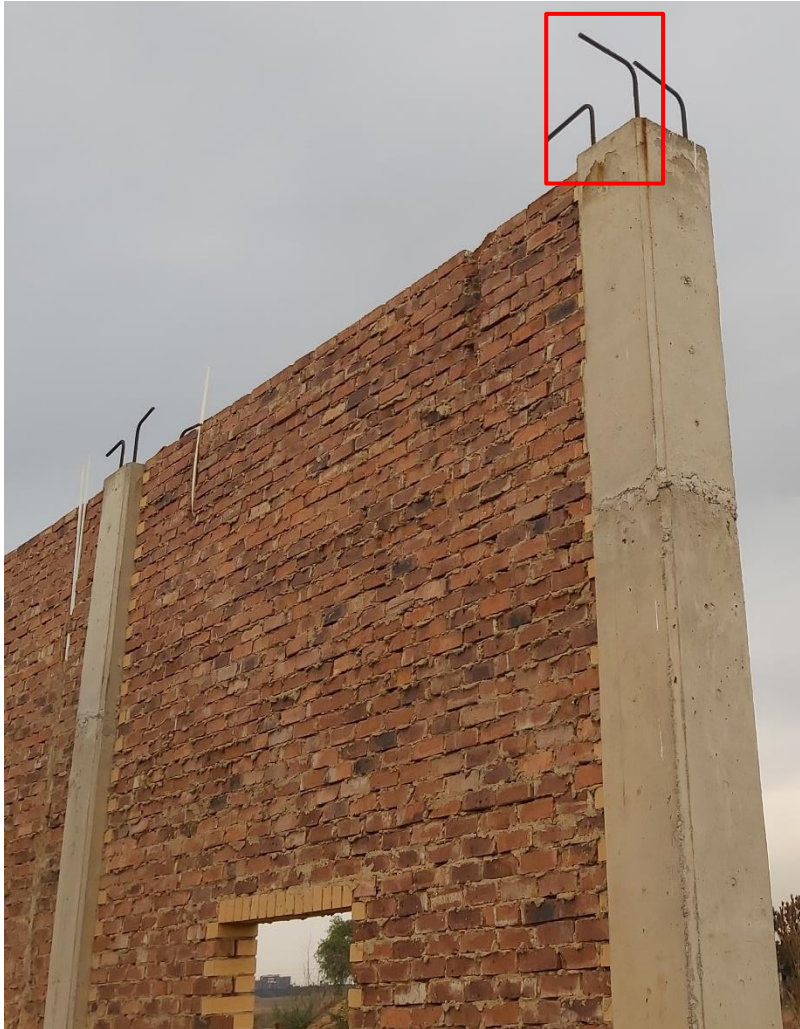
The 400mm wide by 400mm deep ring beam has not been cast, however, some noticeable defects need to be rectified before construction can continue. Firstly, the transfer rebars from the column, outlined in red in Figure 10 above and Figure 16 below, are placed in the incorrect position, hence this will need to be rectified before the cage assembly for the beam.

**Figure 16 - Transfer rebars from column to 400mm x 400mm deep Ring Beam**

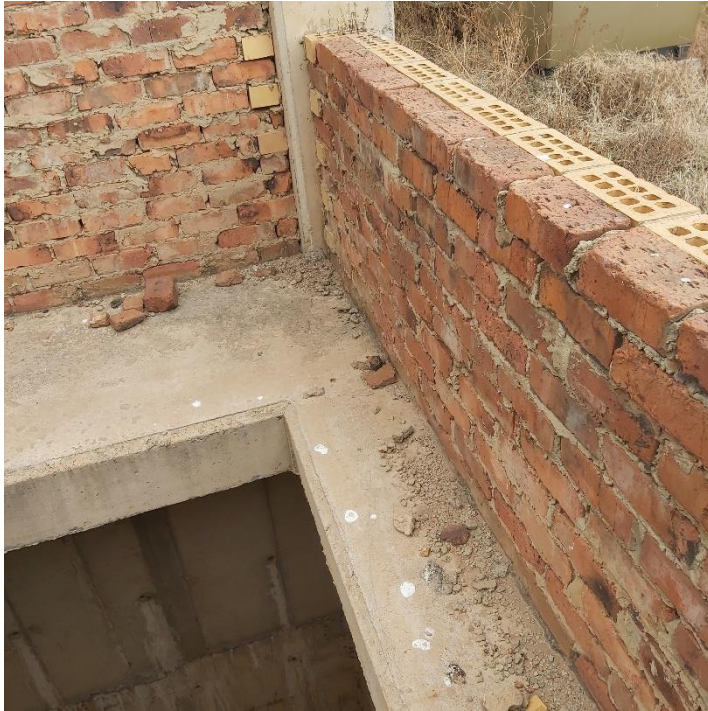
No major defects were observed on the masonry, however, there is a lack of workmanship as seen in Figure 17 below. This is also evident in Figure 16 shown above. However, an investigation is required to confirm the provision of brick-force. This may be remediated, by the incoming contractor, with plaster, for aesthetic purposes.

**Figure 17 - Mansory from Raw Water Pump Station**

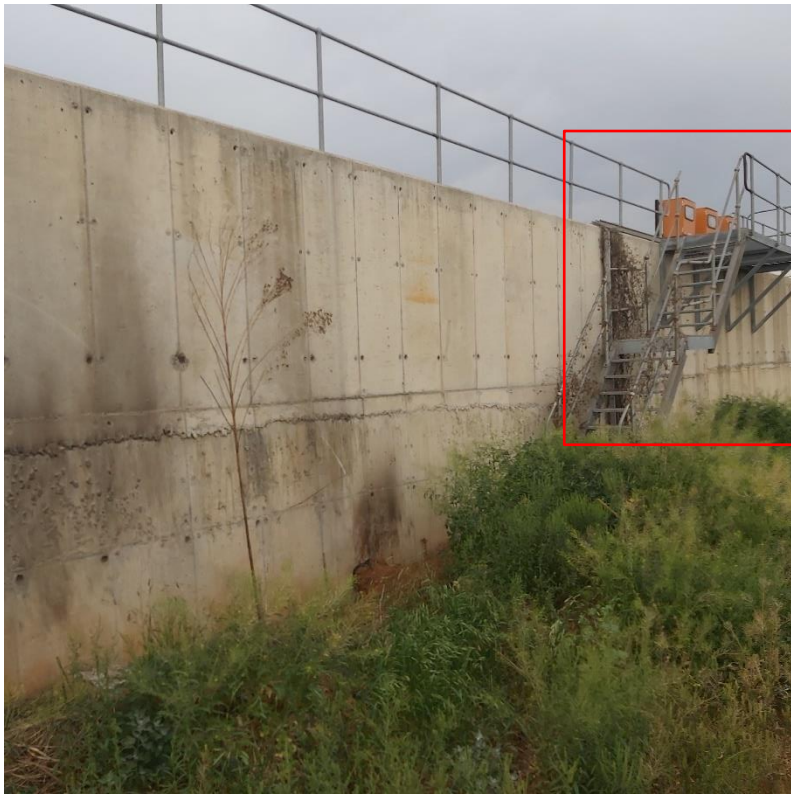
A special focus, in terms of likely distress due to the inadequacy of the foundation was conducted on the as-built structure, however, no settlement cracks were observed on the perimeter of the structure during the site inspection as shown in Figure 19 below.

**Figure 19 - Perimeter of the Biological Reactor**

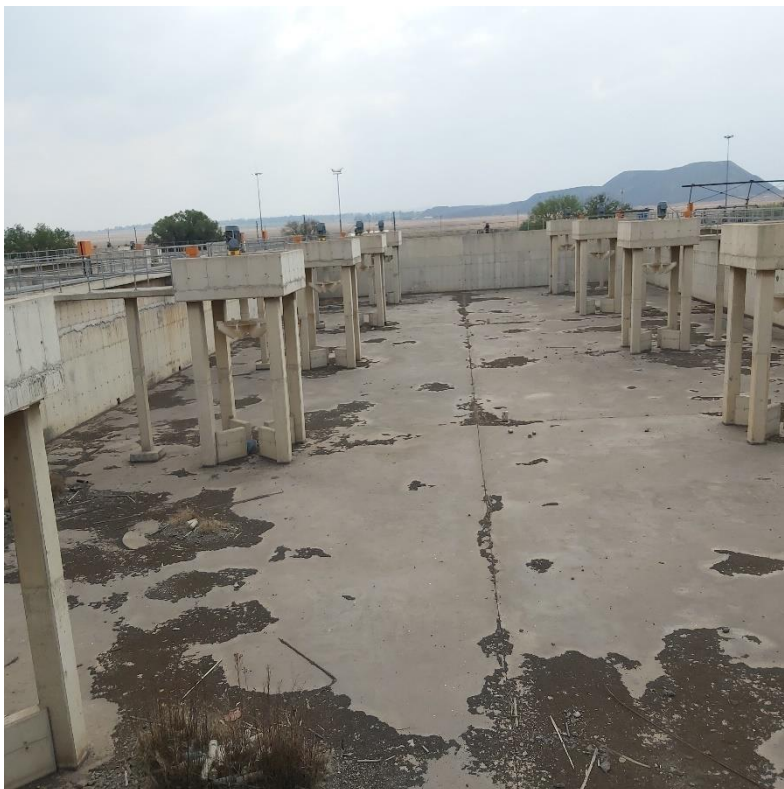
The reinforced surface bed of the biological reactor displayed no major deteriorations or defects, for the section of the biological reactor, outlined in red, on the layout drawing in Figure 18, the remaining sections could not be inspected due to lack of adequate safe access into the other sections of the reactor.

### Figure 20 - View of the Biological Reactor Section Outlined in Red on the Layout

In Figure 20, the presence of vegetation on top of the surface bed needs to be investigated further to determine if this is due to joints which are inadequately sealed or because of the accumulation of soil on top of the surface bed. Thus, in addition to the provision of safe access into the structure, cleaning of the debris on the surface bed must be completed for detailed investigations can occur.

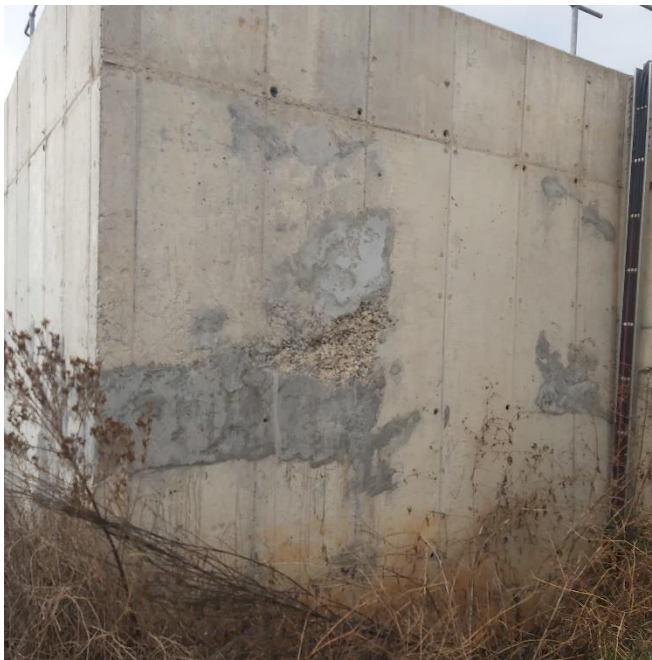
The reinforced concrete walls displayed significant construction defects, including honeycombing, poor off-shutter finished, and the ferrule holes have not been sealed. Significant vegetation is obstructing inspections of the as-built structure, with emphasis on the interface between the surface bed and the walls, as shown in Figure 21.

### Figure 21 - Honeycombing on the Biological Reactor Reinforced Concrete Walls

In Figure 21, it is evident that the contractor attempted to conceal these defects with a cement mixture, post-casting.

These inefficient remedial works must be cleaned to assess the extent of the defect, to ensure that the right remedial works are scoped and implemented, to prevent deterioration.

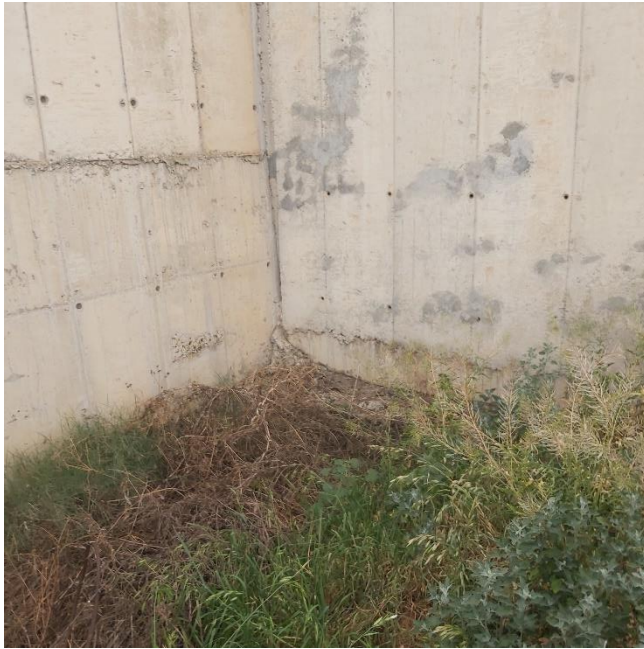
**Figure 22 - Substandard Concrete Joints Observed on the Biological Reactor Reinforced Concrete Walls**

Substandard concrete casting joints were observed around the perimeter of the structure, as shown in Figure 22. This is of concern on a water (sewer) retaining structure, as this may be a possible seepage point, whereas there may be excessive crack depth propagation if there are significant defects within the joint. Further investigation is required to confirm the suitability of the joints to the original design requirements.

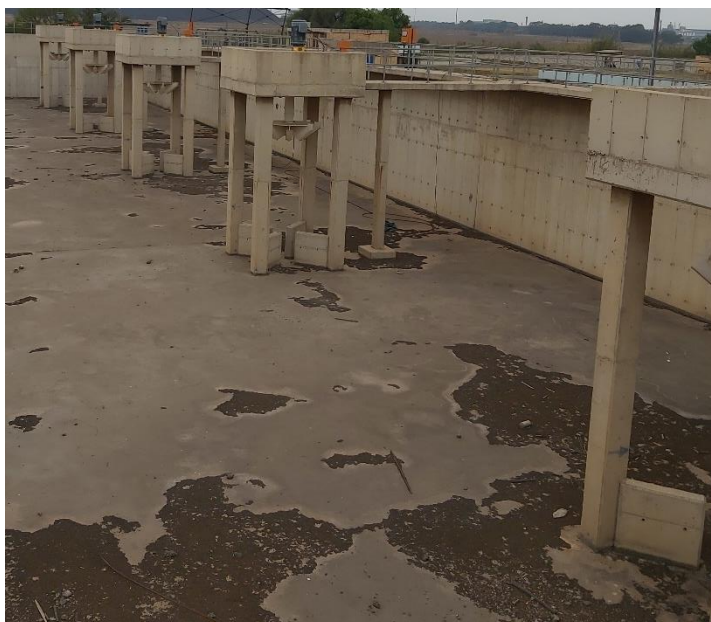
### Figure 23 - Platform Columns and Suspended Slabs in the Biological Reactor

The platform suspended slabs displayed no significant signs of defects, as shown in Figure 23, however, further investigation is required as the visual inspection was conducted from a vantage point above the existing steel mezzanine platform adjacent to the area, outlined in red in Figure 18, on the layout. Access must be first provided to ensure that there is a safe means of accessing all platform suspended slabs for further investigation.

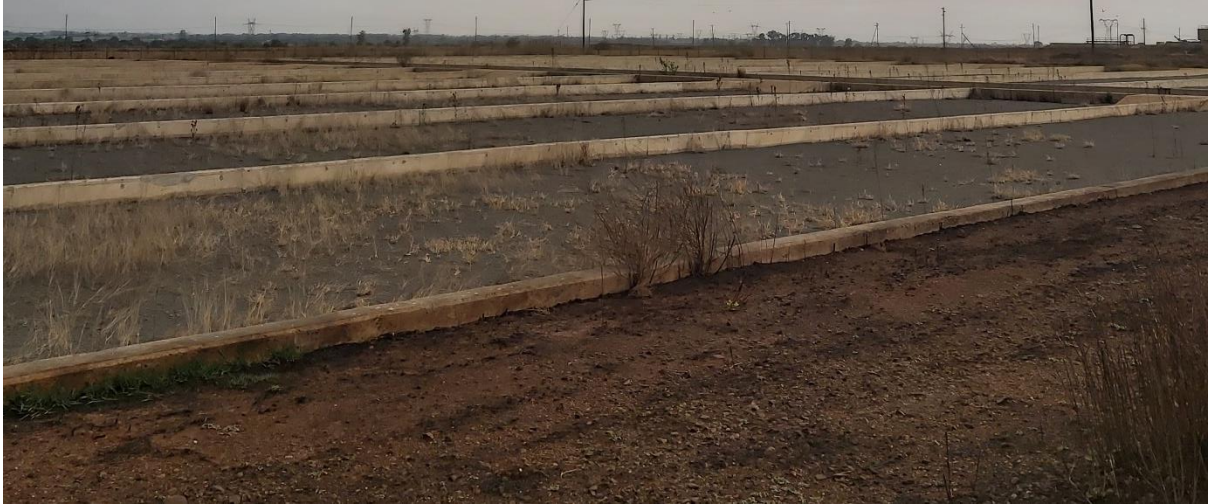
No settlement cracks were observed on the perimeter of the structure during the site inspection as shown in Figure 25 below.

**Figure 25 - Sludge Drying Bed**

The concrete partition upstands were partially covered by soil and vegetation, as shown in Figure 25. It is evident that the vegetation had previously been burned instead of being rooted out, thus concrete integrity investigations are required along the perimeter of the structure to confirm conformance to the original design strengths of the concrete members.

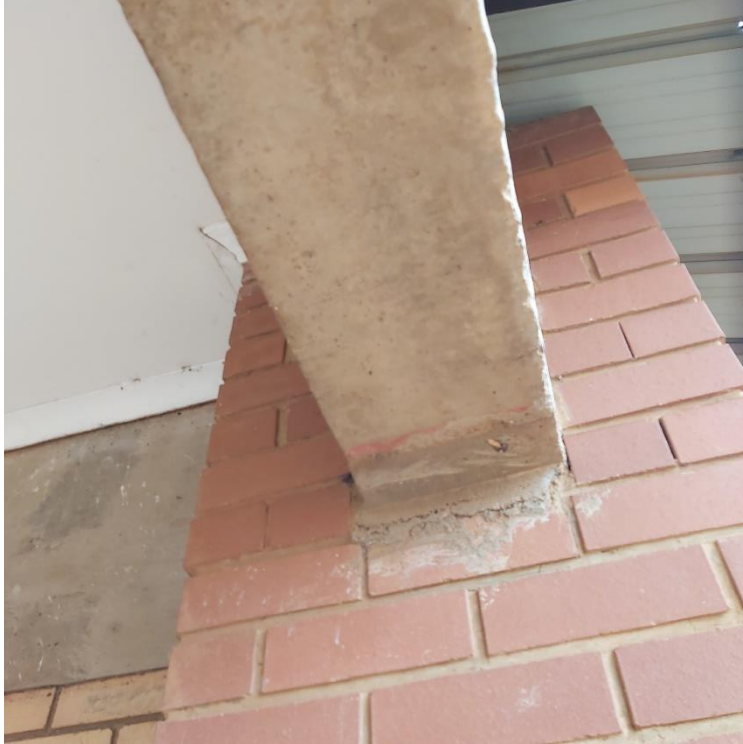
The external concrete ring beam displayed no major signs of deterioration: there were, however, some signs of poor concrete quality control at the beam-to-wall interfaces, and signs of bleeding during construction were visible as shown in Figure 29.

**Figure 29 - Beam-to-Wall Interface of the RC Ring Beam of the Administration Building (external)**

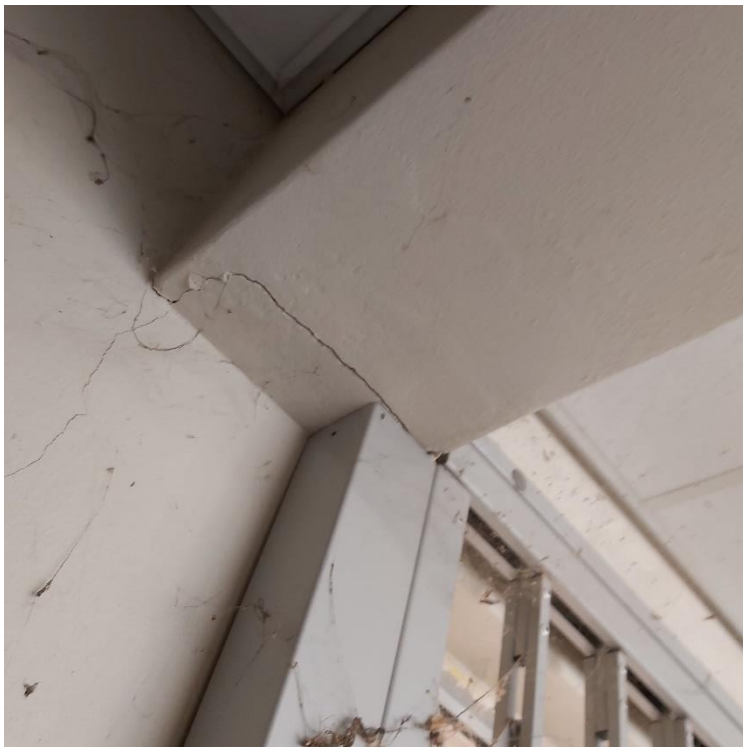
**Figure 30 – Beam-to-Wall Interface of the RC Ring Beam of the Administration Building (internal)**

In Figure 30, we observe that there is a visible crack on the underside of the ring beam, at the section outlined in red in Figure 30. The depth of the crack could not be determined as the members had been plastered, A detailed assessment must therefore be conducted to assess the severity of the defect, and to arrive at a conclusion regarding the underlying cause as well as the remedial actions required.

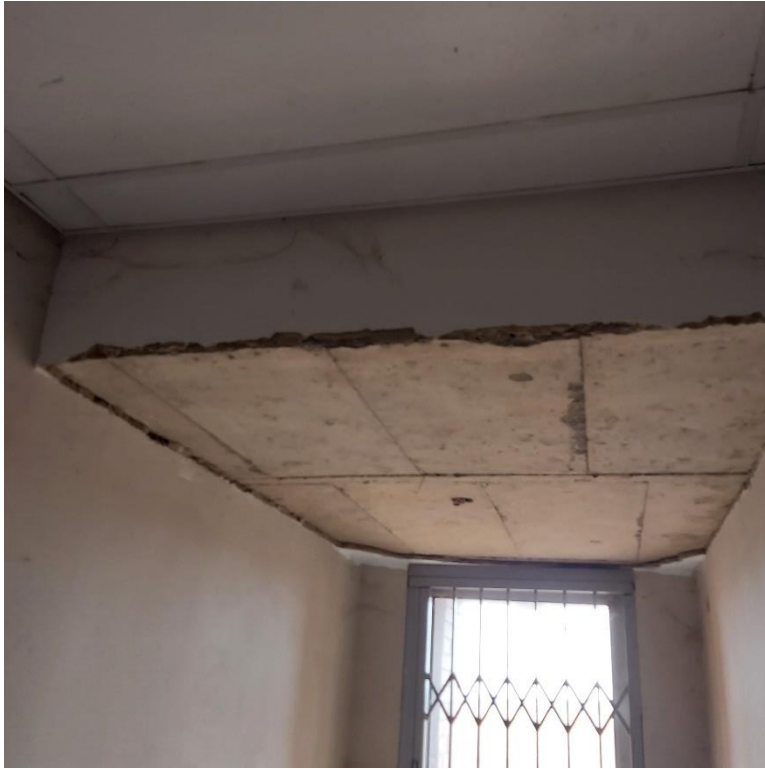
**Figure 31 - Reinforced Concrete Suspended Slab of the Administration Building**

The reinforced concrete suspended slab displayed no significant defects, as shown in Figure 31: however, a 30mm – 40mm plaster had fallen off due to adequate provision to support the significant mass of plaster, this must be remediated, for aesthetic purposes.

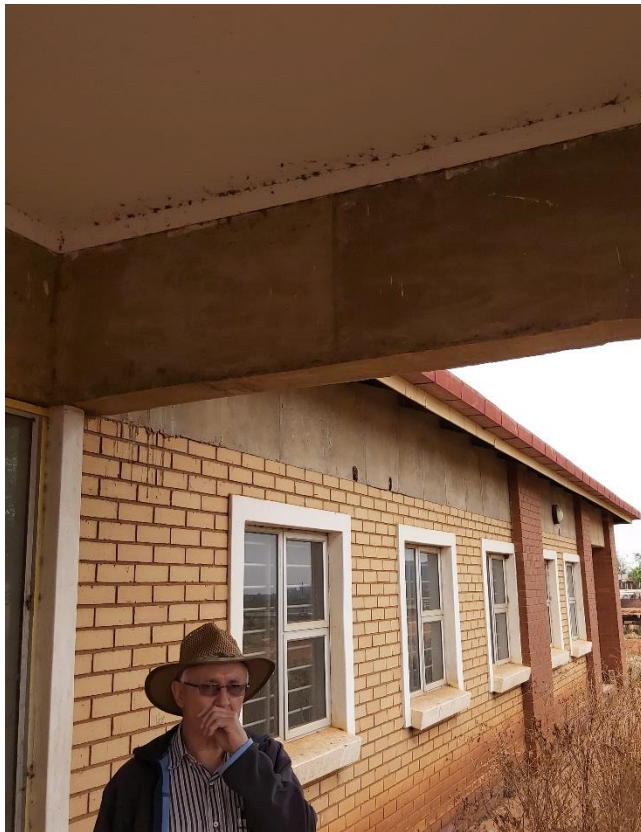
The external masonry displayed no major defects, as shown in Figure 32. The finishes were adequate, but standard 'house-keeping' requirements relating to cleaning and jointing had clearly not been upheld

**Figure 32 - External Brickwork for the Administration Building**

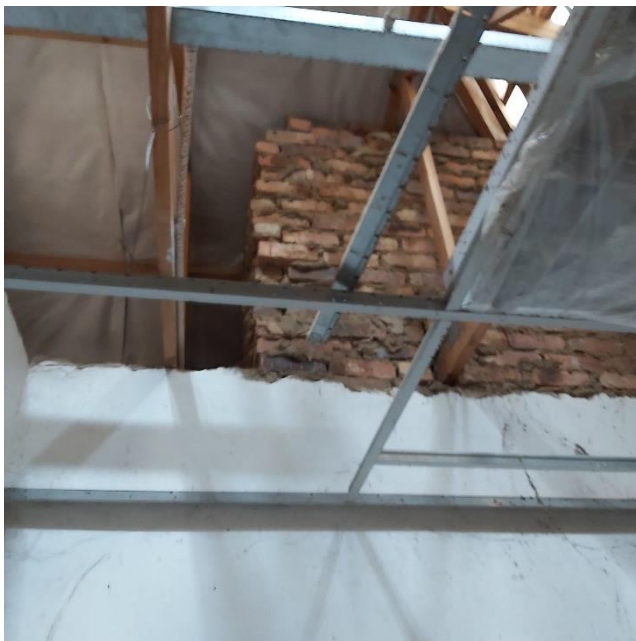
**Figure 33 - Internal Firewall for the Administration Building**

In Figure 33, poor and inadequate workmanship is observed for the firewall: this is located in the storeroom, and is outlined in red in Figure 26. This wall has to be demolished and redone, under strict supervision, to ensure the that the work conforms to SANS 10400: Part K.

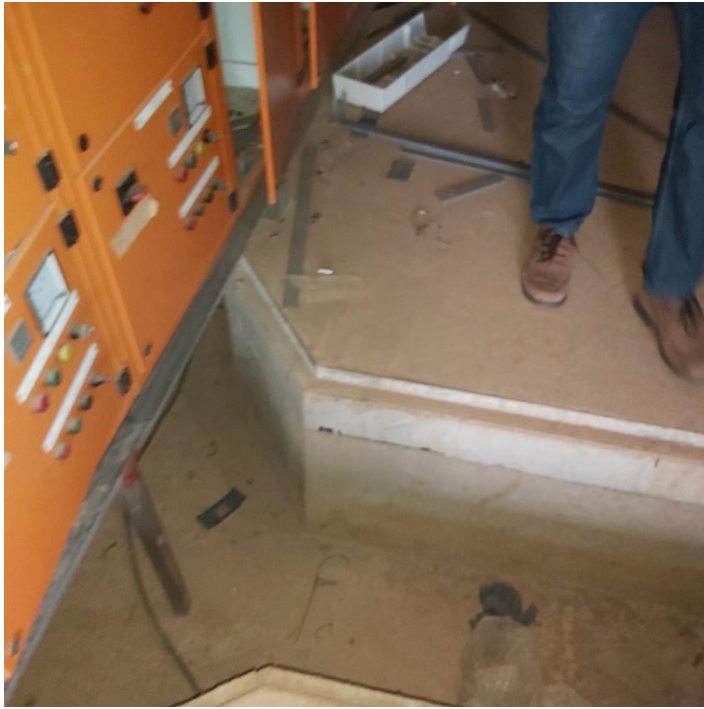
However, as shown in Figure 36 below, the screeding of the surface bed was still outstanding

**Figure 36 - MCC Building Surface Bed and Cable Trench**

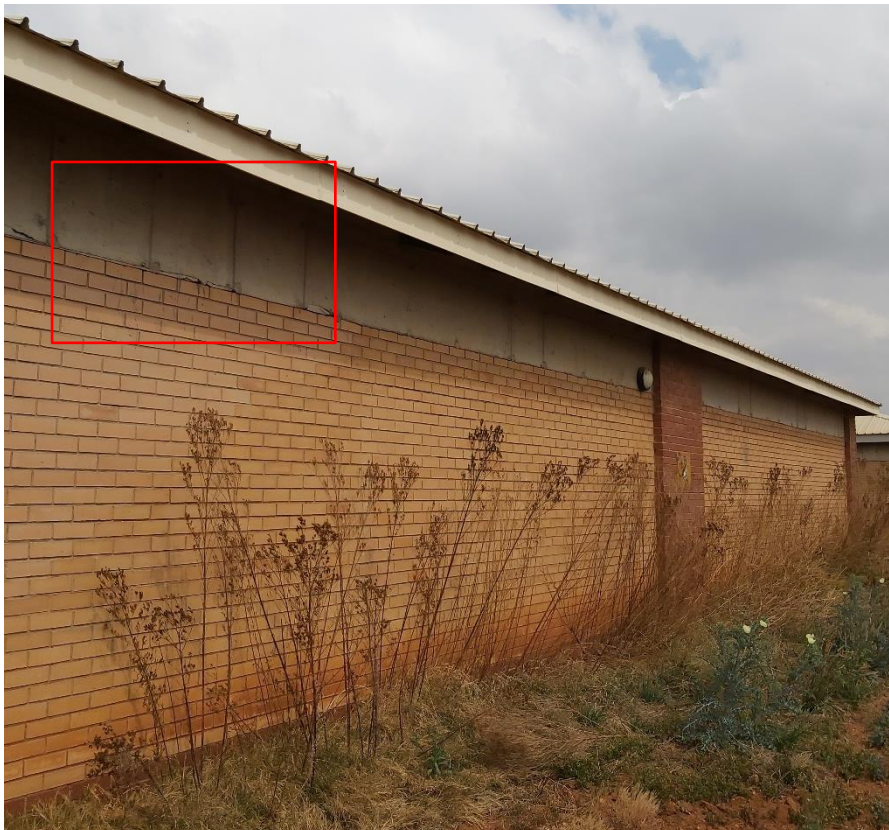
The external concrete ring beam displayed signs of distress, as shown in Figure 37 below. There are vertical cracks aligned to the spacing of the roof timber trusses. A detailed investigation, including coring and rebar scanning, is required to assess the construction quality and accuracy in relation to the original design.

### Figure 37 - Perimeter View of Brickwork and RC Ring Beam of the MCC Building

The external masonry displayed no major defects, as shown in Figure 37. The finishes were adequate, but standard house-keeping requirements relating to cleaning and jointing

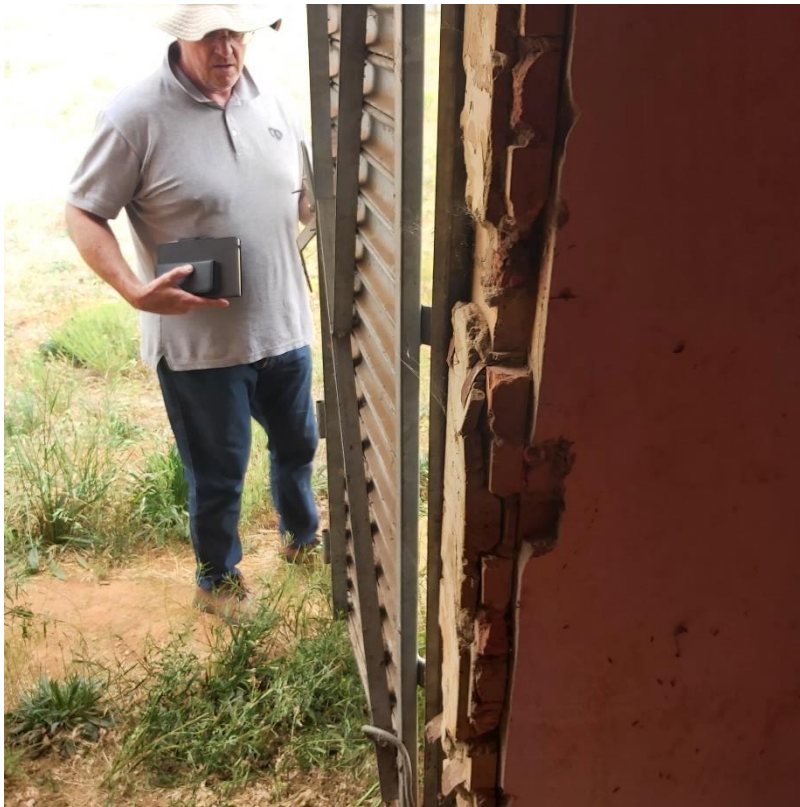
### Figure 38 - Internal Brickwork for the MCC Building

In Figure 38, poor and inadequate workmanship is evident from the entrance of the transformer room of the MCC Building. This wall needs to be remediated to ensure that the work conforms to SANS 10400: Part K.

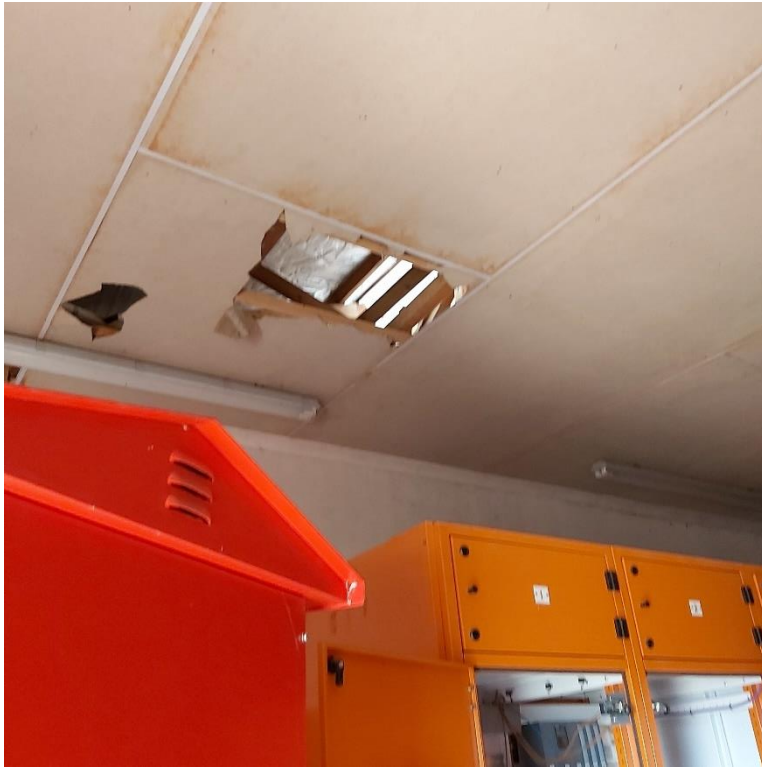
**Figure 39 - Open Section on the Ceiling and Roof of the MCC Building**

There was a hole, on the ceiling of the MCC Building, as shown in Figure 39. The timber trusses have been exposed to weather elements, which is of concern, as the timber's inherent properties deteriorate when exposed to differential wetting and drying. The trusses must therefore be inspected by a specialist and declared fit for use before handing over the structure.
