# TRANSNET NATIONAL PORTS AUTHORITY

## STRUCTURAL ASSESSMENT REPORT

**SITE:** EX-ENSIMBINI SITE, MAYDON WHARF,  
DURBAN

**DATE:** 21/06/2023

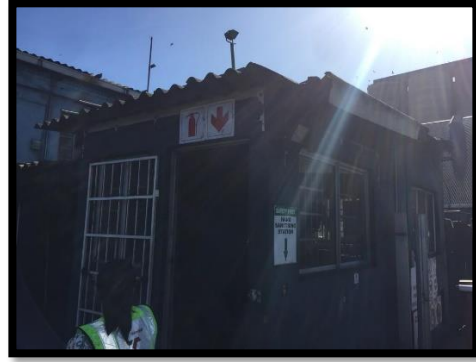
Observations	Photographic records
<p><b>Structure (Exterior)</b></p> <ul style="list-style-type: none"> <li>The structure is adequate and no visible structural damage and structural cracks.</li> <li>The aesthetics of the building is in poor condition.</li> </ul>

- The asbestos roof and fascia boards are damaged.
- There is no roof drainage as the gutters have been damaged and removed.

- Replace asbestos roof and provide proper roof drainage prevent any water ingress,
- Install proper building finishes,
- Install compliant electrical and ventilation system.

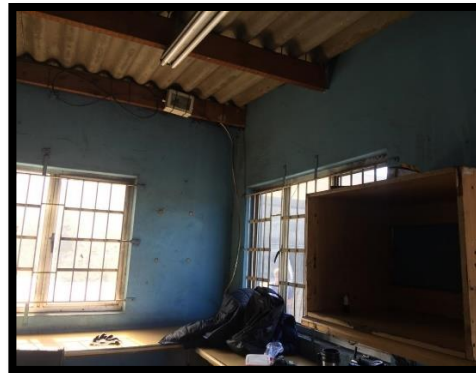
- There are no visible structural defects and no major cracks.
- There is no ceiling installed in the guard house which presents a health risk due to the asbestos sheeting.
- There is no electrical compliance with cabling and electrical fittings installed with no discernable planning or safety consideration.

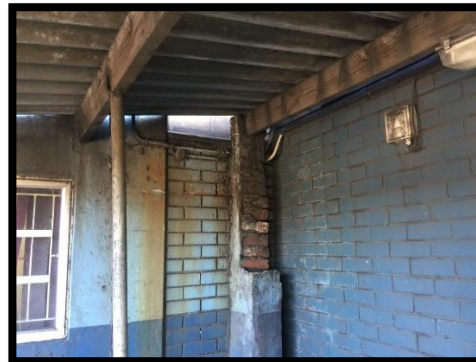
- The canopy structure bridging the guard house and office block is a structural risk. The rafters are supported by a metole pole which is not fixed to the ground. This configuration is prone to collapse and visible deflections are noted.
- There is no proper structural support for the canopy or drainage provided

therefore, there are signs of rainwater damage to the adjacent brick wall supporting the canopy structure.	
--	--

The guard house's overall is structurally sound with no major defects noted on the main structural elements. The exterior of the structure lacks proper finishes, there is an asbestos roof where certain parts show water damage leading to the damage of the adjacent brick wall. There are no major structural cracks on both the exterior and the interior of the guardhouse. The adjacent canopy structure needs to be properly supported or removed. There is no notable roof drainage present.

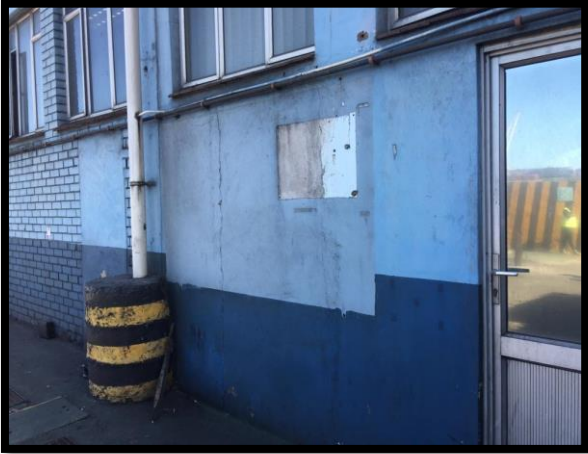
Observations	Photographic record
<p><b>Structure (Exterior)</b></p> <p>The overall structure of the building is adequate.</p> <p>Minor cracks were noted on the exterior wall.</p> <p>The cracks are due to the enclosed previous door opening.</p>

The overall structure of the building is good with no major structural defects noted in the visual assessment. The cracking noted on the exterior wall pose no structural risk and can be repaired by redoing the brickwork to engineering standards. The damage noted to the roof is severe and requires immediate attention.

- Minor cracks repairs on the exterior structure,
- Asbestos roof to be replaced,

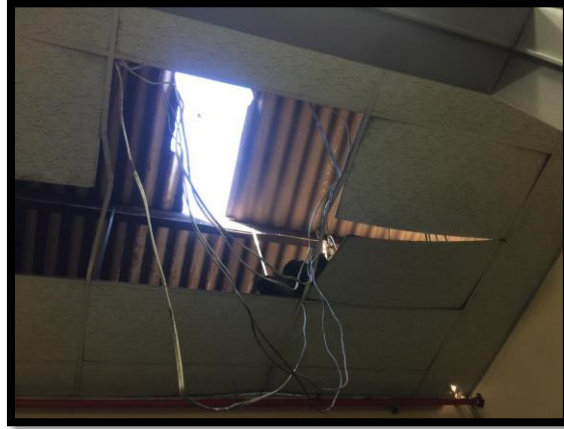
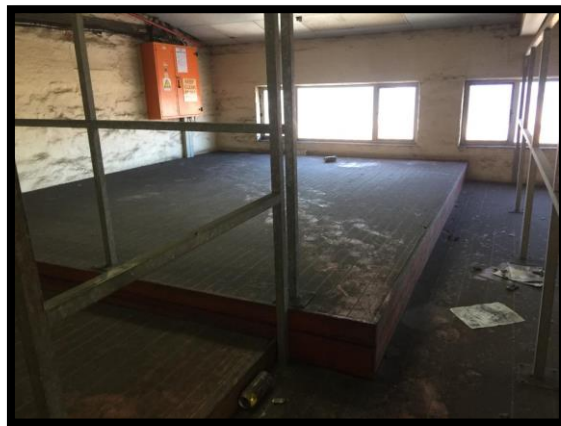
- There are damaged sections of asbestos roof sheeting with large openings which has led to severe water ingress and animal infestation..
- The suspended ceiling has visible damage to façade and interior supports.
- The electrical wiring system has been severely vandalized.
- The interior wall structures are adequate and do not display any major defects.
- The upper-level wooden floor is not deemed safe and posed a safety hazard..
- The interior partition are not in good condition and fire rating could not be determined.

- Interior finishes such as the ceilings, flooring and partitions require replacement,
- Electrical wiring to be repaired / replaced to ensure compliance.

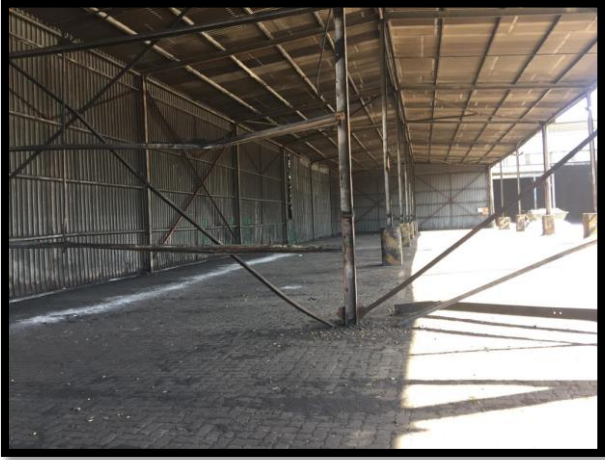
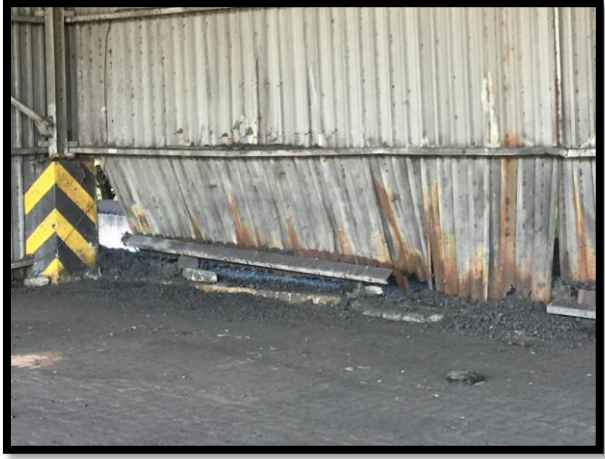
Observations	Photographic record
<p><b>Structure</b></p> <ul style="list-style-type: none"> <li>• It was noted that there are signs of corrosion on the columns, bracing, beams, and sheeting.</li> <li>• Damage and deflection of infrastructure is evident, this is noted by the bent columns and the lighting service ducts.</li> <li>• It was also evident that the eaves beams and purlins show signs of buckling.</li> <li>• There are collision damage visible to the gutter and sheeting of the shed. Various different types of sheeting were used in ad hoc repairs of the years. The different sheeting exhibits different material properties such as different thicknesses and corrosion levels.</li> <li>• The interior paving within the shed is in good condition.</li> <li>• Signs of Ponding and drainage problems at the front to the back of the shed is evident which might be caused by the fact that the floor is sloping towards the back wall of the shed and potentially causing corrosion to the</li> </ul>

<p>sheeting and exposed steel structural elements.</p> <ul style="list-style-type: none"> <li>Some interior columns are damaged due to accidental collisions. The columns have deflected significantly and may pose a structural risk if left unattended.</li> </ul>	
<p><b>Plinths</b></p> <ul style="list-style-type: none"> <li>About 50% of plinths are damaged</li> <li>The steel is exposed on plinths which makes them prone to corrosion and further degradation.</li> </ul>

All corroded steel sheeting needs to be replaced. Structural steel members that exhibit corrosion need to be treated to prevent further corrosion. All deflected columns, purlins, eaves beams and bracing are to be replaced. The Shed surface to be regraded to ensure that any water flows towards the stockpiling yard or into a stormwater drainage system. The gutter and drainage system of the roof to be repaired and directed into stormwater system.

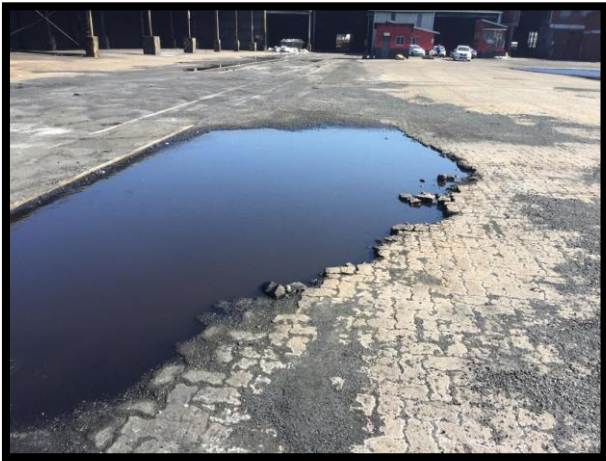
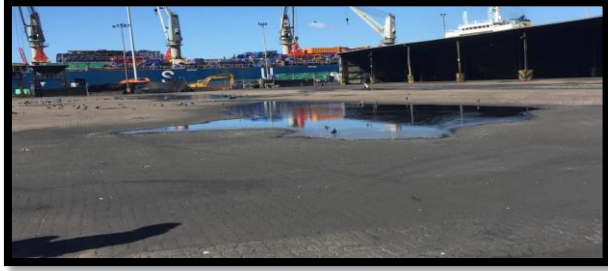
Observations	Photographic record
<p><b>Damaged Stockpile yard Surface</b></p> <ul style="list-style-type: none"> <li>There are visible damage and settlement noted on the yard paving blocks which has resulted in the ponding evident on site.</li> </ul>

- Unblocking of stormwater drainage system,
- Cleaning and repair of perimeter open channel drains,
- Yard resurfacing and proper sloping or profiling.

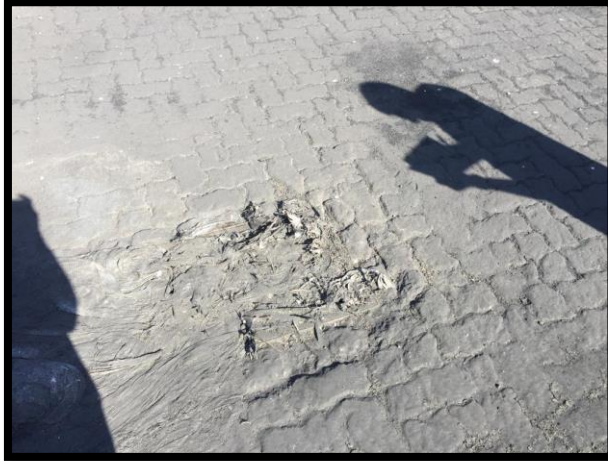
<p><b>Stormwater Drains and manholes</b></p> <ul style="list-style-type: none"> <li>There are blocked drains within the stockpile area which has resulted in the inefficient drainage of the site and ponding.</li> </ul>

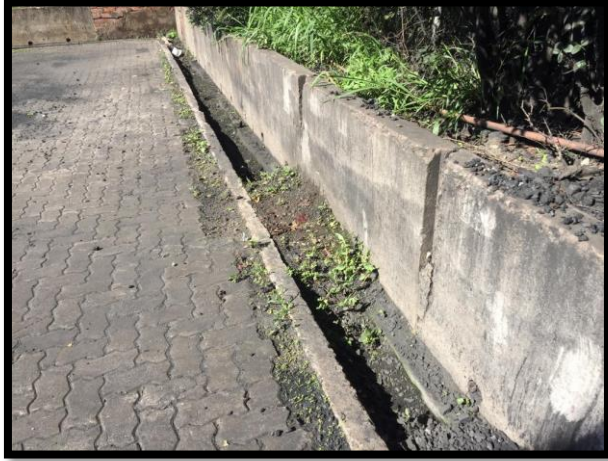
<p><b>Perimeter Drainage Channel</b></p> <ul style="list-style-type: none"> <li>It is evident that the perimeter channel is blocked with stockpiled material resulting inefficient drainage of stormwater.</li> </ul>

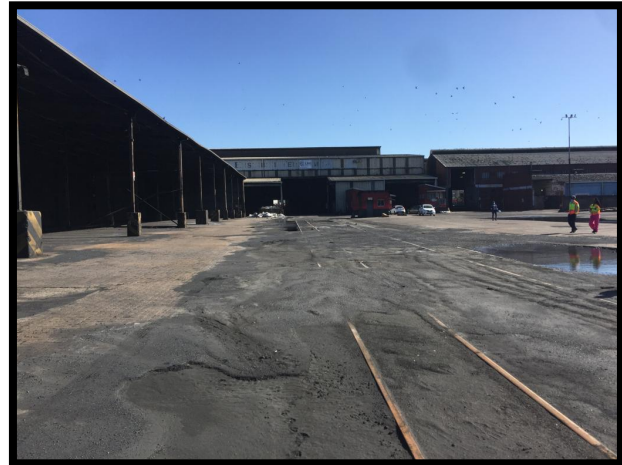
- The coal stockpile residue dust has also been evident and has influence the poor draining and ponding since there are stormwater drains are blocked

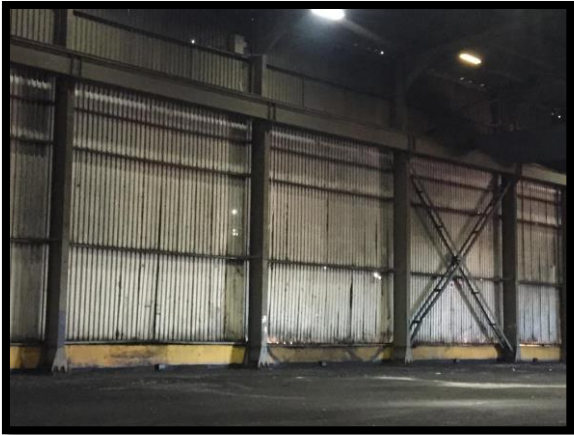
Observations	Photographic record
<ul style="list-style-type: none"><li>• Signs of leakage on the roof sheeting. Minor holes are evident; however roof is in a good condition.</li><li>• Signs of corrosion on the interior sheeting.</li></ul>

The condition of the concrete floors is satisfactory; however, they need to be repaved and profiles in order to prevent water ponding. Steel members need to be treated to prevent corrosion. The machinery and the sprinkler system are required to be tested to ensure compliance and utilization of the systems. Minor holes in the roof need to be repaired.

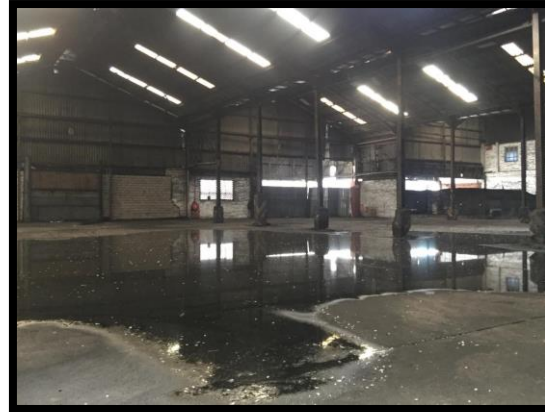
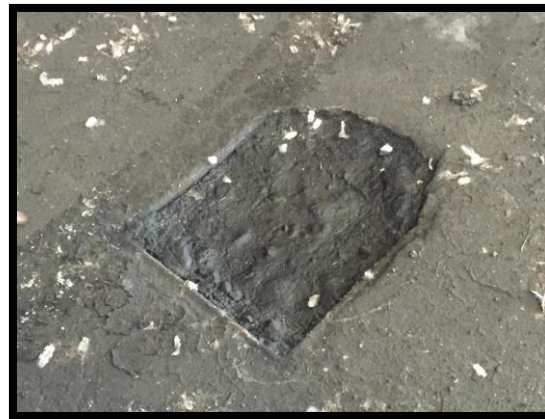
- Signs of leakage on the asbestos roof sheeting with voids present in the sheeting and water ingress within the walls.
- Signs of damage on the asbestos wall sheeting.
- Damage and deflection of columns and column bases, this is noted by the deflected columns and the completed detachment of the concrete column bases from the floor.
- Exposed reinforcement of the floor slab.

The condition of the concrete floors are poor, they require immediate attention. The entire building needs to be waterproofed, and all of the asbestos sheeting is required to be removed and replaced. The stability

of the warehouse is a concern since most of the interior column inspected by the team were detached from the floor, it is therefore recommended that all concrete plinths and deflected columns be replaced.

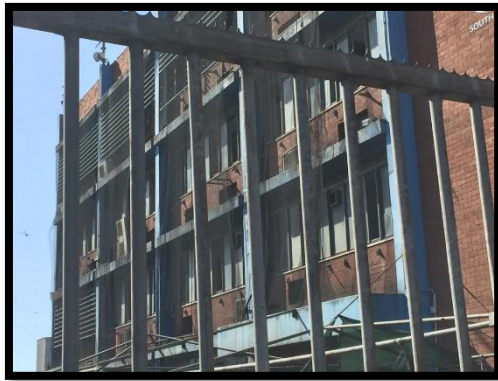
Observations	Photographic record
<b>Structure Exterior</b> <ul style="list-style-type: none"> <li>The overall structure of the building is adequate and structurally sound.</li> <li>No visible cracking on the walls.</li> <li>No visible signs of major water ingress.</li> </ul>

The building is structurally sound. It requires a total renovation and installation of finishings in both the interior and the exterior of the building.

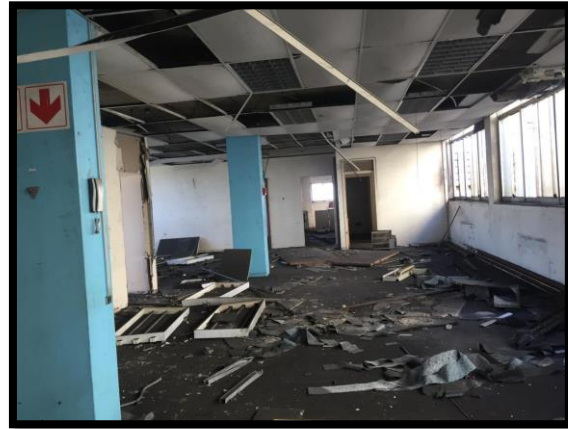
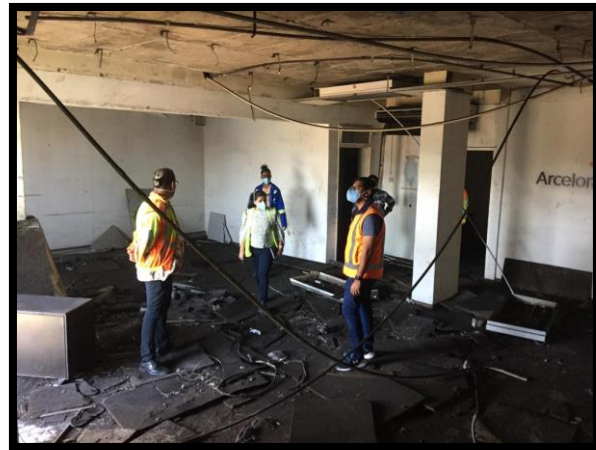
- The building has been totally vandalized.
- The air conditioning system has been removed and left multiple voids on the exterior walls..
- The suspended ceiling has been damaged and removed.
- The wall partition walling has been damaged.
- The majority windows and door frames have been damaged, removed or stolen.
- Electrical equipment and wiring system has been totally stripped.
