DOLOMITE STABILITY INVESTIGATION REPORT: ESKOM ESSELEN SUBSTATION,
ESSELEN, TEMBISA, GAUTENG, SOUTH AFRICA

Client: ESKOM

Report No.: 380-02-2018

Date: Feb 2018

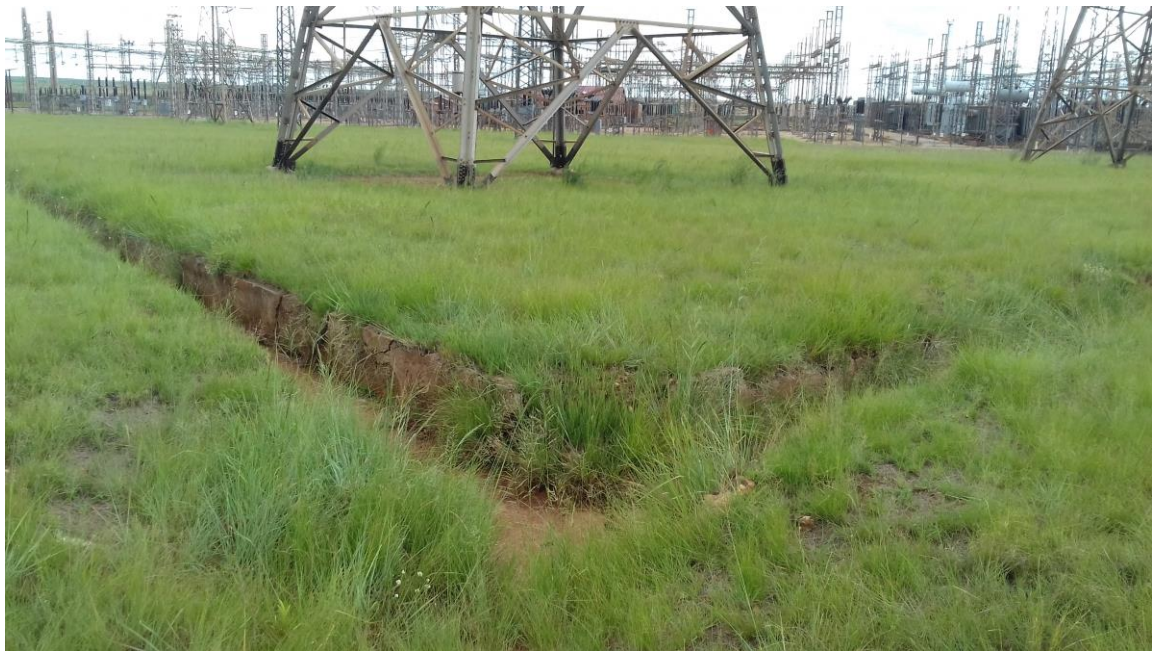
The natural drainage within vicinity of the site is towards the east into the Rietvlei River System. The drainage is controlled by a gentle slope of about 1%. The locality of the site is engineered with concrete surface V-channels drainage systems that induce control and channelling of storm water towards the eastern flank of the site (Figure 2).

Figure 2 shows engineered storm water drainage systems developed at the site.

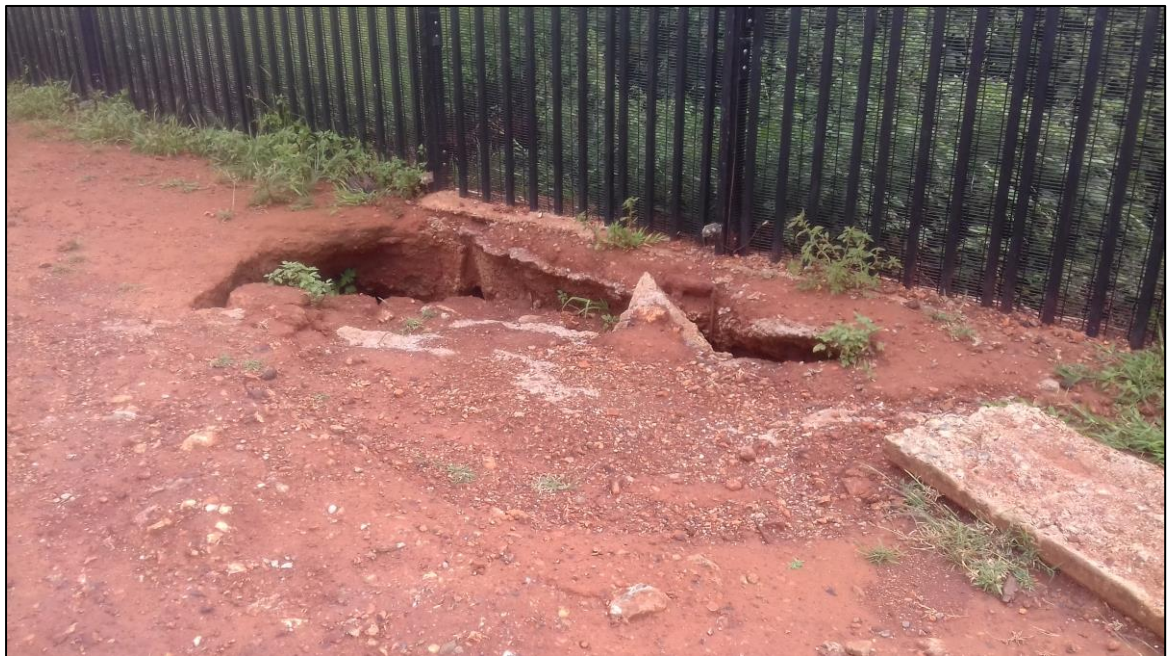
successfully rehabilitated by Thoka Geosciences as a reactionary measure but more sinkholes have manifested at new localities within the site, thus triggering a request to conduct a full dolomite stability investigation at the site. The latest visible sinkhole development at the site may be located by coordinates S26.00678° E28.26650° (

Figure 4 shows the latest sinkhole development at the site

Areas deduced to be IHC 8 from this investigation are recommended for proactive rehabilitation in the form of overburden strip, expose cavity throat and rehabilitation to prevent highly likely sinkhole occurrences.

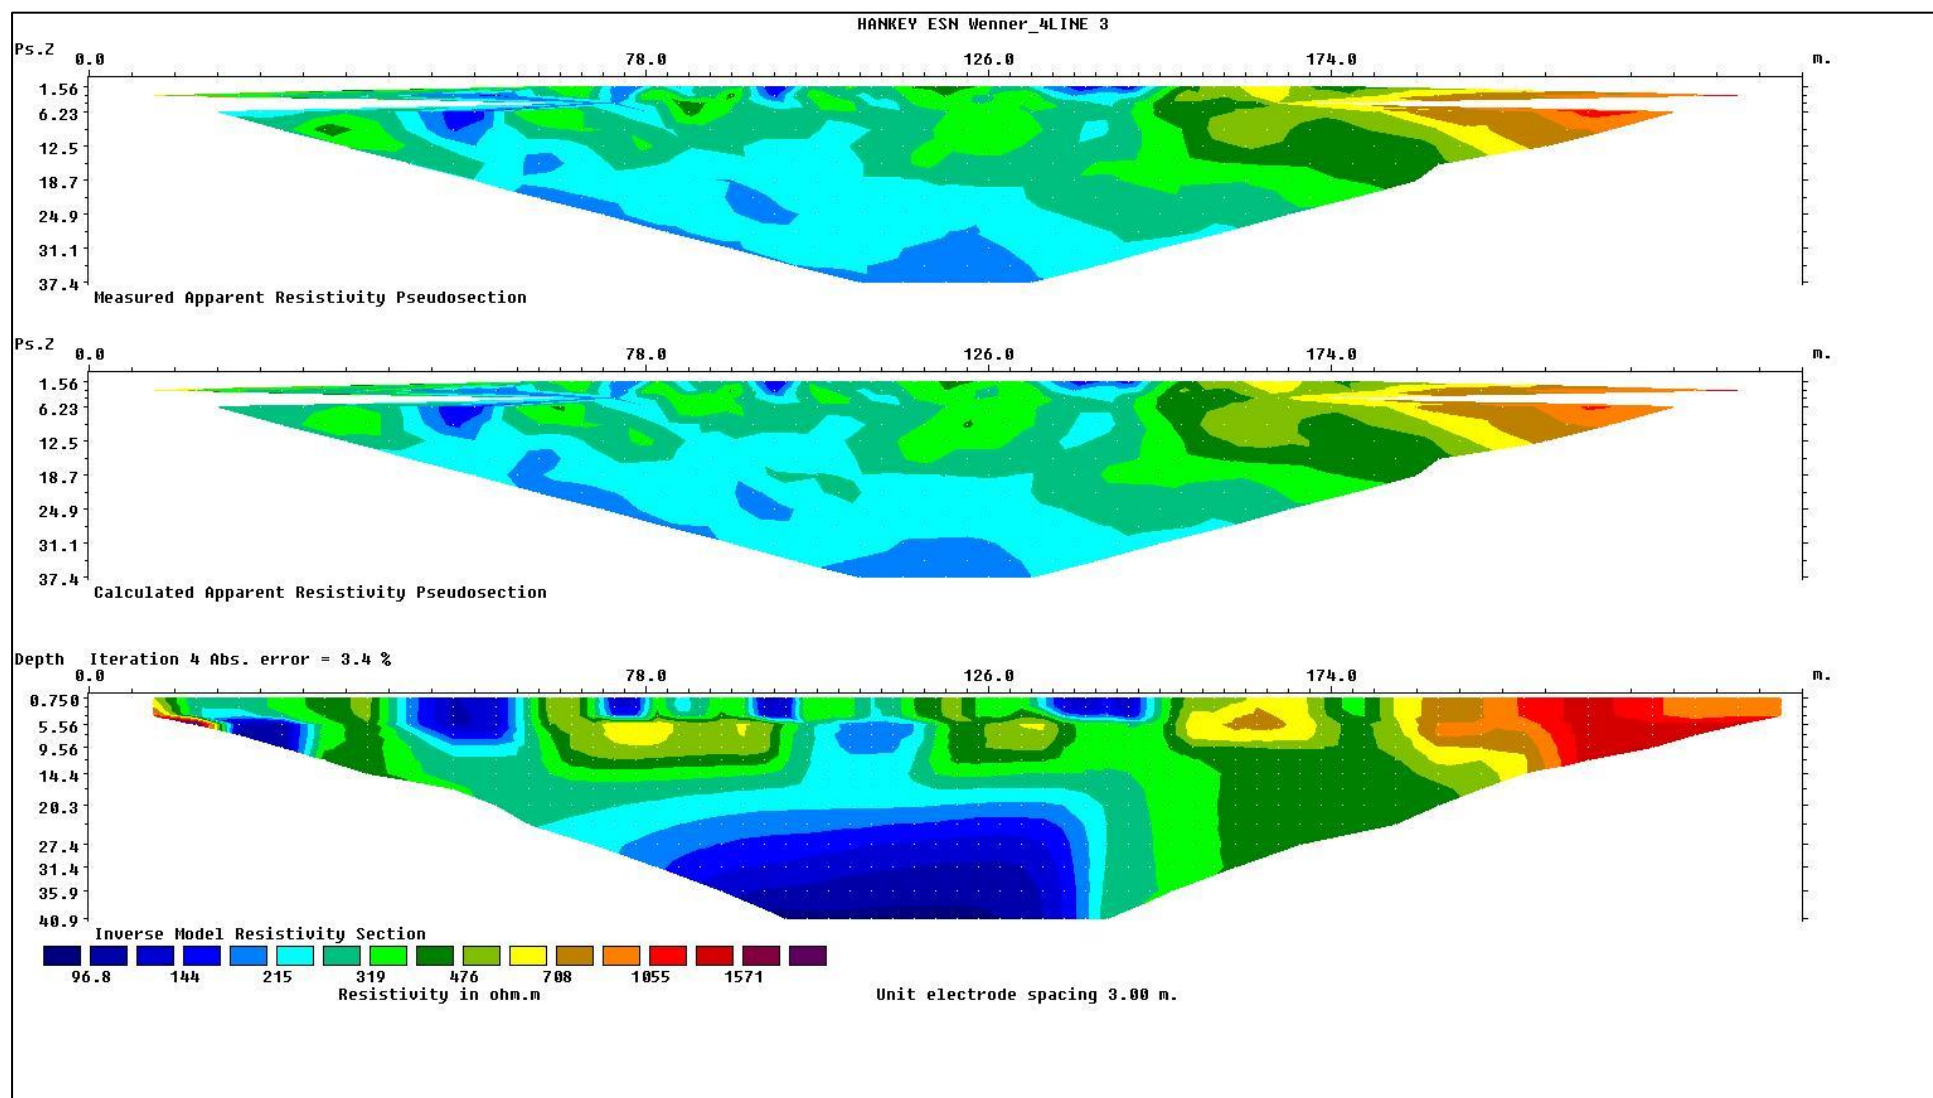
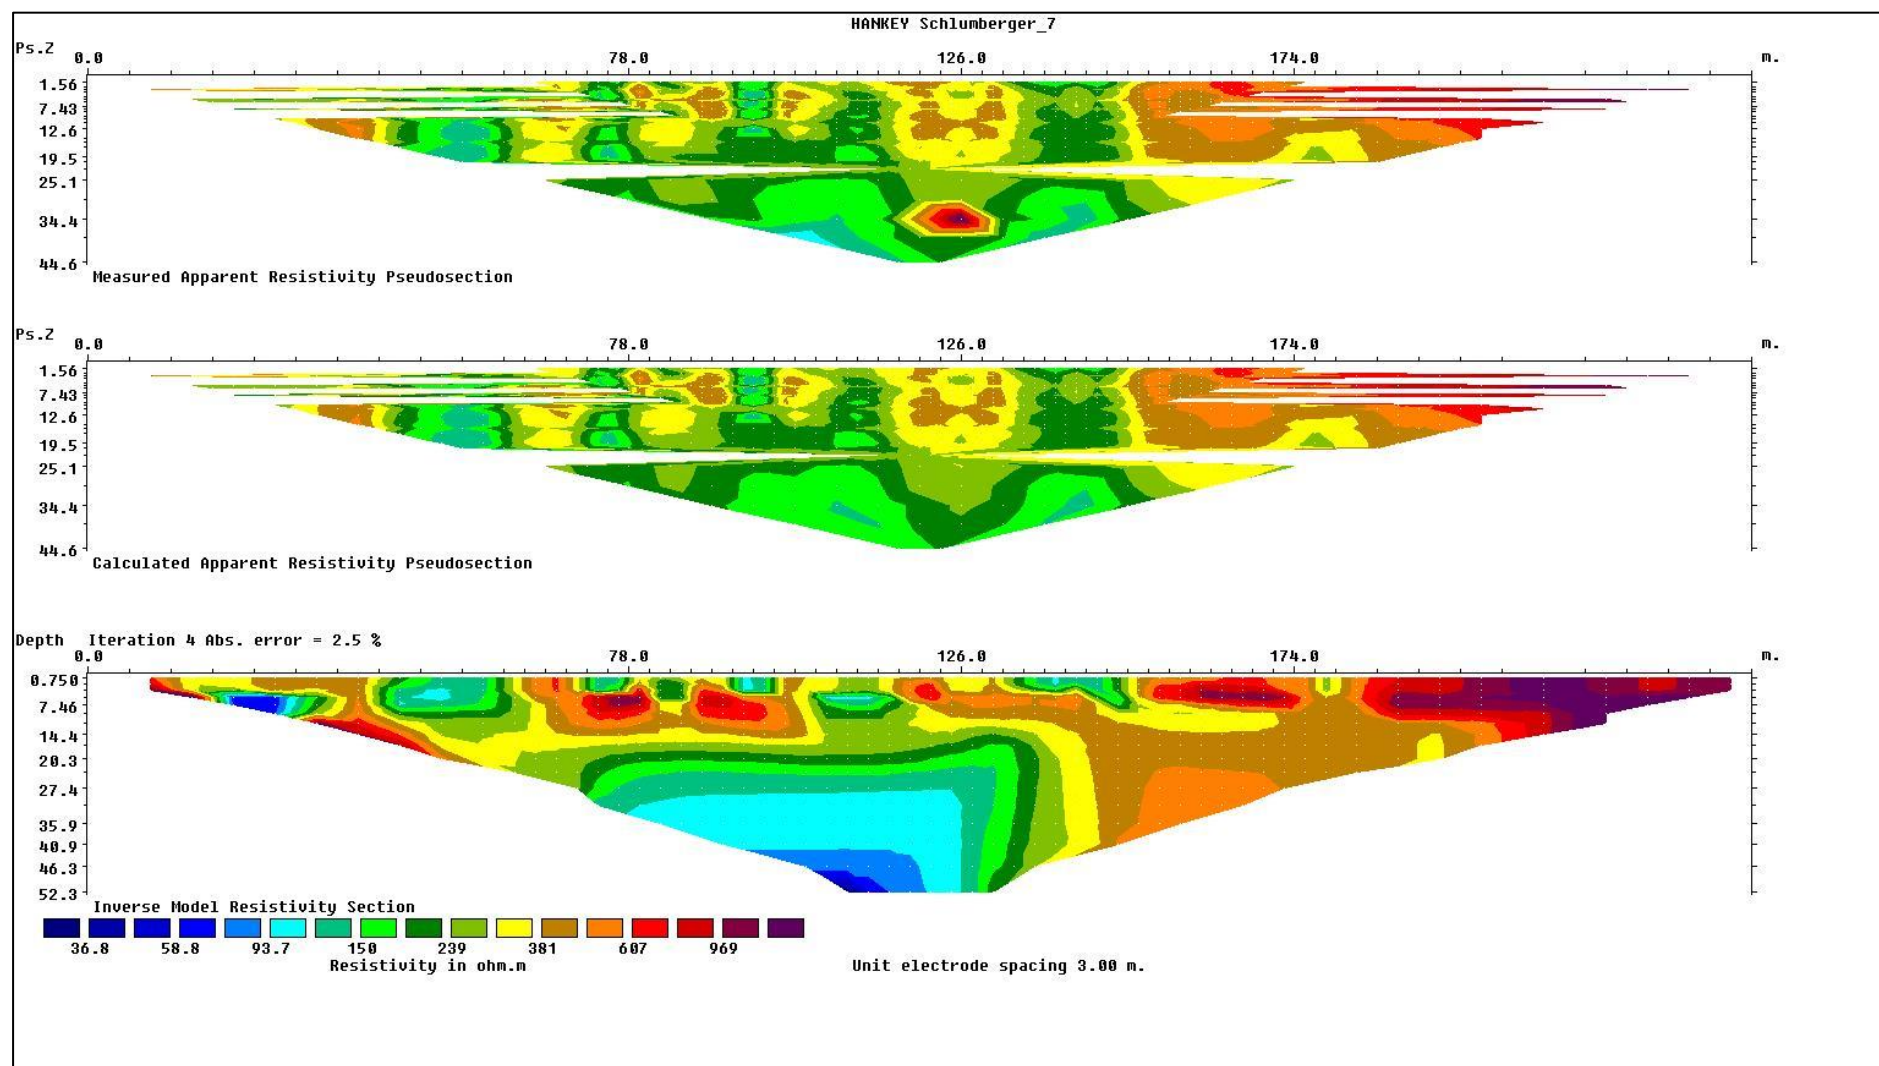
Traverse line 2 which crosses along a southeast-northwest traverse line for a 240 m distance (Figure 9) displays a highly variable geophysical signature which is characterized by isolated pockets of low (dark blue color code) – intermediate (green) resistivity material close to surface. The Traverse line 2 passes within region of the recorded gravity low region northeast of the Esselen Substation characterized by deep dolomite bedrock. On the northern flank of Traverse line 2 from about 180 m to 240 m traverse distance, a resistive material is recorded which coincides the boundary of gravity high zones recorded on the gravity survey.

Figure 9 shows the resistivity survey line 2 conducted along a southeast-northwest direction over a 240 m traverse line

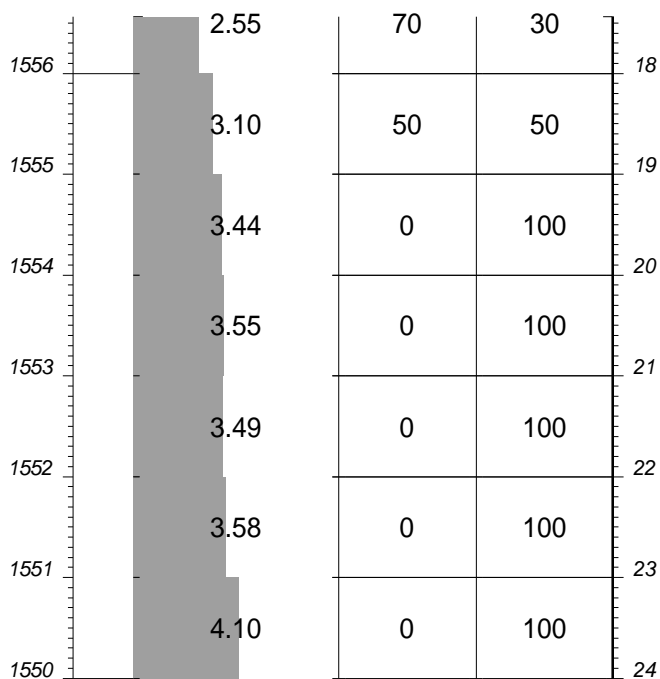
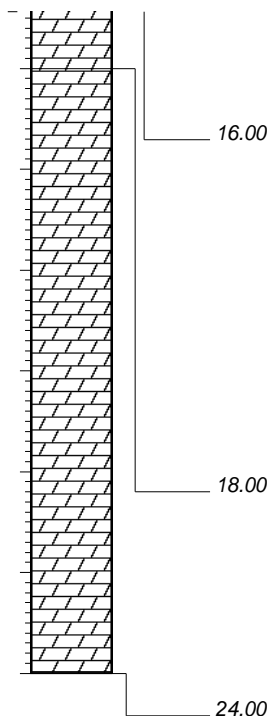
TOTAL SAMPLE LOSS, rapid penetration rate indicate cavities

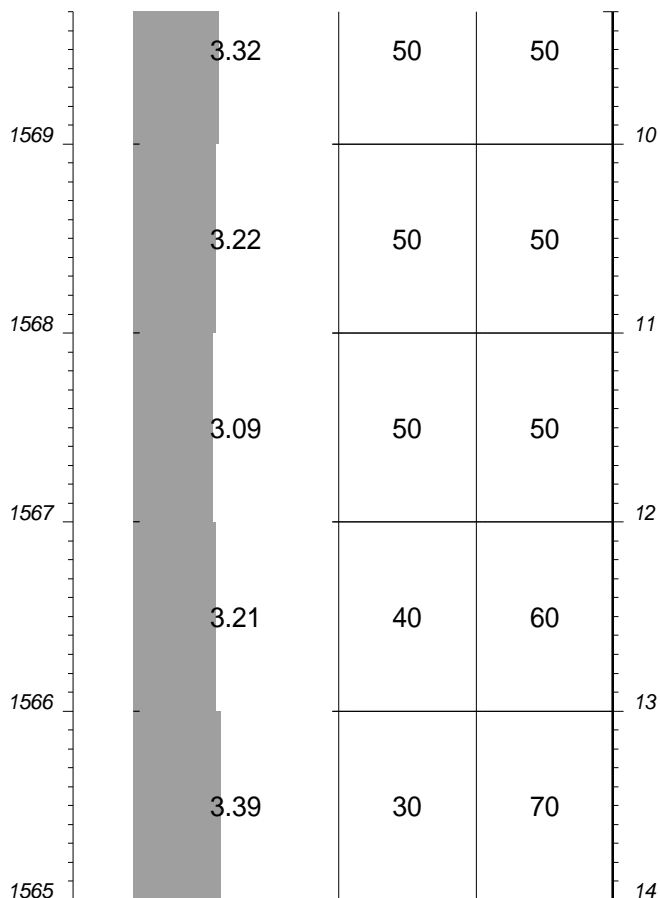
TOTAL SAMPLE LOSS, rapid penetration rate indicates cavity

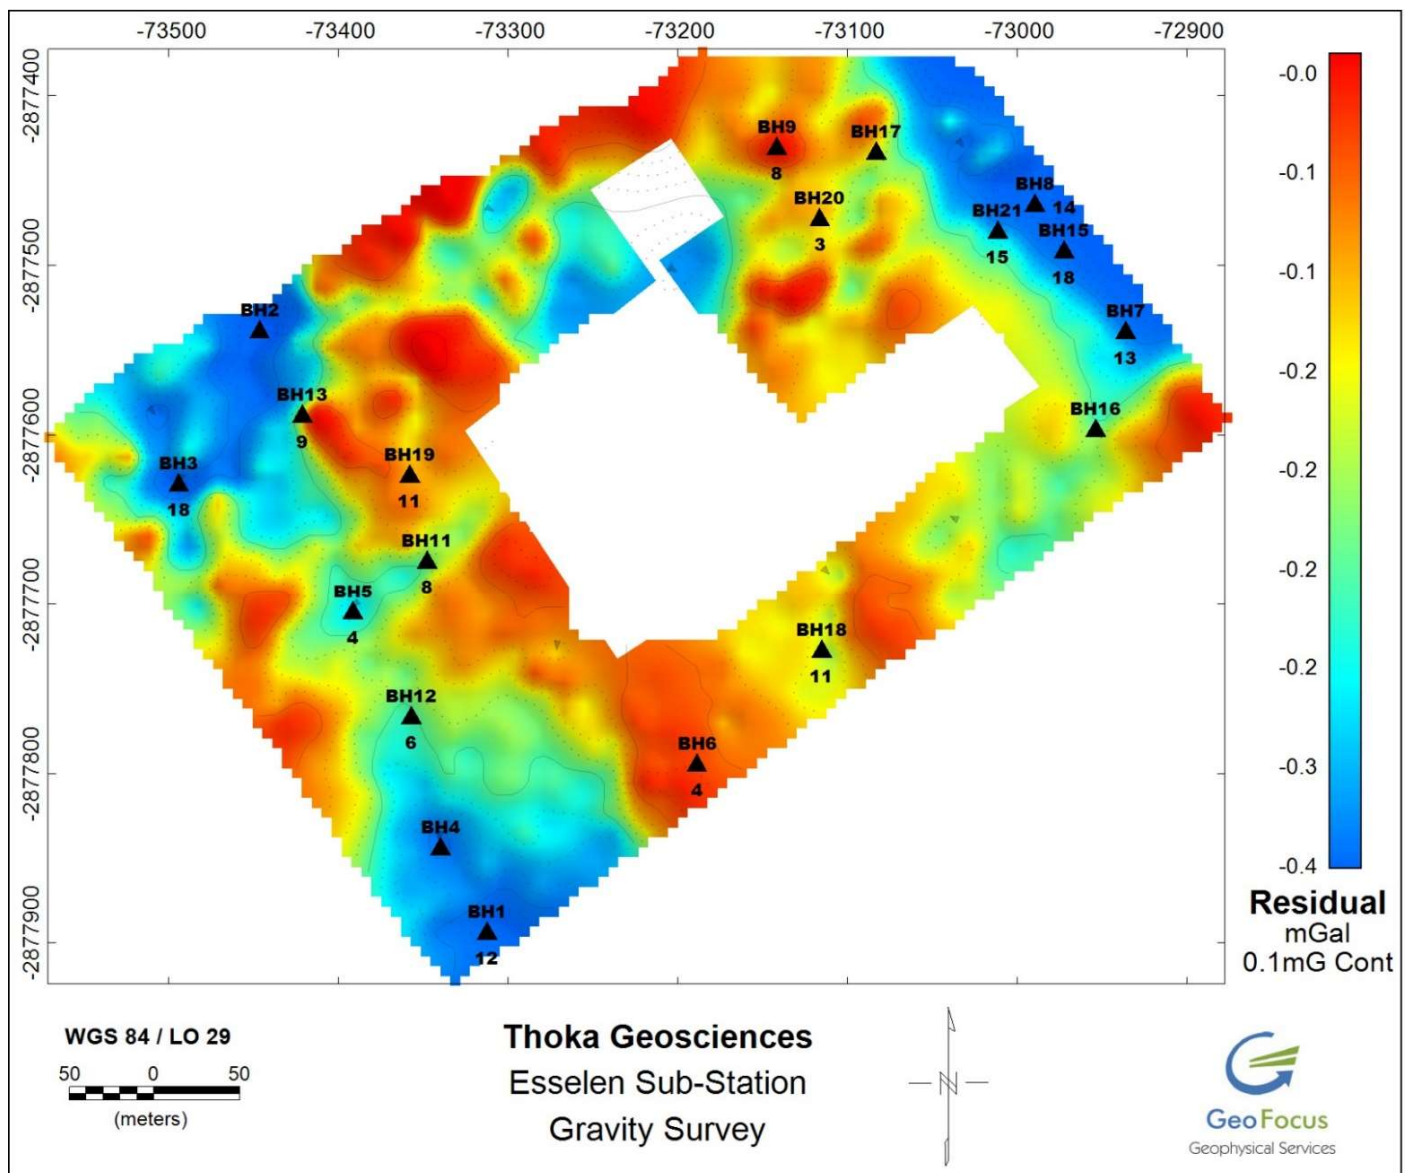
Figure 3: Residual gravity (0.1mGal contours) & drilling results

Corrections were applied to the residual gravity data based on a set of nineteen (19) boreholes drilled across the site (Figure 3). It is understood that rehabilitated sinkholes exist within the surveyed area which are likely underlain by concrete and other foreign rock material. The broad gravity high which spans most of the surveyed area, and surrounds the existing substation, is shown to consist of shallow (3m to 4m) dolomite bedrock head as intersected by boreholes BH20 and BH6. Subtle changes in the residual

gravity, within the broader high, correspond with variations in weathering as noted by boreholes BH9, 11, 13 & 18 - 19 which intersected competent bedrock formation at between 8m and 11m deep. Bedrock deepens toward the northeast, coincident with a broader gravity low, where boreholes BH7 - 8, 15 & 21 intersected bedrock head between 13m and 18m deep. In most cases small cavities were intersected which caused sample loss. Boreholes 16 & 17, drilled on the gravity gradient, intersected fairly large cavities and were terminated at 19m and 14m respectively; both of these locations fall on subtle and small lows originating from the larger gravity low. The gravity low toward the southwest is more irregular and appears to be comprised of two lows, located in the northwest and southwest, connected by narrow, rectilinear lows. This is supported by boreholes BH1 & 3 which intersected bedrock at 12m and 18m respectively while boreholes BH2 & 4 were terminated after intersecting fairly large voids. Although boreholes BH5 & 12 showed bedrock to be around 5m depth, the gravity suggests they may have been drilled on the edge of a slot. Overall the drilling results show the gravity to be a fair reflection of bedrock topography.
