**TITLE: GEOTECHNICAL INVESTIGATION OF THE CONSTRUCTION SITE FOR ATDC DAM,
ROAD AND BORROW PIT, IN FREE STATE PROVINCE.**

Mbani Projects Pty (Ltd) is appointed by Department of Agriculture in Free State Province to conduct geotechnical investigation to establish whether the ground conditions within the vicinity of ATDC Dam are suitable for development of a retain dam and the access road.

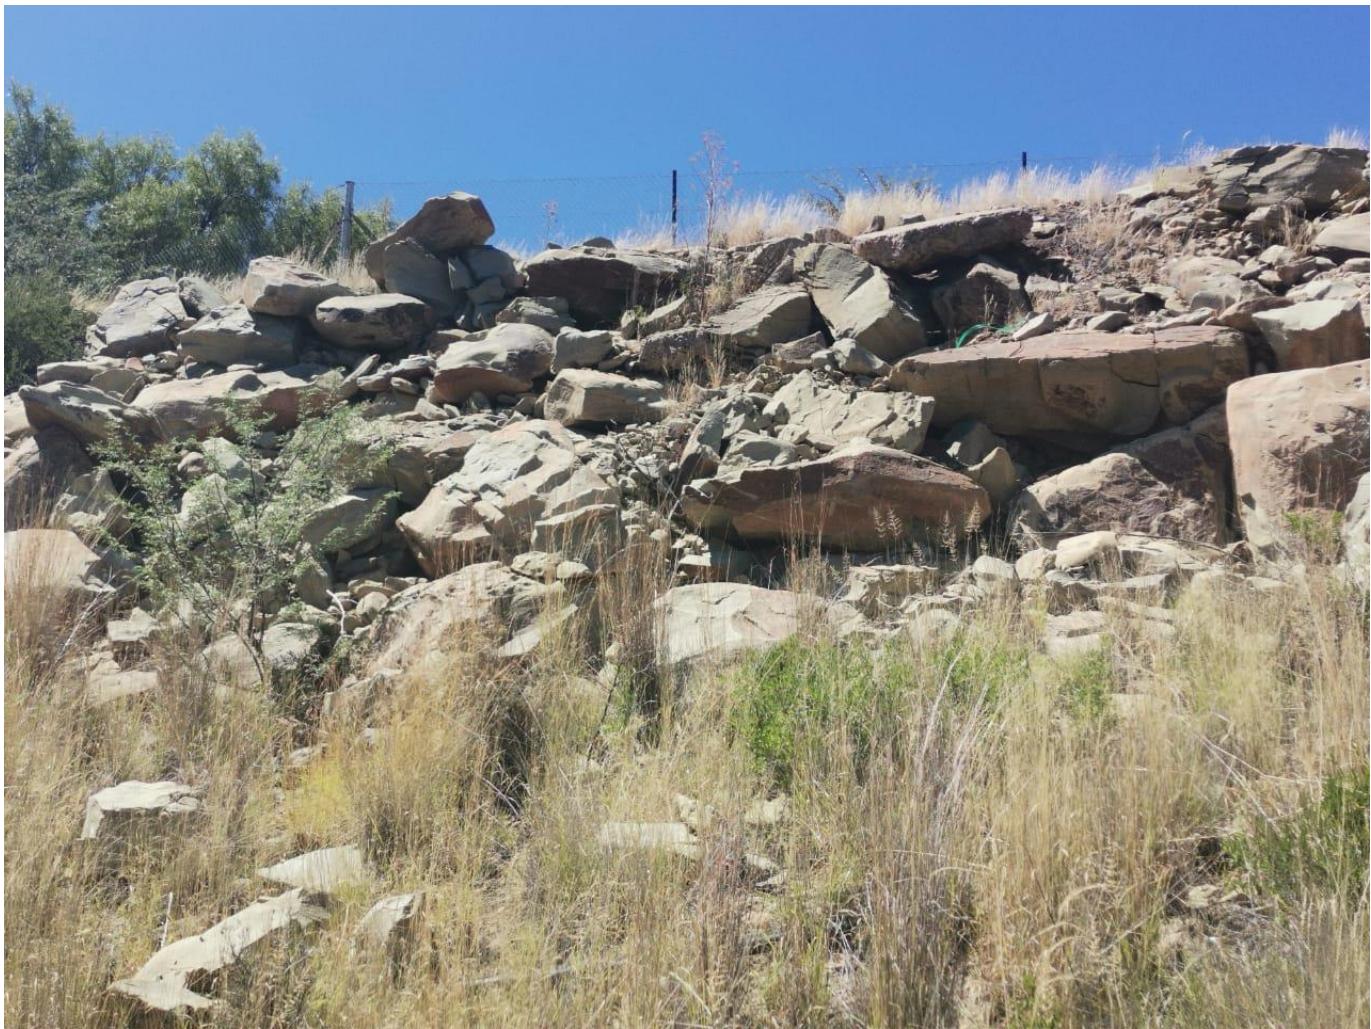
Picture 1. Illustrates SANDSTONE boulders within borrow 1.

The SANDSTONE for the retain walls of the dam has been allocated within borrow pit 1 by GPS coordinate 30°37'37.62"S 25°28'27.88"E.

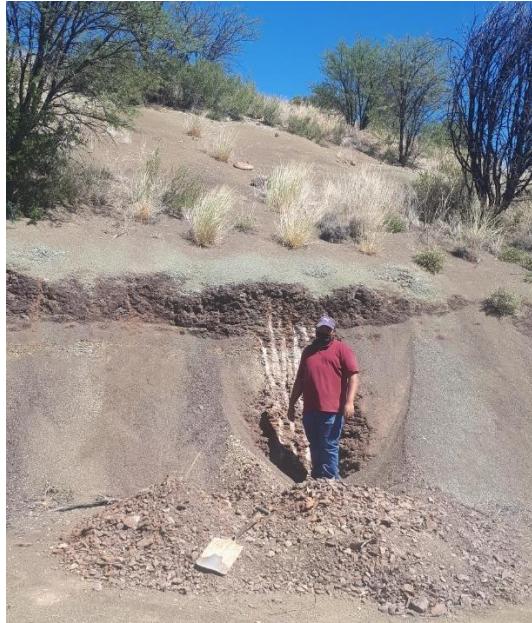
Picture 2. Pit test 1 (GPS coordinate 30°37'31.78"S 25°28'49.19"E) within the borrow 2.

This is pit test 1(GPS coordinate 30°37'31.78"S 25°28'49.19"E) within borrow pit 2.

It illustrates the MUDSTONE rock occurring in reddish brown to greyish blue.

It has been earmarked for the aggregate for the road subbase construction as well as the wearing course or crown of the road..

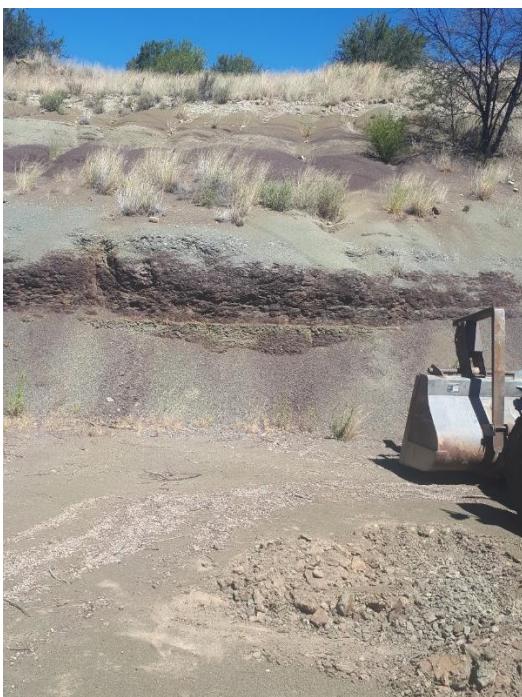
Picture 3. Pit test 2 (GPS coordinate 30°37'30.78"S 25°28'52.04"E) within the borrow 2.

This is pit test 2 (GPS coordinate 30°37'30.78"S 25°28'52.04"E) within the borrow 2.

It illustrate the alternative material for CLAY required for the core of the dam construction.

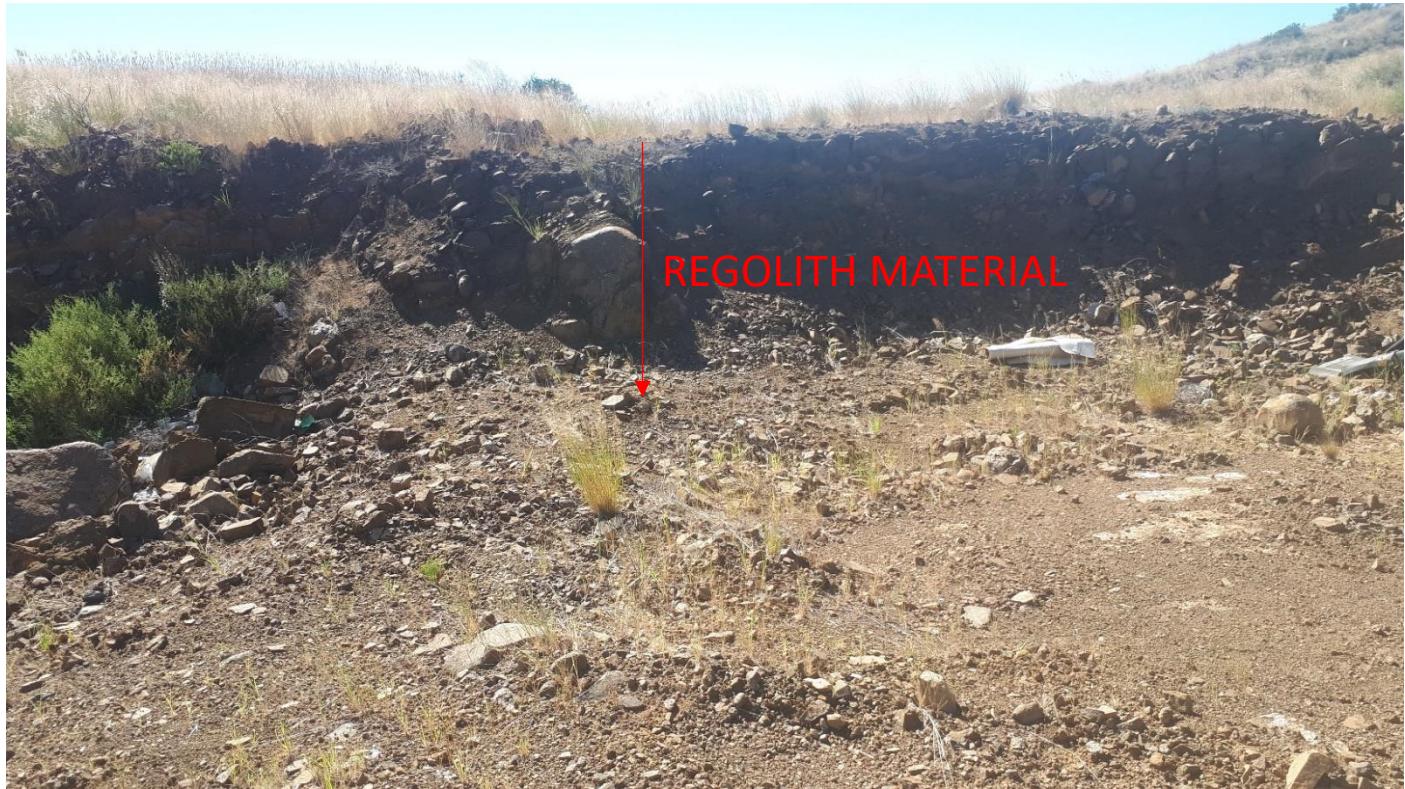
Picture 4. Illustrates test pit 1 (by GPS coordinate 30°36'40.46"S 25°28'59.43"E) within borrow pit 3.

This is test pit 1 (by GPS coordinate 30°36'40.46"S 25°28'59.43"E) within borrow pit 3.

This borrow pit has been selectively excavated, previously.

Unweathered rock, MUDSTONE, need to be drilled and blasted.

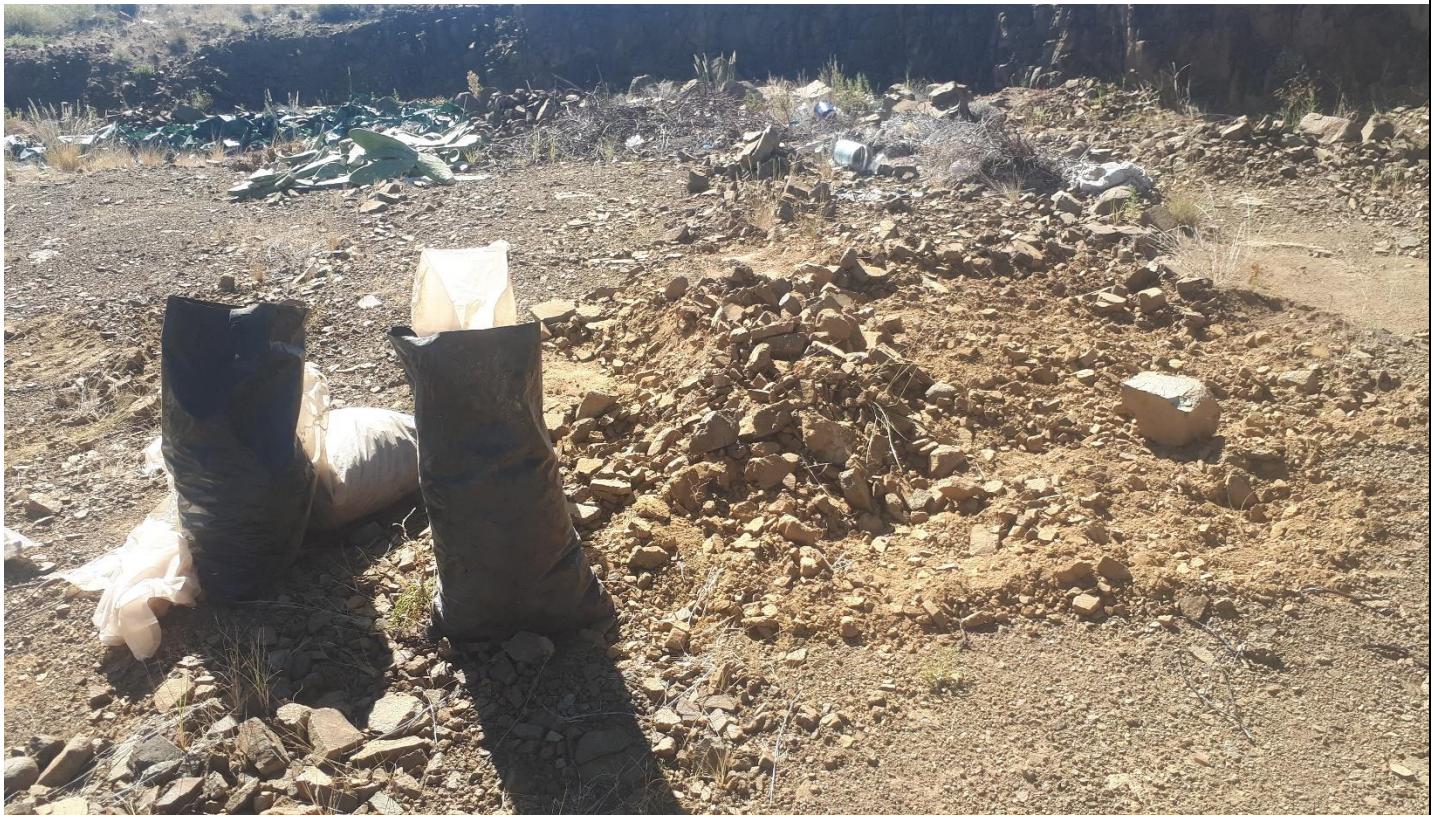
Picture 5. test pit 2 (by GPS coordinate 30°36'39.06"S 25°29'0.22"E) within borrow pit 3.

This is test pit 2 (by GPS coordinate 30°36'39.06"S 25°29'0.22"E) within borrow pit 3.

This borrow pit has been selectively excavated, previously.

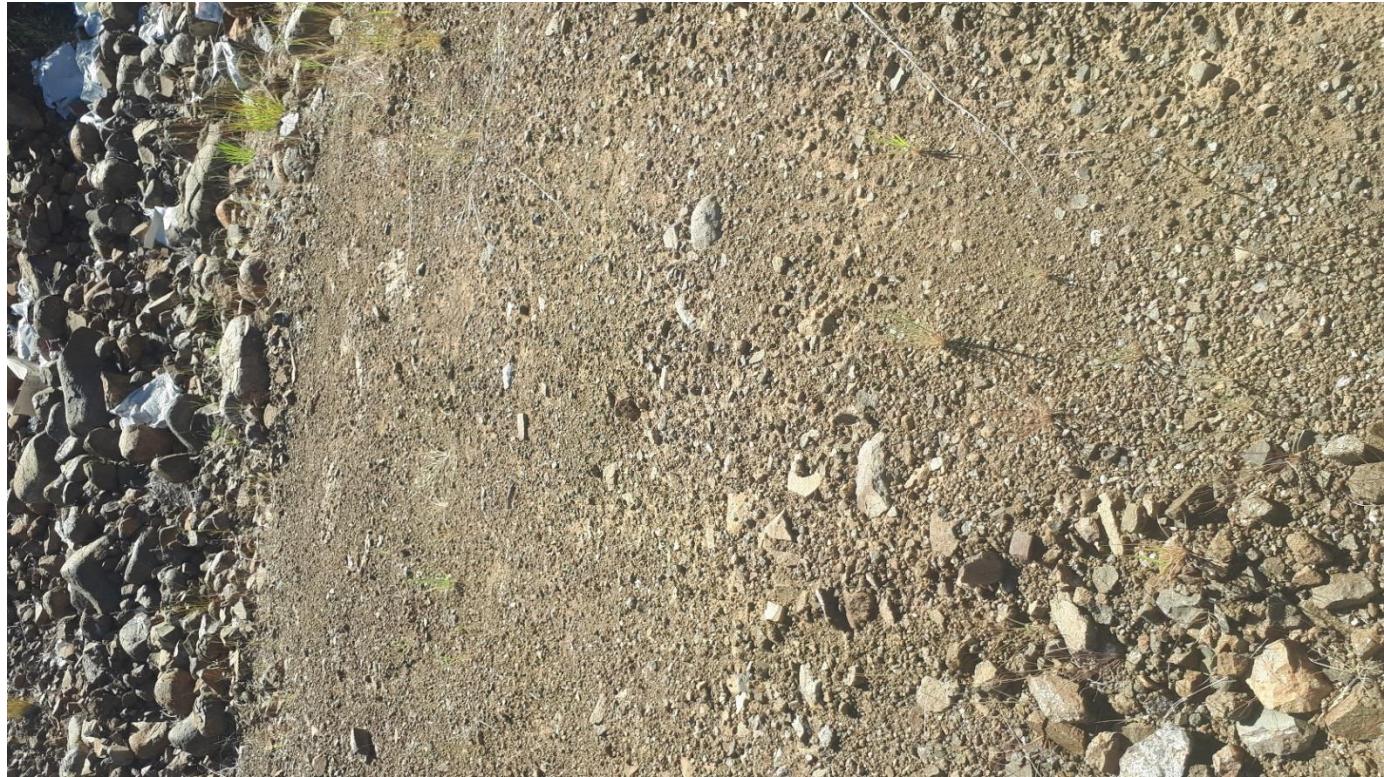
Picture 6. Illustrates test pit 1 (by GPS coordinate 30°36'40.20"S 25°28'31.32"E) within borrow pit 4.

This is test pit 1 (by GPS coordinate 30°36'40.20"S 25°28'31.32"E) within borrow pit 4.

This borrow pit has been selectively excavated, previously.

No rock dust matrix observed, but mainly top soil present.

Unweathered rock, MUDSTONE, need to be drilled and blasted in order to be excavated.

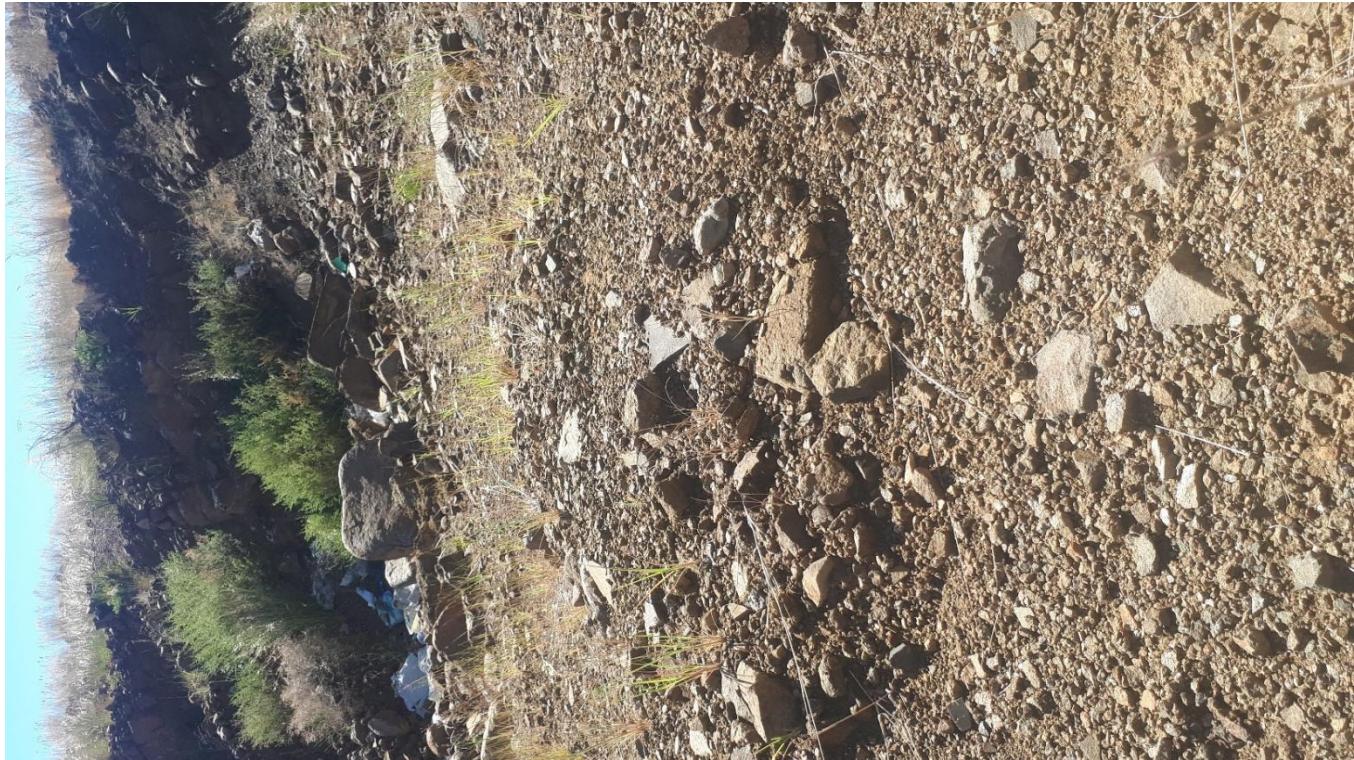
This is test pit 2 (by GPS coordinate 30°36'37.86"S 25°28'32.68"E) within borrow pit 3.

This borrow pit has been selectively excavated, previously.

No rock dust matrix observed, but mainly top soil present.

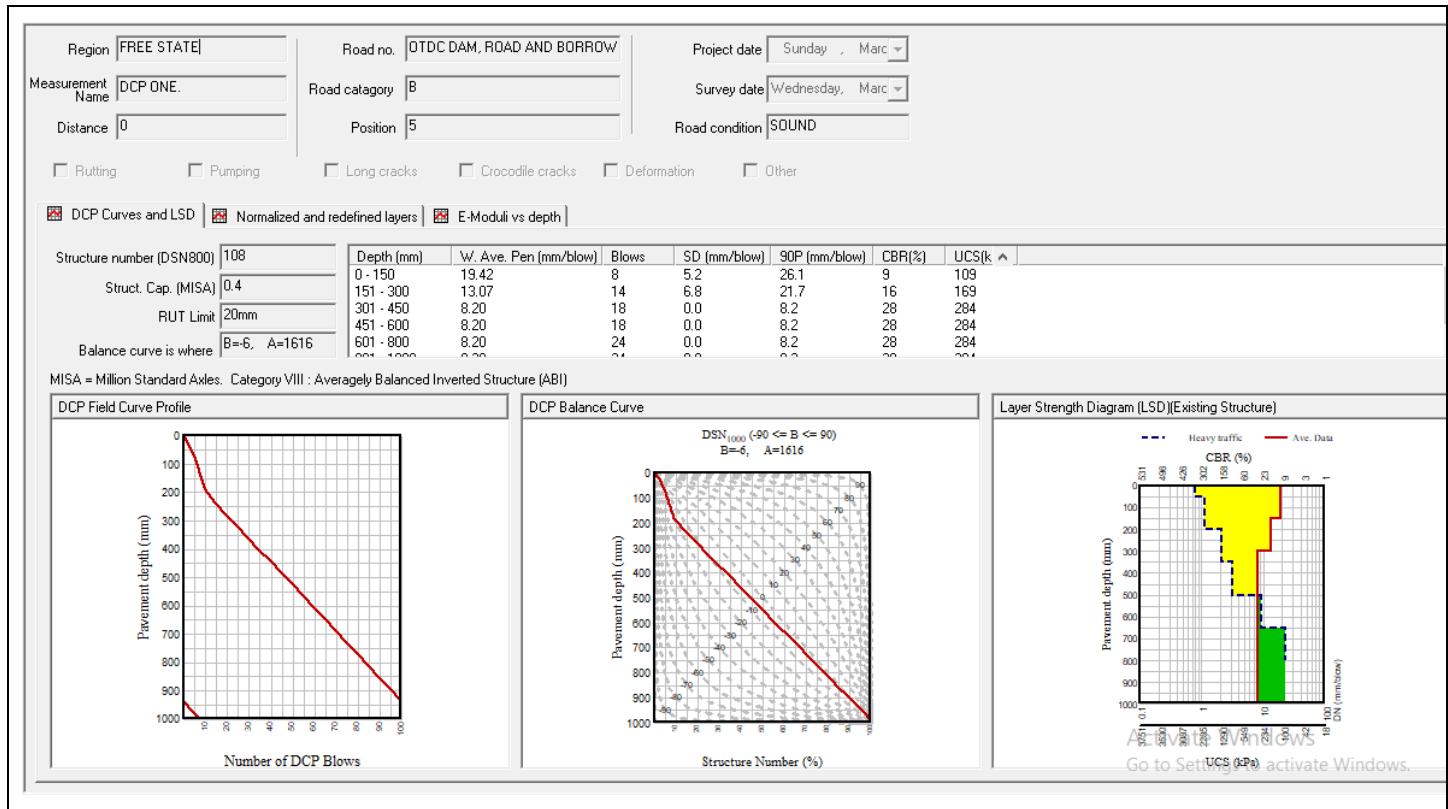
Figure 10 The summary of the representative DCP test results and interpretation within the construction site.

The DCP test further depicts homogeneous alluvial SILT, i.e. no boulders or rocks that disturbed the penetration within the construction site. See the above figure for further engineering properties.

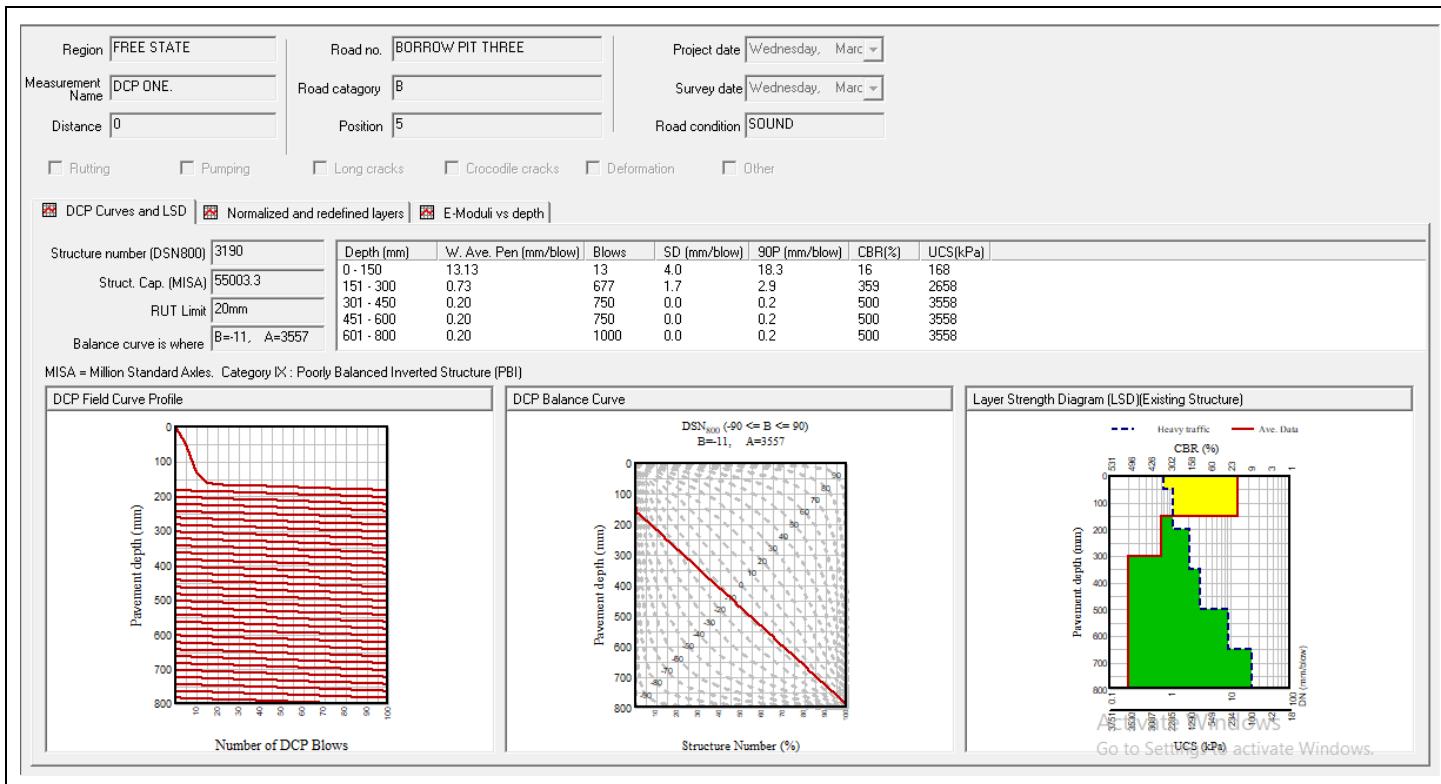
Figure 11. The summary of the representative DCP test results and interpretation within borrow pit. The DCP test penetrated top soil and immediately intersect refusal at 189 mm due to the bed rock. NB DCP TEST 2 WWITHIN BORROW PIT 2, 3 AND 4 IS DISCARDED, DUE TO ROCK OUTCROPS.
