ANNEXURE A: PICTORIALS KNIGHTS

PASSENGER RAIL AGENCY OF SOUTH AFRICA

ANNEXURE A: PICTORIALS KEMPTON PARK

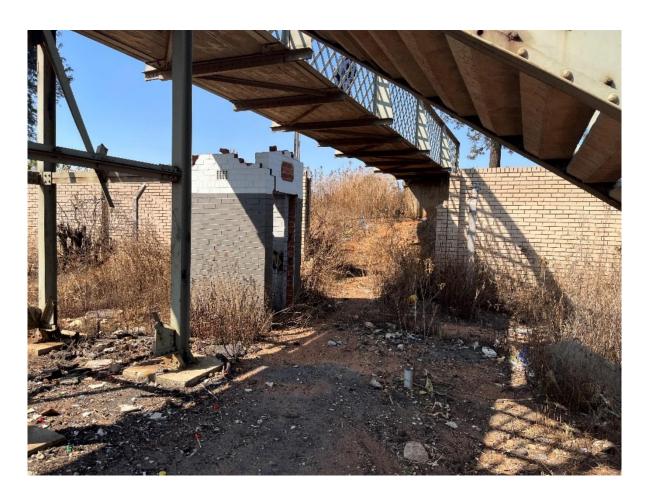
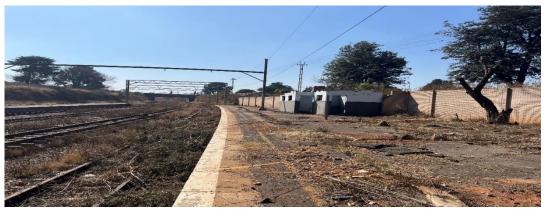
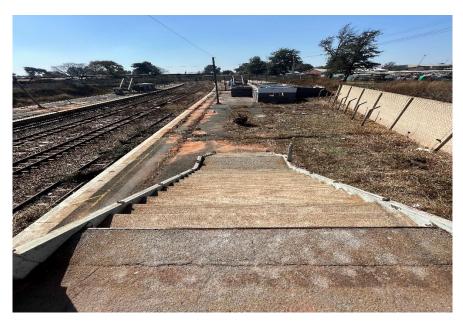
Vandalised Buildings and Infrastructure

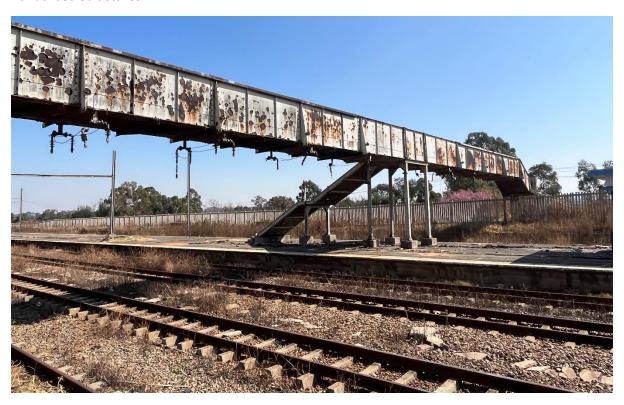
Vandalised Structures
