STAGE TWO: CONCEPT REPORT
GROOTE SCHUUR ESTATE MUSEUM

OVERALL ASSESSMENT & IDENTIFICATION OF KEY PRIORITY AREAS AND REPAIR & MAINTENANCE CONCEPT
Groote Schuur Estate, Rondebosch,
Cape Town, Erf 46165.

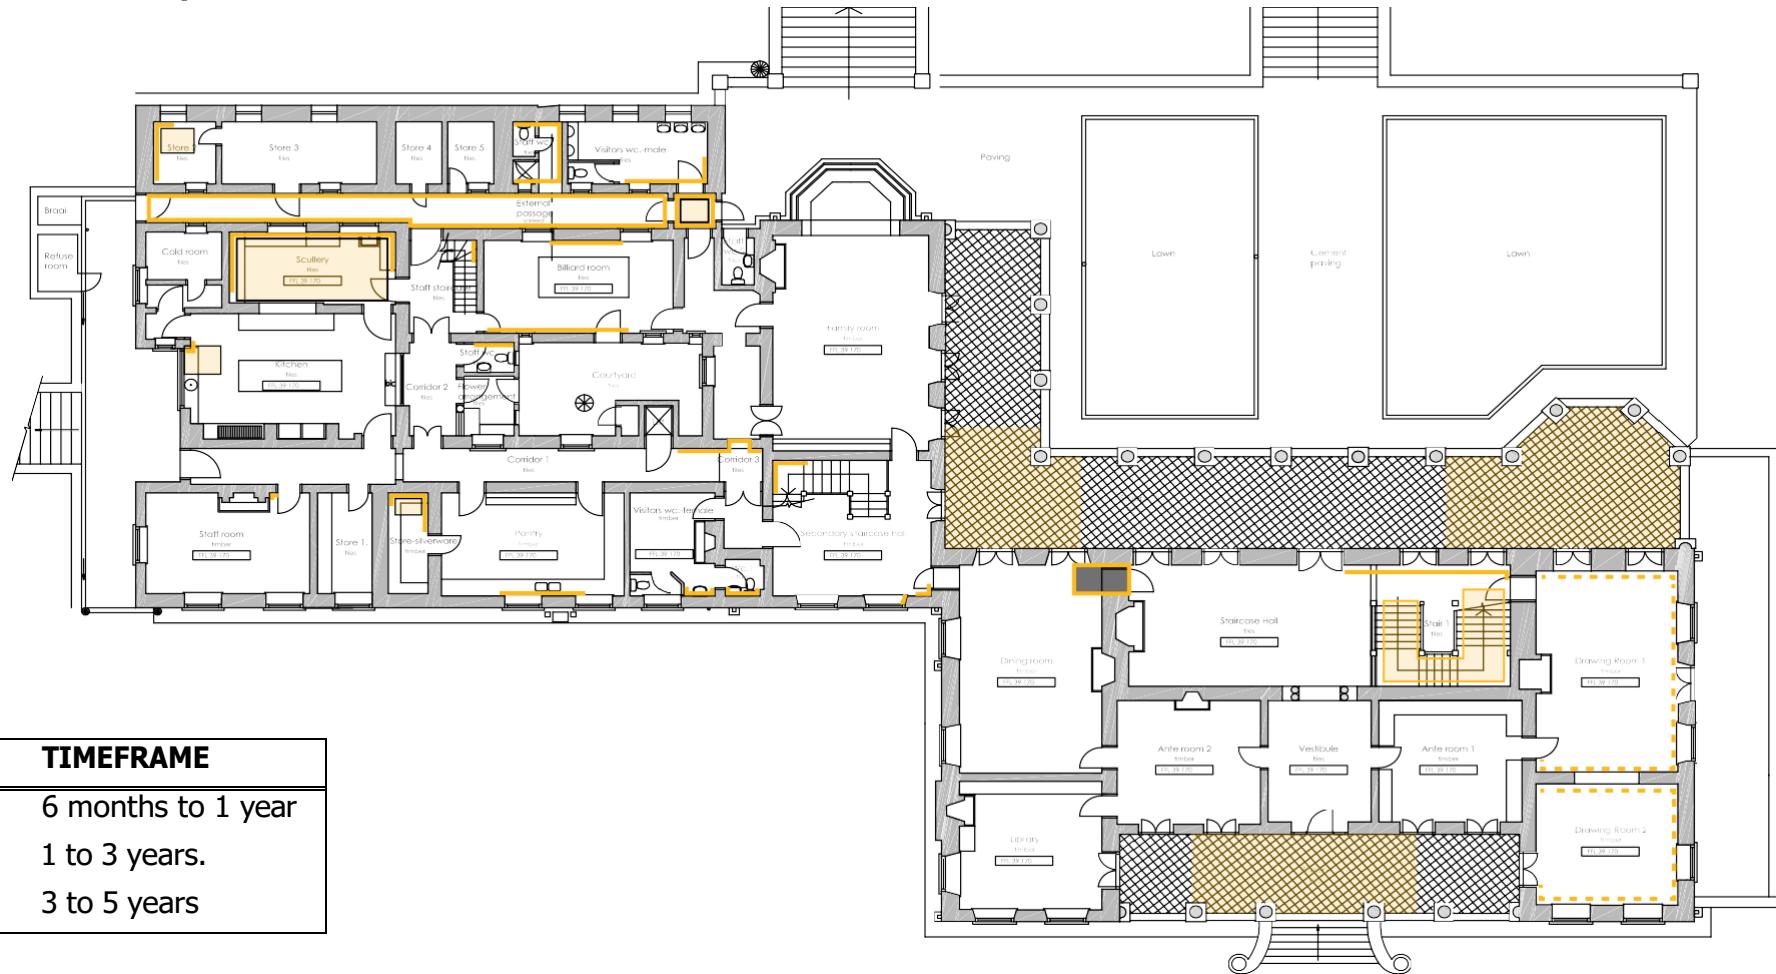
ground floor plan
scale 1:100

CATEGORY	TIMEFRAME
'Cat a'	6 months to 1 year
'Cat b'	1 to 3 years.
'Cat c'	3 to 5 years
