ANNEXURE A: PICTORIALS ISANDO

ANNEXURE A: PICTORIALS Tembisa

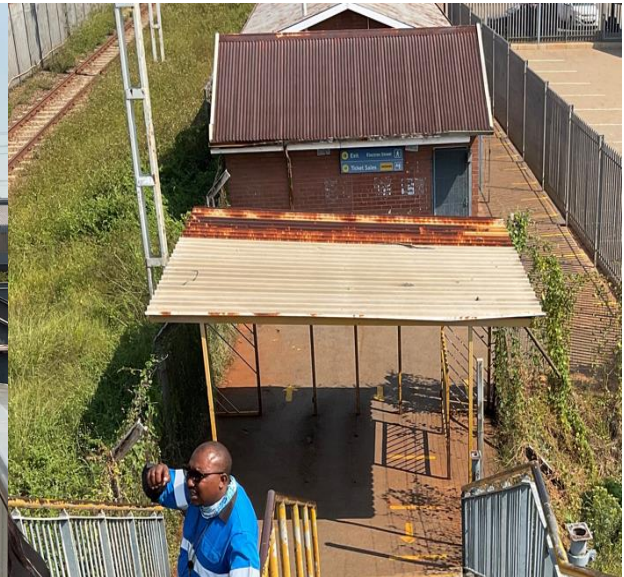
Figure S01: Platform Entrance Facility 01 – Poor maintenance of steel members and ageing of the facility but structurally sound. No structural defects observed.

Figure S02: Entrance Facility 02 – Structure appears stable but aluminium sheeting have minor rust and sagging.

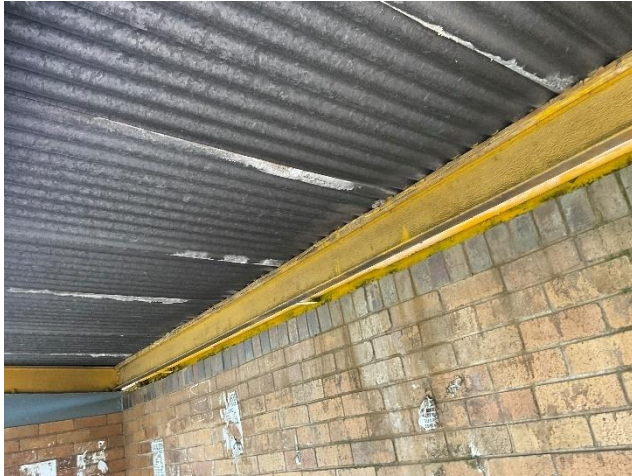
Figure S13: Platform Shelters – white rust as surface zinc observed on aluminium roof sheeting

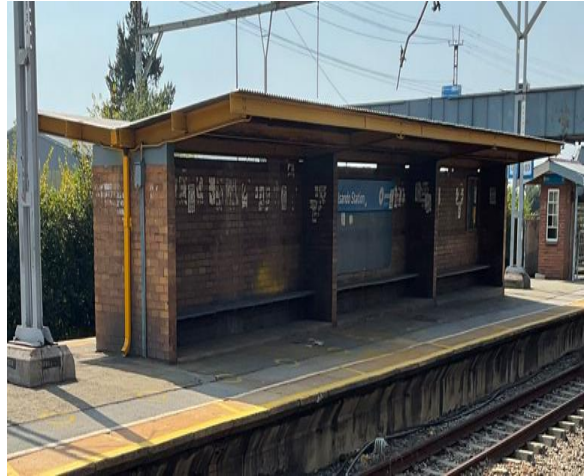
Figure S14: Platform Shelters - structurally sound

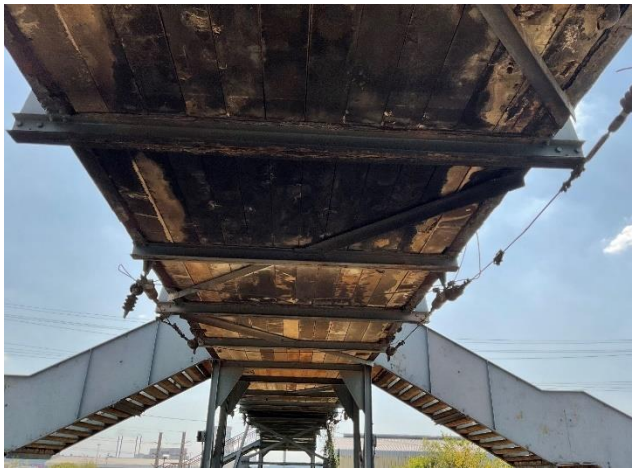
Figure S15: Bridges - fire damages on steel members and precast concrete slabs

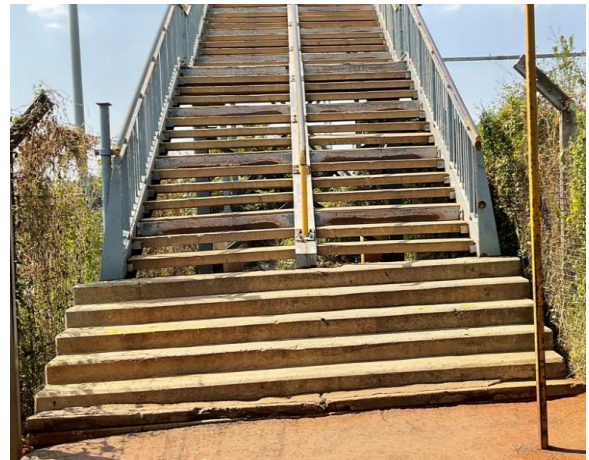
Figure S16: Bridge stairs – precast concrete members have cracks

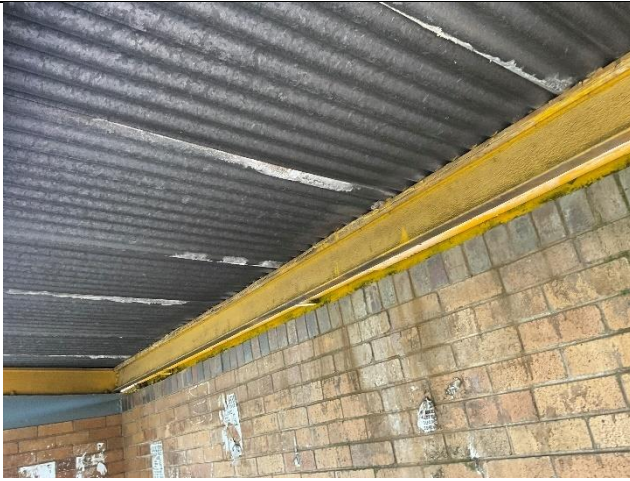
Figure S13: Platform Shelters – white rust as surface zink observed on aluminium roof sheeting

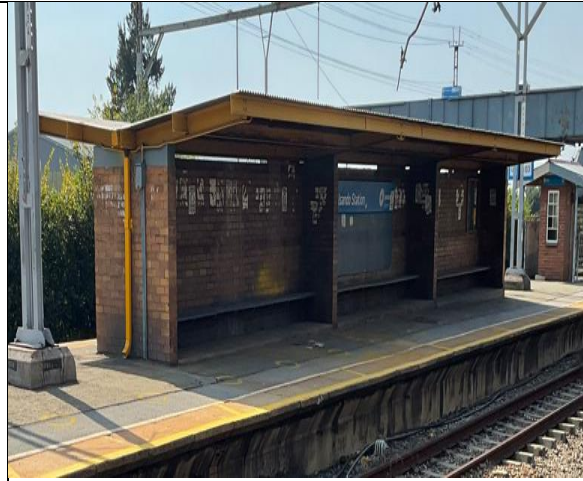
Figure S14: Platform Shelters - structurally sound

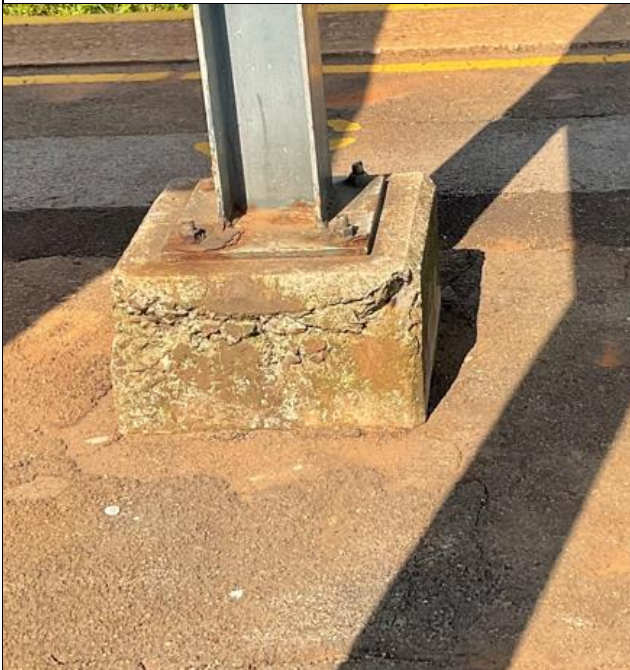
Figure S19: Bridges Supports – Cracked concrete plinths

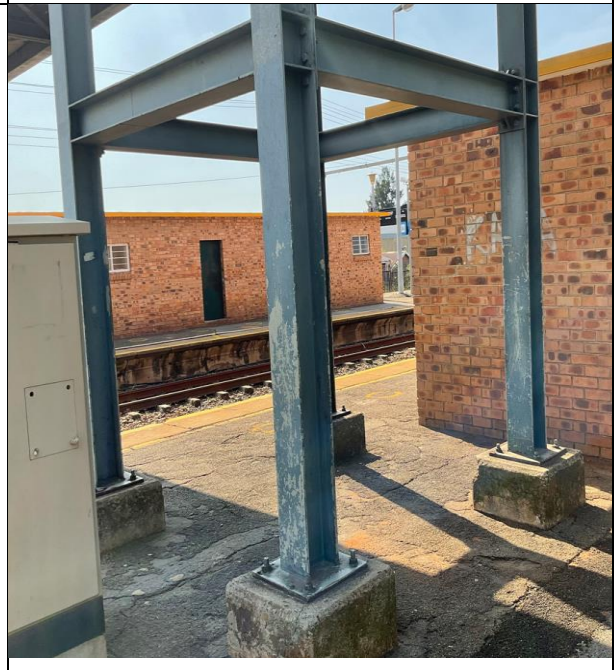
Figure S20: Bridges column supports – Concrete plinths and steel columns are structurally sound

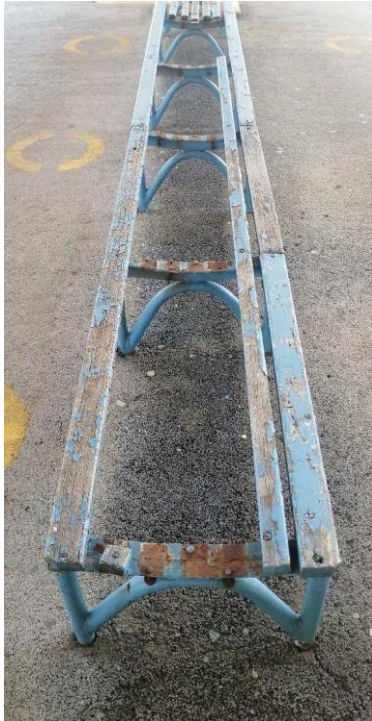
Vandalised Benches

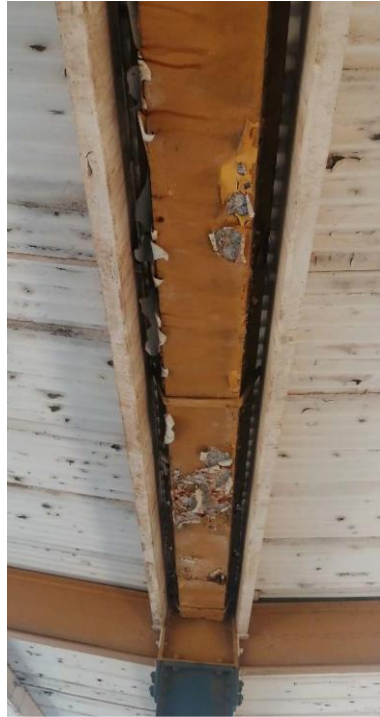
Rusted members and gutters on shelter

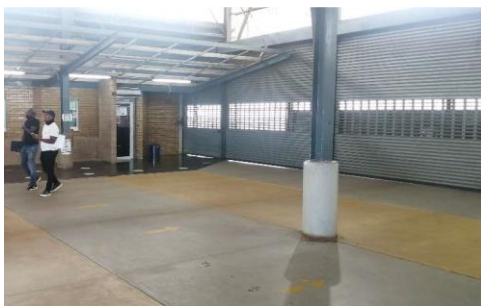
Damaged Polycarbonate Sheeting

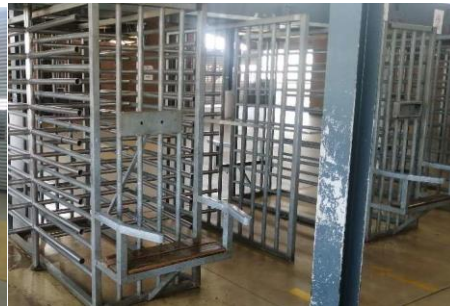
Cumbersome TVP

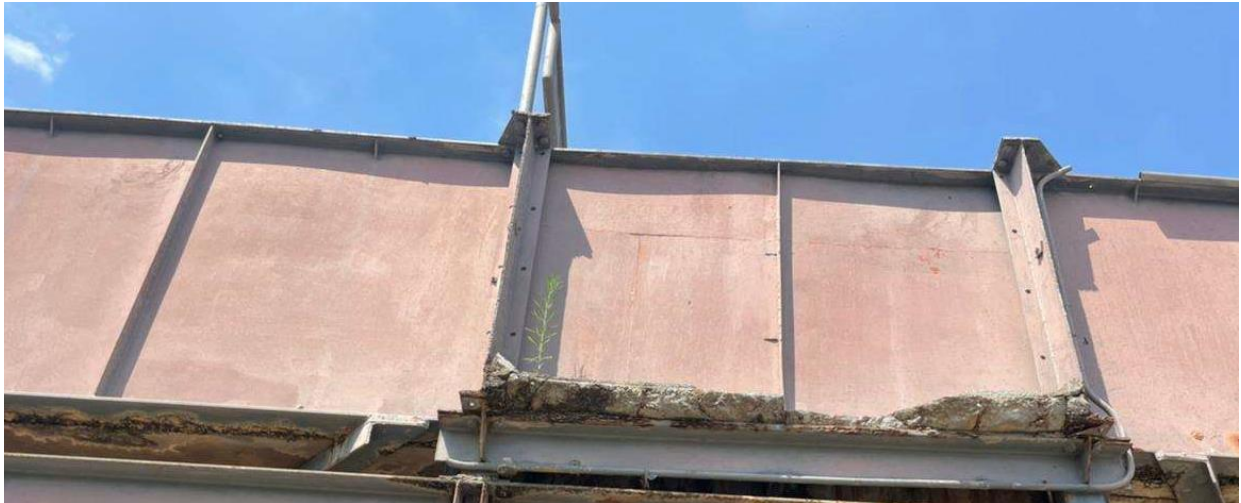
Rusted Pedestrian Bridge
