<p style="text-align: center;"><b>Scope of Work</b></p>	<p style="text-align: center;"><b>Tutuka Power Station</b></p>
---	---	--

Title: **Refurbishment of Coal Silo 1-6 Scope of Work** Document Identifier: **15ENG CIVIL-2041**

Area of Applicability: **Tutuka Power Station**

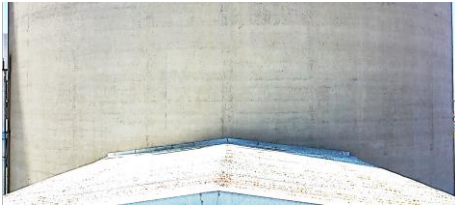
<p>West, bottom of silo. Evidence of deterioration of the concrete silo wall and porous concrete. Evidence of damage and corrosion to the bottom conveyor roof sheeting and flashing.</p>

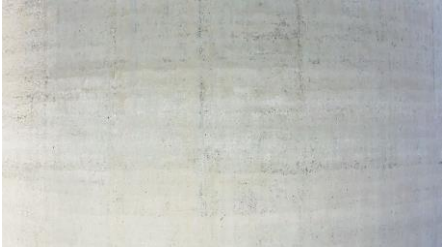
<p>West, bottom of silo. Evidence of deterioration of the concrete silo wall, and of porous concrete.</p>

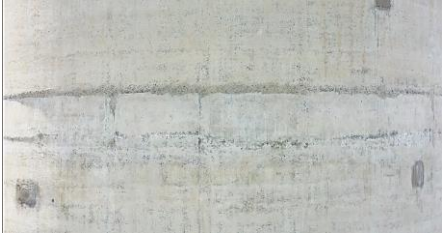
<p>West, middle of the silo. Evidence of deterioration of the previous repairs and of the concrete, and of porous concrete. Evidence of horizontal construction/cold joints with white sulphate deposits.</p>

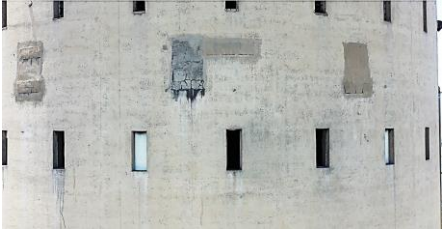
<p>West, at the silo roof slab level under the conveyor gantry. Evidence of deterioration of the concrete, previous concrete repairs, and of porous concrete.</p>

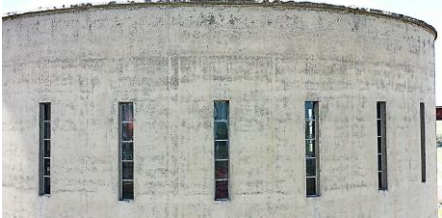
<p>West, at the silo roof level. Evidence of a possible horizontal construction/cold joint, porous concrete, and deterioration of the concrete.</p>

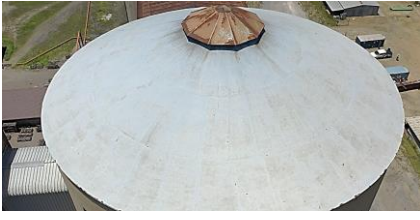
<p>West, at silo roof level. Evidence of deterioration of the roof waterproofing and corroded top steel cone.</p>

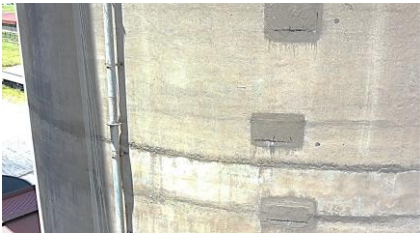
<p>North-West, above the middle of the silo wall. Evidence of deterioration of the previous repairs and the concrete silo wall, and of porous concrete. Evidence of possible construction/cold joints.</p>

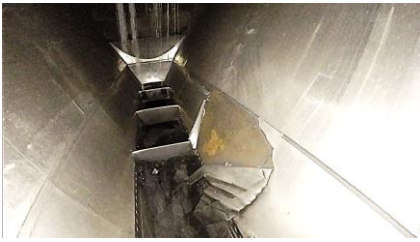
<p>East (bottom), damage and missing areas of the stainless-steel hopper liner plates above the conveyor spiral bars on the south of the hopper wall.</p>

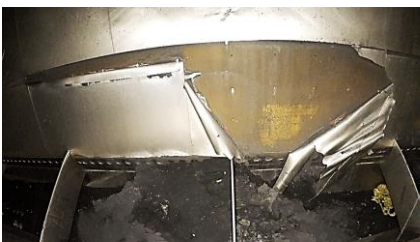
<p>South (bottom), evidence of damaged, and missing areas of the stainless-steel hopper liner plates. Concrete surface of the hopper starts to show degradation. Immediate repairs and replacement of stainless-steel hopper plates needed.</p>

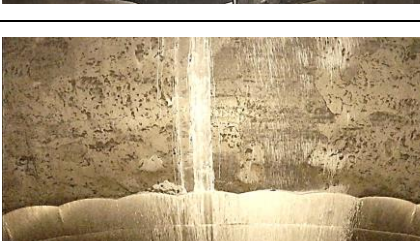
<p>East bottom above the circumferential stainless-steel silo wall liner plate. Evidence of degradation, porous concrete, an, abrasion of the silo concrete wall. Evidence that a cementitious coating was applied on the existing concrete degradation face of the concrete silo wall. Evidence that this cementitious.</p>

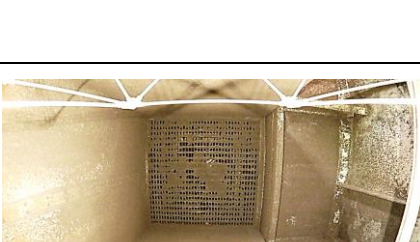
<p>North (top), evidence of corrosion of the roof slab steel support beams, and evidence of corrosion on the extraction fan steel casing and steel grid.</p>

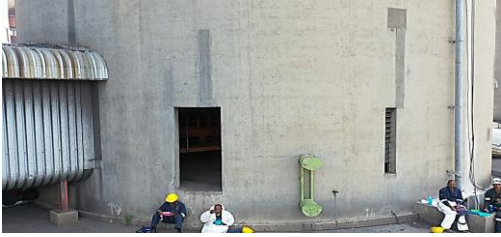
<p>South-West, bottom of silo. Evidence of failure of previous repairs.</p>

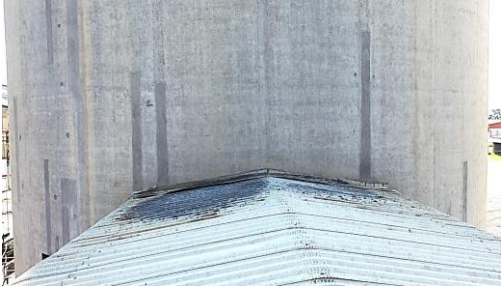
<p>West, bottom of silo. Evidence of previous repairs, still in good condition. Evidence of damage and corrosion to the bottom conveyor roof sheeting and flashing.</p>

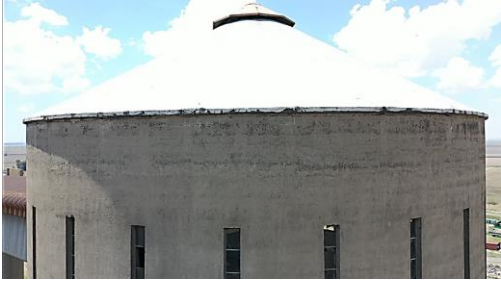
<p>North, at silo roof level. Evidence of concrete deterioration, and deterioration of the roof waterproofing.</p>

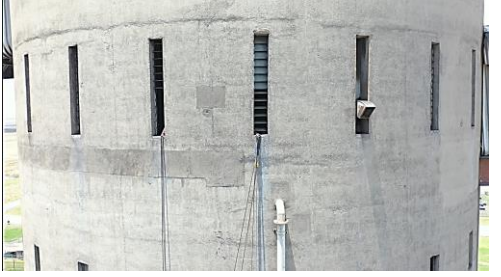
<p>North above the roof slab level. Evidence of deterioration of concrete, and failure of the previous repairs. Evidence of a horizontal construction joint.</p>

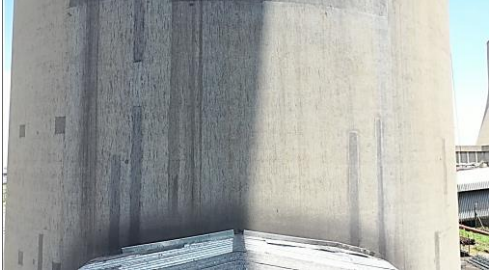
<p>East, bottom of the silo above the extraction conveyor gantry. Evidence of failure of the previous concrete repairs, and concrete deterioration.</p>

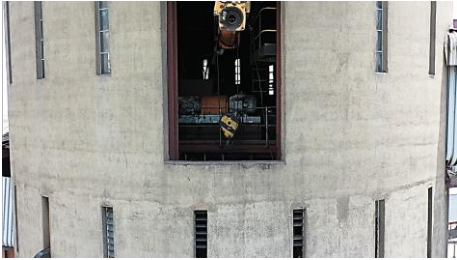
<p>South, top of the silo. Evidence of concrete deterioration and previous concrete repairs. Evidence of a possible horizontal construction/cold joint.</p>

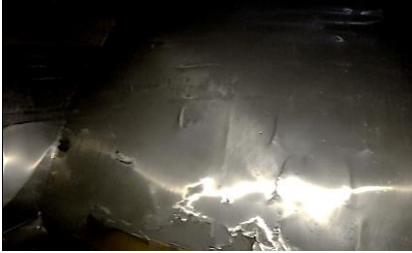
<p>North-West corner (bottom), damaged and missing areas of the stainless-steel hopper liner plates.</p>

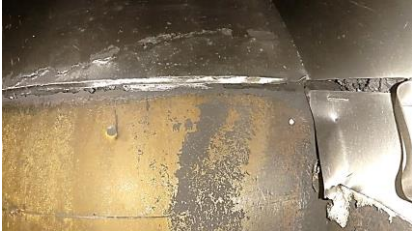
<p>South (bottom), west corner, damaged and missing stainless-steel hopper liner plates. Concrete surface of the hopper starts to show degradation. Immediate repairs and replacement of stainless-steel hopper plates needed.</p>

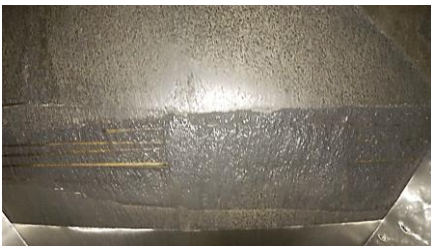
<p>North-West corner (bottom), damaged areas of the stainless-steel hopper liner plates. Evidence of corroded and damaged exposed rebar and degradation of the west mass concrete hopper wall.</p>

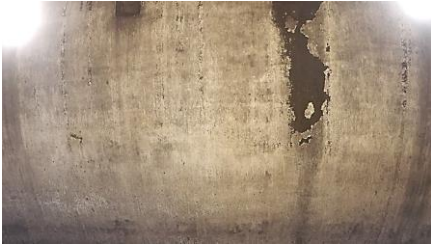
<p>North (top), concrete degradation, abrasion, and sulphate deposits on the silo wall. Evidence of a small crack in the silo wall.</p>

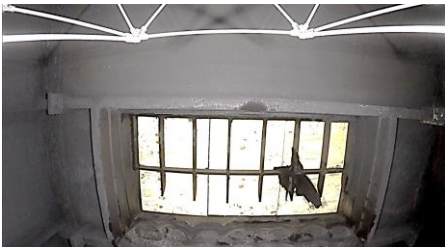
<p>South (top), soffit of the roof slab. Evidence of damage to the steel grid in the opening of the feed conveyor.</p>

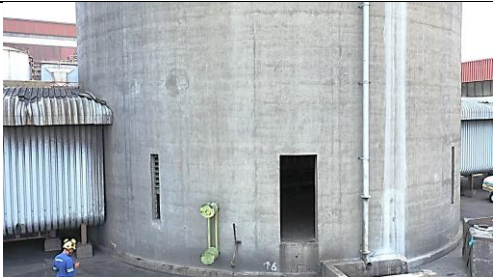
<p>South-West, bottom of silo. Evidence of severe corrosion and damage to the conveyor roof sheeting. Evidence of a construction/cold joint and deterioration of the previous concrete repairs and concrete silo wall.</p>

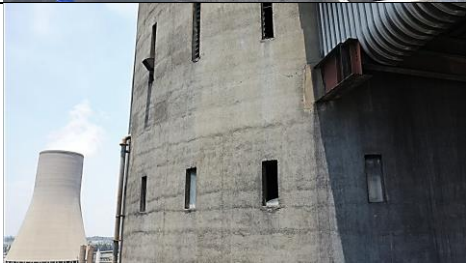
<p>West, at silo roof slab level under the conveyor gantry. Evidence of deterioration of a previous repair and the concrete, and corrosion of the steel conveyor. Evidence of possible horizontal cracks.</p>

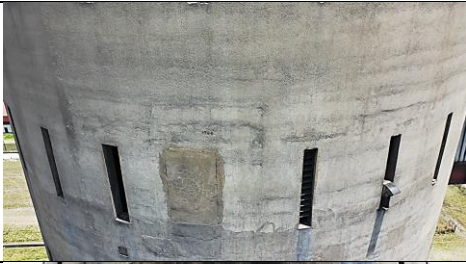
<p>North, above the roof slab level. Minor concrete spalling at windowsills and evidence of concrete deterioration. Evidence of previous concrete repair deterioration and failure, and possible horizontal cracks.</p>

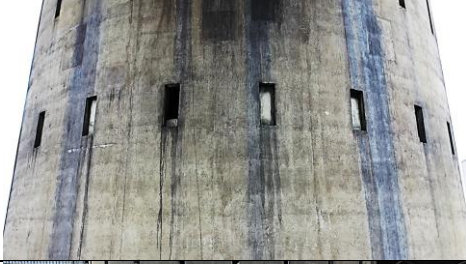
<p>East, top under the silo roof slab. Evidence of concrete deterioration and missing and broken windowpanes.</p>

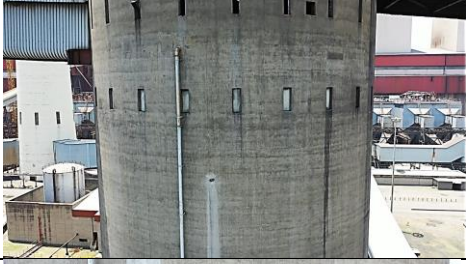
<p>South, top of the silo. Evidence of concrete deterioration, failure of previous concrete repairs, and concrete spalling at the openings. Evidence of possible horizontal cracks and a construction/cold joint. Location of the top concrete core and NDT tests.</p>

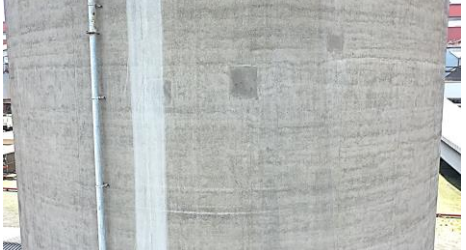
<p>South, between the bottom and the middle of the silo. Evidence of concrete deterioration, porous concrete, and failure of previous concrete repairs. Evidence of a possible horizontal crack, and a horizontal construction/cold joint.</p>

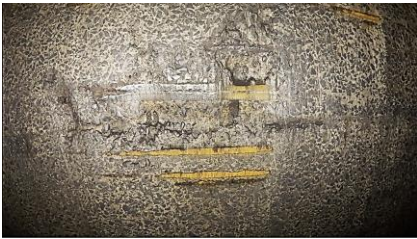
<p>East (bottom), damaged and corroded rebar. Deterioration and loss of fines on the concrete hopper wall above the stainless-steel hopper liner.</p>

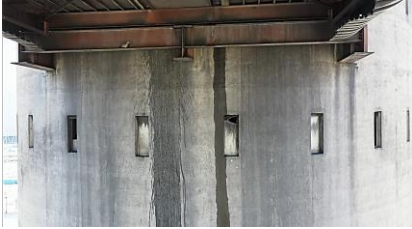
<p>West, at silo roof slab level under the conveyor gantry. Evidence of concrete deterioration.</p>

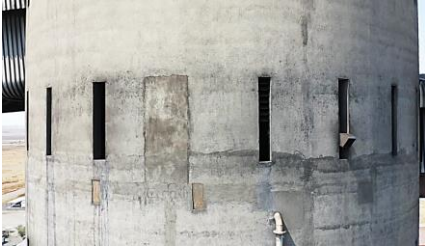
<p>North-West, above the roof slab level. Evidence of deterioration of concrete, failure of the previous repairs, and of horizontal cracks.</p>

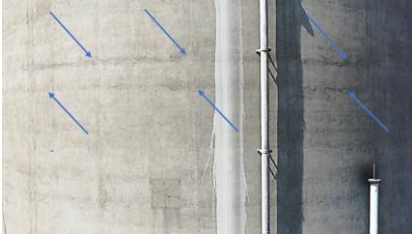
<p>North, above the bottom of the silo wall. Evidence of failure of the previous concrete repair and deterioration of the concrete silo wall. Evidence of possible horizontal cracks.</p>

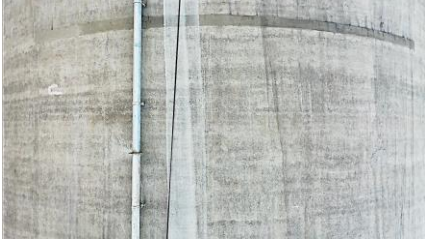
<p>South, top of the silo. Evidence of concrete deterioration, and failure of previous concrete repairs.</p>

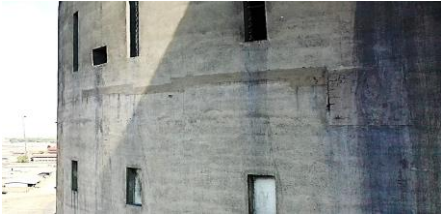
<p>South-East, top of the silo. Evidence of previous concrete repair failure, concrete deterioration, and concrete spalling at the window openings.</p>

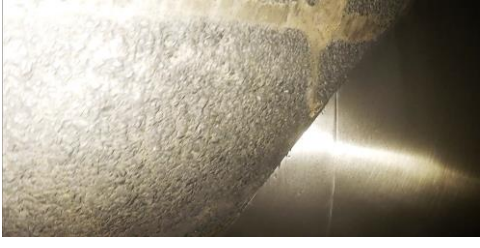
<p>North-West (bottom), corner of the hopper, exposed aggregate, fines missing due to abrasion of the coal.</p>
 	<p>North (top), the extraction fan casing is still intact but shows signs of corrosion.</p>

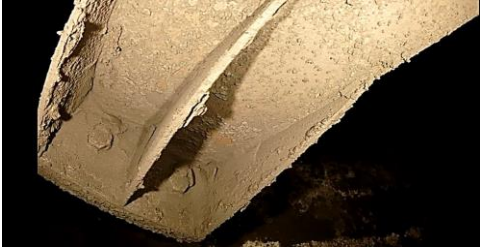
<p>East (top), Evidence of corrosion on the roof slab steel support beam.</p>
 	<p>West, evidence of concrete degradation with white and yellow/brownish sulphate deposits. Evidence of corrosion on the roof slab steel support beam.</p>

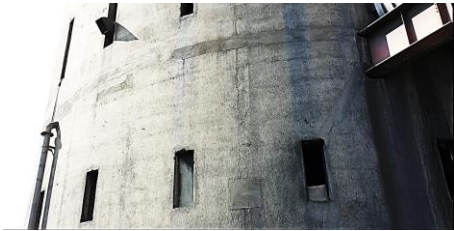
<p>North, at silo roof slab and conveyor gantry level. Evidence of previous repairs with minor deterioration.</p>

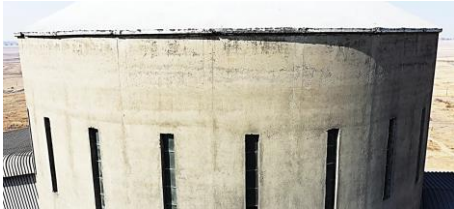
<p>North, evidence of concrete deterioration on the silo tube, below the silo roof.</p>

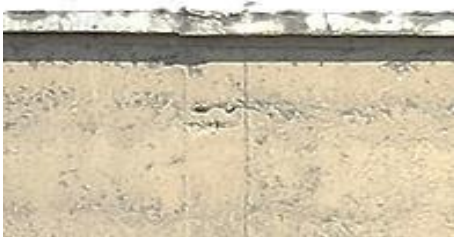
<p>East, Horizontal crack.</p>

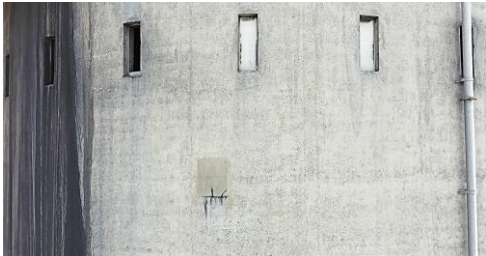
<p>South-West, previous concrete repairs with evidence of minor failure of the previous concrete repair.</p>

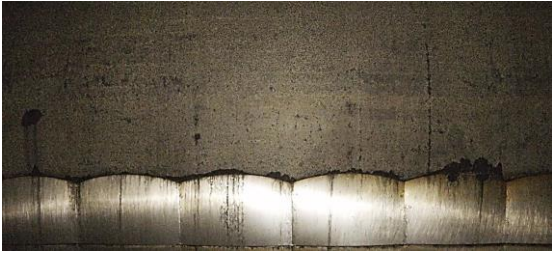
<p>North-West, concrete degradation, vertical cracks, and abrasion on the silo wall. Evidence of possible horizontal cracks on the rebar above the stainless -steel liner plate at the silo wall and concrete hopper transition.</p>

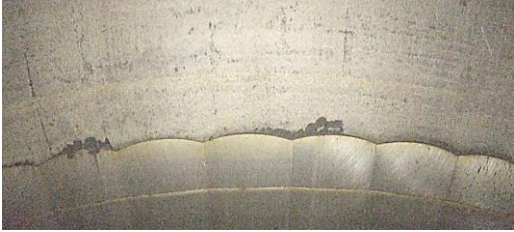
<p>North, concrete degradation, vertical cracks, and abrasion on the silo wall. Evidence of possible horizontal cracks on the rebar above the stainless -steel liner plate at the silo wall and concrete hopper transition.</p>

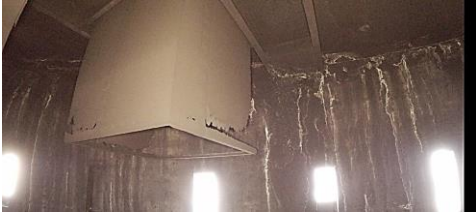
<p>North, concrete degradation, sulphate deposits, and abrasion on the silo wall under the silo roof slab. Evidence of corroded extractor fan casing.</p>

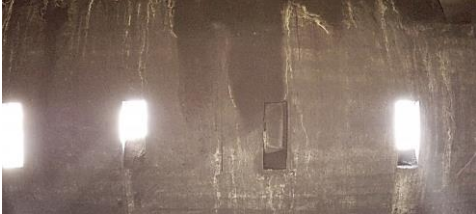
<p>North-East, concrete degradation, sulphate deposits, and abrasion on the silo wall under the silo roof slab.</p>

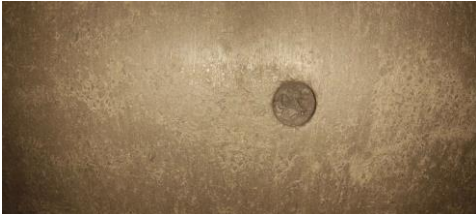
<p>South, abrasion on the silo wall and evidence of a previous core hole repair.</p>
