ANNEXURE "B" - STATIONS CURRENT AND VANDALISED PICTURES

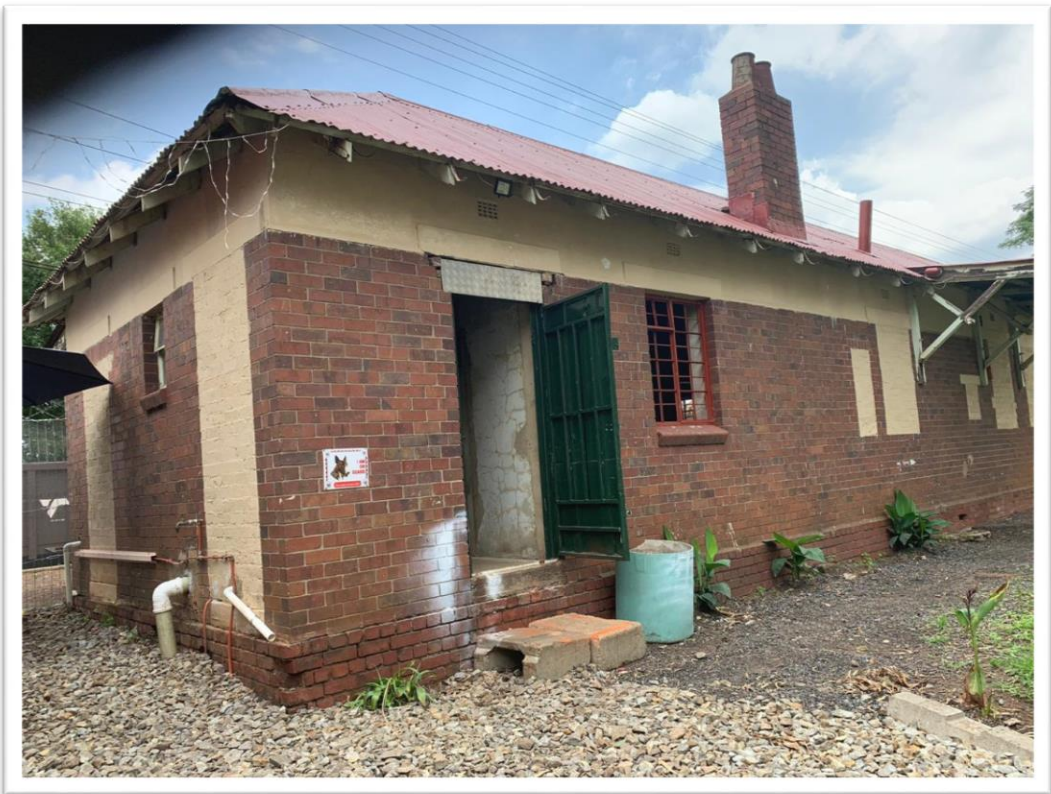
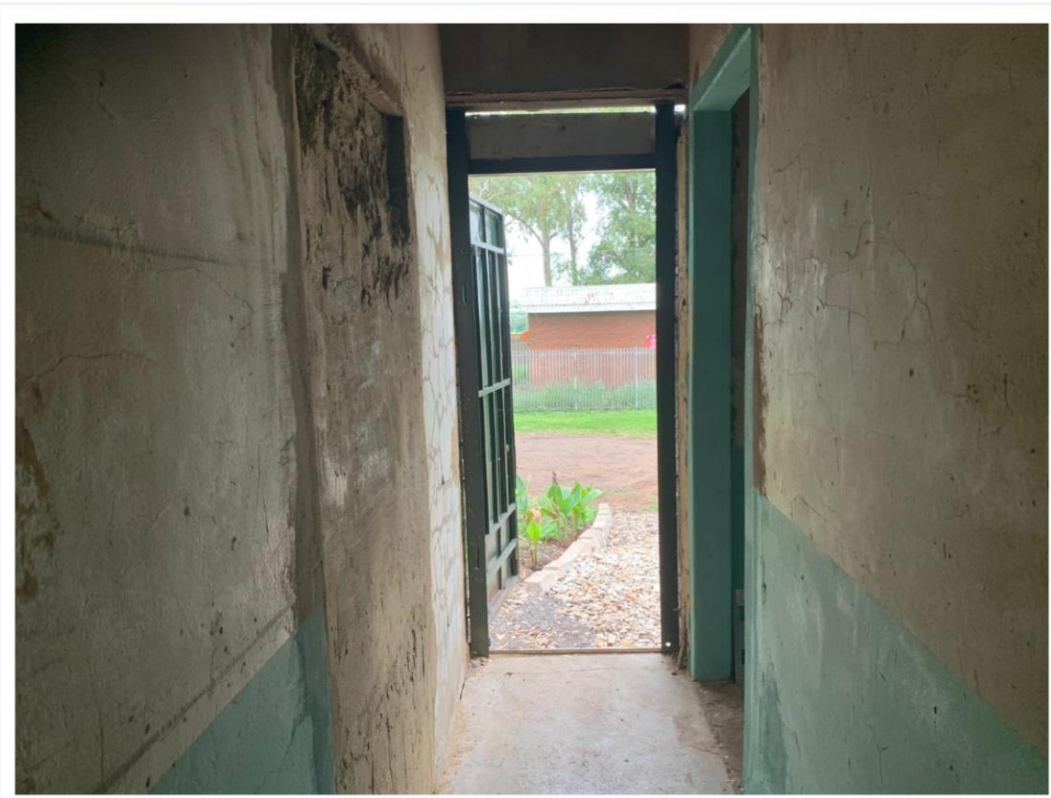
Physical deterioration of building due to vandalism and aging.

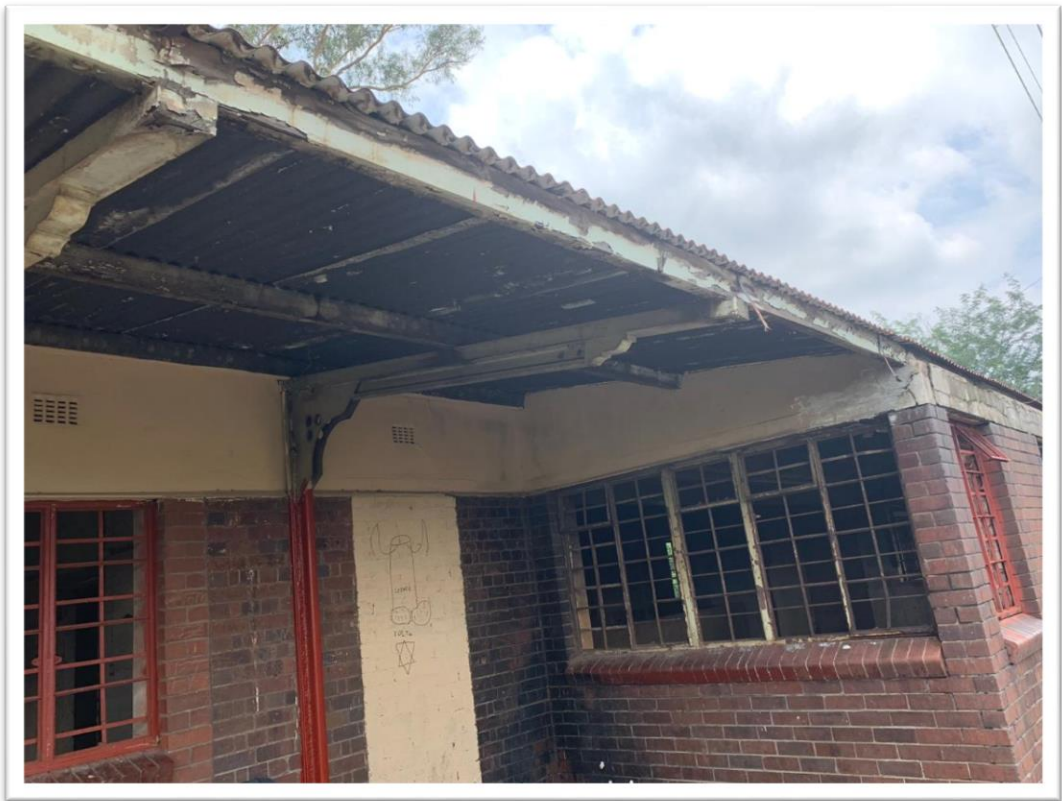
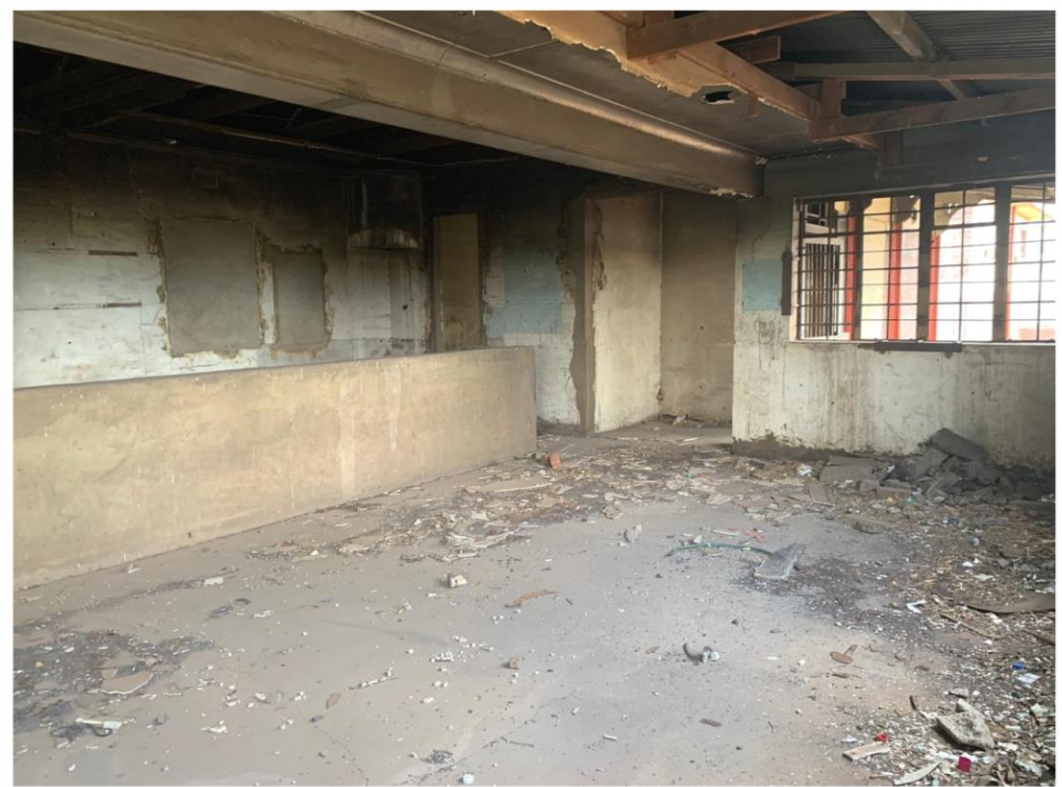
Functional obsolescence.

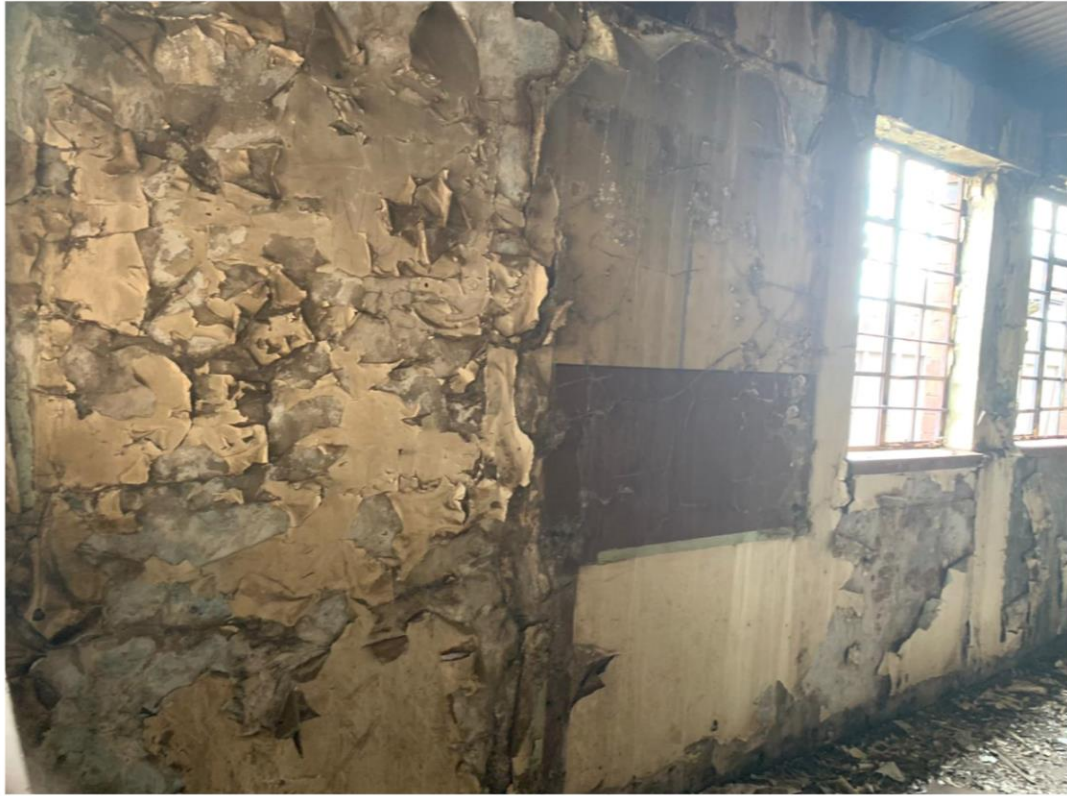
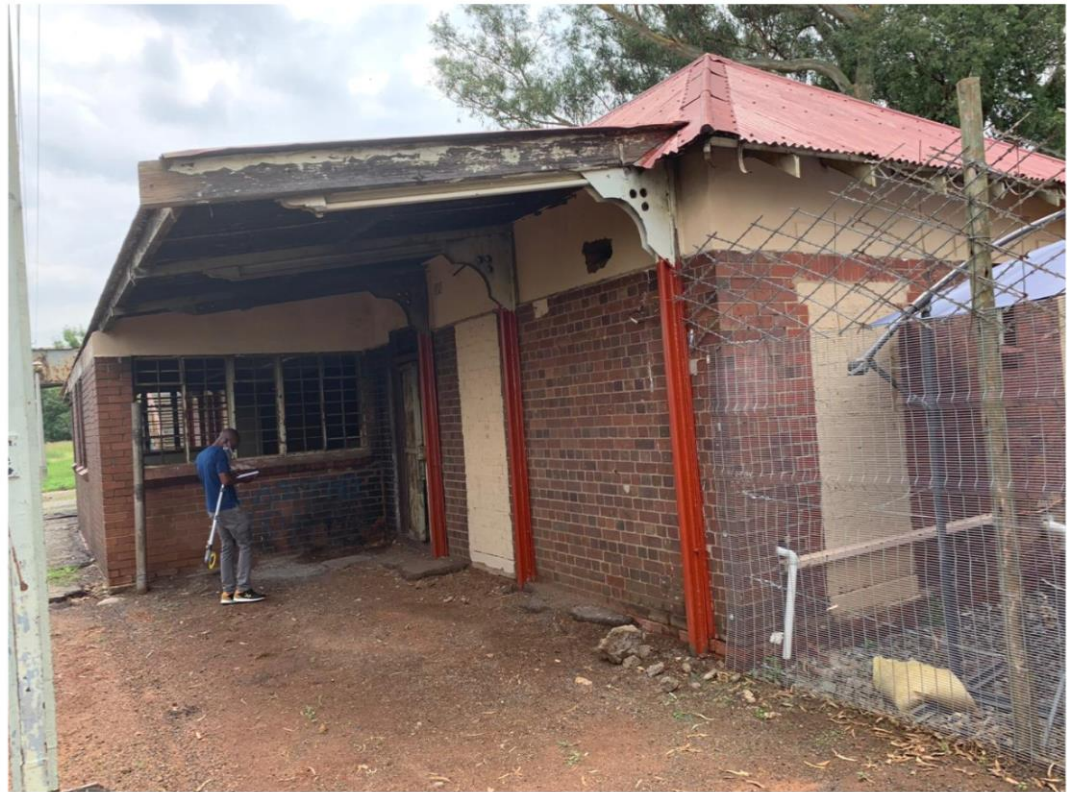
Burned building.

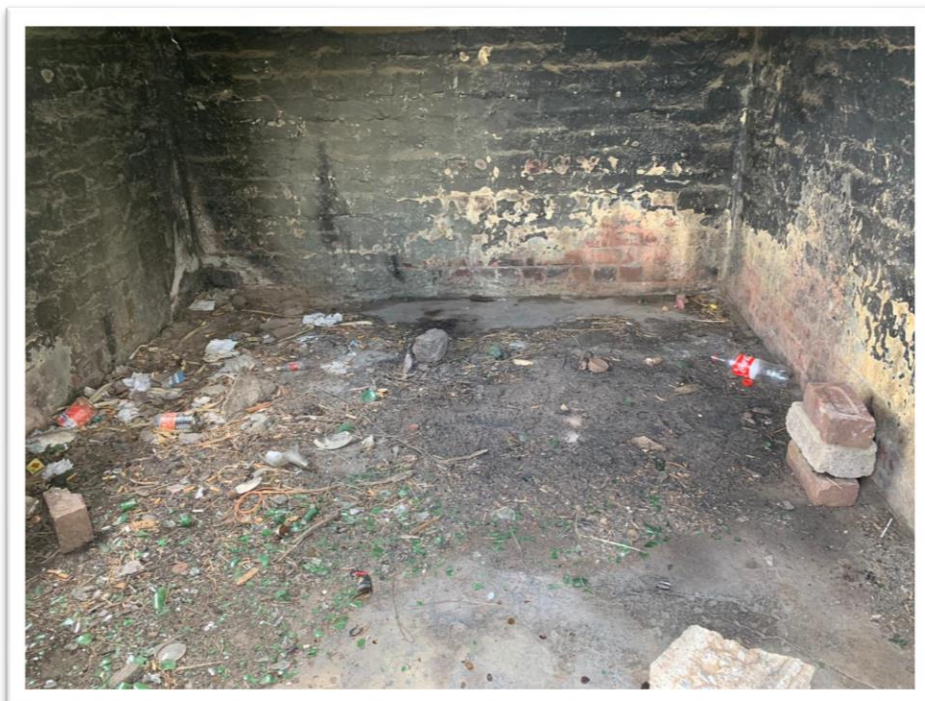
Burned building.

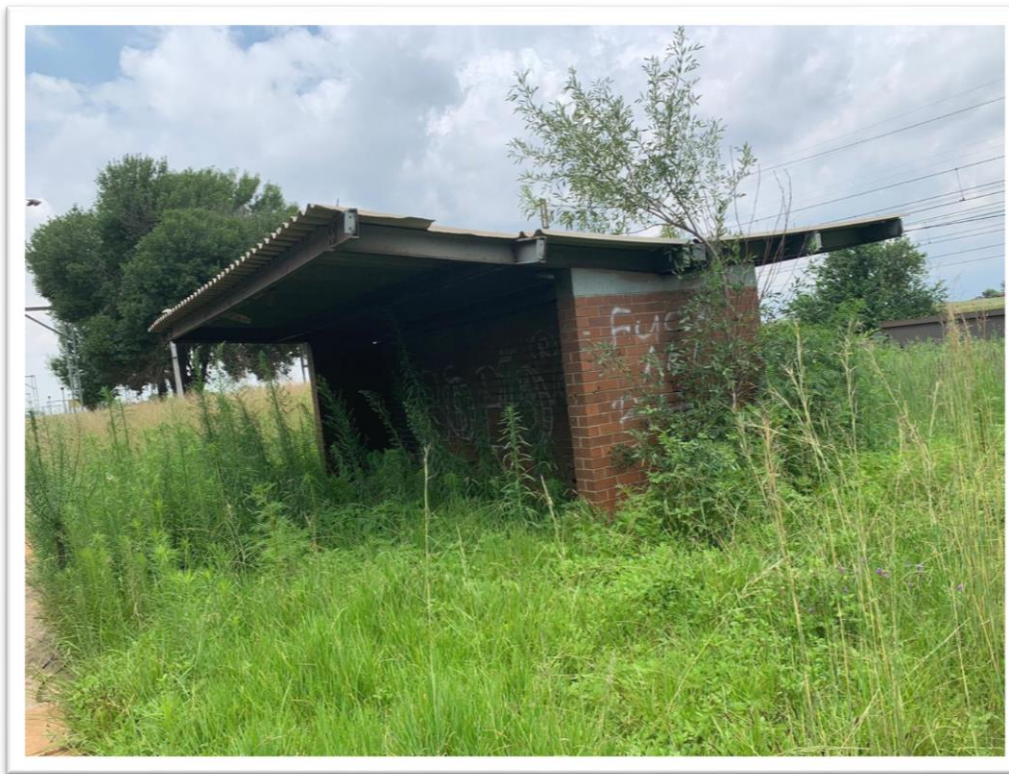
Vandalized and burned shelters.

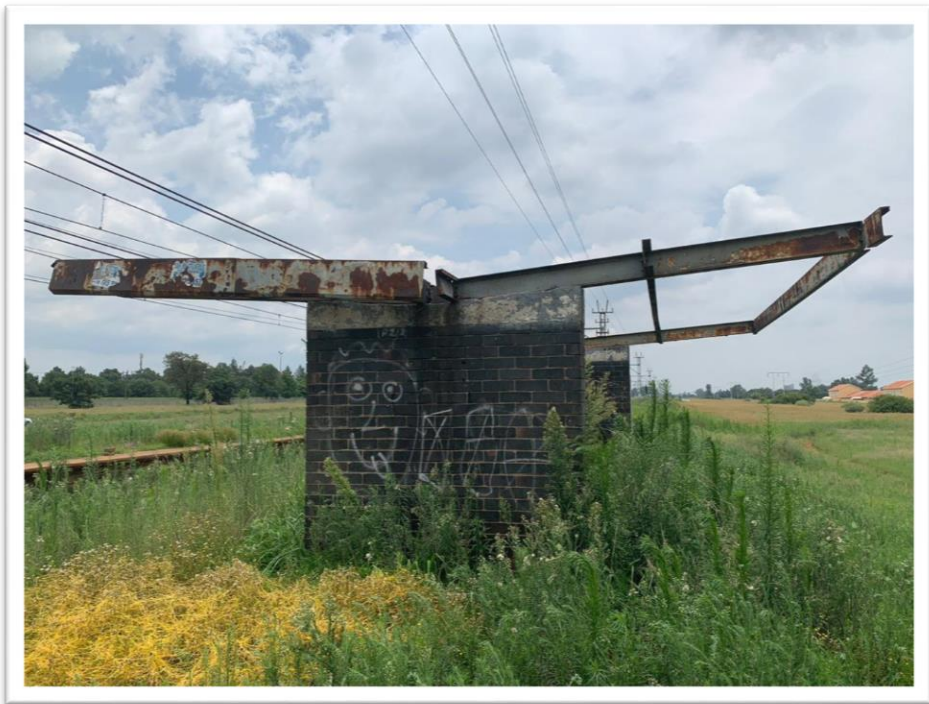
Vandalized Shelters.

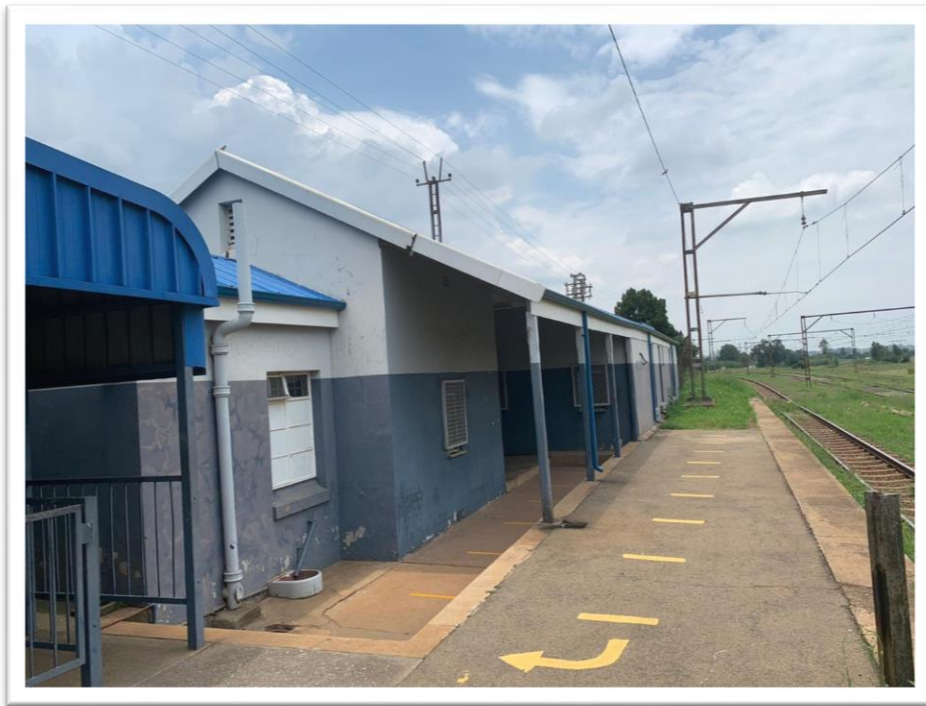
Aging paint on walls.

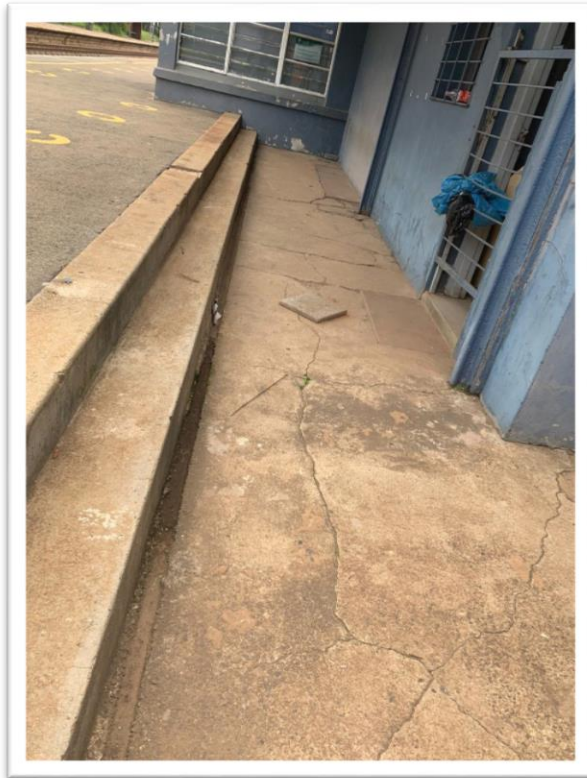
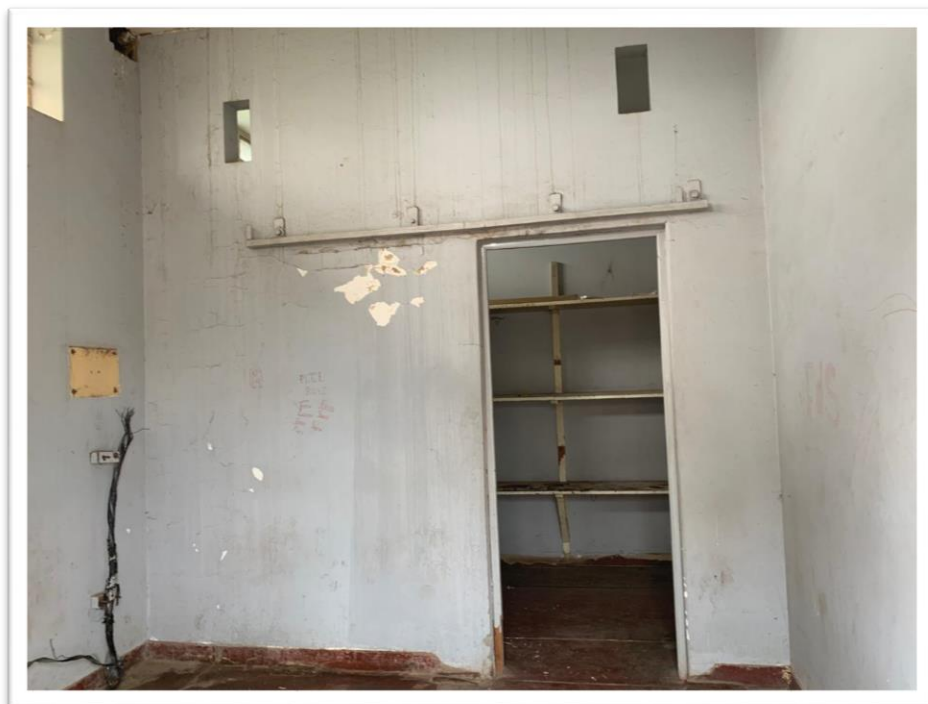
Physical deterioration of building due to aging, storm damage, and vandalism.

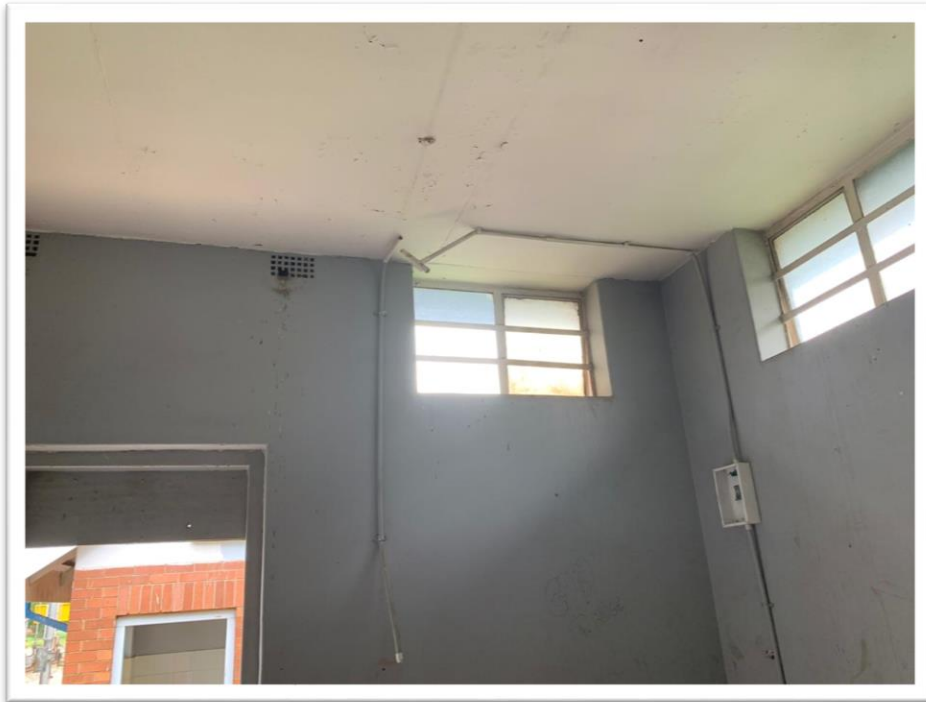
Physical deterioration of building.

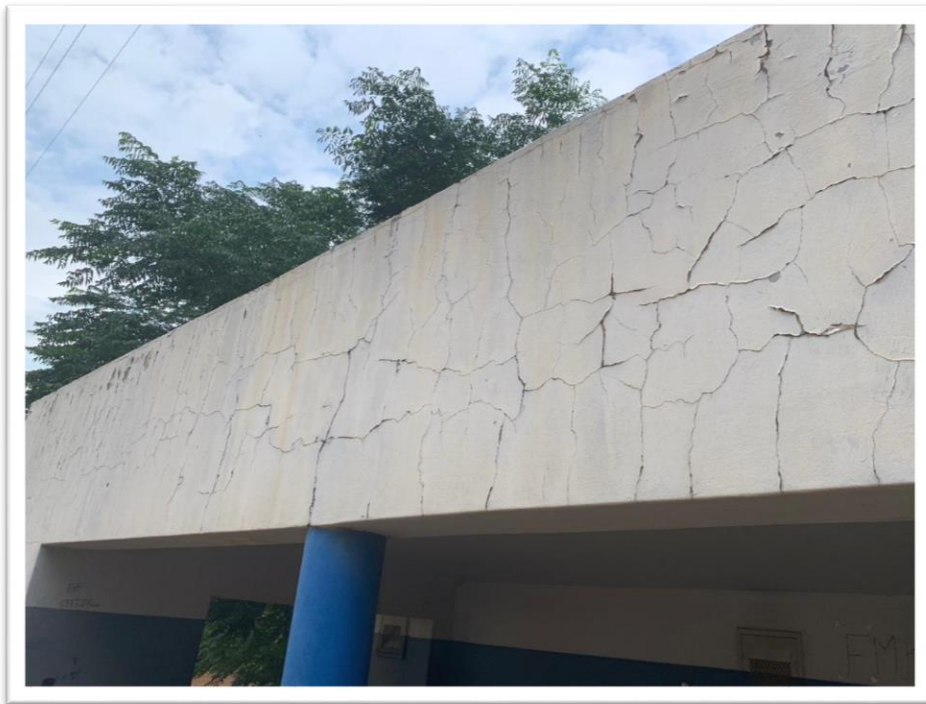
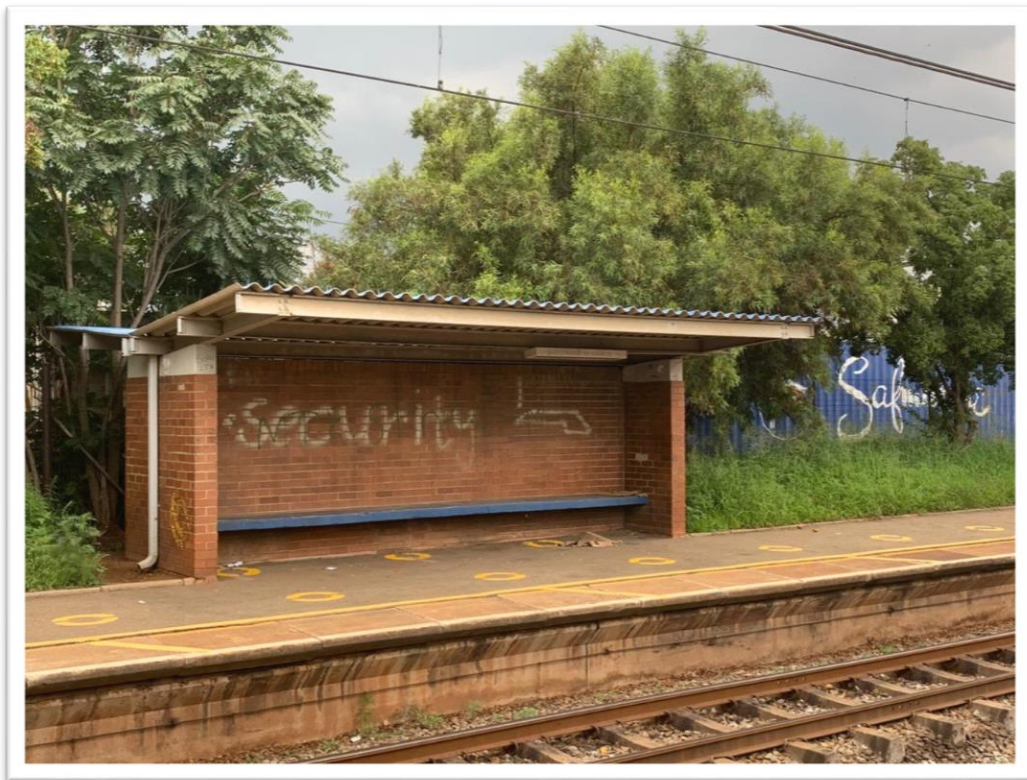
Paint peeling off walls.

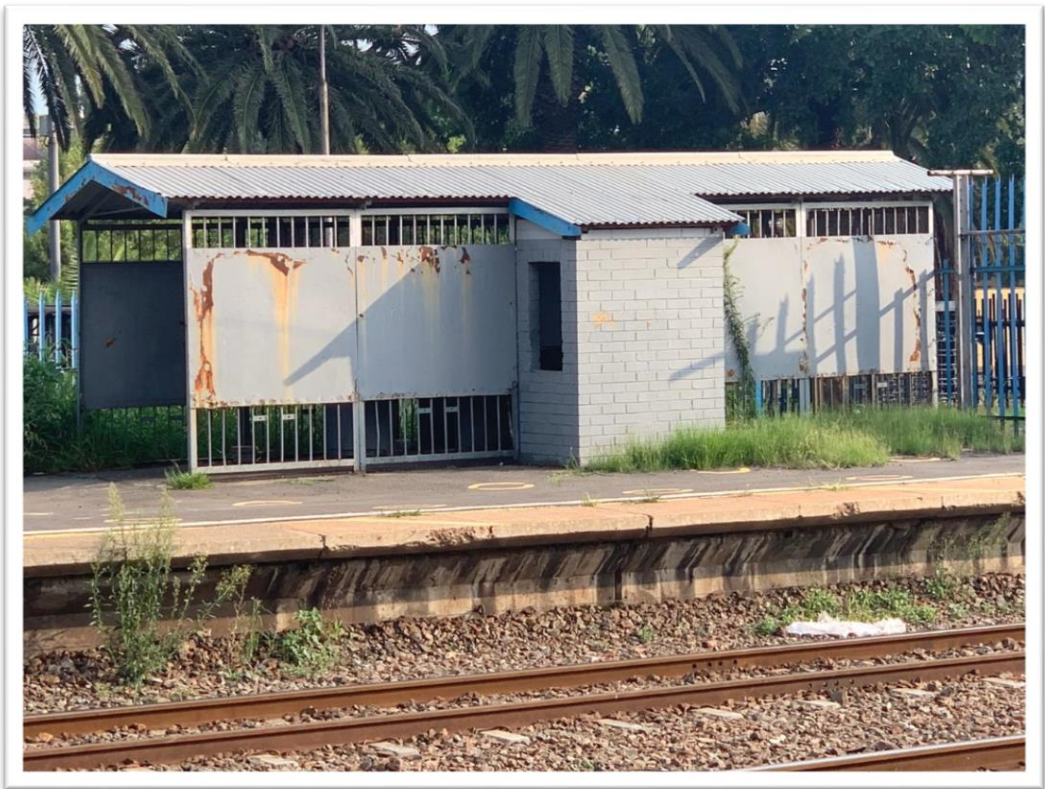
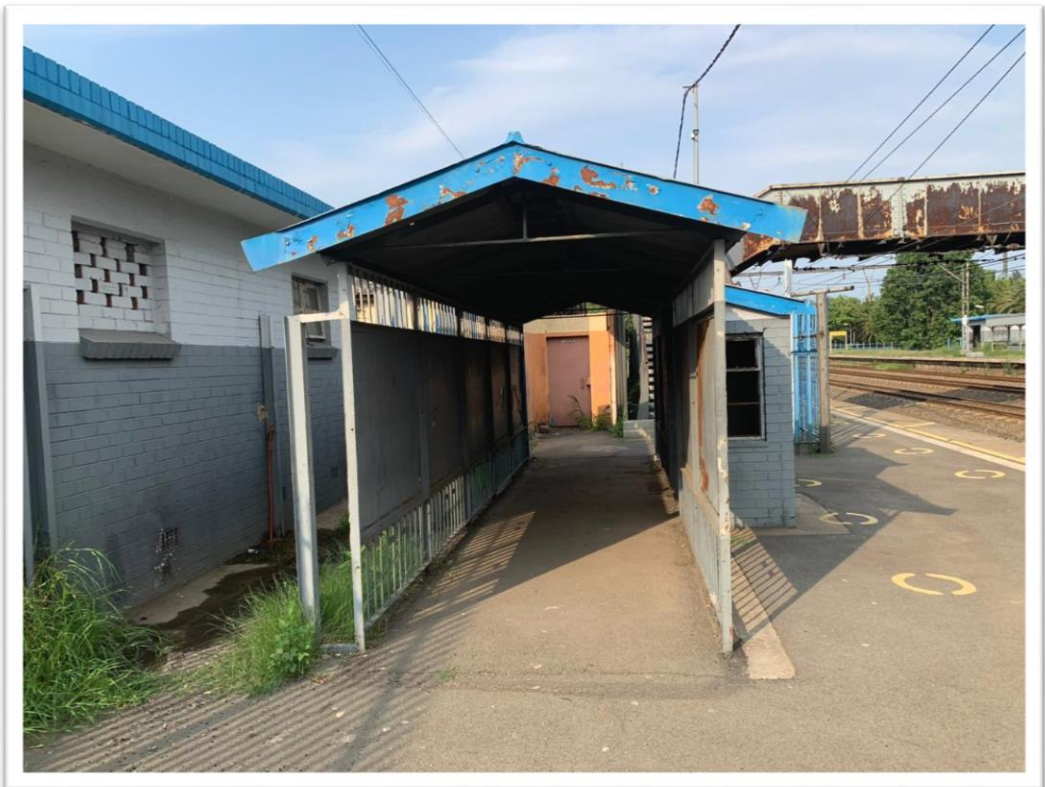
Rust spots on steel.

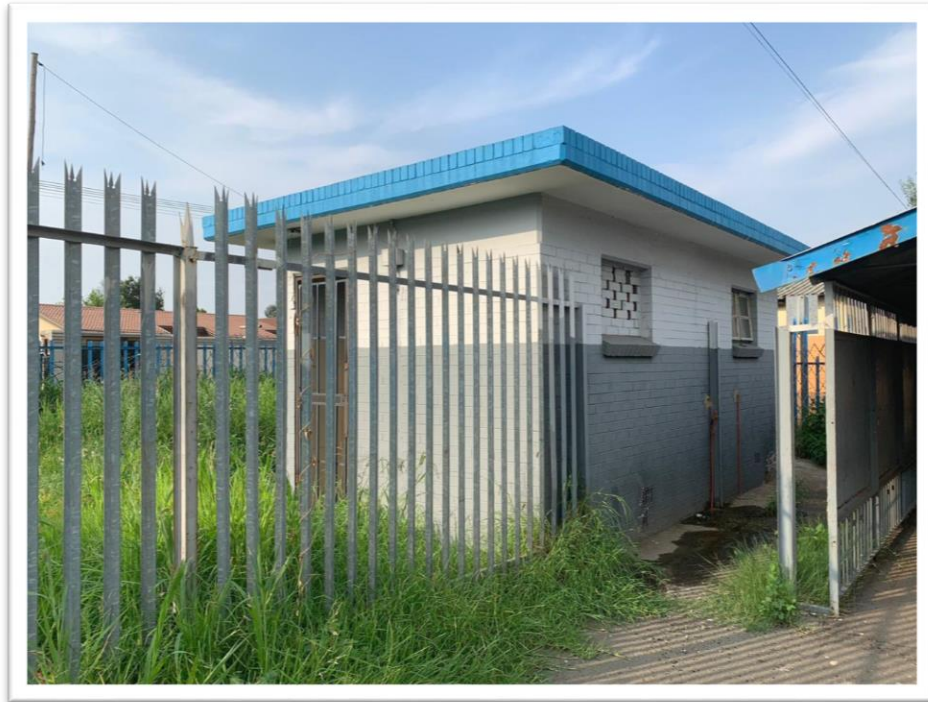
Broken window panes, and aging fascia boards.

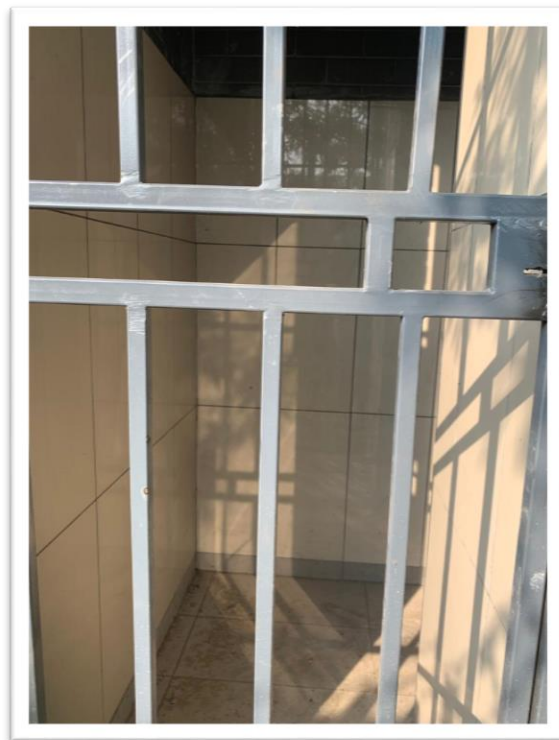
Leaking toilet pipes.

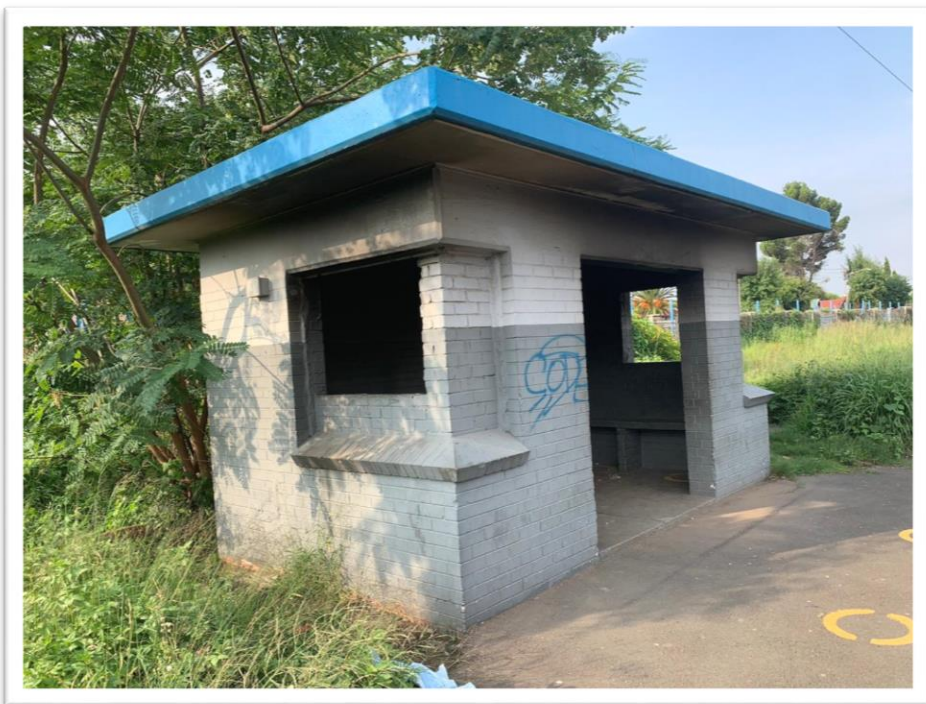
The toilet blocks were locked on arrival, and it appears that they were recently renovated.

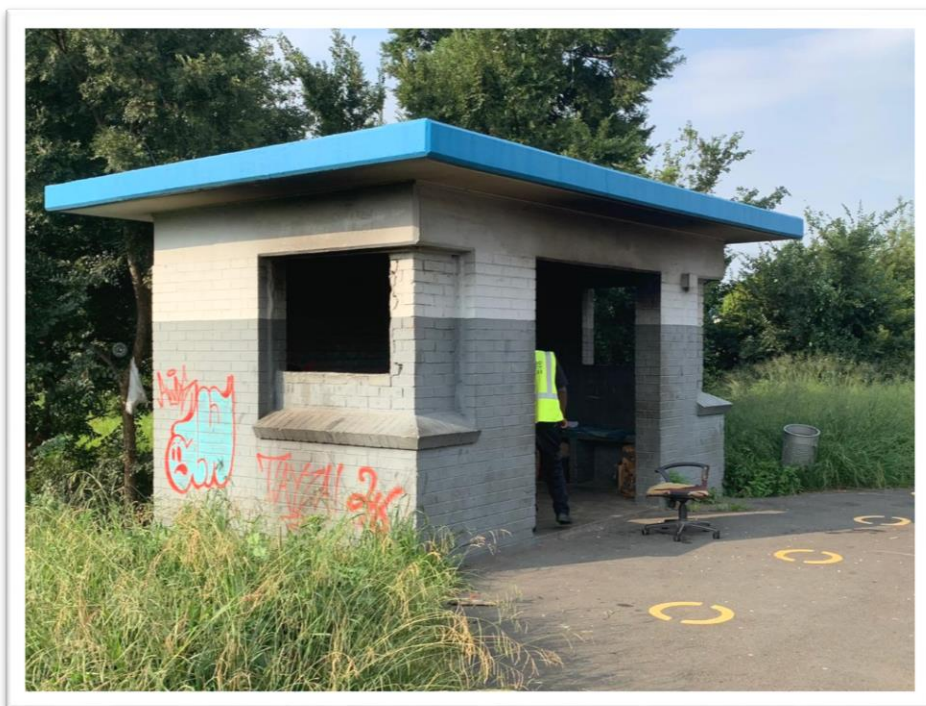
Partly burned shelters.

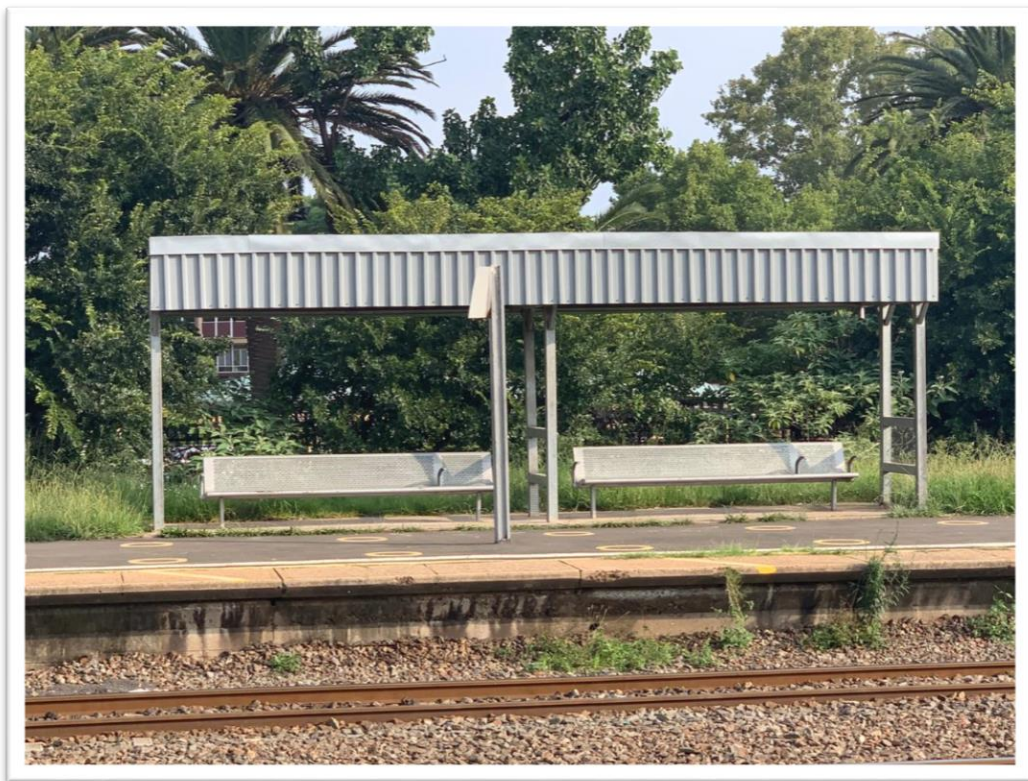
The shelters are in a fairly good condition.
