### **GPR survey of the route for the new 20" Jet fuel feeder pipeline at OR Tambo International Airport**

**Report No.: PER0256**

**Client:** Megchem Pty Ltd

**PROJECT** : **GPR survey for 20" Jet Fuel pipeline**

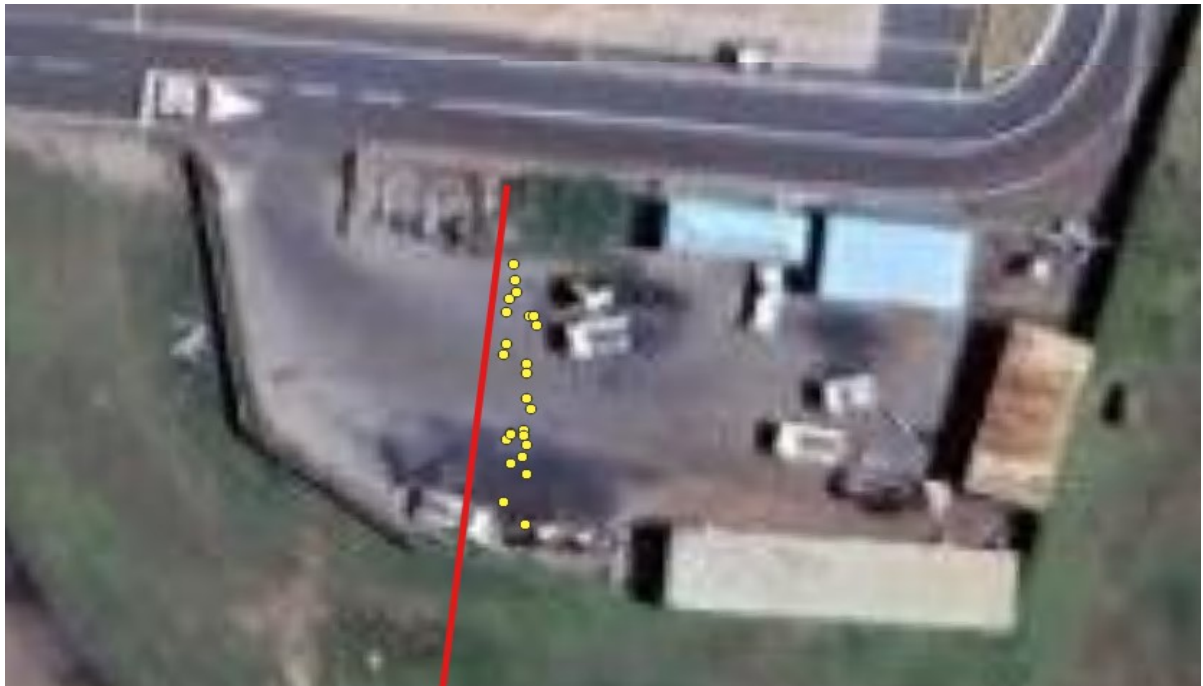
The equipment "enclave" or storage area just south of Bravo apron was surveyed. No continuous linear structures cutting across the planned route were detected. There were many shallow reflectors detected, but none of them were detected across all the lines, as shown in Figure 3.

Figure 2: Bravo Apron storage area reflectors (yellow) with the existing pipeline in red.

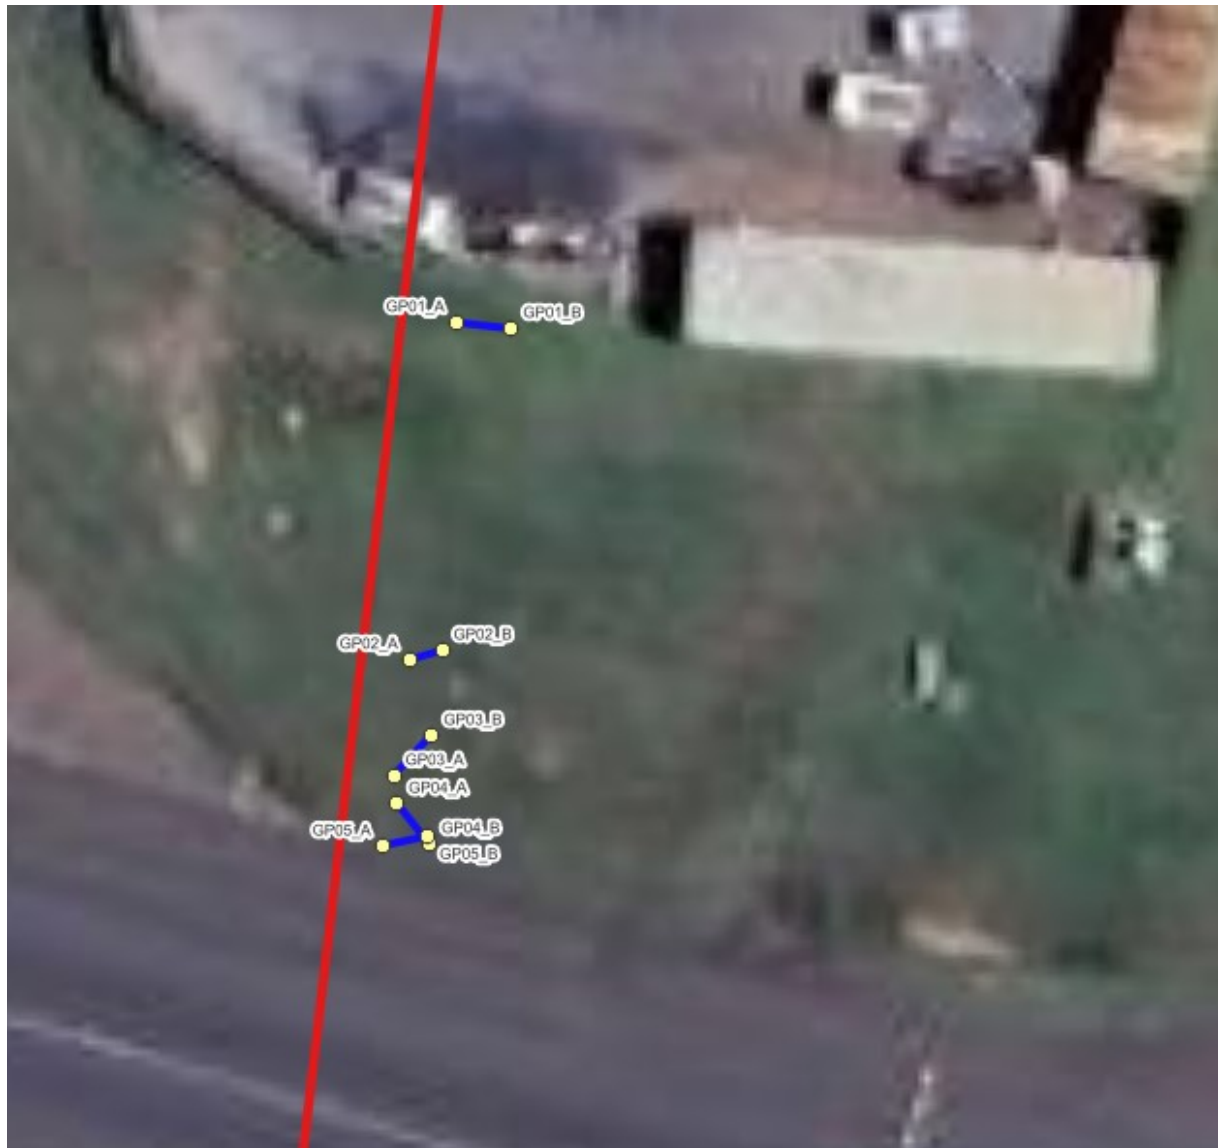
Five possible linear reflectors were detected in this area, as shown in Figure 4. Their depth varied from 25cm to 90cm. (All coordinates are referenced to the WGS84 geodetic datum.)

Figure 3: Grass Area 01 Linear Reflector Positions.

There are several shorter linear reflections indicated in each section. These do not appear to be long or continuous. These locations should be hand excavated for verification should the final pipeline route be located directly over any of these reflections.

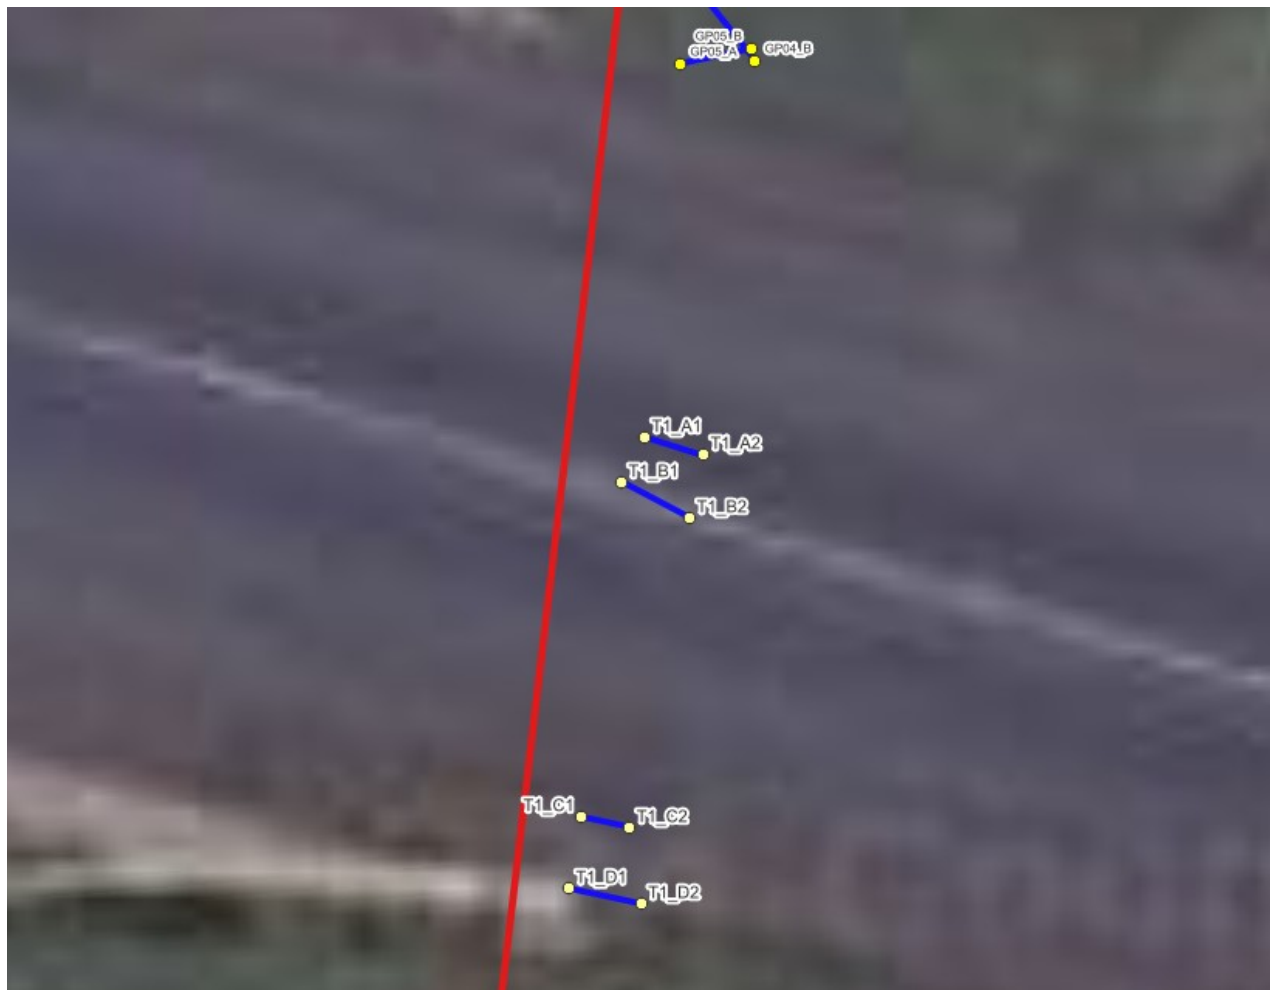
Four possible linear reflectors were detected in this area, as shown in Figure 5. Their depth varied from 25cm to 50cm.

Figure 4: Taxiway 01 Linear Reflector Positions.

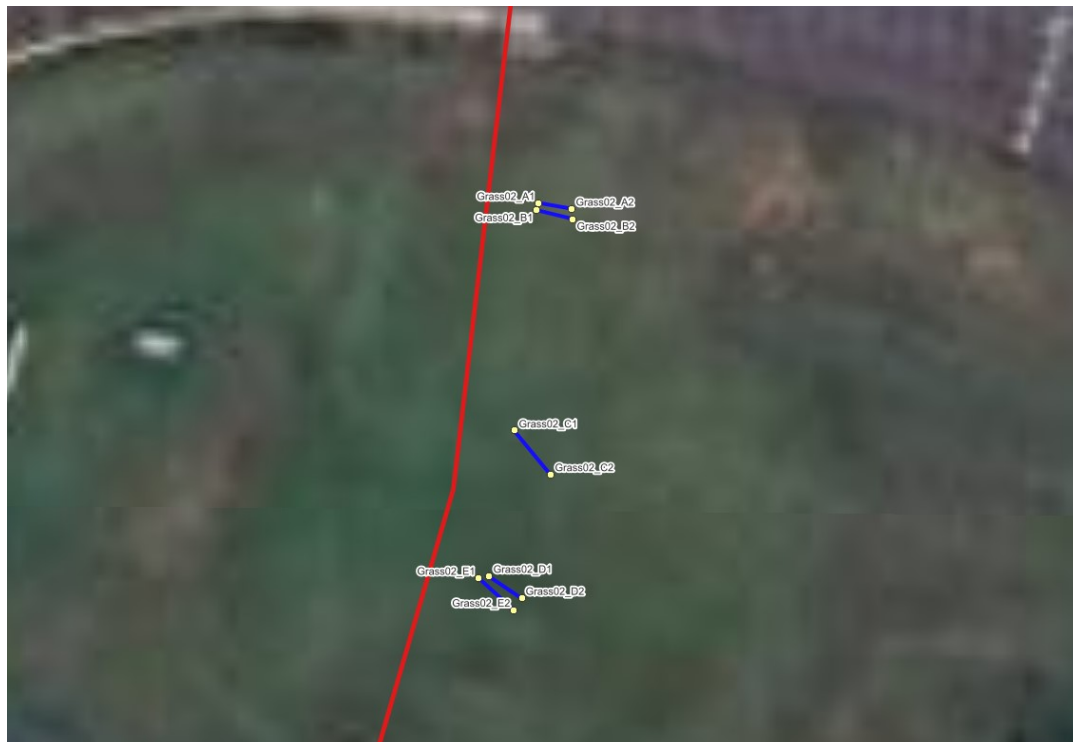
Five possible linear reflectors were detected in this area, as shown in Figure 6. Their depth varied from 25cm to 80cm.

Figure 5: Grass Area between the First and Second Taxiway South of Bravo Apron, Linear Reflector positions.

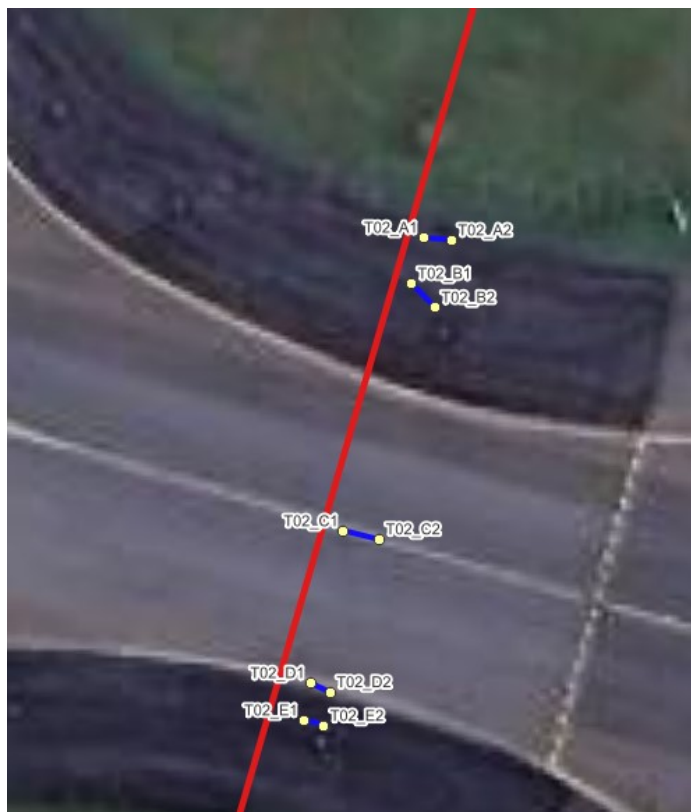
Five possible linear reflectors were detected in this area, as shown in Figure 7. Their depth varied from 30cm to 60cm.

Figure 6: Taxiway 02 Linear Reflector Positions.

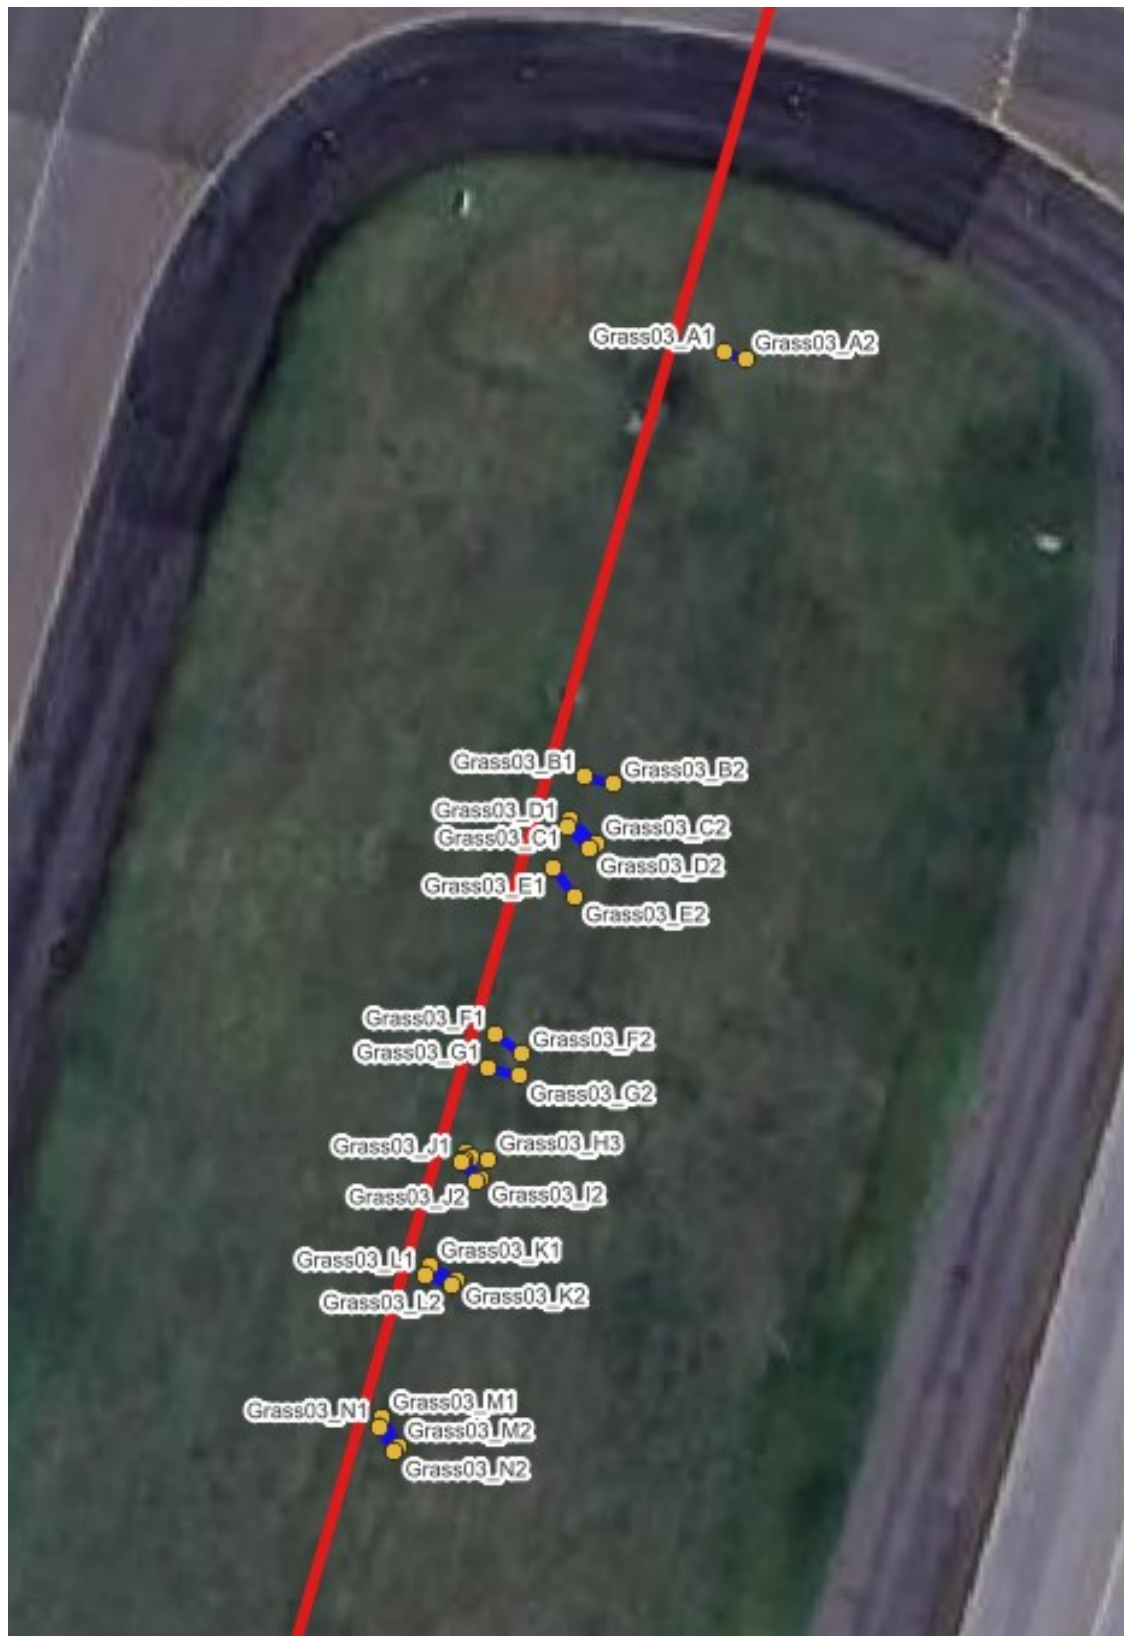
Fourteen possible linear reflectors were detected in this area, as shown in Figure 9. Their depth varied from 20cm to 80cm.

Figure 8: Grass area up to 185m south of Taxiway 02.

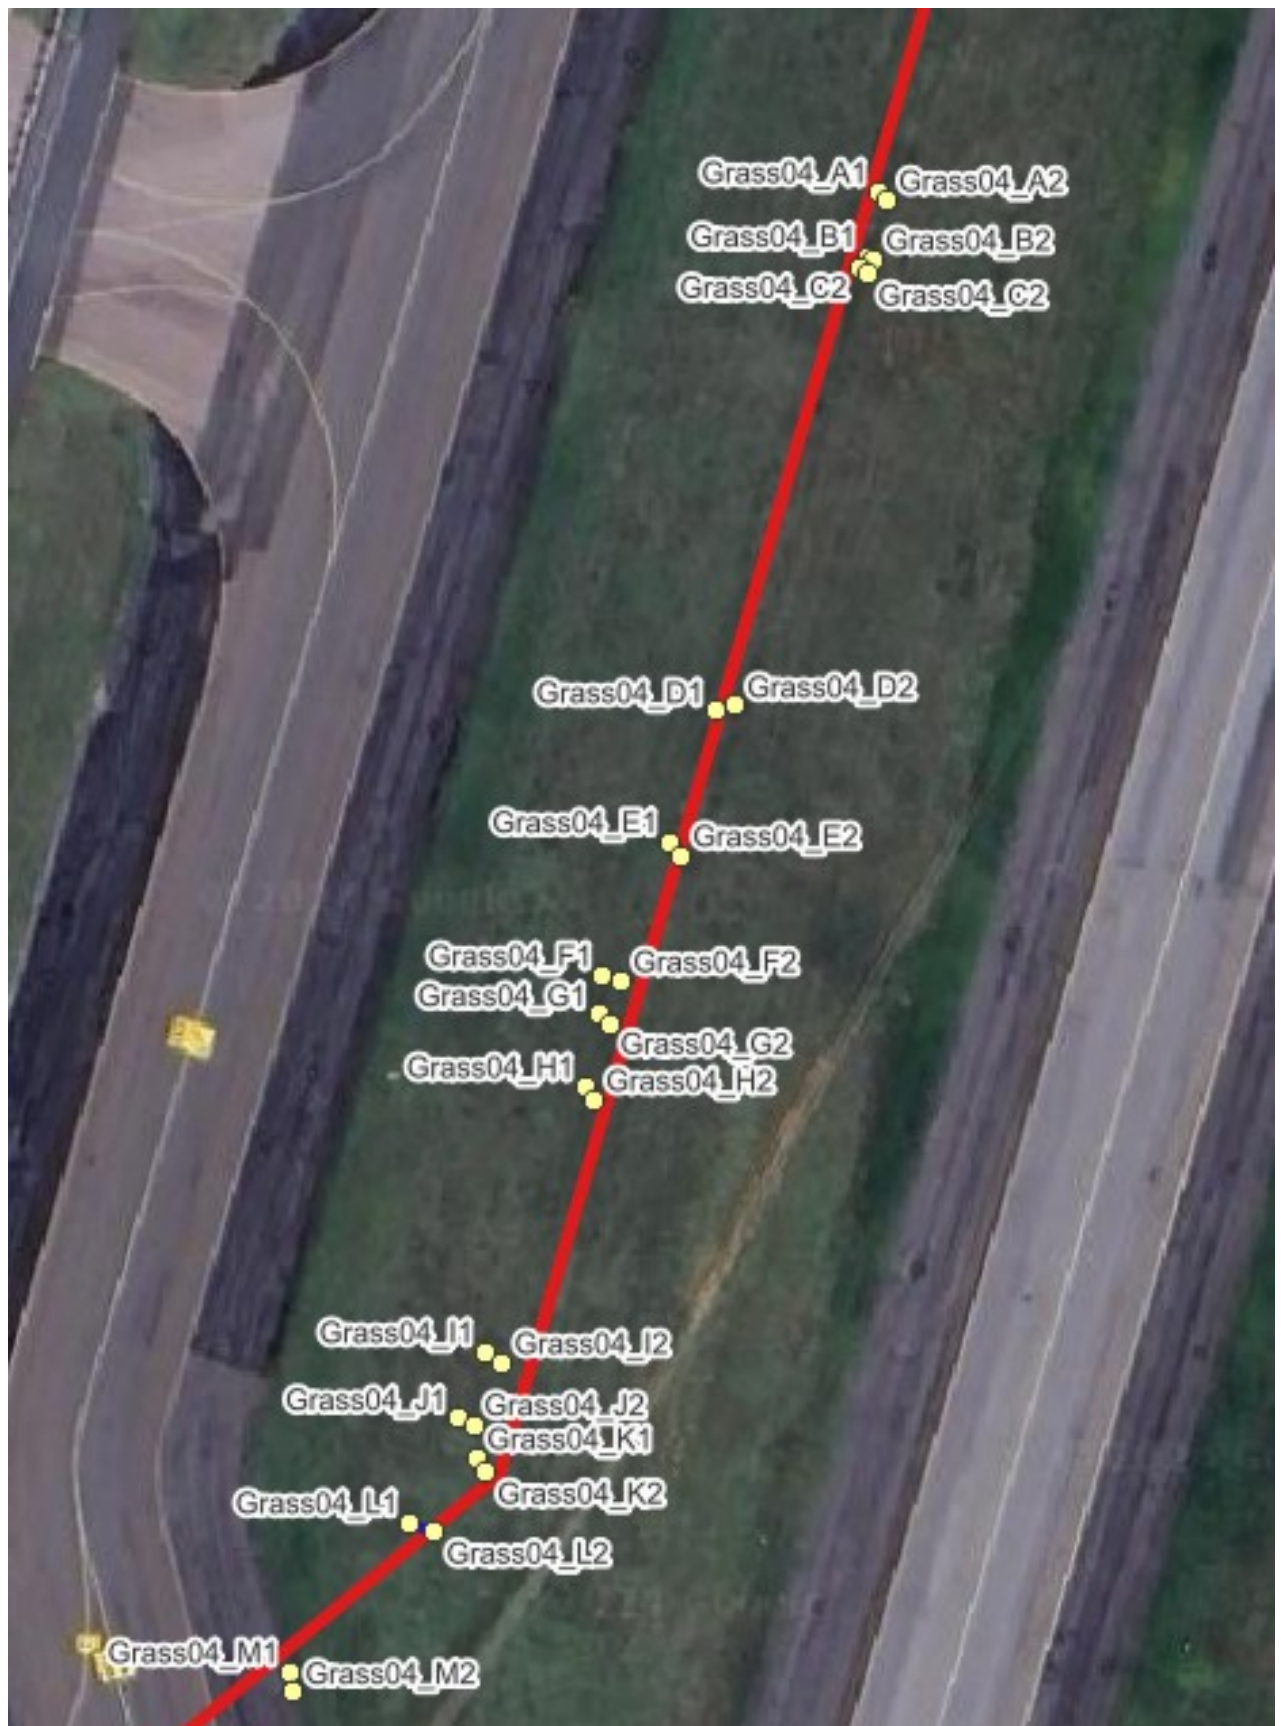
Thirteen possible linear reflectors were detected in this area, as shown in Figure 10. Their depth varied from 20cm to 70cm.

Figure 9: Remainder of grass area up to Taxiway 03.

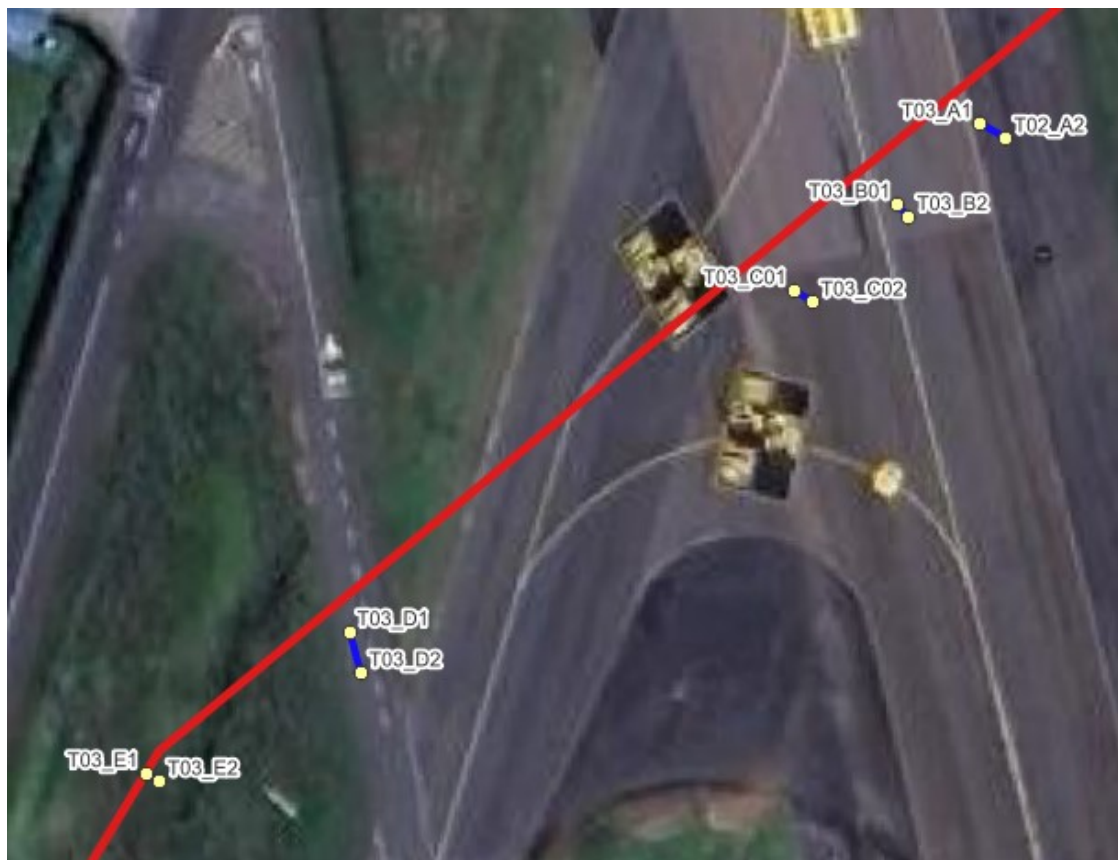
Five possible linear reflectors were detected in this area, as shown in Figure 11. Their depth varied from 20cm to 60cm.

Figure 10: Taxiway 03 Linear Reflector Positions.

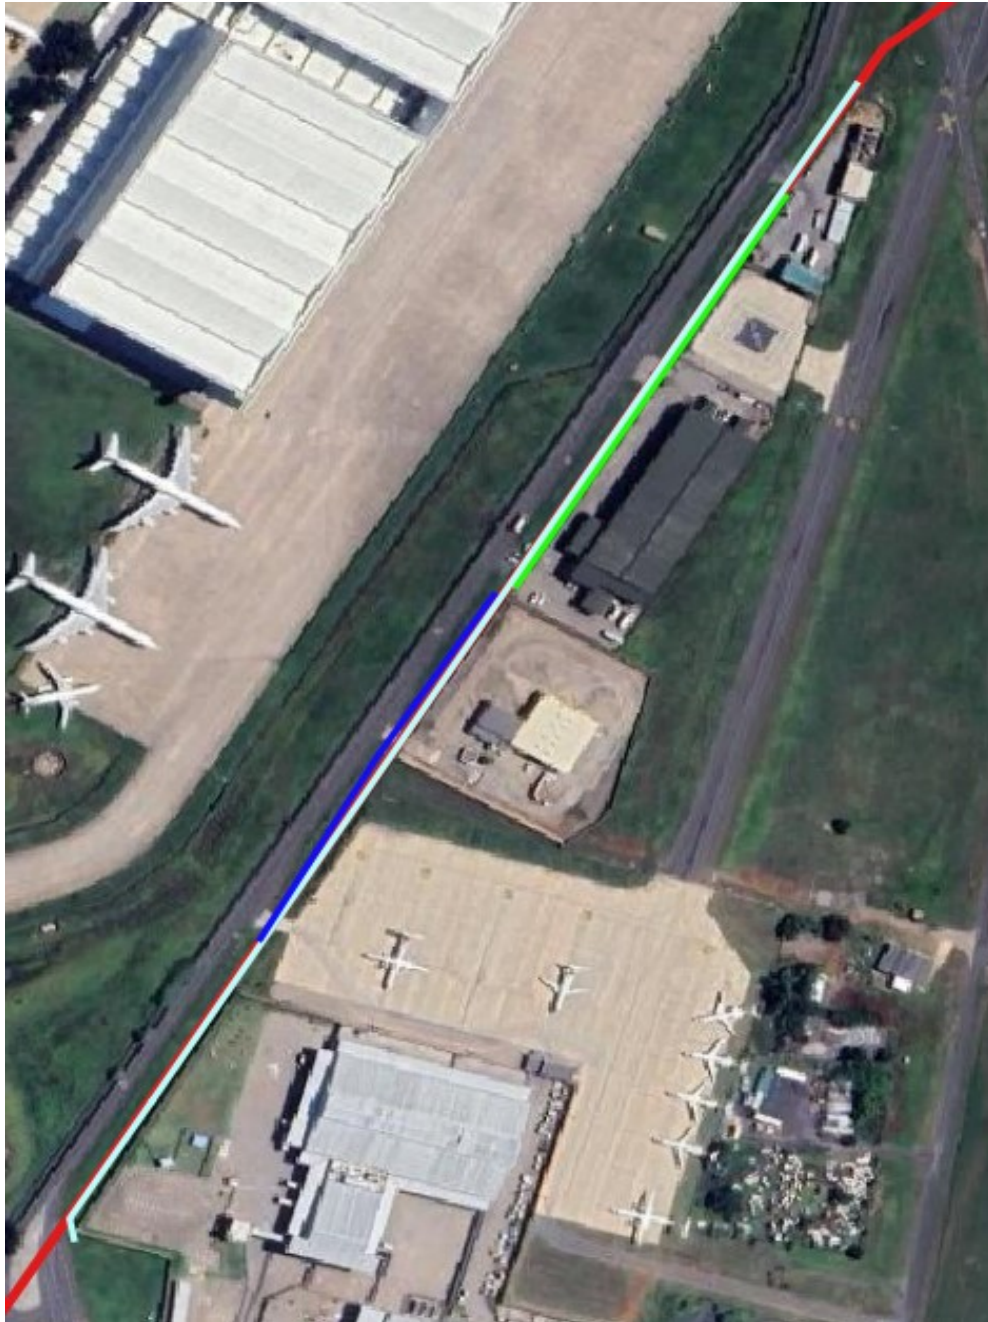
There is a 315 kVA transformer installed at the road entrance to this damaged building. It is linked to another 315KVa transformer located 227m further south along the road. The connection between them is with an 11KV cable that is buried next to the fence. This information comes from electricians that were working on the

The access roads to buildings east of the Super Southgate access road were surveyed. Pipe-like reflectors were detected in some areas at depths varying from 1.1 m to 1.27 m where the old 20-inch pipe was supposed to be located.

The fibre optic cable(s) were detected at only one position at depth of approximately 75cm below the surface. There are surface markers for the optical fiber lines, and they were surveyed using the Leica GPS system.

Markers for a 1kVA line were also located. This line runs approximately 3.1 m to the west of the old 20-inch line for a distance of approximately 203 m. It could not be determined where the line originated from or where it finally ends as the surface markers abruptly started and ended. It could not be determined if this line is still active.

Figure 11: Red = Original 20 Inch line; Green = Buried 11 kVA line, Blue = Buried 1 kVA line, Cyan = Buried Optical Fibre line.

The 11 kVA cable is the main obstacle detected during the survey.

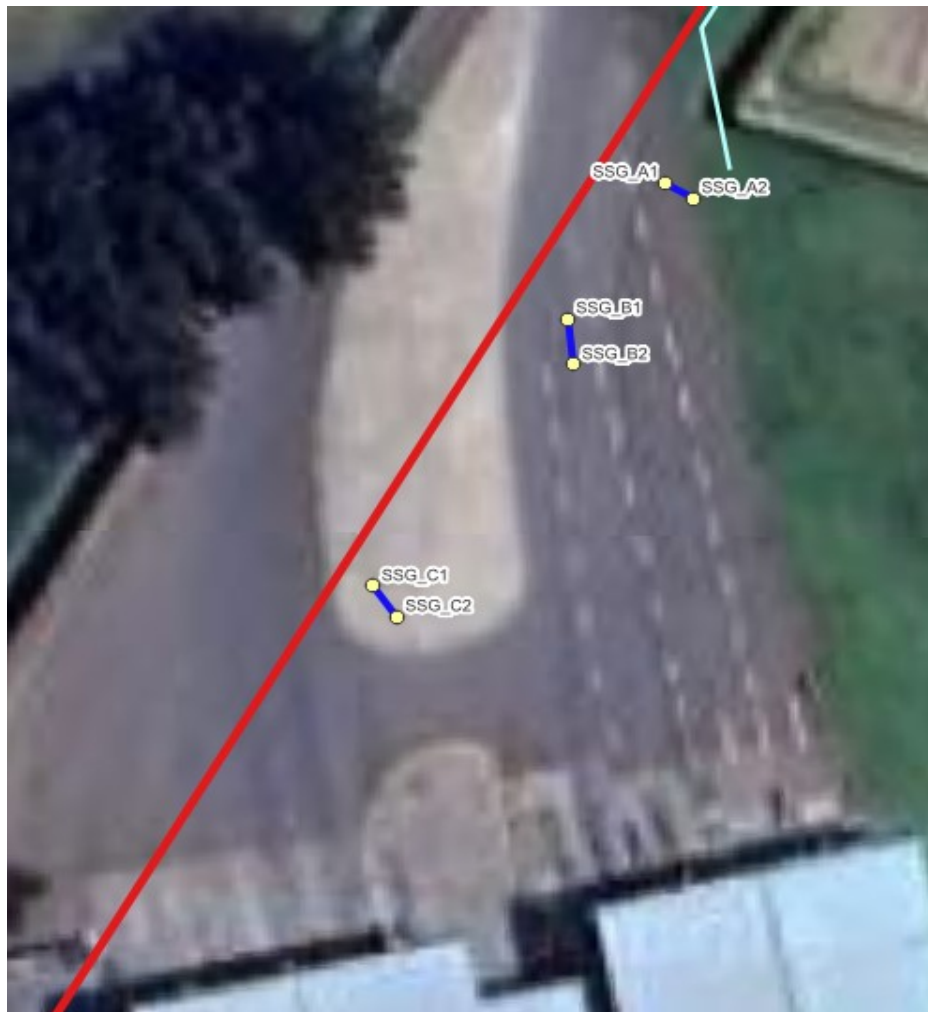
Three possible linear reflectors were detected in this area, as shown in Figure 13. Their depth varied from 30cm to 70cm.

Figure 12: Super Southgate Linear reflector positions.

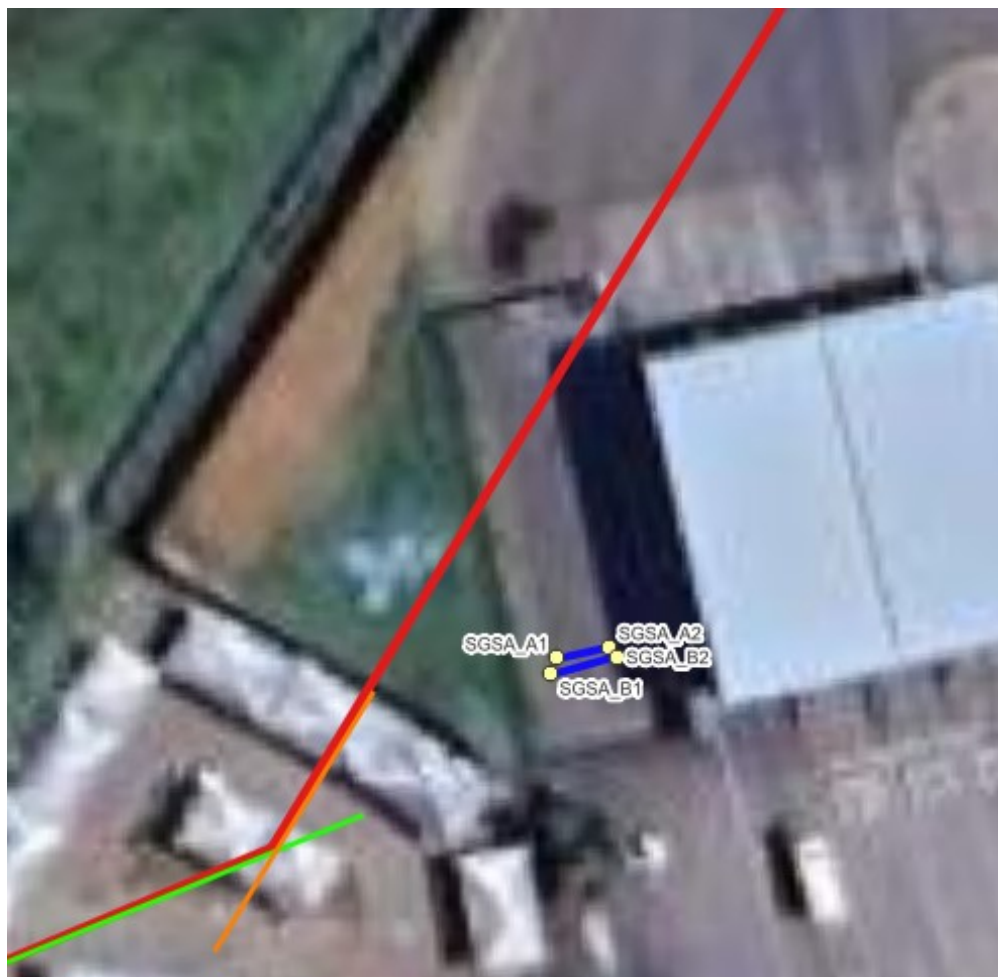
This area was surveyed as the planned route was obstructed by large metal plates that were dumped on the path, as shown in Figure 14. There is a hydraulic vehicle barrier on the inside of this area as well as a fire hydrant next to the building. The pipes leading to the fire hydrant were not detected as they appear to run against the side of the building.

Figure 13: Super South Gate special access area Linear reflector positions.

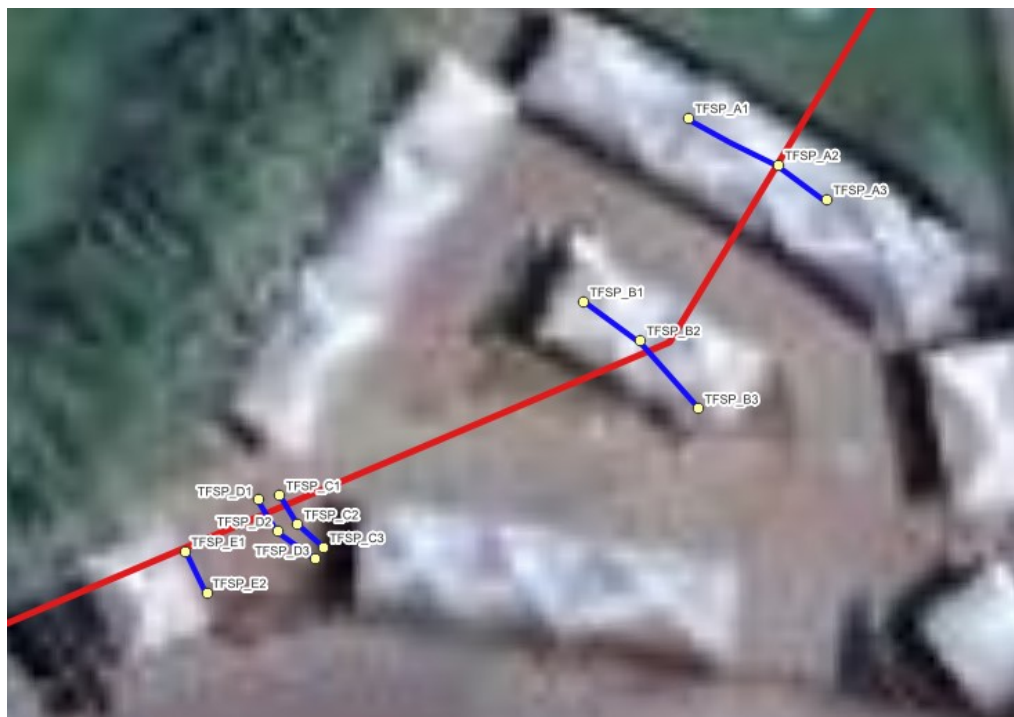
Five possible linear reflectors were detected in this area, as shown in Figure 15. Their depth varied from 40cm to 90cm.

Figure 14: Tank Farm safe parking area Linear Reflector Positions.

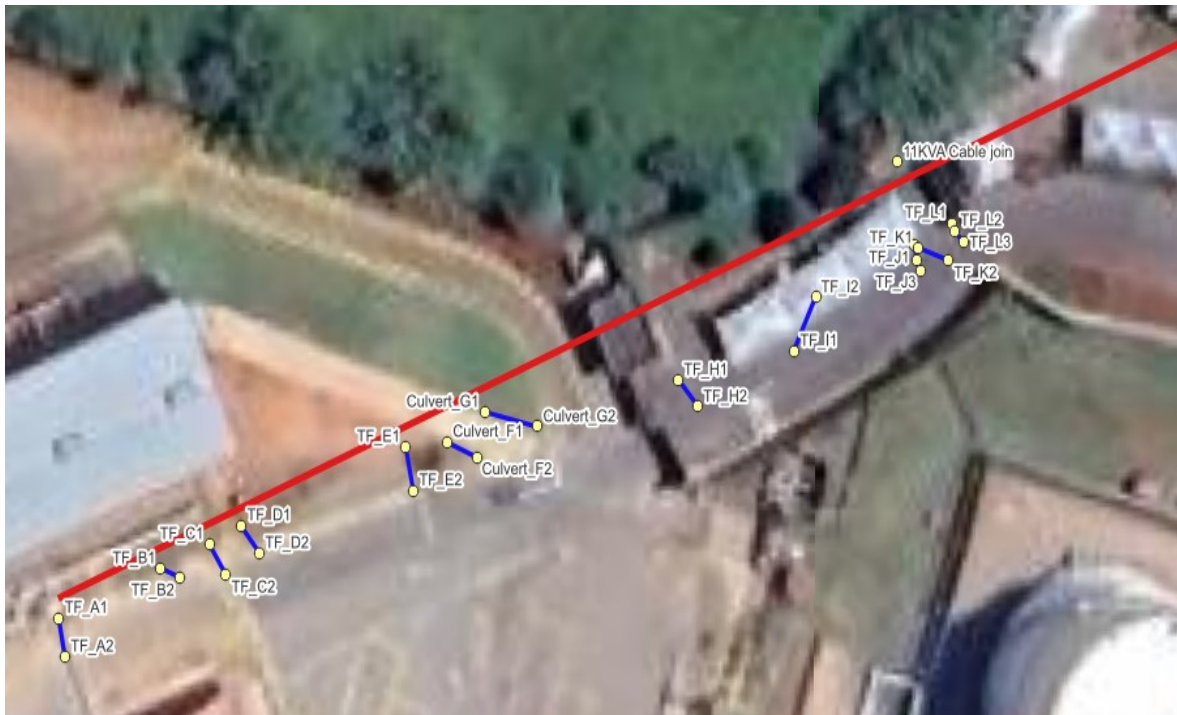
Twelve possible linear reflectors were detected in this area, as shown in Figure 16. Their depth varied from 20cm to 60cm.

Figure 16. Tank Farm Linear Reflector Positions.

There is a ground marker for an 11kVA cable joint in the parking lot corner just outside the entrance to the tank farm. The area is too congested to survey around the marker. An attempt was made, but nothing was detected.
