## ENGINEERING SERVICES INVESTIGATION REPORT

STATUS	INVESTIGATION REPORT
SUBJECT:	DWS: Boskop Area Offices Multidisciplinary condition assessment

<b>STATUS</b>	<b>TECHANICAL INVESTIGATION REPORT</b>
<b>SUBJECT:</b>	<b>Department of Water and Sanitation (DWS): Boskop Area Offices Electrical Infrastructure Condition Assessment</b>

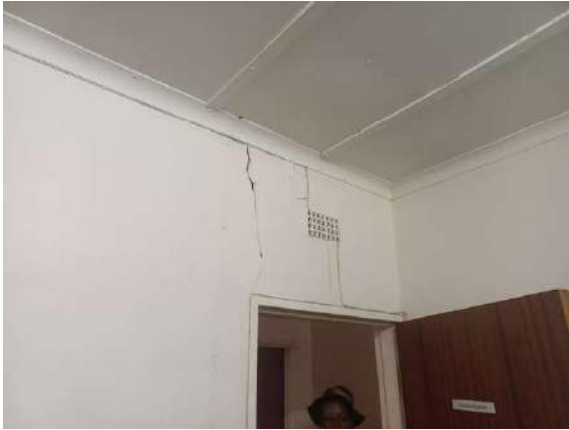
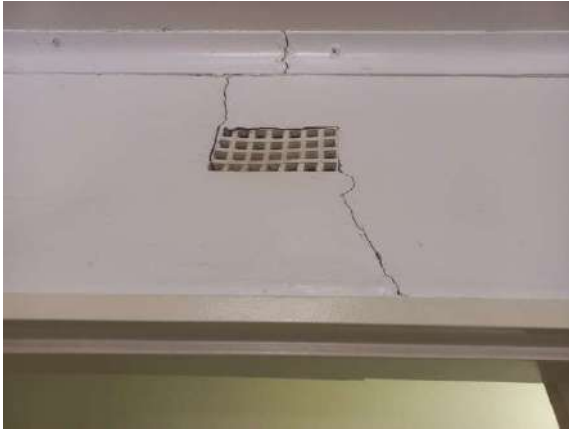
<b>A2.1</b>	<b>Block 1 – Admin block</b>	<b>A2.2</b>	<b>Block 1 – Admin block</b>
<b>IMAGE</b>		<b>IMAGE</b>

<b>Position:</b> Main Building		<b>Position:</b> Main Building	
<b>Category:</b> Walls/masonry		<b>Category:</b> Walls/masonry	
<b>Description:</b> Repair of vertical crack as per Structural Engineer. (To advise regarding structural integrity in affected areas).		<b>Description:</b> Plinth to be sealed and refurbished.	
Int <input checked="" type="checkbox"/> Ext <input type="checkbox"/>		Int <input checked="" type="checkbox"/> Ext <input type="checkbox"/>	
<b>Risk assessment</b>			
<b>Impact</b>	Insignificant	Minor	Significant <b>Major</b> <input checked="" type="checkbox"/> Severe
<b>Rating</b>	High Risk		
<b>Consequence</b>	Rare	Unlikely <input checked="" type="checkbox"/>	Possible Likely Almost certain
<b>Remarks</b>	Walls have major cracks. Serious preparation and sealing and new paintwork are required to put the walls to acceptable standards.

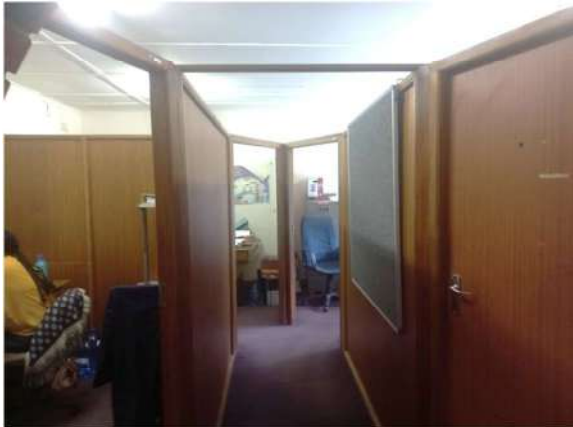
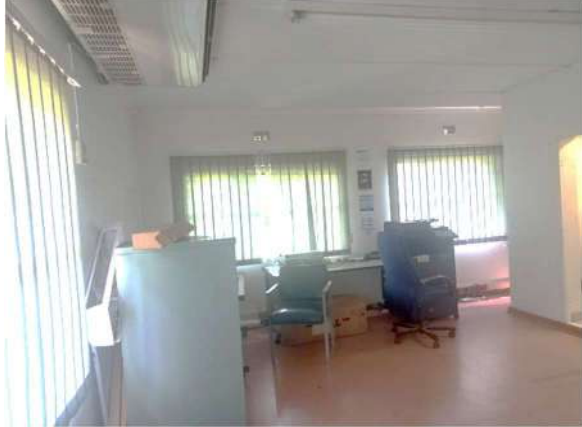
<b>A2.3</b>	<b>Block 1 – Admin block</b>	<b>A2.4</b>	<b>Block 1 – Admin block</b>
<b>IMAGE</b>		<b>IMAGE</b>

<b>Position:</b> Offices		<b>Position:</b> Digitizing room	
<b>Category:</b> Walls & Alterations		<b>Category:</b> New walls	
<b>Description:</b> Cubicles to be demolished. Alterations as per design drawings		<b>Description:</b> Area at which subdivision will be done.	
Int <input checked="" type="checkbox"/> Ext <input type="checkbox"/>		Int <input checked="" type="checkbox"/> Ext <input type="checkbox"/>	
<b>Risk assessment</b>			
<b>Impact</b>	Insignificant <input checked="" type="checkbox"/>	Minor	Significant Major Severe
<b>Rating</b>	Eliminated		
<b>Consequence</b>	Rare <input checked="" type="checkbox"/>	Unlikely	Possible Likely Almost certain
<b>Remarks</b>	New design drawings will be required for detailed estimates on the next stage (DDR).

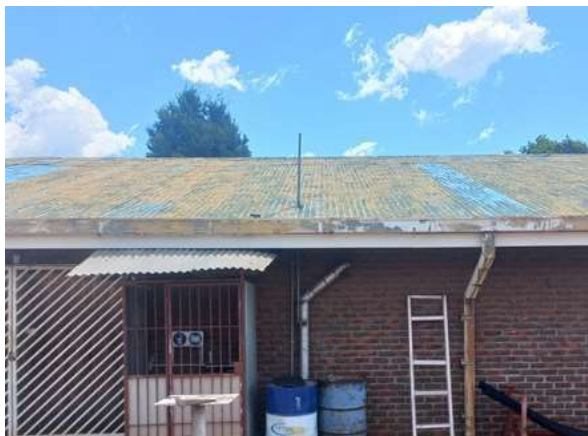
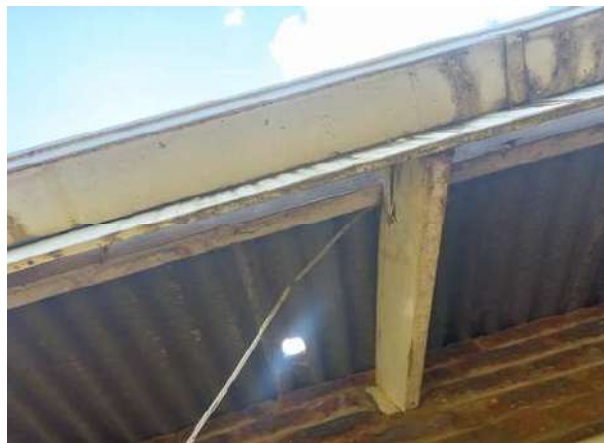
A3.1		Block 2		A3.2		Block 2	
IMAGE				IMAGE

Position: Storage area		Category: Roof covering		Position: All blocks		Category: Roof covering	
Description: Roof required attention. Leaks to be checked prior to repair and coating works		Int <input type="checkbox"/> Ext <input checked="" type="checkbox"/>		Description: Damaged fascia and gutters to be replaced.		Int <input type="checkbox"/> Ext <input checked="" type="checkbox"/>	
Risk assessment							
Impact	Insignificant	Minor		Significant <input checked="" type="checkbox"/>		Major	Severe
Rating	High Risk						
Consequence	Rare	Unlikely		Possible <input checked="" type="checkbox"/>		Likely	Almost certain
Remarks	Trapped water in concealed gutters and downpipes overflows into office spaces and cause substantial damage to ceilings and building contents.

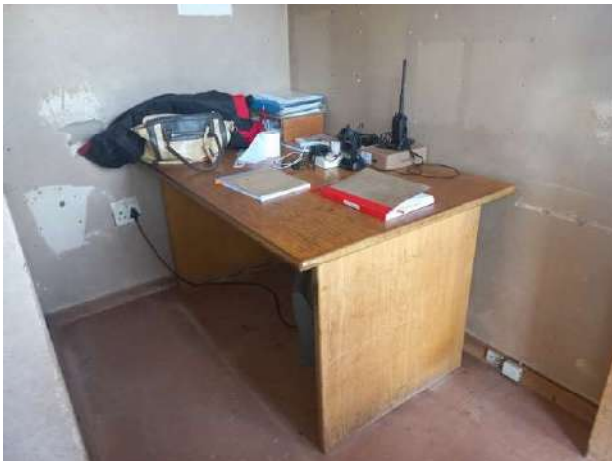
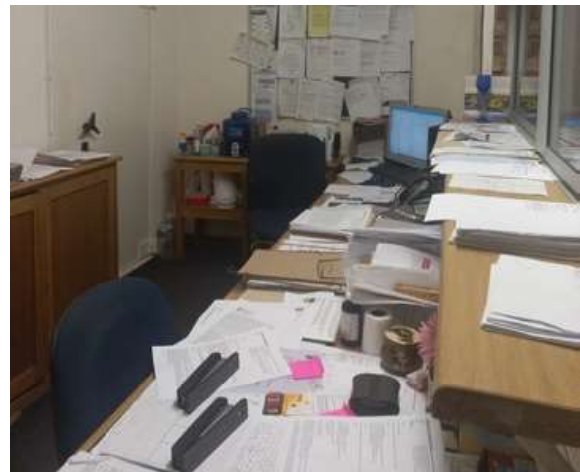
A4.1	Block 5 – Guard House	A4.2	Block 1 – Admin
IMAGE		IMAGE

Position: Guard house	Category: Joinery and fittings	Position: Reception	Category: Joinery and fittings
Description: A new fixed counter for guard house is proposed.		Description: New fixed counter and glazed screen is proposed for the reception area.	
Int <input checked="" type="checkbox"/> Ext <input type="checkbox"/>		Int <input checked="" type="checkbox"/> Ext <input type="checkbox"/>	
Risk assessment			
Impact	Insignificant <input checked="" type="checkbox"/>	Minor	Significant
Rating	Eliminated		
Consequence	Rare <input checked="" type="checkbox"/>	Unlikely	Possible
Remarks	New design drawings will be required for detailed estimates on the next stage (DDR).

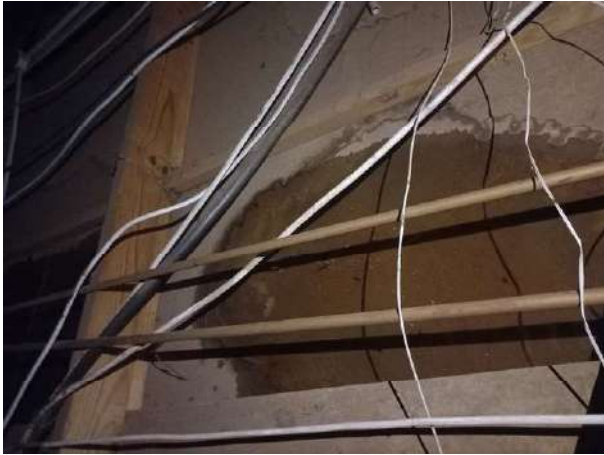
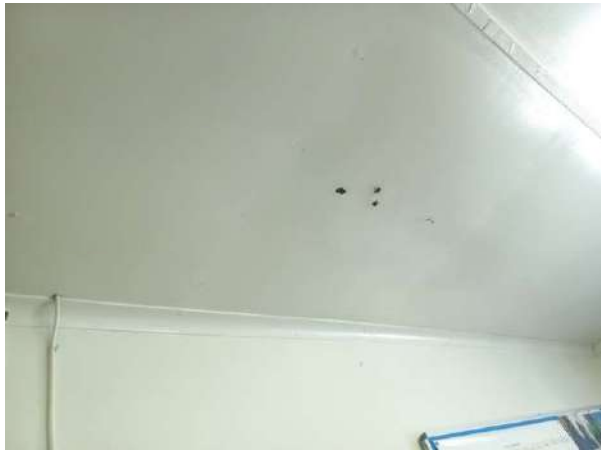
A5.1 Block 2 – Storage area		A5.2 Block 1 – Administrative area	
<b>IMAGE</b>		<b>IMAGE</b>

<b>Position:</b> Roof space	<b>Category:</b> ceilings	<b>Position:</b> Offices	<b>Category:</b> Ceilings
<b>Description:</b> Damaged plumbing causes leakages and damage in other offices. To be repaired before replacement of ceiling. Roof sisalation is necessary to keep dust and pest away.		<b>Description:</b> Blemishes in ceiling to be fixed before painting is done	
Int <input checked="" type="checkbox"/>		Int <input checked="" type="checkbox"/>	
Ext <input type="checkbox"/>		Ext <input type="checkbox"/>	
<b>Risk assessment</b>			
<b>Impact</b>	Insignificant	Minor	Significant <input checked="" type="checkbox"/>
<b>Rating</b>	High Risk		
<b>Consequence</b>	Rare	Unlikely	Possible <input checked="" type="checkbox"/>
<b>Remarks</b>

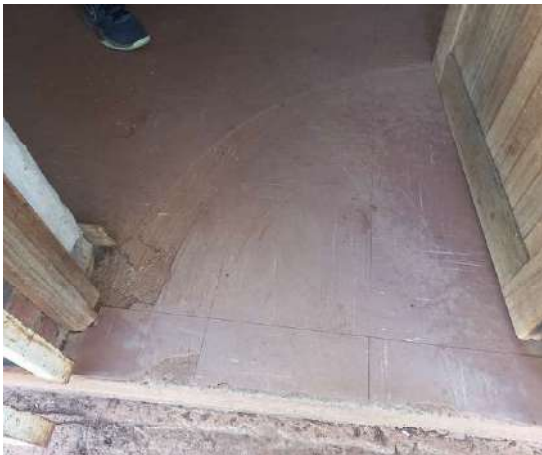
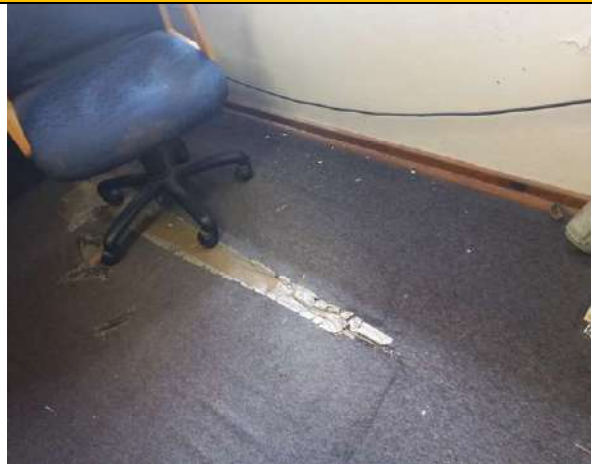
<b>Position:</b> Guard House	<b>Category:</b> Floors	<b>Position:</b> Block 1 & 2	<b>Category:</b> Floors
<b>Description:</b> Vinyl tiles to be replaces in the Guard House.		<b>Description:</b> Carpet tiles to be replaced in offices.	
Int <input checked="" type="checkbox"/>		Int <input checked="" type="checkbox"/>	
Ext <input type="checkbox"/>		Ext <input type="checkbox"/>	
<b>Risk assessment</b>			
<b>Impact</b>	Insignificant	Minor	Significant <input checked="" type="checkbox"/>
<b>Rating</b>	High Risk		
<b>Consequence</b>	Rare	Unlikely	Possible <input checked="" type="checkbox"/>
<b>Remarks</b>

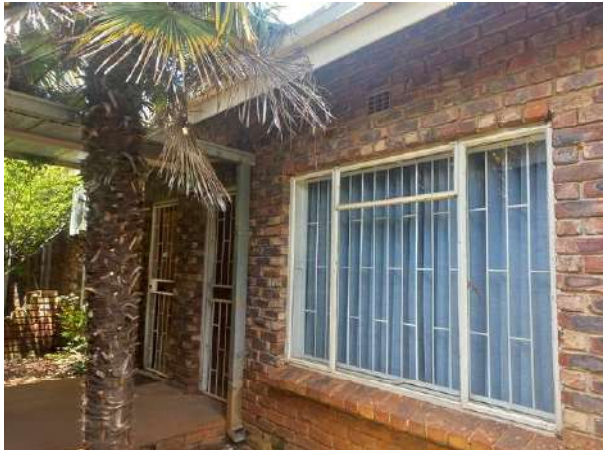
<b>A7.1</b>	<b>Block 1</b>	<b>A7.2</b>	<b>Block 3 – Storage</b>		
<b>IMAGE</b>		<b>IMAGE</b>

<b>Position: General</b>	<b>Category: Doors &amp; IM</b>	<b>Position: Escape routes</b>	<b>Category: Doors &amp; ironmongery</b>		
<b>Description:</b> Damaged locksets to be replaced.		<b>Description:</b> Fire doors to be provided. Burglar gates to be removed where applicable.			
Int <input checked="" type="checkbox"/> Ext <input type="checkbox"/>		Int <input type="checkbox"/> Ext <input checked="" type="checkbox"/>			
<b>Risk assessment</b>					
<b>Impact</b>	Insignificant	Minor	Significant	Major <input checked="" type="checkbox"/>	Severe
<b>Rating</b>	<b>Critical Risk</b>				
<b>Consequence</b>	Rare	Unlikely	Possible	Likely	Almost certain <input checked="" type="checkbox"/>
<b>Remarks</b>	Safety risk, evacuation risk

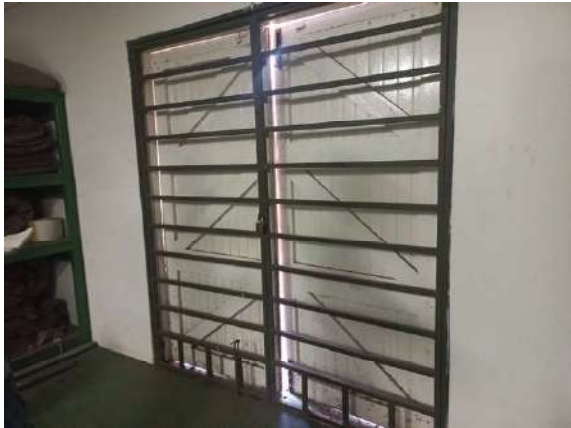
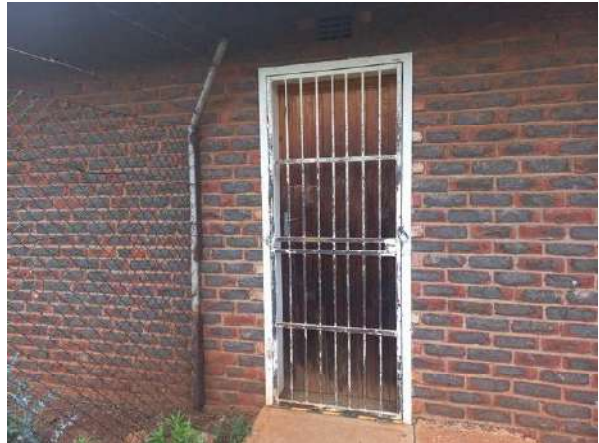
<b>Position: Storage</b>	<b>Category: Metalwork</b>	<b>Position: Exterior</b>	<b>Category: Metalwork</b>		
<b>Description:</b> Repair burglar gates and repaint.		<b>Description:</b> Repair burglar gates and repaint.			
Int <input checked="" type="checkbox"/> Ext <input type="checkbox"/>		Int <input type="checkbox"/> Ext <input checked="" type="checkbox"/>			
<b>Risk assessment</b>					
<b>Impact</b>	Insignificant	Minor <input checked="" type="checkbox"/>	Significant	Major	Severe
<b>Rating</b>	<b>Moderate risk</b>				
<b>Consequence</b>	Rare	Unlikely <input checked="" type="checkbox"/>	Possible	Likely	Almost certain
<b>Remarks</b>

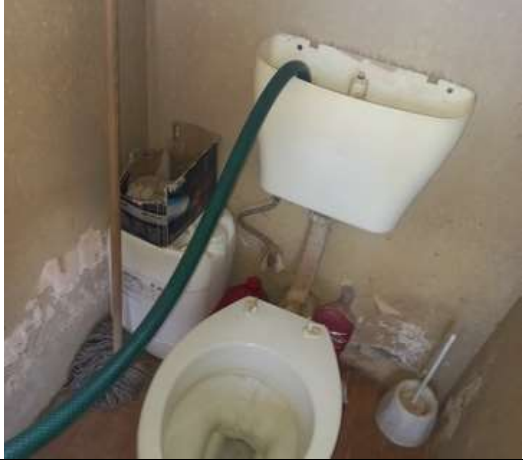
<b>Position:</b> External	<b>Category:</b> Plumbing & drainage	<b>Position:</b> Toilet	<b>Category:</b> Plumbing & drainage
<b>Description:</b> Plumbing system to be repaired.		<b>Description:</b> Damaged sanitary fixtures to be replaced. Water supply to be repaired.	
Int <input type="checkbox"/> Ext <input checked="" type="checkbox"/>		Int <input checked="" type="checkbox"/> Ext <input type="checkbox"/>	
<b>Risk assessment</b>			
<b>Impact</b>	Insignificant	Minor	Significant <input checked="" type="checkbox"/>
<b>Rating</b>	High risk		
<b>Consequence</b>	Rare	Unlikely	Possible <input checked="" type="checkbox"/>
<b>Remarks</b>	Lack of maintenance result in system collapse.

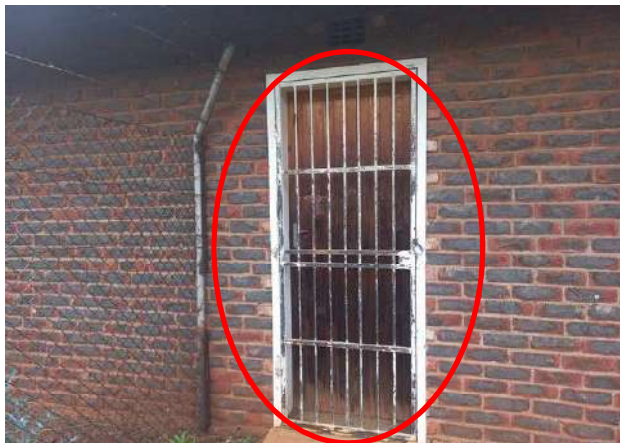
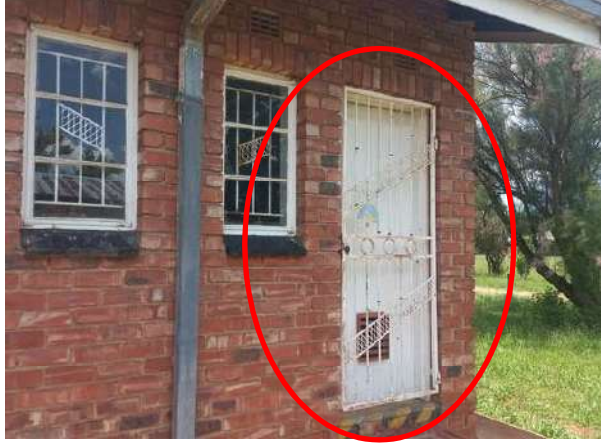
Position: Roof		Category: Doors		Position: Entrance		Category: Doors	
<b>Description:</b> Replace damaged internal and external wooden doors.			Int <input checked="" type="checkbox"/> Ext <input checked="" type="checkbox"/>	<b>Description:</b> Replace damaged steel doors.			Int <input type="checkbox"/> Ext <input checked="" type="checkbox"/>
<b>Risk assessment</b>							
Impact	Insignificant	Minor <input checked="" type="checkbox"/>	Significant	Major	Severe		
Rating	Moderate Risk						
Consequence	Rare	Unlikely	Possible <input checked="" type="checkbox"/>	Likely	Almost certain		
Remarks	Doors must be varnished/painted regularly to prolong the service period and strength.

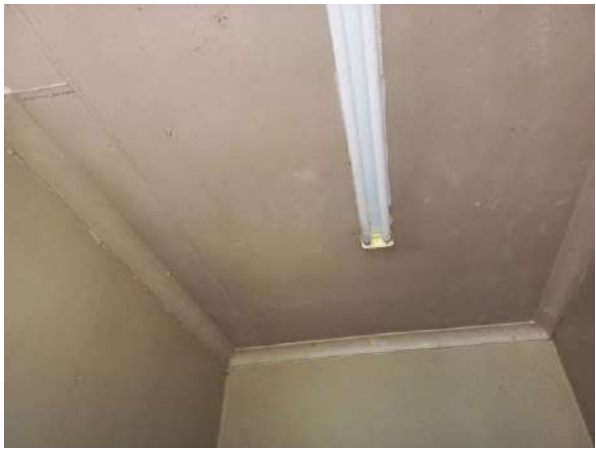
Position: Roof		Category: Windows		Position: Entrance		Category: Windows	
<b>Description:</b> Prep wall and repaint.			Int <input checked="" type="checkbox"/> Ext <input type="checkbox"/>	<b>Description:</b> Putty to be replaced and windows re-painted.			Int <input checked="" type="checkbox"/> Ext <input type="checkbox"/>
<b>Risk assessment</b>							
Impact	Insignificant	Minor <input checked="" type="checkbox"/>	Significant	Major	Severe		
Rating	Minor Risk						
Consequence	Rare <input checked="" type="checkbox"/>	Unlikely	Possible	Likely	Almost certain		
Remarks	Paint peeling may cause discomfort and sometimes health hazard.

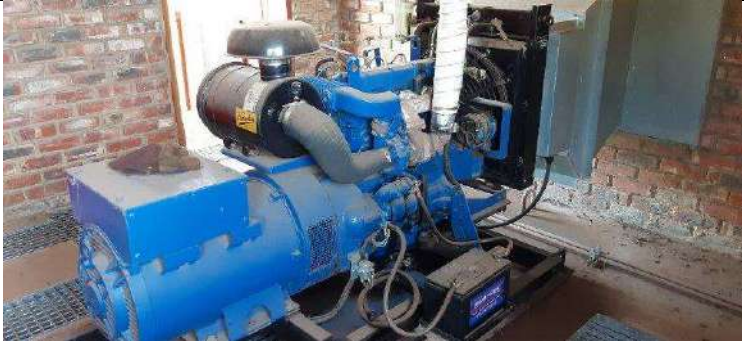
<p><i>Picture 5: Standby Generator located in the Generator Room</i></p> <p>The generator has a power rating of 75kVA, 3 ph @ 0.8 power factor. It is currently non-operational and has accumulated dust. It only supplies the main office building.</p>
5	X

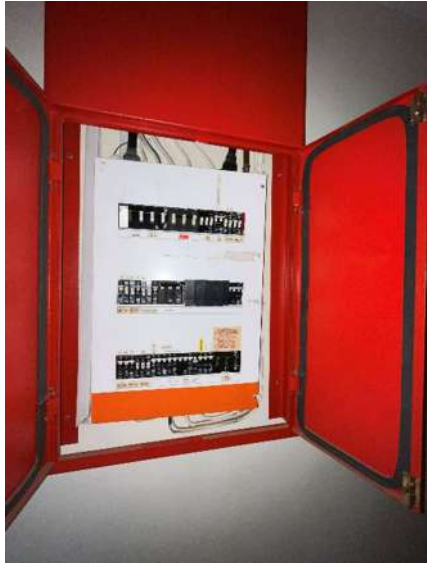
<p><i>Picture 7: Main Office DB (DB-001)</i></p> <p>The main office DB is located in the main office building near the reception. It has a main breaker rating of 60A, 3ph, with a fault level current of 5kA. It is non-compliant to SANS10142 due to some of the spare ways not properly blanked, not properly labelled and missing a legend card. It has emergency provision from the standby generator.</p>
7	X

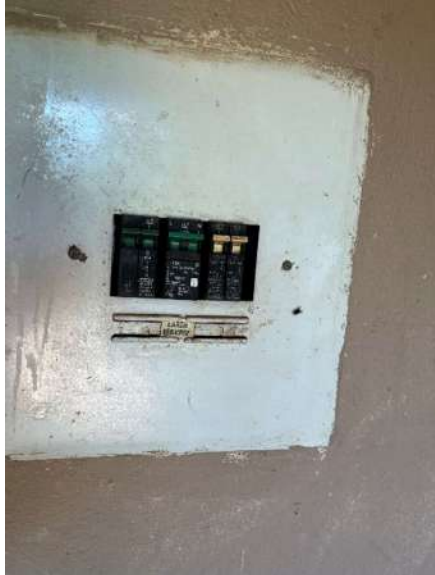
<p><i>Picture 13: Sub DB for Guard House</i></p> <p>The sub DB is located in the security guard house. It is in fair condition since it is non-compliant to SANS10142.i.e. Breakers not completely labelled, no warning signs and no legend card. It needs to be cleaned.</p>
13		X

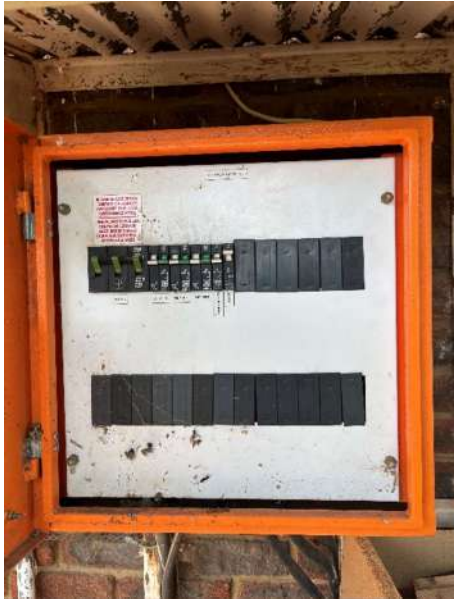
<p><i>Picture 14: Main DB for Single and Married Quarters</i></p> <p>The Main DB is located outside the ablution building near the single and married quarters. It is fed from “kiosk No. 4” and has a main breaker rating of 100A, 3 ph, with a fault level current of 10kA. It is in fair condition and complaint to SANS10142. i.e Properly labelled, warning sign in place and spare ways are blanked with blanking plates. It only needs to be cleaned.</p>

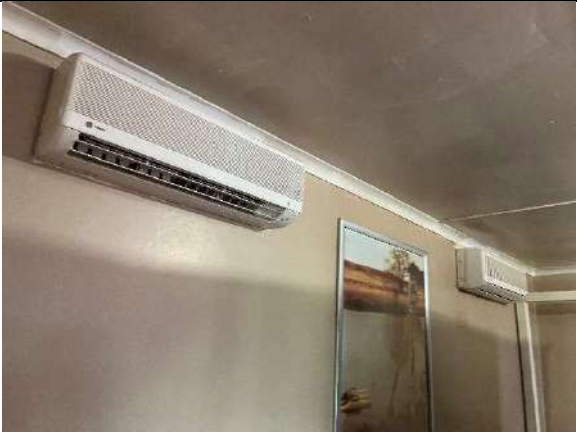
<p><i>Picture 15: Air conditioners (Indoor unit) in the board room</i></p> <p>Air conditioners are located in the board room and some other offices in the main building. They both do not have indoor isolators. They currently only have outdoor isolators.</p>
15			X

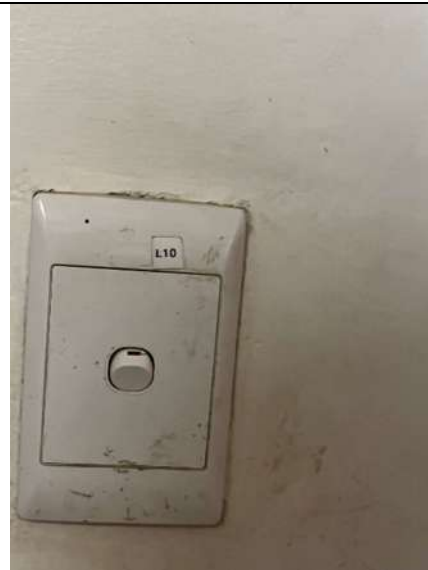
Picture 20: Light Switches

All light switches are in good working condition. Few switches need to be cleaned.

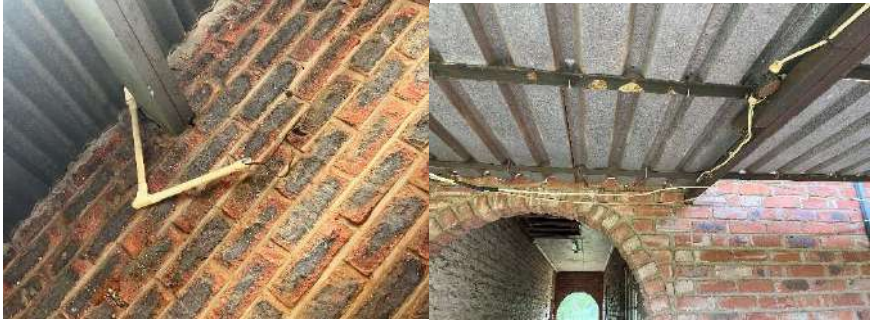
<p><i>Picture 21: Power cables for lights</i></p> <p>Power cables for some of the single quarters lights are in poor condition. i.e. exposed and not properly trunked nor channelled in conduit.</p>
21		X

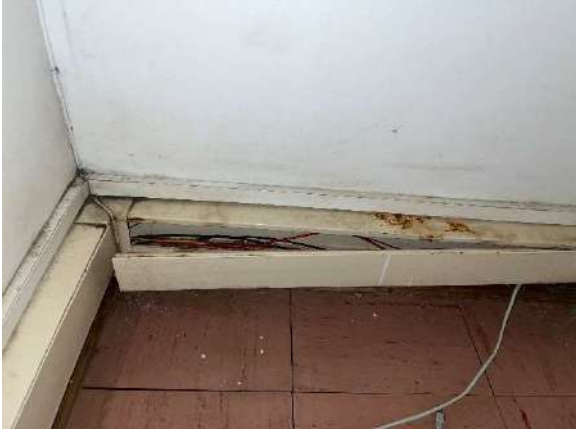
<p><i>Picture 22: Damaged power skirting</i></p> <p>Power skirting are damaged in some of the offices and show signs of rust. This exposes the power cables and violates SANS164 standards.</p>
22		X

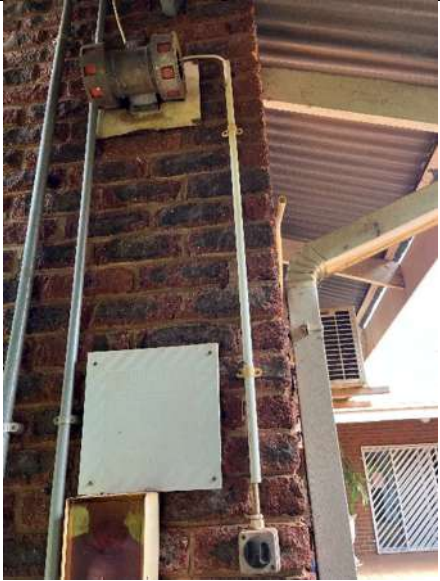
<p><i>Picture 23: Fire alarm Siren</i></p>

Fire alarm siren is in fair condition and operational. The switch is obsolete and the siren is old technology.
23			X

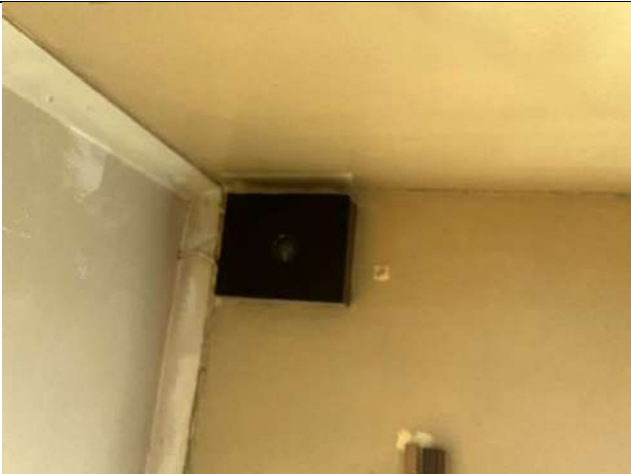
<p><i>Picture 24: Public Address Speaker</i></p> <p>The public address speaker is only installed in the boardroom and is not working</p>
24

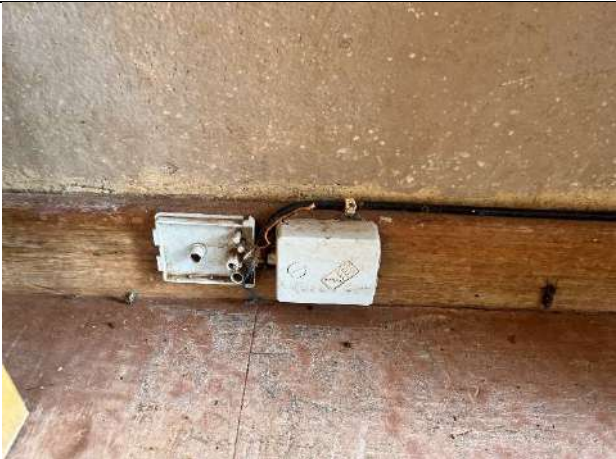
<p><i>Picture 25: Data Outlets</i></p> <p>Majority of the data outlets are damaged and not operational. They are all surface-mounted and not flush-mounted, which makes them prone to damages.</p>

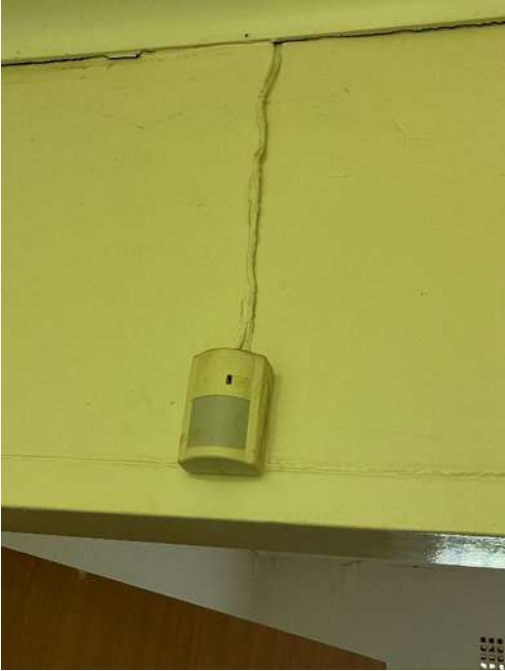
<p><i>Picture 26: Motion Detectors</i></p> <p>All the motion detectors are currently not working and are in poor condition.</p>
----	--	--	---	--

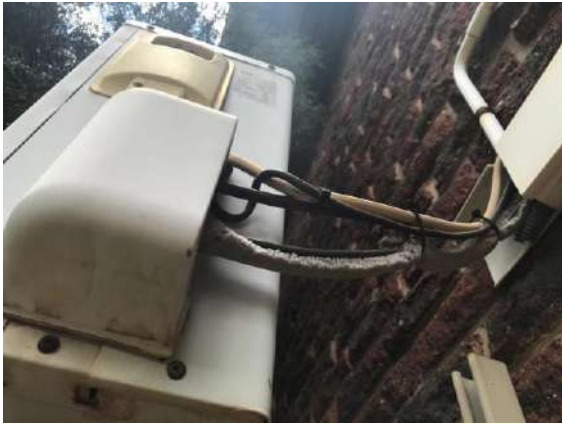
<p>Figure 5. Condenser refrigerant pipes</p> <p>The condenser units are mostly in fair condition with apparent signs of wear and tear on the refrigerant pipes. The pipes need to be re-insulated to ensure that minimal heat transfer occurs between the pipes and environment.</p>
D		X

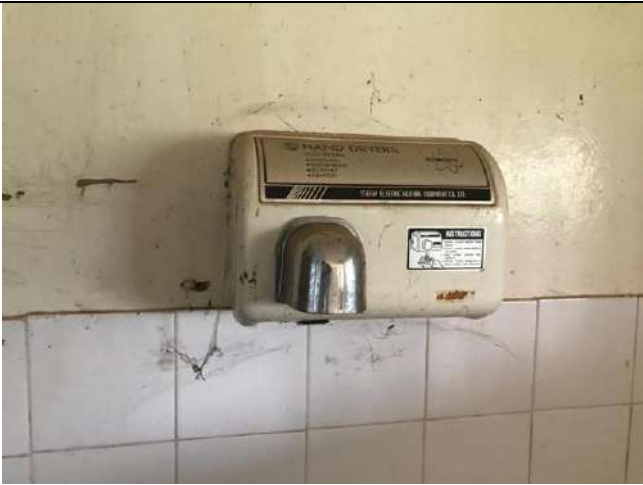
<p><i>Figure 7. Toilet hand dryer</i></p> <p>The hand dryer in the toilet is in poor non-operational condition. The hand dryer should be replaced with paper towels as hand dryers spread germs and bacteria more rapidly than paper.</p>

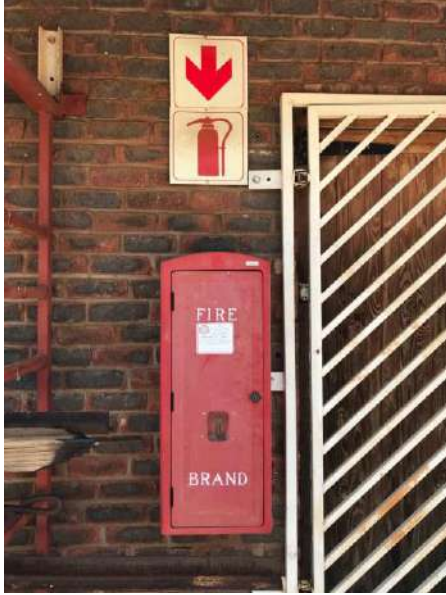
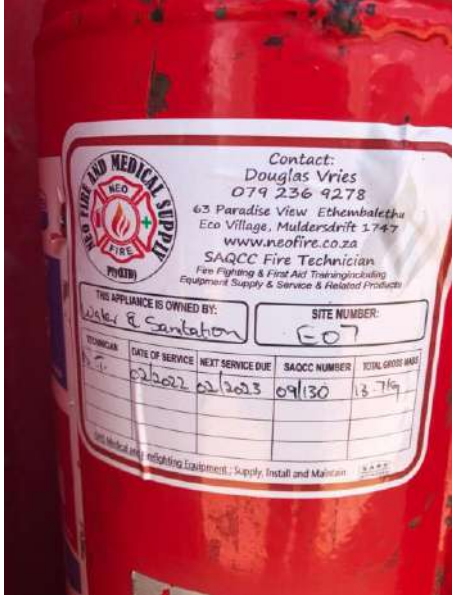
<p><i>Figure 8. Fire extinguisher</i></p> <p>The fire extinguishers are in fair to poor condition with signs of wear. The equipment has been serviced to comply with statutory regulations. The</p>

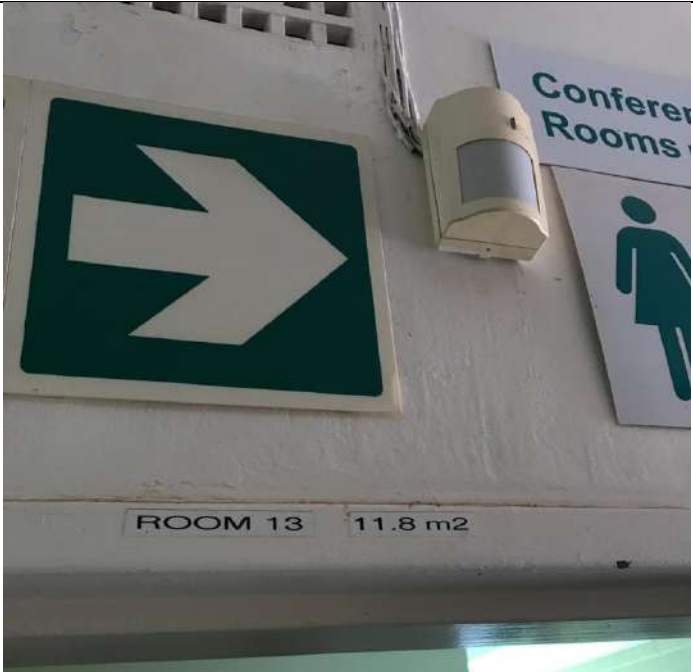
<p><i>Figure 10. Direction signage</i></p> <p>The fire signage is mostly in good condition and does not need to be replaced.</p>

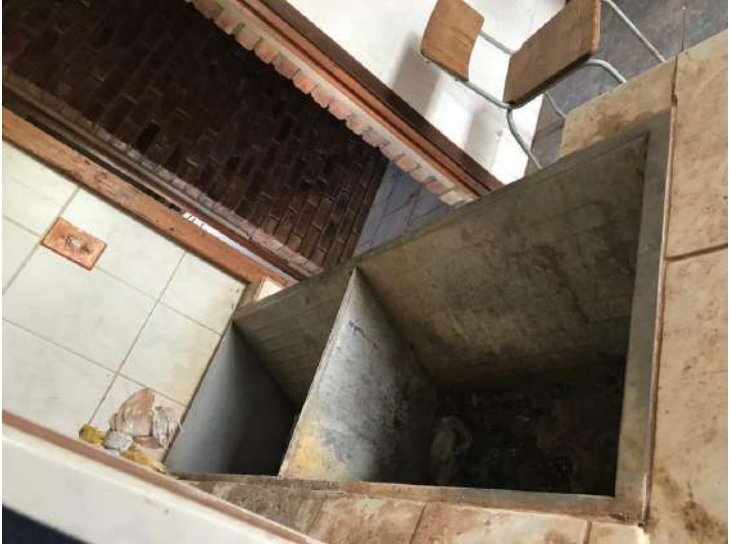
<p><i>Figure 15. Laundry basin</i></p> <p>The laundry basin in the staff residence is in poor condition with extensive signs of deterioration.</p>
E			X

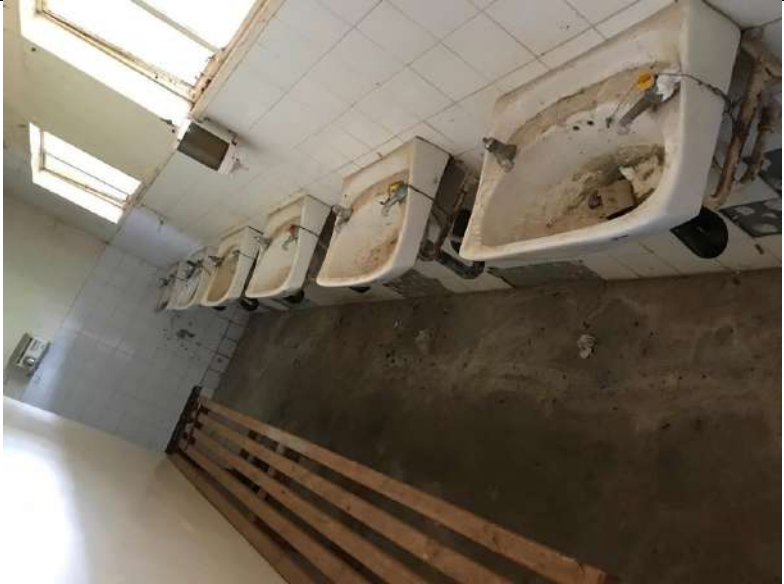
<p><i>Figure 16. Married basins for the communal ablution facility</i></p> <p>The wash hand basins are in poor condition and do not have running water. The poor water supply pipes should be replaced and flexible pipes, coupled with isolating valves should be connected to the copper pipes connected to the fixtures.</p>

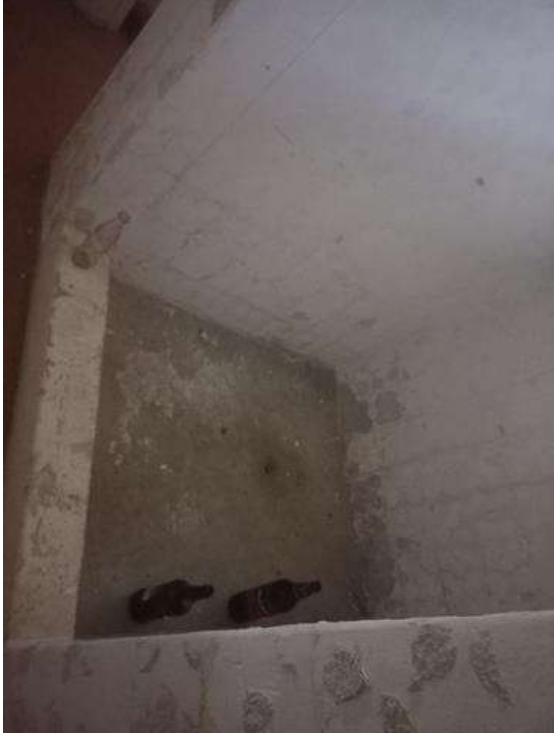
<p><i>Figure 17. Shower in poor condition</i></p> <p>The shower in the conference area is in poor condition. There is no running water and the drainage is also clogged with debris. Therefore, this should be reconstructed or converted into an additional toilet.</p>
G			X

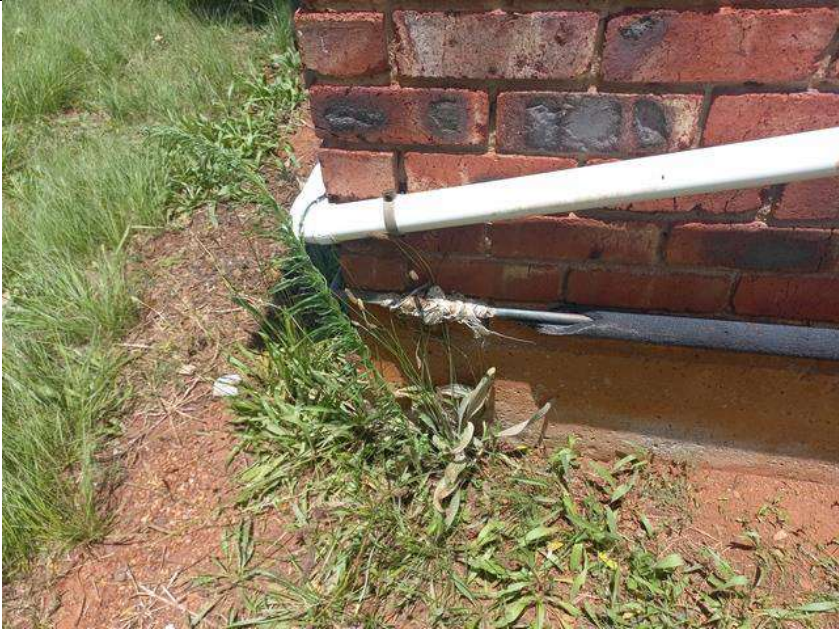
<p><i>Figure 18. Pipe insulation in poor condition</i></p> <p>The pipe insulation has worn out, thus leaving the water pipe exposed to the environment. The pipes should be replaced since they have severe leakages and insulated to avoid reduce heat transfer.</p>

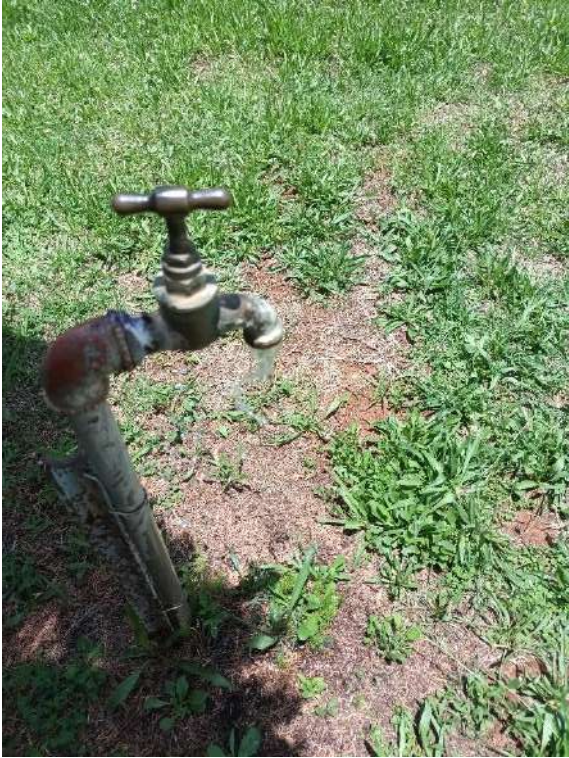
<p><b>Garden tap:</b> located outside the office building, it does not have sufficient pressure.</p>
2.		x		  <p>Gutter at the office building is rusting with the paint chipping off. The down pipe is disconnected to the gutter.</p>

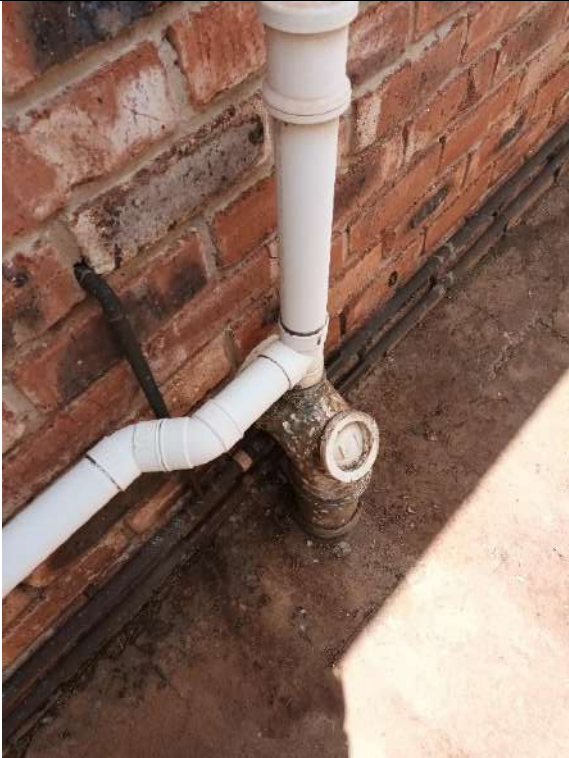
<p><b>Outlet sewer pipe:</b> pipe shows evidence of leaking from the pipe connection.</p>
4.		x

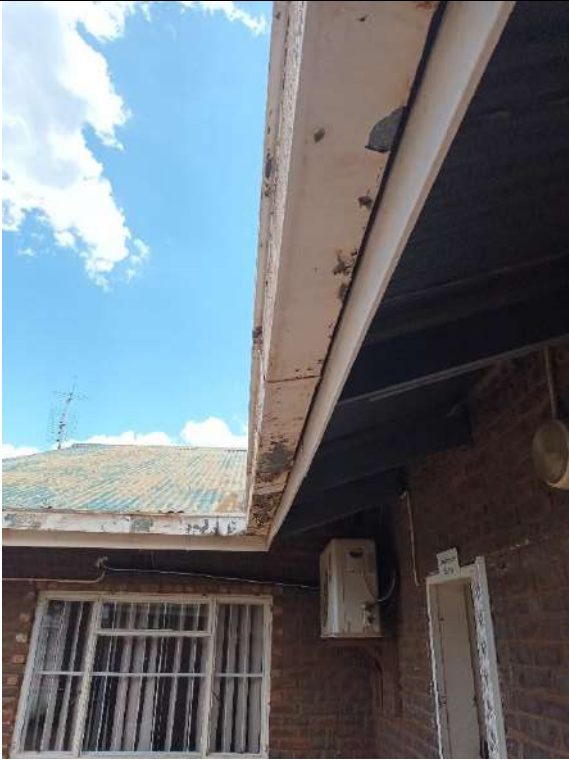
<p>The gutter paint chipped off.</p>

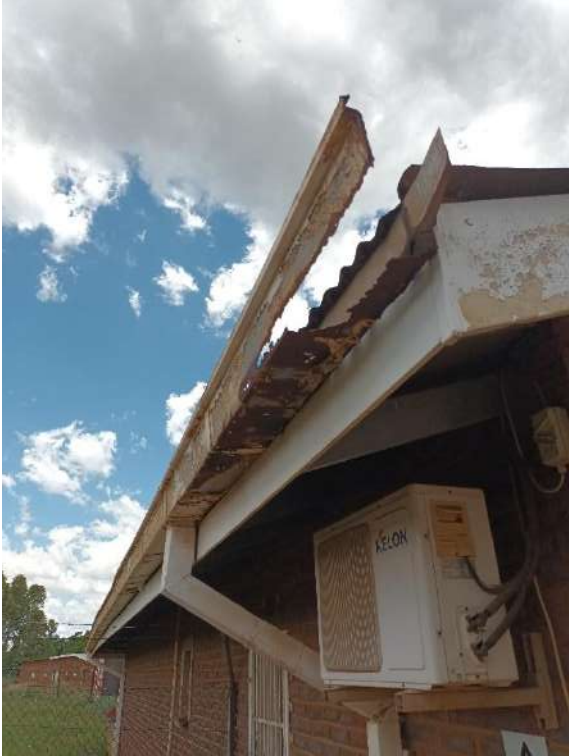
<p>The gutter is rusting and detaching from the roof fascia with the paint already chipped off.</p>
6.		x

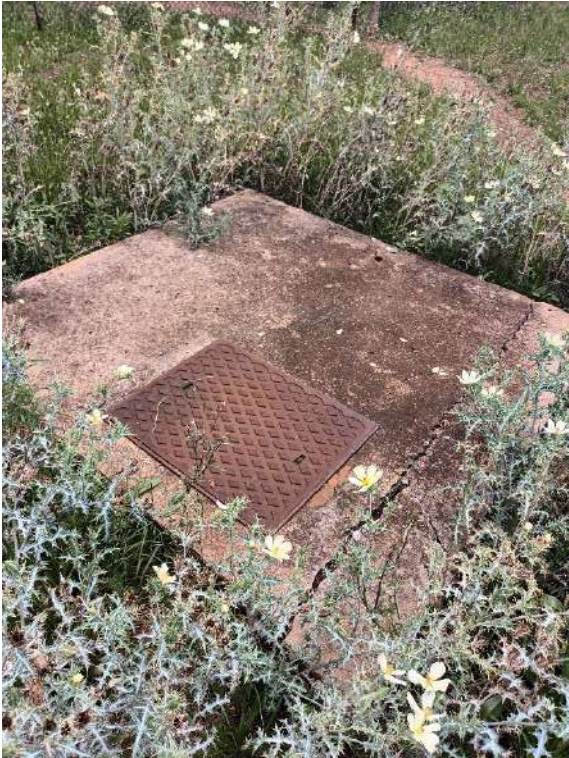
<p><b>Septic tank:</b> slab cover is cracked. The size and capacity of the septic tank is unknown.</p>

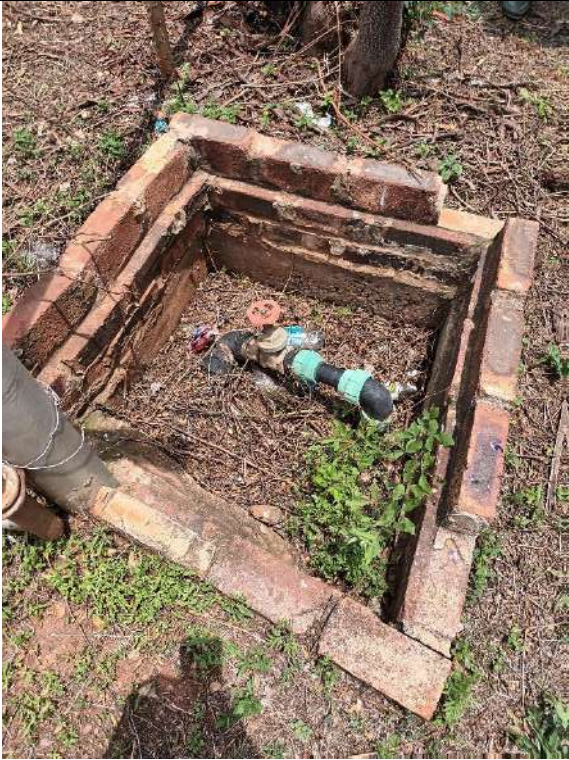
<p><b>Exposed HDPE pipe and Valve:</b> the chamber cover is removed and is no longer stable with deposits of tree material. The gate valve is damaged.</p>

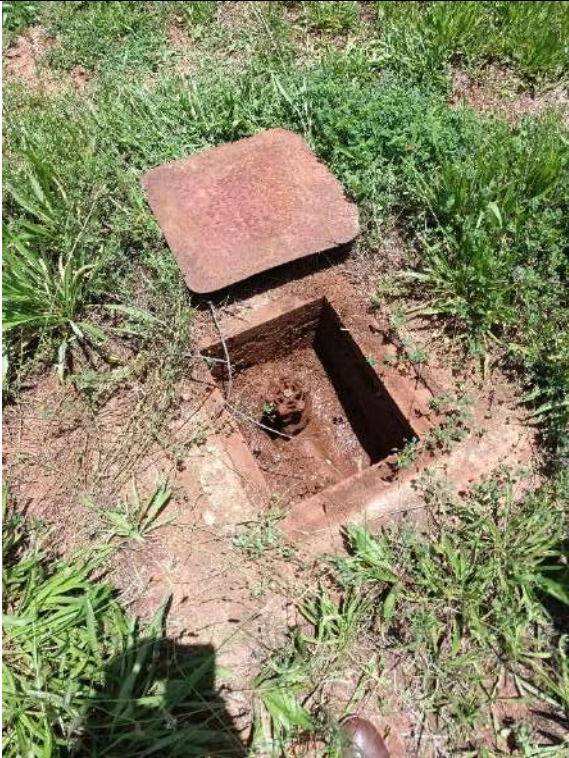
<p><b>Chamber cover and Valve:</b> the valve chamber cover has rusted and the gate valve is damaged.</p>
10.			x

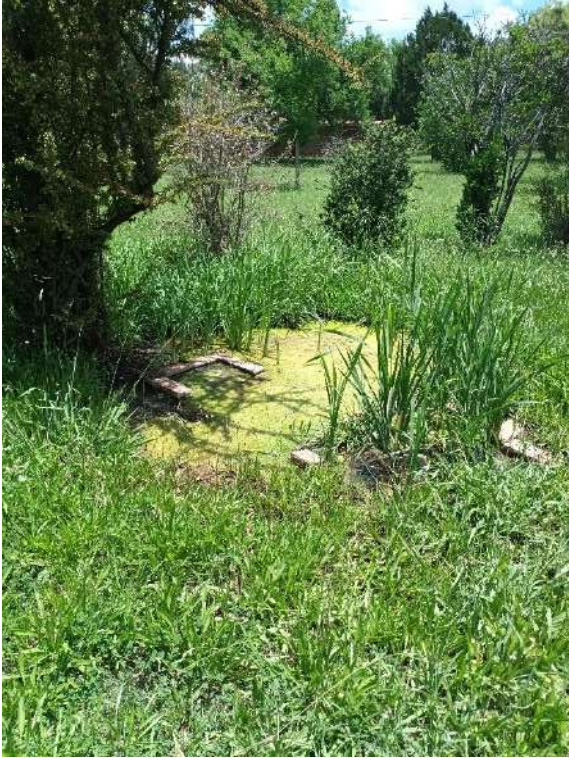
<p><b>Water ponding:</b> valve chamber collapsed causing possible water leakage that has resulted in water ponding with algae.</p>

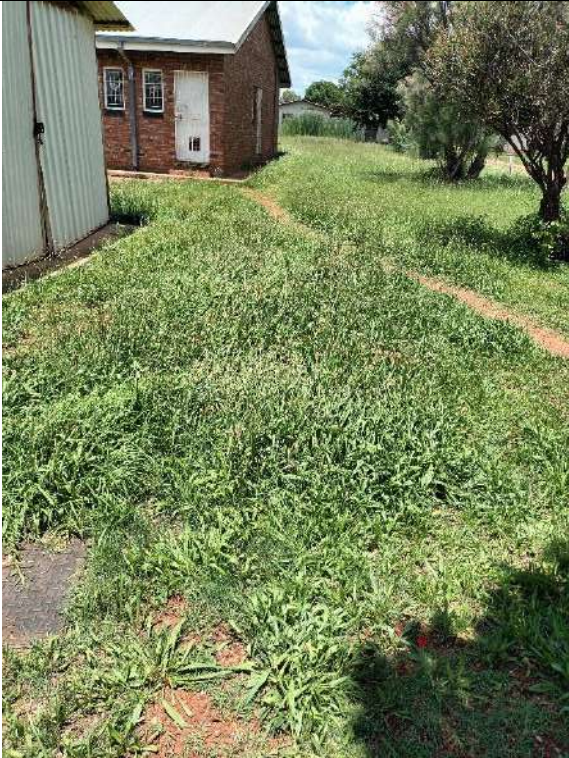
<p><b>Guardhouse septic tank:</b> there might be a possible leakage of the septic tank, which sproutes vegetation.</p>
14.	x

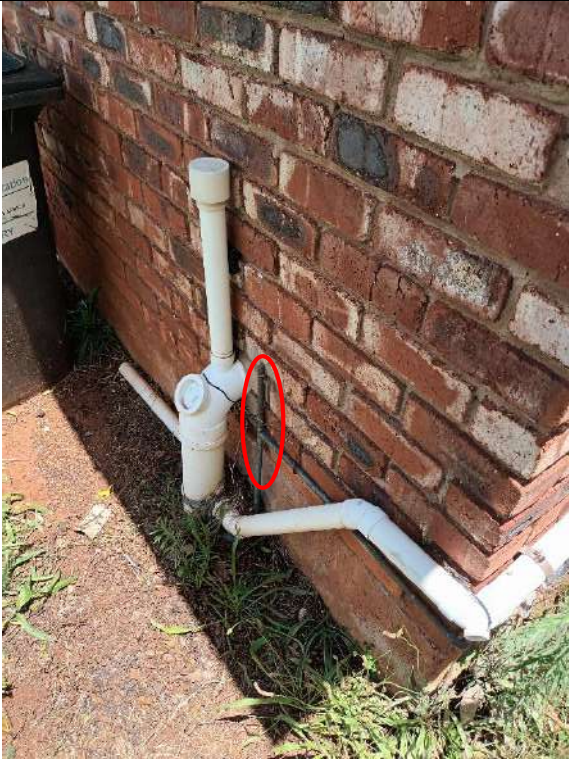
<p><b>Sewer drainage pipe and the inlet water supply pipe:</b> the sewer-drainage pipe for the guard house is in good functioning condition however there is no water supply for the inlet water supply pipe for the toilet.</p>

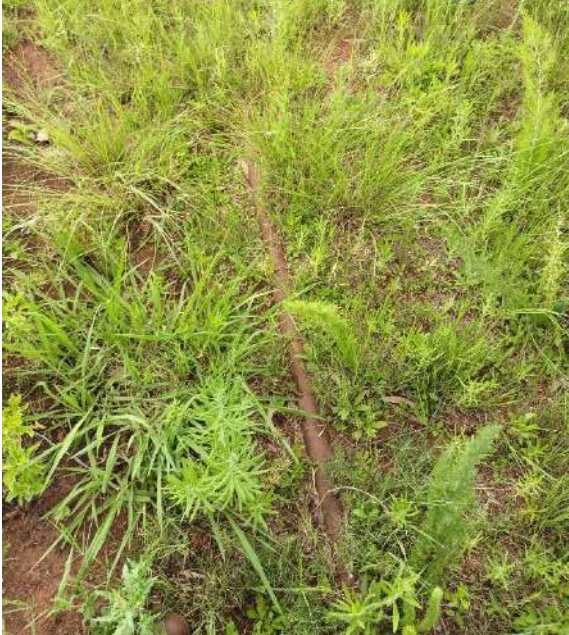
<p>Above ground steel pipe has rust. No visible marking for above ground pipeline.</p>

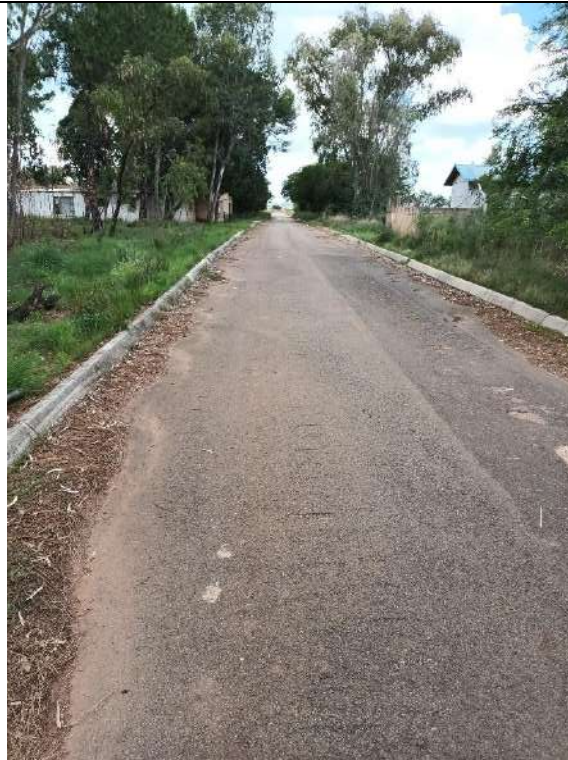
**Access road:** Crack sealing and maintenance is required

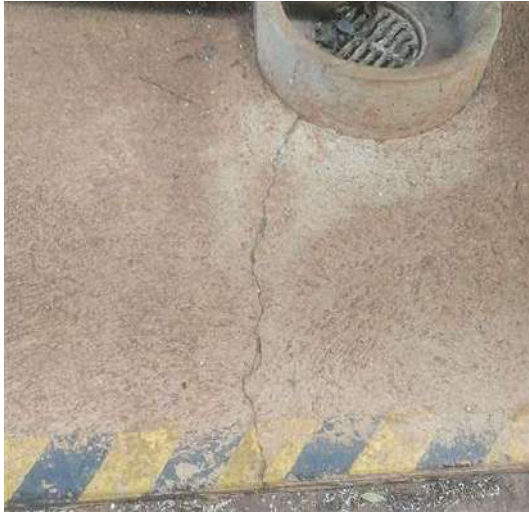
<p>Figure 5: Crack on apron slab – Snoepie room</p>		X		<p><b>Findings:</b></p> <ul style="list-style-type: none"> <li>The apron slab outside the Snoepie room had transverse cracks &lt; 5mm. Refer to <b>Figure 5</b>.</li> </ul> <p><b>Impact/Risk:</b></p> <ul style="list-style-type: none"> <li>The cracks serve as openings which may lead to moisture ingress into underlying soil and foundation.</li> </ul> <p><b>Recommendation:</b></p> <ul style="list-style-type: none"> <li>Clean the surface of the crack, apply epoxy coating to fill the crack as specified by a Structural Engineer.</li> </ul>

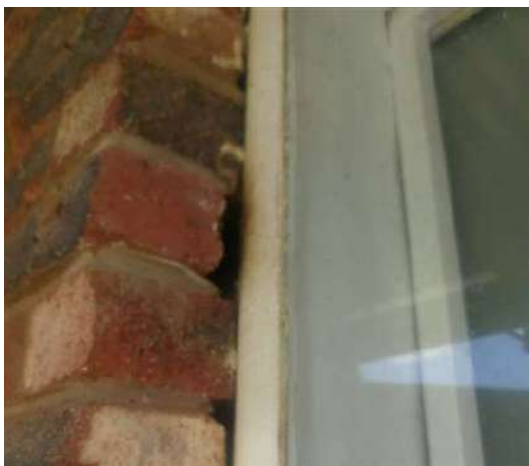
Figure 9: Voids in the mortar along the window opening - Archive		X		<p><b>Findings:</b></p> <ul style="list-style-type: none"> <li>• The window opening of the Archive office had visible voids from the missing mortar. Refer to <b>Figure 9</b>.</li> </ul> <p><b>Impact/Risk:</b></p> <ul style="list-style-type: none"> <li>• Moisture ingress into the masonry wall and the building.</li> </ul> <p><b>Recommendation:</b></p> <ul style="list-style-type: none"> <li>• Chip out all loose material and fill voids with mortar.</li> </ul>

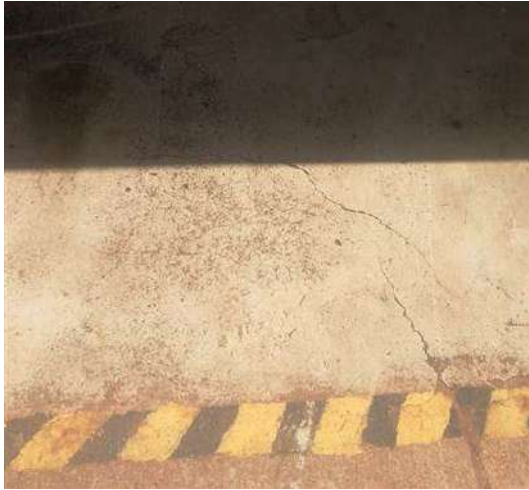
<p>Figure 10: Map cracks on ramp - Workshop</p>		X		<p><b>Findings:</b></p> <ul style="list-style-type: none"> <li>The ramp leading to the workshop had map cracks &lt; 5mm. Refer to <b>Figure 10</b>.</li> </ul> <p><b>Impact/Risk:</b></p> <ul style="list-style-type: none"> <li>Refer to the impacts/risks associated with <b>Figure 5</b>.</li> </ul> <p><b>Recommendation:</b></p> <p>Refer to the recommendations made for <b>Figure 5</b>.</p>

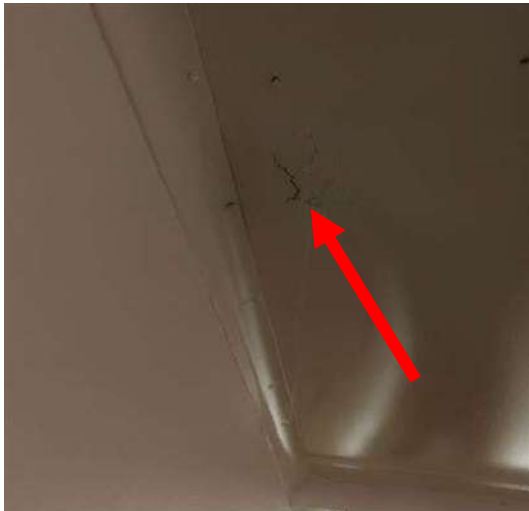
<p>Figure 11: Leaking ceiling - Hallway</p>			X	<p><b>Findings:</b></p> <ul style="list-style-type: none"> <li>Signs of water leakages were observed on the hallway ceiling. Refer to <b>Figure 11</b>.</li> </ul> <p><b>Impact/Risk:</b></p> <ul style="list-style-type: none"> <li>The water may cause rotting of the timber trusses above the ceiling.</li> </ul> <p><b>Recommendation:</b></p> <ul style="list-style-type: none"> <li>Further assess the timber trusses to determine the extent of damage (if any). Repair and/or replace the timber trusses if needed.</li> <li>Determine the source(s) of the water leaks and seal them off.</li> </ul>

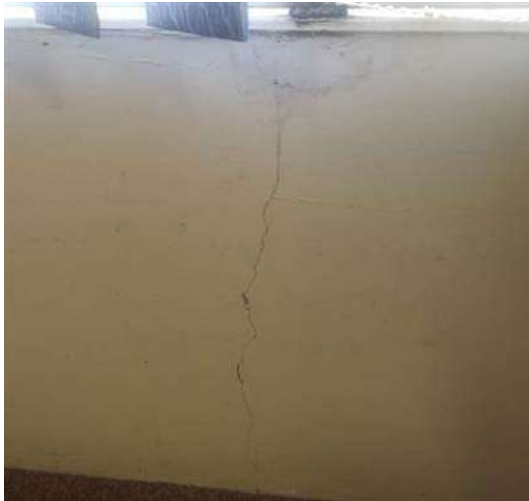
<p>Figure 13: Vertical crack under the window sill - Boardroom</p>
