## ENGINEERING SERVICES INVESTIGATION REPORT

STATUS	INVESTIGATION REPORT
SUBJECT:	DWS: Boskop Area Offices Multidisciplinary condition assessment

<b>STATUS</b>	<b>TECHANICAL INVESTIGATION REPORT</b>
<b>SUBJECT:</b>	<b>Department of Water and Sanitation (DWS): Boskop Area Offices Electrical Infrastructure Condition Assessment</b>

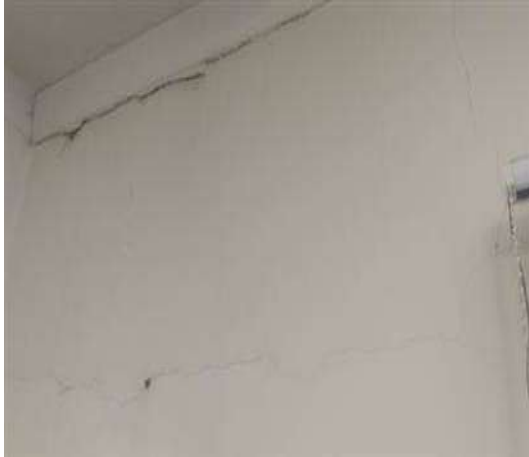
<p>Figure 14: Cracks on walls - Boardroom</p>		X		<p><b>Findings:</b></p> <p>The following defects were observed in the boardroom:</p> <ul style="list-style-type: none"> <li>• A vertical crack &lt; 5mm going through the air brick above the entrance. Refer to <b>Figure 12</b>.</li> <li>• A vertical crack &lt; 5mm going from the window sill to the surface bed level. Refer to <b>Figure 13</b>.</li> <li>• A horizontal and vertical crack on a section of the wall. Refer to <b>Figure 14</b>.</li> </ul> <p><b>Impact/Risk:</b></p> <ul style="list-style-type: none"> <li>• Refer to the impact/Risk associated with <b>Figures 2, 3, and 4</b>.</li> </ul> <p><b>Recommendation:</b></p> <ul style="list-style-type: none"> <li>• For the defects associated with <b>Figure 12</b>, perform detailed analyses and investigations to determine if the beam is properly supported and the most effective remedial action.</li> <li>• For <b>Figures 13 and 14</b> refer to the recommendations made for <b>Figures 2, 3, and 4</b>.</li> </ul>

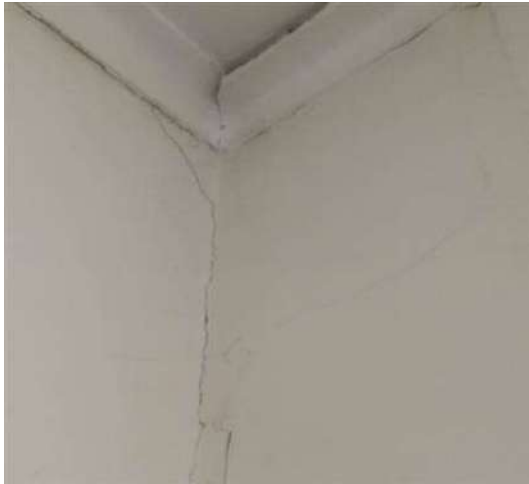
<p>Figure 19: Vertical crack at the corner (1 of 2) - Toilet</p>

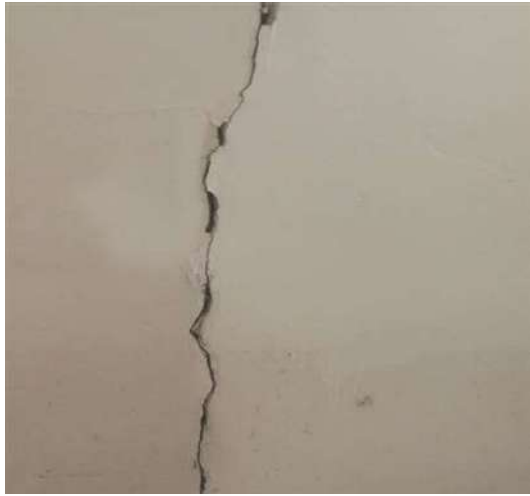
<p>Figure 21: Vertical crack on storeroom wall – Store 1</p>

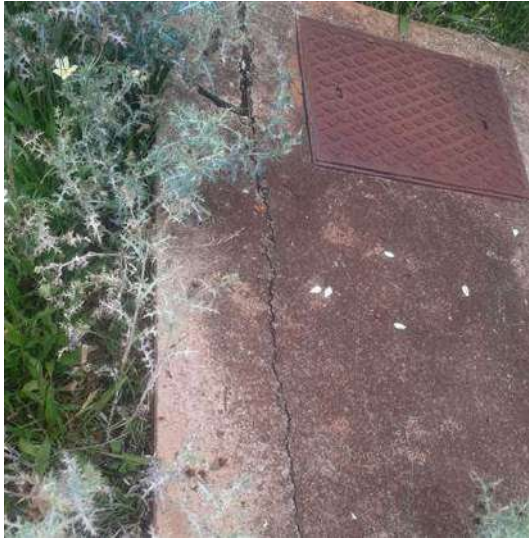
<p>Figure 27: Transverse crack on septic tank slab</p>			X	<p><b>Findings:</b></p> <ul style="list-style-type: none"> <li>The septic tank next to office block A had a crack spanning across its surface ranging from approximately 3mm to 10mm. Refer to <b>Figure 27</b>.</li> </ul> <p><b>Impact/Risk:</b></p> <ul style="list-style-type: none"> <li>The crack exposes the slab to external elements (i.e. moisture), resulting in loss of mechanical strength.</li> <li>The crack poses an Occupational Health and Safety risk.</li> </ul> <p><b>Recommendation:</b></p> <ul style="list-style-type: none"> <li>Demolish and recast the concrete slab.</li> </ul>

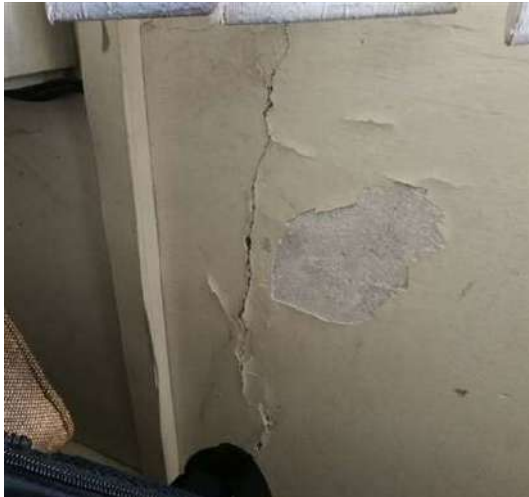
<p><i>Figure 29: Vertical crack under the window sill – Data room</i></p>				<p><b>Findings:</b></p> <ul style="list-style-type: none"> <li>The Data room (room 16) had a vertical crack &lt; 5mm going from the window sill to the surface bed level. Refer to <b>Figure 29</b>.</li> </ul> <p><b>X Impact/Risk:</b></p> <ul style="list-style-type: none"> <li>Refer to the impact/Risk associated with <b>Figures 2, 3, and 4</b>.</li> </ul> <p><b>Recommendation:</b></p> <p>Refer to the recommendation made for <b>Figures 2, 3, and 4</b>.</p>

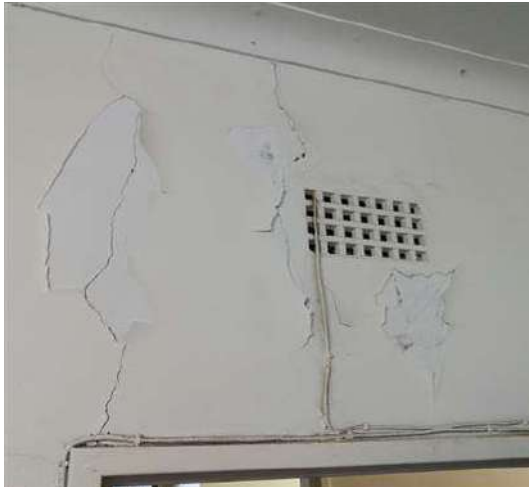
<p><i>Figure 30: Vertical cracks above entrance - Deon</i></p>				<p><b>Findings:</b></p> <p>The following defects were observed in Deon office:</p> <ul style="list-style-type: none"> <li>Vertical cracks &lt; 5mm above the doorway that are visible on both sides of the wall. Refer to <b>Figure 30</b>.</li> </ul> <p><b>X</b></p> <ul style="list-style-type: none"> <li>Map cracks surrounding the air brick. Refer to <b>Figure 31</b>.</li> </ul>
