LEPELLE NORTHERN WATER

CONDITION ASSESMENT ON 9.5KM PIPELINE AT PHALABORWA WTW.

COASTTECH PROJECTS (PTY) LTD.

15 March 2024

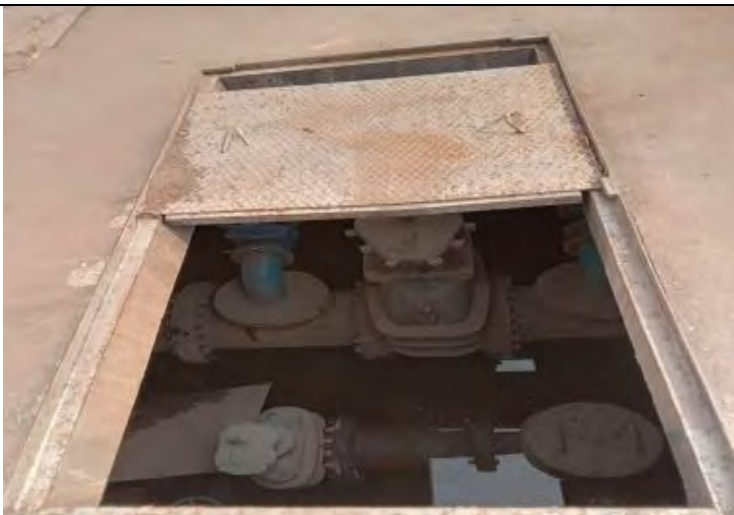
There are vandalized test stations situated along the pipeline route. The test stations are classified as critical bond, bonding and/or monitoring test stations. Start and end potential readings were taken at the valves at the WTW and Chambers, concluding a 9000m survey. The detailed test station report is contained in Appendix 1. Other valve chambers were opened and visually inspected, most contained water surrounding the pipeline. External corrosion was visible in areas where the pipe was in-direct contact with the water, inside the valve chamber.

FIGURE 1 : WATER FLOODED VALVE CHAMBER.

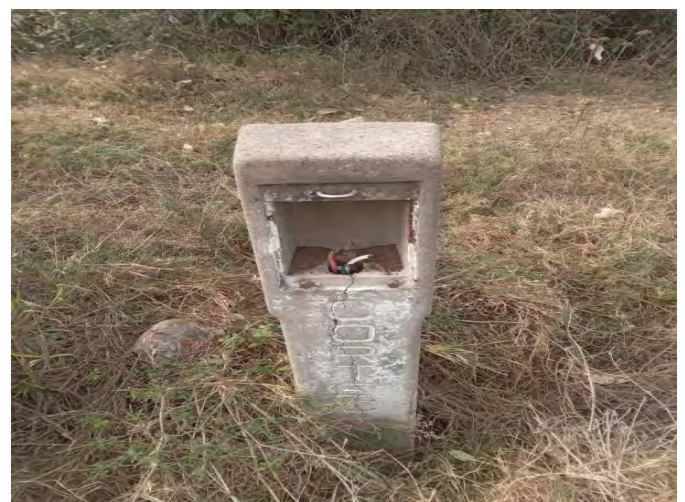
FIGURE 2 : CP TEST POST

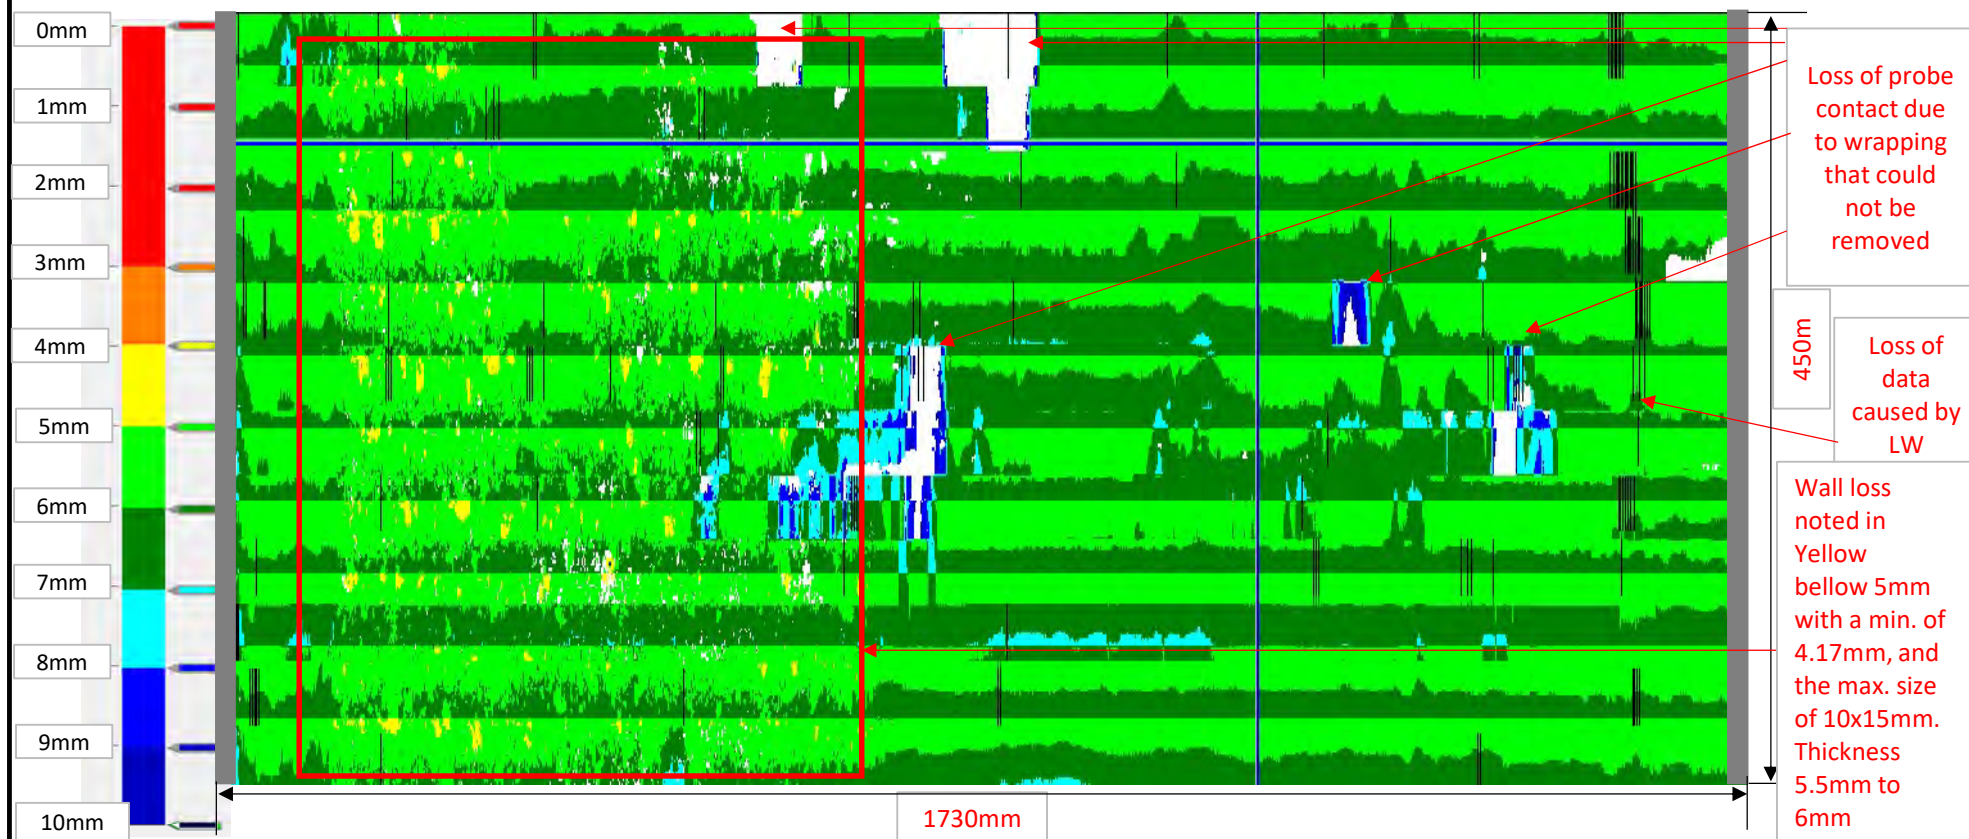
NDT tests measured a pipe wall thickness of 4.17mm to 6mm at Scan Excavation 1A and pipe wall thickness at Scan Excavation 1B indicating no wall loss noted as thickness ranges from 5.5mm.

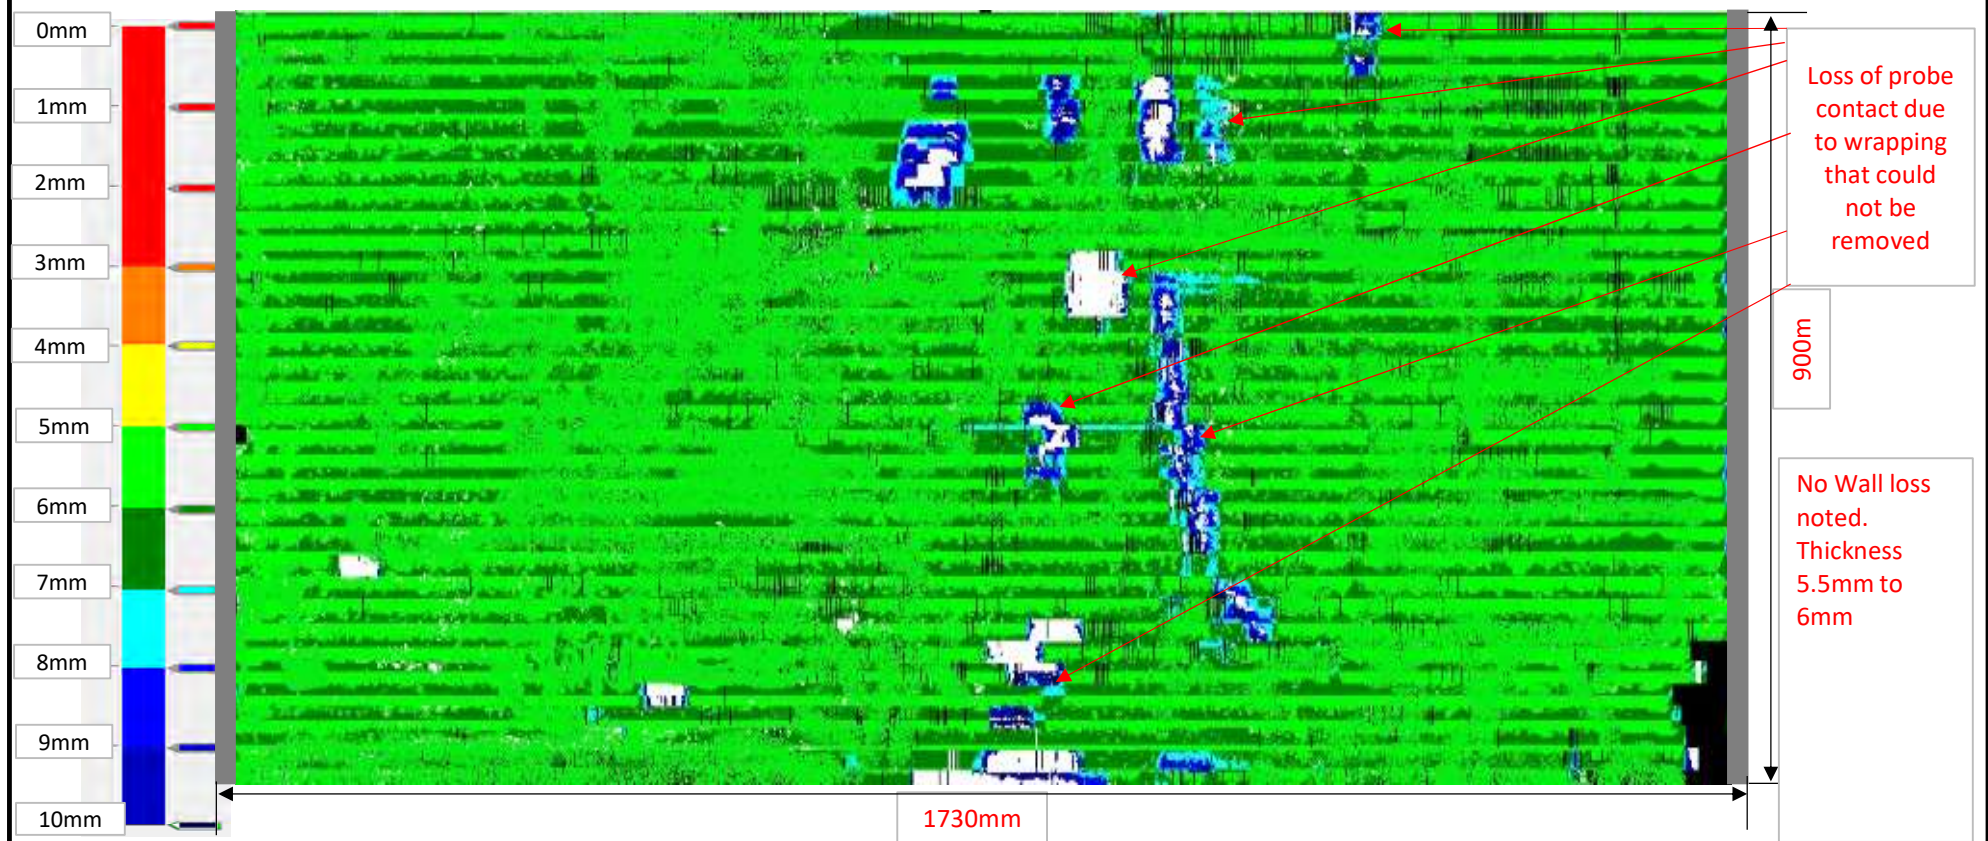
Scan Excavation 2

No visible metal loss was found on removal of the coating. NDT tests measured a pipe wall thickness of 5.5mm along this section and were reported as acceptable.

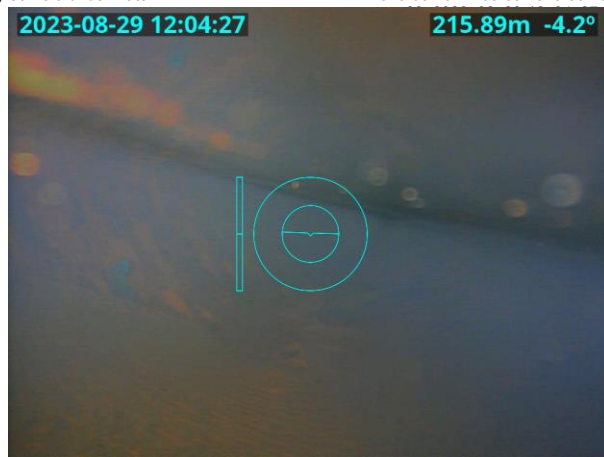
(CU) Camera under water . /2023-08-29-11-35-09/2023-08-29-11-35-
2023-08-29 12:04:27 215.89m -1.2° 41.jpg

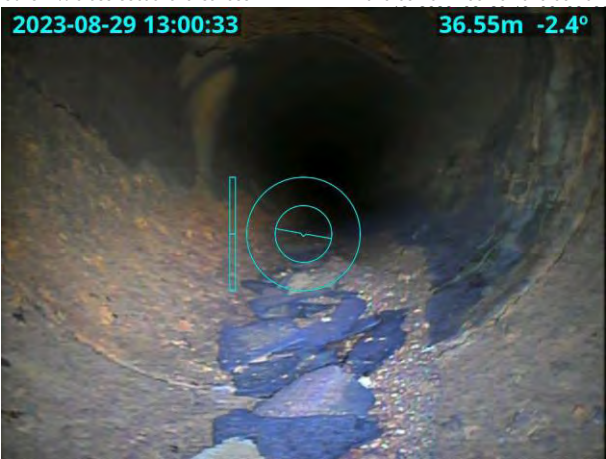
(DE) Debris ...% cross-sectional area loss
 ./2023-08-29-12-55-16/2023-08-29-12-55-16_2023_08_29-13_25_01_923.jpg

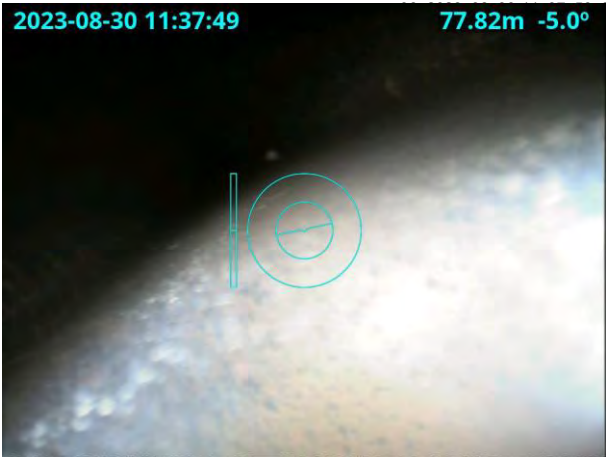
(CU) Camera under water
