Duvha Power Station	Unit	2
	Genix ID	17610
	Date	2020/03/08

Outage type	MGO	Outage start date	2022/01/07
Department	Turbine Engineering	System	Main turbine Condenser
Scope review date	N/A

1. DETAILED SCOPE OF WORK: MAIN TURBINE CONDENSER

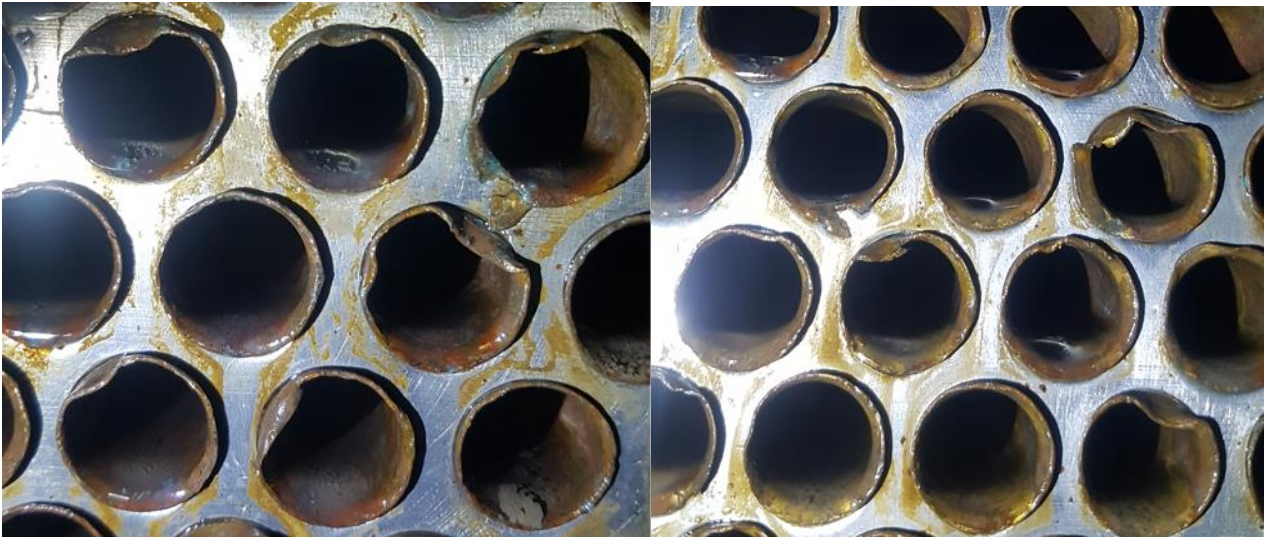
Figure 2: Cold condenser “B” pass inlet tubesheet

From the photo it is apparent that there are mechanical damage to the tube inlets. It is possible that this damage could have been caused by a loose sacrificial anode plate that got thrown around in the waterbox.

This damaged can be repair by either using a expander to slightly expand the tubes or flaring tool or a combination of the two. The final process will be discussed with the appointed contractor in the kick of meeting. It is suggested that the appointed contractor inspect the damaged tubes before quotation to ensure the extent of the damage are catered for. The *Contractor* will be responsible for all the indicated repairs.

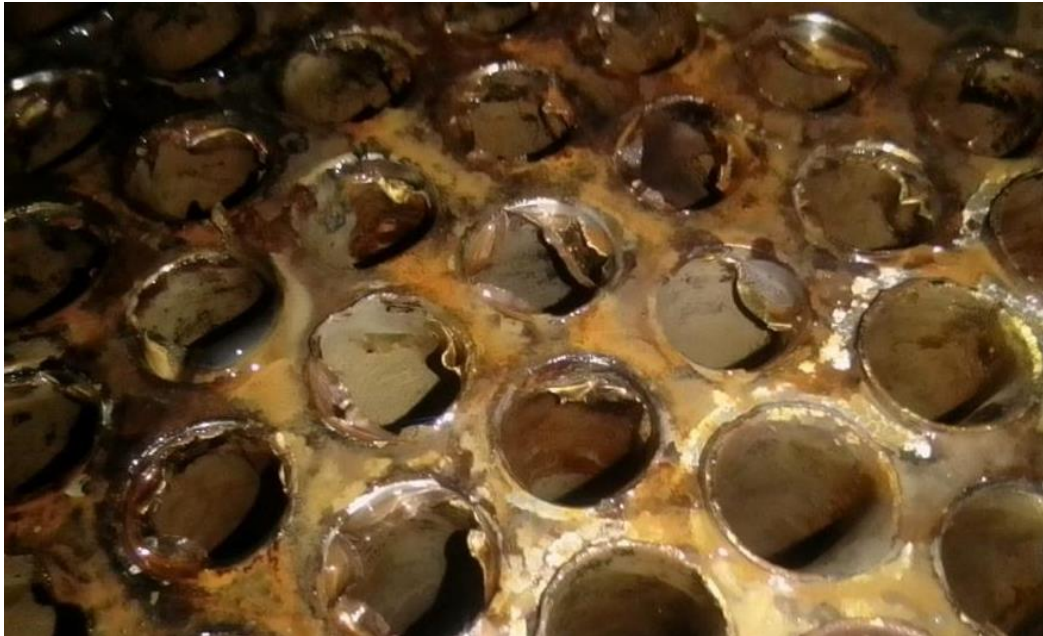
Figure 3: Hot condenser “B” pass inlet tubesheet

In the photo below the hot condenser “B” pass tubesheet are shown. With closer inspection it could be seen that tube inlet wall thickness is very thin. Some of the pieces was broken of and the thickness was measured to be 0.1 to 0.2 mm. The damage mechanism is a combination of tube inlet end erosion and damaged caused by HP water jetting.

A combination of tube pulling(including plugging) and re-expansion of the tube ends will be necessary to repair the damaged tube ends. It is suggested that the *Contractor* inspect the damaged tubes before quotation to ensure the extent of the damage are catered for. The *Contractor* will be responsible for pulling and plugging of the tubes as well as all expansion related activities.
