### **PRELIMINARY STRUCTURAL CONDITION ASSESSMENT REPORT FOR FISH JETTY BUILDING AT WILSON'S WHARF**

Project Name : Preliminary Condition Assessment (Fish-Jetty Building)

Owner : Transnet National Ports Authority

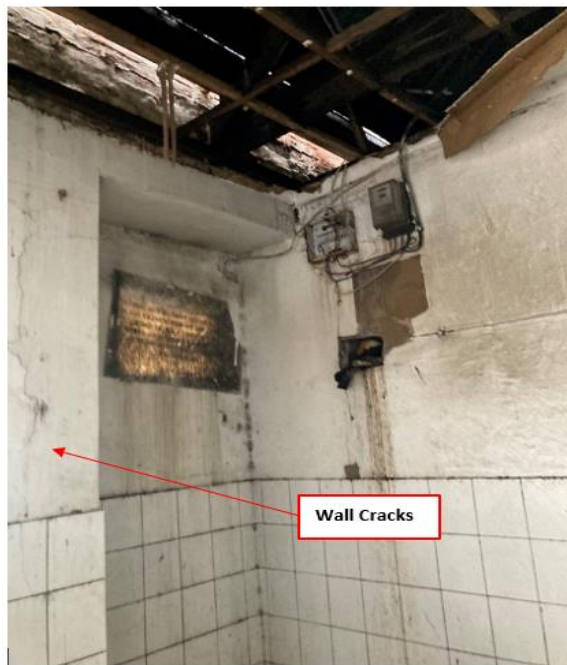
*Figure 4: Interior Walls on the Western Section*

For the interior walls, especially at the western section (formally used for frozen food storage), significant cracks can be seen. There were no loading testing excises done but with engineering judgement from the visual inspection; the cracks are taken as indication of minor settlement of the structure. The other sections consist of ceramic tiled walls. Significant cracks are also observable along the window lintels as shown on Figure 5. Structural dampness can also be observed on the walls of the building (Figure 6), this could be either the result of intrusion from outside or condensation from within the structure. A high proportion of damp problems in buildings are caused by ambient climate dependent factors of condensation and rain penetration.

The current state of the building renders it unsuitable for occupancy, as there is a significant quantity of cracks present in the load-bearing walls, indicating structural settling. Consequently, a comprehensive evaluation is required to assess the stability of the building's foundation and the surrounding soil conditions.

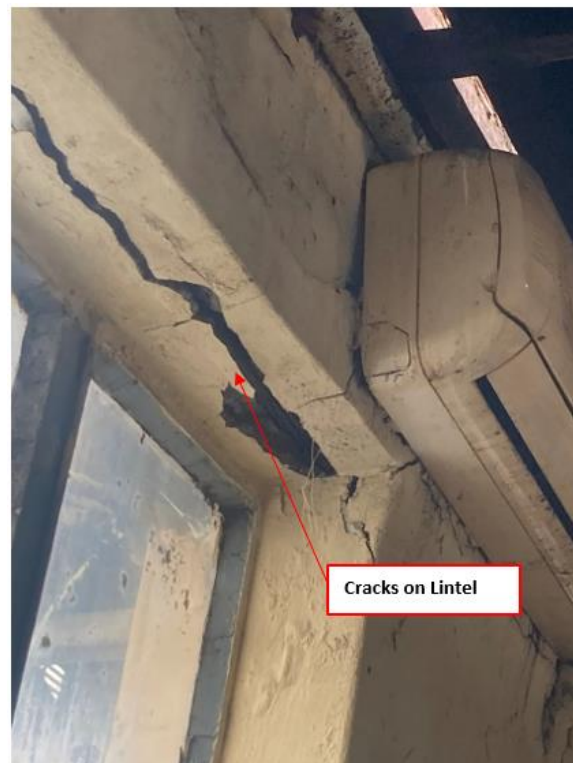
*Figure 5: Wall Cracks Close to Windows*

- The observed cracks require further investigation to establish the root cause. It is typical for vertical cracks to form on building walls when there is minimal settlement on the structure's foundation.
- The Wall dampness combined with cracks on the concrete lintel above the window could also compromise the strength of the wall.

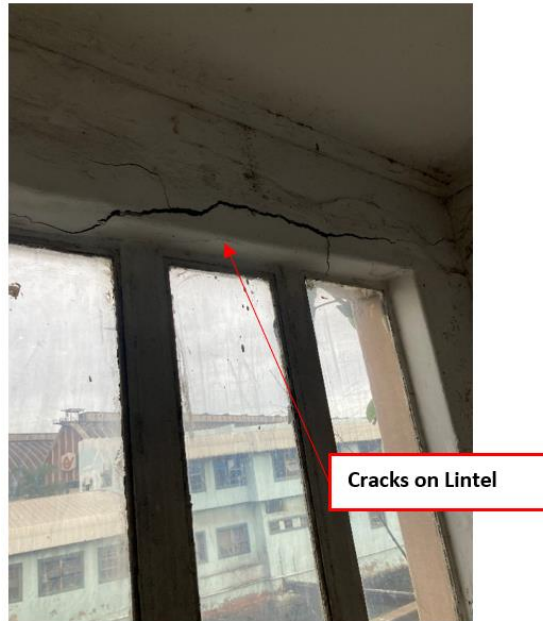
*Figure 7: Eastern Section Cracks on Concrete Lintel*

The observation from the Eastern wing also indicates similar level of damages, with most significant cracks found around the window lintel. Figures 7 & 8 show the identified damages.

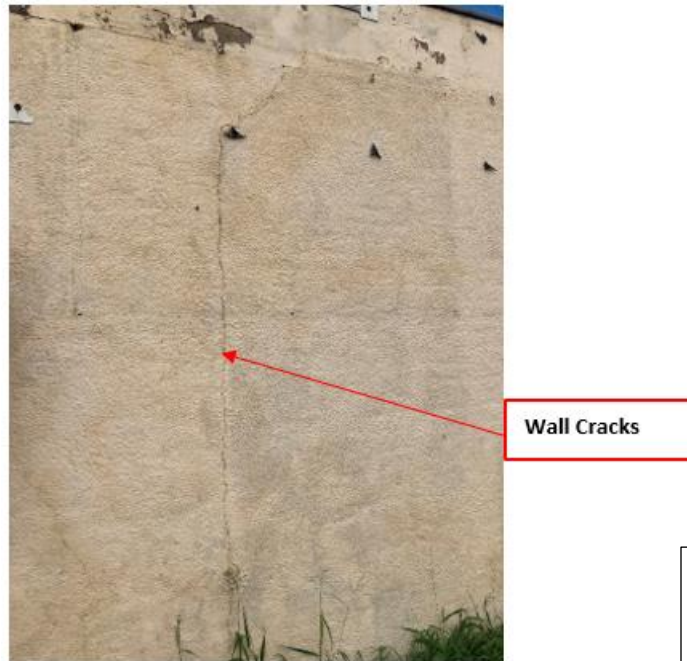
*Figure 9: Exterior Cracks*

A thorough structural examination is advised due to the discovery of small fractures primarily concentrated on the western portion of the exterior walls.

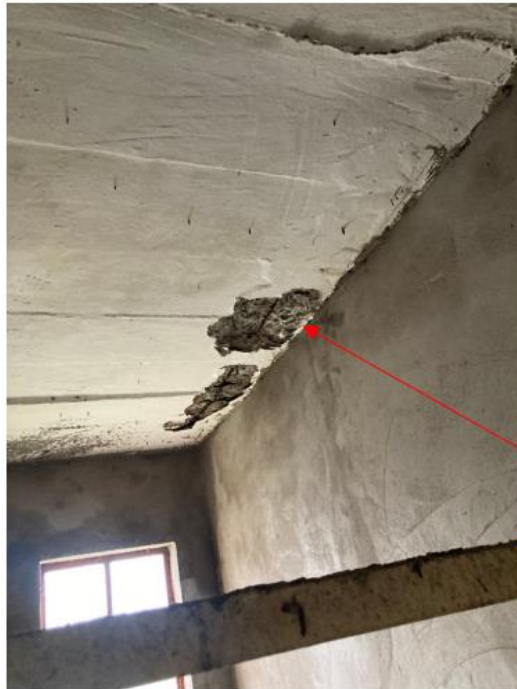
*Figure 12: Concrete Spalling*

Findings from the building inspection reveal spalling on the soffit of the roof slab, specifically in the eastern section. In the western section, the roof is composed of asbestos sheets supported by timber trusses. The asbestos sheeting has sustained damage, and the trusses have been exposed to prolonged rain, leading to evident harm to the ceiling and carpets. Figures 12 & 13 show the extent of damage.

**Concrete Spalling on  
Rood Slab Soffit**

Some spalling was identified on the underside (soffit) of the roof slab. However, there were no major concrete refurbishment required.

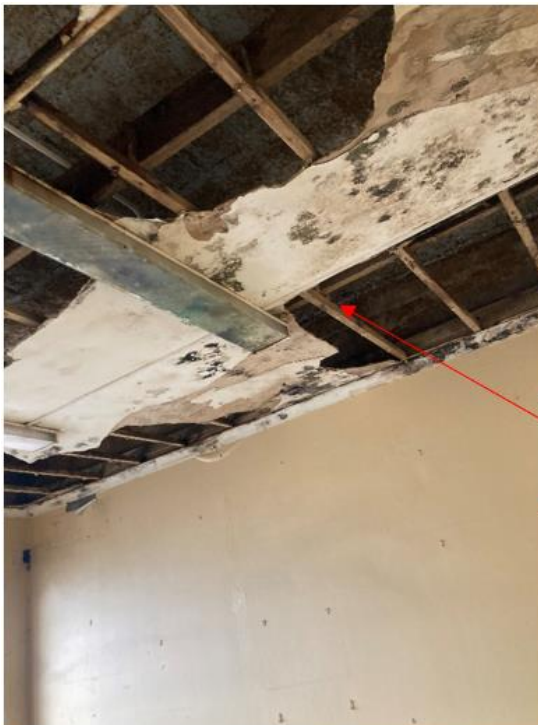
*Figure 13: Damaged Ceiling*

**Damaged Ceiling  
Board**

- a) Replacement of the asbestos roof.
- b) Further evaluation of the timber roof frame to determine the residual strength of its members.
- c) Arrangement of necessary equipment, such as scaffolding, to inspect the roof drainage system.
- d) Restoration of the interior drywall, floors, doors, and windows.
- e) Cleaning of the floor surface followed by a visual inspection.
- f) Engagement of a Professional Service Provider to perform a structural assessment of the building's foundation.

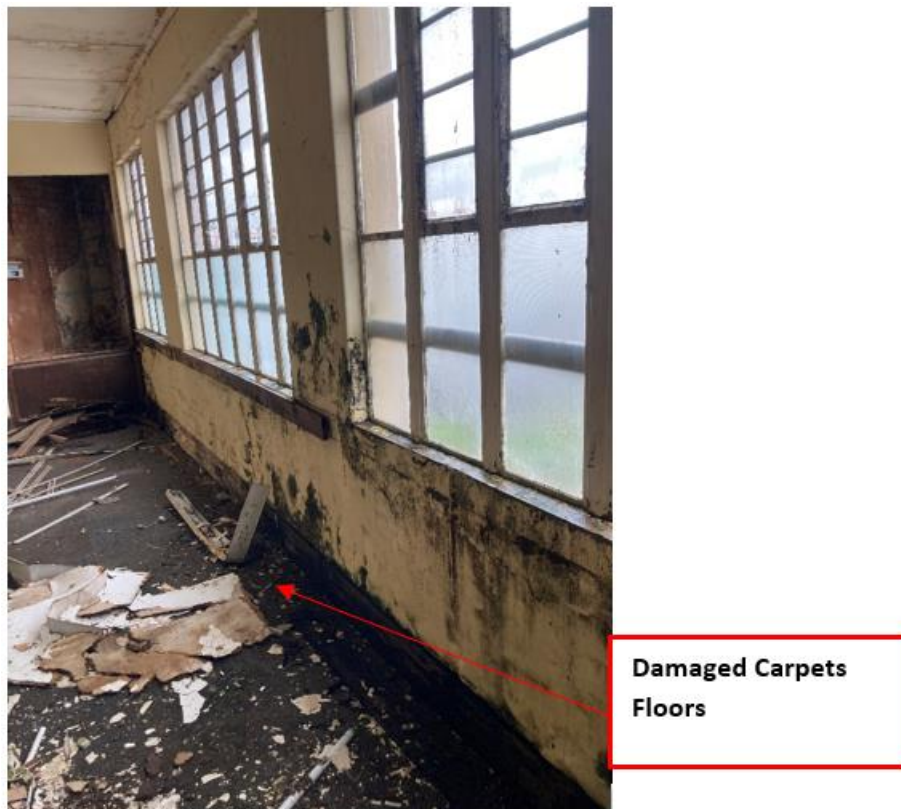
*Figure 14: Damage on Carpets*

The building consists of sections with floated concrete floors and carpeted floors for workshops and offices respectively. The findings from a visual inspection did not show significant structural damages on the floors. However due to damages on the roof the carpets have been exposed to rainfall. Figure 14 shows the condition of the carpets.
