CONDITION ASSESSEMENT OF THE OVERVAAL TUNNEL

10 November 2023

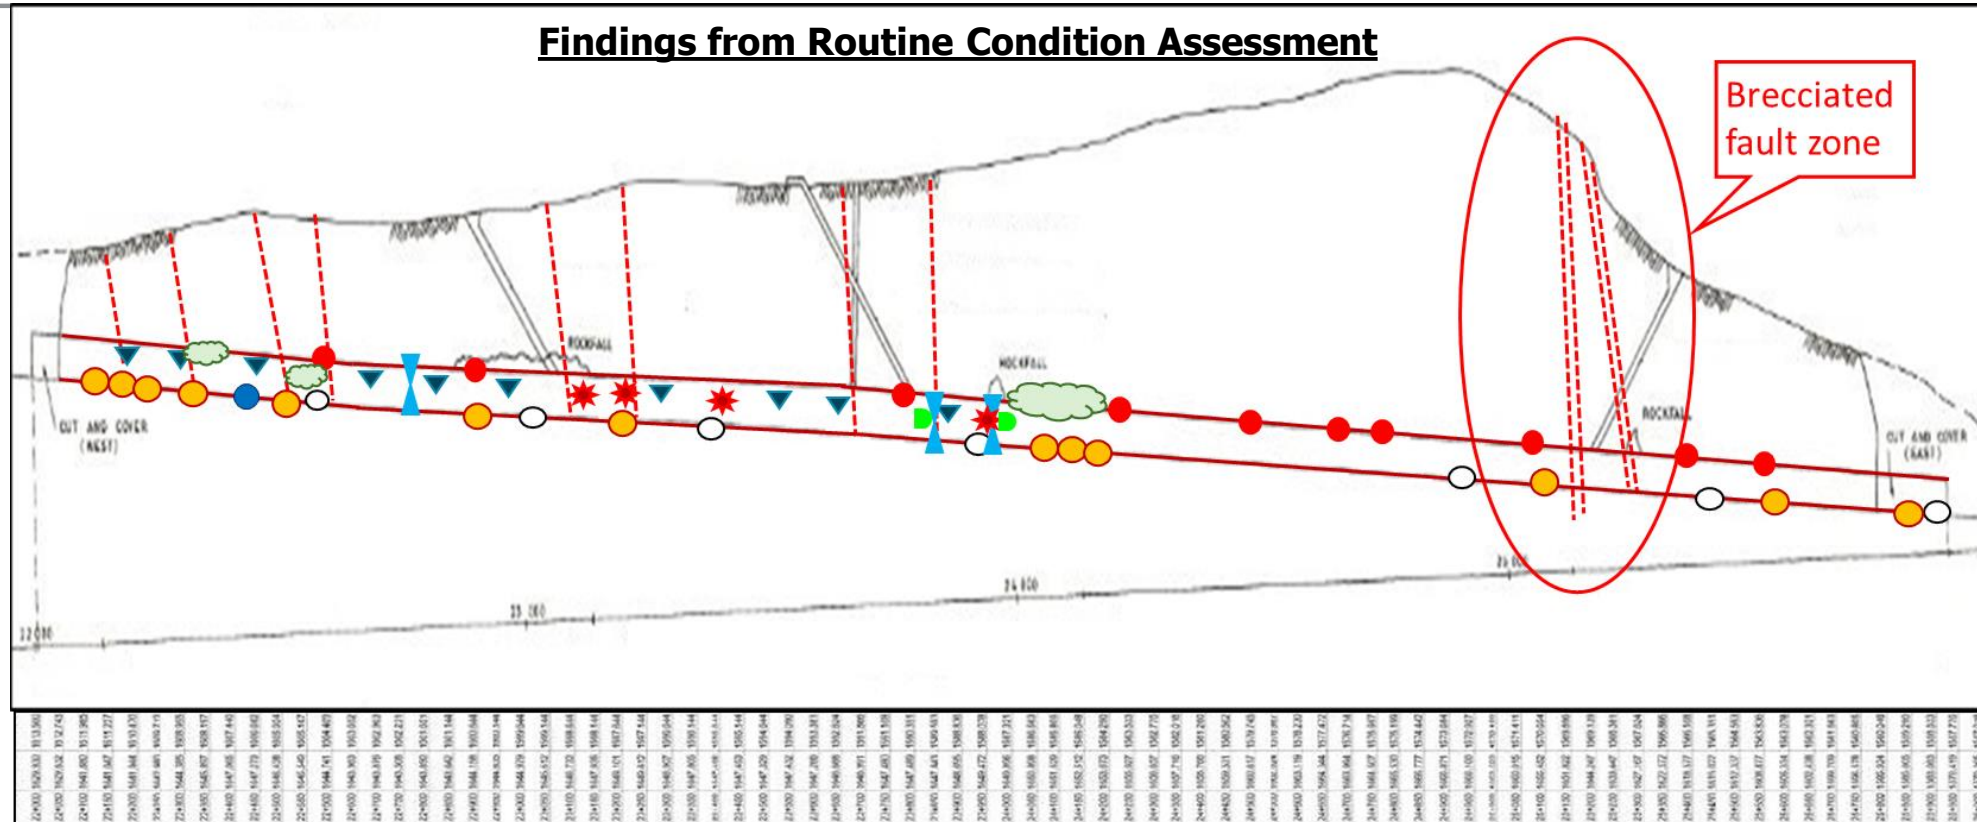
- Tunnel longitudinal profile
- Track slab pump action
- TQI exceed STD by +3
- Stagger C-Exceptions
- Height C-Exceptions
- - - Fault zone
- ★ Exposed wire mesh
- ▼ Water seepage through lining
- ▼ PVC channels over OHTE
- ☁ Concrete delamination on Tunnel lining
- Concrete Lining Heaving

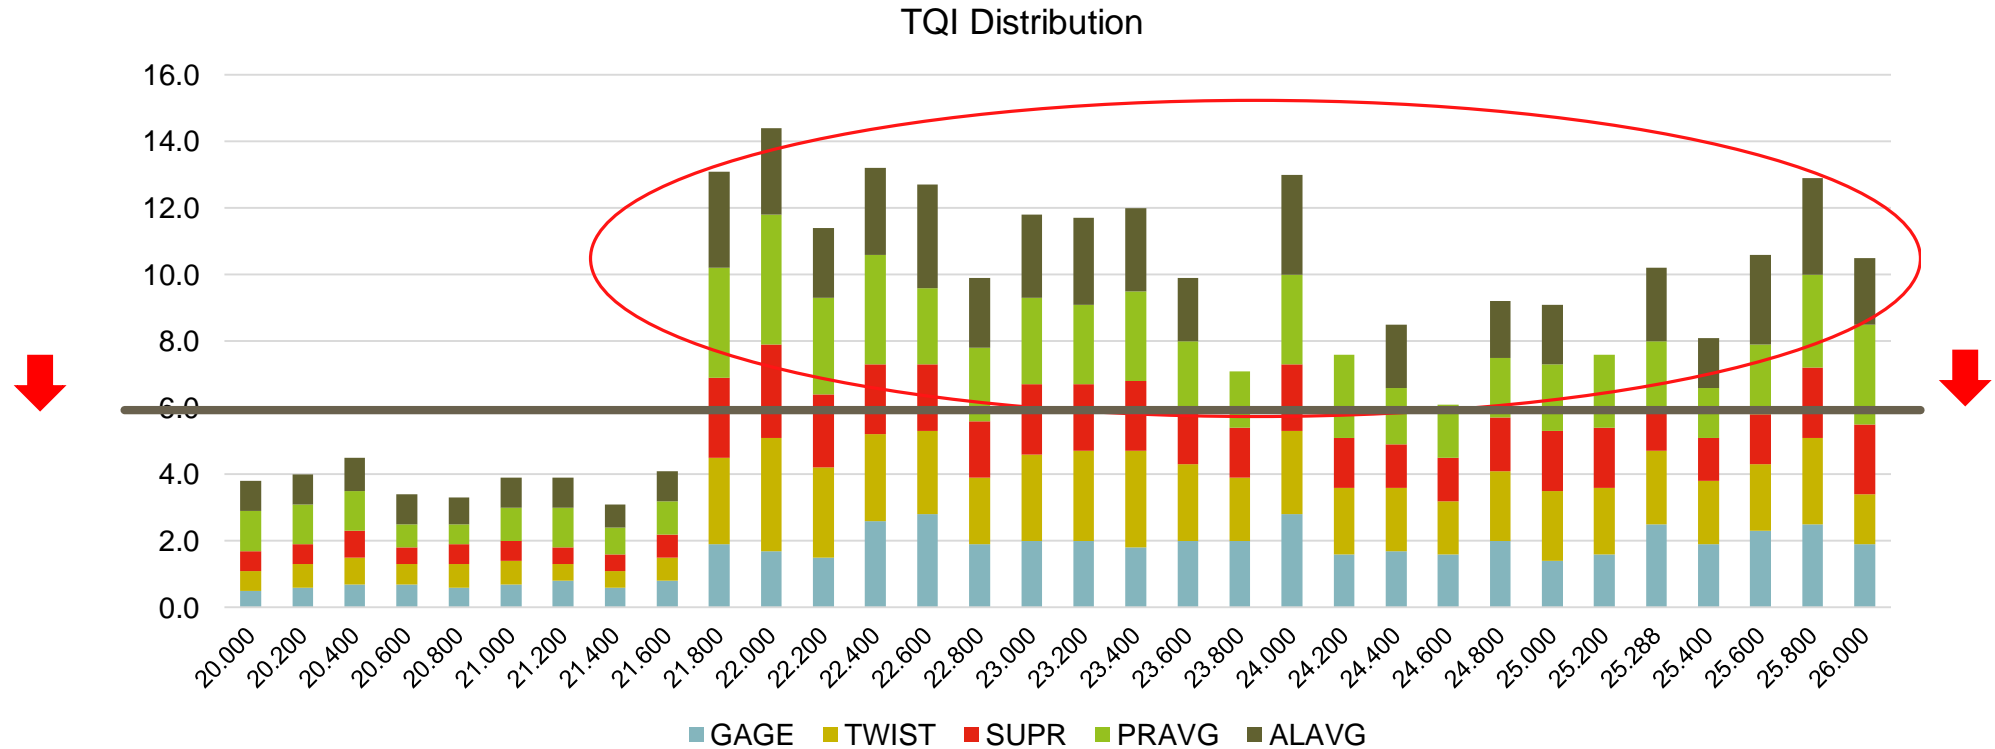
- S-Line classification: Adopted TQI target = 6
- Increased variance in TQI specifically in the Overvaal tunnel.
- TQI range is relatively similar before and after the tunnel.

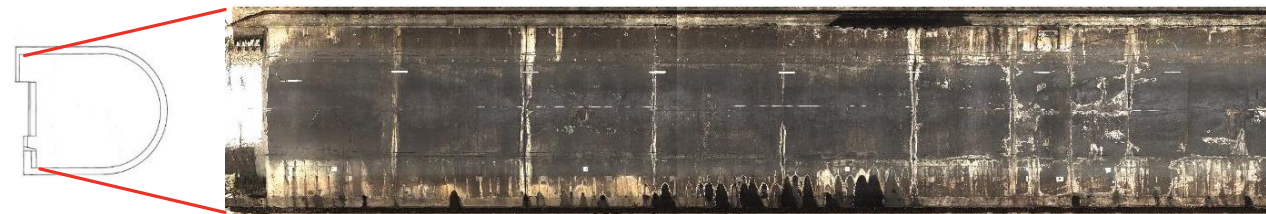
Image of tunnel lining captured for inspection

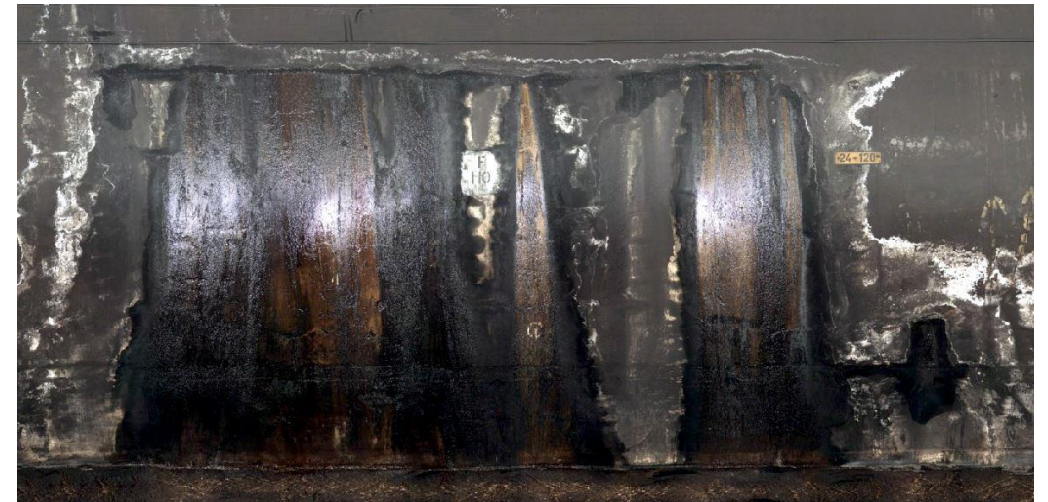
Defect	Quantity	Total length/Area
Cracks	2230	5887.9m
Horizontal	418	2313.3m
Vertical	1684	3065.8m
Diagonal	100	246.9m
Horizontal + Diagonal	2	6.9m
Horizontal + Vertical	26	255m
Crazing	13	186.4m²
Water Seepage	96	1607.6m²
Delamination	2	0.04m²
Miscellaneous defects	38	3252m²
Spalling	2	7.8m ²
Efflorescence	21	772.8m ²
Efflorescence + Seepage	14	2471m ²

- Significant cracks on the light density reinforced tunnel lining are mainly induced by the rock mass movement as well as the hydrostatic pressure
- Interconnected cracks presents a risk of collapse
- No corrosion visible: Potential corrosion none destructive test recommended
- Evolution of the cracks is being monitored

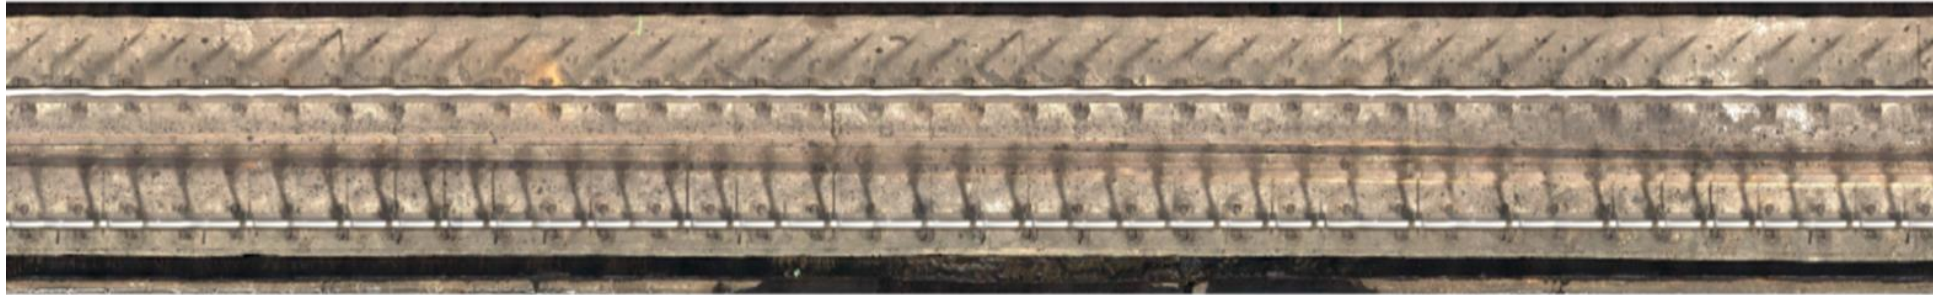
Defect	Quantity	Total length/Area
Cracks	97	62.8m
Transversal	94	47m
Longitudinal	3	15.8
Crazing	0	0
Water Seepage	1	0.3m²
Delamination	10	1.5m²
Miscellaneous defects	7	21.95m²
Spalling	5	0.25m ²
Efflorescence	2	21.7m ²
Efflorescence + Seepage	0	0

- No critical cracks observed
- Water seepage from cracks with width > 2mm posing a threat of corrosion of rebar
- Minor areas of de-bonding
- The movement is to be confirmed by the continuous condition monitoring

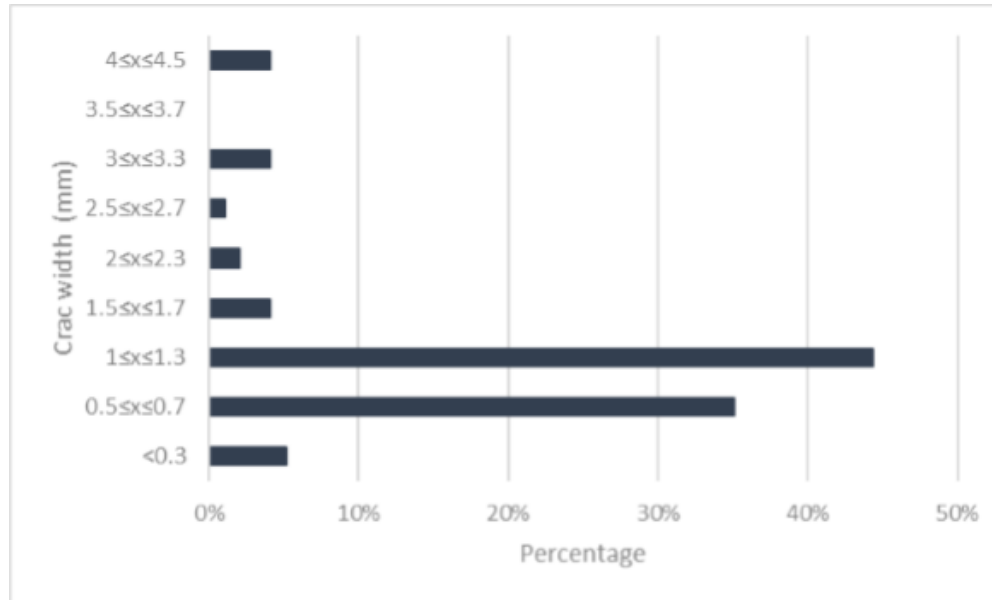
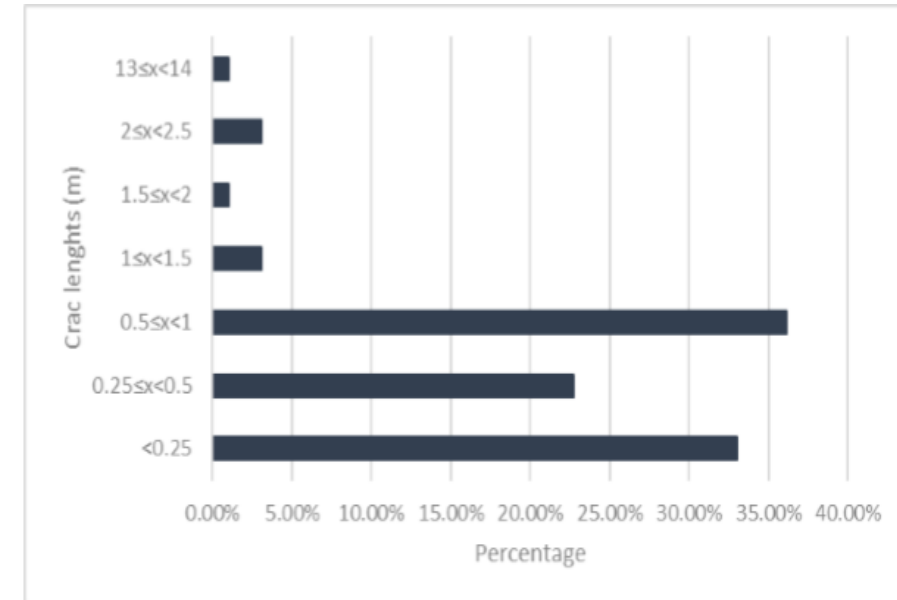
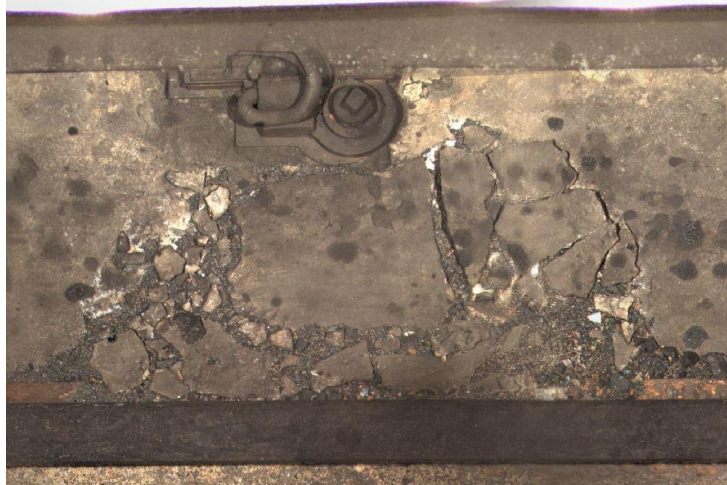
- 85% of the cracks have a width of less or equal to 1.3mm
- Only six (6) cracks have an opening ranging between 2mm to 4mm.
- 92% of the crack's lengths are less than 1m
