NELSON MANDELA PRISON HOUSE

**DESCRIPTION OF THE WORKS AND TECHNICAL SPECIFICATIONS  
FOR REPAIRS AND MAINTENANCE**

**PREPARED BY:** OSMOND LANGE ARCHITECTS

**ISSUE DATE:** AUGUST 2025

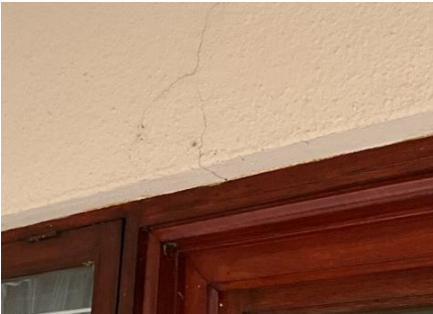
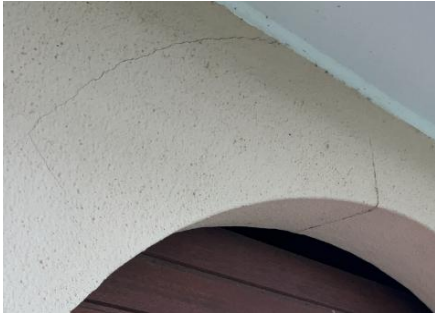
Walls were originally white during Nelson Mandela's incarceration, but in recent years they have been painted a cream colour. Localised areas of minor cracking in paint/plaster and weathering are evident. Wall cracks are to be repaired. Heritage Architect recommends that a paint specialist investigate the paint layers to establish the historic paint used. All external walls of the main house are to be repainted in accordance with the specialist's report and recommendations.

</div>	<div><div>1.</div><div>2.</div><div>2.1.</div><div>2.2.</div><div>3.</div><div>3.1</div><div>3.2.</div><div>4.</div><div>4.1.</div><div>4.2.</div><div>4.3.</div></div>	<div><p><b>Inspection:</b> Visually inspect all exterior wall plaster surfaces of the Nelson Mandela Prison House and identify areas that require repair i.e. Plaster cracks, hollow plaster, damaged cement areas.</p><p><b>Preparation:</b></p><p>2.1. Clean surfaces with a Sugar soap/water solution, or a similar product, to remove all surface contaminants and chalky residue. Rinse thoroughly with clean water and allow to dry.</p><p>2.2. Prepare surfaces by removing all paint coatings, friable deposits, grease, dirt, etc. Sand thoroughly to break the surface to provide a uniform finish. Brush down and wash to remove dust and surface contamination and wipe clean. (Use of water jet NOT allowed)</p><p><b>Fine Crack Repair</b></p><p>3.1 Spread Professional Bridging Compound, or similar, to be thinned 5-10 % with water over the entire fine cracked area to a wet film thickness of 400 µm (a medium pile or short pile roller may be used with thinned material to avoid texturing the coating. Stipples should be smoothed out while still wet using a water wet brush).</p><p>3.2. Crazed cracking: A second diluted coat will be required after a drying time of two hours to fill and bridge these cracks.</p><p><b>More Severe Crack Repair</b></p><p>4.1. Open damaged area sufficiently to allow repair material to be adequately filled to achieve a mechanical bond.</p><p>4.2. Clean away dust, grease and grime from surface.</p><p>4.3. Fill areas with the appropriate Masonry Patching Plaster using a putty knife or trowel. Smooth off whilst still wet. Allow to dry for 24hours. Patch prime using newly repaired areas with the appropriate primer, and allow 16 hours drying at 23°C. NB: Texture on repaired areas must be finished off to match the existing profile.</p></div>

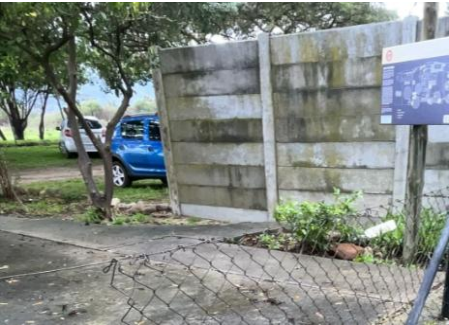
CLEAN VIBRACRETE WALL

The vibracrete wall between the Main House and Guard House is in an acceptable condition with signs of weathering. The vibracrete wall is to be cleaned.

<div>1.</div> <div>2.</div>	<p><b>Preparation:</b></p> <p>Sensitively trim vegetation, only as needed, to allow access to the vibracrete wall.</p> <p><b>Pressure Wash:</b></p> <p>Pressure wash the vibracrete wall of grime, moss and other forms of weathering. Care must be taken not to damage the wall or its surrounds.</p>

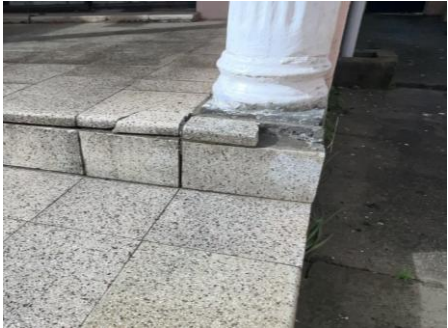
The pavement areas that are finished with terrazzo tiles are in acceptable condition considering their age, but they are severely weathered. There are localised areas where a tile has cracked or is coming loose from the surface it was mounted to. There is also evidence of poor past repair.

<div>1.</div> <div>2.</div> <div>2.1</div> <div>2.2.</div>	<p><b>Preparation:</b></p> <p>Remove leftover tile &amp; mortar bedding. Ensure the area where the tile is to be installed is clean of dirt and grease.</p> <p><b>Replace tile:</b></p> <p>Replace tile with an existing spare tile stored onsite. Care must be taken not to damage the tile while cutting it to size. The remaining tile is to be stored and returned to Iziko.</p> <p>Install tile using an appropriate cement-based adhesive in accordance with the manufacturer's specifications</p>

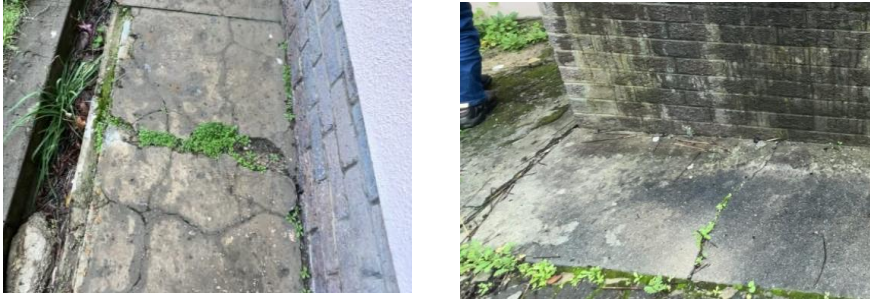
TYPE OF REPAIR	IMAGE	NR	REPAIR INSTRUCTION
REPAIR CONCRETE PAVED AREA TYPE 1

Concrete paved area type 1: This type refers to small paved concrete areas. The paving shows signs of severe weathering, mild to moderate cracks forming in the concrete, and minor vegetation growth affecting the pavement. The cracks are to be repaired, vegetation is to be removed, and concrete paving is to be power-washed.

<div>1.</div> <div>2.</div> <div>2.1.</div> <div>2.2.</div> <div>2.3.</div> <div>2.4.</div> <div>3.</div> <div>3.1.</div> <div>3.2.</div>	<p><b>Inspection:</b> Visually inspect all concrete pavement surfaces and identify areas that require repair, such as cracks. Discuss and agree extent of remedial work with the architect before proceeding.</p> <p><b>Preparation:</b></p> <p>Remove all loose debris, vegetation and deteriorated concrete.</p> <p>Open the damaged area sufficiently to allow repair material to be adequately filled in to achieve a mechanical bond.</p> <p>Once cracks have been grinded out, clean the area again of debris and dust.</p> <p>Wet the surface of the concrete or apply an appropriate bonding agent.</p> <p><b>Application</b></p> <p>Apply an appropriate concrete repair mix to the newly opened cracks in strict accordance with the manufacturer's instructions</p> <p>Allow the concrete repair mix to properly cure following the manufacturer's instructions</p>

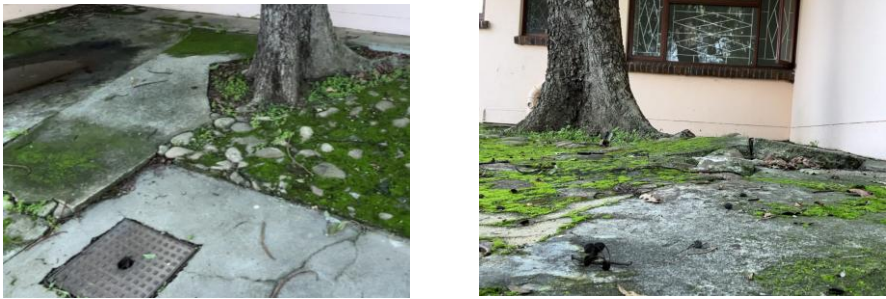
REPAIR CONCRETE PAVED AREA TYPE 2

Concrete paved area type 2: This type refers to a larger paved concrete area with cast-in-stone. The paving shows signs of severe weathering, and the paving is lifting in areas due to tree root growth. It was noted that the large, paved area has a drainage issue, allowing water to pond in places. The paving is to be demolished, the concrete paving is to be recast, and the tree root issues are to be addressed by a landscaper.

<div>1.</div>	<p><b>NOTE: Consult the landscaper regarding the removal or trimming down of tree roots that are affecting the pavement.</b></p> <p>The concrete and stone mixed paving in this area is to be demolished and reconstructed, following the architectural and structural engineer's details. The details are to be issued at a later date. Prior to demolition, the paving is to be measured up and documented. Quantity surveyor to allow for the reconstruction of the pavement to match the existing and grinding down of the surface to make it level between finishes.</p>
REPAIR SLIDING DOOR TO LOINGE (G04)

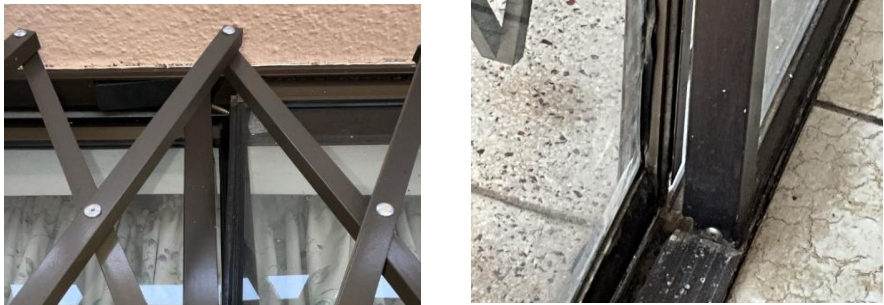
External timber doors are in good condition. The sliding door, leading to the swimming pool, has the frame pulling loose from the glass pane and appears to be detached from the sliding track. The sliding door needs to be repaired and placed back on its rail. There are two single timber garage doors with tongue and groove horizontal boarding that have been varnished. One of the garage doors is missing its topmost horizontal board.

<div>1.</div> <div>2.</div> <div>2.1</div> <div>2.2.</div> <div>3.</div>	<p><b>Inspection:</b> It appears that the frame is pulling loose from the glass panel and the rubber seal. A sliding door expert is to inspect the sliding door to assess the extent of the damage, whether or not it must be screwed back into place, whether or not reusing existing screws is possible, or if the screws are to be replaced. The sliding door also appears to be derailed.</p> <p><b>Repair sliding door frame:</b></p> <p>Tighten the silding door frame screws. Ensure that the rubber seal is in place correctly before rescrewing the frame.</p> <p>If existing srews are to be replaced, the sliding door expert is to recommend a suitable replacement screws.</p> <p><b>Realign sliding door:</b> Sliding door to be placed back on its guiding rail.</p>

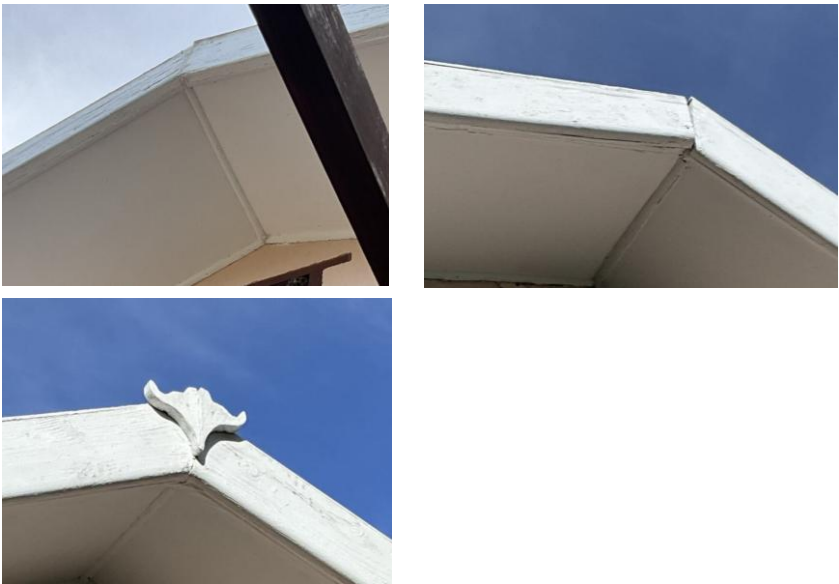
TYPE OF REPAIR	IMAGE	NR	REPAIR INSTRUCTION
REPAIR & REPAINT BARGE BOARD

All barge boards show signs of weathering. Barge boards are to be replaced with new ones and repainted. One of the barge boards has a decorative finial that is to be replicated and installed on the other barge boards.

<div>1</div> <div>1.1</div> <div>1.2</div> <div>1.3</div> <div>2.</div> <div>3.</div>	<p><b>Preparation</b></p> <p>Remove the decorative finial from the barge board. It is to be replicated using a piece of timber and installed on all barge boards in the same position as the existing one.</p> <p>Wipe down timber barge boards to remove grime, dust and flaking paint. Sand wood with 120 grit paper and finish off with 220 grit paper in the direction of the grain. Dust off.</p> <p>Fill holes and defects using an appropriate wood filler following the manufacturer's instructions. Note: the wood filler must be paint compatible. Once holes and defects have been filled, ensure to remove excess wood filler while it is wet. Allow 8 hours to dry. Sand to a smooth finish.</p> <p><b>Primer:</b></p> <p>Apply one coat of an appropriate timber primer to achieve a continuous film. Primer is to be applied following the manufacturer's specifications.</p> <p><b>Fishing coat:</b></p> <p>Apply an appropriate exterior paint following the manufacturer's instructions. Paint colour: WHITE</p>

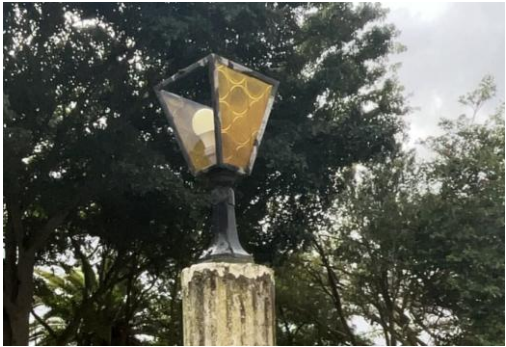
TYPE OF REPAIR	IMAGE	NR	REPAIR INSTRUCTION
REPAIR PILLAR LIGHT

There are two pillar lamps located in the garden area. The concrete fluted pillars show signs of severe weathering and minor damage to the pillar surface. The damaged surfaces of the pillar are to be repaired and repainted. The lamp's light bulbs need to be corrected to stand in the upright position. One of the lamps has a broken glass pane and is missing its top cap, which is to be reinstalled.

<div>1.</div> <div>2.</div> <div>2.1.</div> <div>2.2.</div> <div>2.3.</div>	<p><b>NOTE: All electrical/electronic accessories are to be inspected by an electrical engineer. NOTE: All electrical/electronic work to be carried out by a qualified electrician.</b></p> <p><b>1. Outdoor pillar lighting</b> To be repaired as per the electrical engineer's specifications.</p> <p><b>2. Reinstate pillar light casing</b></p> <p>2.1. Dismount the pillar light frame and clean it all of old coatings, dirt and grease.</p> <p>2.2. Powder coat the metal frame. Powder coating to be done in strict accordance with the manufacturer's instructions. Colour: BLACK</p> <p>2.3. The missing glass of the light is to be have a new glass section to be installed. The new glass is to match the existing, as reasonably possible.</p>
REPAIR STOEP LANTERN LIGHTS
