MULTI-DISCIPLINE CONDITION ASSESSMENT REPORT

REFURBISHMENT OF CARGO WAREHOUSE AND CARGO OFFICES: CONTRACT NO 560.04/2015

Project number: ORT.560.04/2015

Date prepared: 15 October 2018

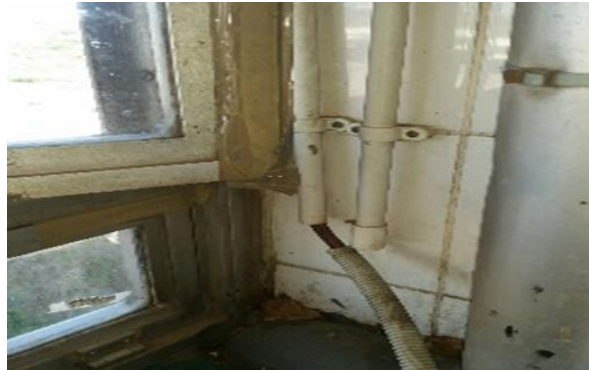
- Poor maintenance, renovation is needed
- Unsafe condition

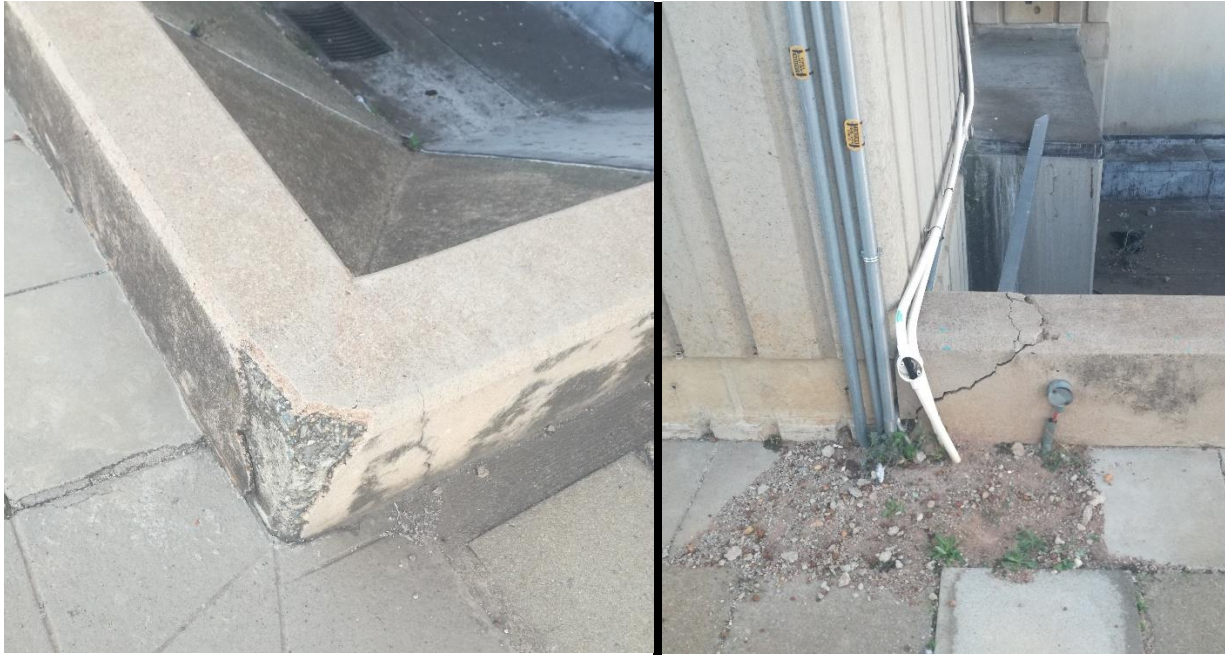
Figure 1 Cracked and exposed concrete walls

- **Remedial:** Refer to defect D1 solution and descriptions.

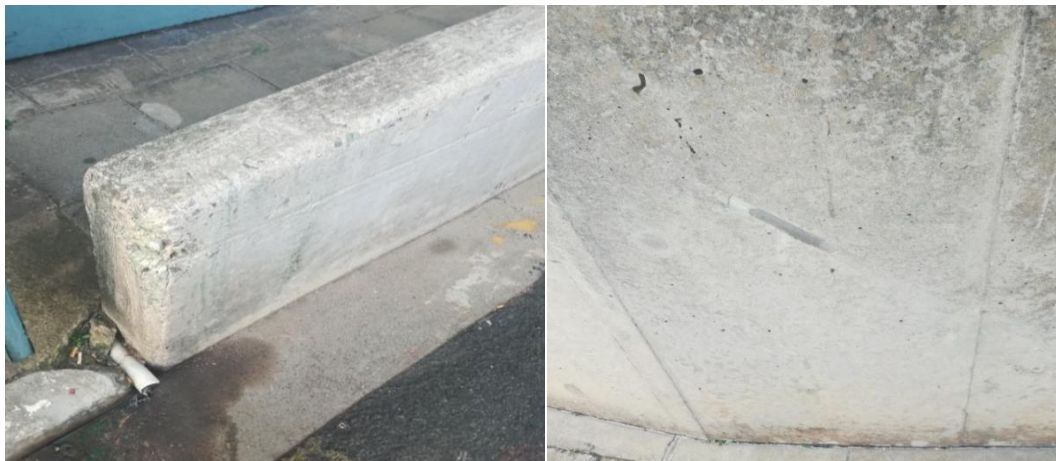
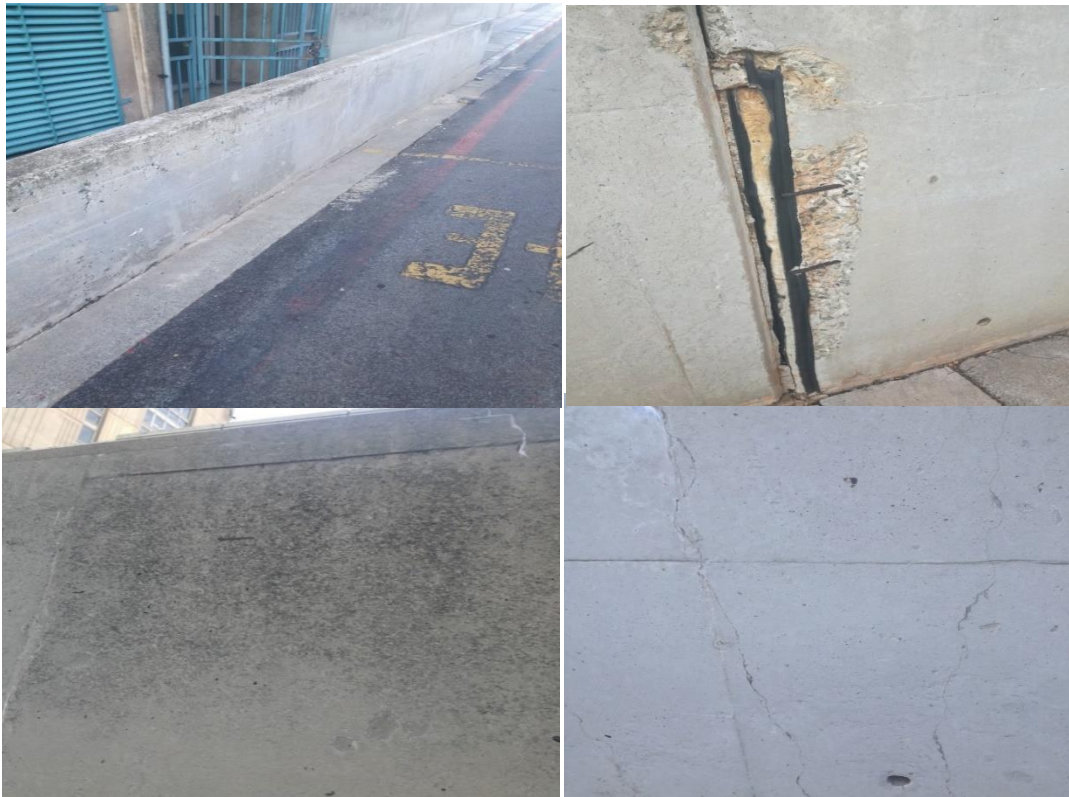
- The concrete upstand beams and retaining walls damaged: the damage is in the form of the concrete surface damage. All of the 6 photos below was taken at different positions in the walls.
 - **Remedial:** Refer to defect D1 solution and descriptions.

Figure 2 Concrete upstand beam and retaining walls failure

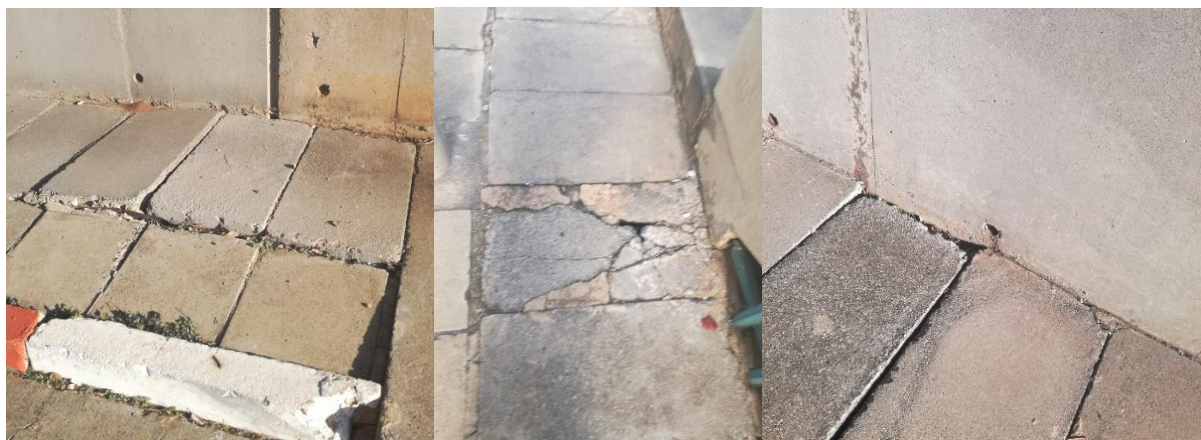
- A cable trench was constructed next to the Northern retaining wall, this trench has precast covers to cover the trench (see Figure). The first picture show covers sitting at a higher level than the external concrete pavement:
 - **Remedial:** The covers have to be reconstructed and replaced.

Figure 4 Concrete covers failure

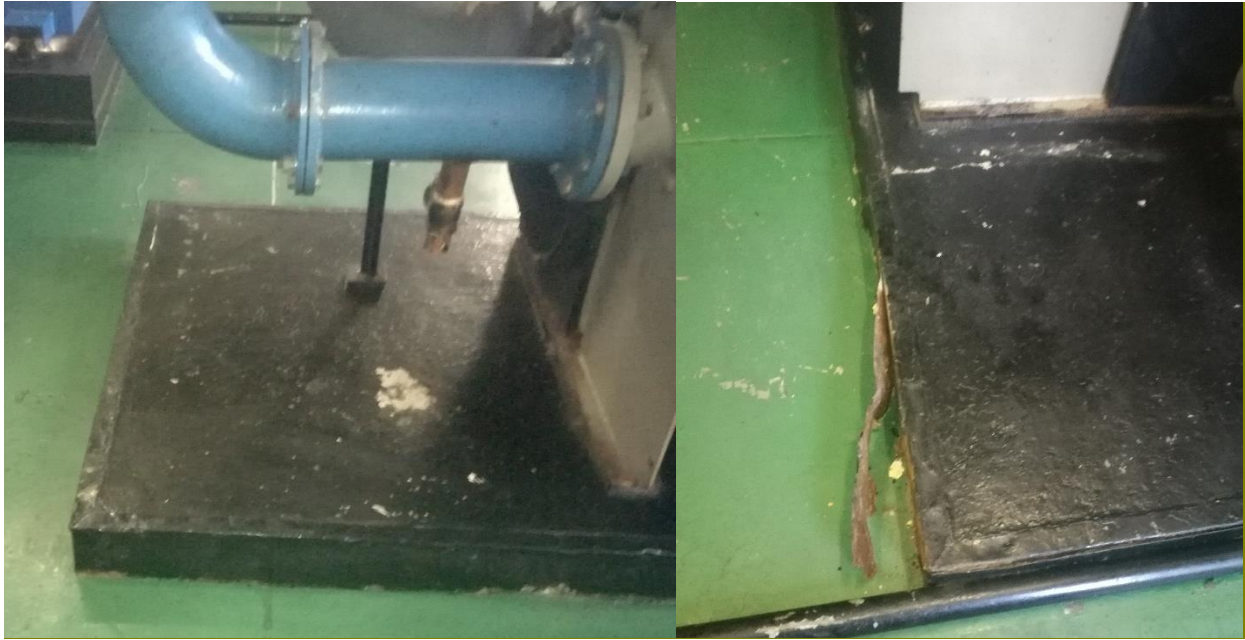
- Concrete plinths are located in the AC plantroom which support the mechanical equipment. The plinths in question have edge protection plates which shown sign of deterioration (refer to Figure 1).
 - **Remedial:** The plate must be replaced with a new angle (chemically doveled in to existing plinth).

Figure 4 Damaged edges on plant room plinths

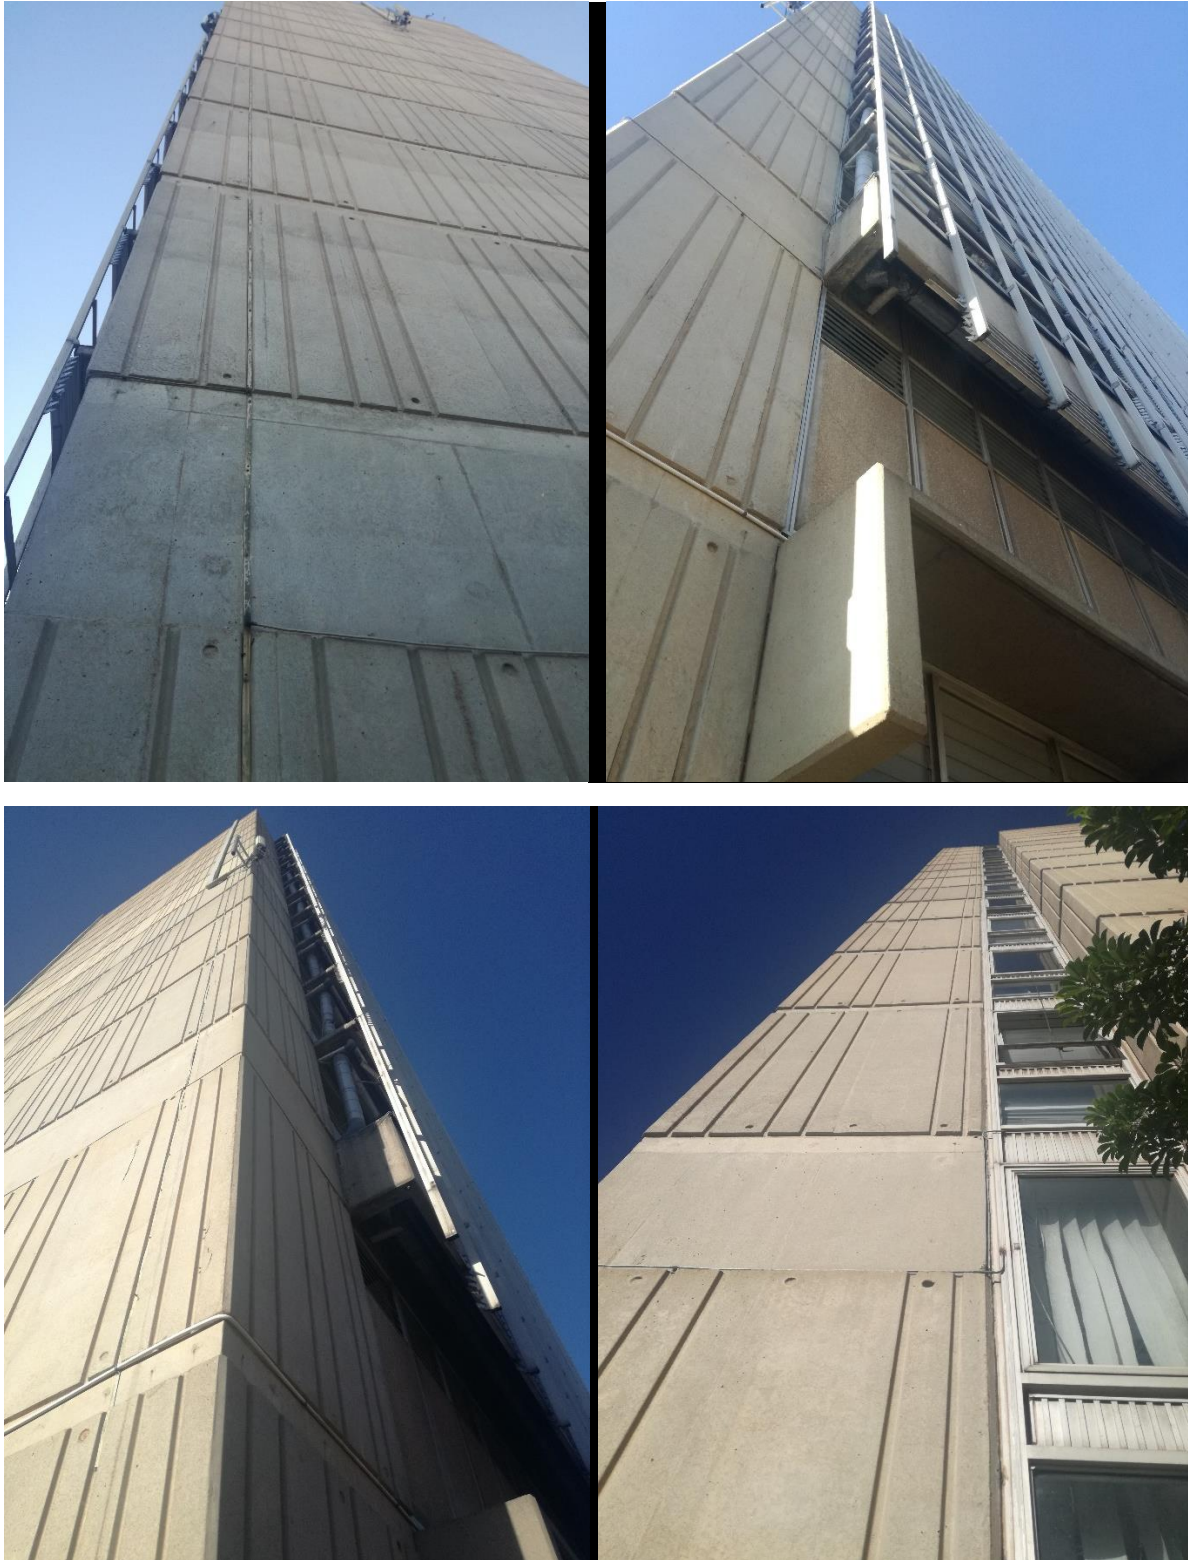
- Below are photos showing the external elevations of the office building. The external walls were constructed with a specific groove pattern. The concrete is damaged at building edges. The damage forming at these edges can ultimately expose the reinforcement, this will cause corrosion of the reinforcement. The degraded reinforcement compromises the building strength and is classified as a common defect for the building (see **Error! Reference source not found.** Defect D1).

Figure 5 Elevation photos of Cargo offices

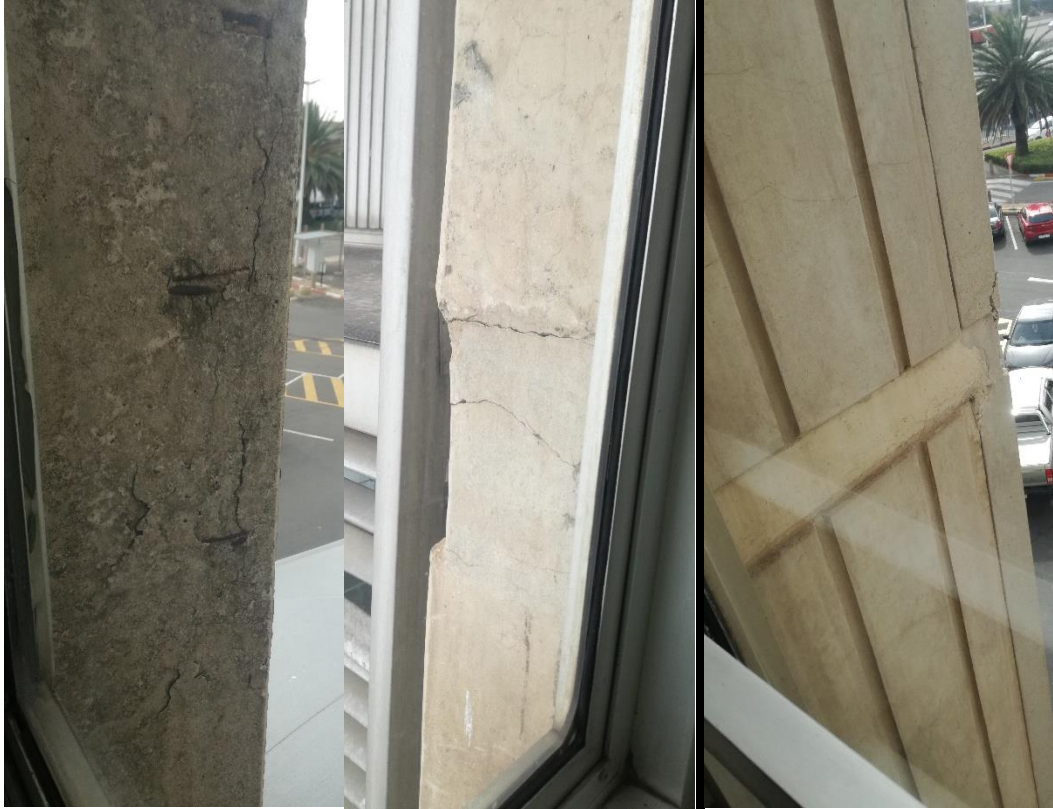
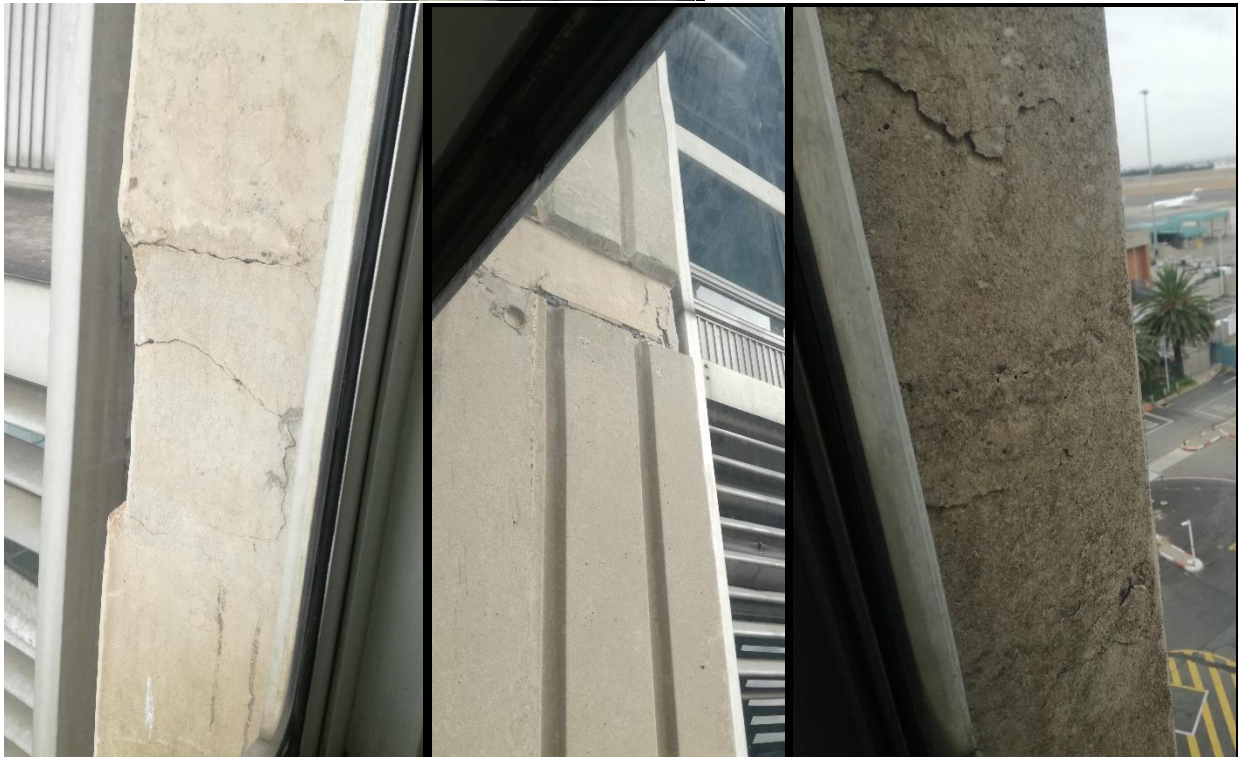
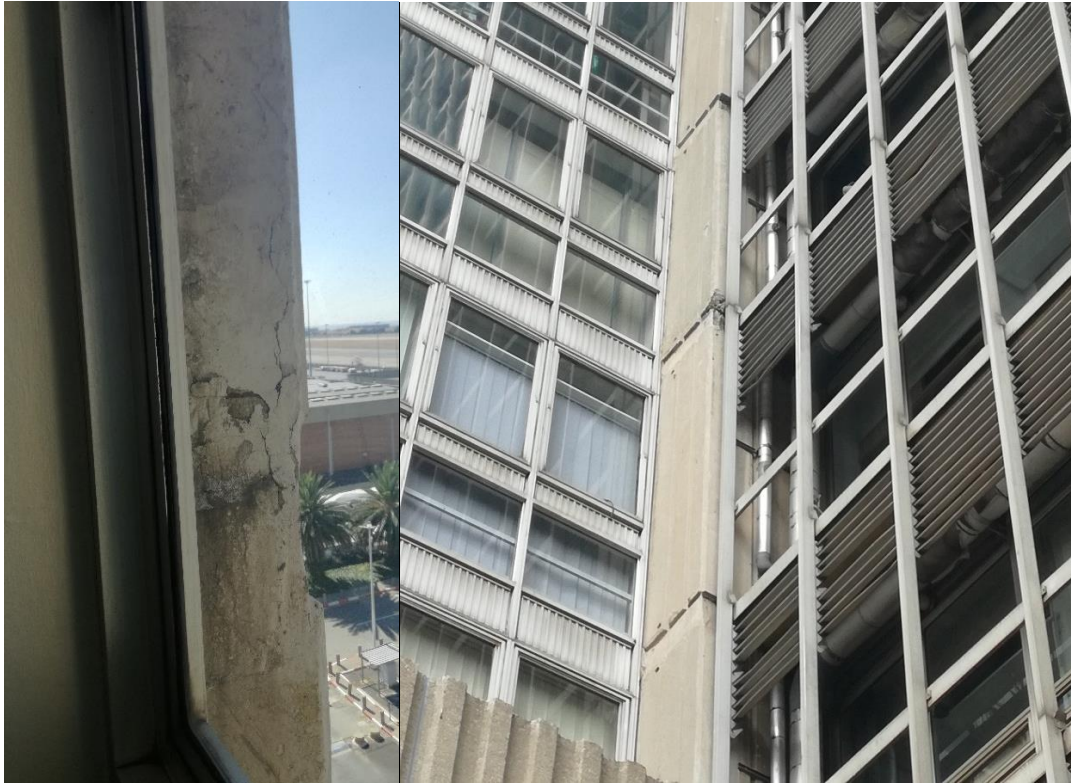
- Damage to the concrete shear walls can be seen through the windows at the staircase on the west side of the building. Other isolated areas are also present on the building, the large shear walls (east wall and west wall) cannot be visibly inspected through windows. It is unclear if there would be cracks for these and other walls. The damaged concrete edges have been marked up on the master drawing and is fairly repetitive over the height of the building.
 - **Remedial:** Repair should be carried out as per preferred solution D1 (**Error! Reference source not found.**).

Figure 6 Concrete damage on building corners

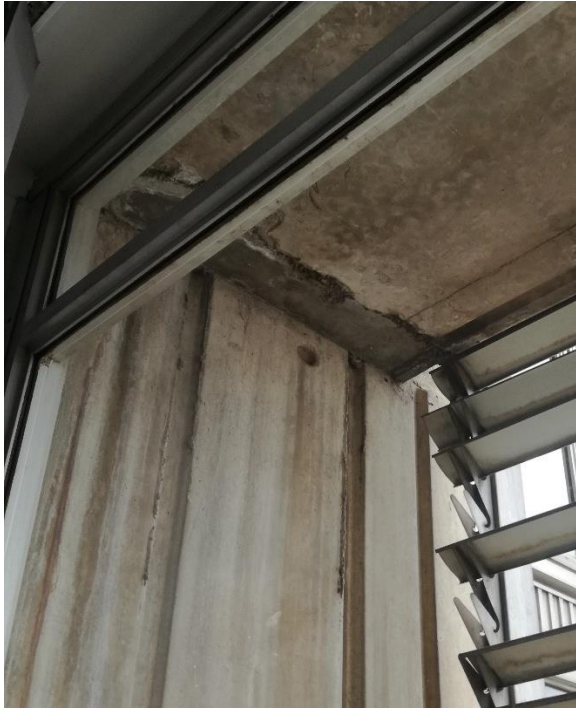
- Concrete canopies were constructed over windows. A drip slot is provided to the edge of the canopy slab soffit, it seems that rainwater runs past the slot and deteriorates the concrete canopy. This specific canopy (in the picture below) was seen on the Third floor, the soffit of most of the concrete canopies is not visible from the inside of the building. There may be many similar canopies with similar defect throughout the building.
 - **Remedial:** Refer to Defect D1. Defect D1 is applicable to vertical walls, however the same principals and techniques apply for horizontal surfaces also.

Figure 7 Slab soffit concrete damage

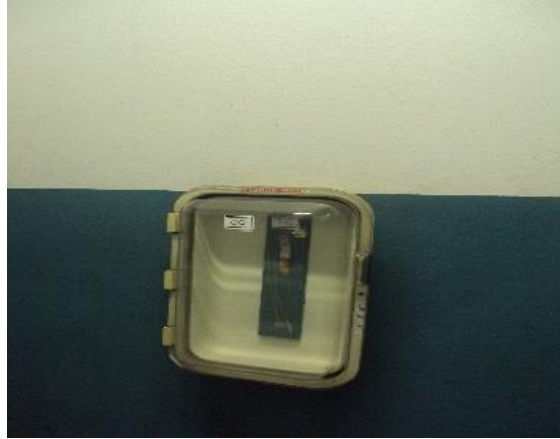
- Inadequate number of fire extinguishers
- Fire extinguisher was missing

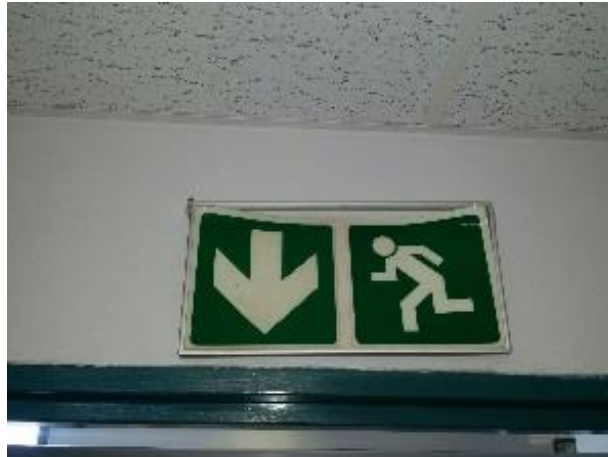
- Fire detection system has never been tested (no records)
- Emergency signages and notices damaged

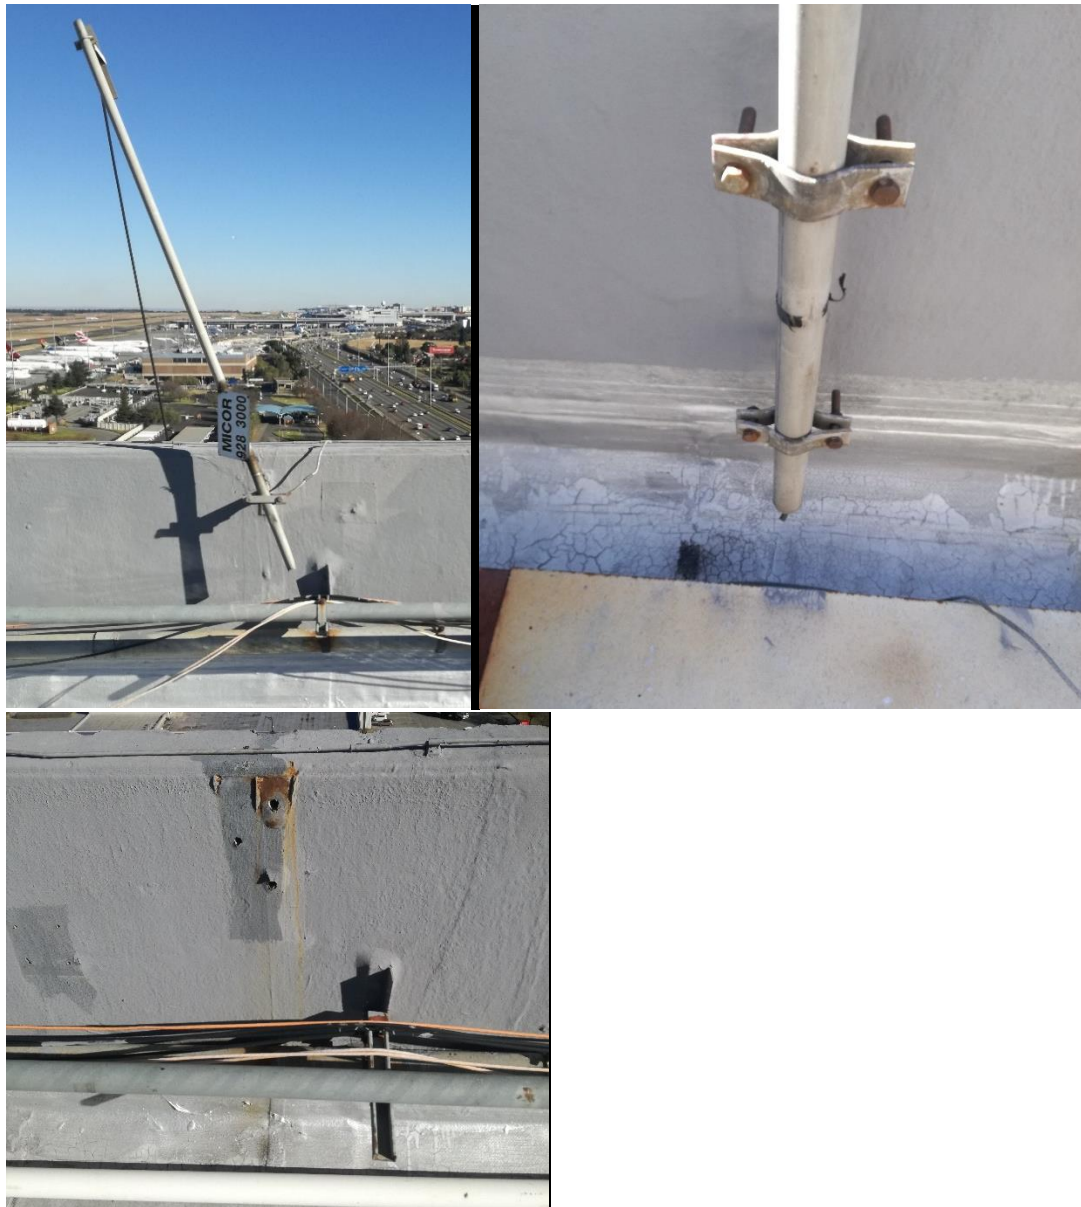
- Some of the masts are very loose and in danger of falling from the roof floor (refer to the two masts in **Error! Reference source not found.**), this poses a major safety risk.
 - **Remedial:** All masts should be inspected on a regular basis, the following must be determined:
 - is it still in use (if not the remove the mast),
 - is the current fixing system compliant (if not, rectify).
- Masts have been removed and no patchwork was done to seal the old anchor holes (see last image below). This can pose as a waterproofing issue.
 - **Remedial:** Anchor holes must be patched up and ensure that the waterproofing is made good.

Figure 5 Condition of network masts on roof floor

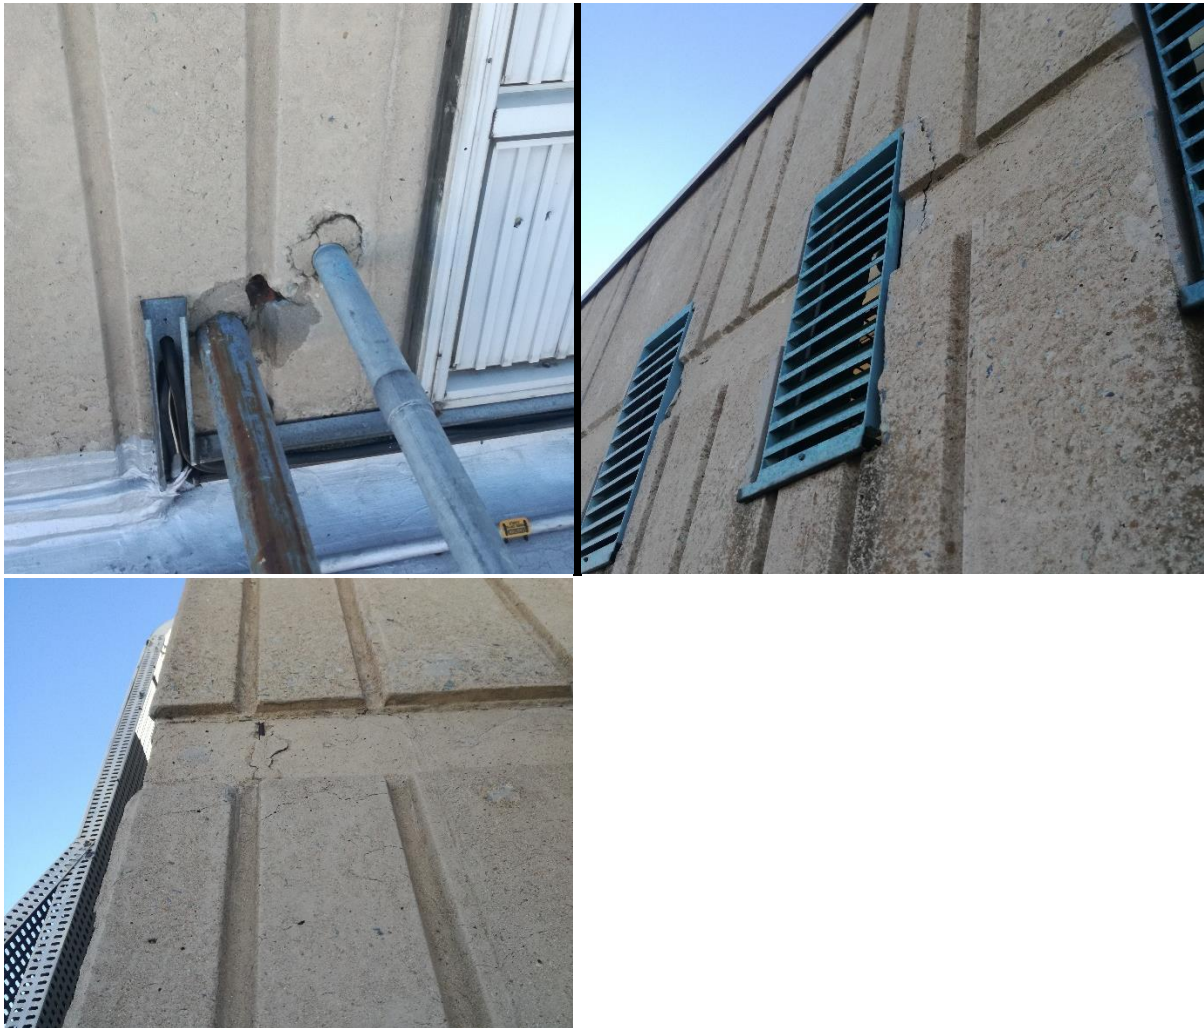
Figure 6 Damaged concrete edges

- **Remedial:** Refer to defect D1 for concrete patchwork.

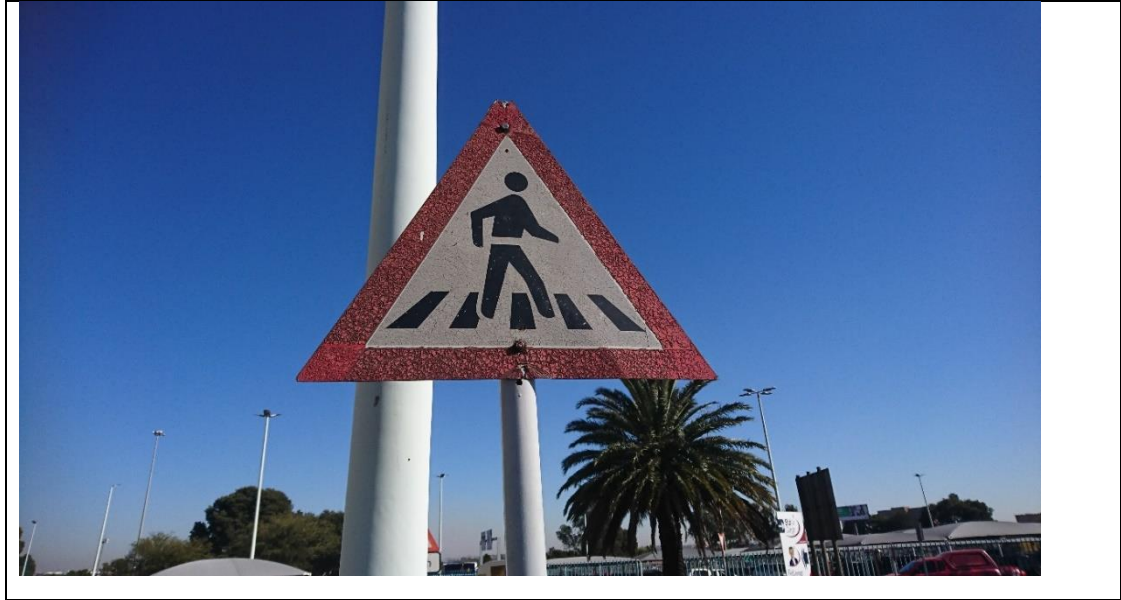
Figure 9 Road sign damage

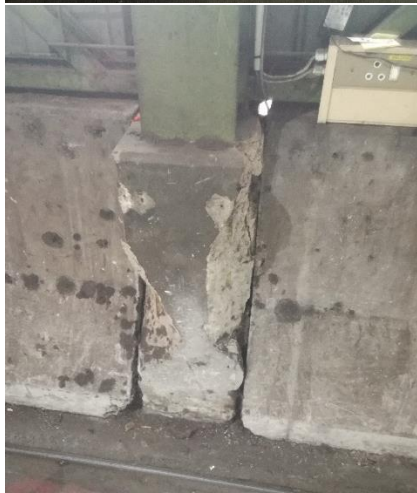
D1

Concrete column surface damage is caused by impact loads from the forklifts. The impact breaks off concrete and in severe cases exposes the reinforcement. This weakens the structural integrity of the concrete column.

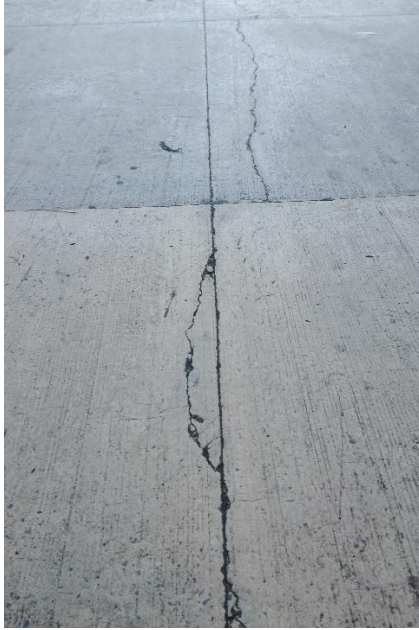
D2

<p>Concrete surface bed cracks are caused by insufficient joint spacing or insufficient joint construction. This defect identified is applicable to an individual crack or only a few cracks and is not applicable to fatigue damage or damages caused by excessive wheel load. The occurrence for this defect is expressed as a percentage of the concrete floor per warehouse. Three percentages were used in the findings: 0-15%, 15-40%, 40-75%.</p> <p>Remedial:</p> <p>The crack should be repaired by a concrete crack repair compound. Saw cut joints must be repaired.</p>
D3

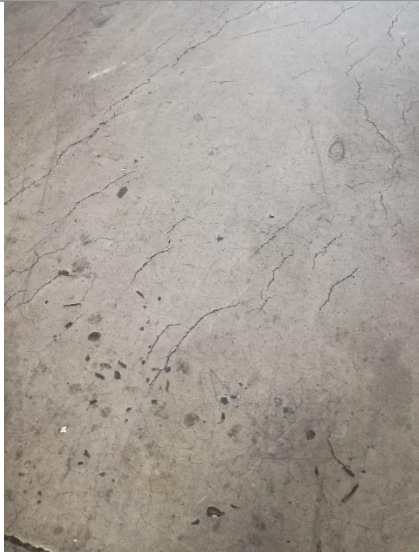
<p>Damaged concrete surface are applicable to areas of the buildings where floor cracks are more regularly spaced. The surface is also worn-out with an 'unsealed' appearance to it. The reason for the damaged surface can be either fatigue, weak supporting layer below, or excessive wheel loads. The occurrence of this defect is expressed as a percentage of the warehouse area. Three percentages were used in the findings: 0-15%, 15-40%, 40-75%.</p>

<p>Remedial:</p> <p>It is suggested that the concrete has to be recast. Depending on soil tests, it may be required to compact the layer works below the new concrete surface.</p>
D4

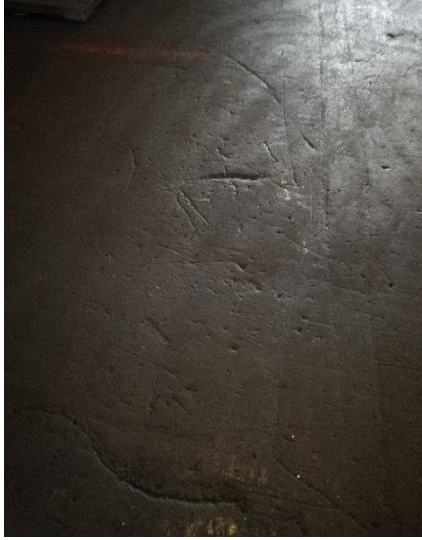
<p>Asphalt surface damage is applicable to areas where the asphalt surface have cracks or scratches of roughly 3 to 5mm wide. The cracks are closely spaced (typically 500mm apart). It is possible for the asphalt to disintegrate over time. There are areas where the asphalt has disintegrated completely leaving the old concrete floor exposed. This occurs typically at the airside entrance to the warehouse.</p> <p>Remedial:</p> <p>To upgrade the surface, the asphalt has to be either relayed on top of the existing asphalt or a bitumen sealing compound to seal the cracks.</p>

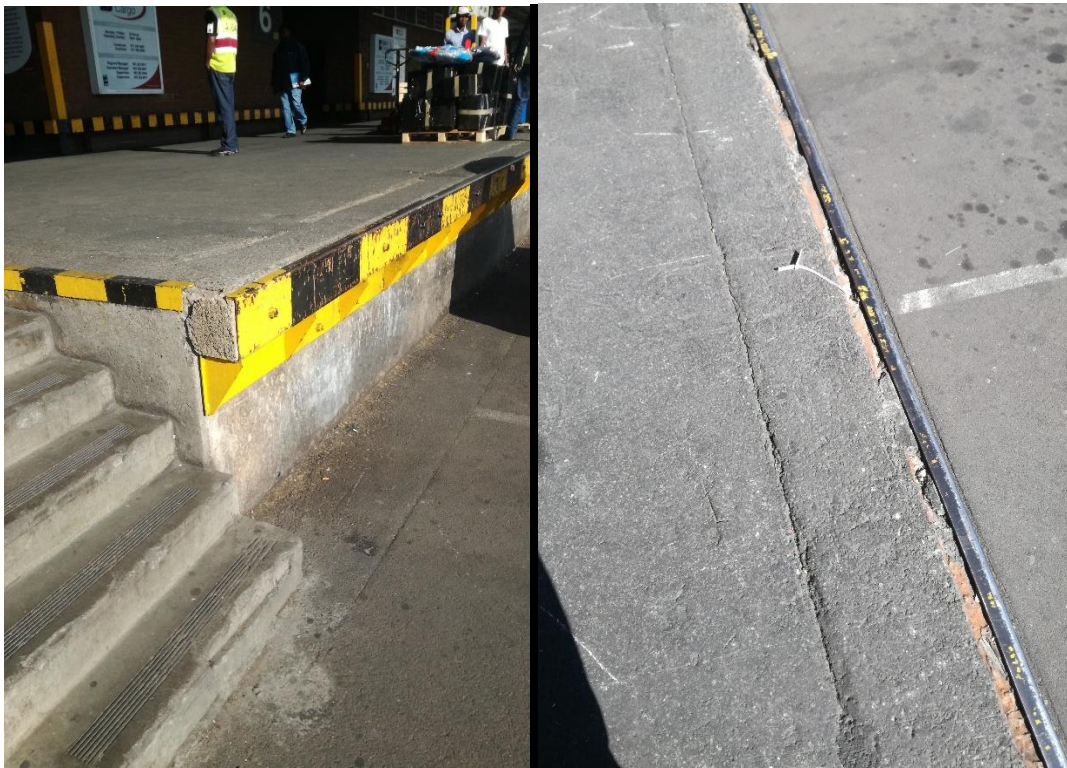
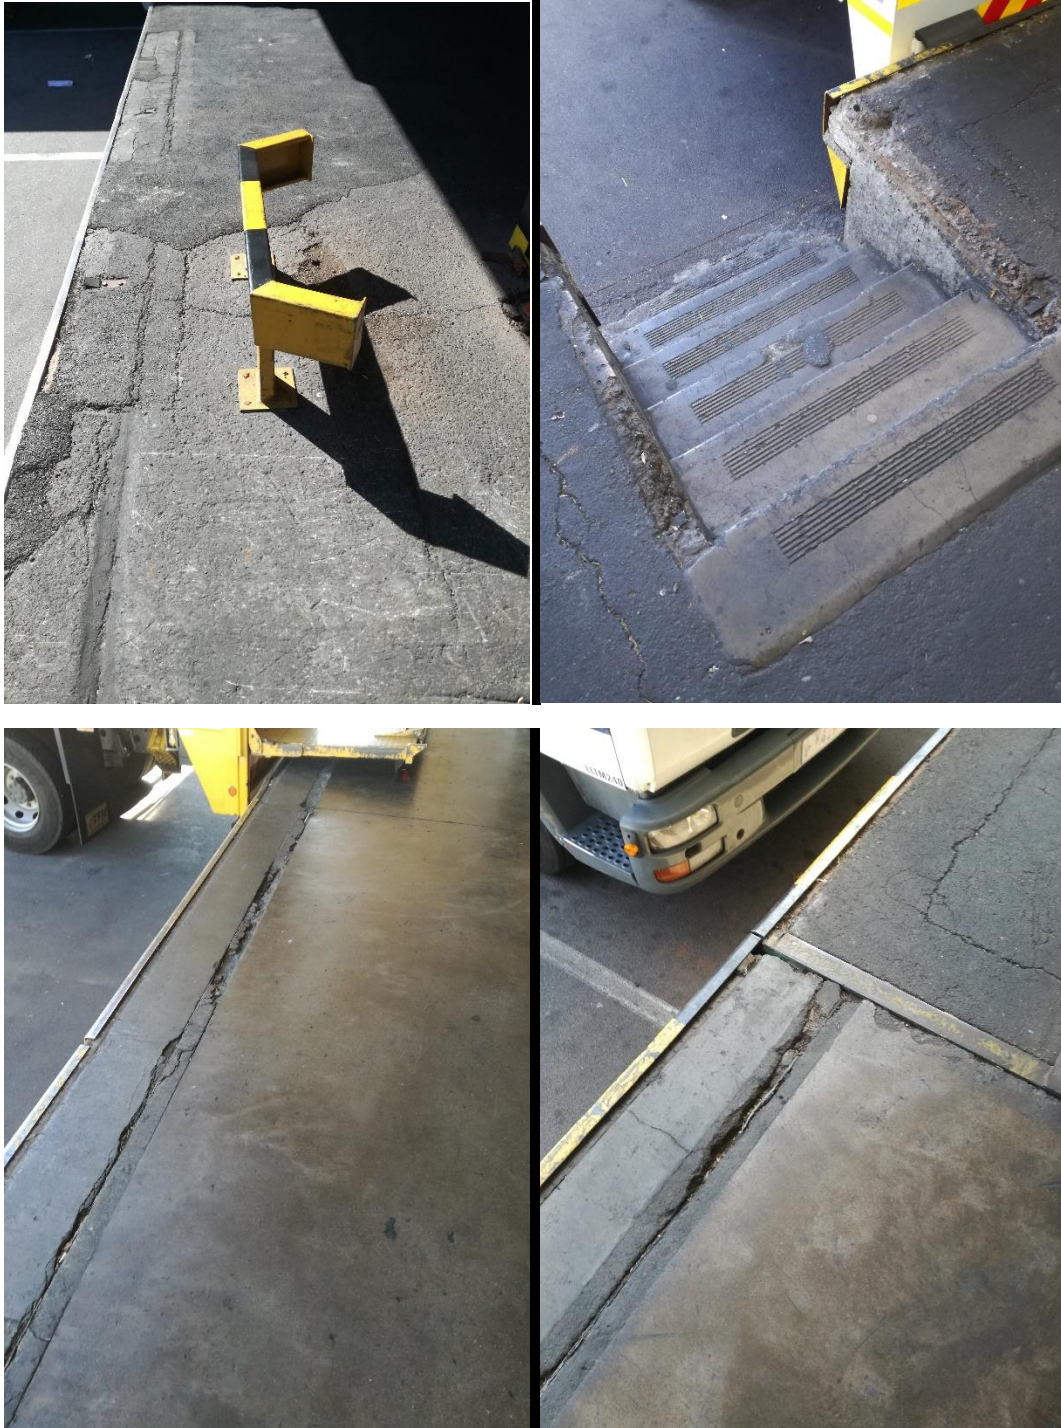
- The loading dock in the front of the warehouse has been damaged throughout the years. The damage is due to cargo trucks colliding against the protective barrier system.
 - **Remedial:** The protective barrier should be demolished and replaced by casting a new wall with a new protective barrier system.

Figure 16 Cargo Warehouse docking protective barrier

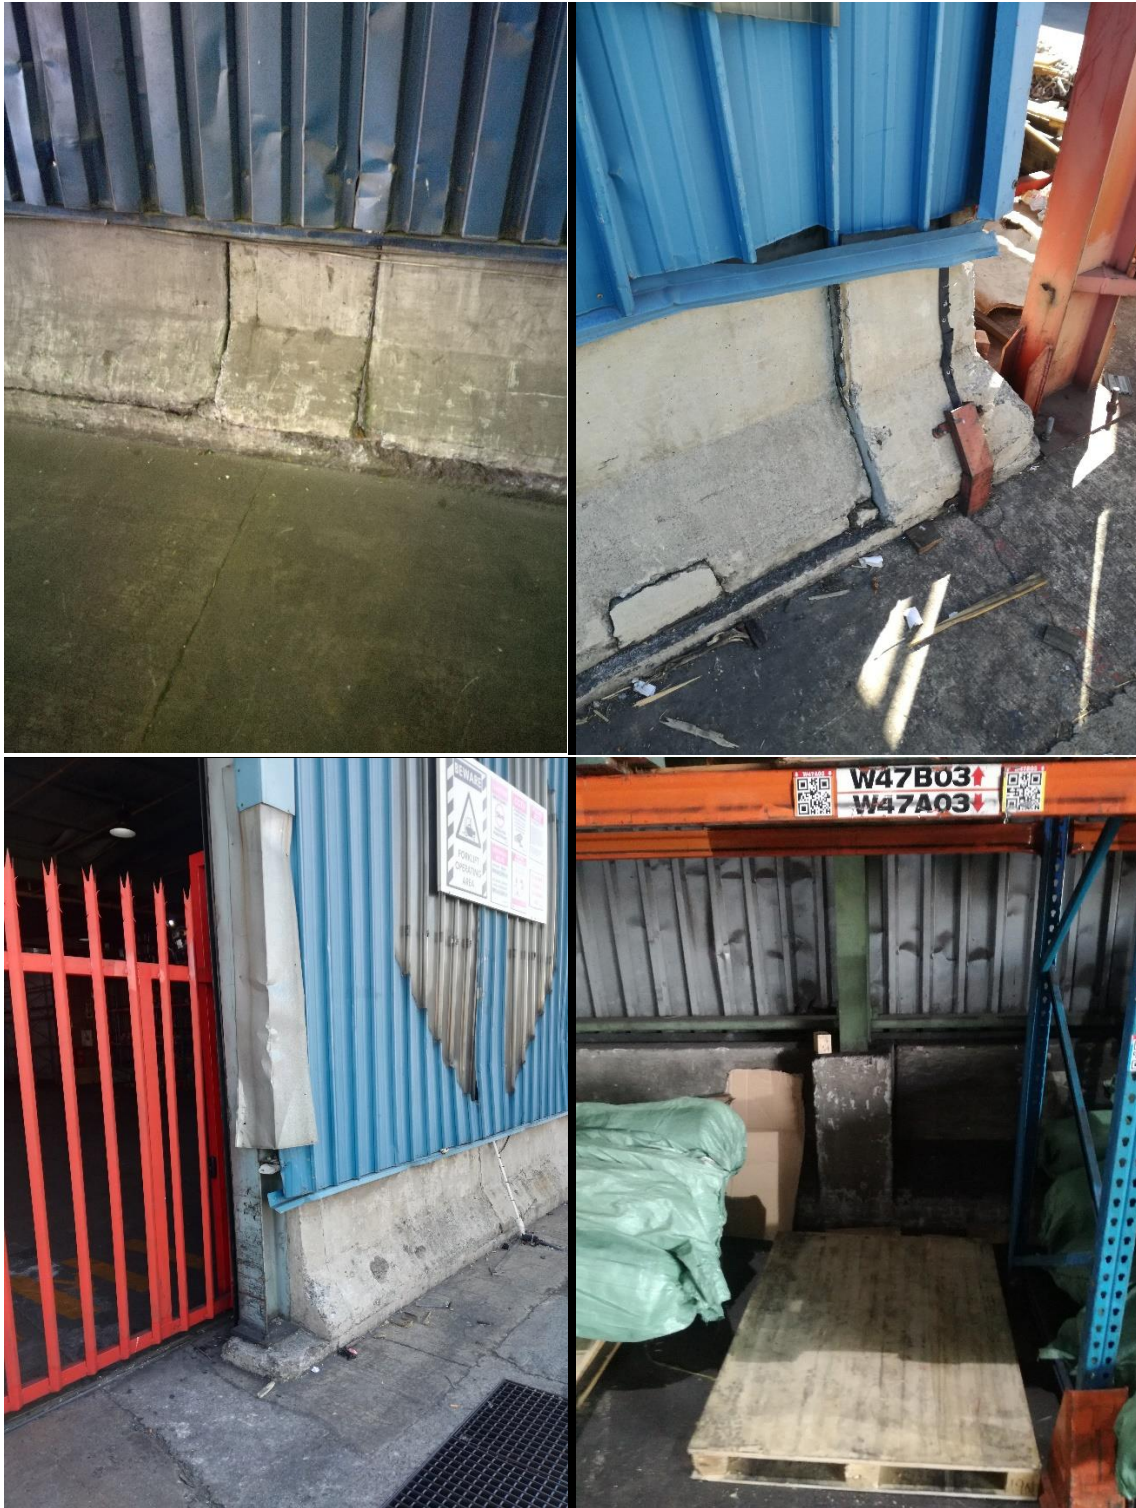
- **Remedial:** It is suggested that the barriers can either be repaired (refer to defect D1) or be replaced, where the barrier have excessive damage (less than 10% of the time)
- As part of the extension, steel frames with purlins spanning between steel columns are also provided. Some of the purlins are damaged. Only 15% of the purlins are estimated to have damage and only the first two purlins are influenced. Total length of purlin influenced is then 140m (included are 30m on the airside of the building).
 - **Remedial:** Only option is to replace the purlins when damaged.

Figure 17 Examples of concrete barrier and purlin damage

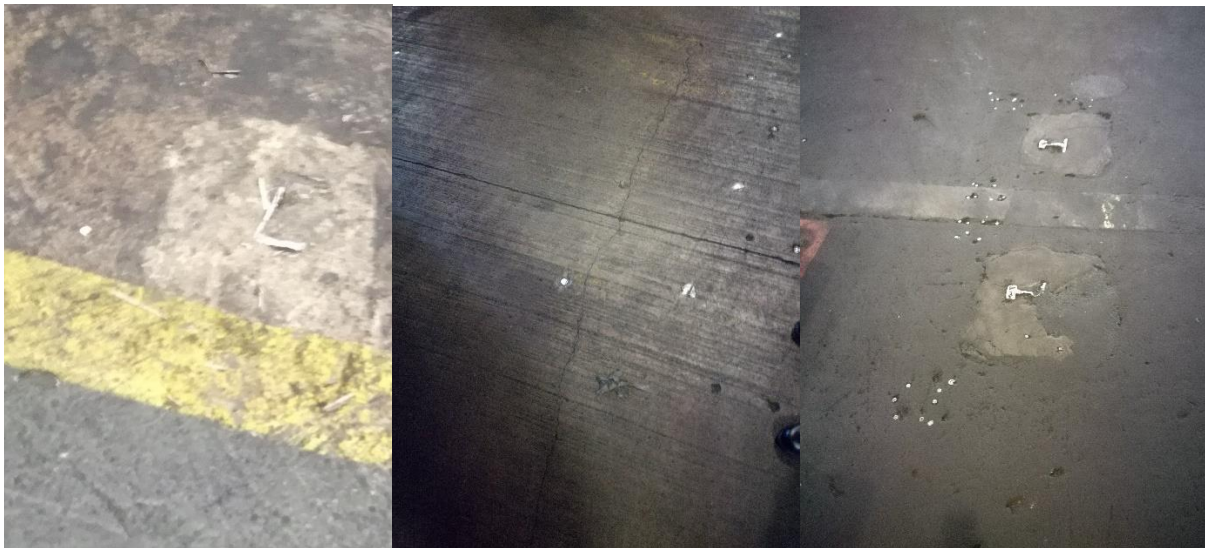
- Tenants for warehouses may change over time, when a tenant leaves a warehouse they would usually remove the racks or internal structures erected by themselves. Often the tenant leaves the warehouse with steelwork exposed to the surface. The steelwork (rails in some cases) damages the forklifts tires. The steelwork induces weak spots in the concrete around it.
 - **Remedial:** The concrete should be broken out around the steel. The steel should be cut below the concrete slab thickness or removed completely. Concrete should be reinstated or patched with structural repair mortar.

Figure 18 Exposed steel in concrete floors

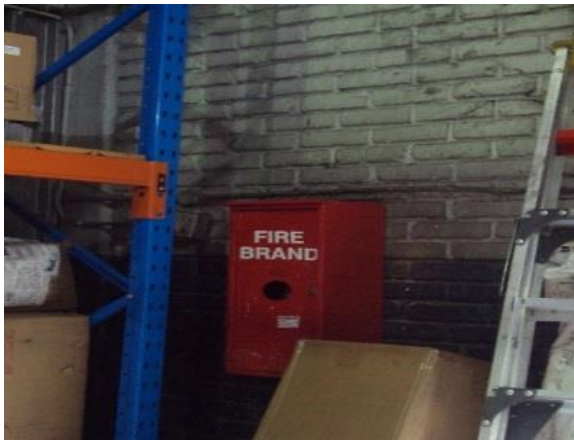
- Fire extinguisher is missing
- Signages and notices are missing

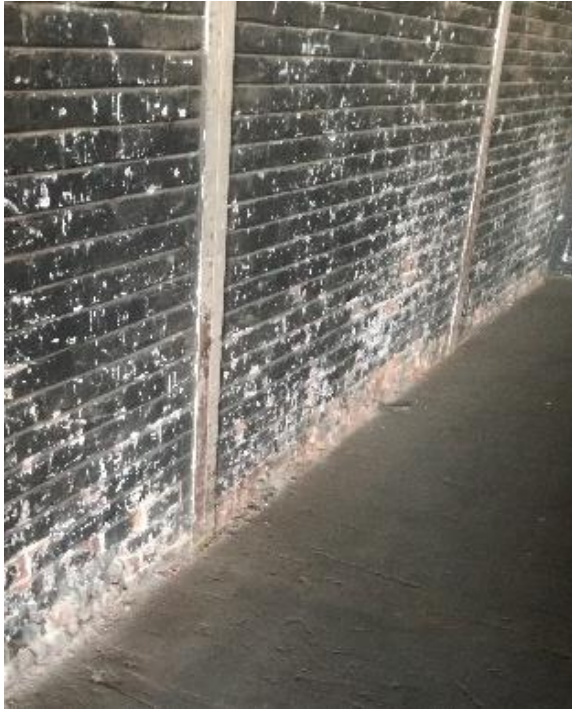
- Steel columns are used in some areas to provide lateral support for brickwork. The steel columns are subjected to collisions by the forklifts. There is limited damage to these columns but remedial work will be required.
 - Remedial:** Where a flange has deformed, the flange should be spliced by welding extra steel plates across the deformed section. The loads can then be transferred across the weak deformed section.

Figure 19 Deformed steel columns

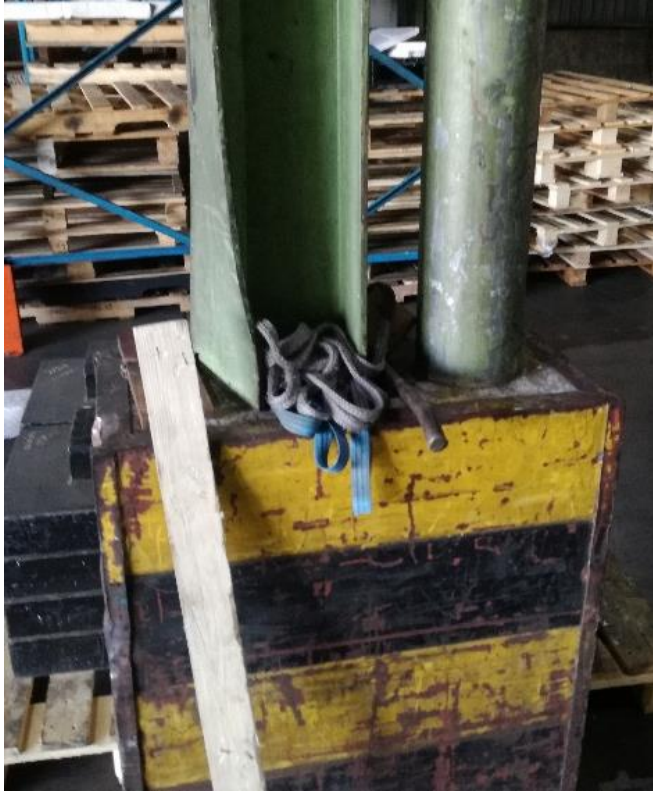
- Between Warehouse 31 and 32 a column was constructed to support the roof at the airside extension. This column has a concrete block cast around it to serve as protection against collisions. There is however one column (see image below) that has been struck by a forklift just above the concrete block. The flange has sheared off on the one side which lowers the strength capacity of the column.
 - Remedial option:** The flange must be bent back to its original position, can be achieved by a hammer. The steel should then be welded to the baseplate in its original position.

Figure 20 Sheared steel column flange

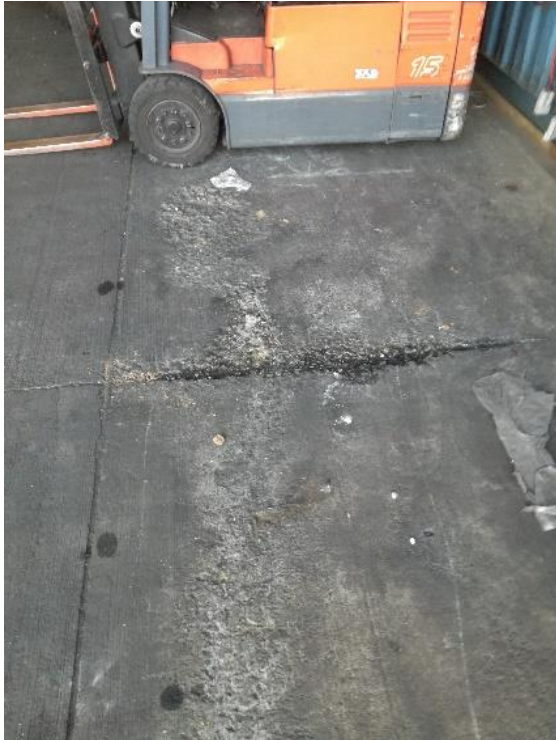
- Forklifts can either be electrical or fuel driven. At warehouse 38 a charging area is allocated for the forklifts to charge the forklift batteries. Some of the forklifts have been leaking battery acid on to the concrete surface bed at the charging bays. The chemical composition of the concrete has changed and the concrete has been damaged in the process.
 - **Remedial:** The concrete should be replaced (refer to defect D3) and tenants must follow environmental legislation rules and regulations in disposing of the concrete rubble.

Figure 21 Battery leakage on concrete floor

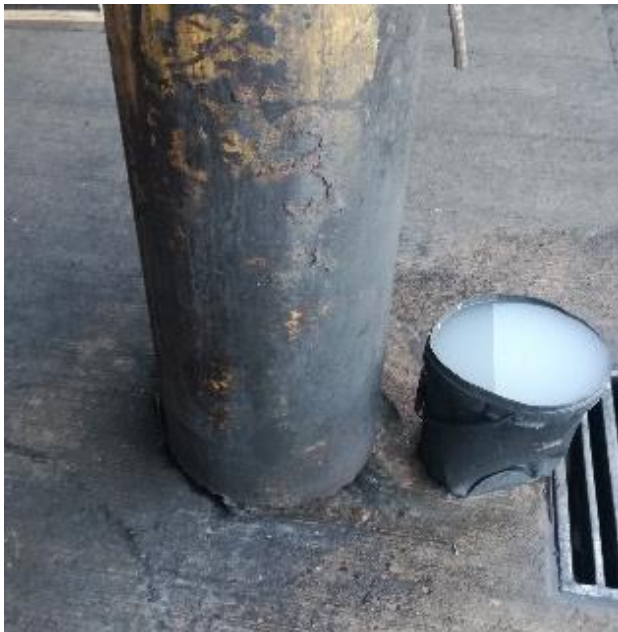
Figure 21 Loose concrete column

- **Remedial:** The steel column has to be temporarily supported by beams. The surface bed should then be broken out to expose the foundation and layer works should be excavated out up to the top of base level. The concrete portion of the column can then be demolished and a new column should be cast up to the steel column level. Reinforcement for the new column should be doveled directly in to the concrete footing. Temporary supports are removed once the concrete have set to the designed strength.

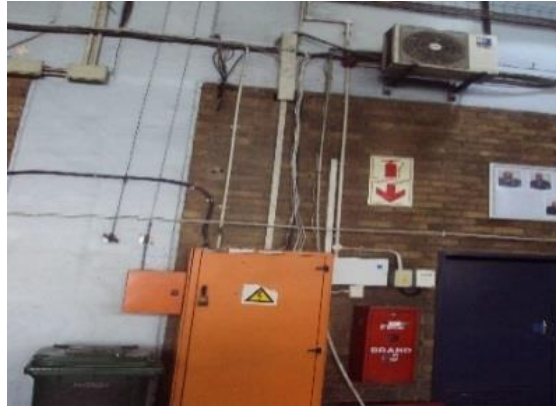
- Fire extinguisher is missing
